**PROCESSIONAL WAY, ELY
CATHEDRAL, ELY,
CAMBRIDGESHIRE**

**AN ARCHAEOLOGICAL
EXCAVATION AND WATCHING
BRIEF**

PCA REPORT NO: R13373

AUGUST 2018

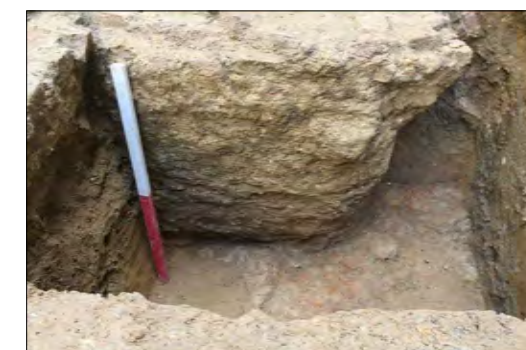
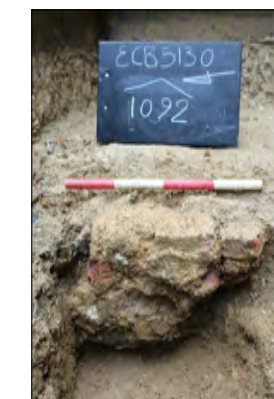
Figure 7
Phase 2 plan of site showing medieval Checker building foundations
Plan 1:50; Elevations 1:25 at A3

- 6.3.3 Foundation [1059] (Figure 7, Elevation 1, Plates 7) appears to have been constructed by digging a hole down to the level of the hard natural greensand

- 6.3.4 Foundation [1092] (Figure 7, Elevation 2, Plates 9 & 10) appeared much less substantial than [1059], apparently only extending to a depth of 0.25m, though it was of similar construction, comprising yellow sandy mortar incorporating brick rubble and greensand fragments, with a single course of red bricks on top. The bricks and mortar were identical to those used in Foundation [1059]. As this foundation was only observed in the watching brief, its overall size and form are not well understood although there is some indication that its base was reached in the shallow slot monitored for the retaining wall (Plate 10; ground reduced to 19.69m OD only), the foundation could just as well have been flaring outwards towards its top, and continued downwards and slightly eastwards to the rear of the exposed elevation. There is also a slight hint of the beginning of an archway on the south side of the feature, though only apparent from the curvature of the mortar and rubble rather than there being angled brick courses, as in Foundation [1059]. Foundation [1092] cut the east end of Grave [1087].

- 6.3.13 Foundations [1059] and [1092] exactly match the positions in plan of the two

east-west brick and stone walls recorded by Dixon. They were also encountered at a similar level (20.22m and 20.19m OD, respectively) and, in the case of [1059], it was also constructed on the greensand bedrock. The shallow depth of [1092] is slightly problematic as the wall recorded by Dixon of which it appears to be a continuation was also founded on bedrock, and survived to just under a metre high. However, as discussed above, Foundation [1092] was only seen in a watching brief and may well not have been fully exposed. On the basis of its location, level, and apparent contiguity with the northern wall in the 2000 trench, [1092] can probably be equated with it.

- 6.3.14 The overall ground plan of the building foundations is not absolutely clear. However, the form of Foundations [1059] and [1092], particularly the probable presence of an archway extending south from the former, suggest that they are more likely to be piers within a north-south-aligned wall rather than the west ends of parallel west to east walls. Of course, this does not necessarily preclude the presence of an adjoining set of east-west walls. Overall size of foundations - see plan.

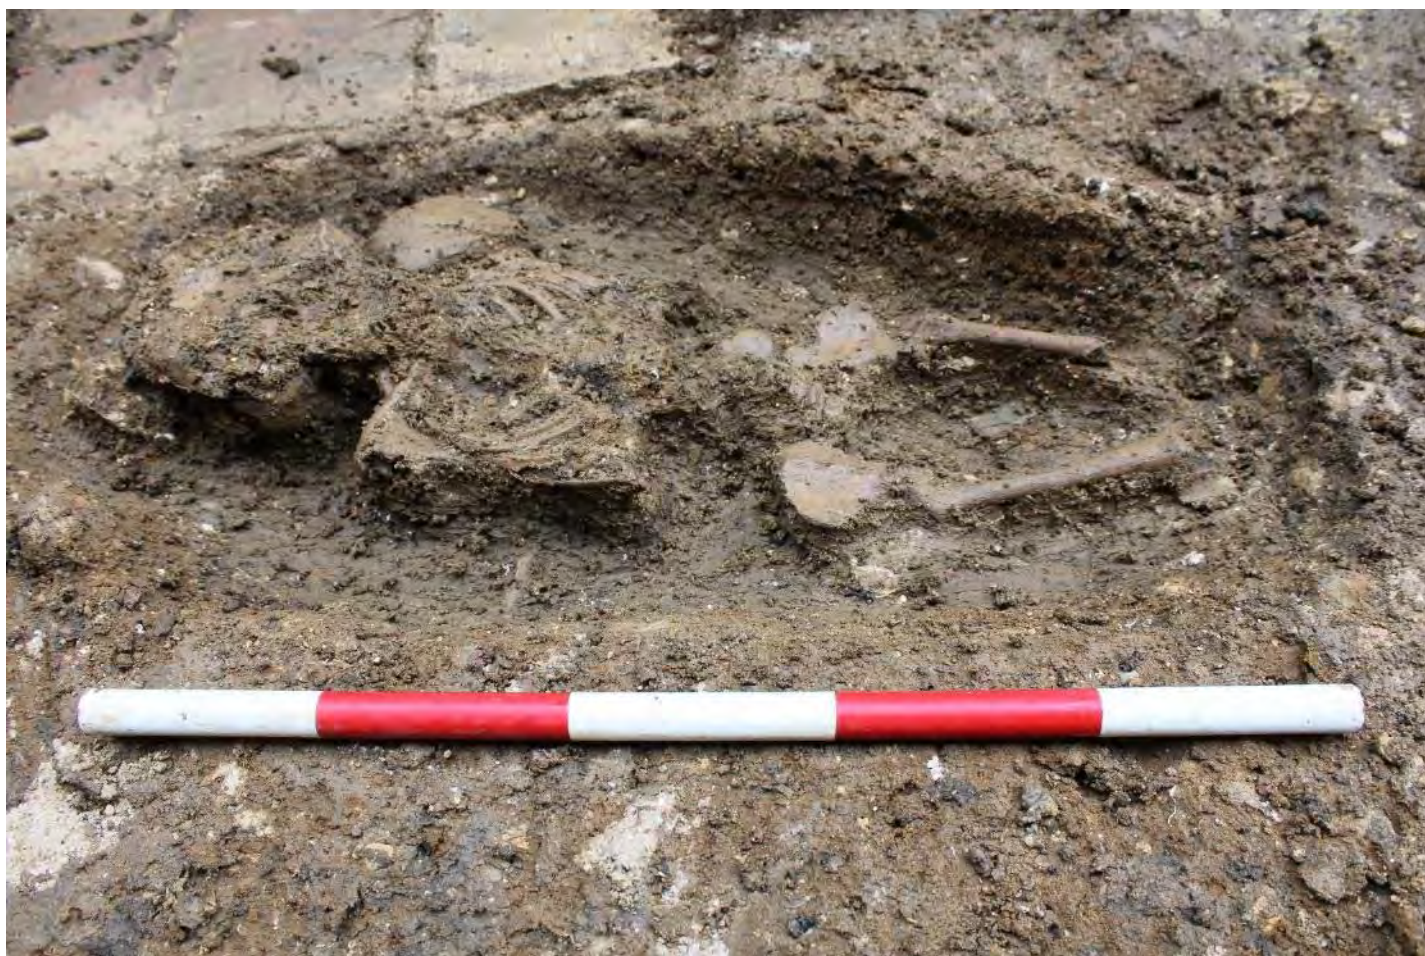
Plate 3: Grave [1042] with Sk.1043, view north

- 6.2.5 In the south-west corner of the site, Grave [1042] was cut into Layer (1030) from a level of 20.04m OD (Figures 5 & 6; Plate 3). This shallow grave (depth: 0.06m) contained SK1043, an infant skeleton in an extended, supine position, with the head at the western end of the grave. The grave fill (1041) contained SF5, a small medieval copper alloy buckle fitting, found at a level of 19.98m OD next to the right shoulder of the skeleton (AD 1350-1450; see Beveridge, Section 7.4), in addition to two small sherds (2g) of late Saxon to early medieval Thetford ware and St. Neots ware pottery (c. AD 875-1100) (see Jarrett, Section 7.1). This grave had suffered truncation from Construction Cut [1034], most likely associated with the installation of the 18th-century drain (see below), resulting in the lower legs and feet being absent.

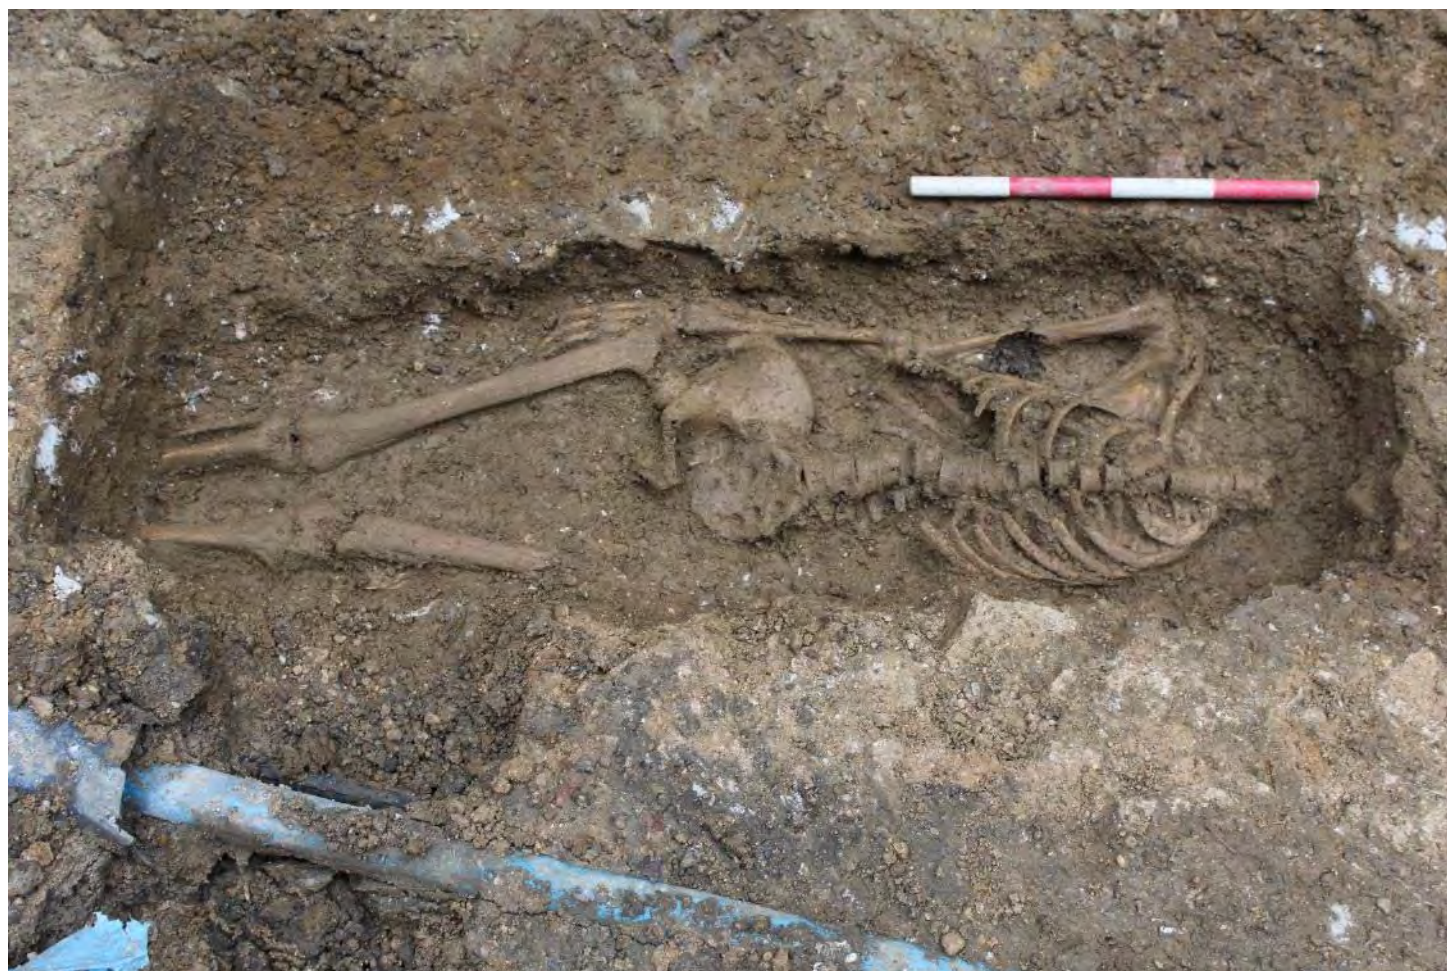
Plate 6: Grave [1087] with Sk.1088 and modern services to north, view south

- 6.2.8 In the north-eastern corner of site, Grave [1087] was cut into patches of Layers (1071) and (1069) from a level of 19.94m OD (Figures 5 & 6; Plate 6). This grave (depth: 0.18m) contained SK1088, a middle-mature adult female in an extended supine position, on a west-east orientation. This individual appeared to have suffered truncation from unknown sources later in the stratigraphic sequence, with the absence of the skull and a modern marquee peg damaging her right humerus. Feature [1090] truncated this grave to the north, while the potential Checker building foundations [1092] truncated the individual's lower legs.

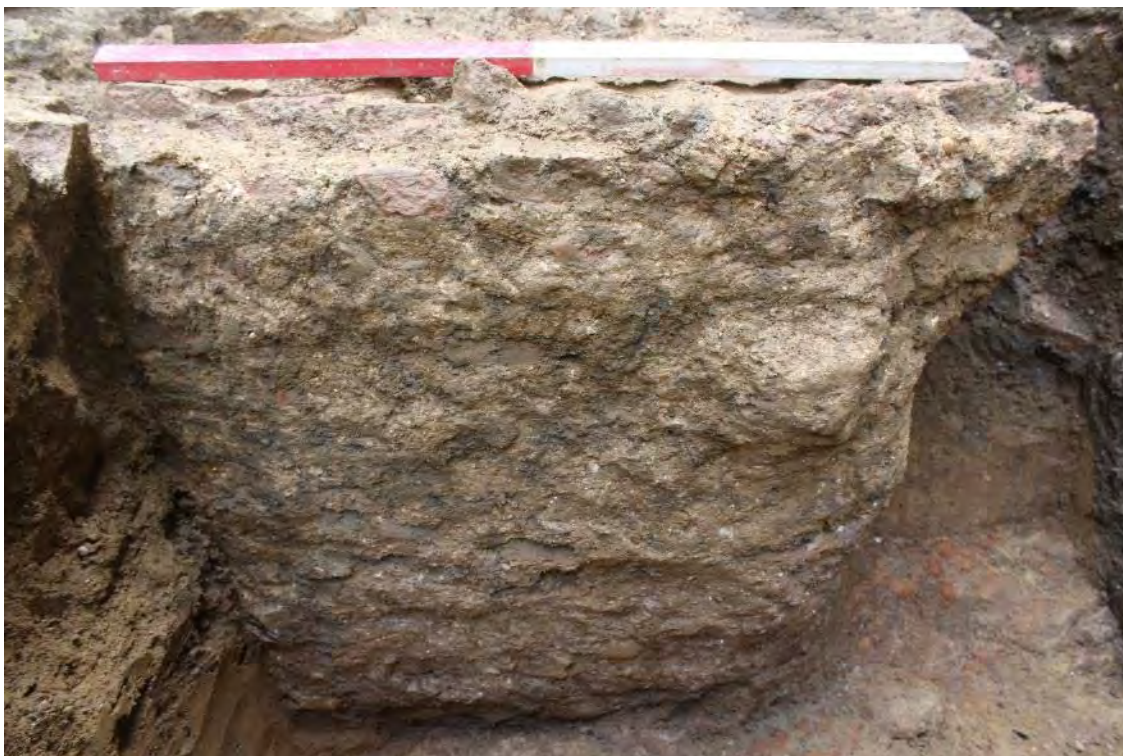
Plate 7: West-facing elevation of Foundation [1059]

bedrock (19.20m OD) and then building a structural pier by filling the hole with successive layers of yellowish sandy mortar, with occasional greensand and brick fragments included to provide additional strength. The resulting pier had dimensions of 1.4m long, 0.73m wide and 1.3m deep. At the top of the south side of the foundation, three partial courses of angled unfrogged red bricks set in mortar had the appearance of the beginning of an archway extending southwards from the pier. The bricks are of transitional late medieval/ early post-medieval manufacture (c. AD 1400-1600/1700); the mortar is in keeping with this date.

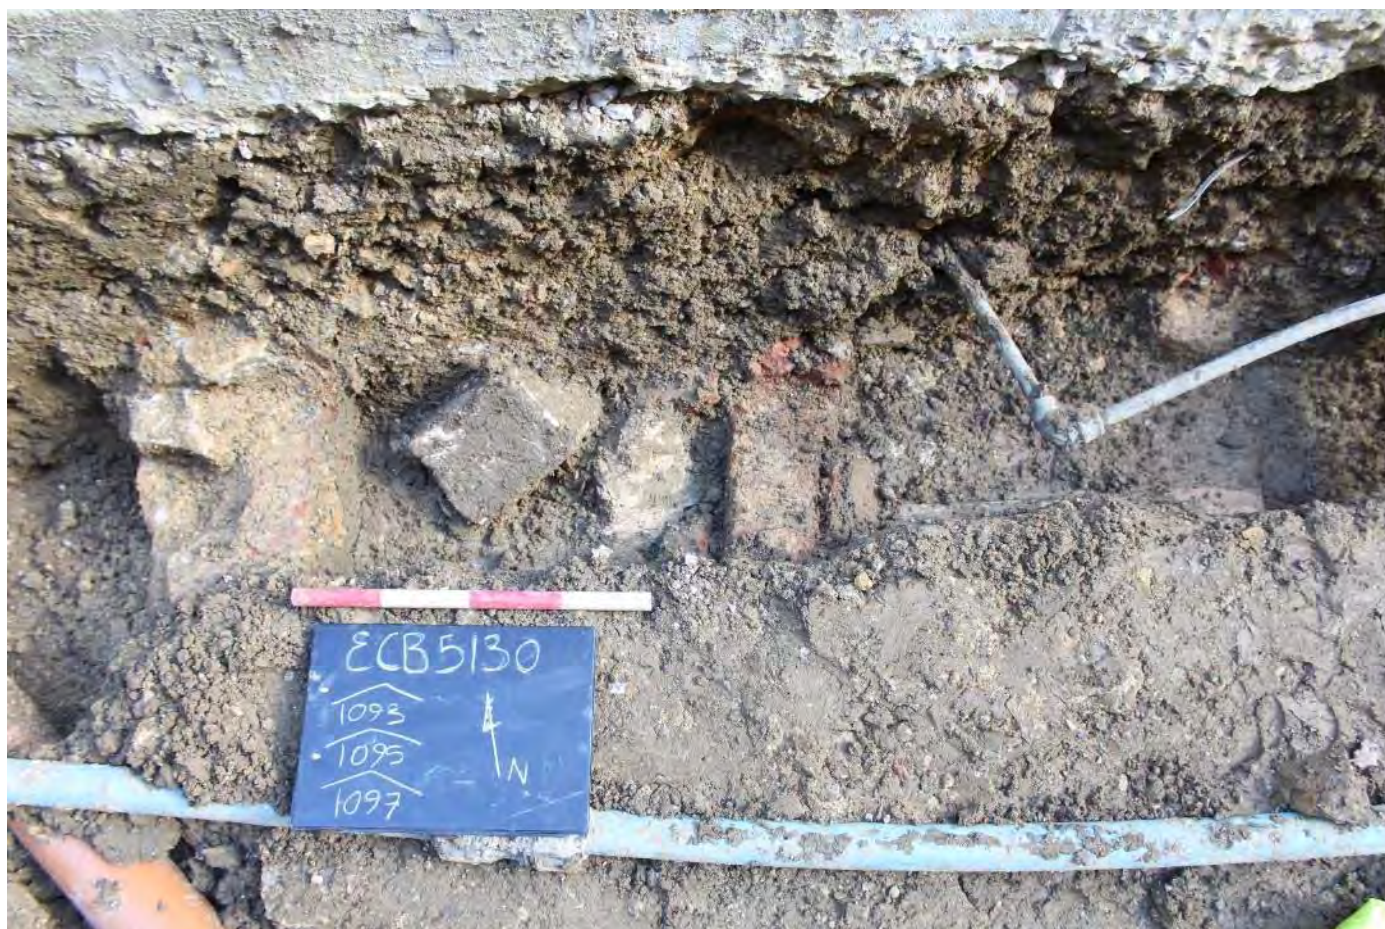
Plate 12: From left to right; Drains [1097], [1095], [1093] in watching brief trench, view north

- 6.5.14 The stratigraphic relationships between Drains [1093], [1095] and [1097] are not clear and probably represent repairs or replacements of parts of the same drainage channel over time. The unusually straight edge of Deposit (1105) indicates that it had been truncated by these drains and if this is the case these channels predate [1008] et al. (6.5.16 and Figure 11). The preservation of the small section of these three drains was made possible due to their location under a modern pipe, thus avoiding the levelling and horizontal truncation. Additionally, these drains and those located at the western end of site are both on the same level (20.02m OD). The likelihood is that these remains are dateable to the 18th Century and are undoubtedly related to drainage features recorded or referenced during the Processional Way (2000) excavations but no direct links could be made.

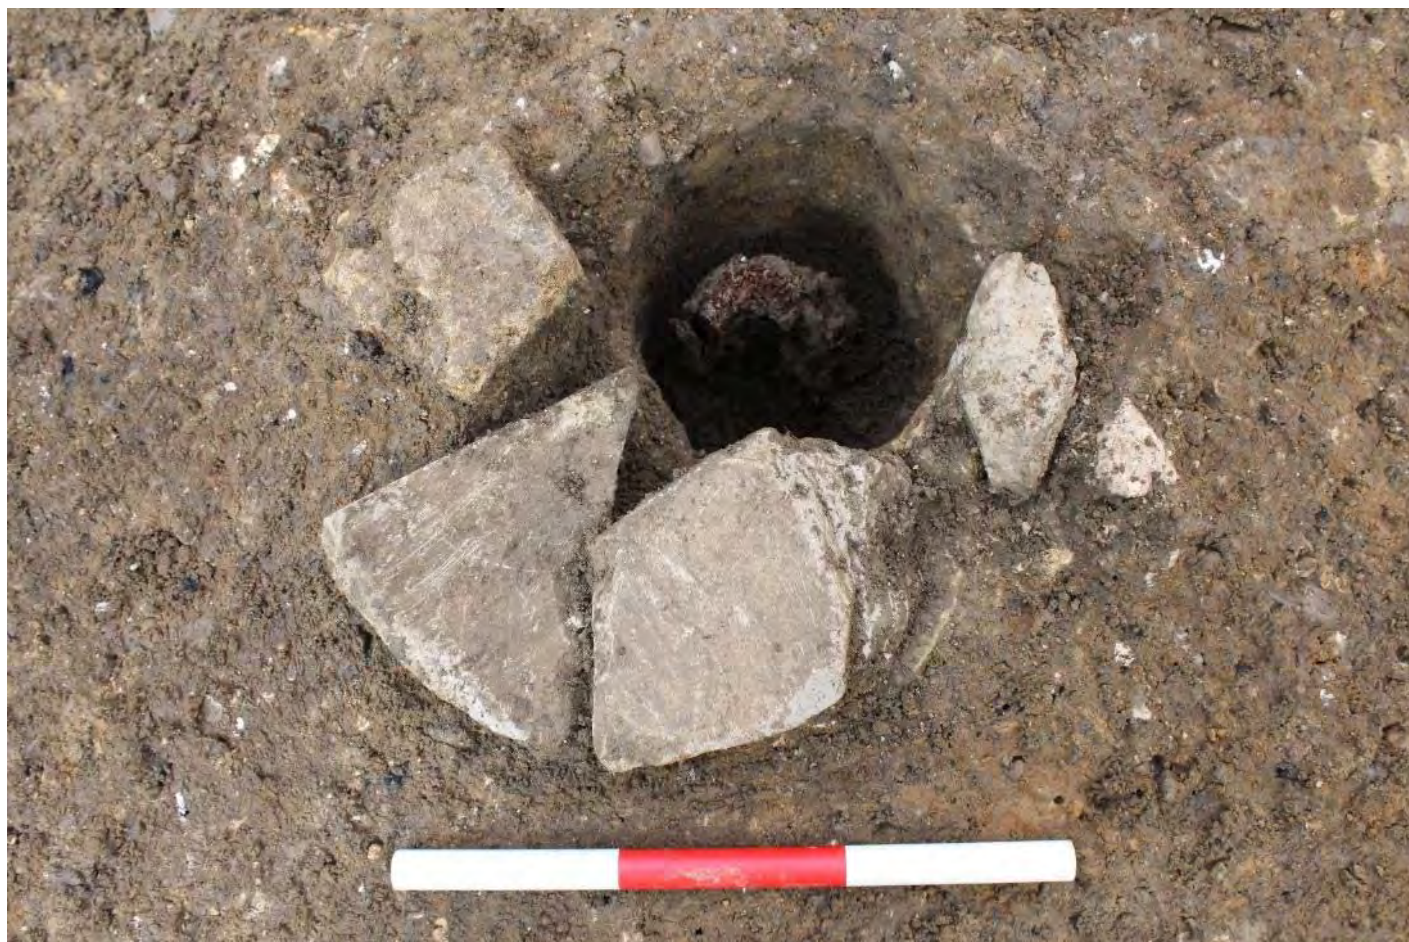
Plate 20: Posthole [1073] with post in situ, view south

6.6.1 Posthole [1073] was in the south-east corner of the site, truncating layer (1065) (Plate 20). This contained the well-preserved remains of a timber post, taken as Sample <1001>, and a loose dark silt fill (1074). This posthole is assigned to this late phase because of the preservation of the timber and the fact that it appears to be unrelated to any other earlier features in the vicinity. No other postholes were present. Several similar postholes were excavated at the adjacent Processional Way excavation (2000) and were identified as evidence of wooden lean-to buildings or scaffolding for repair work (Cessford and Dickens 2007).

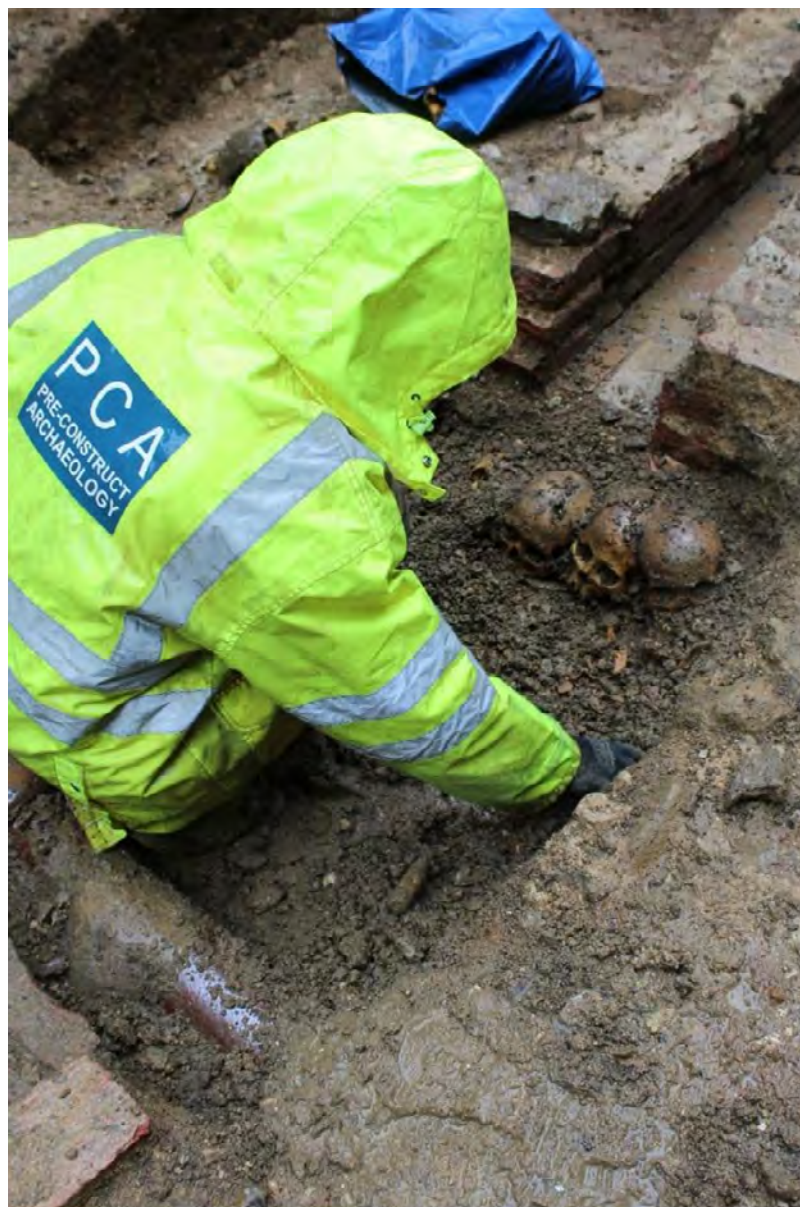
Plate 21: Modern charnel pit [1050] during excavation, Drain [1021] extending to the top right corner of the frame

- 6.7.4 A modern charnel pit ([1050], fill (1051)) was discovered and the contents exhumed (Plate 21). It was created following the CAU Processional Way excavation in AD 2000, in order to re-inter the human remains uncovered there. This rectangular pit was 1.20m long by 0.90m wide and 0.21m deep. It was inserted adjoining the north-south ceramic water pipe, further disturbing the 18th-century drain [1021]. The human remains had been reinterred and then the disturbed bricks from the drain were loosely laid back on top of the infilled pit, creating rubble pile (1020).
