**HISTORIC BUILDING RECORDING
AND WATCHING BRIEF
ON THE REPAIR (PHASE II) OF THE
FLAMSTEED TURRET STEPS
IN THE WHITE TOWER,
HM TOWER OF LONDON,
LONDON BOROUGH OF TOWER
HAMLETS**

PCA REPORT NO: R13279

JULY 2018

Site Code: TOL169

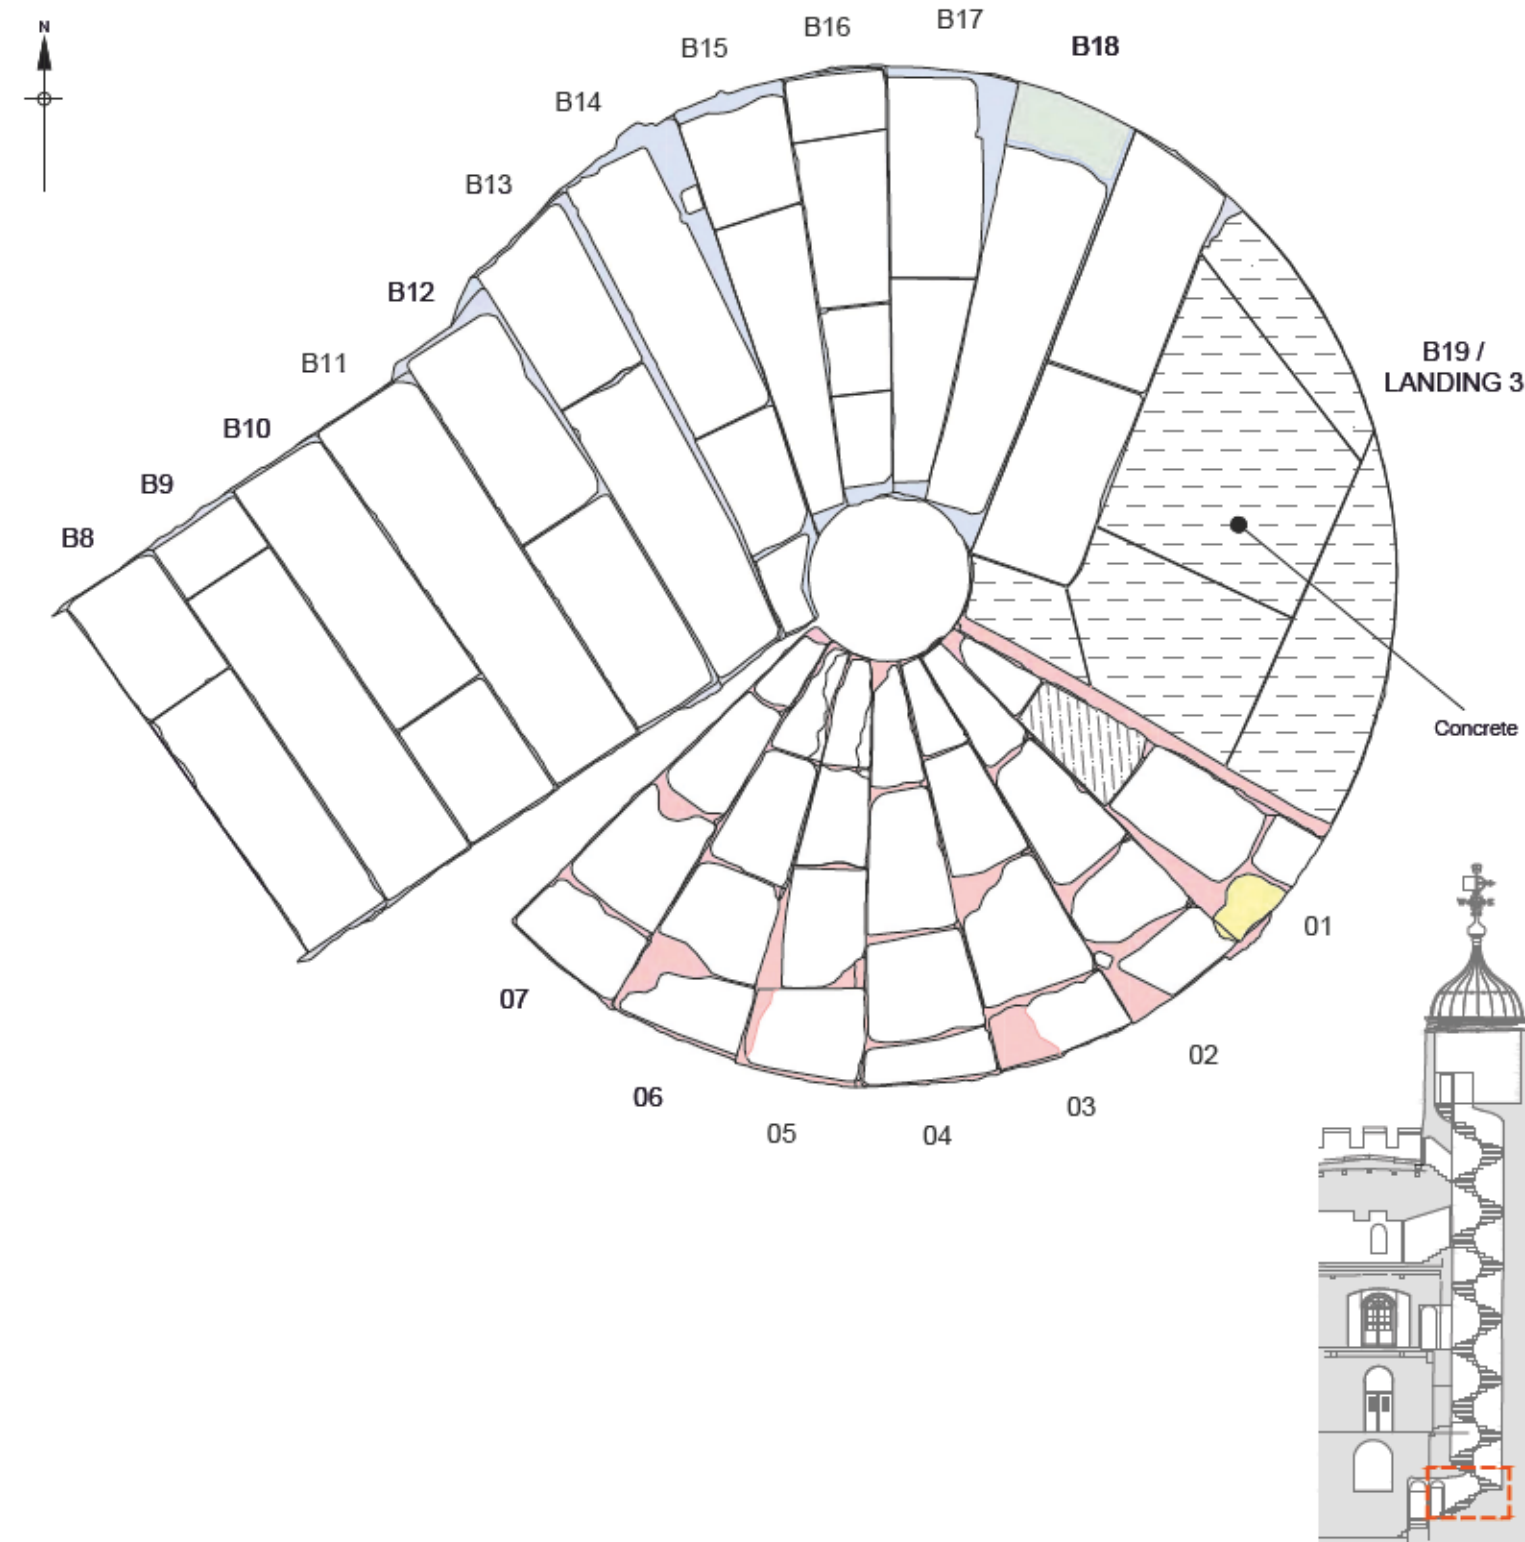
Figure 22
Plan and Elevations of Steps B8 to B19 (Landing 3) and 1 to 7: Mortar Types
with inset showing location of stairs
1:25 at A3

- 6.2.4 As a result, there has been minor stone step repair/replacement of the outermost paver of the lowest three steps using Ketton stone (Step 1), Reigate stone (Step 2), Caen stone (Step 3) (**Figure 21**; **Plate 65**). The mortar fill behind outermost paver of Step 1 consists of Roman cement, a mortar type patented only after the mid-19th century (Mortar T4), which would provide an indication of the date of these minor repairs (**Figure 22**).

(**Figures 22 and 24; Plate 72**). It seems likely that any axe marks would have been removed or worn away by wear and tear given that malmstone is a relatively soft material, unlike the better quality harder limestone materials that was used just before and after the building break, which has well preserved markings (**Figures 29 and 30; Plates 48 and 49**).

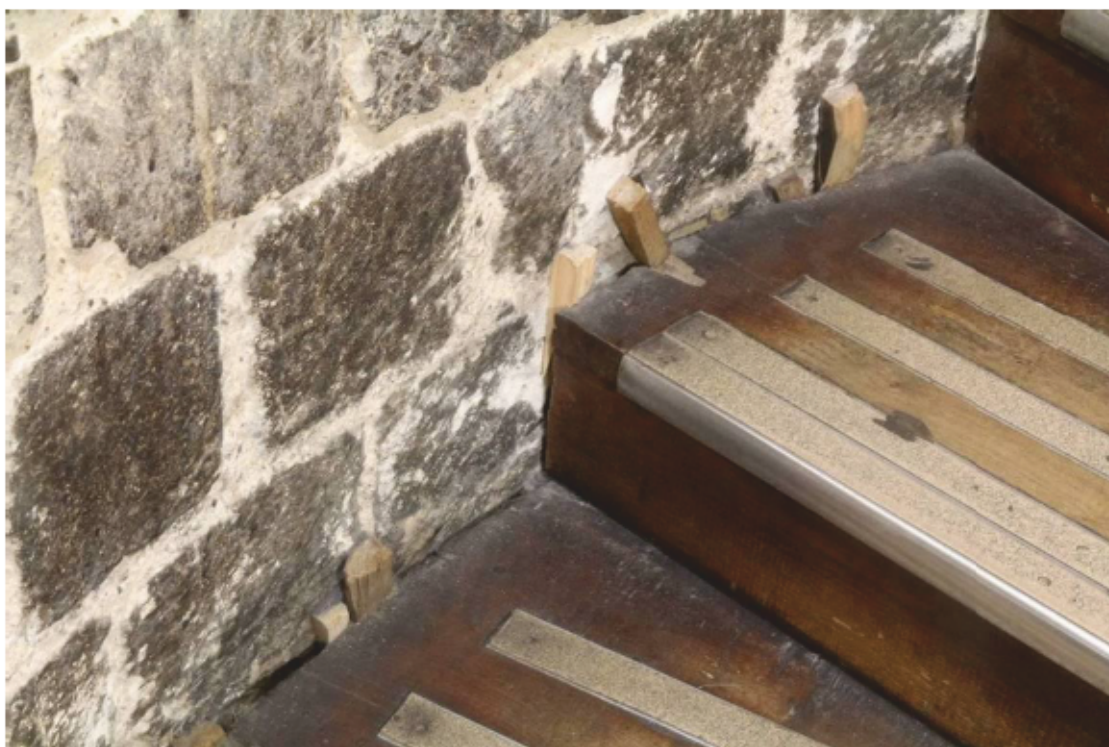
Plate 17: Softwood wedges showing some signs of damage to the walls of the Flamsteed Turret (Steps 12 and 13)

- 5.3.4 Softwood wedges had been hammered in at irregular intervals on both sides of the treads, beside the wall and newel (**Plates 16 and 17**). These wedges were added sometime after the timber staircase had been constructed to improve the structural tension of the timber treads, which were not keyed into the historic fabric of the turret. The movement of the timber treads due to the heavy footfall had caused the wedges to rub on the outer wall and newel of the turret (**Plates 17, 20 and 21**). No wedges had been used on Step 90 and above because these covers had been individually made to fit each stair in contrast to the same sized treads and risers used for the timber covers below.
