**BLOSSOM STREET,  
MANCHESTER M4 5AF**

**AN ASSESSMENT OF AN  
ARCHAEOLOGICAL EXCAVATION**

**SITE CODE: BLS17**

**PCA REPORT NO: R13312**

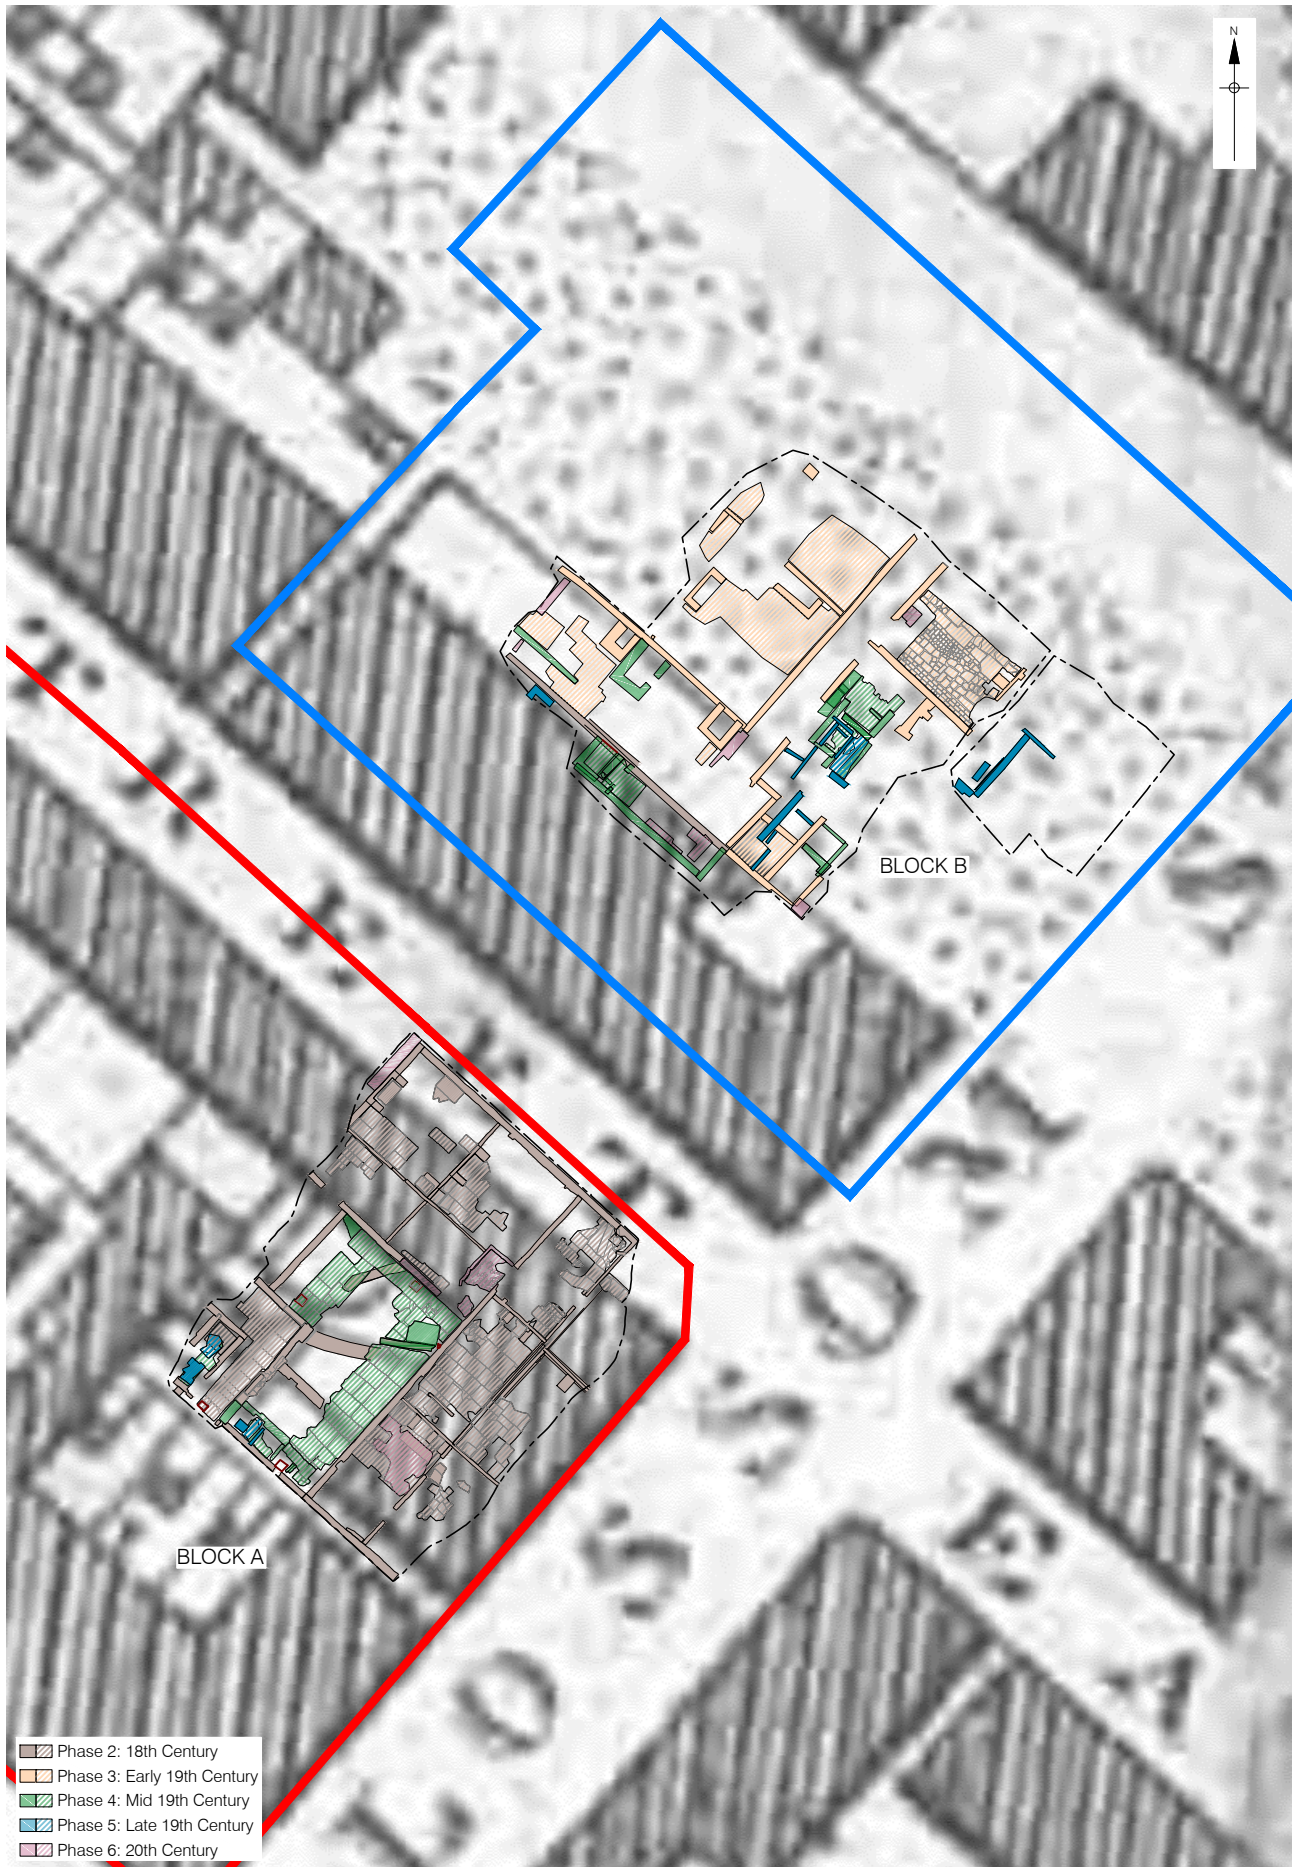
Figure 14  
Features overlain on an extract of William Green's Plan of Manchester and Salford, 1794  
1:250 at A4

- 7.3.10 The 1794 Green Map (Figure 14) shows a small outbuilding separated from the rear yards of the terraces by the ginnel. The building was constructed of red unfrogged brick double skin walls [116], [117], [118], and [113], and was likely originally used as a privy. It had a red brick floor, [130], the top of which was recorded at a height of 48.98m OD. The backfill of this privy, [129], was a 0.50m thick loosely compacted dark grey/black clay silt, containing hearth waste. A near complete cat skeleton was recovered from the top of this context, as was late 18th-19th-century pottery (Appendices 2 and 7). A small red brick wall fragment, [112], abutted the south-west face of wall [113], continuing into the limit of excavation; two skins thick, the wall was bound by a mid grey lime mortar and measured 0.40m in length.

7.3.13 Buildings fronting Gun Street on Block B are also visible on the 1794 Green map (Figure 14), however, the majority of these structures were outside of the excavation area and only the rear boundary wall was exposed. The rear wall, [32]/[214], was two skins thick, and composed of red unfrosted brick measuring 230mm x 110mm x 70mm. It was at least 12 courses high, with English Garden Wall bonding and a light grey lime mortar. The wall was 9.7m in length and ran north-west to south-east across the site.

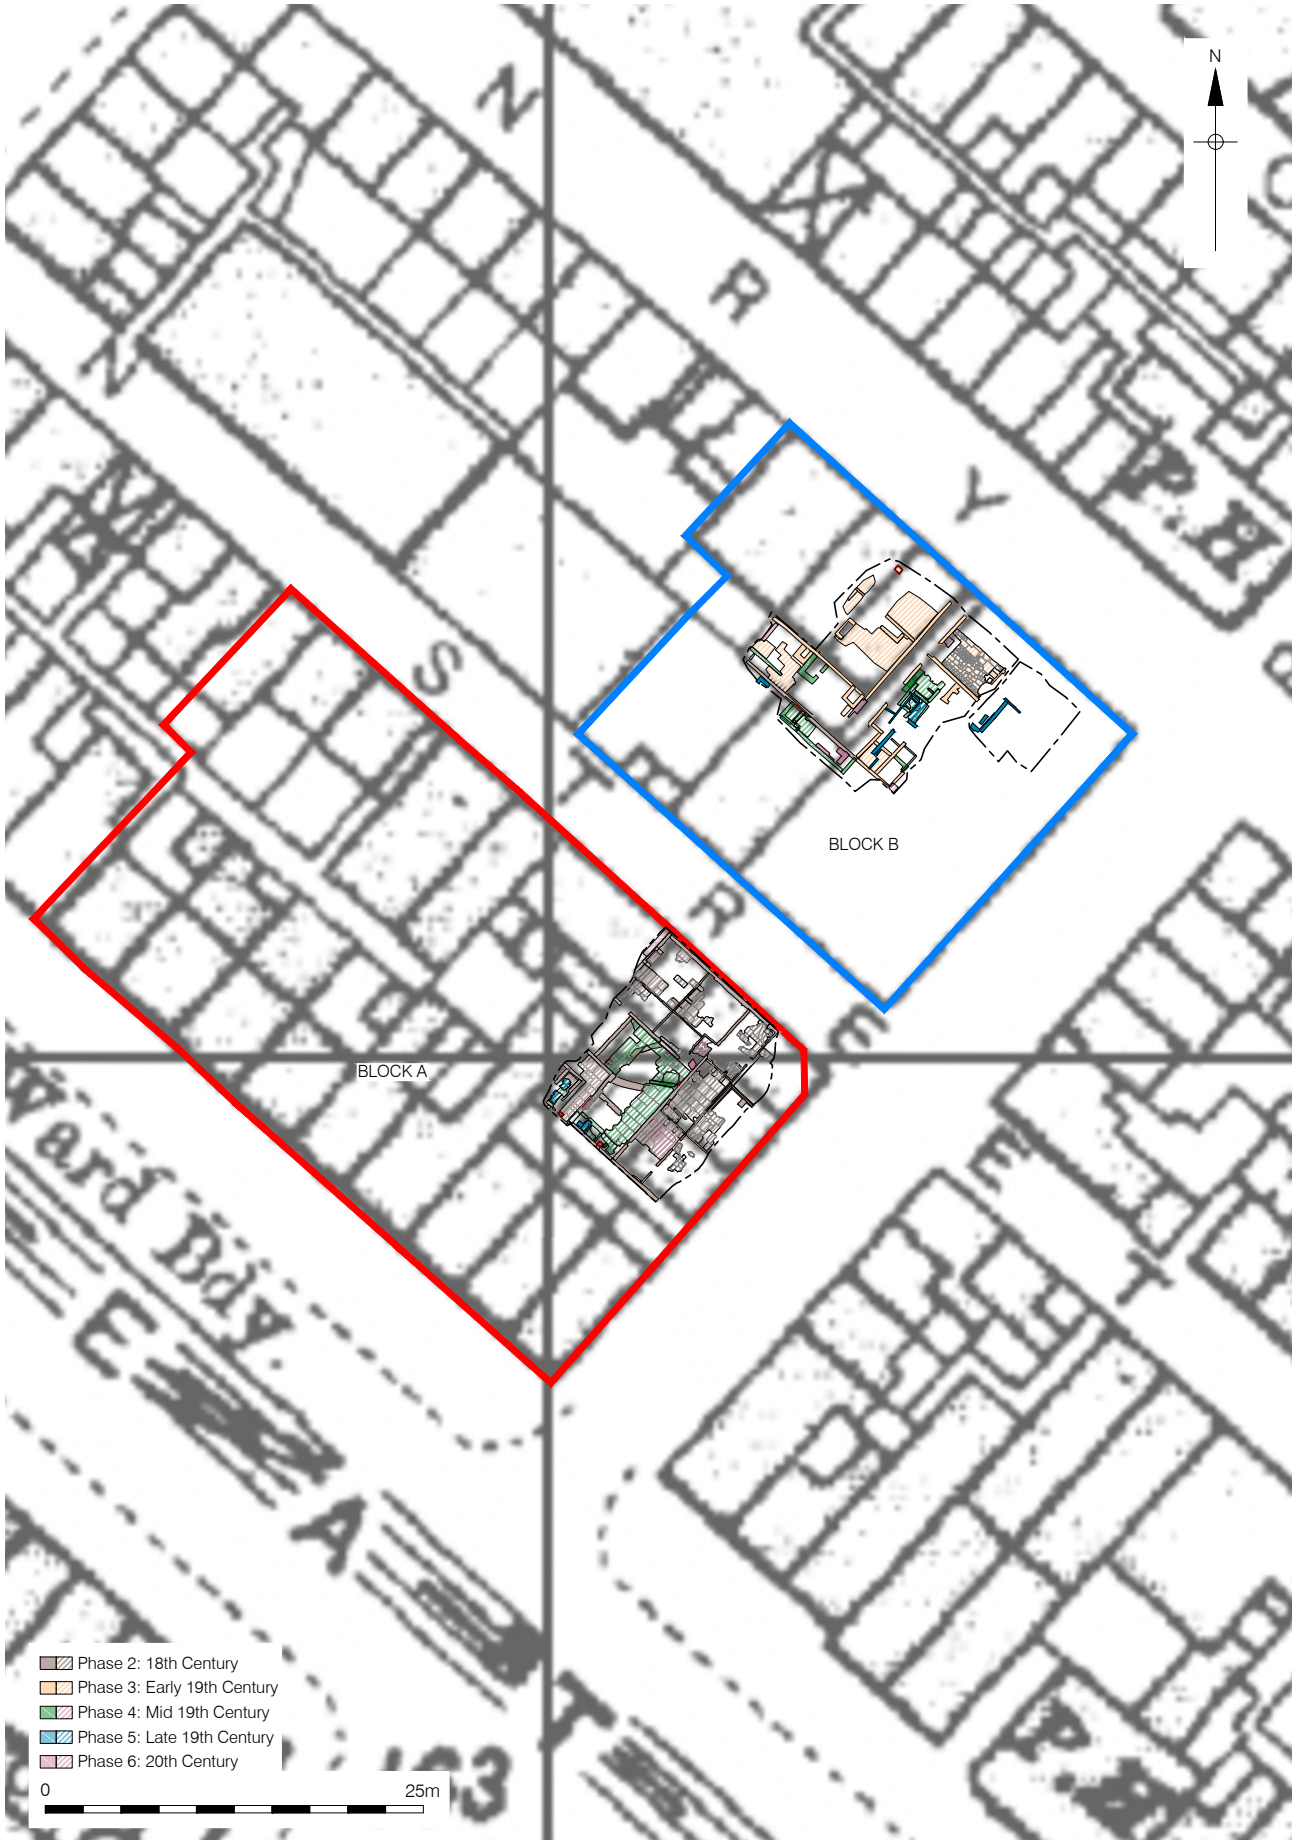
Figure 18  
 Features overlain onto 1908 Ordnance Survey  
 1:500 at A4

- 8.4.4 Between 1904 and 1908, the houses and yard buildings in the south-eastern half Block B were demolished; this is shown on the 1908 Ordnance Survey map (Figure 18). The back-to-backs to the north-west of the ginnel were knocked through to form longer houses, and yard walls were erected through what was previously Parker's Court. The buildings formerly fronting Gun Street were replaced with other structures, extending from Gun Street to the yard boundary wall. By the 1932 Ordnance Survey, a large warehouse building occupied the south-eastern half of the site; this is labelled on the 1943 Goad Fire Insurance Plan (not illustrated) as a two storey 'Vegetable Oil Warehouse', with a concrete floor (Plate 25). The 1943 Goad Fire Insurance Plan also shows that the houses along the north-western half of Block B had been demolished and replaced by a garage. At some point in the 20th century, stanchions surrounded by concrete had been placed across site; this was likely during the construction of the warehouse. These stanchions truncated parts of the earlier structures on site, with brickwork remaining between the concrete truncations.

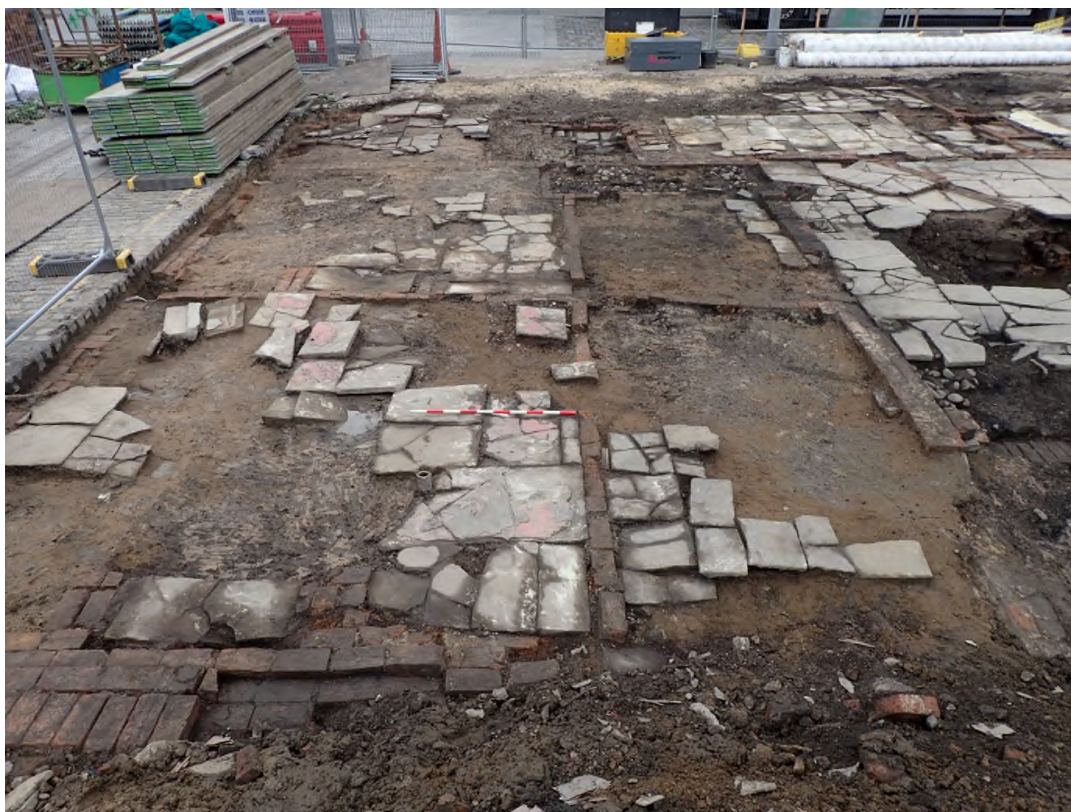
Plate 4: Floor [133] in No. 7 Blossom Street, looking south-east

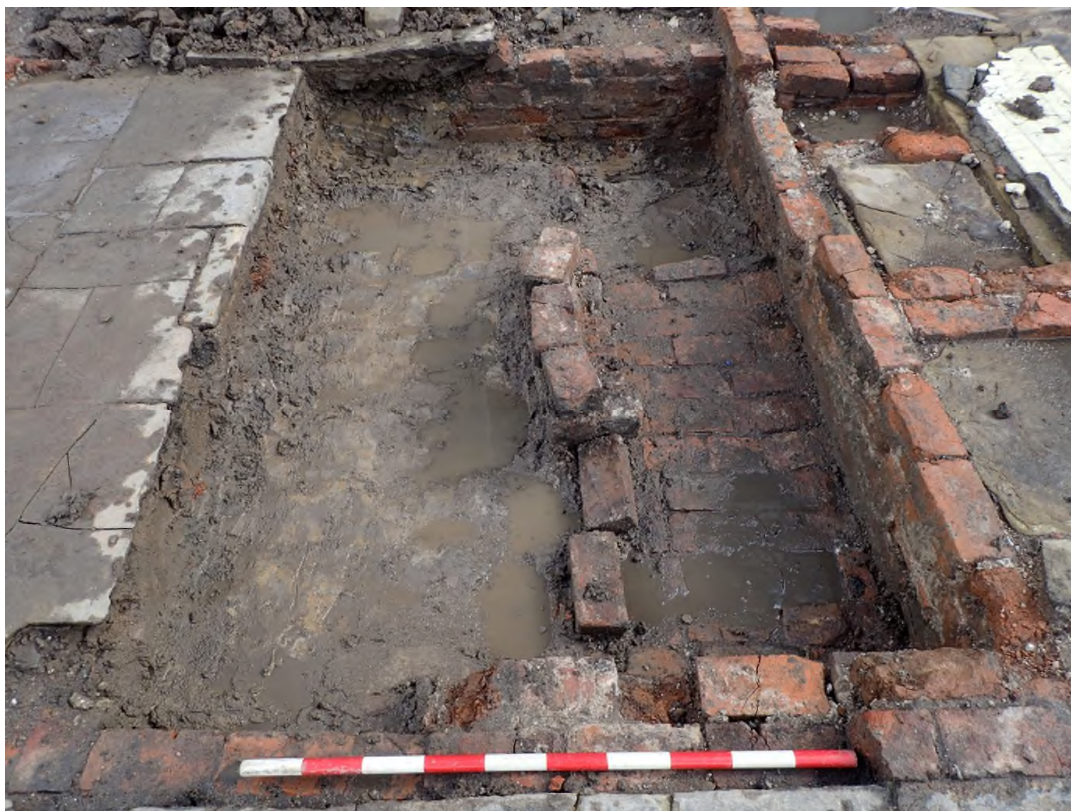
*Plate 5: Floor [78] in No. 9 Blossom Street, looking north-west*

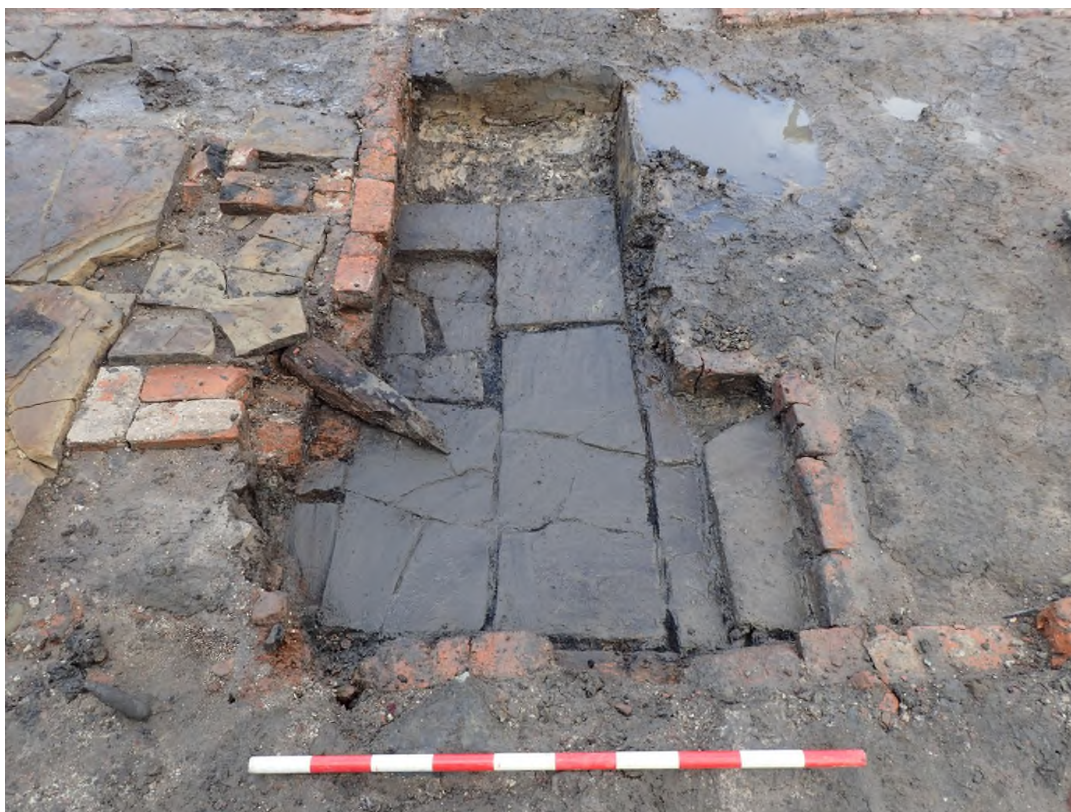
*Plate 6: Fireplace [145] in No. 9 Blossom Street, looking east*

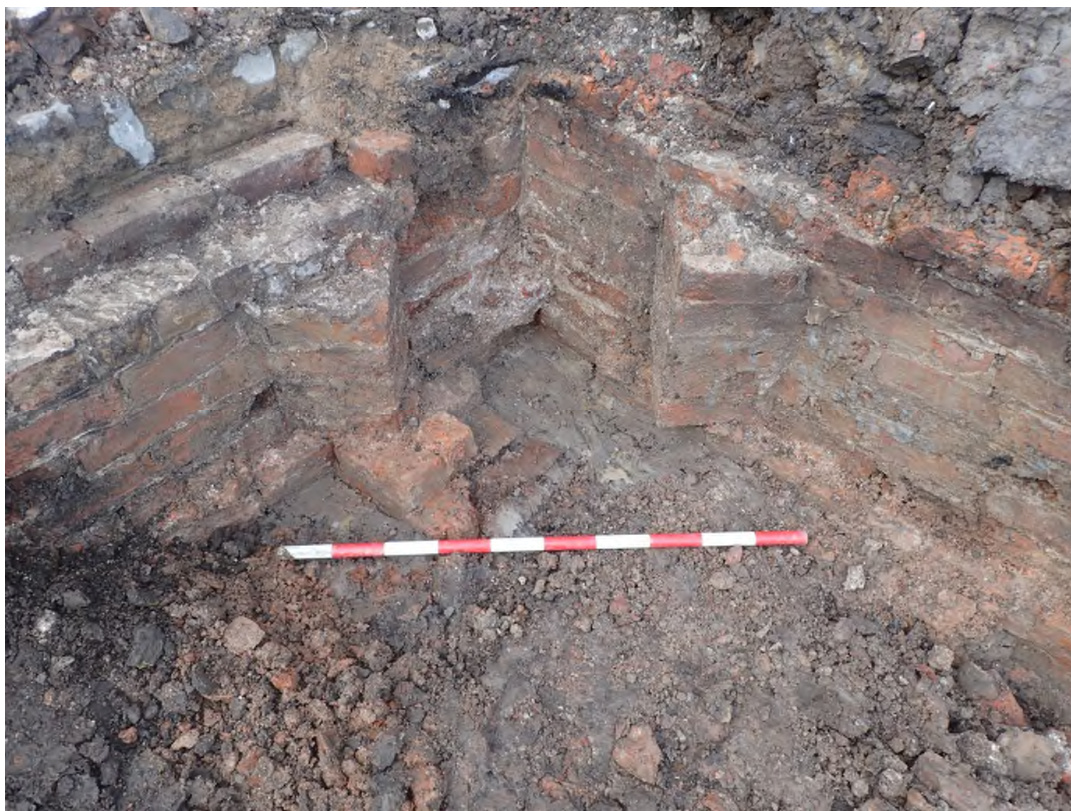
Plate 7: Yard buildings with threshold slab [111], looking south-east

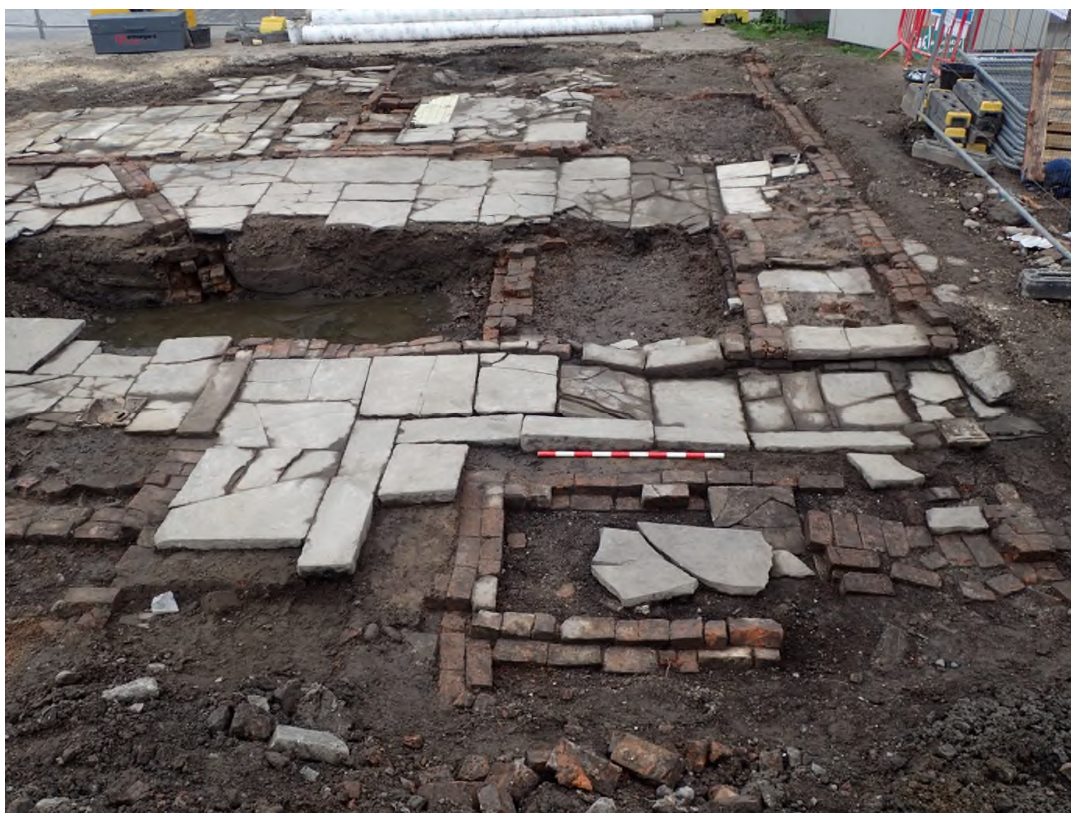
*Plate 9: 18th-century rear yard walls [22], [103], [121], and [115], looking east*

7.3.11 The yard boundary walls were composed of red unfrosted brick, with those that formed the rear terrace walls measuring two skins thick (Plate 9). The rear yard of No. 5 Blossom Street was a rectangle formed of walls [22], [68], [103], and [106], enclosing an area of 6.81m<sup>2</sup>. Wall [22] was three skins thick, extending north-west to south-east between walls [68] and [103], which were each two skins thick. These walls also formed the rear yard of No. 7 Blossom Street, along with east-west running wall [20]/[151]. An irregularly shaped yard, its area measured 11.25m<sup>2</sup>. Wall [20]/[151] was four skins thick, laid in a stretcher bond. Walls [20]/[151] and [68] were also part of the rear yard of No. 9 Blossom Street, which was additionally composed of walls [88], and [121]. Wall [121] was primarily laid in a stretcher bond, three skins thick. A layer of clay packing, [149], was recorded against walls [121] and [88].

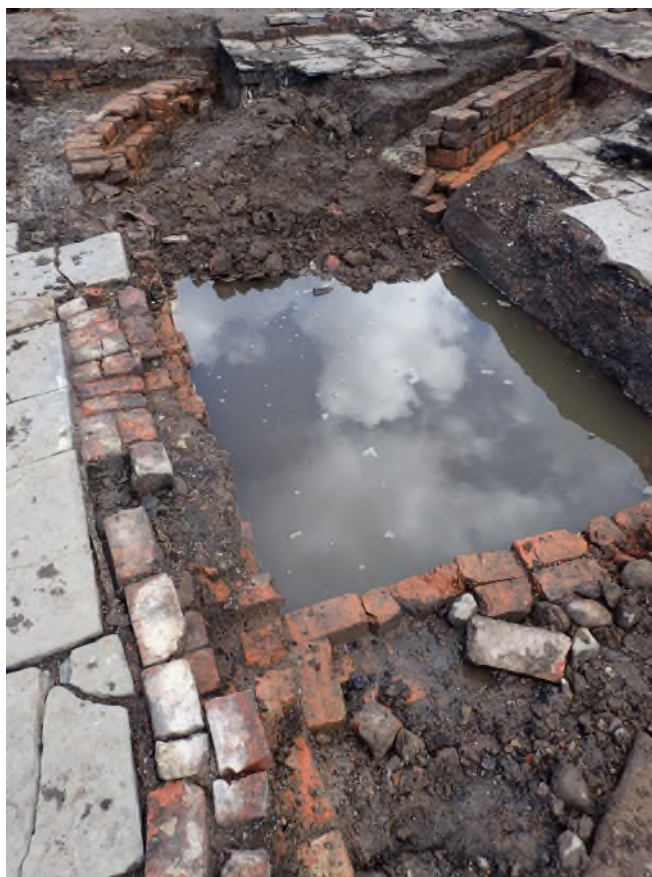
*Plate 10: 19th-century yard wall [98] overlying 18th century yard wall [151], looking west*

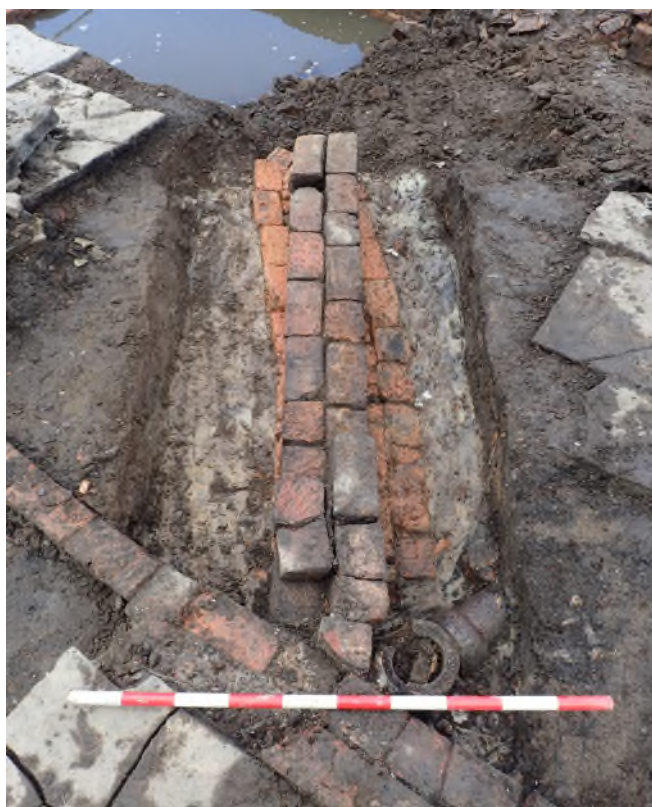
Plate 11: Slab [119] for 19th-century outbuilding, overlying surface [96] and abutting wall [98], looking south

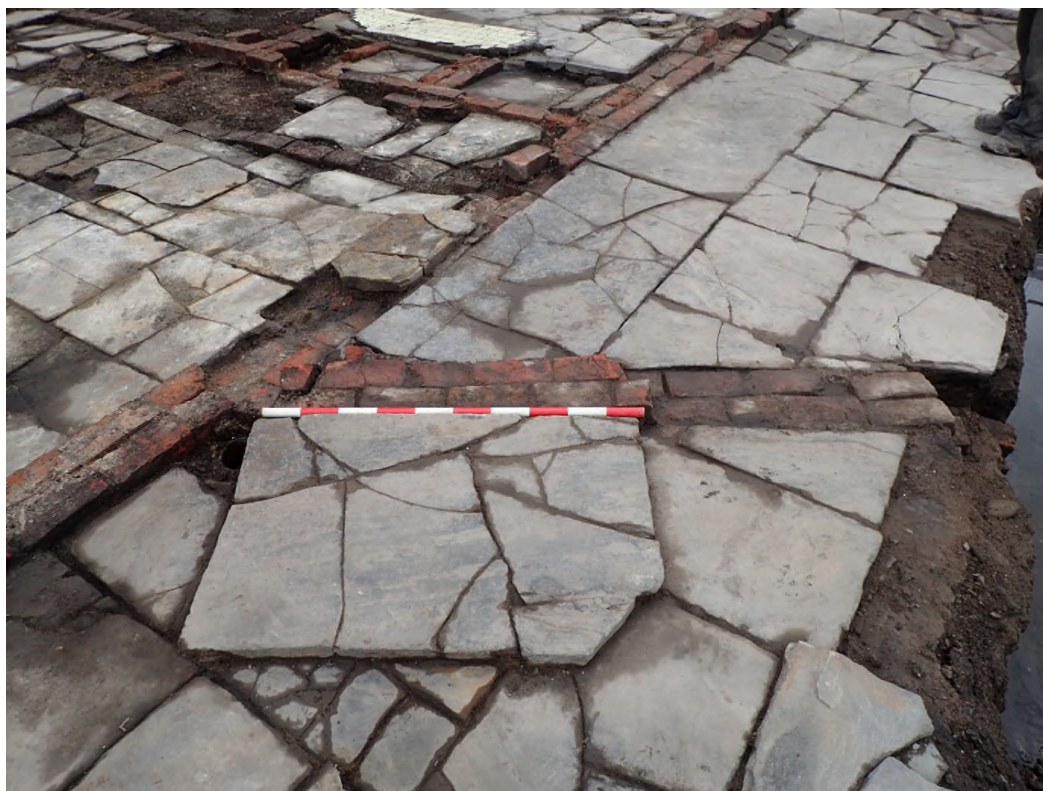
Plate 12: Outer hearth of fireplace [67], built into floor [69] for No. 5 Blossom Street, looking north-east

- 7.7.2 A secondary floor surface, [69], was observed in the rear room of No. 5 Blossom Street. This flagstone slab floor overlay the original floor, [66], and was embedded with a hearth of plain yellow encausted tiles associated with fireplace [67] (Appendix 6; Plate 12).

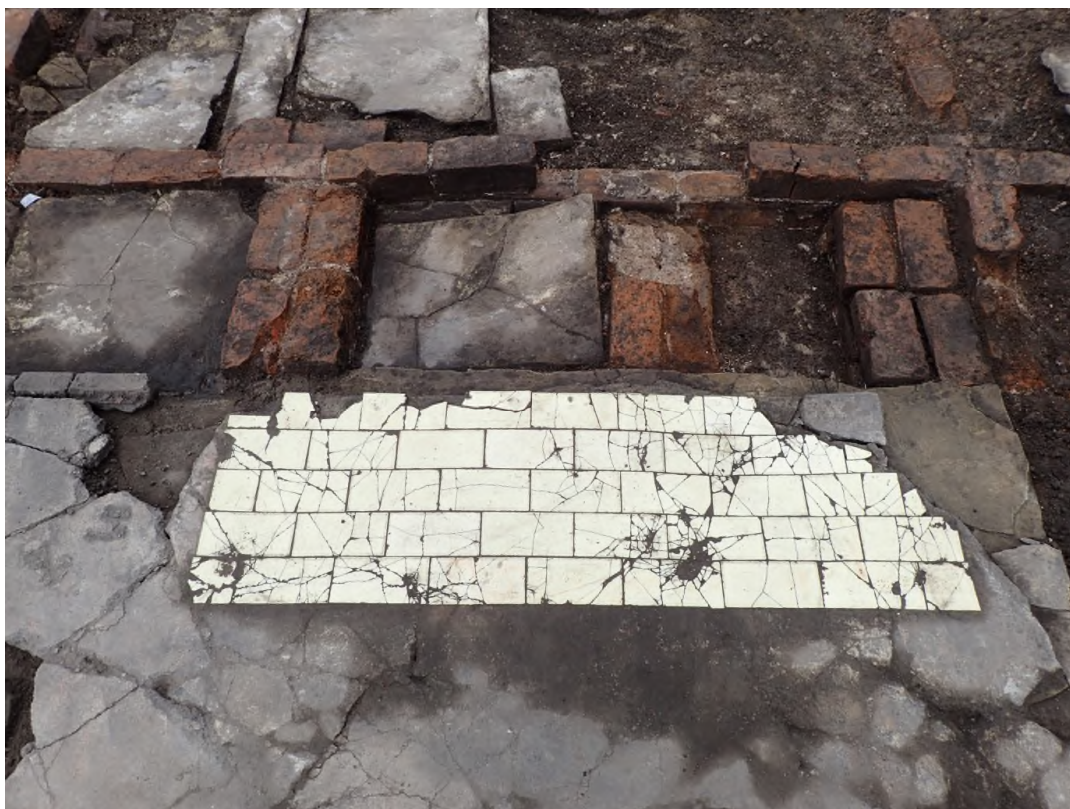
Plate 13: Parker's Court, showing stairpads [219] and [221] abutting wall [174], looking north-west

7.5.14 Although not marked on any of the maps, a red brick structure, [220], was constructed in Parker's Court against wall [174], immediately adjacent to stair pad [221]. This building measured 1.62m in length by 1.28m in width and was partially truncated by a ceramic drain pipe; this pipe likely connected with the drain pipe observed within [220], abutting wall [214]. A possible outhouse, only three courses remained of this structure.

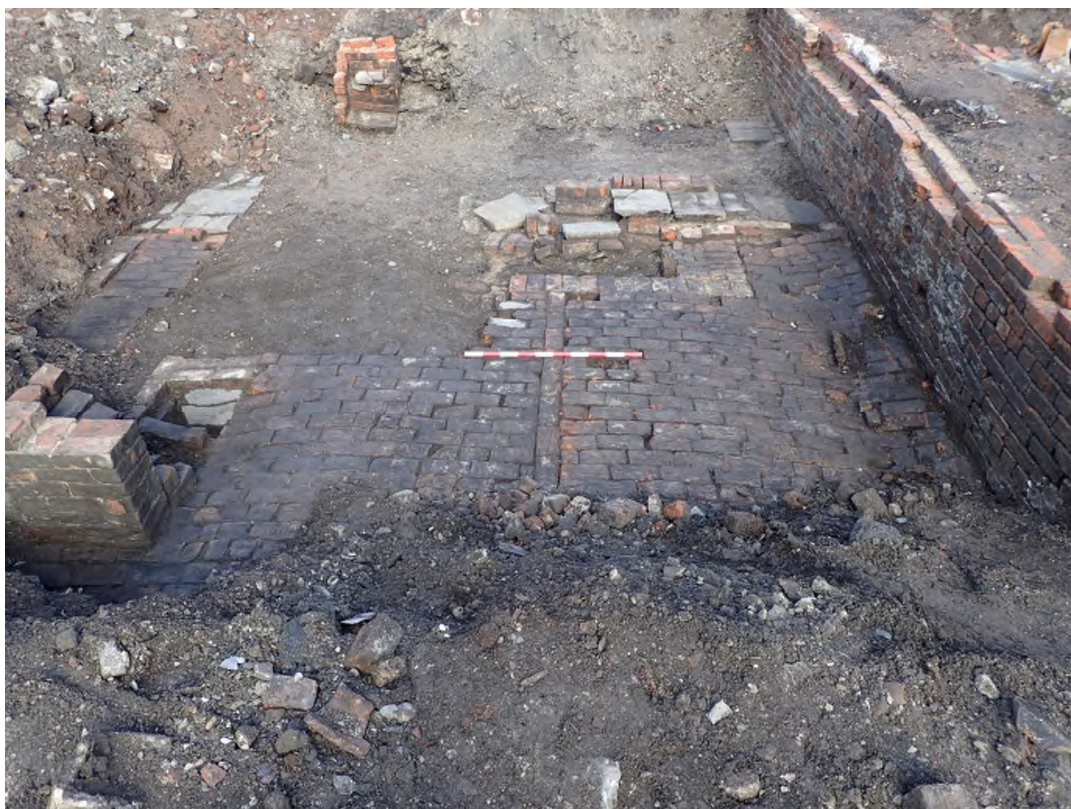
Plate 15: No. 54 Henry Street, looking north-west

- 7.4.8 No. 54 Henry Street was formed by walls [159], [160], and [162]. The rear wall, [162], was two skins thick, while the internal partition between No. 54 Henry Street and No. 56 Henry Street, [160] was a single skin red unfrosted brick wall. The floor of No. 54 Henry Street, [163], was a mix of flagstones

and red unfrosted bricks (Plate 15). It is possible that the floor was originally composed of just flags, and that the bricks date to a later repair. Extending north-west from wall [160] was a three skin thick red brick buttress, [180]. Measuring 0.45m in length and 0.31m in width, this brickwork may have originally been part of a fireplace. A partially exposed north-west to south-east aligned two skin thick wall, [161], tied into [160], and extended into the limit of excavation. Abutting the rear wall of No. 54 Henry Street was a 1.54m long red unfrosted brick wall, [165], which was bonded with a light lime grey mortar. This brickwork had no obvious function and was possibly associated with the drainage in the rear yard.

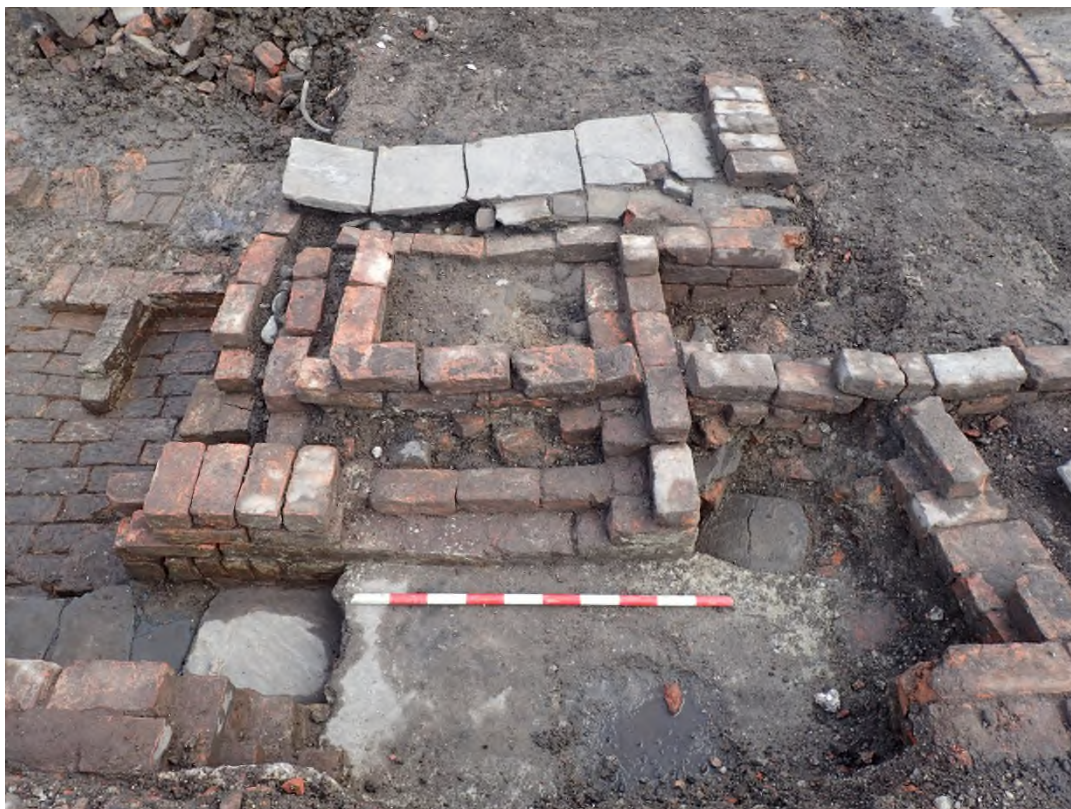
Plate 19: 19th-century outbuilding with cobbled surface [84] and drain [236], looking north-west

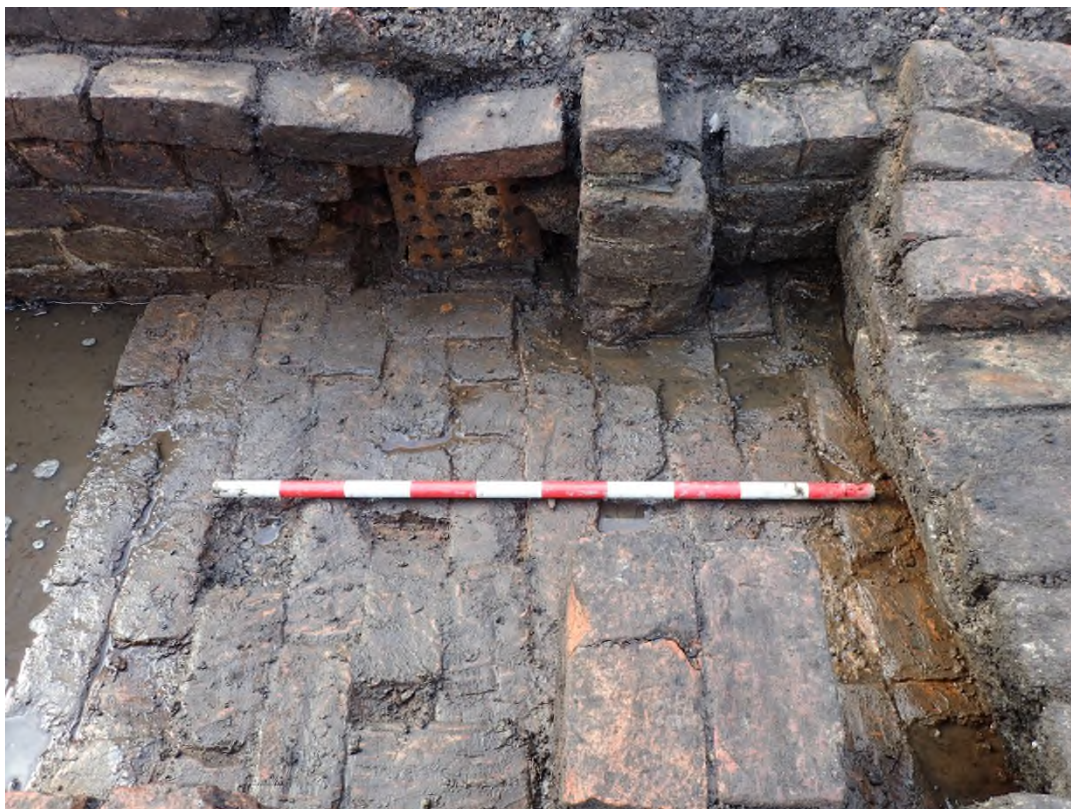
Plate 21: Floor [233] and wall [207] overlying original floor [212] of privy, looking south-east

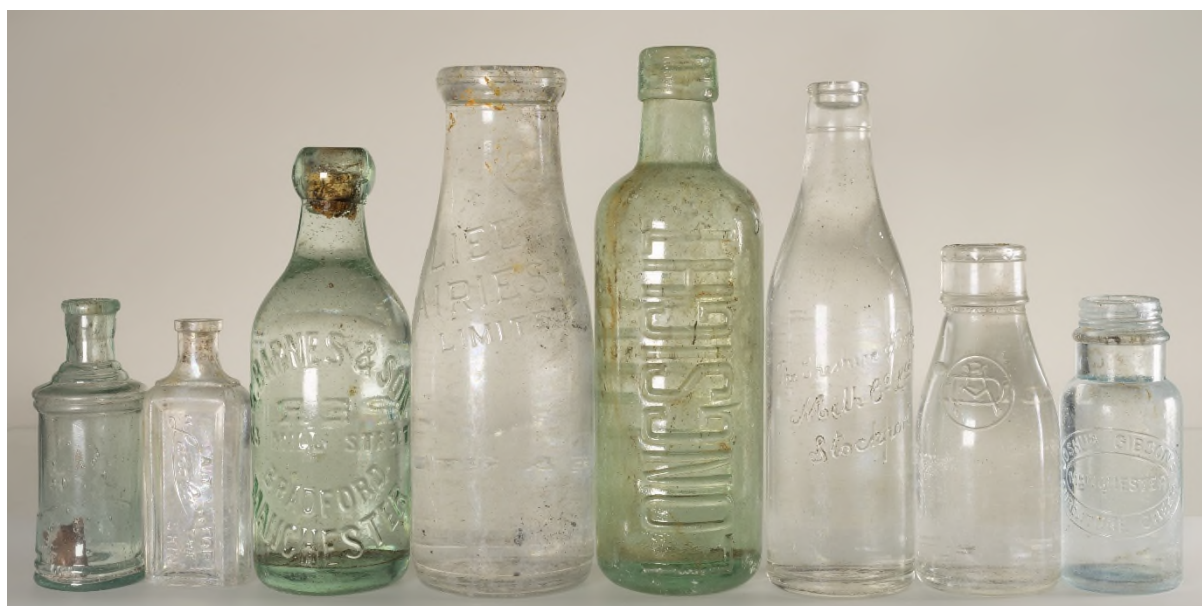
Figure 1: Late 19th/early 20th-century dated glass bottles used as containers for various products: for skin care ("Late" Lanola), milk (Allied Dairies and The Cheshire Sterilized Milk Co. Ltd., Stockport), mineral waters etc. (G. Barnes & Son, 123 Mill Street, Bradford/Manchester and Edge, Longsight), as well as for furniture cream (Joshua Gibson).

It is recommended that a brief mention of the glass assemblage is included on the site display board and that a group photo of the bottles embossed with Manchester and Salford businesses are photographed to supplement the text (Figure 1).

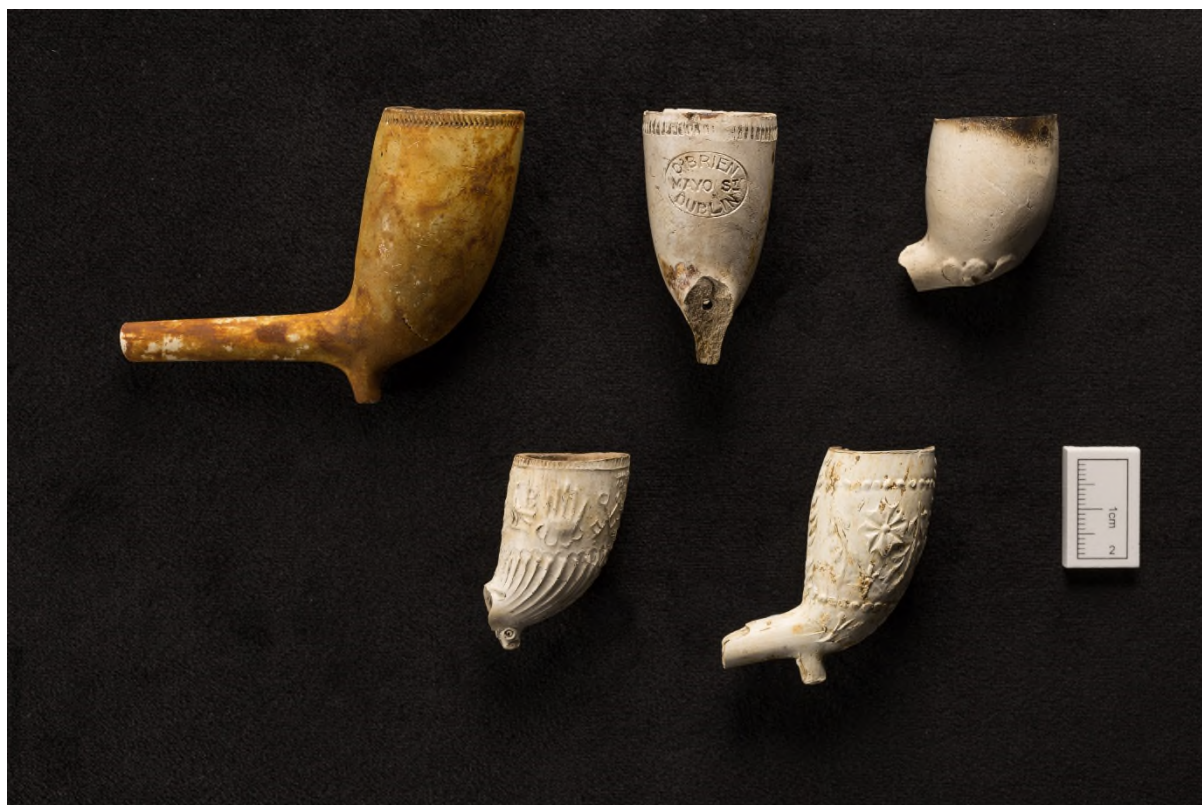
Figure 1: Mid and late 19th-century clay tobacco pipes produced in the Greater Manchester area. These bowls either have Irish motifs, such as shamrocks or copy Irish-type bowl shapes and includes an example with a fake name and address (O'Brien, Mayo St., Dublin). These bowls were marketed to the large number of Irish immigrants who were arriving in Britain after c.1840, although the bowl shapes became popular with the nation's smokers as a whole.

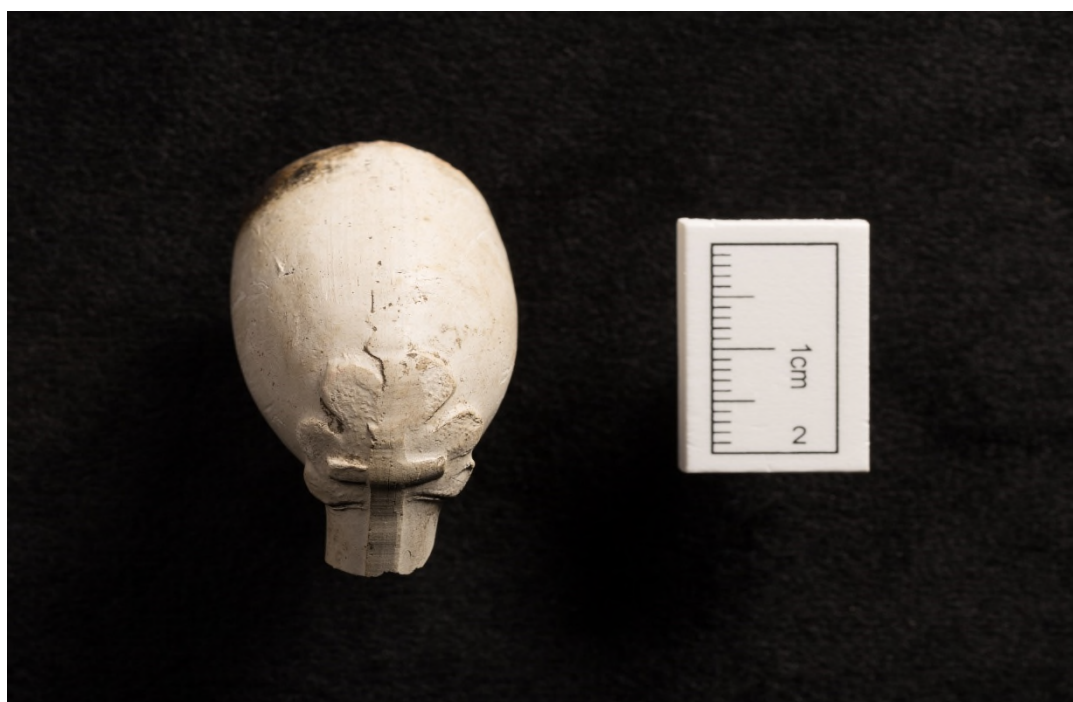
Figure 2: Clay tobacco pipe bowl with shamrock

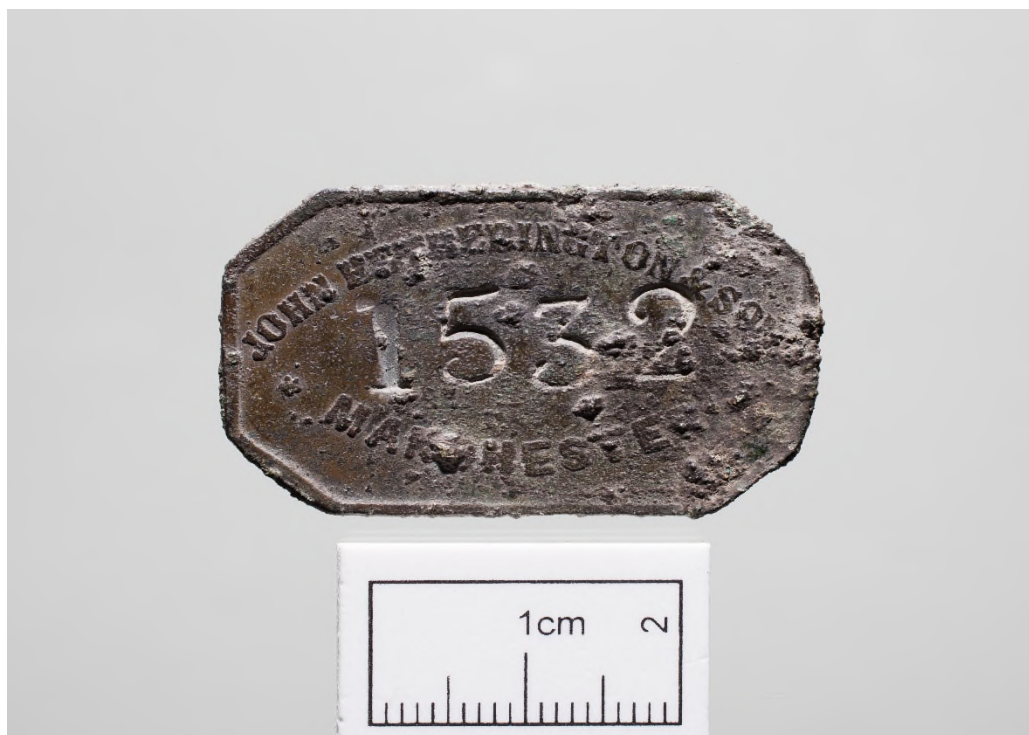
Figure 2: Copper-alloy token 'JOHN HETHERINGTON & SONS'; stamped 1532

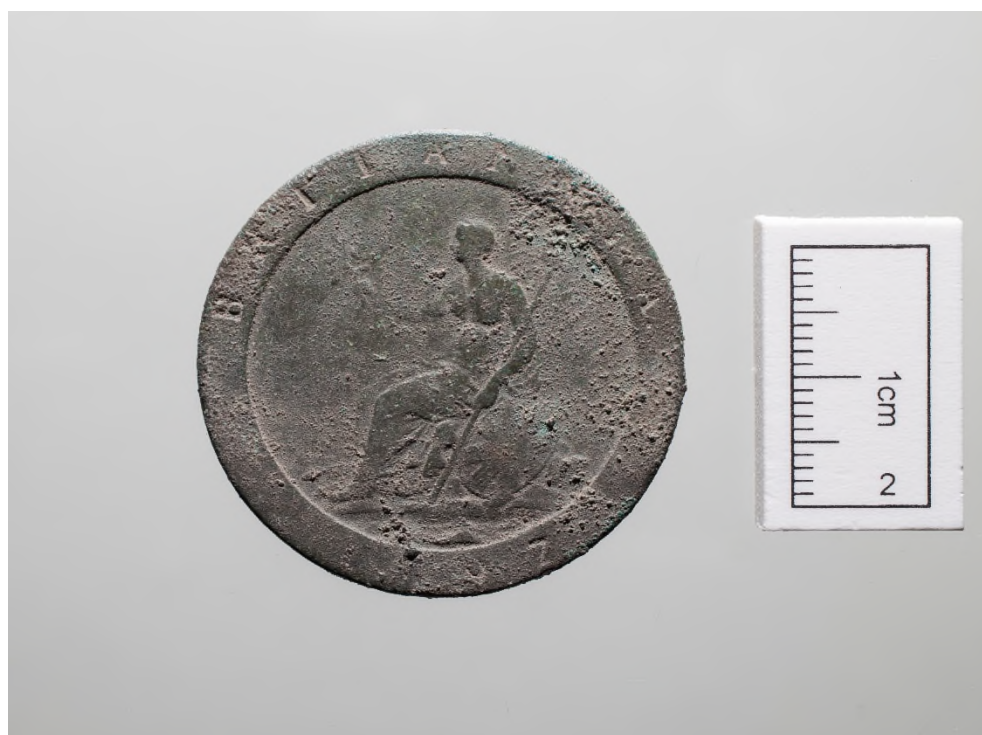
Figure 3: George III 1797 cartwheel penny SF11
