**BECKENHAM PLACE PARK,
BECKENHAM,
LONDON BR3 5DE**

**AN ARCHAEOLOGICAL EVALUATION
OF THE AREA OF THE RESTORED
LAKE**

PCA REPORT NO: R13284

SITE CODE: BPL17

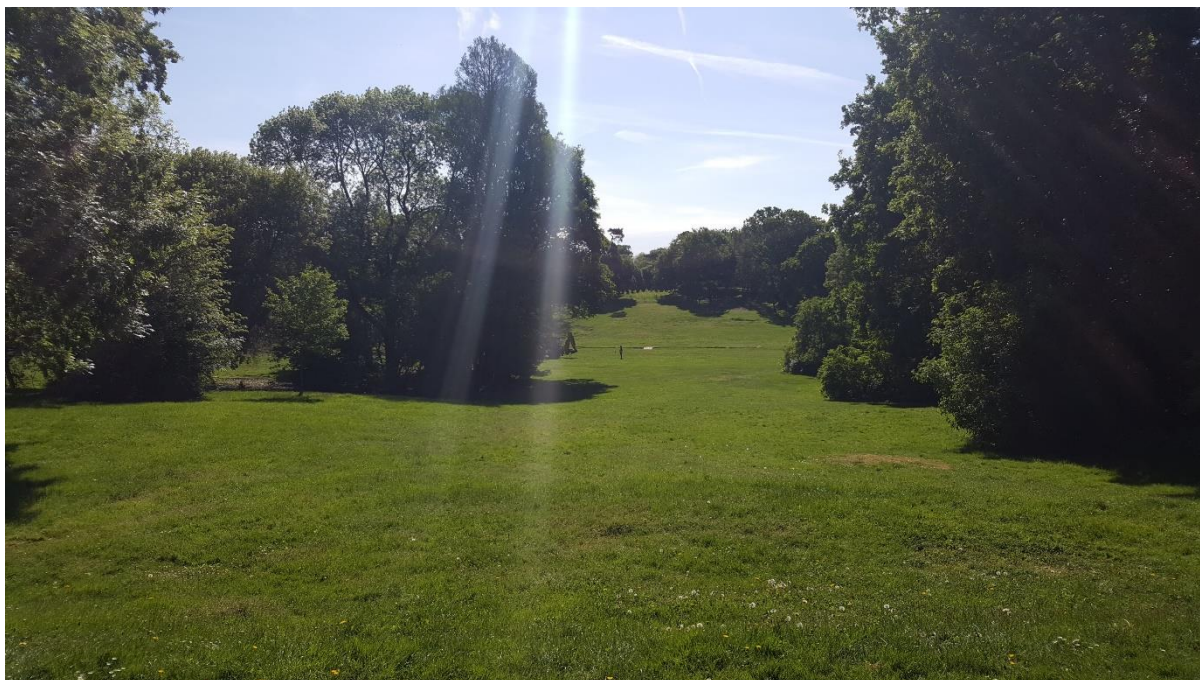
Thus the location of the lake is identifiable as a hollow in the wider landscape (Plate 1).

Plate 1: View taken just north of the Homesteads, looking west across the park and the southern edge of the lake location. The mechanical excavator is visible at the centre of shot, working on Trench 3.

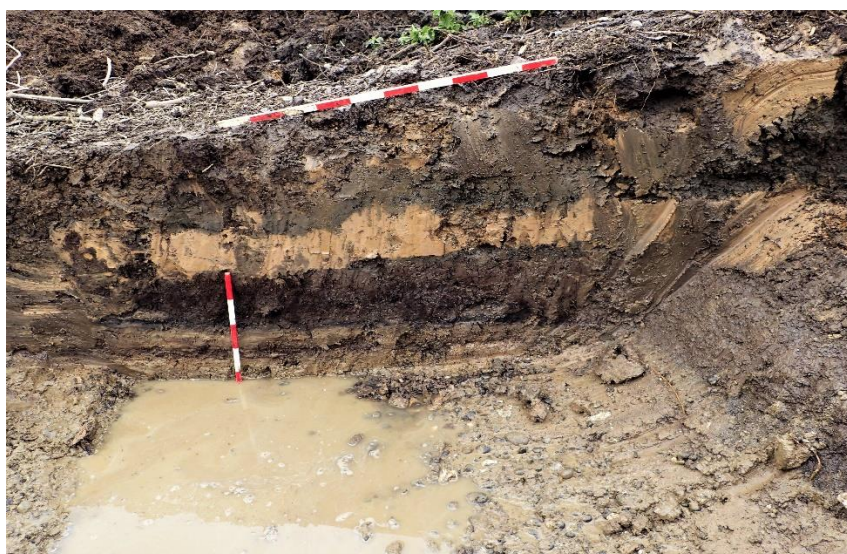
Plate 2: Trench 1, Section 50, NE facing, scale 1m & 0.5m.

- 7.1.2 The cut of the lake was identified as [55] in Section 50 (Plate 2, Figure 4) and as [125] in Section 51 at the north-west end (not illustrated). This was seen to shelf down from 30.14m OD in the north-west to 29.45m OD in the south-east.

- 7.1.3 The natural silting of the lake was visible in Section 50 (Plate 2, Figure 4) as alternating laminations of clay alluvium and organic layers [53,54] sealed by a more substantial, highly organic layer [52] which was 0.37m thick. All layers followed the gentle downward slope of the lake edge falling away to the south-east. Organic layer [52] was at 30.03m OD at its highest to 29.95m OD at its lowest.

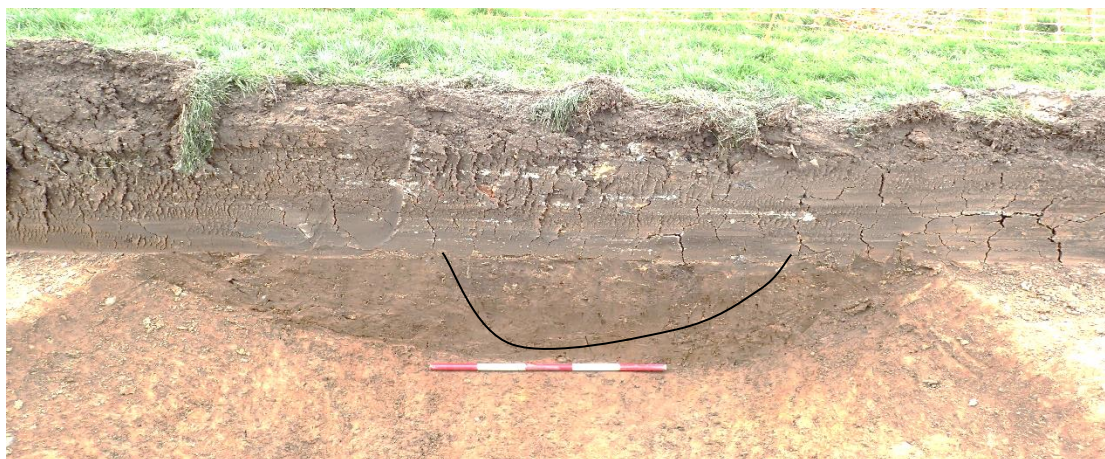
Plate 3: Trench 2, Section 55 (south-facing), ditch [78], scale 0.5m (line shows actual ditch cut)

brickearth. It required over-cutting to clearly see it in section. It was a friable orange-ish mid brown clayey silt and both struck and burnt flint was recovered from this fill (Appendix 7). The cut of the ditch was recorded at 31.62m OD, it being 0.30m deep.

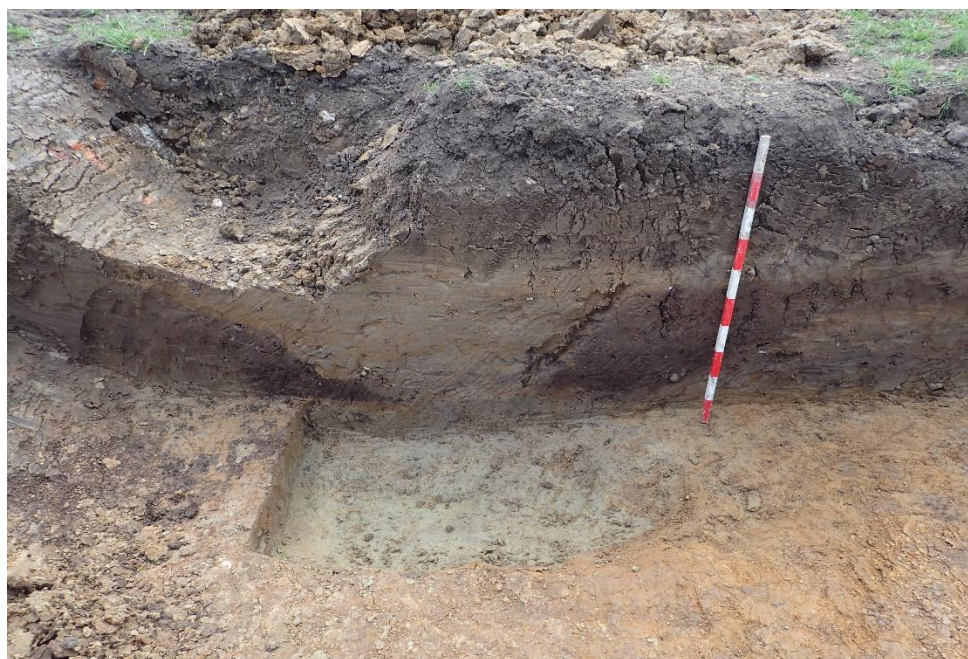
Plate 4: Trench 2, Section 52 (north-facing), possible channel/ditch [65], scale 1m

- 7.2.6 The archaeological sequence recorded in Section 52 was further confused by the presence of a possible channel or ditch [65], filled with a firm brownish light grey silty clay. Although hand-cleaned it provided no finds, contained a single homogenous fill and was archaeologically sterile. The ditch was not located in any of the other trenches and is poorly understood in relation to the underlying layers that it had cut. Its absence elsewhere suggests an anomaly or short run of drainage ditch. If the underlying layers that it had cut were the result of natural

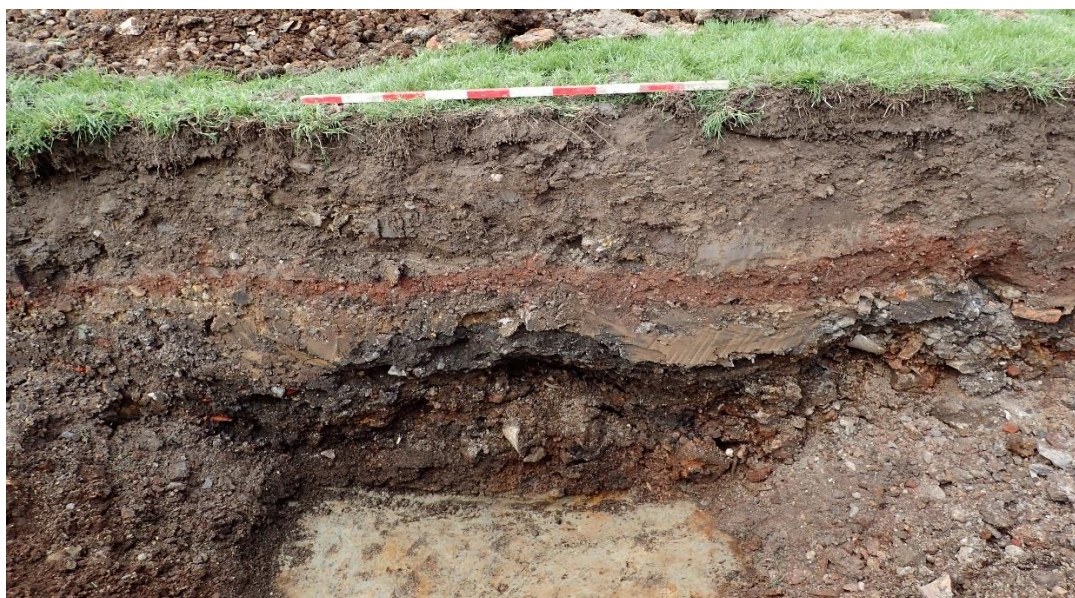
Plate 5: Trench 3, Section 54 (south-east facing), natural clay [76] at base, scale 1m

7.3.3 Made ground layers were recorded as [75] in Section 54 (Plate 5, Figure 4) and as [80-82] in Section 56 (not illustrated). Turf and topsoil landscaping layers were recorded as [74] and [79] respectively.

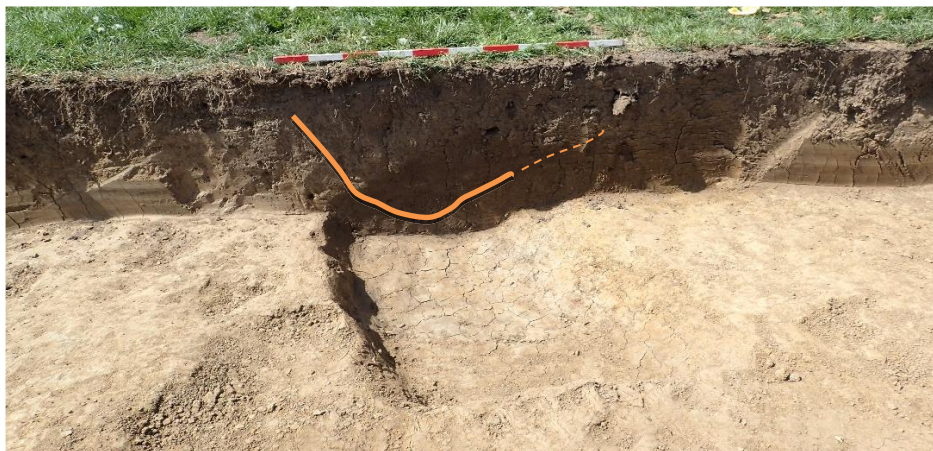
Plate 6: Trench 4, Section 60 (north-east facing) showing ditch [97], orange line shows poorly defined ditch cut, scale 1m.

- 7.4.2 In Section 60 a linear was investigated that had a 'U' shaped profile: this was well defined on its south-eastern edge but was poorly defined on its north-western side (Plate 6, Figure 4). However, it was identified as the cut of a ditch [97] which may have been the southern counterpart to the ditch [78] seen in Trench 2 to the north (this will be discussed in a later section of the report, Chapter 8). Unfortunately, its fill [96] – consisting of a greyish mid brown silty clay - did not contain any finds.

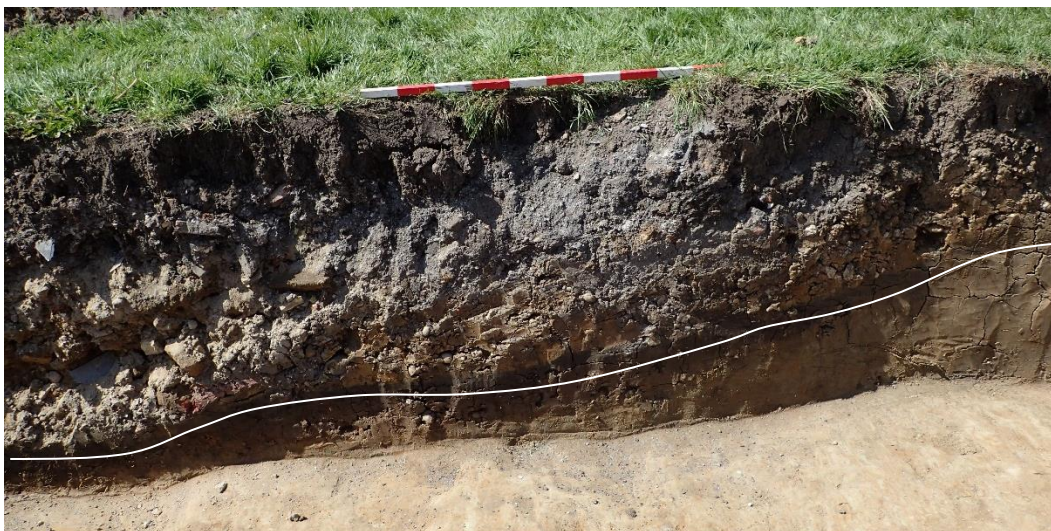
Plate 7: Trench 4, Section 59 (north-east facing), white line indicates top of clay lining [93]

- 7.4.3 The cut of the 18th century ornamental lake and its clay lining was recorded in Section 59 where a long section was created to show its profile. Cut [139] was recorded at its north-west end at 32.49m OD which gradually sloped down to 32.04m OD cutting the underlying brickearth [95]. The exploitation of the natural fall of the ground along with the removal of top and any sub soils seems to have been used in this location to create the lake profile. A layer (or indeed fill) of firm, greyish dark brown clay [93] was interpreted as the clay lining for the lake which was 0.24m at its thickest at the south-east end tapering up to 80mm at the north-west end. However, no lake 'fills' representing the natural silting of the lake were apparent, but they may have been located further to the east and in deeper ground beyond the trench.

8.1.14 Although a clay lining (or some water-retaining material) to the lake had been expected, it did not appear to be present except where noted in Section 59 as fill/layer [93]. This layer was notably different to other fills recorded as a firm, greyish dark brown sandy clay with occasional rounded pebble inclusions. It widened from a thin wedge high in Section 59, thickening to the base where it was c.0.20m thick (Figure 4).

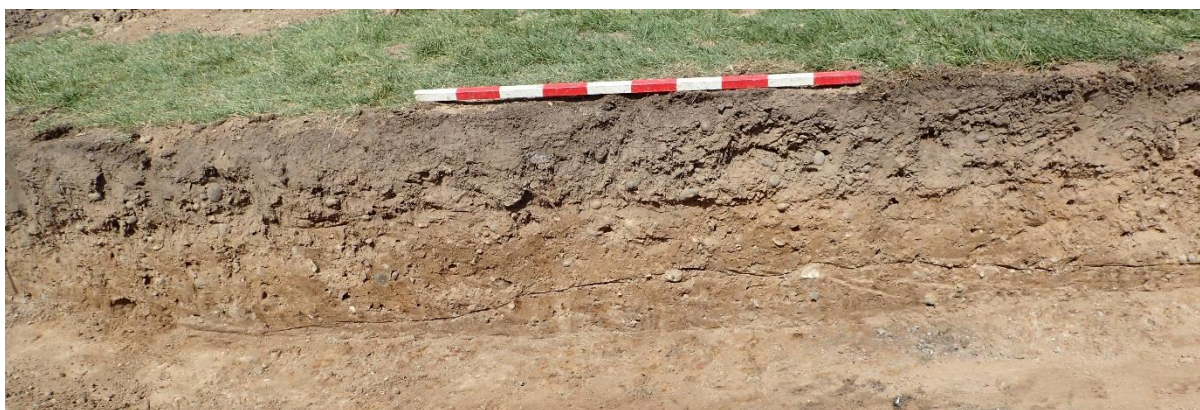
Plate 8a: Trench 5, Section 70, view to the N showing burnt layer, scale 1m

- 7.5.2 At the surface of layer [141] was an area or layer of burning which contained charcoal, burnt and struck flint [124] (Plate 8, Figure 4). This area was superficially hand cleaned by trowel but its limits were not detected; the loose spoil was kept as an environmental sample and sieved, producing a further 101 burnt flint fragments. It was recorded at a height of 30.86m OD at the east end falling to 30.38m OD at the west.

- 7.5.3 Deposit [124] was overlain by a modern landscaping layer numbered [123] in Section 70 (Plate 8, Figure 4) and [130] and [132] in Sections 67 and 69 respectively (not illustrated). Turf and topsoil was recorded as [122], [129] and [131] over the three sections.

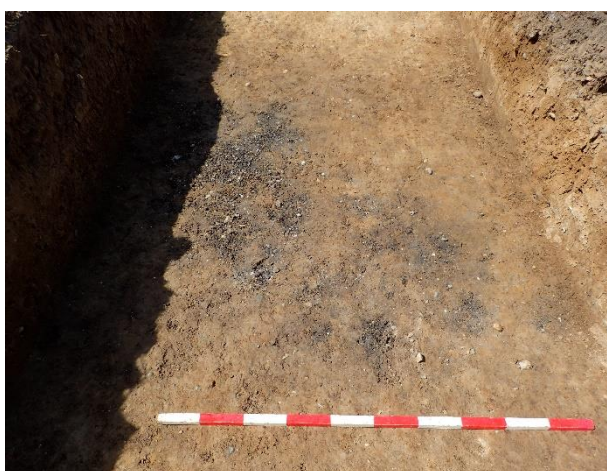
*Plate 8b: Trench 5, burnt layer [124],
view to W, scale 1m*

8.2.4 The burnt layer [124] in Trench 5 is also enigmatic, containing both burnt and struck flint but no other anthropological material which may have provided a closer date for the feature. Light trowelling of the feature did not delineate the feature or show any discrete limits or edges. However, taking the cultural material into account, it could be one of three possible features –

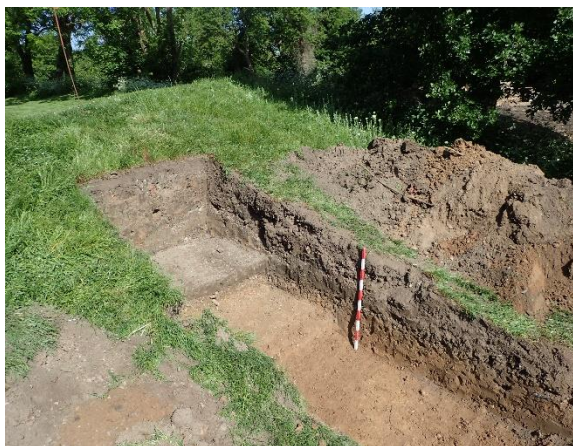
Plate 9a: Trench 6, Section 63, view to NW showing earthwork on south bank of lake, scale 1m.

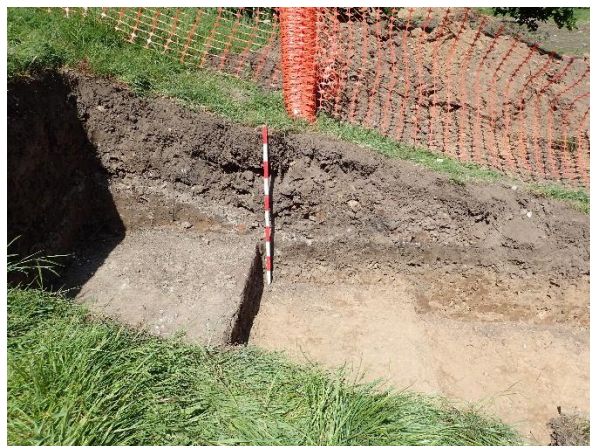
Plate 9b: trench 6, Section 63, view to N showing made ground layers over natural, scale 1m.

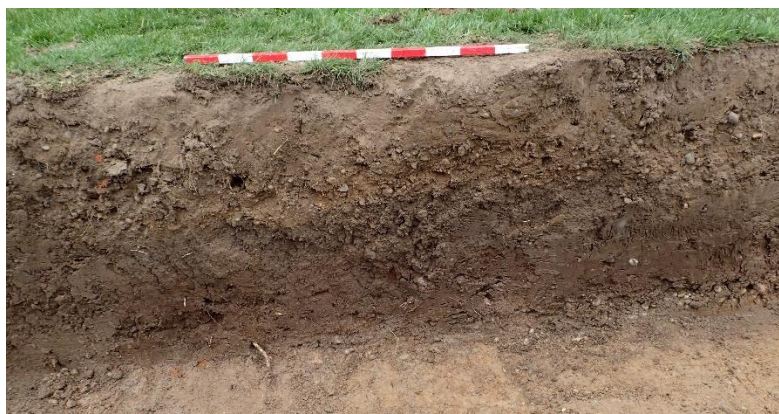
Plate 10: Trench 7, Section 63, view to SE, showing natural brickearth layer [106] sloping downwards towards the north (left of picture), scale 1m

- 7.7.3 The sedimentary lake deposit [133] was sealed by a number of layers including backfill of the lake [135] (consisting of fragmentary building materials including grey asbestos roofing sheets) and made ground layers [102], [104] & [105]. Turf and topsoil was recorded as layers [101], [103] and [134].

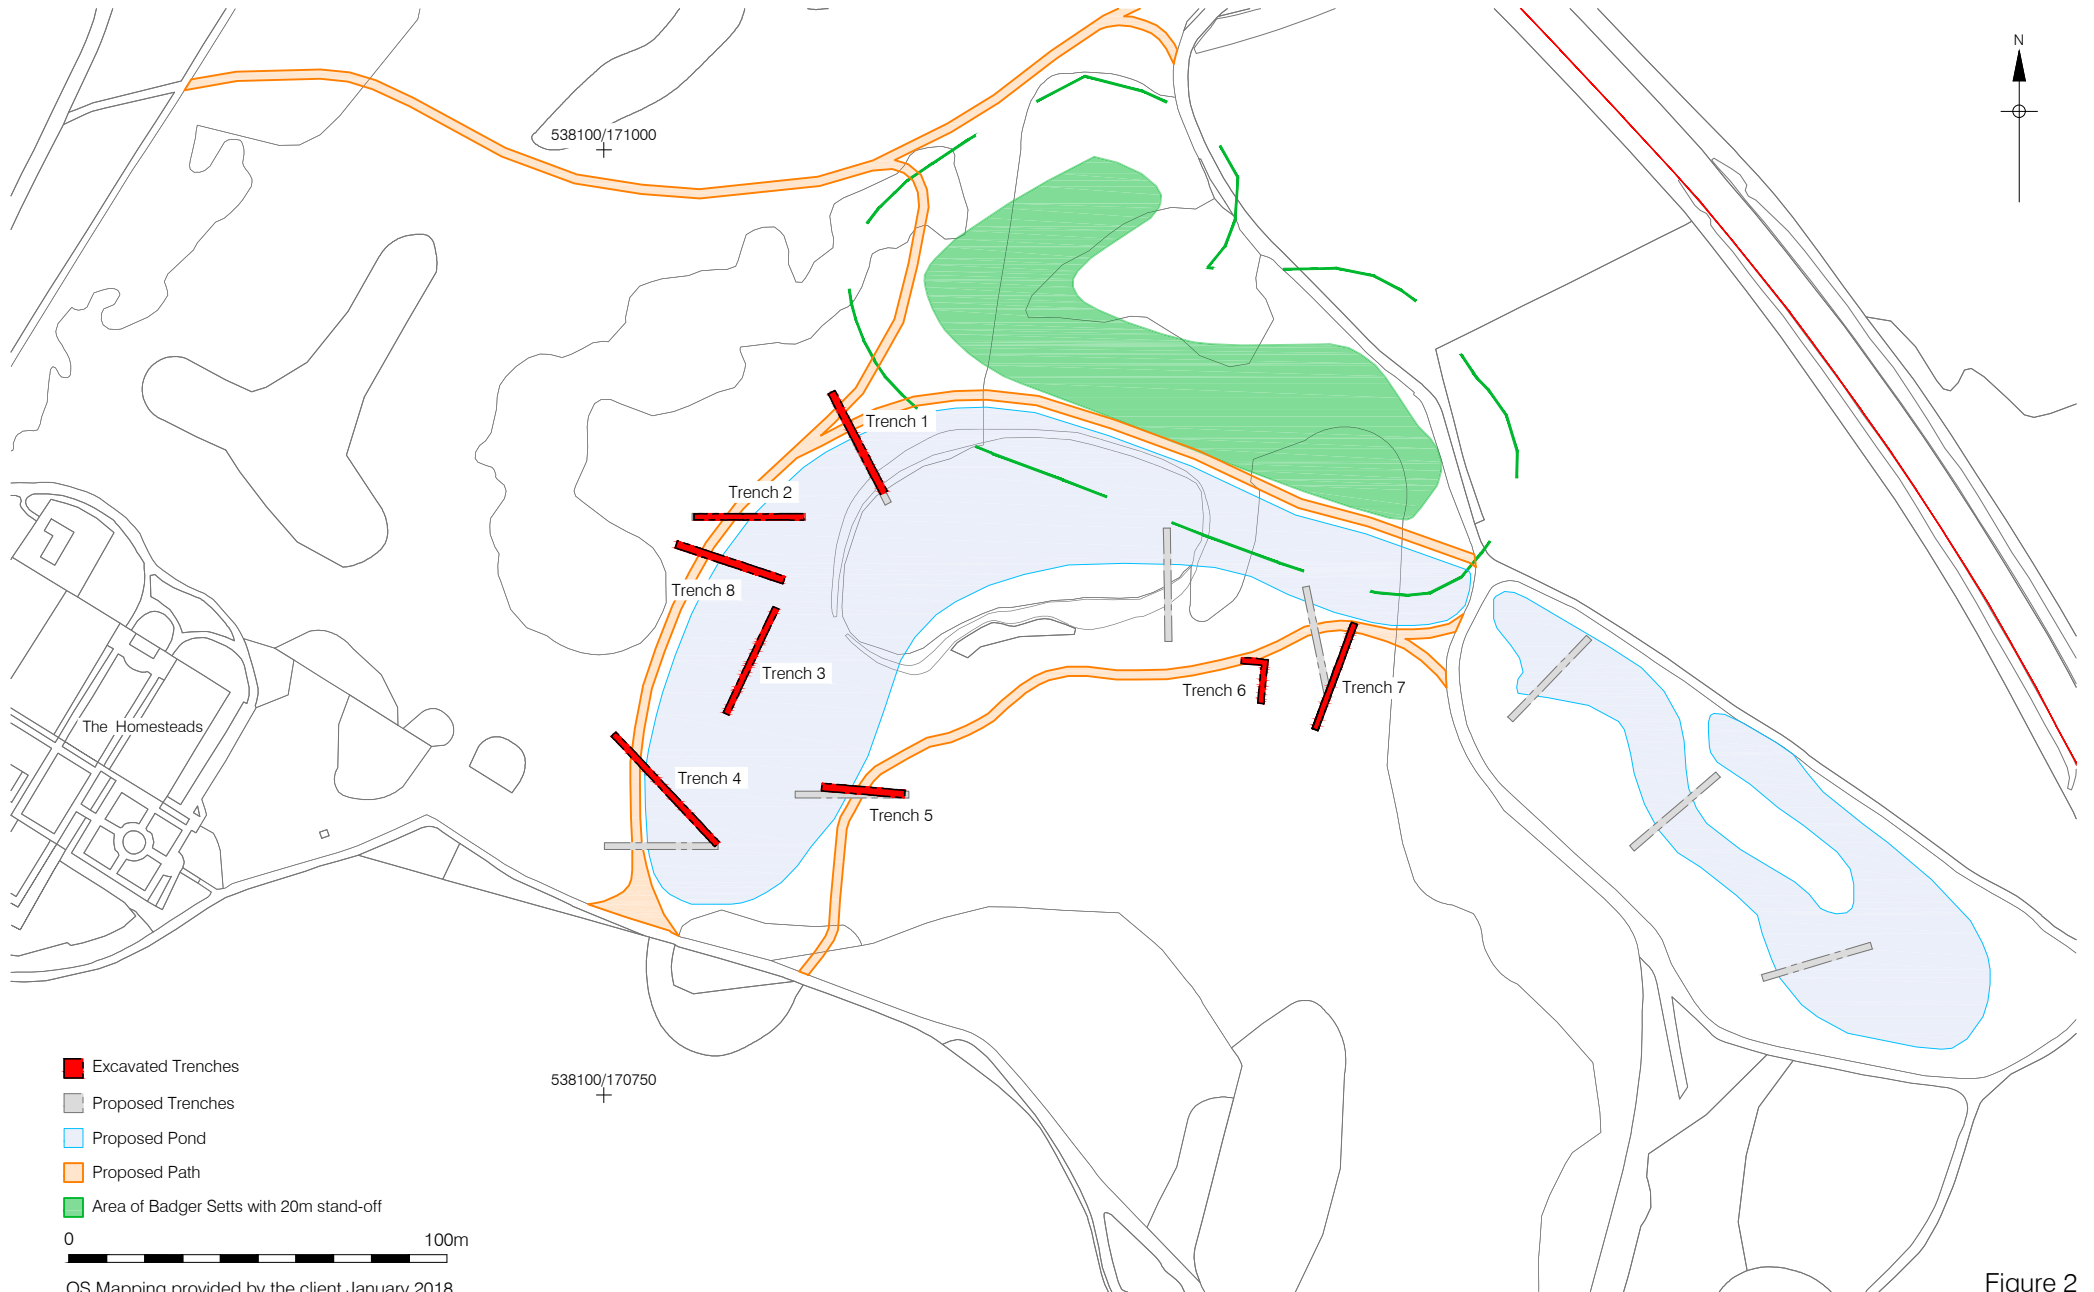
Figure 2
 Trench Location
 1:2000 at A4

- Excavated Trenches
- Proposed Trenches
- Proposed Pond
- Proposed Path
- Area of Badger Setts with 20m stand-off

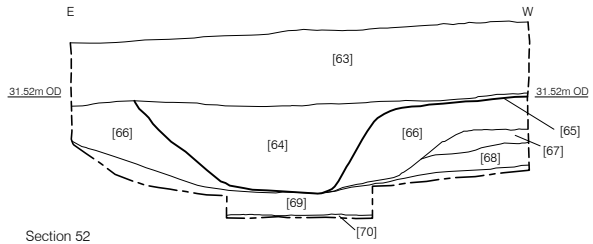
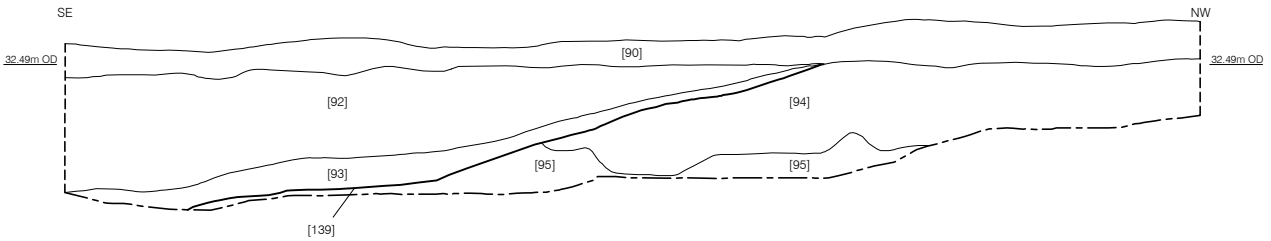
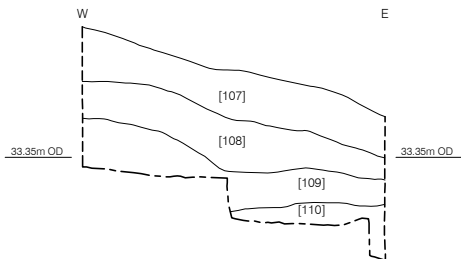
Section 50
North East facing
Trench 1

Section 52
North facing
Trench 2

Section 55
South facing
Trench 2

Section 59
North East facing
Trench 4

Section 63
North West facing
Trench 7

Section 64
South facing
Trench 6

Section 70
South facing
Trench 5

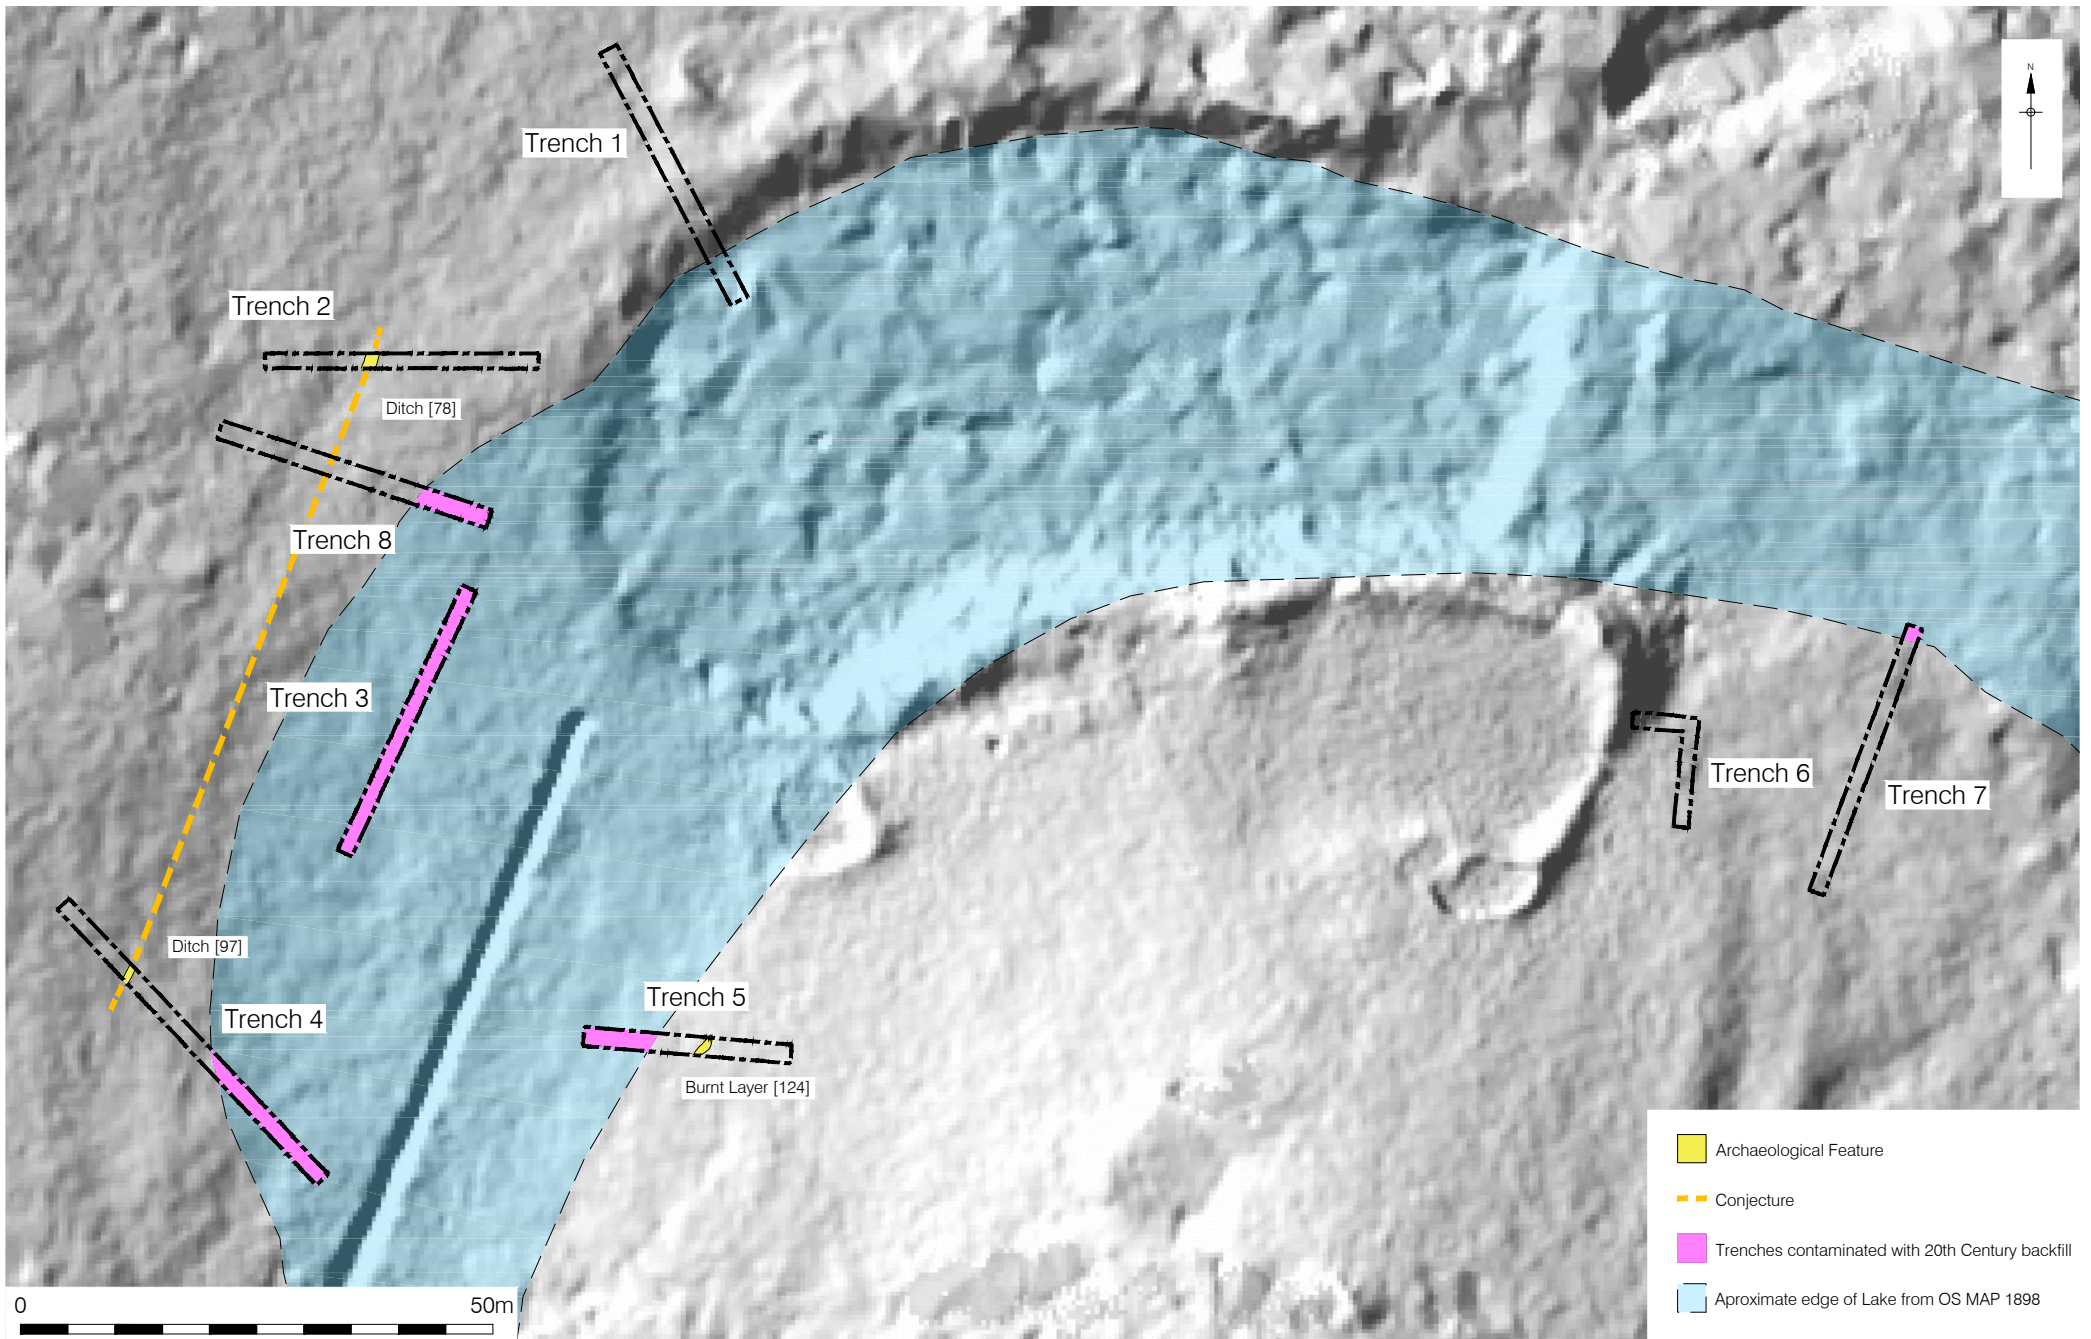
Figure 5
Trenches overlain onto Lidar Data
1:800 at A4

- Archaeological Feature
- Conjecture
- Trenches contaminated with 20th Century backfill
- Aproximate edge of Lake from OS MAP 1898
