**LAND AT STATION HILL, BURY ST
EDMUNDS, SUFFOLK:**

**AN ARCHAEOLOGICAL
EVALUATION**

PCA REPORT NO: R13318

JULY 2018

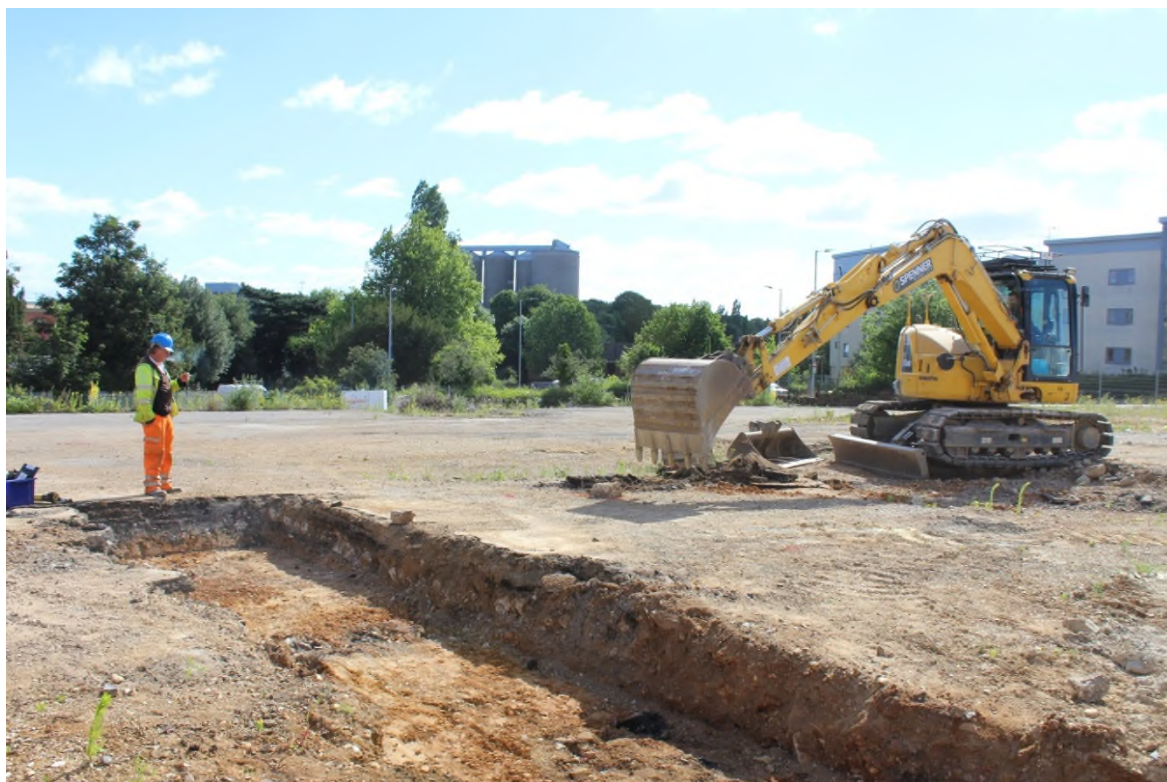
Plate 1: Machining methodology

4.2.1 Excavation of trenches during the evaluation was carried out using a 12 ton 360° tracked mechanical excavator (Plate 1), operating under close archaeological supervision. The trenches all contained modern made ground deposits; this overburden was removed in spits down to the level of the undisturbed natural geological deposits where potential archaeological features could be observed and recorded. With the exception of two brick walls and a brick wall or surface in Trench 1, and a demolished wall line in Trench 2, no significant archaeological deposits were present above the level of the surviving natural sand and gravel.

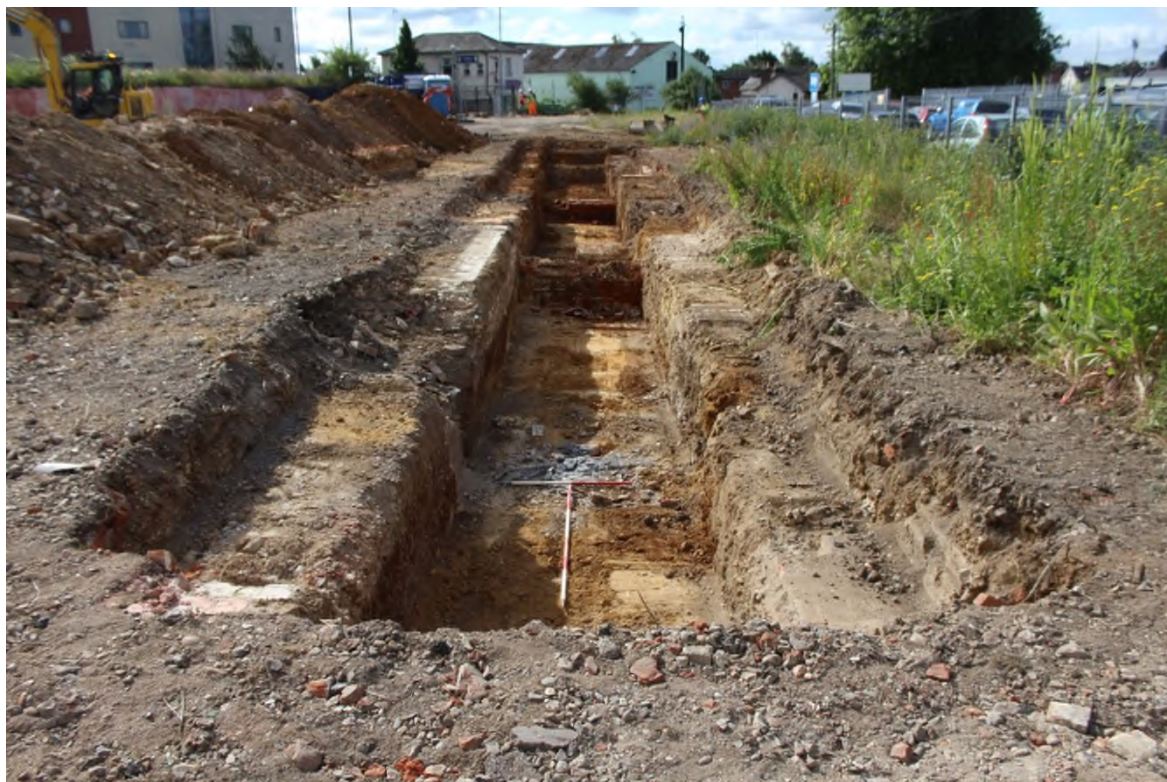
Plate 2: Trench 1, facing east

TRENCH 1	Figure 5	Plates 2, 3 & 4		
Trench Alignment: NW–SE	Length: 30m	Height of natural (m OD): 34.25–34.64		
Deposit	Context No.	Average Depth (m)		
		NW End	Centre	SE End
Modern demolition debris	(001)	0.40m	0.10m	0.11m
Made ground (mixed rubble/ sand)	(045)	1.14m	n/a	0.78m
Brick coursing	(004)	n/a	0.37m	n/a
Foundation (flint and mortar)	(005)	n/a	0.35m	n/a
Made ground (redeposited sand/ gravel)	(006)	n/a	0.25m	n/a
Natural sand (max. machined depth)	(007)	1.54m+	1.07m+	0.89m+
Summary				
Trench 1 was located in the south-west of the southern area of the site.				
The trench contained remains of two parallel red brick wall lines, 10.5m apart, and other foundations relating to a former railway building. A substantial construct consisting of five courses of Suffolk white bricks (04) over a flint and mortar foundation (05), visible in the south-facing section of the trench, indicated a possible base for heavy machinery to rest on. The walls exactly match a building shown on the 1886 1 st Edition Ordnance Survey Map (Fig. 3), which was still extant in 1965 (Fig. 4).

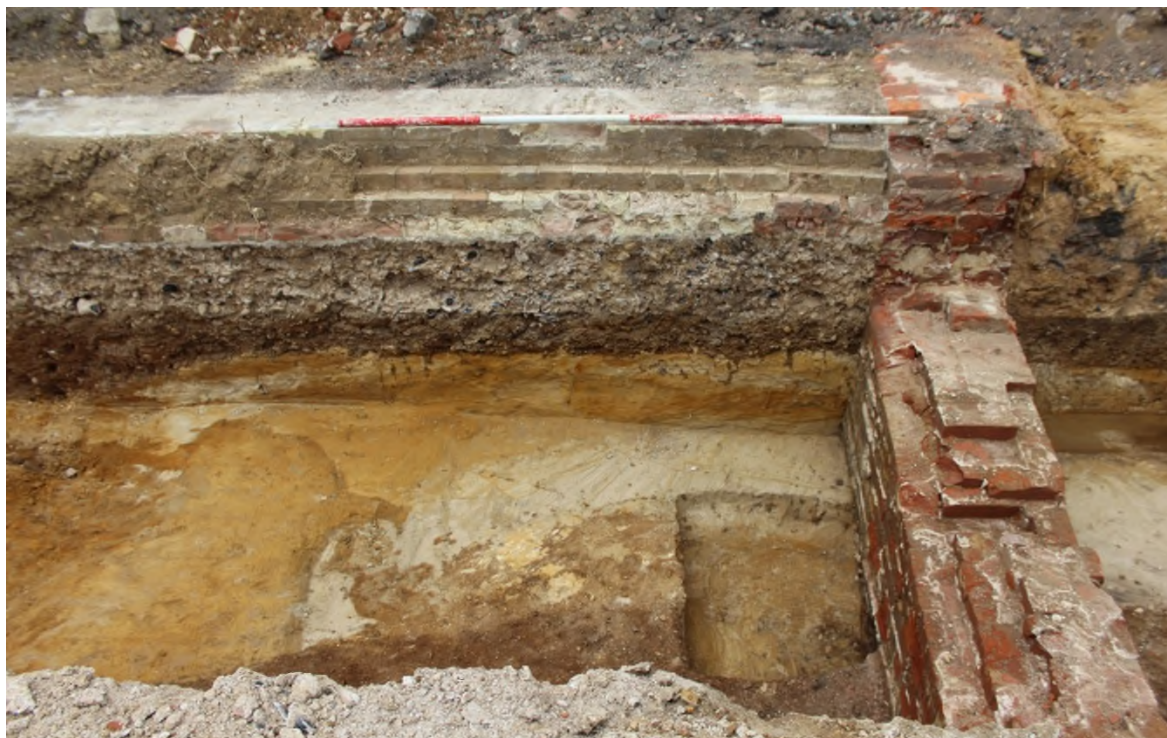
Plate 3: Trench 1, south-facing section showing Foundations (4) and (5)

7.2.3 Towards the west end of the trench, a substantial construction was visible in the south-facing section of the trench. It consisted of five courses of Suffolk white bricks (4) on a solid flint and mortar foundation (5), 0.37m thick. Beneath this was a layer of brown sand and gravel makeup (6), 0.30m deep, forming a levelling layer over the natural yellow sand (7) at the base of the trench.

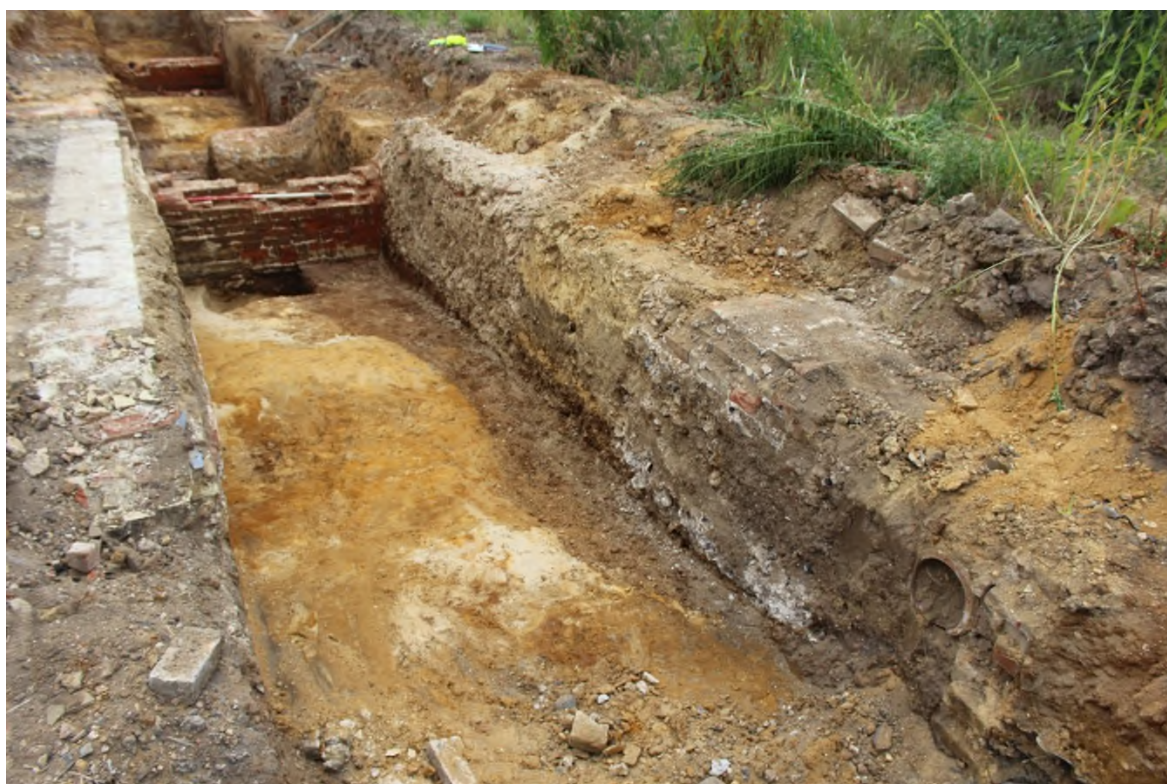
Plate 4: Trench 1; Wall (2) built over backfilled Pit [9], view south-east

The parallel brick walls had been constructed over an infilled earlier pit [9], which continued southwards beyond the trench. It had a sterile fill, which contained no finds in the excavated slot; it may have been an infilled quarry pit, or the beginning of the terracing which is still visible at ground level (there is a pronounced drop to the south of the site boundary).

- 7.2.6 Wall line (10) had been built over a large pit [9], which extended southwards beyond the limit of the trench. The fill of the pit (8) was similar to the levelling layer (6) in the south-facing trench section. It is suggested that this pit is either a remnant of sand/ gravel quarrying on the southern slope of the hill, which was backfilled at the time of construction of the building, or that it is the edge of another terrace cut into the slope of the hill, which is still visible at ground level in the form of a pronounced drop beyond the southern boundary of the site. The area to the south contained further railway tracks and a coal yard in 1965 (Fig. 4) and it is presumed that the terrace was a cutting for these tracks.

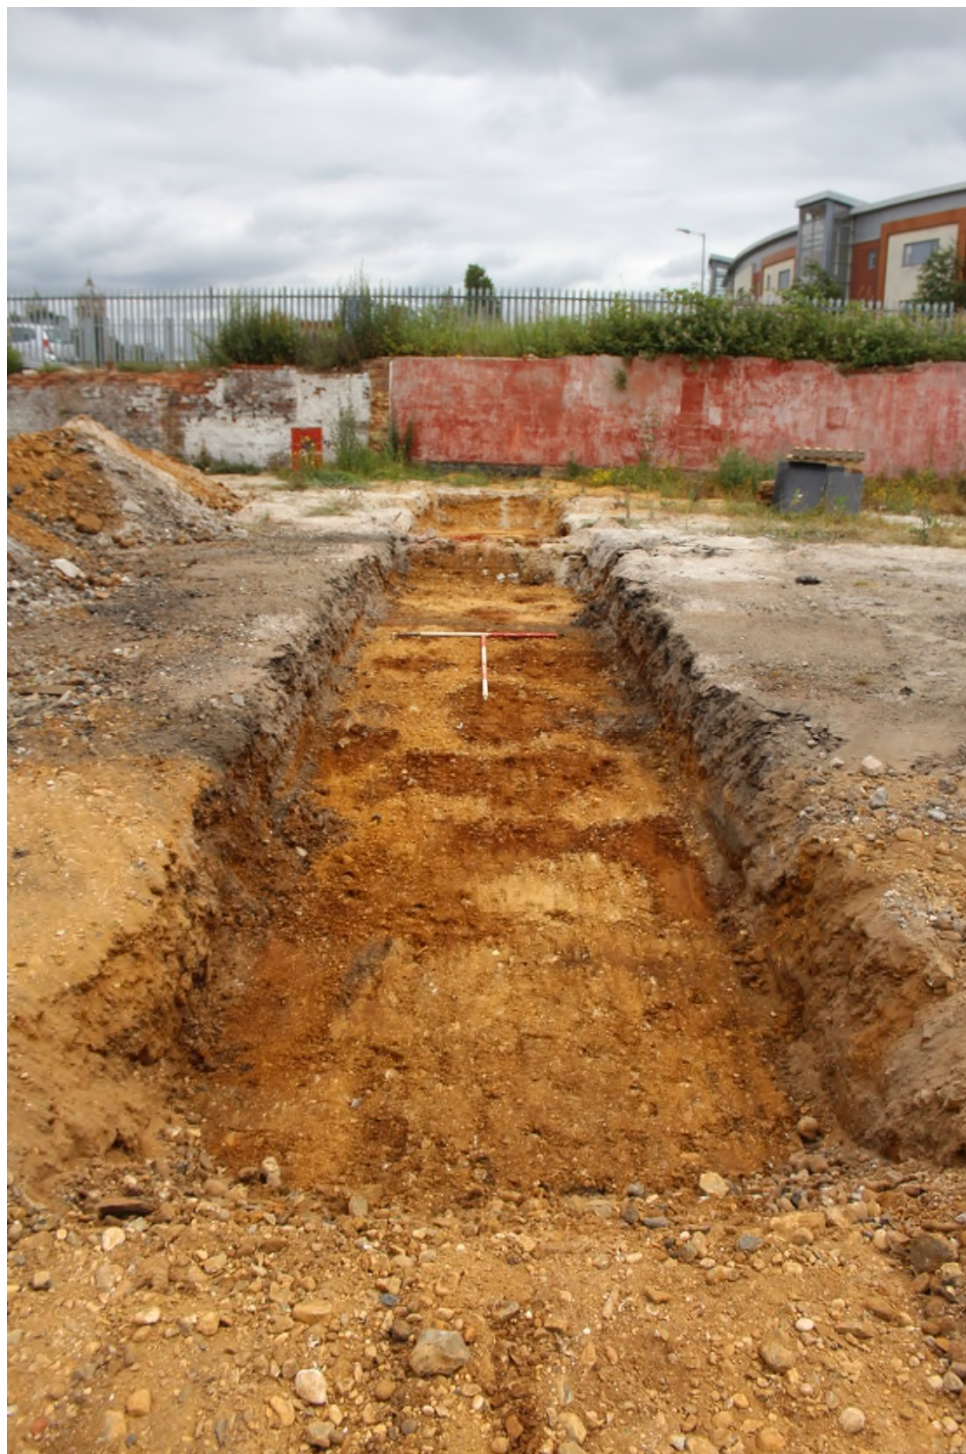
Plate 5: Trench 2, view north with backfilled Wall Foundation [43] in middle ground

TRENCH 2	Figure 5		Plate 5	
Trench Alignment: NE–SW	Length: 20m	Height of natural (m OD): 35.43–35.67		
Deposit	Context No.	Average Depth (m)		
		NE End	SW End	
Modern demolition debris	(011)	0.17m	0.16m	
Made ground (redeposited sand/ gravel)	(012)	0.42m	0.42m	
Natural sand (max. machined depth)	(013)	0.59m+	0.58m+	
Summary				
<p>Trench 2 was located in the east of the southern area of the site.</p> <p>The trench contained the cut of a north-west- to south-east-aligned wall foundation [43], backfilled with broken-up concrete, which matches the south wall of a building shown on the 1886 and 1965 Ordnance Survey maps (Figs. 3 and 4). The wall appears to have been less substantial than Walls (002) and (010) in Trench 1.</p>

- 7.2.7 Trench 2 contained the remains of another wall, comprising a foundation cut [43] backfilled with broken-up concrete. This wall corresponds with the south wall of another building shown on the 1886 and 1965 Ordnance Survey maps (Figs. 3 and 4), part of the same complex as that exposed in Trench 1.

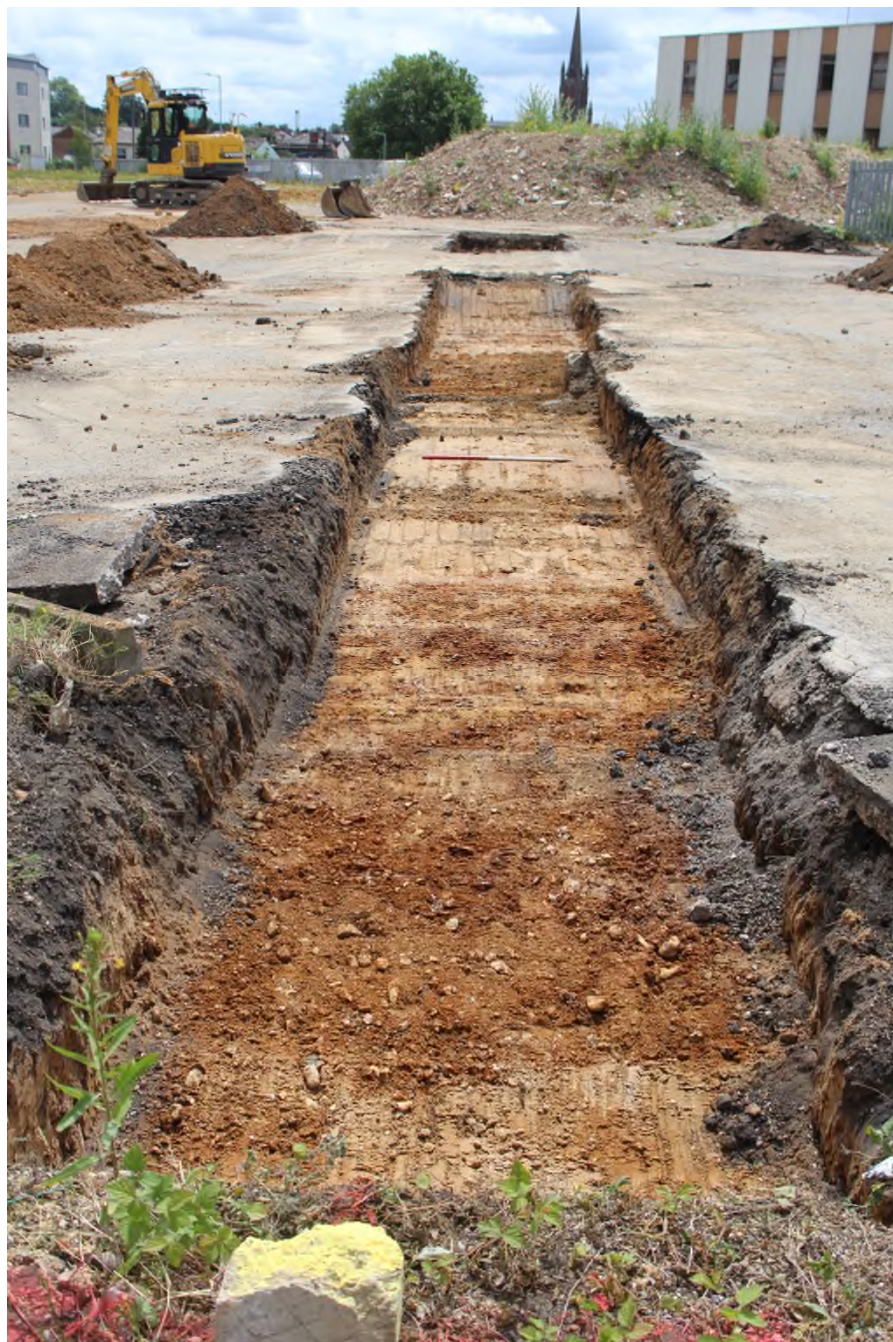
Plate 6: Trench 3, view south

TRENCH 3	Figure 2		Plate 6	
Trench Alignment: N–S	Length: 30m	Height of natural (m OD): 37.08–37.67		
Deposit	Context No.	Average Depth (m)		
		N End	S End	
Modern demolition debris	(014)	0.32m	0.36m	
Natural sand (max. machined depth)	(015)	0.32m+	0.36m+	
Summary				
<p>Trench 3 was located in the north-west of the northern area of the site.</p> <p>A 2m wide portion of the trench was left unexcavated due to a live high voltage cable crossing the line of the trench from west to east. The deposits exposed to either side of this break in the trench were identical.</p> <p>The trench contained no archaeologically significant features or deposits.</p>

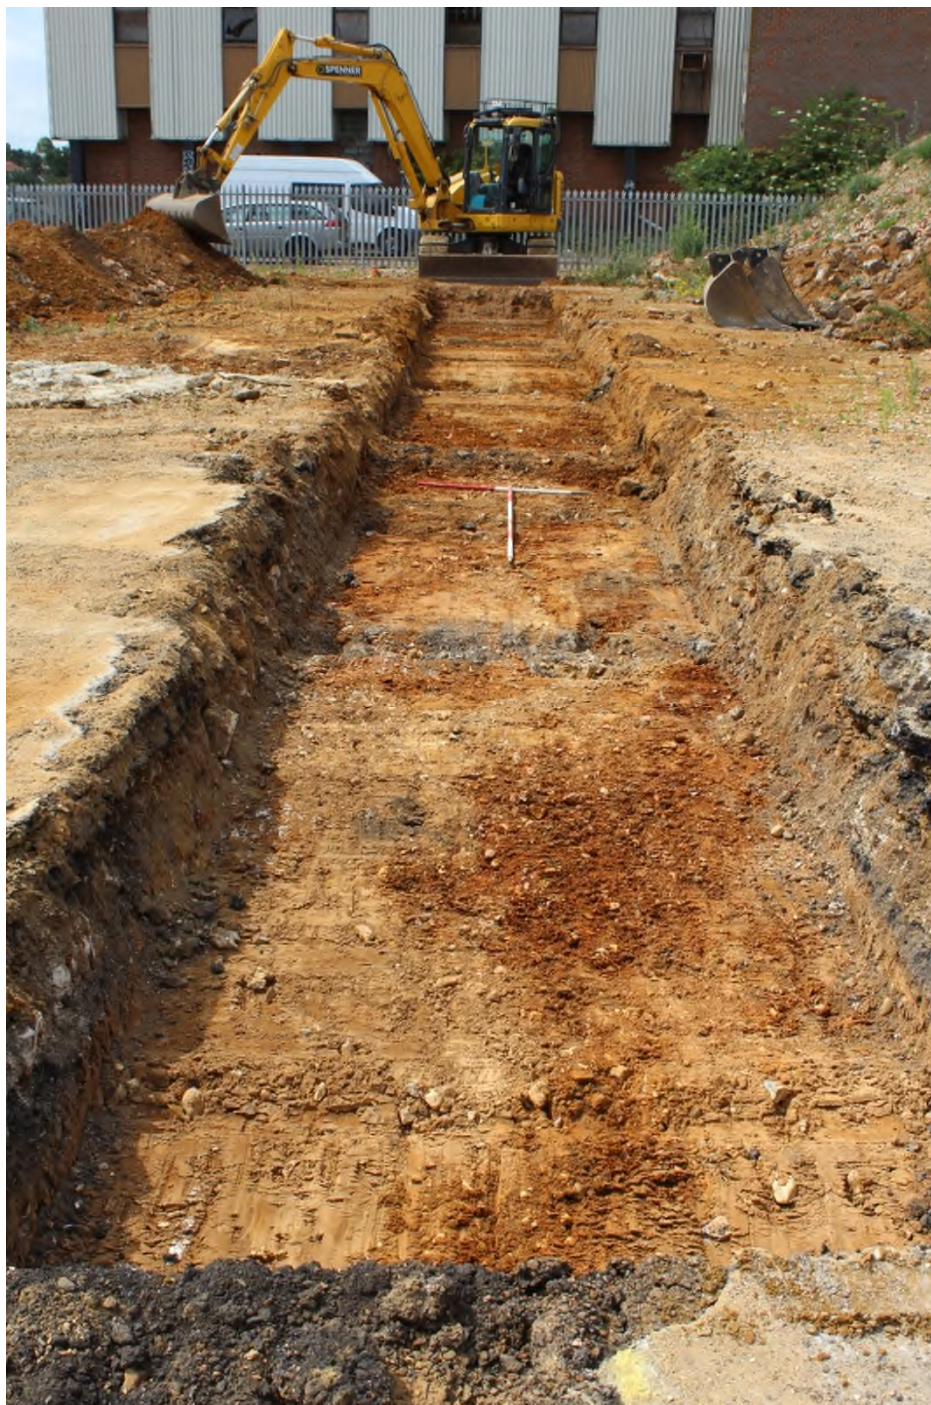
Plate 7: Trench 4, view south-west

Asphalt	(037)	0.14m	0.15m
Made ground (concrete rubble/ sand)	(038)	0.31m	0.32m
Natural sand (max. machined depth)	(039)	0.45m+	0.47m+
Summary			
Trench 4 was located in the west of the northern area of the site.			
The trench contained no archaeologically significant features or deposits.

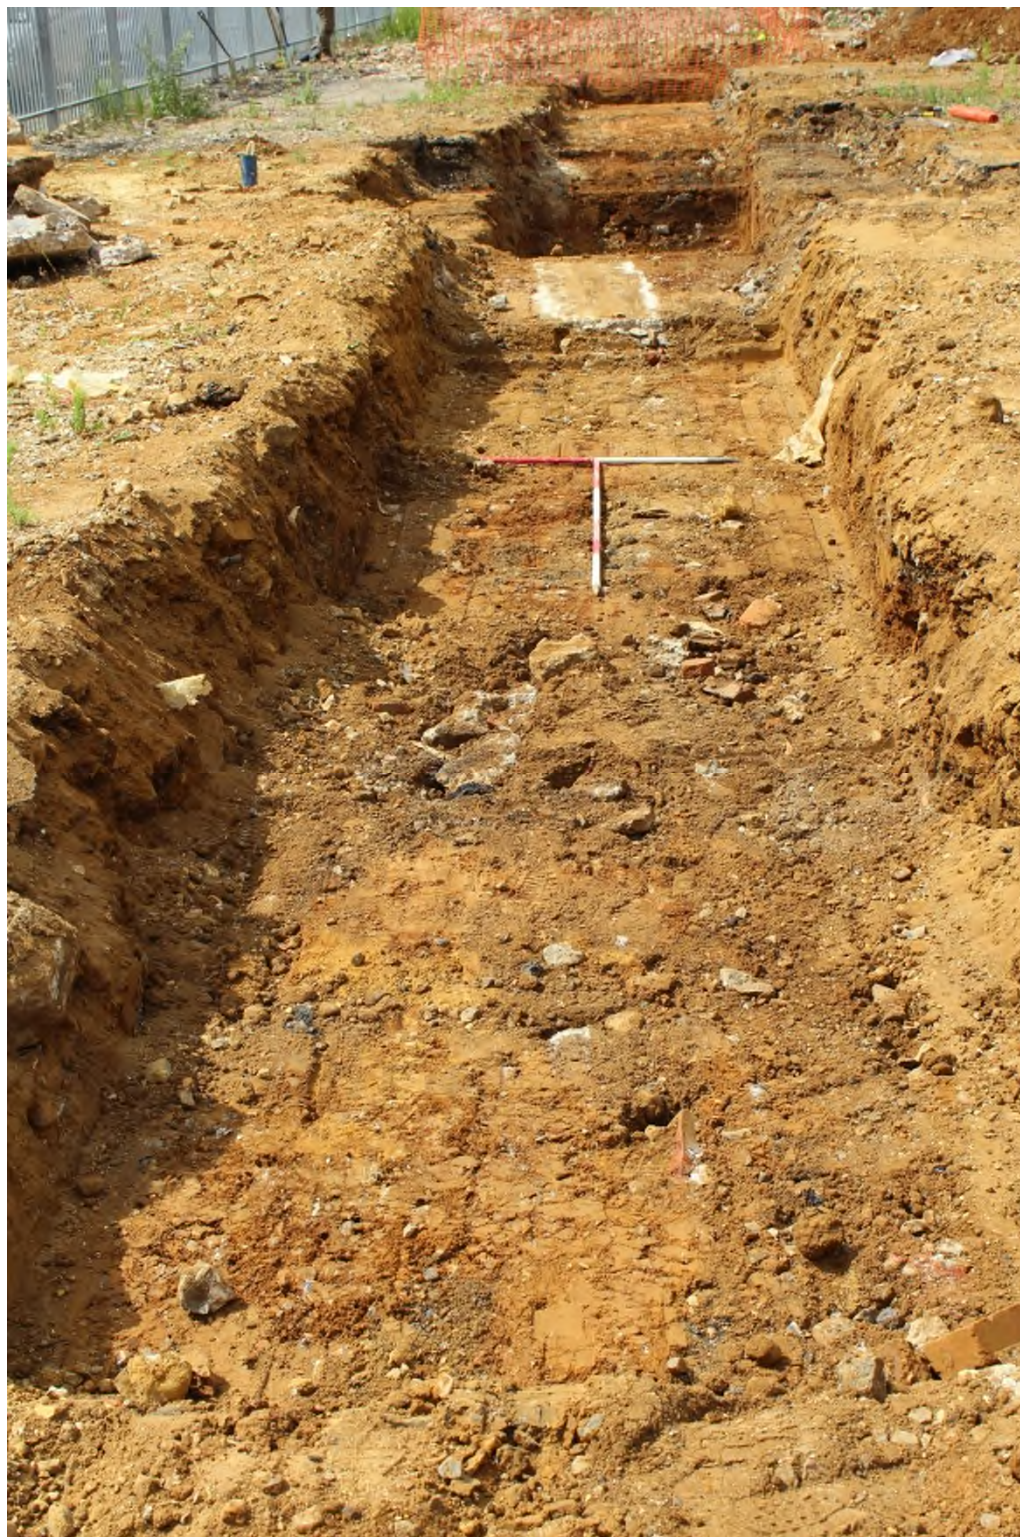
Plate 8: Trench 5, view north-west

TRENCH 5	Figure 2	Plate 8	
Trench Alignment: NW–SE	Length: 30m	Height of natural (m OD): 36.60–37.82	
Deposit	Context No.	Average Depth (m)	
		NW End	SE End
Modern demolition debris	(040)	0.34m	0.45m
Made ground (redeposited sand/ gravel)	(041)	0.82m	0.27m
Natural sand (max. machined depth)	(042)	1.16m+	0.72m+
Summary			
Trench 5 was located in the south of the northern area of the site.			
A sondage was excavated at the north-west end of the trench to ascertain the level of the natural sand and gravel. It is possible that the depth of overburden above the undisturbed natural sand here indicates part of an infilled quarry pit located in this area of the site.			
The trench contained no archaeologically significant features or deposits.

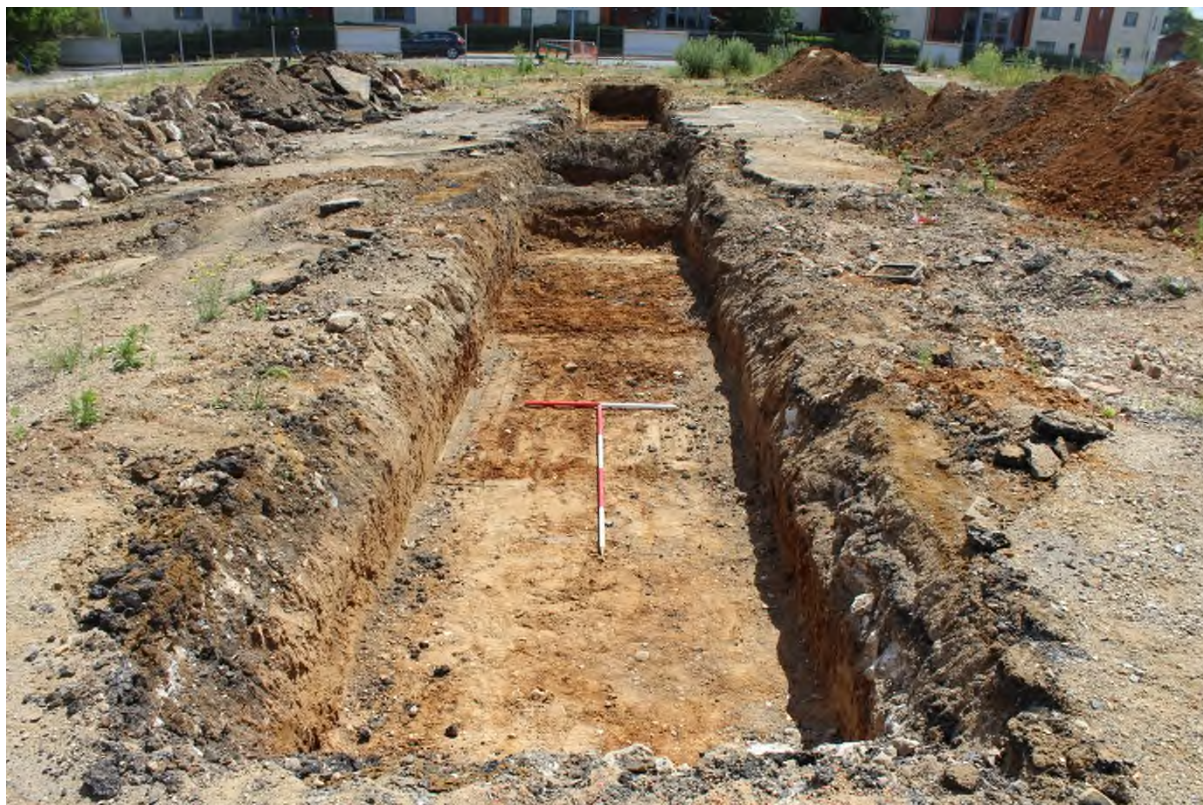
Plate 9: Trench 6, view south-east

Natural sand (max. machined depth)	(007)	0.85m+	0.93m+
Summary			
Trench 6 was located in the centre of the northern area of the site.			
The trench contained no archaeologically significant features or deposits.

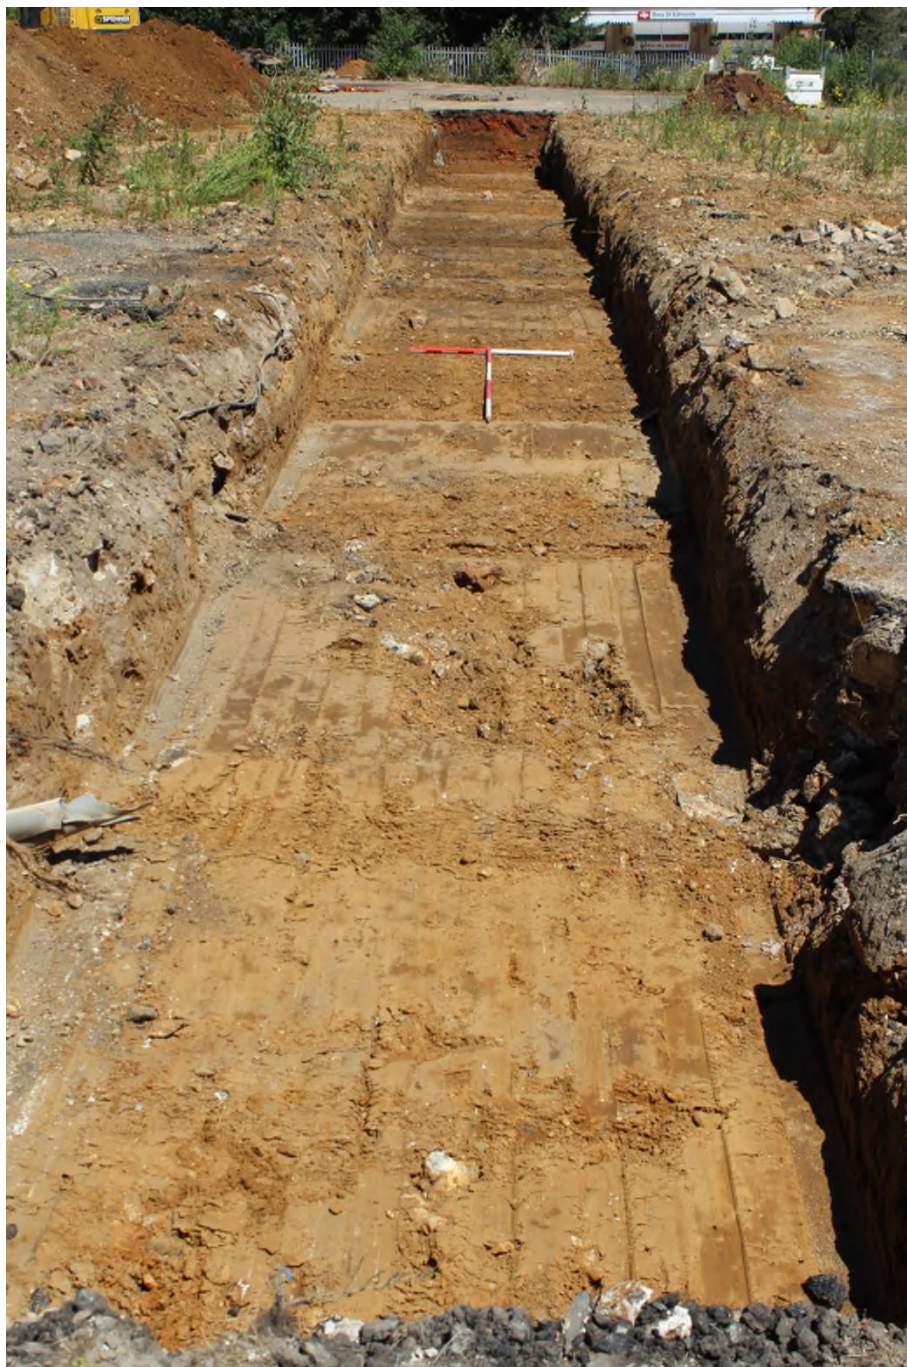
Plate 12: Trench 8, view north

Trench 8 was located in the east of the northern area of the site.
 The trench contained no archaeologically significant features or deposits.

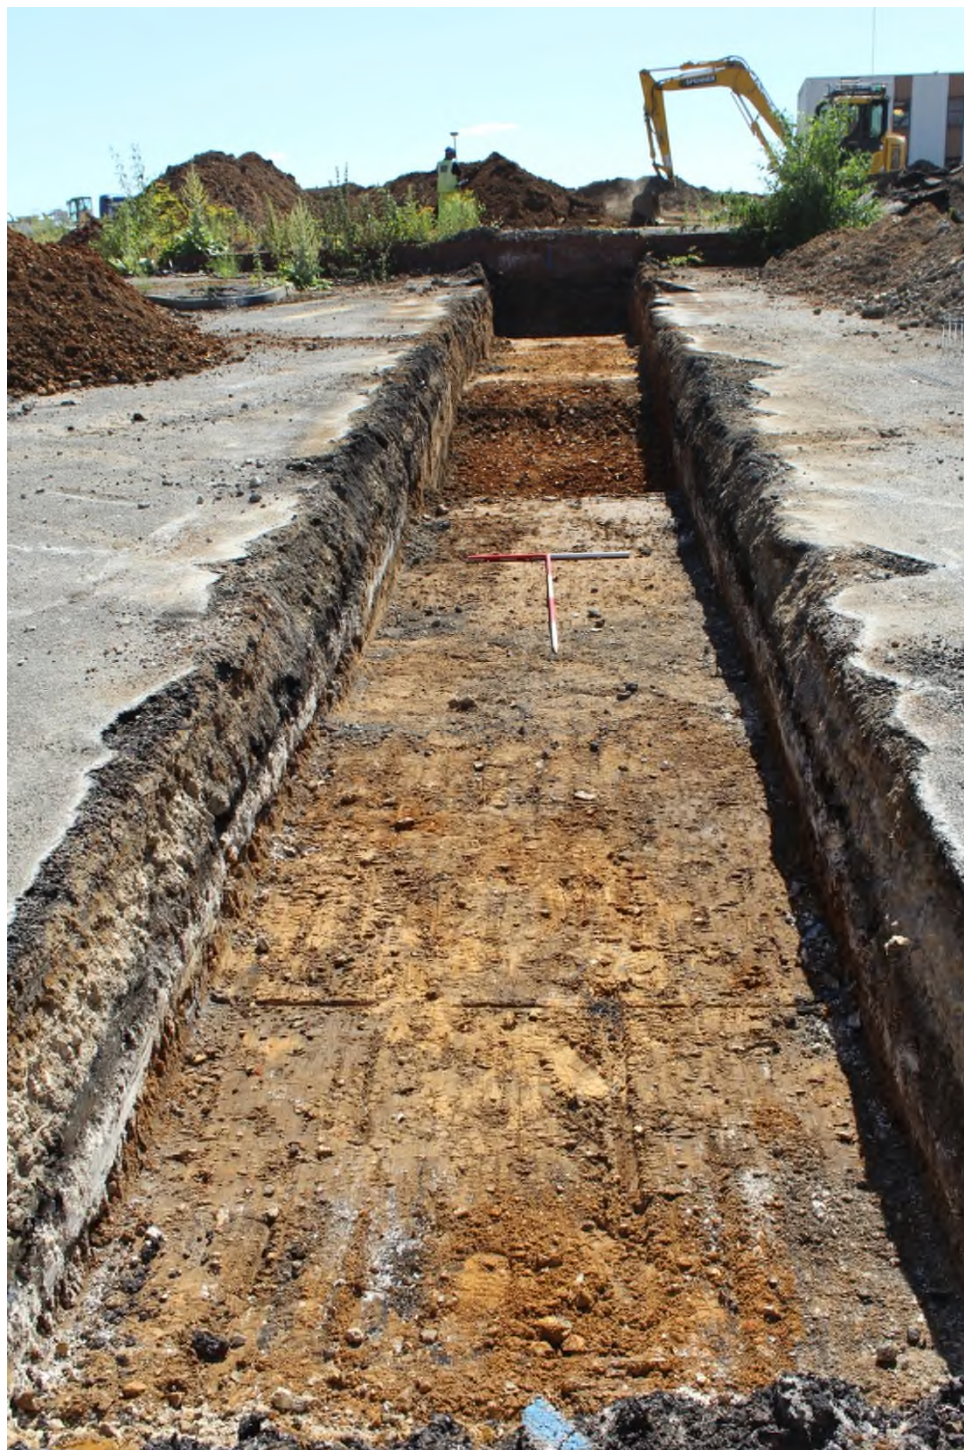
Plate 13: Trench 9, view south-west from north-east end

TRENCH 9	Figure 2		Plates 13 & 14	
Trench Alignment: NE–SW	Length: 30m	Height of natural (m OD): 34.55–35.56		
Deposit	Context No.	Average Depth (m)		
		NE End	SW End	
Asphalt surface and gravel make-up	(036)	0.15m	0.15m	
Made ground (rubble layer)	(035)	0.27m	0.33m	
Coal/ bitumen levelling layer	(034)	0.15m	n/a	
Chalk levelling layer	(033)	0.18m	n/a	
Made ground (redeposited sand/ gravel)	(032)	0.13m	n/a	
Natural sand (max. machined depth)	(007)	0.88m+	0.48m+	
Summary				
Trench 9 was located in the north-east of the northern area of the site. The trench contained no archaeologically significant features or deposits.
