**HUBBARD'S FARM,  
HUBBARD'S CLOSE,  
COLHAM GREEN,  
LONDON BOROUGH OF  
HILLINGDON**

**ARCHAEOLOGICAL  
'STRIP, MAP & RECORD'  
INVESTIGATION AND  
WATCHING BRIEF**

**SITE CODE: HUF17**

**JULY 2018**

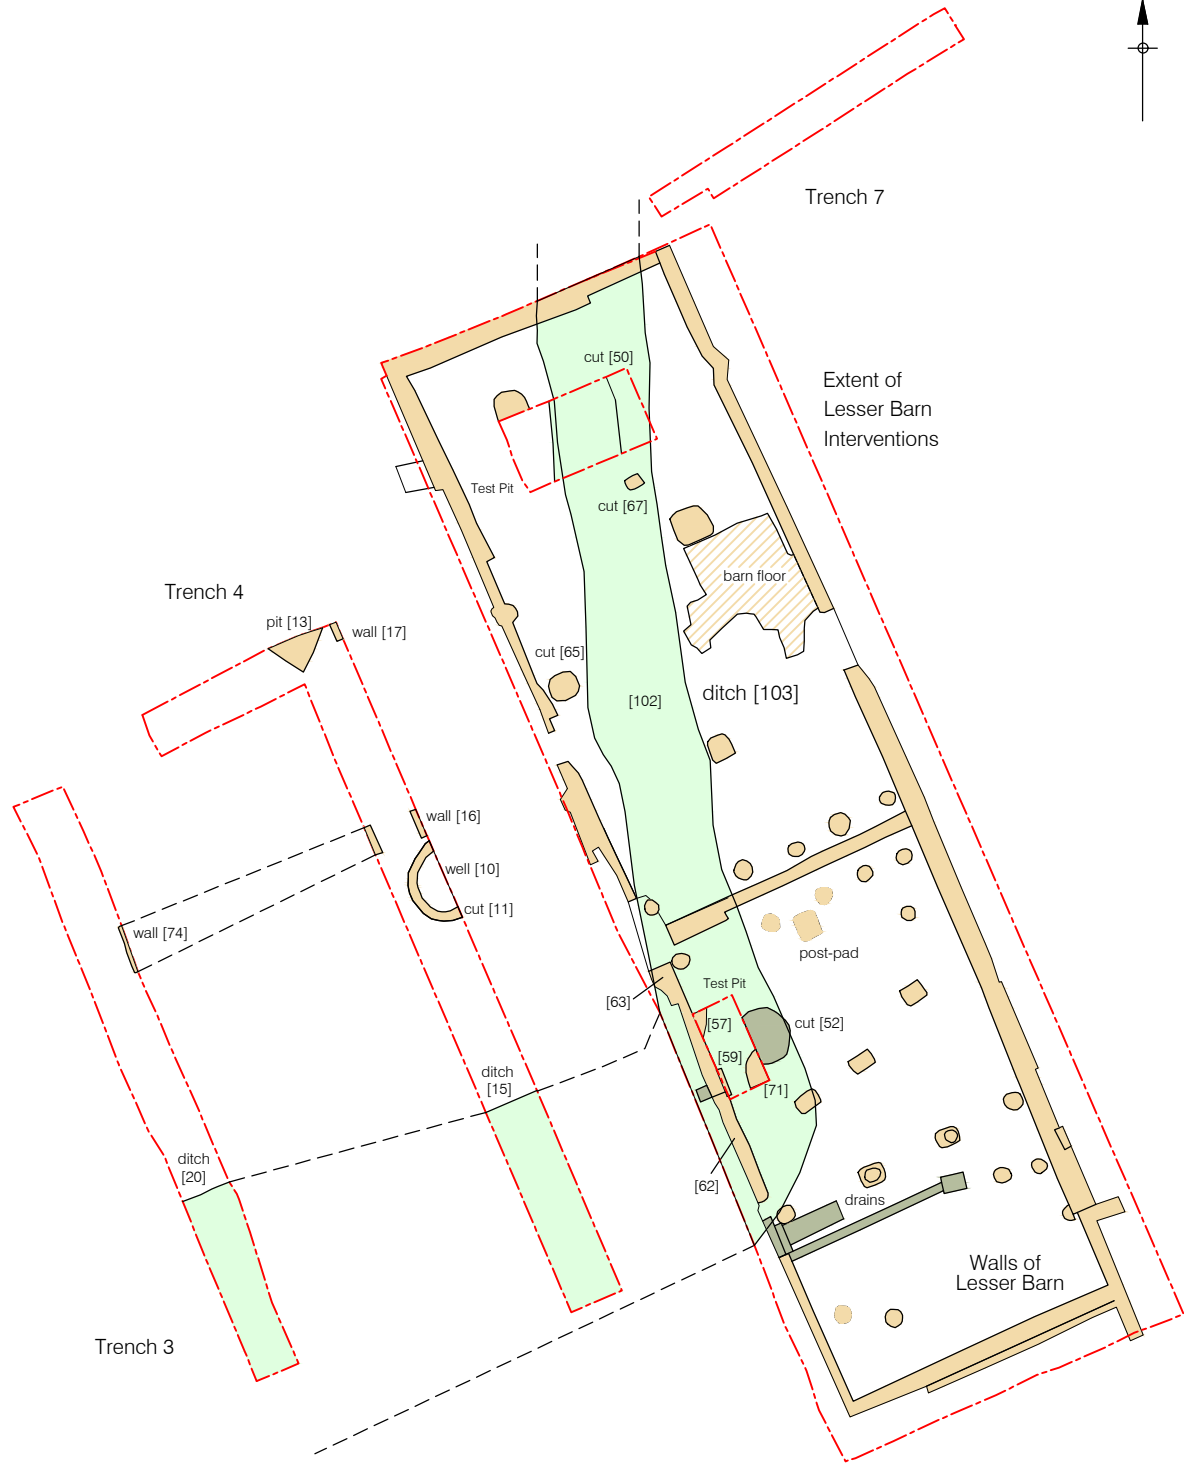
Figure 5  
Plan of Features in Lesser Barn Area  
1:125 at A4

- 8.8 **Phase 4: Post Medieval**
- 8.8.1 A large number of posts were seen across the entire footprint of the Lesser Barn, mostly representing internal walls seen prior to the collapse of the barn (Figure 5). Two were excavated as a representative sample. Post-hole [65] contained a sizable assemblage of rusted metal objects within a loose mid brown sandy silt [64]. The metal objects retrieved included items of agricultural and domestic use including iron chain, tethering loops, handles and a door hinge. Two stone hones also formed part of this assemblage.

- 8.8.10 Wall [17] was truncated by a 0.46m by 1.00m pit [13] (Figure 5) which continued beyond the northern limit of the excavation of Trench 4. This pit was filled with a dark brown silty sandy clay [12] with frequent fine to medium pebbles, occasional CBM fragments and moderate flecks of CBM and charcoal.

- 8.9 **Phase 5: Modern**
- 8.9.1 To the south of the Lesser Barn, layer [53] was truncated by a shallow circular pit [52] (Figure 5, Figure 6 Section 8). This pit contained a soft dark brown organic silt sandy clay [51] which contained two fragments of struck flint along with modern material including a soft toy.

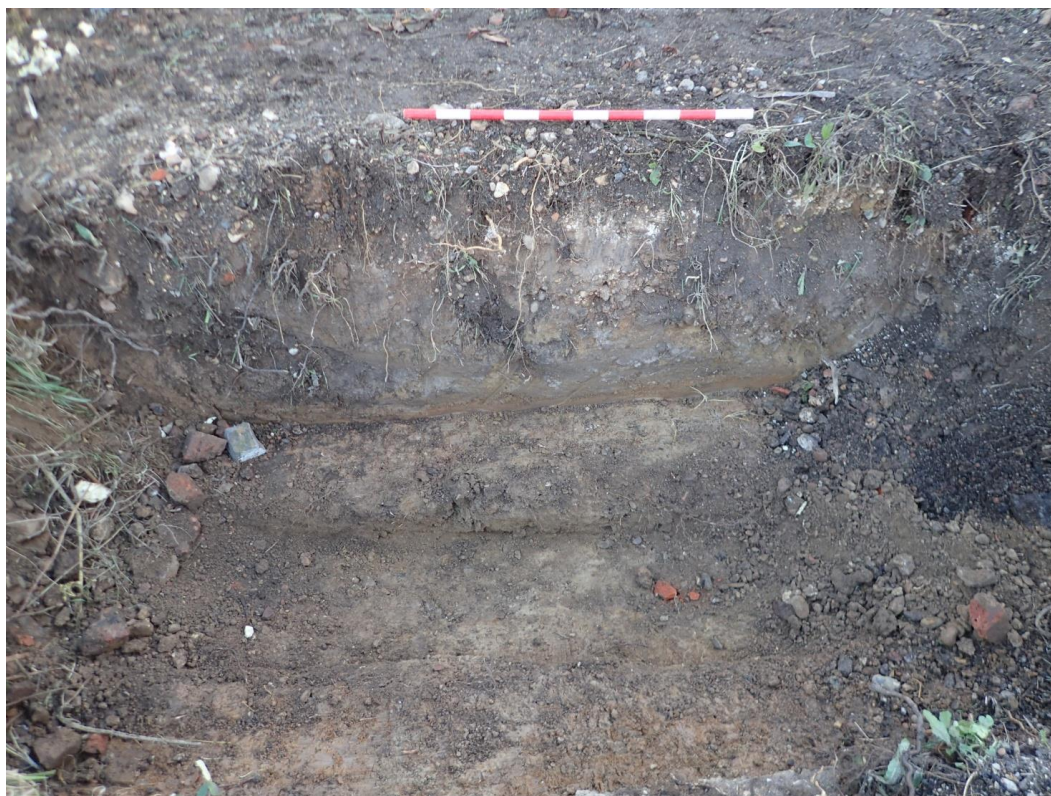
**Plate 1:** looking south, Trench 5, [+] over natural [45] with east-west wall cut for southern wing of Greater Barn visible at base (1m scale)

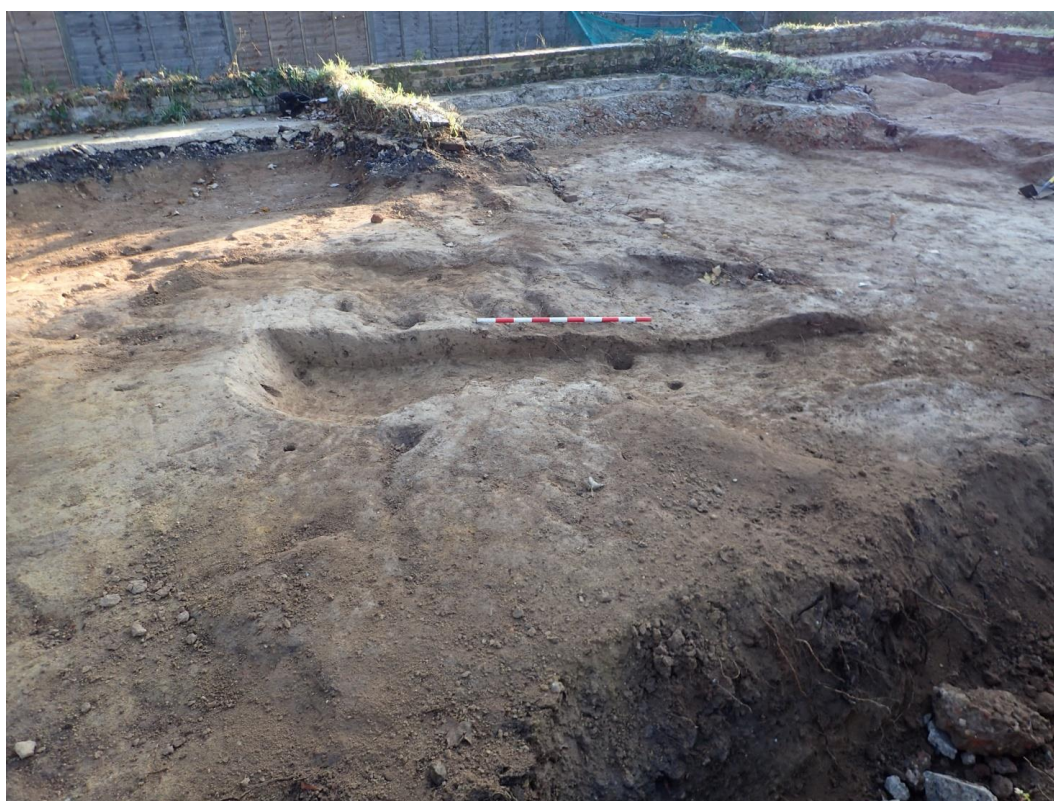
**Plate 2:** looking southeast, pits [40] and [42] within the footprint of the Greater Barn (1m scale)

8.2.2 Whilst no artefactual remains were recovered from layer [24], it was cut by a shallow semi-circular pit [42] (Figure 4; Plate 2) containing a dark brown sandy silt [41] from which pottery fragments, worked flint and fire cracked flint were retrieved. The pottery from this deposit has been broadly dated as between 50 and 400AD.

10.3.1 During the 2000 Oxford Archaeological Unit evaluation medieval remains were discovered, although during the current works within the Greater Barn only one medieval feature was seen. A small pit (Plate 2) was excavated, dating to between 1050 and 1200. Struck and burnt flint was also recovered from this feature.

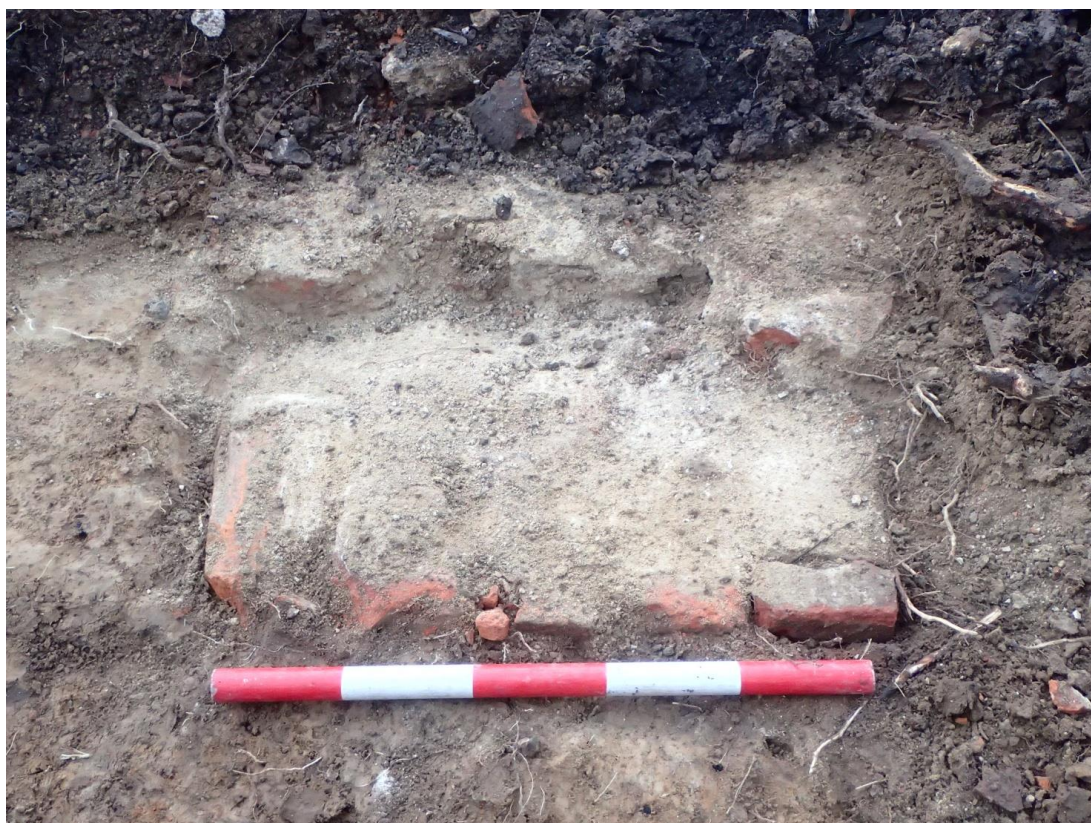
**Plate 3:** looking west, section of masonry [100] (0.5m scale)

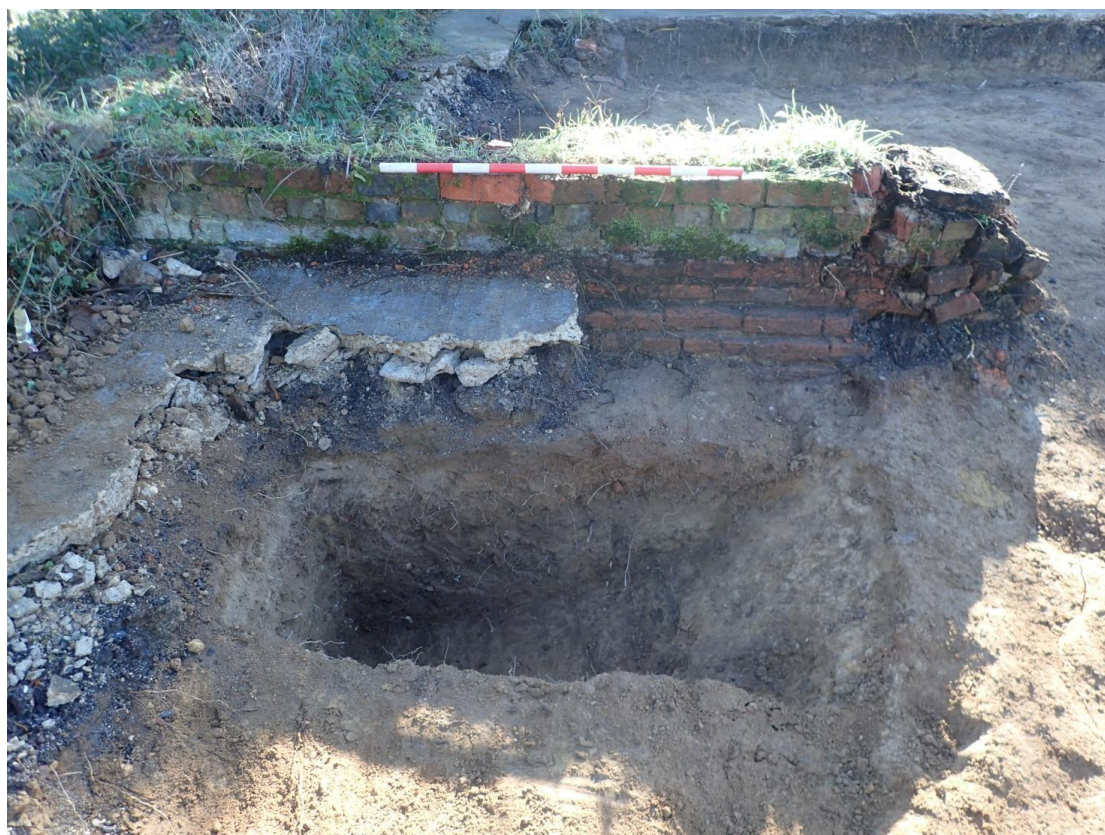
**Plate 4:** looking south, brickwork [25] and [75] over Ditch [23] (1m scale)

- 8.4.4 The construction cuts [26] for the internal bay walls [25] (Figure 6 Section 5) were seen to truncate the upper part of the ditch, and where the wall was able to be exposed two phases of masonry were seen (Plate 4). The lower three courses of brickwork [75] were constructed from pinkish orange red unfrogged bricks measuring between 221mm and 223mm in length by 100 to 120mm in width and 50mm in height, suggestive of handmade bricks laid with an irregular coursing and bond in the form of a stepped foundation surviving to a height of 43.60m OD. Due to the lack of visible mortar on the face of the brickwork, and inability to take a brick and mortar sample (due to the current listed status of the barn) a date has not been obtainable for this, however, it is not impossible for these bricks to have been reused. Above this were five courses of reddish brick [25] measuring between 210 and 220mm in length by 100mm in width and 70mm in height.

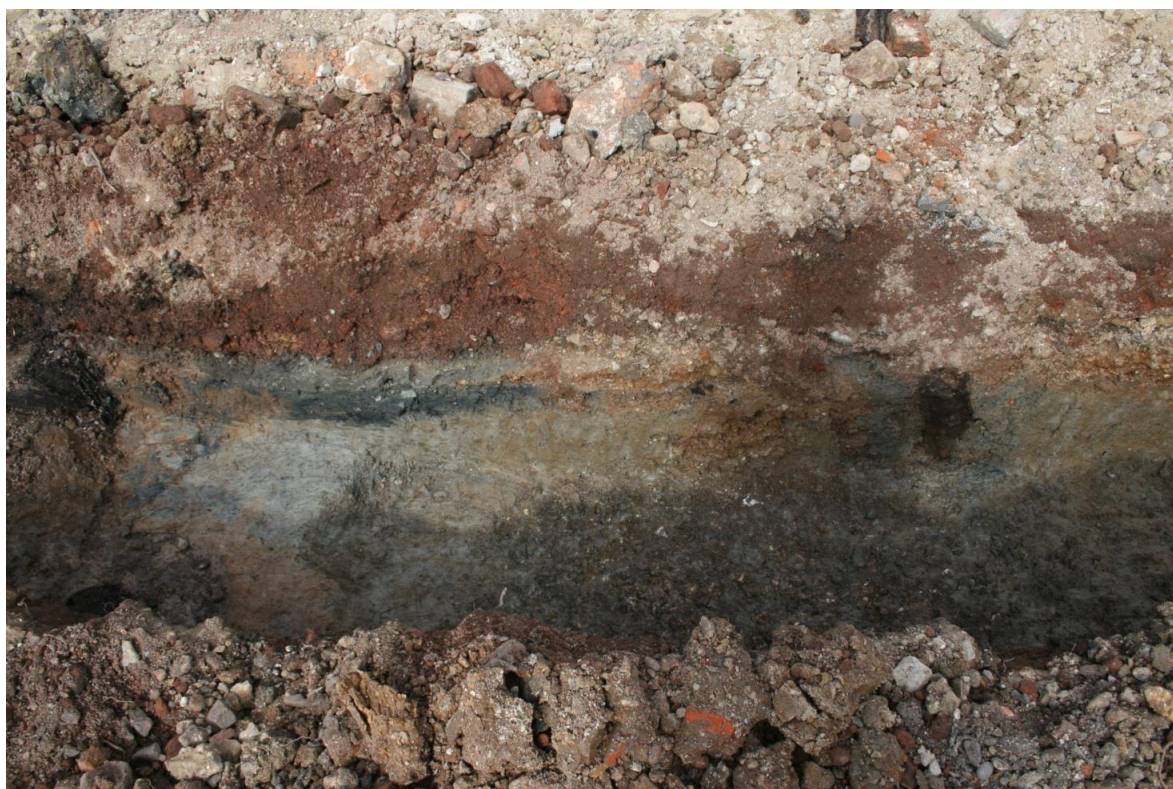
**Plate 5:** looking north, post [209] and pit [207] cut into layer [212] overlaying layer [208]

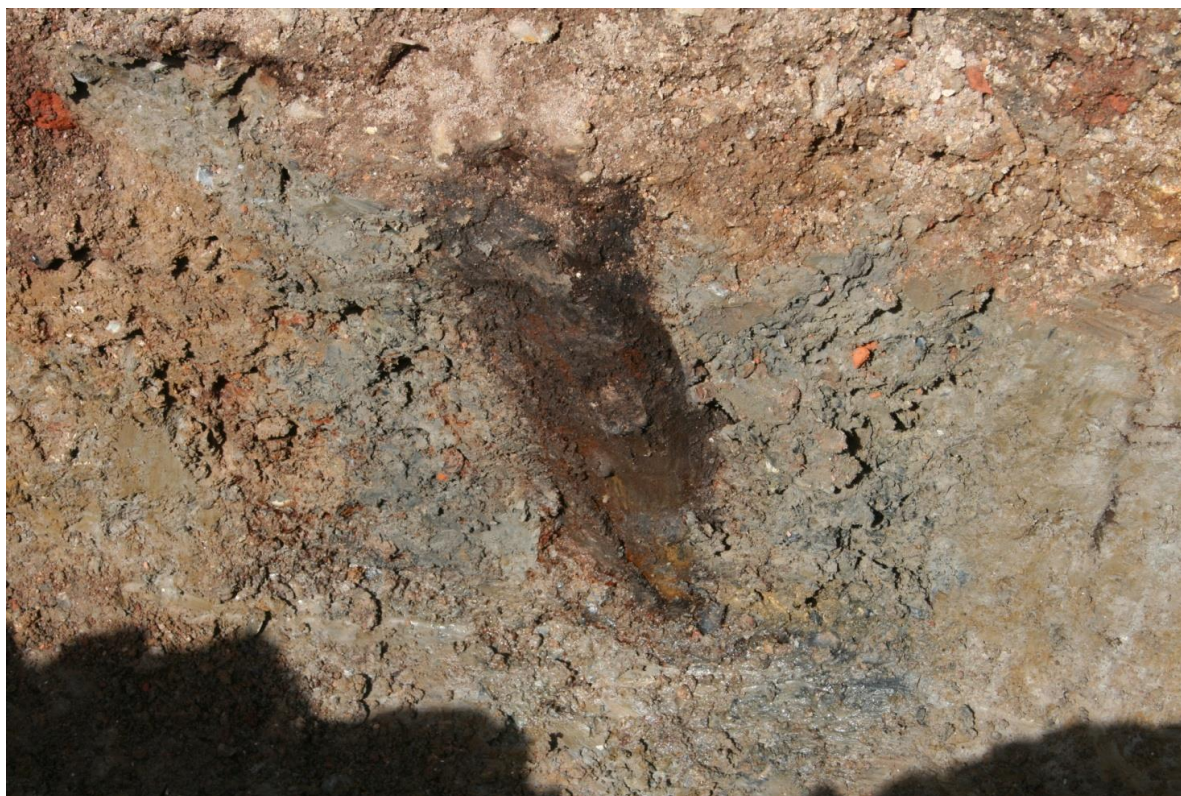
**Plate 6:** looking north, Detail shot of post [209] within posthole [211]

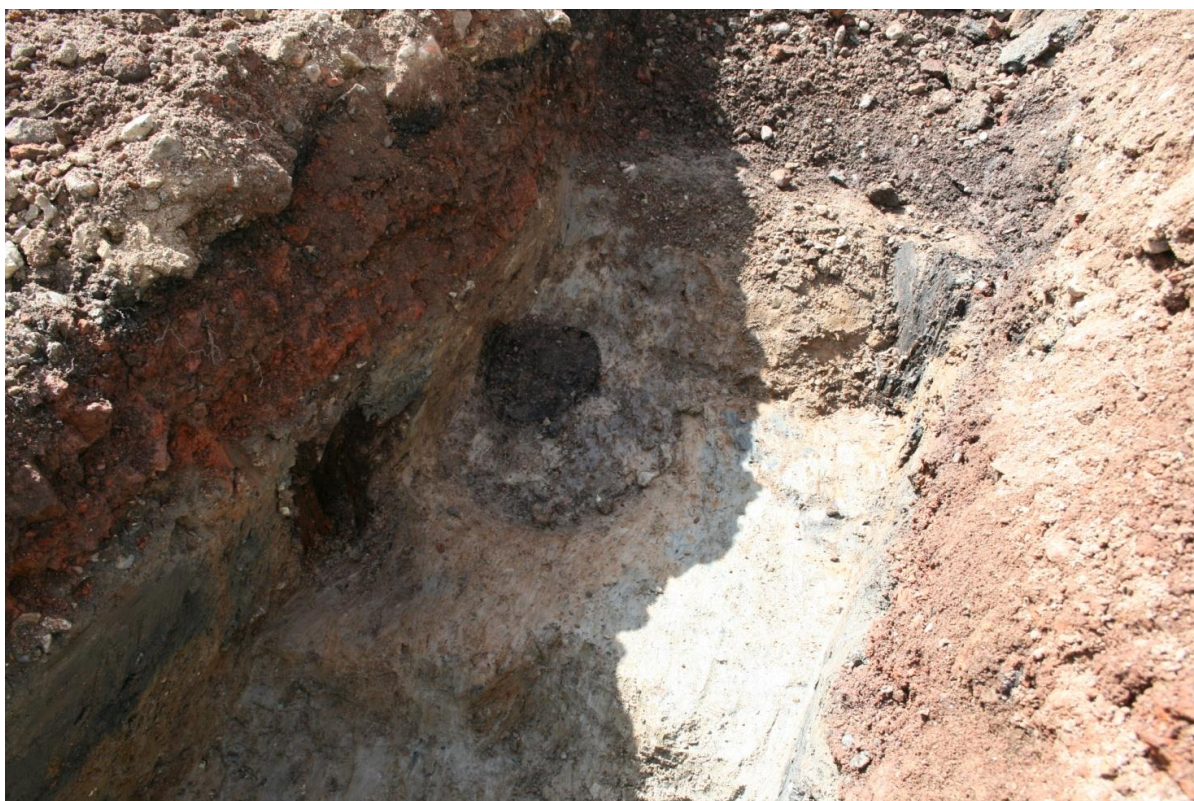
**Plate 7:** looking southwest, posts (from left to right) [217], [201] and [200]

8.4.10 Within posthole [203] an oval post [200] measuring 130mm by 140mm and continuing below the LOE was found, posthole [205] contained a rectangular post [201] measuring 110mm by 110mm and continuing below the LOE, postholes [211] and [219] contained circular posts [209] and [217] which both measured 120mm in diameter and continued below the LOE.

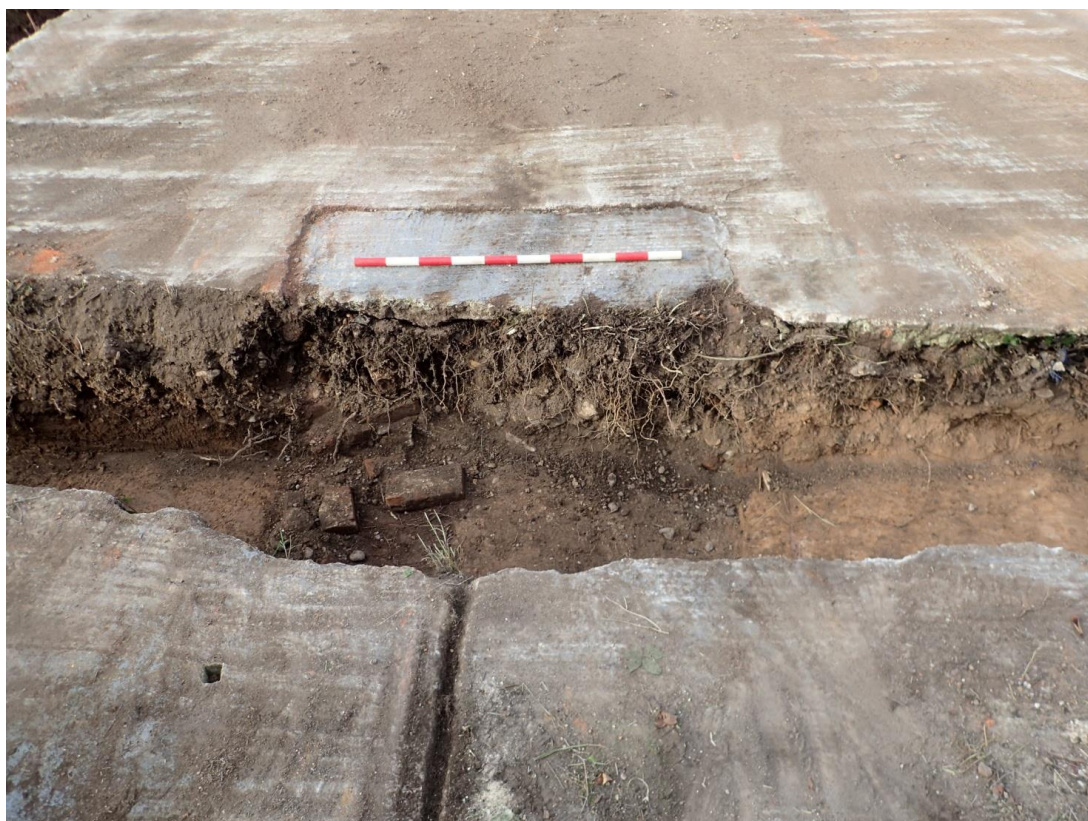
**Plate 9:** looking north, modern square pit [3] with ridge within concrete surface to the south (1m scale)

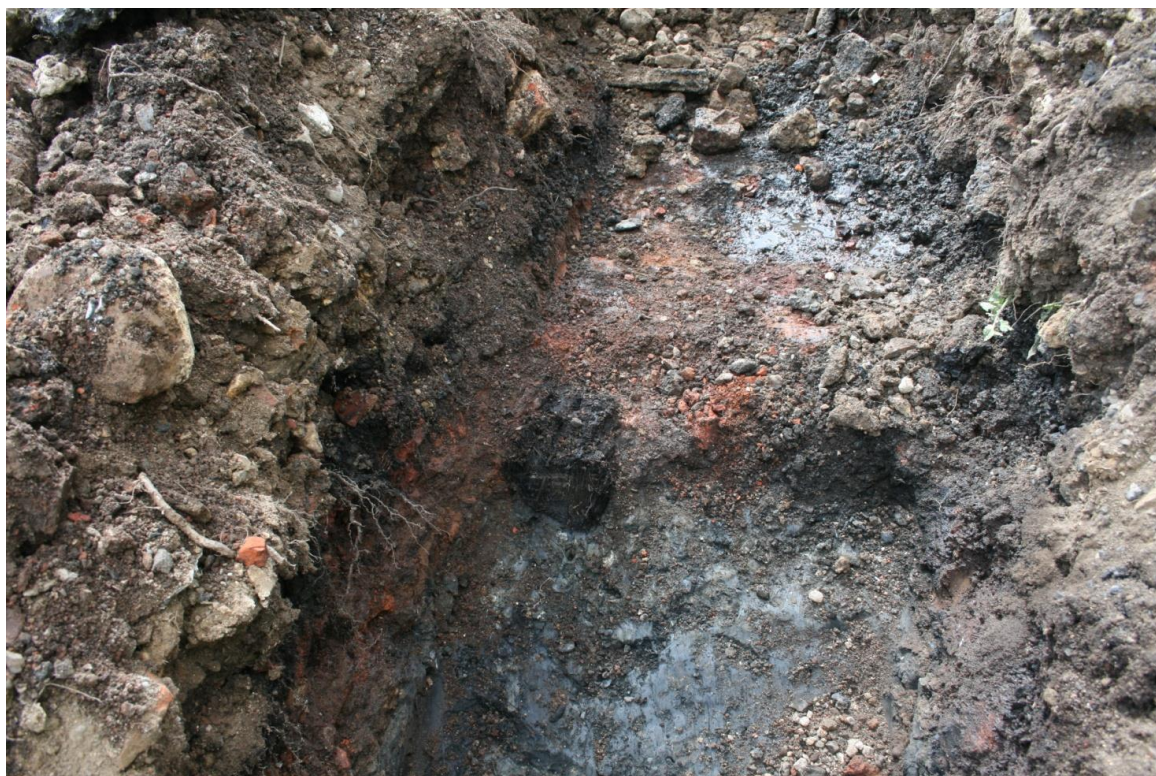
**Plate 10:** looking west, post [215]

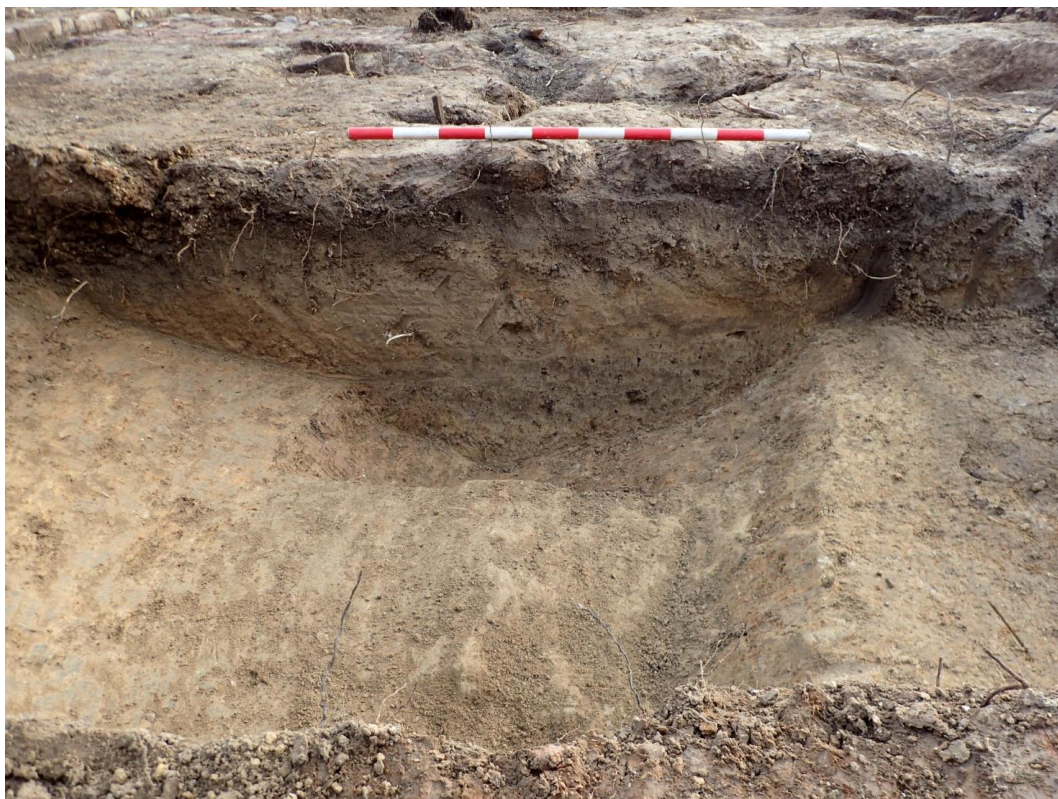
**Plate 11:** looking south, medieval ditch [50] within the footprint of the Lesser Barn (1m scale)

8.6.1 The earliest deposit found within the area of the Lesser Barn was a layer of mid yellow orange silty clay [18], [21] (Figure 6 Sections 3 and 4), [68] (Plate 11), [69], [106] and [223]. This natural brickearth was seen between the heights of 42.47m OD and 43.00m OD within the Lesser Barn, and up to a height of 43.27m OD within Trench 3.

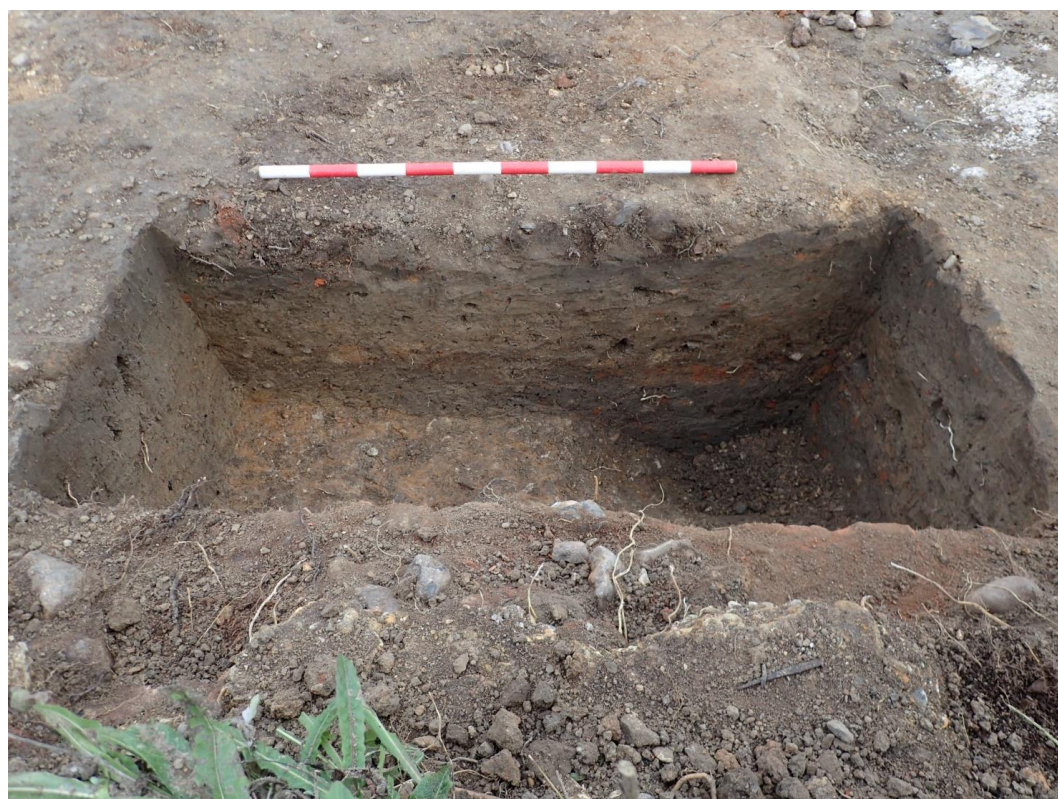
**Plate 12:** looking east, slot through modern Pit [52], layers [53], [54] and [55], post-medieval Pit [71] and Ditch [57] (1m scale)

- 8.7.5 Pit [71] was overlain by a firm mid yellow grey silty clay layer [54] [55] (Figure 5, Figure 6 Section 8; Plate 12) with frequent CBM and charcoal flecking and occasional fire cracked flint. This layer had dropped into the top of pit fill [70]. This was in turn overlain by a layer of compact mid grey silty clay [53] with frequent flecks of CBM and charcoal, occasional fragments of pottery, fire cracked flint and daub.

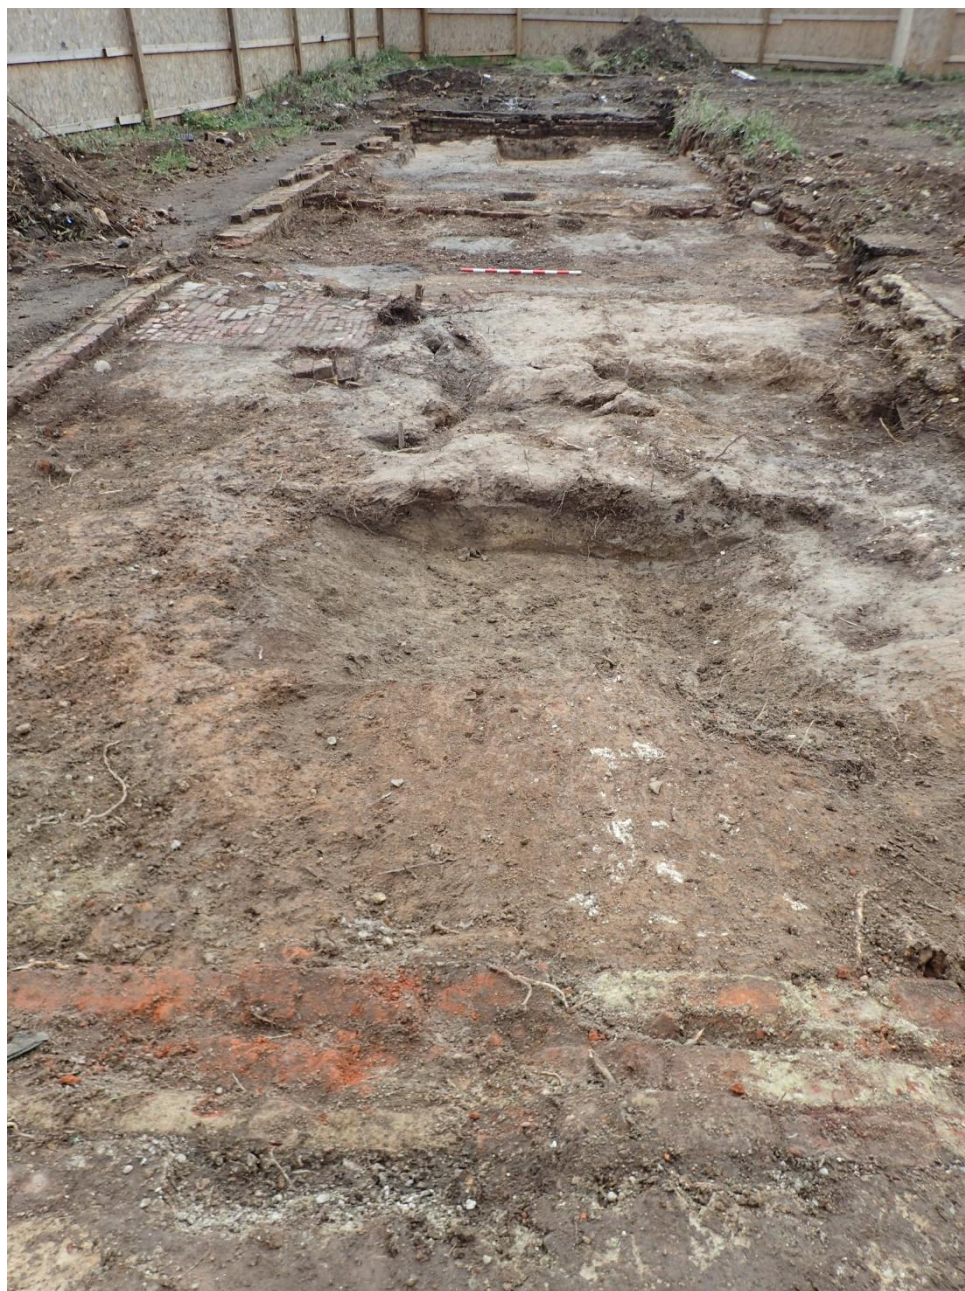
**Plate 13:** looking south, southern part of the Lesser Barn showing layer [53] (1m scale)

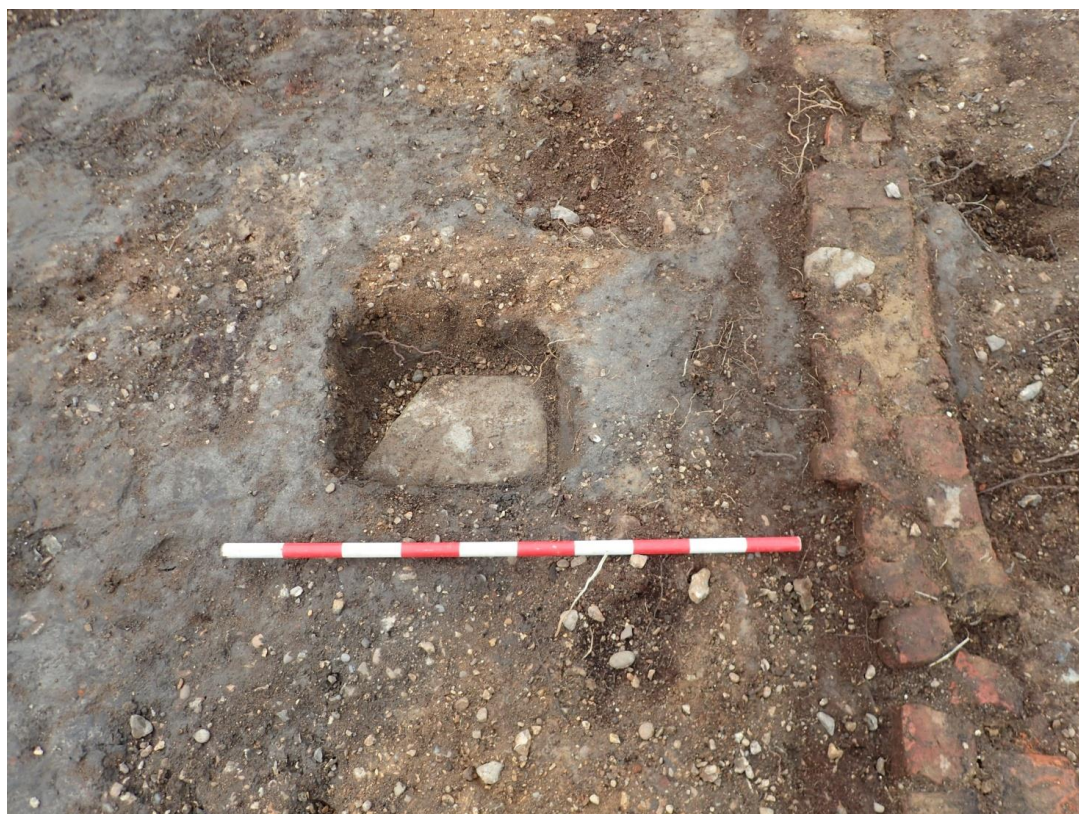
**Plate 14:** looking west, post-medieval post-hole with potential stone post pad (1m scale)

- 8.8.3 A large flat stone pad was seen in a posthole to the south (Plate 14), this was not lifted during excavation.
- 8.8.4 The construction cut [60] was seen to cut through layer [53] towards the southern end of the Lesser Barn, into which a wall of mid pinkish red brick had been constructed forming a brick pad foundation [59].

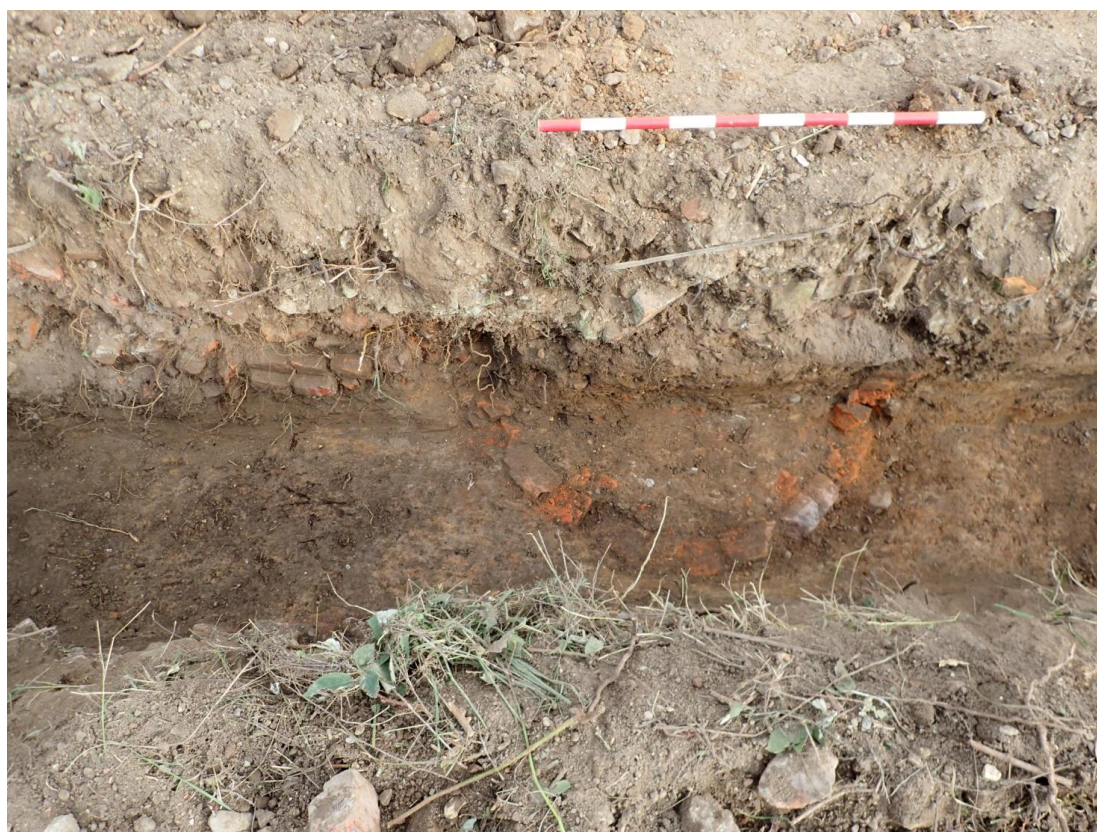
**Plate 15:** looking east, brick well [10] and truncated wall [16] (1m scale)

- 8.8.7 To the west of the Lesser Barn an east-west wall [74]/[16] (Figure 5 and Figure 6 Section 4) was seen in both Trench 3 and 4 where it had been truncated by previous works. This wall was constructed from orange (220mm by 105mm by 60mm) and purplish red (220mm by 110mm by 60mm) unfrosted bricks (Plate 15).

- 8.8.8 To the south of this a possible well was uncovered [11] (Figure 5, Figure 6 Section 4, Plate 15), constructed from pink (230mm by 95mm by 55mm) and orange (223mm by 115mm by 65mm) unfrosted bricks [10] and backfilled with a light brown grey silty clay [9] with occasional fragments of CBM and frequent charcoal and CBM flecking.

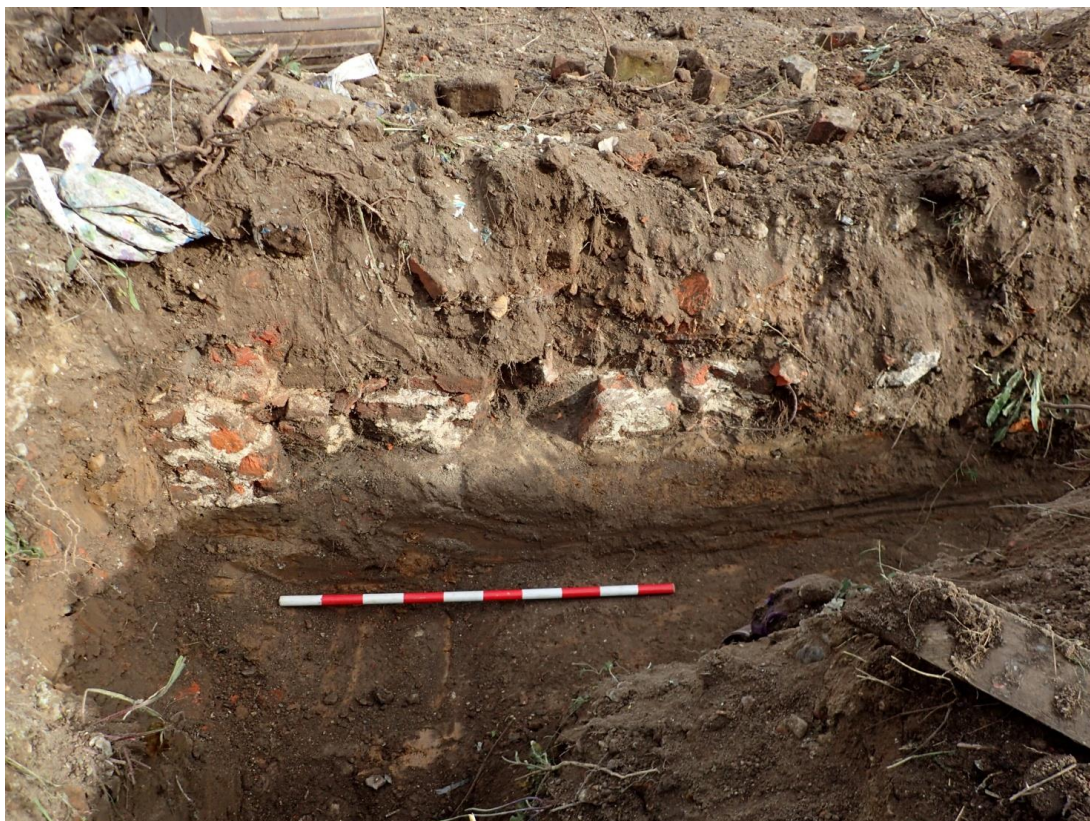
**Plate 16:** looking east, section of masonry [17] (1m scale)

- 8.8.9 Within the north-eastern corner of Trench 4 a small remnant of masonry was seen [17] constructed from red unfrosted bricks in a white fine sandy lime mortar (Figure 5, Figure 6 Section 4; Plate 16).

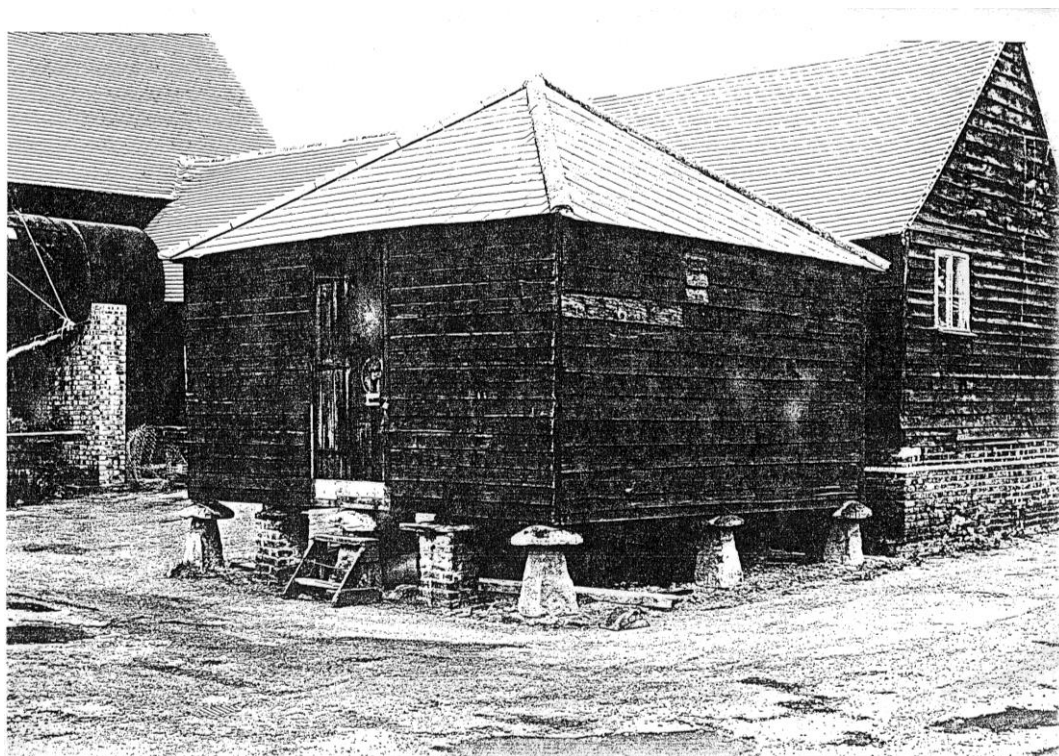
**Plate 17:** looking southeast, showing the granary building in its previous location to the north of the southern wing of the Greater Barn, c. 1970s courtesy of Penny Copeland

- 8.4.6 The construction cut [110] and masonry foundation of a brick pillar [109] (Figure 4 and Figure 7 Section 16) measuring 0.55m by 0.50m and surviving to a height of 0.40m was seen towards the north of the presumed southern wing of the Greater Barn. This structure may have been a pillar foundation for the Granary in its previous location (Plate 17).

10.4.2 The construction of the Greater Barn clearly post-dated the north-south ditch which contained post-medieval pottery (dated 1600-1900) and CBM (1480-1700). Evidence of repair and alteration to the masonry of the Greater Barn was seen during the evaluation and watching brief, which is not unexpected for a functional building on a farm complex. Also, evidence of the southern wing of the barn along with the previous location of the Granary building was also seen in the form of a masonry pillar to the north of the southern wing (Plate 17).
