**LAND AT 32C–34A NEWGATE  
STREET, DODDINGTON,  
CAMBRIDGESHIRE**

**AN ARCHAEOLOGICAL  
EVALUATION**

**PCA REPORT NO: R13330**

**SITE CODE: ECB5421**

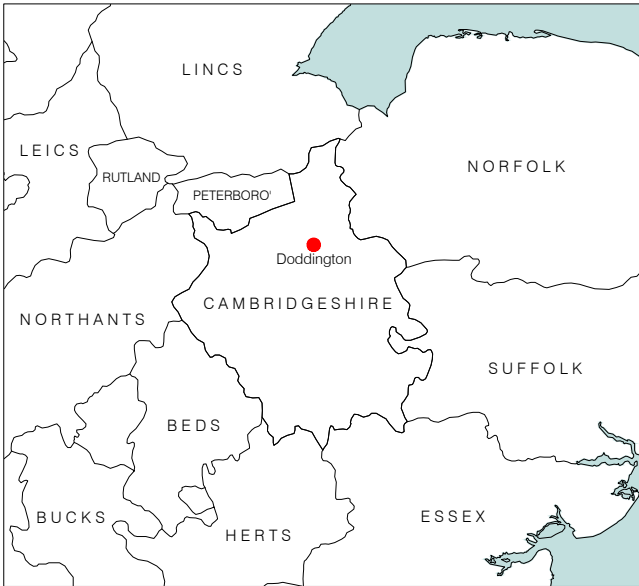
Figure 2  
Detailed Trench Location  
1:500 at A4

- 1.5 A total of three 1.8m wide evaluation trenches (c. 26.5, 21.5 & 27.5m long) totalling 135.9 sq. m of trenches were excavated and recorded (Figure 2). The WSI originally called for three 1.8 x 25m trenches, positioned on the footprints of the proposed new buildings. The positions and lengths of these trenches were slightly adjusted due to the presence of on-site constraints such as power and sewer lines, but the sample provided by the trenches remains approximately 5% of the overall development area.

TRENCH 1	Figure 2	Plate 3	
Trench Alignment: NW–SE	Length: 26.54m	Level of Natural (m OD): 0.88–1.00	
Deposit	Context No.	Maximum depth below ground level (m)	
		NW End	SE End
Topsoil	(100)	0.31	0.32
Subsoil	(101)	0.48	0.42
Natural Clay	(102)	0.50+	0.43+
<p><b>Summary</b></p> <p>Trench 1 was located in the northern half of the site area.</p> <p>The trench contained three ditches, all of which were aligned approximately north-west to south-east.</p> <p>Datable material recovered from the features was limited, being confined to pottery and iron recovered from ditch slots [104] and [110]. These assemblages are of medieval and post-medieval date, although the medieval potsherd is considered to be residual.</p>

TRENCH 2	Figure 2	Plate 5	
Trench Alignment: NE–SW	Length: 27.47m	Level of Natural (m OD): 0.50–0.70	
Deposit	Context No.	Maximum depth below ground level (m)	
		NE End	SW End
Topsoil	(100)	0.34	0.35
Subsoil	(101)	0.44	0.38
Natural Clay	(102)	0.45+	0.39+
<p><b>Summary</b></p> <p>Trench 2 was located in the western half of the site area.</p> <p>The trench contained four ditches and four pits, the latter arranged into two 'pit alignments', all of which were aligned approximately north-west to south-east.</p> <p>Datable material recovered from the features was limited, being confined to pottery, ceramic building material and clay tobacco pipe, recovered from ditch slots [112], [114] and Pit [132]. These assemblages are of post-medieval date.</p>

TRENCH 3	Figure 2	Plate 8	
Trench Alignment: NW–SE	Length: 21.43m	Level of Natural (m OD): 0.73–0.86	
Deposit	Context No.	Maximum depth below ground level (m)

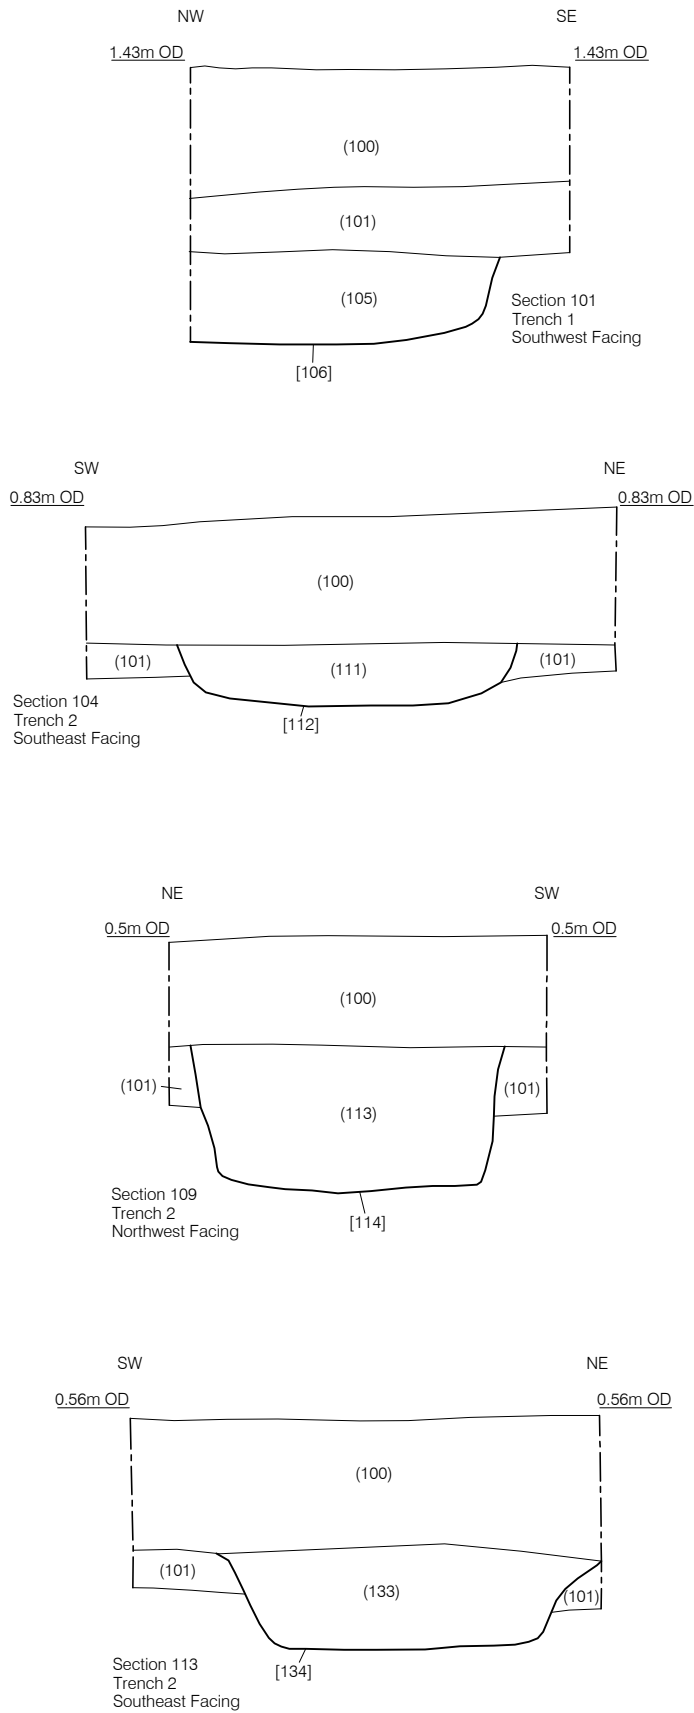
6.2.4 Ditch [106] (DITCH 5) (Plate 4, Figure 3, Section 101) was located at the north-west end of the trench and appeared to be aligned north-west to south-

- 6.3.3 Ditch [112] (DITCH 7) (Figure 3, Section 104) was located near the south-west end of the trench and was aligned north-west to south-east, extending beyond the limits of excavation in both directions. It was relatively narrow and shallow, measuring c. 0.90m wide by 0.17m deep. It contained a single fill (111), a dark brown/ black clayey silt which contained a small assemblage of Refined Whiteware pottery, some with transfer printed decoration, dating to AD 1820–1900. The feature was visible cutting through the subsoil in the edge of the trench.

- 6.3.4 Ditch [114] (DITCH 4) (Plate 6, Figure 3, Section 109) was located near the south-west end of the trench and was aligned north-west to south-east,

- 6.3.10 Pit [134] (PIT ALIGNMENT 1) (Figure 3, Section 113) was located centrally within the trench and was not fully visible in plan (c. 0.90m wide by 0.26m deep), extending beyond the limit of excavation to the north-west. It had a single fill (133), a dark brownish-grey clayey silt which contained no finds. The feature formed a part of a possible pit alignment with Pit [118] in Trench 2 and Pit [130] in Trench 3. The feature was visible cutting through the subsoil in the edge of the trench.

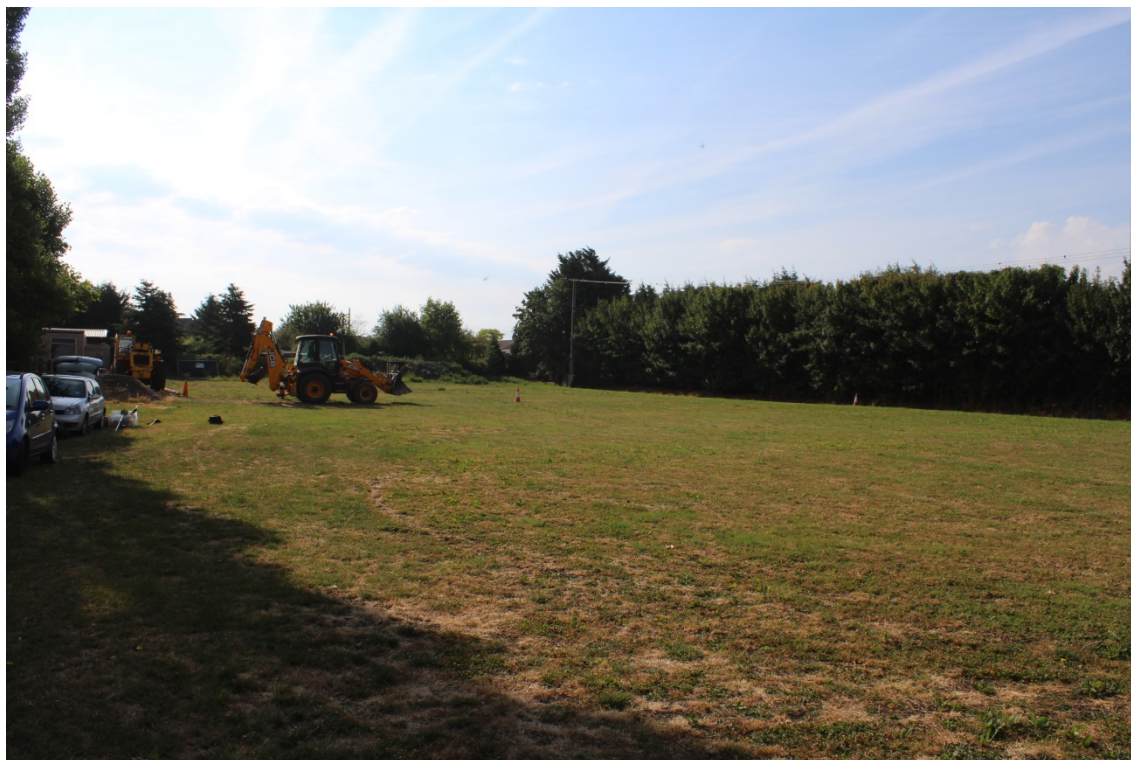
- 1.1 A programme of archaeological trial trench evaluation was undertaken by Pre-Construct Archaeology Ltd (PCA) on land to the rear of 32C-34A Newgate Street, Doddington, Cambridgeshire, PE15 0SR (centred on Ordnance Survey National Grid Reference (NGR) TL 3951 9034) on the 9th and 10th of July 2018 (Figure 1; Plate 1).

Plate 1: The site, view south-east

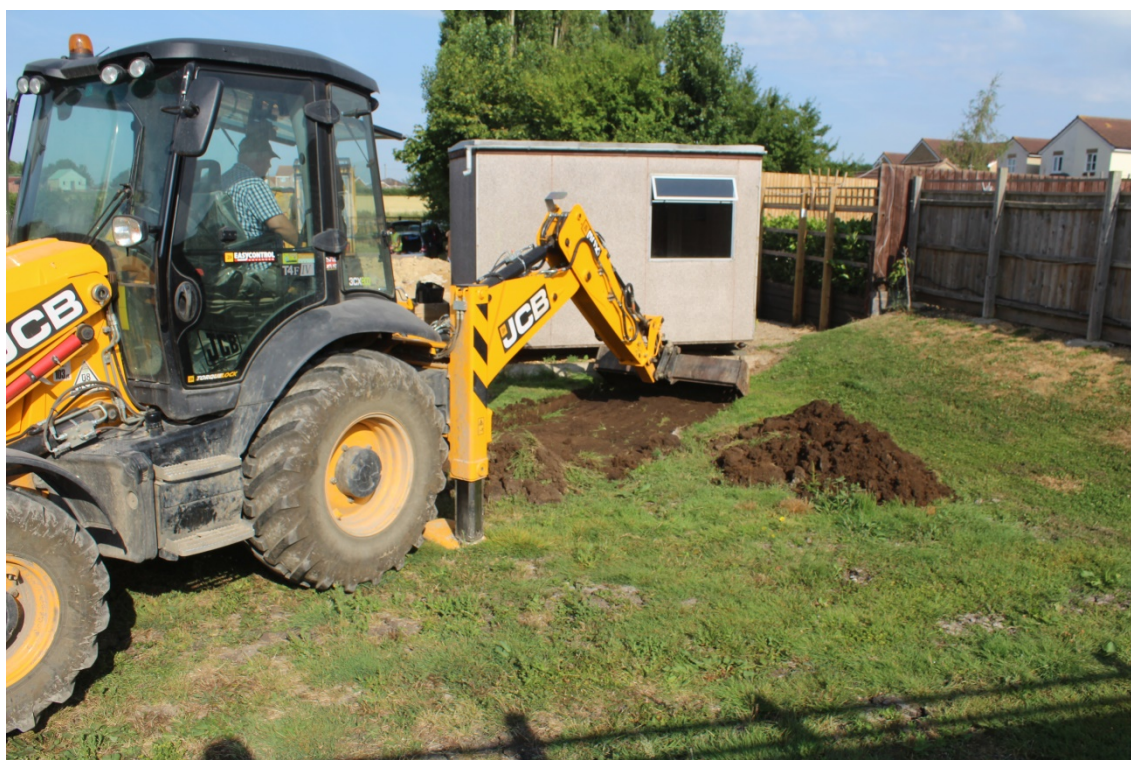
- 4.2.1 Ground reduction during the evaluation was carried out using a 7 ton 180° wheeled mechanical excavator (Plate 2). Topsoil and other overburden deposits were removed in spits down to the level of the undisturbed natural geological deposits, where potential archaeological features could be observed and recorded. The majority of the features were partially visible cutting through the disturbed subsoil layer; however, given the late post-medieval to modern date of these features the level was machined down to the natural deposits, in order to expose any archaeological features of earlier date.
- 4.2.2 Exposed surfaces were cleaned by trowel and hoe as appropriate and all further excavation was undertaken manually using hand tools.

Plate 2: The site, machining, view north-west

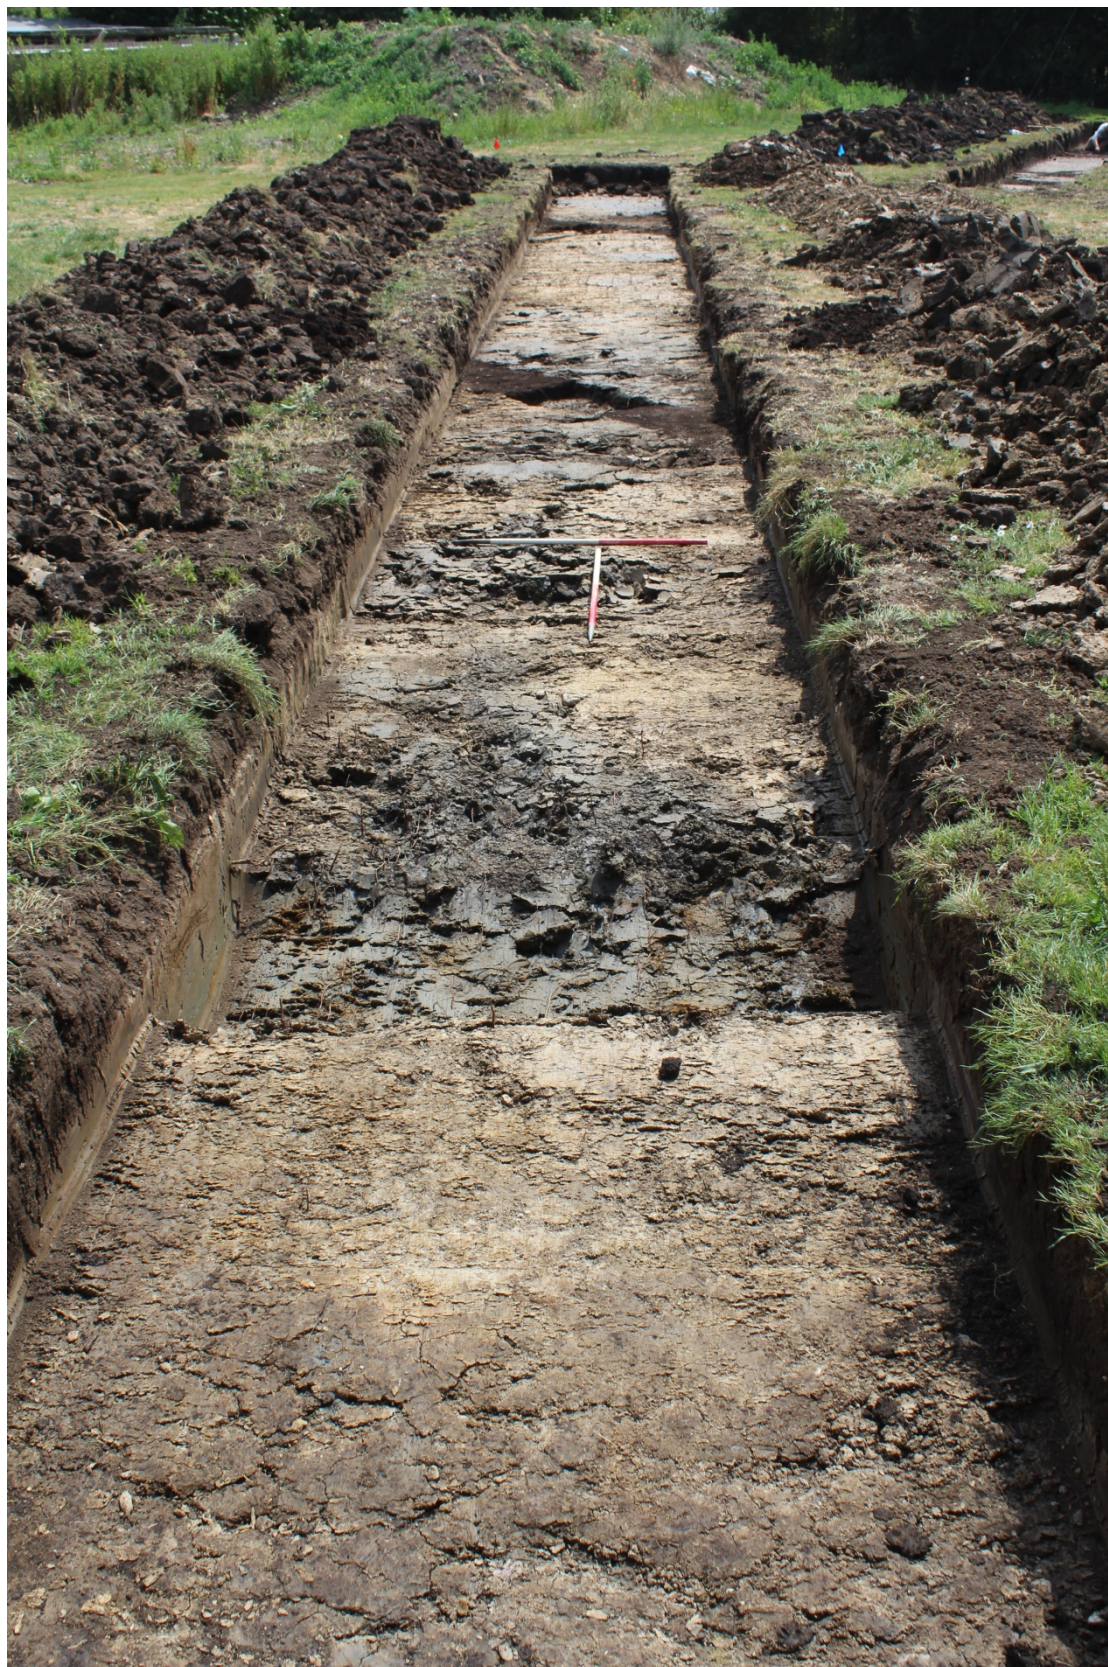
6.2.1 Trench 1 (Plate 3) contained three ditches, all of which were aligned approximately north-west to south-east and continued out of the trench in both directions.

Plate 3: Trench 1, view south-east

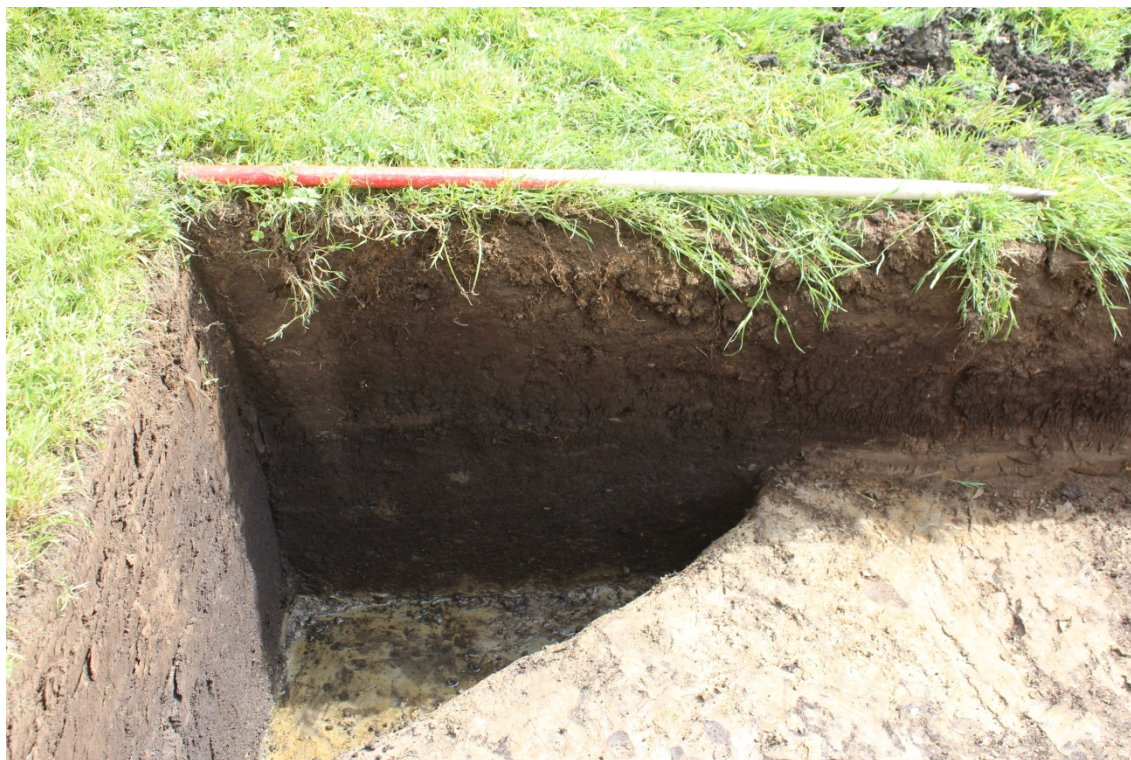
east, extending beyond the limits of excavation to the west, east and north. The exposed part of the feature was narrow and shallow, measuring c. 0.42m+ wide by 0.25m deep. It contained a single fill (105), a dark black/grey clayey silt which contained no finds. The feature was sealed by the subsoil.

Plate 4: Ditch [106], Trench 1, view north-east

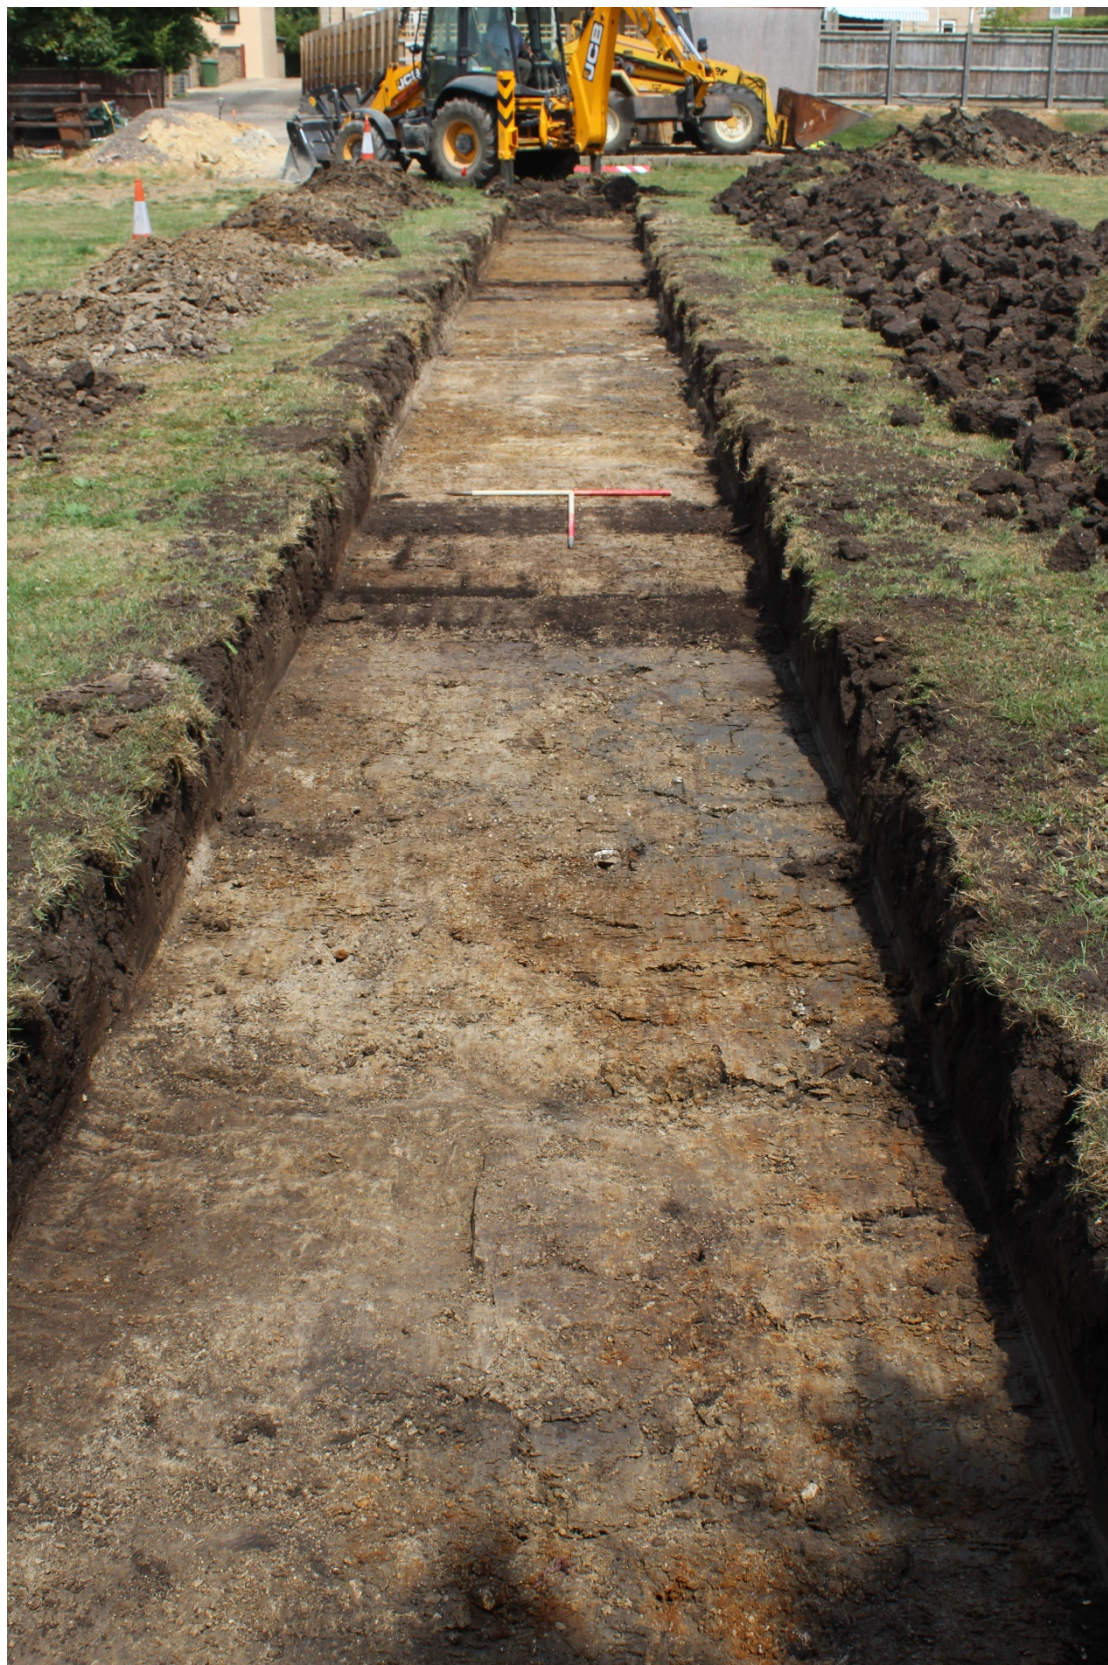
- 6.3.1 Trench 2 (Plate 5) contained four ditches and four pits, the latter forming two 'pit alignments', all of which were aligned approximately north-west to south-east and continued out of the trench in both directions.

Plate 5: Trench 2, view north-east

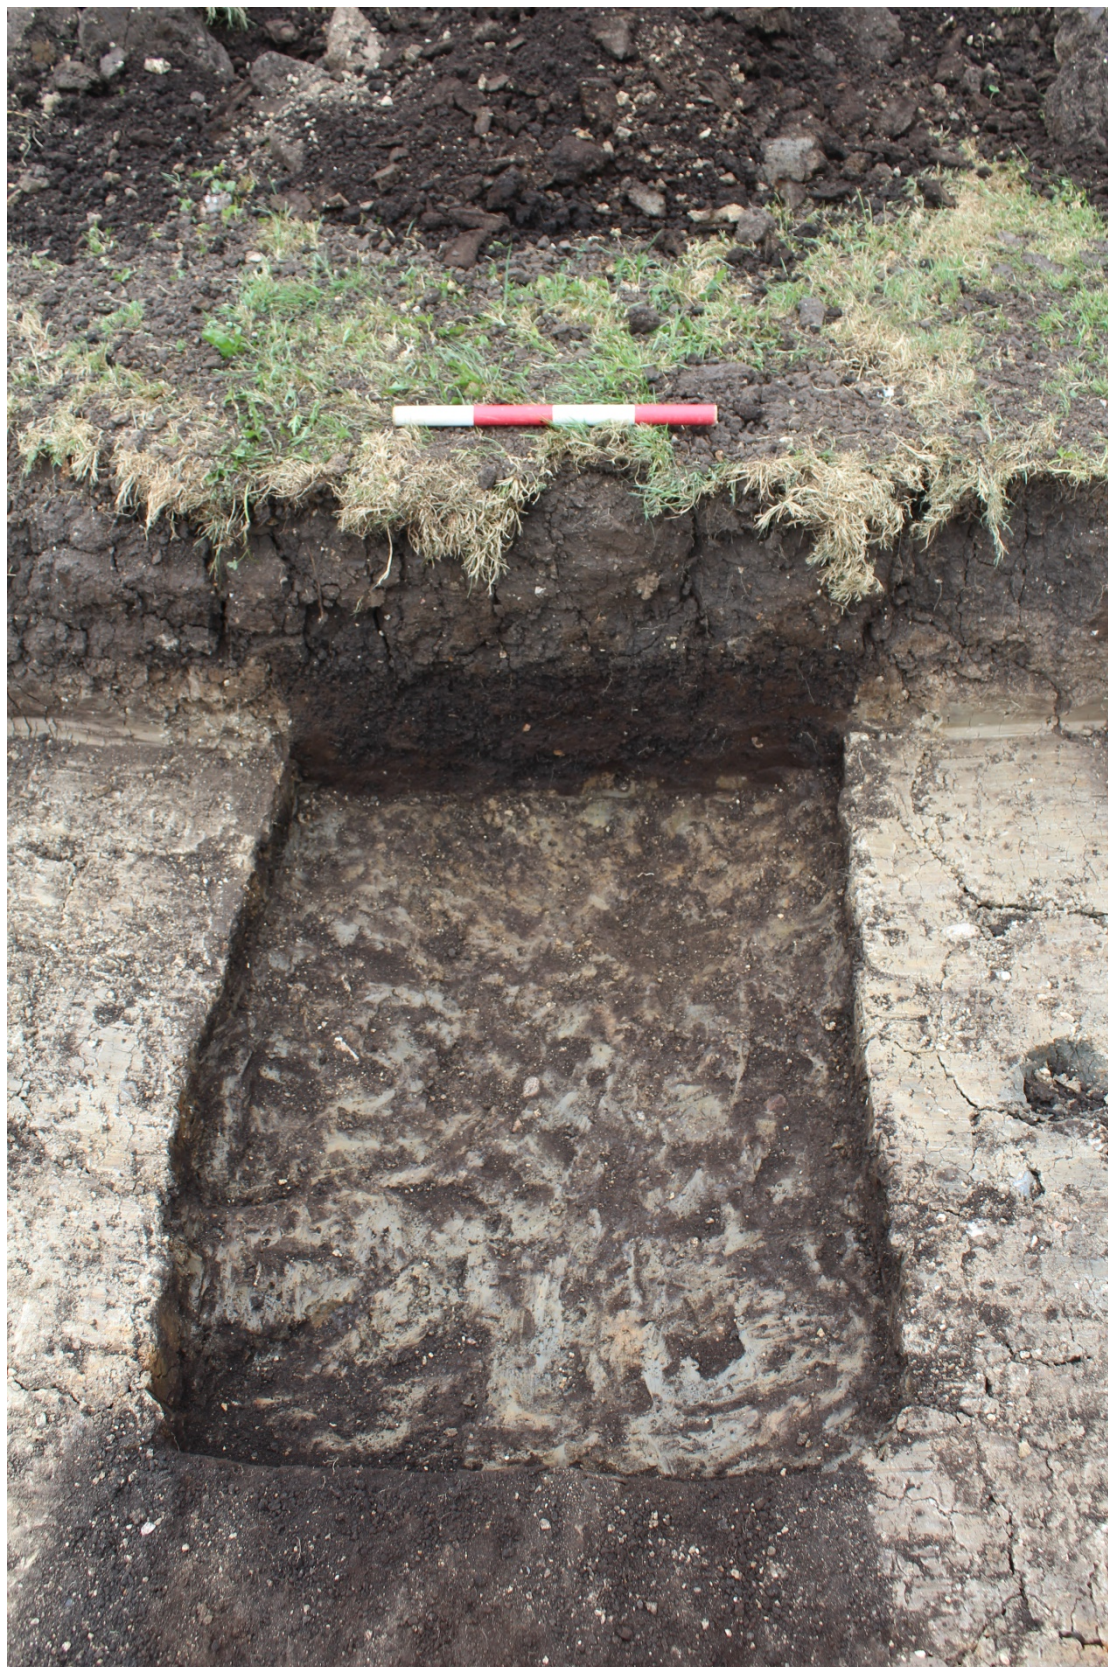
extending beyond the limits of excavation in both directions. It was relatively narrow and shallow, measuring c. 0.80m wide by 0.39m deep. It contained a single fill (113), a dark brown/black clayey silt which contained a small assemblage of Glazed Red Earthenware pottery, dating to AD 1550-1900, as well as a single fragment each of ceramic building material and clay tobacco pipe stem. Based on common alignment and profile, Ditch [114] is considered to be the same feature as Ditch [108] in Trench 3. The feature was visible cutting through the subsoil in the edge of the trench.

Plate 6: Ditch [114], Trench 2, view south-east

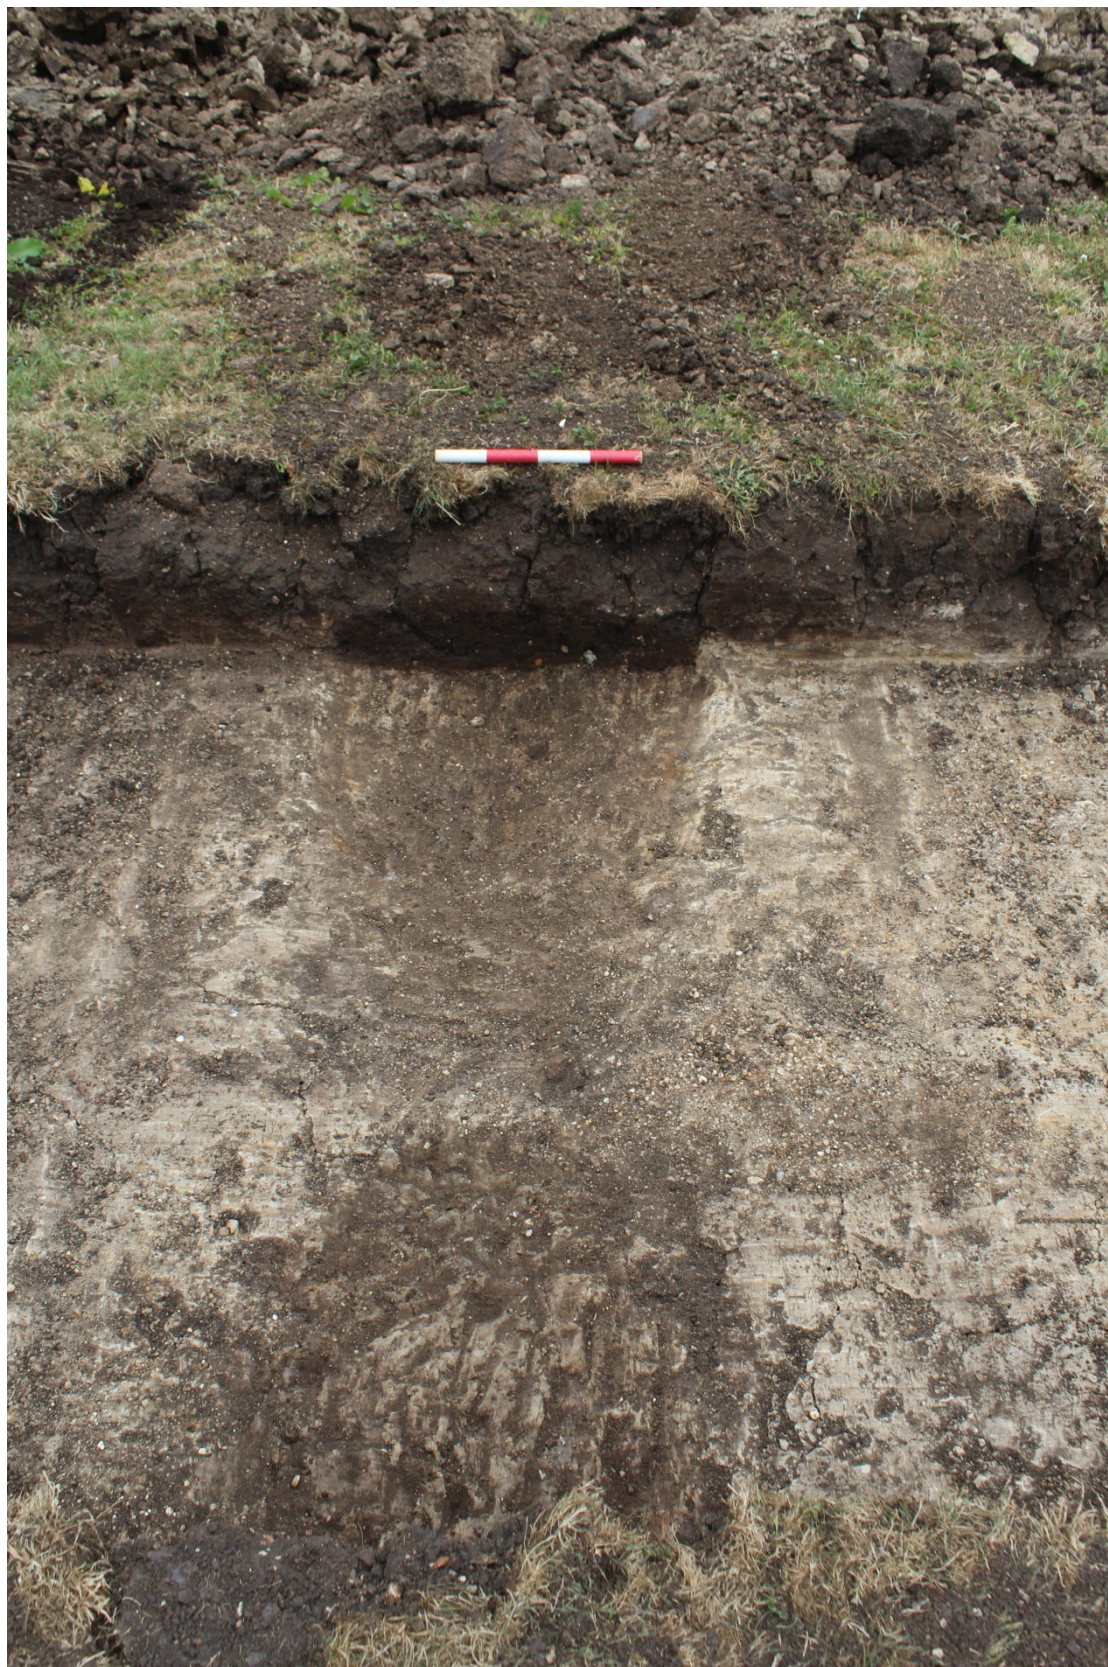
- 6.3.7 Pit [116] (PIT ALIGNMENT 2) (Plate 7) was located to the south-west within the trench and was not fully visible in plan (c. 0.72m wide by 0.14m deep), extending beyond the limit of excavation to the south-east. It had a single fill (115), a dark brown/black clayey silt which contained no finds. The feature formed part of a possible pit alignment with Pit [132] in Trench 2 and Pit [126] in Trench 3. The feature was visible cutting through the subsoil in the edge of the trench.

- 6.3.9 Pit [132] (PIT ALIGNMENT 2) (Plate 7) was located towards the south-west end of the trench and was not fully visible in plan (c. 0.73m wide by 0.15m deep), extending beyond the limit of excavation to the north-west. It had a single fill (131), a dark brown/black clayey silt which contained a small assemblage of Creamware pottery with slip decoration, dating to AD 1775–1830. The feature formed part of a possible pit alignment with Pit [116] in Trench 2 and Pit [126] in Trench 3. The feature was visible cutting through the subsoil in the edge of the trench.

Plate 7: Pit [116], Pit [132] in foreground, Trench 2, view south-east

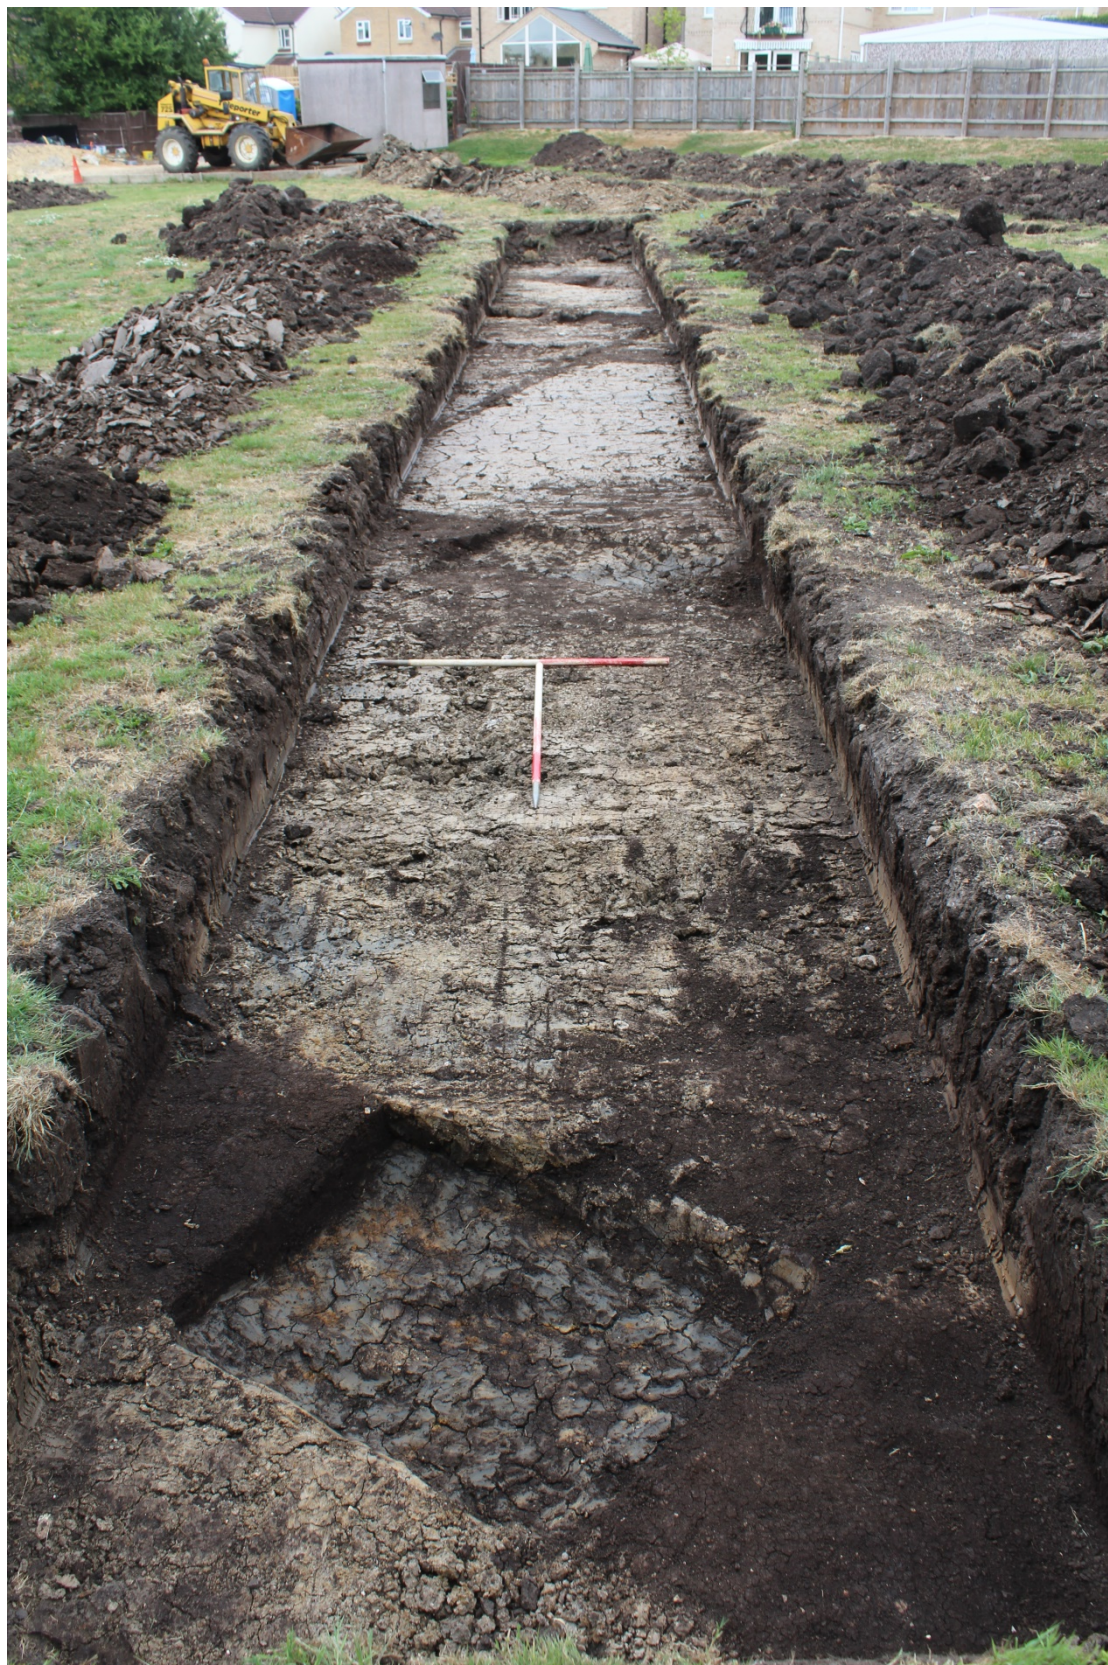
- 6.4.1 Trench 3 (Plate 8) contained three ditches and two elongated pits, forming two pit alignments, all of which were aligned approximately north-west to south-east and continued out of the trench in both directions.
- 6.4.2 Datable material recovered from the features was limited, being confined to pottery, clay tobacco pipe stem and undiagnostic iron fragments, recovered from ditch slots [108] and [124] and Pits [126] and [130]. These assemblages are of post-medieval date.
- 6.4.3 Ditch [108] (DITCH 4) was located at the south-east end of the trench and

Plate 8: Trench 3, view north-west

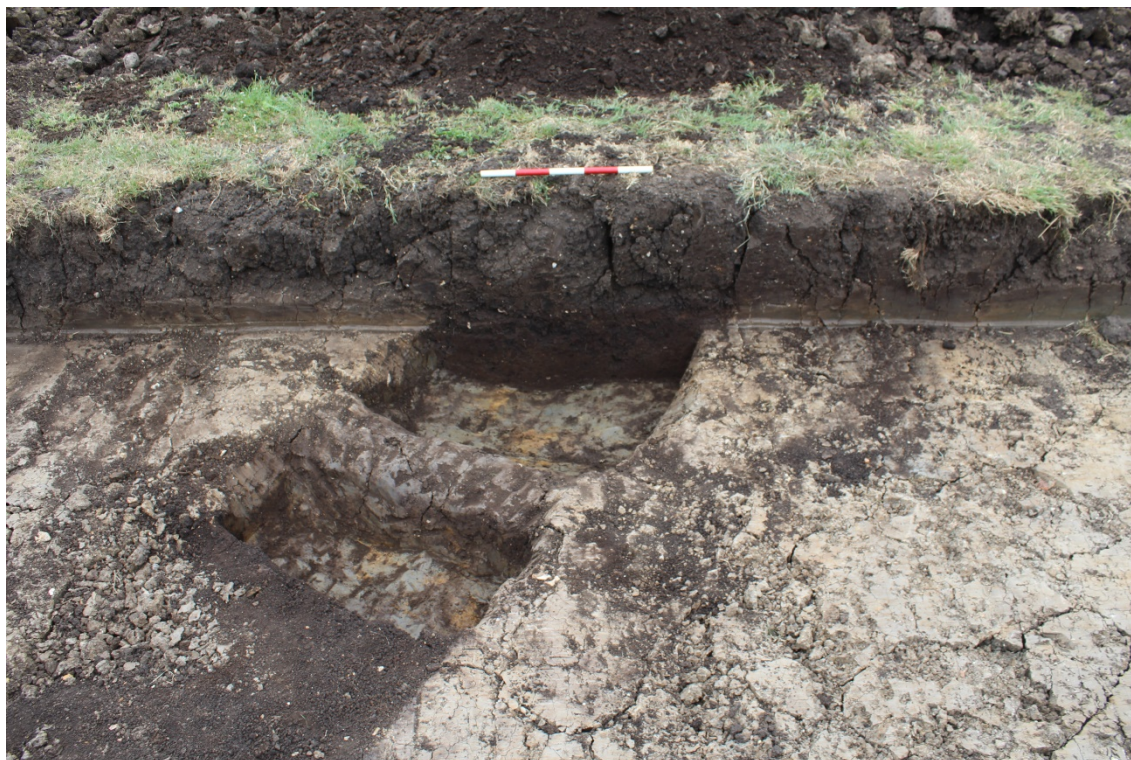
- 6.4.7 Pit [130] (PIT ALIGNMENT 1) (Plate 9) was located towards the north-west end of the trench and was aligned north-west to south-east, extending beyond the limits of excavation in both directions. It had a single fill (129), a dark brownish-grey clayey silt which contained a small assemblage of Creamware, Glazed Red Earthenware and Staffordshire-type Combed Slipware pottery, dating to AD 1740–1800, as well as two fragments of clay tobacco pipe stem. Although resembling a ditch in plan, upon excavation the feature had the form of two rectangular pits, located end to end, measuring c. 1.22m wide by 0.32m deep, which had been excavated and backfilled contemporaneously. The feature formed a part of a pit alignment with Pits [118] and [134] in Trench 2. The feature was visible cutting through the subsoil in the edge of the trench.

Plate 9: Pit [130], Trench 3, view north-west
