**ST. GEORGE'S HOSPITAL PHASE 1,
117 SUTTONS LANE,
HORNCHURCH, RM12 6RS**

**AN ARCHAEOLOGICAL
EVALUATION**

SITE CODE: SUS18

Pre-Construct Archaeology Ltd	
Project Number	K5708
Report Number	R13401

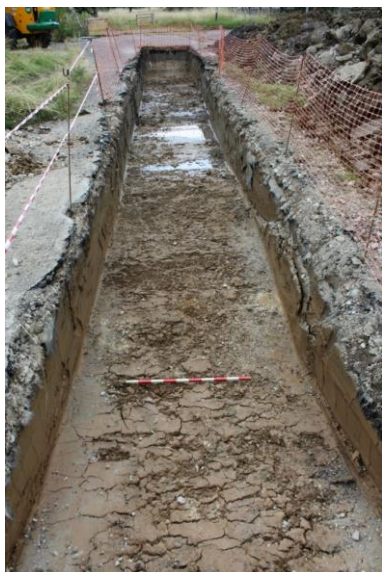
Plate 1: Trench 1 – Looking West

- 8.1.1 The earliest deposit encountered in this trench was a firm mid to light brown clay [2] with occasional lenses of gravel. This layer was interpreted as a natural deposit and was encountered at 14.30m OD.

- 8.1.2 Sealing the natural deposit in this trench was a layer of dark grey clay [1]. The layer was encountered at 14.62m OD and was 0.40m thick.

- 8.1.3 Sealing the natural deposits were various layers of modern made-ground up to 0.20m thick which in turn was sealed by a thin layer of surface tarmac. The ground level on the surface of the tarmac was 14.82m OD.

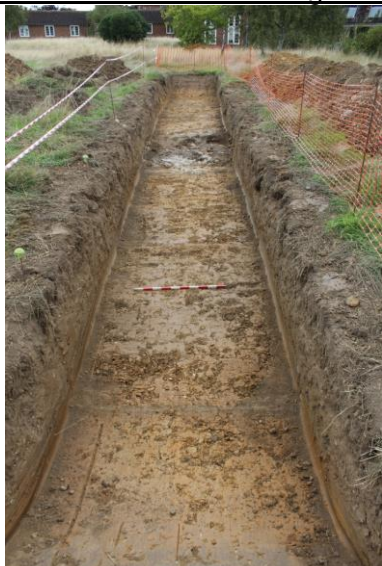
Plate 2: Trench 2 – Looking North-West

- 8.2.1 The earliest deposit encountered in this trench was a mixed clay and gravel layer [4] interpreted as a natural deposit. The layer was a firm dark brown clayey silt layer with bands of gravel. It was recorded at 14.56m OD.

- 8.2.2 Sealing the natural was a layer [3] of soft to firm mid grey brown sandy silt with occasional sub-angular stones which was encountered from 14.81m OD and was 0.45m thick. The layer was interpreted as being part of a sequence of subsoil.

- 8.2.3 Sealing the subsoil was a layer of topsoil which formed the current ground surface. This layer was 0.30m in thickness and had a surface level of 15.41m OD.

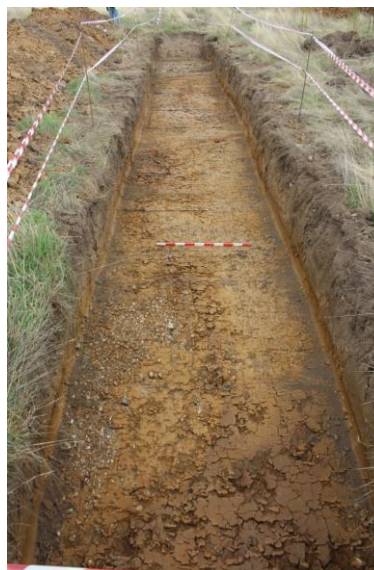
Plate 3: Trench 3 – Looking South-East

- 8.3.1 The earliest deposit identified in this trench was a layer of clay gravel [6] seen at the base. It was a firm dark brown clay silt with bands of sand and gravel. It was recorded from 14.67m OD and was interpreted as being part of a sequence of natural deposits.

- 8.3.2 A sandy silt layer [5] was sealing the natural deposits, it was encountered at 14.96 OD and was 0.40m thick. This layer was part of the sequence of subsoil seen across the site.

- 8.3.3 The subsoil was capped by a layer of topsoil which formed the current ground surface. This layer was approximately 0.40m in thickness and had a surface level of 15.41m OD.

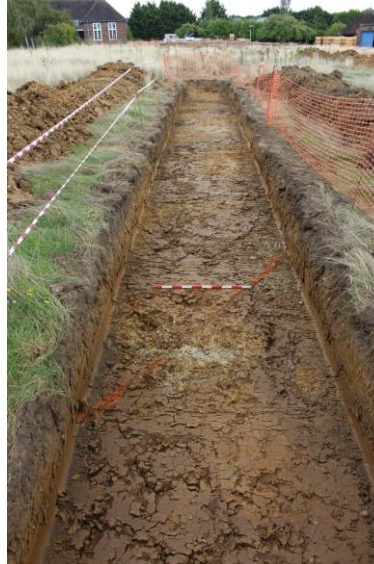
Plate 4: Trench 4 – Looking North-East

- 8.4.1 A layer of clay gravel [8] was the earliest deposit encountered in this trench. It was a firm dark brown clay with bands of sand and gravel, was interpreted as being part of the natural sequence of deposits and was recorded at 14.93m OD.

- 8.4.2 Sealing the natural in this trench was a layer [7] of sandy silt with occasional lenses of gravel and flecks of coal. It was recorded at 15.13m OD and was 0.20m thick. This layer was interpreted as being part of the sequence of subsoil seen across the site.

- 8.4.3 The subsoil was capped by a layer of topsoil which formed the current ground surface. This layer was 0.20m in thickness and had a surface level of 15.33m OD.

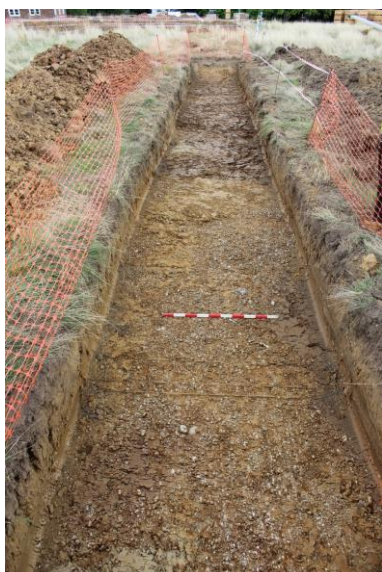
Plate 5: Trench 5 – Looking North-East

- 8.5.1 The earliest deposit encountered in this trench was [10] a firm dark brown clay with lenses of sand and gravel. This layer was interpreted as a natural deposit and was encountered at 14.60m OD.

- 8.5.2 Sealing the natural deposits was a layer of soft grey brown sandy silt [9] with occasional small sub-angular stones. It was recorded at 14.92m OD and was 0.30m thick. This layer was interpreted as being part of the sequence of subsoil.

- 8.5.3 Sealing the subsoil was a layer of topsoil which formed the current ground surface. This layer was 0.20m in thickness and had a surface level of 15.20m OD.

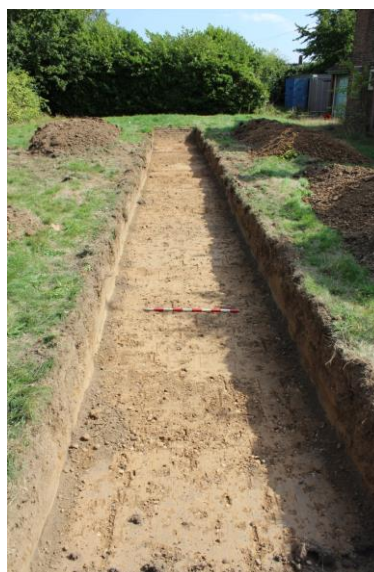
Plate 8: Trench 8 – Looking East

8.8.1 A layer of clay gravel [41] was the earliest deposit encountered in this trench, it was a firm dark brown clay with bands of sand and gravel. It was interpreted as being part of the natural sequence of deposits, recorded at 13.78m OD.

8.8.2 Sealing the natural was a layer [40] of sandy silt with occasional lenses of gravel and small fragments of CBM. It was recorded at 13.93m OD and was 0.20m thick. This layer was interpreted as being part of the sequence of subsoil seen across the site.

8.8.3 The subsoil was capped by a layer of topsoil which formed the current ground surface. This layer was 0.20m in thickness and had a surface level of 14.23m OD.

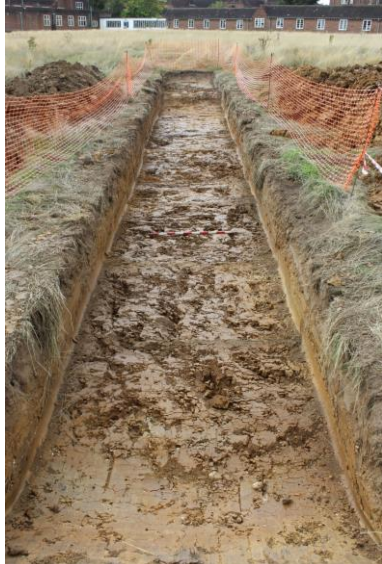
Plate 6: Trench 6 – Looking South-West

- 8.6.1 The earliest deposit encountered in this trench was mixed clay and gravel layer [12] interpreted as a natural deposit. The layer was a dark brown clay silt with bands of gravel, it was encountered at 13.94m OD.

- 8.6.2 Sealing the natural was a layer [11] of soft to firm mid grey brown sandy silt with occasional sub-angular stones which was encountered from 14.06m OD and was 0.30m thick. The layer was interpreted as being part of the sequence of subsoil.

- 8.6.3 Sealing the subsoil was a layer of topsoil which formed the current ground surface. This layer was 0.20m in thickness and had a surface level of 14.56m OD.

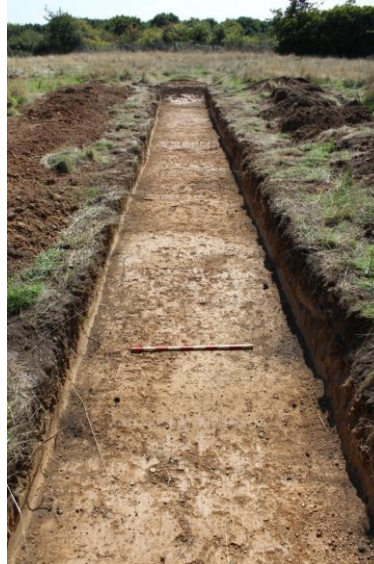
Plate 9: Trench 9 – Looking South

8.9.1 The earliest deposit encountered in Trench 9 was a firm dark brown clay [22] with lenses of sand and gravel. This layer was interpreted as a natural deposit and was recorded at 13.10m OD.

8.9.2 Sealing the natural deposits was a layer of soft grey brown sandy silt [21] with occasional small sub-angular stones. It was recorded at 13.24m OD and was 0.20m thick. This layer was interpreted as being part of the sequence of subsoil.

8.9.3 Sealing the subsoil was a layer of topsoil which formed the current ground surface. This layer was 0.20m in thickness and had a surface level of 13.54m OD.

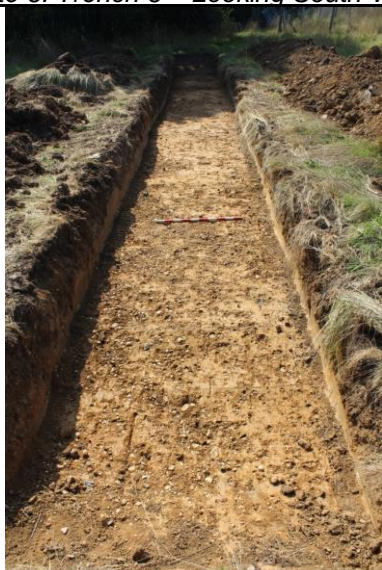
Plate 7: Trench 7 – Looking South

8.7.1 The earliest deposit identified in this trench was a layer of clay gravel [35] seen at the base of the trench. It was a firm dark brown clay with bands of sand and gravel, was recorded from 11.49m OD and was interpreted as being part of a sequence of natural deposits.

8.7.2 A sandy silt layer [34] sealed the natural deposits, it was encountered at 11.99 OD and was 0.40m thick. This layer was part of the sequence of subsoil seen across the site.

8.7.3 The subsoil was capped by a layer of topsoil which formed the current ground surface. This layer was 0.30m in thickness and had a surface level of 12.29m OD.
