**STROOD FLOOD DEFENCE  
SCHEME, STROOD, KENT.  
PHASE 1 SITE (CIVIC CENTRE)**

**ARCHAEOLOGICAL EVALUATION  
AND WATCHING BRIEF**

**SITE CODE: KSFA18**

**SEPTEMBER 2018**

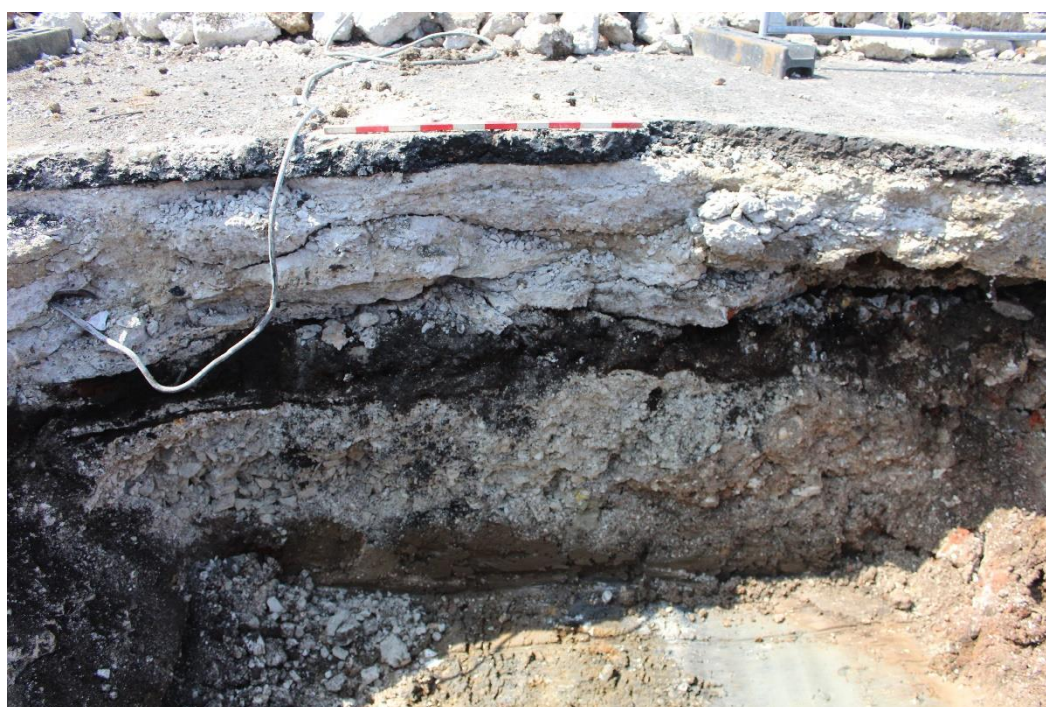
*Plate 1: North-east facing section 1 in Trench 2 (1m scale)*

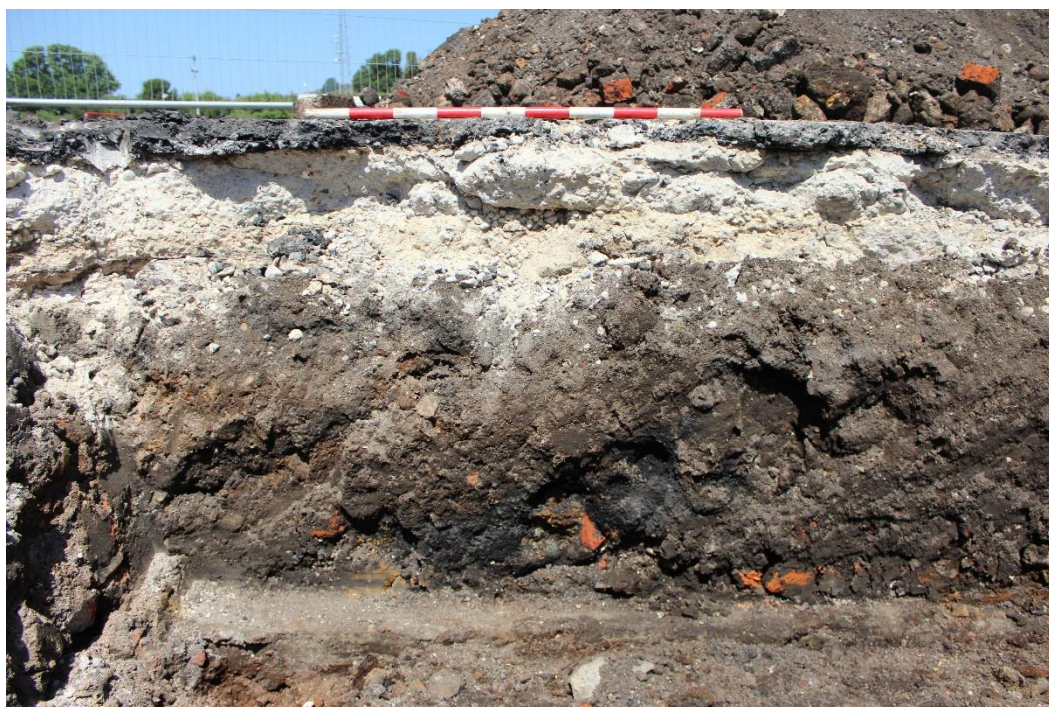
- 7.3.1 The excavation of this trench revealed modern concrete at 3.16m OD. The concrete was in turn sealed by modern made ground, approximately 0.60m thick in turn capped by 0.42m thick concrete slab and tarmac for the existing car park. The tarmac was recorded at 4.16m OD. The made ground was significantly contaminated and the excavation of the trench was limited to its (proposed) west and east ends. The modern sequence was recorded in the west end of the trench.

*Plate 2: South-east facing section 5 in Trench 3 (1m scale)*

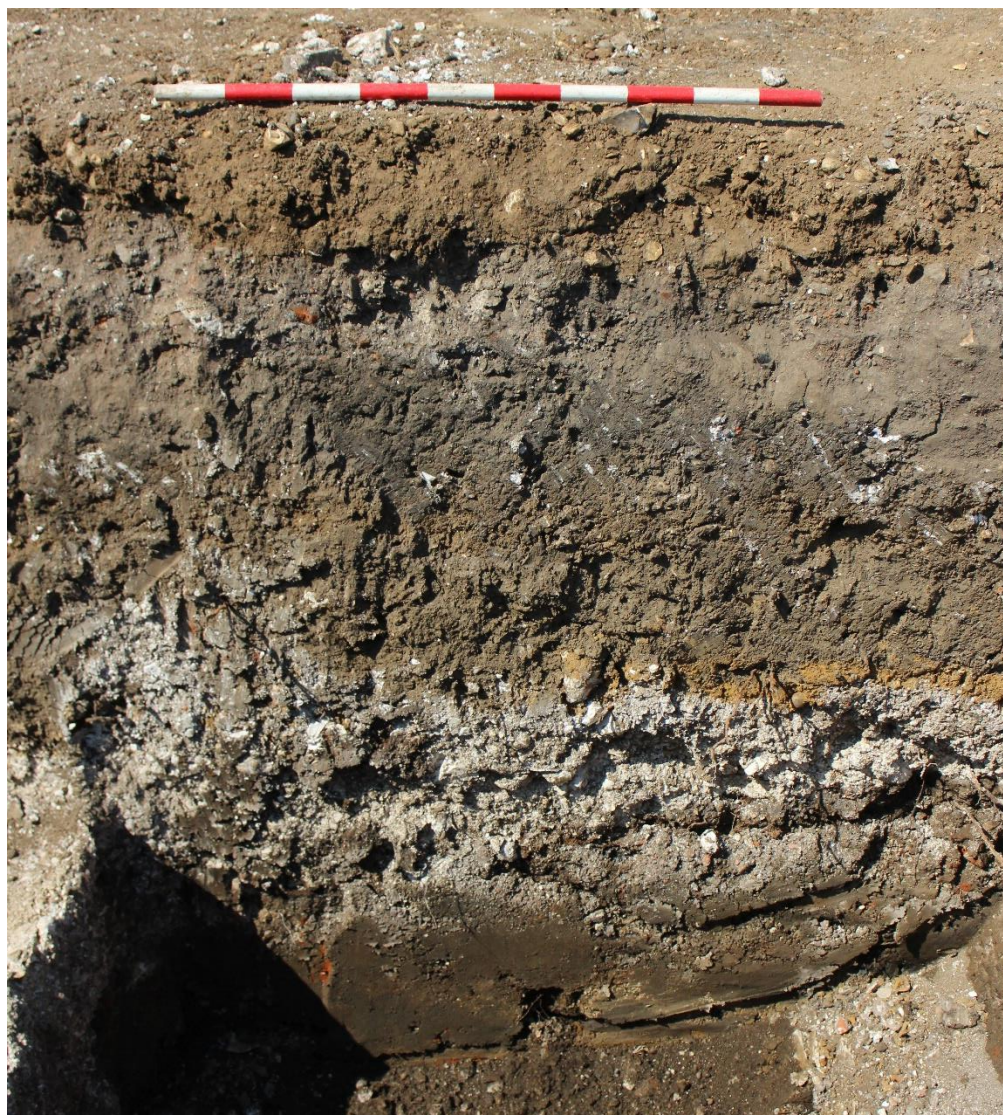
- 7.4.1 The excavation of the west part of this trench revealed a sequence of modern deposits. The base of the trench revealed modern made ground at 2.90m OD capped at 4m OD by approximately 0.25m thick concrete and tarmac forming the ground level of the existing car park.
- 7.4.2 The excavation of the east part of Trench 5 revealed a sequence of post medieval made ground layers (Plate 3) recorded as [8], [7], [6] (Group 41) and [5] (Group 55) between 2.08m OD and 2.89m OD. The sequence was recorded between the base of Trench 5 (context [8]) and the top of context [5]. The sequence was sealed by modern made ground and in turn capped by the concrete and tarmac for the existing car park at 3.88m OD.

*Plate 3: South facing section of Trench 5 (1m scale)*

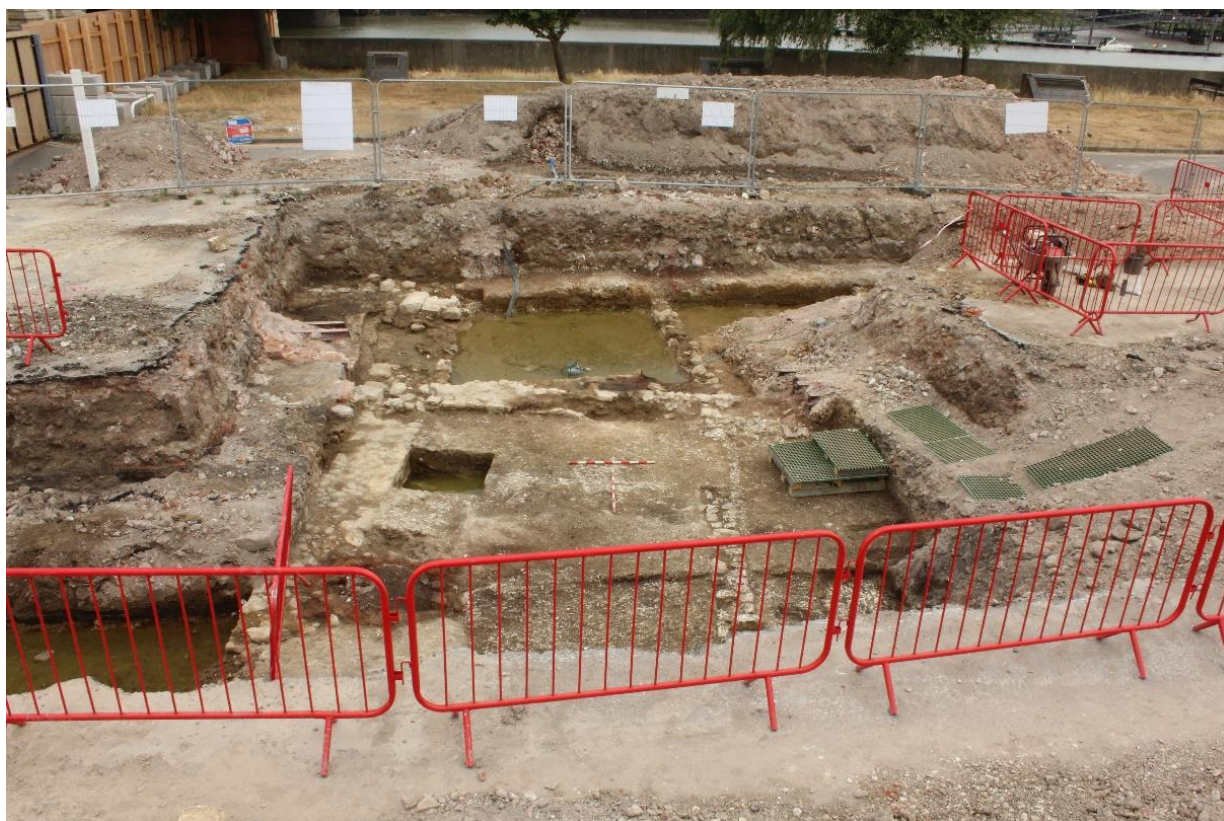
7.5.1 The excavation of Trenches 6 and 7 revealed sequence of masonry structures consisting of stone foundation and floor surfaces spanning the medieval and late post-medieval periods. To better understand the archaeological sequence in this part of the site it was decided to extend the southern and northern halves of Trenches 6 and 7 and merge the two trenches into one Trench 6/7 (Plate 4).

*Plate 4: General view of Trench 6/7, looking south-east*

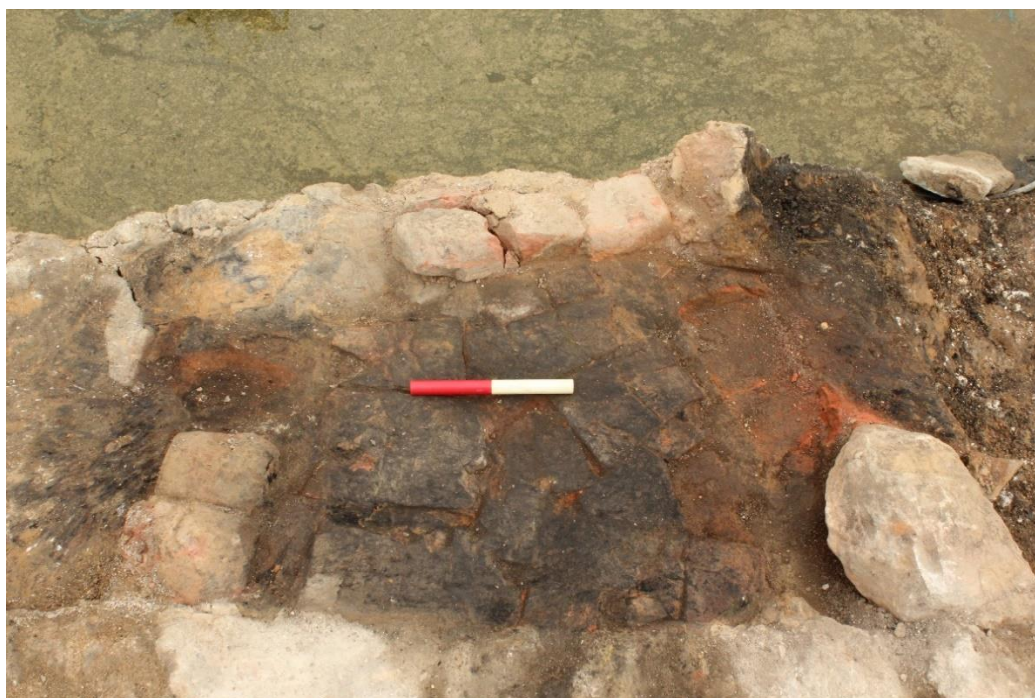
7.5.11 In the central area of the trench, walls [42], [41], [43] and [165] (Group 26) were recorded at 2.58m OD, 2.67m OD, 2.53m OD and 2.55m OD respectively. These masonry remains represent the sides of a north-west to south-east orientated rectangular building with an overall dimension of 5.70m by 5.67m with an internal area of 4.70m long by 3.35m wide. A layer consisting of firm brownish clay with frequent chalk and charcoal fleck inclusions was recorded within the building itself at 2.55m OD and represent a floor surface which was assigned context number [36] (Group 26). Just to the north of the north-east corner of the building was recorded sub-triangular masonry [35] at 2.55m OD. This 0.98m by 0.65m large masonry structure, consisting of one course of bricks and tiles constructed against the south-east face of masonry [41], presented evidence to have been exposed to intense fire and as a result was interpreted as part of a fireplace (Plate 5). Brick samples from masonry [35] dated the fireplace between 1600 and 1800.

*Plate 5: Fireplace [35], looking south-east (1m scale)*

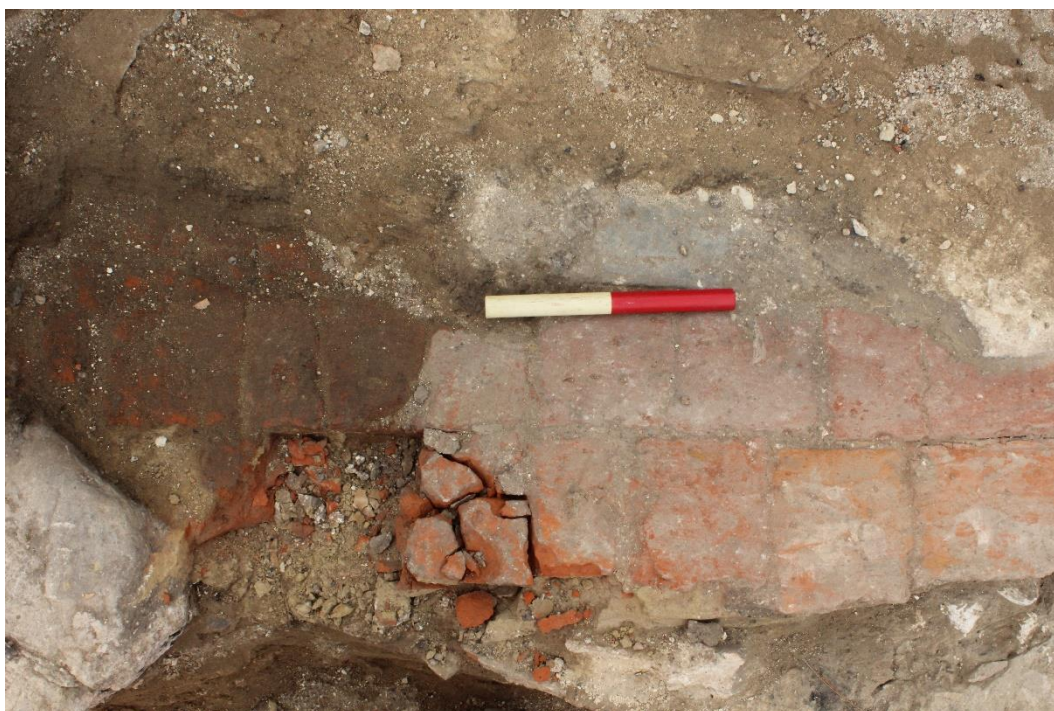
7.5.12 Evidence for the extension of the building described above was recorded in the central part of the trench (Group 26). Two parallel walls, recorded as [53] and [166] at 2.99m OD and 2.50m OD, abutted the north-eastern faces of walls [33] and [42] and extended beyond the north-eastern limit of the trench. This north-eastern extension (Group 25) measured 6.96m north-west to south-east by approximately 2m. Evidence for a brick floor within the extension was recorded as masonry [52] at 2.74m OD (Plate 6). This floor (Group 25) was observed in south-west facing Section 7 and measured 0.89m by 0.20m by 0.09m thickness and was dated between 1600 and 1800.

*Plate 6: Close up of brick floor [52] (10cm scale)*

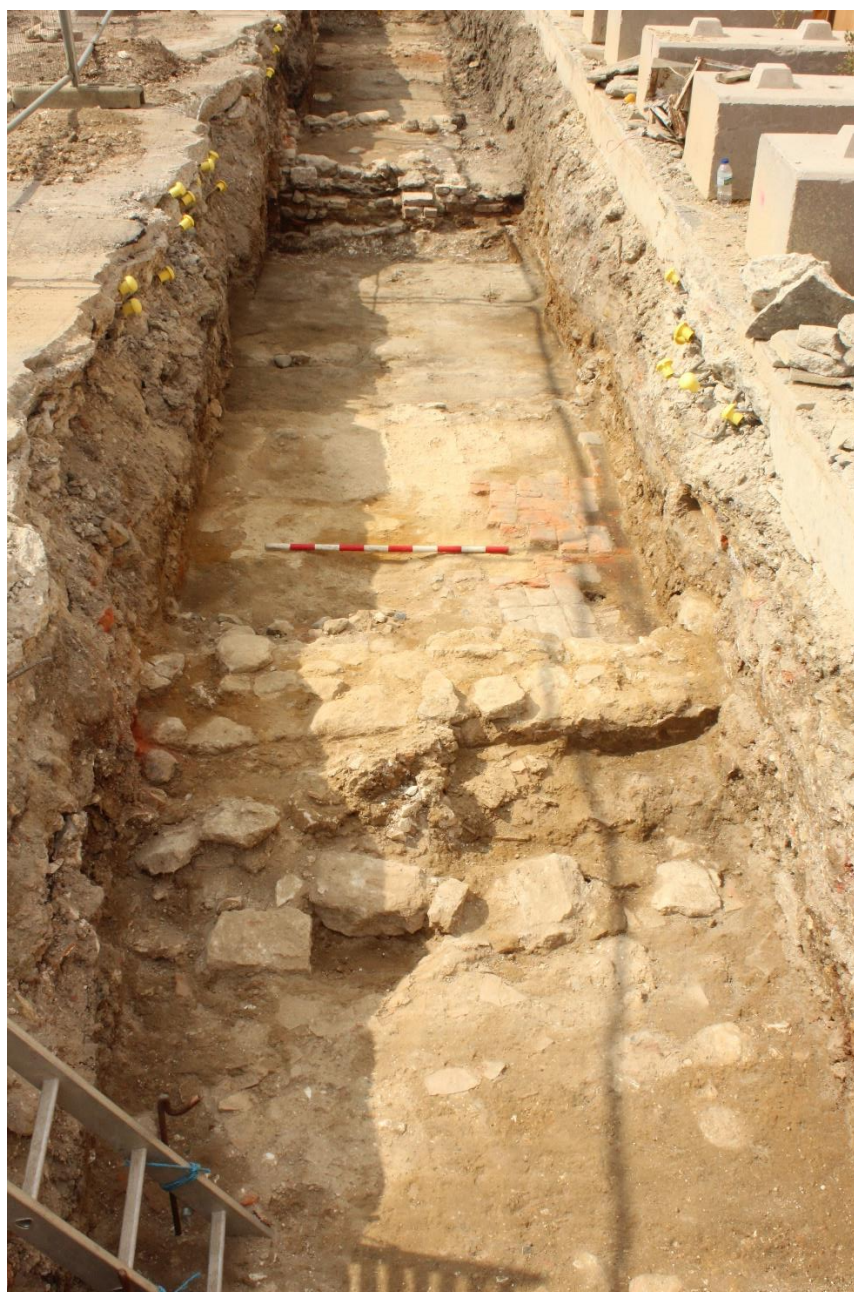
- 7.6.1 The excavation of this trench unearthed a complex sequence of masonry foundations, walls and floor surfaces. The earliest deposit recorded in this trench consisted of clayey chalk [124] (Group 5) with moderate charcoal flecks inclusion. This moderately firm layer was found at 2.70m OD and was 0.70m long by 0.10m thick and was interpreted as part of a consolidation deposit dated to the medieval period. Context [124] was in turn sealed at 2.83m OD by layer [123] (Group 11) which consisted of silty clay with fragments of CBM and charcoal and chalk flecks inclusion. This layer measured 0.90m long and 0.12m thickness and was interpreted as ground raising/consolidation deposit dated to the medieval period.

*Plate 7: General view of Trench 8, looking north-west (1m scale)*

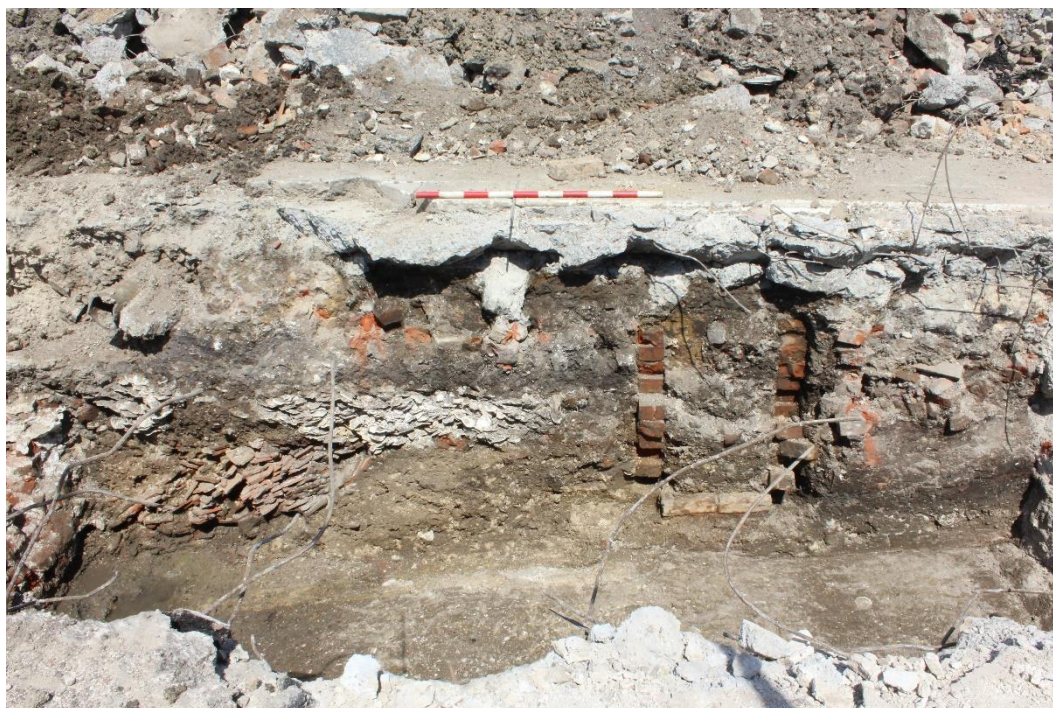
7.7.1 The archaeological deposits observed in Trench 9 were all recorded in Section 8. The earliest deposit consisted of post-medieval made ground [115] (Group 19) recorded at 2.74m OD. This was in turn sealed by post-medieval deposit [114] (Group 43) to the east at 3.12m OD and truncated to the west by large post-medieval rubbish pit [113] (Group 42) which was backfilled by a series of fills recorded as [112], [111], [110], [109], [108] sealed by upper fill [107] at 3.29m OD. The overall dimensions of cut [113] were approximately 3m south-west to north-east and 1m depth but the pit was not fully excavated. [109] consisted mainly of post-medieval roof tiles.

*Plate 8: South-east facing section in Trench 9 (1m scale)*

- 7.7.5 In the north-eastern area of Trench 9 Group 60 was truncated by a possible brick soakaway or manhole (Group 61) consisting of construction cut [116], masonry [100] and backfill [99] (Plate 8). Group 61 was found at 3.64m OD and measured 0.70m wide and 0.90m deep.

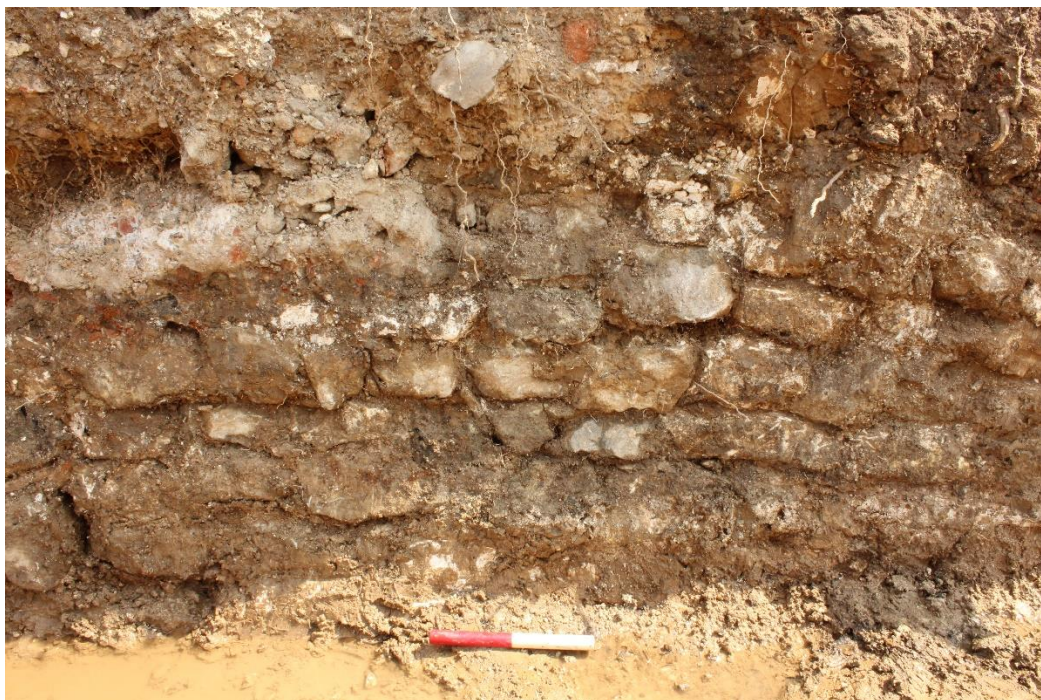
- 7.10.2 Alongside the east side of the trench a 15m long by 0.60m wide wall was present and it was orientated north-east to south-west and found at 2.50m OD. It was recorded as [210] (Group 35) (Plate 9). This masonry consisted of chalk, flint nodules and ragstone with the north-western face constructed with small rough-hewn ragstones. This masonry, previously recorded in Trench 6-7 as [156], was interpreted as a boundary wall or a wall defining the south-eastern side of a north-east to south-west orientated alleyway with a possible 17th century date. Possible threshold or steps [157] also recorded in Trench 6/7 appeared to have been associated with [210].

*Plate 9: Close up of masonry [210], looking south-east (10cm scale)*

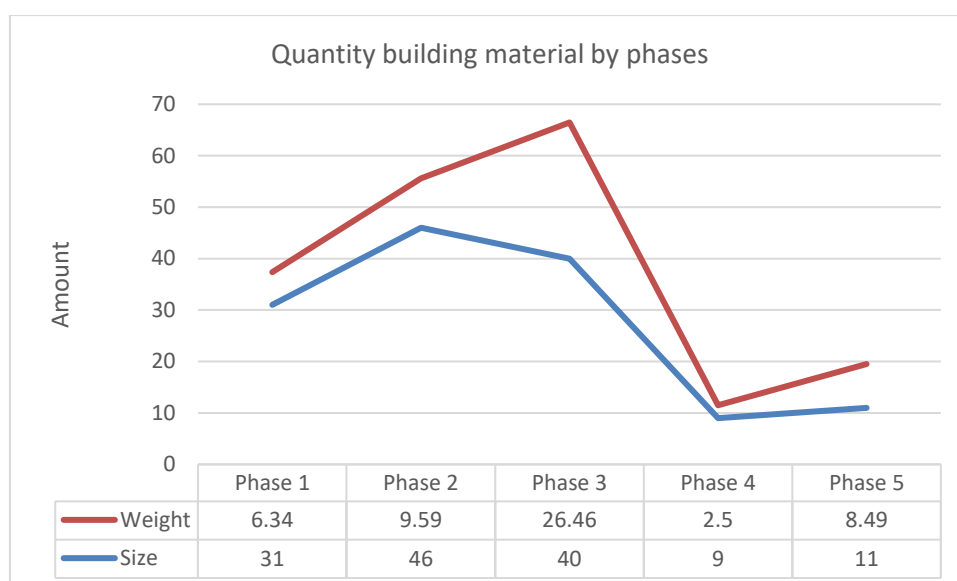
Figure 1 illustrates the phase distribution for this site. It can be seen that a majority of the ceramic building material (by number of fragments) comes from Phase 2. However, most of this material was in a highly fragmentary condition and the much smaller weight if Figure 1 is a more true representation of their presence. By contrast, Phase 3 has the largest amount of building material by weight because of an increase in the use of bricks.

Figure 1. Building material collected from different phases by size and weight<sup>1</sup>
