**NORTHERN STANLEY
BUILDING**

KING'S CROSS

**HISTORIC BUILDING
RECORDING**

Historic building recording of the northern Stanley Building, London Borough of Camden

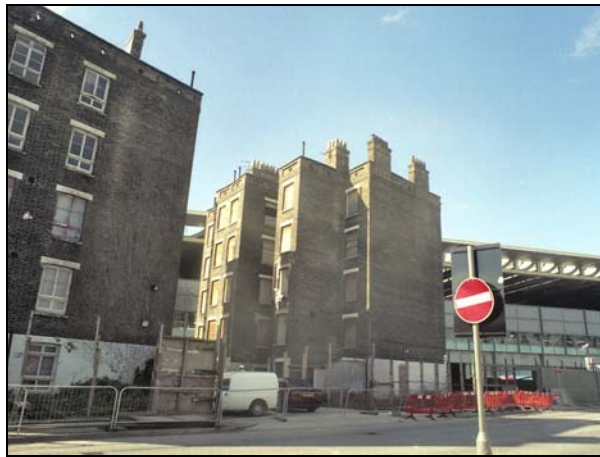
Plate 1: View of northern Stanley building from the east

5.1.1 The building (plates 1 and 2) is situated within a plot of land which is bounded to the north-west by a Channel Tunnel Rail Link construction site, to the north-east by the diverted Pancras Road, to the south-east by Clarence Passage and to the south-west by St Pancras railway station (figs. 1 and 2). The northern block and its sister block to the south are enclosed by hoarding, and the main entrance is through a gate on Pancras Road which provides access to the area between the buildings.

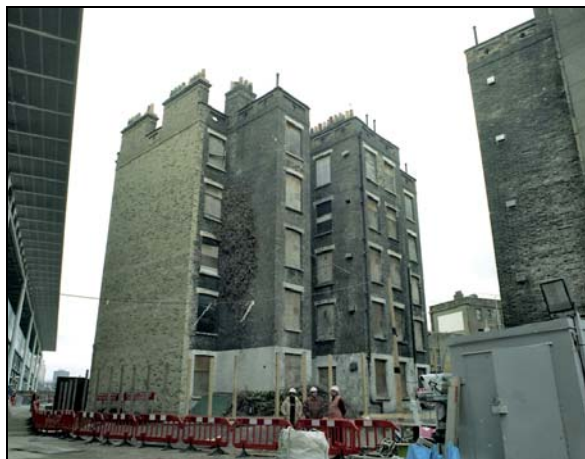
Plate 2: View of northern Stanley building from the south

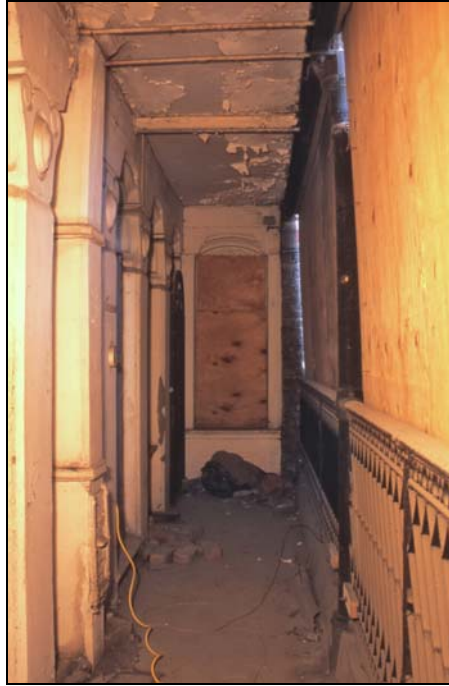
Plate 3: Communal access balcony, looking south-west

5.2.1.2 Each access balcony consists of a recessed space with reinforced concrete floor, the support for which is provided by a central torus-moulded slim cast-iron column, one per floor, beneath a C-section girder. The column-beam junction is anchored back into the balcony wall by two wrought-iron tie-rods (plate 4). The columns are situated on the outer edge of the balconies, and have decorative wrought-iron lattice grille panels bolted to them on either side, running the full width of the recess (figs. 28 and 29). The ironwork has been painted black. At ground floor level there are no railings, but modern decorative steel grille gates have been inserted to the full height of the recess, and are also painted black.

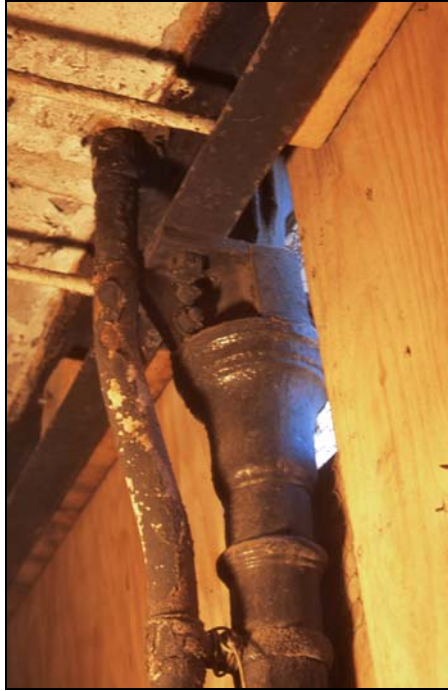
Plate 4: Detail of column-beam junction on balcony

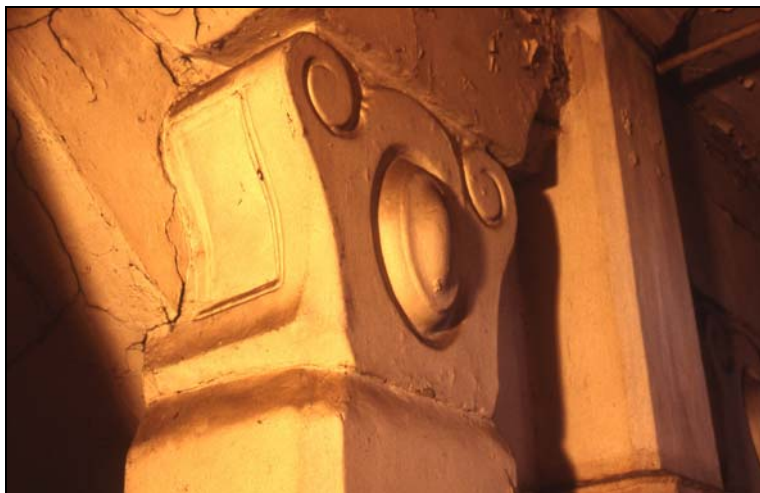
5.2.1.3 Within the recess, to the rear and either side, are a series of white-painted decorative concrete arches with scroll-moulded imposts (plate 5) carrying an oval emblem, framing the doorways to the central staircase and access corridors, and also four sash windows, currently boarded. The central arch is blank, and down it runs a rectangular iron chute with hatch at hand level marked 'Dust and Ashes' (fig. 30; plate 6). This chute runs the full height of the building, and has a hatch on every floor. It terminates in a cupboard at ground floor, where presumably the ashes were collected and removed (shown on figs. 15 and 21).

Plate 5: Detail of scroll-moulded impost on balcony

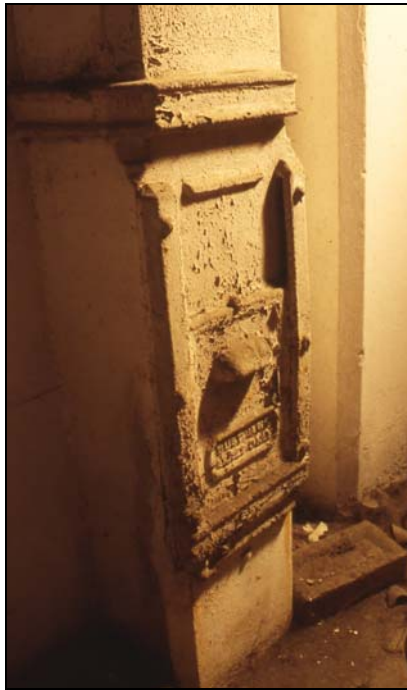
Plate 6: Detail of dust and ashes chute on balcony

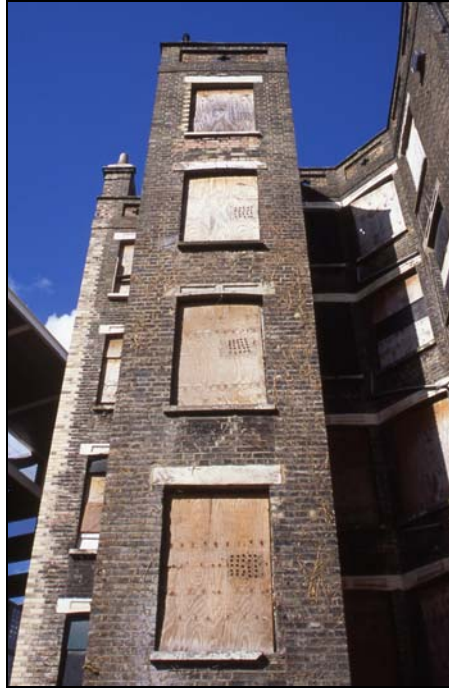
5.2.4.1 The south-east elevation (figs. 13 and 14; plate 7) is constructed of brick, and includes three rear extensions, the middle one of double width. At ground level, the east side of the west extension, both sides of the central extension and the west side of the east extension contain back doors, and the south walls of the extensions and recesses contain windows. These openings are repeated on all floors above, where all contain windows. In all, sixty-five windows are present, although all are boarded. These all possess simple concrete sills and either a simple rectangular replacement concrete lintel or a more elaborate original concrete lintel with two recesses and an arched bottom edge (fig. 32). Those window openings in the south walls of the extensions appear to contain planking in their lower quarter, with a window above which is reduced in size compared to the other frames. This probably relates to the function of the rear extensions as bathrooms, and a desire for more privacy from public view in these areas. It appears to be an original arrangement, as the phenomenon is uniform across the two Stanley Buildings.

Plate 7: Southernmost rear extension, from the south-east

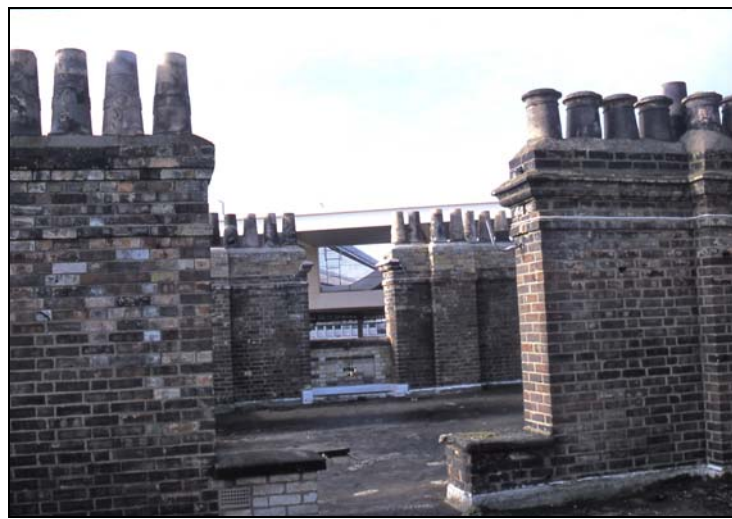
5.2.5.1 The roof of the building (fig. 20; plate 8) is flat, as it was originally intended as a play space for children and an area to hang washing. It is constructed of reinforced concrete, felted to provide waterproofing, and is surrounded by a parapet wall with decorative recesses containing cruciform voids (see fig. 33 for a typical example). This breaks on the north-west elevation to contain a section of wrought-iron lattice grille panels, echoing those of the balconies below.

Plate 8: View of the roof, looking south-west

5.2.5.4 The roof is in a generally poor state of repair, with noticeable sagging occurring along the parapet wall and on the concrete roof itself. The waterproofing has failed in several areas, resulting in the ingress of water to the flats below.

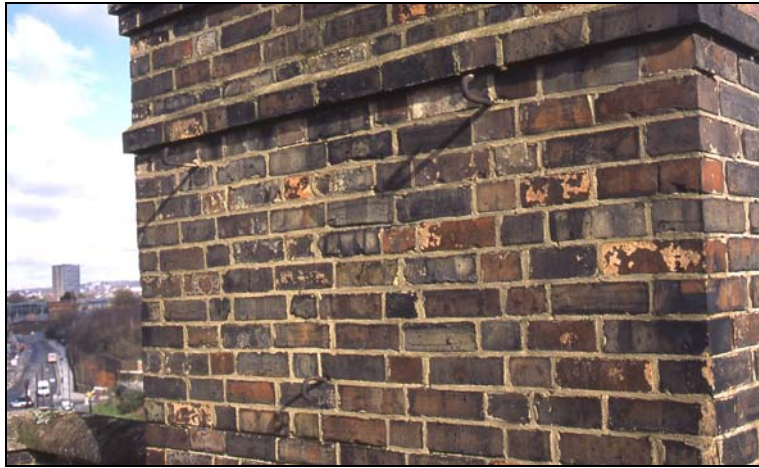
5.2.5.3 The roof contains eight substantial chimneystacks with a variety of chimney pots, original types mixed with modern replacements (see fig. 31 for typology). This reflects the generous provision of fireplaces within the flats. On several of these metal hooks are present (plate 9), which may be original to the 19th-century use of the roof for clothes-drying.

Plate 9: Clothes-line hooks on chimneystack

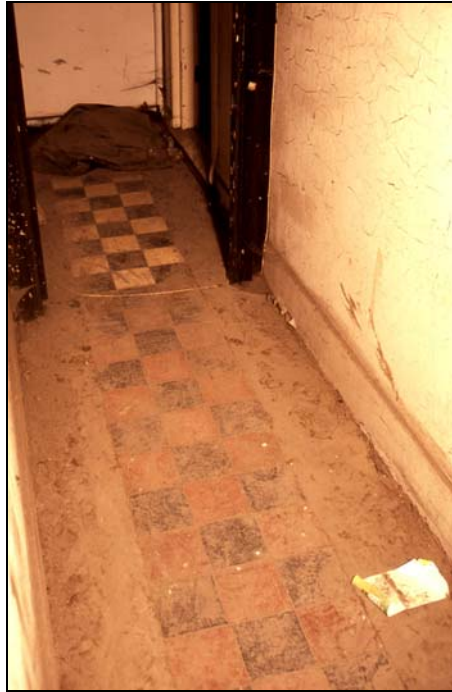
Plate 10: Original red, white and black tiles inset in access corridor concrete floor

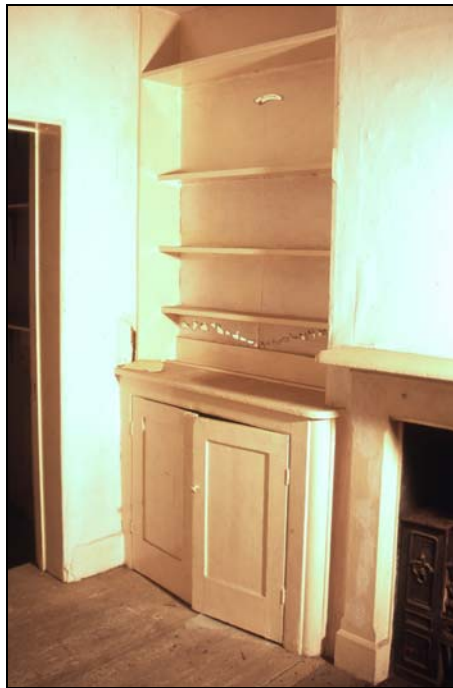
- 5.3.5 The fabric of the building is in the most part original, and though many fixtures and fittings have been removed, a significant number remain. The numerous built-in cupboard and shelving units (plate 11) appear to be original, and though many are altered, some remain intact. These were probably intended as larders for the 19th-century tenants.

Plate 11: Typical original cupboard and shelving unit

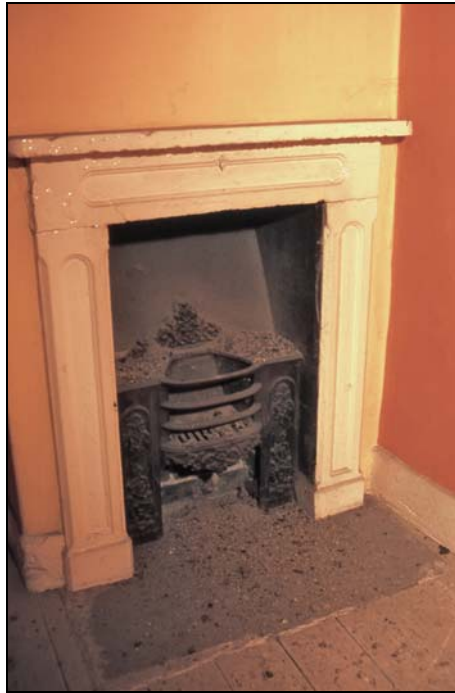
- 5.3.6 Many decorative cast-iron fireplaces and ranges survive (figs. 34-42; plates 12-14), in various states of repair, indicating the original heating, washing and cooking facilities. However, with the exception of two small ranges of the type shown in plate 15, the washing, cooking and WC facilities which originally occupied the rear extensions have been removed. Only four cast-iron pipes remain, one rising through each rear extension room on all floors, presumably included to provide ventilation.

Plate 12: Fireplace in room SNS19

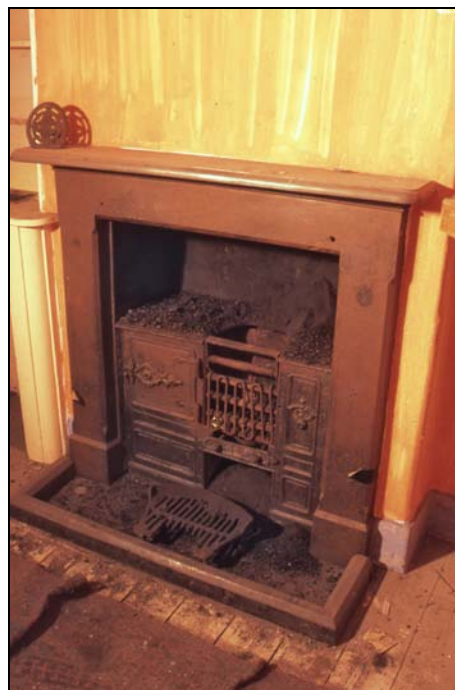
Plate 13: Range in room SNF21

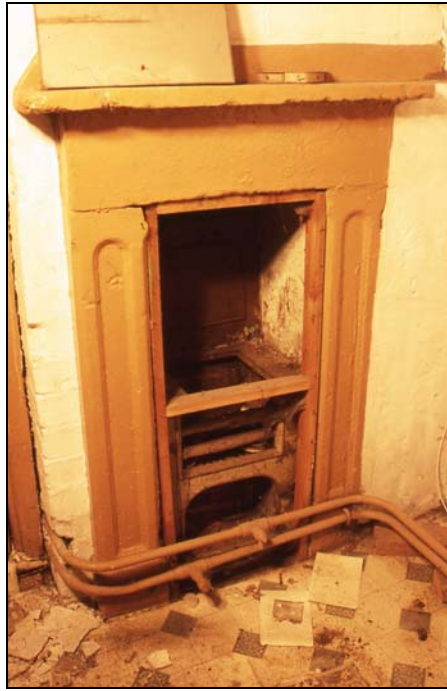
Plate 14: Range in rear room SNT16

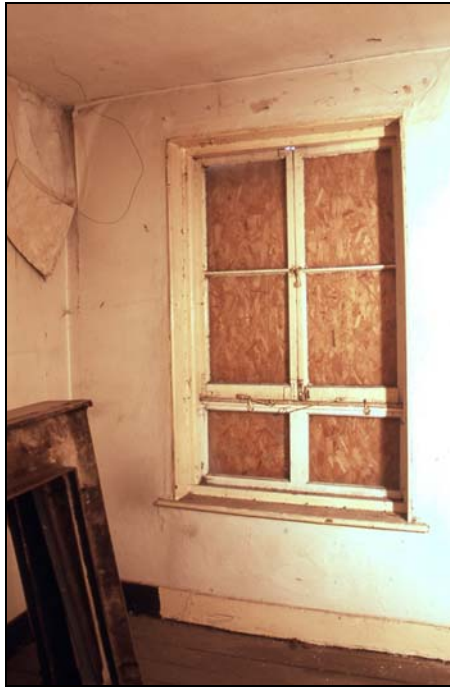
- 5.3.9 The windows, however, are largely original and of an unusual type; timber-framed, with twin opening casements each with two panes (some now replaced by single panes), above a lower fixed light with two panes (plate 15). These lower lights were originally of ornamental ground glass, eliminating the need for blinds, and were fixed to prevent young children falling out. In the rear windows of the extensions, these lower lights contain timber planking rather than glass, which may be an original arrangement.

Plate 15: Typical rear window

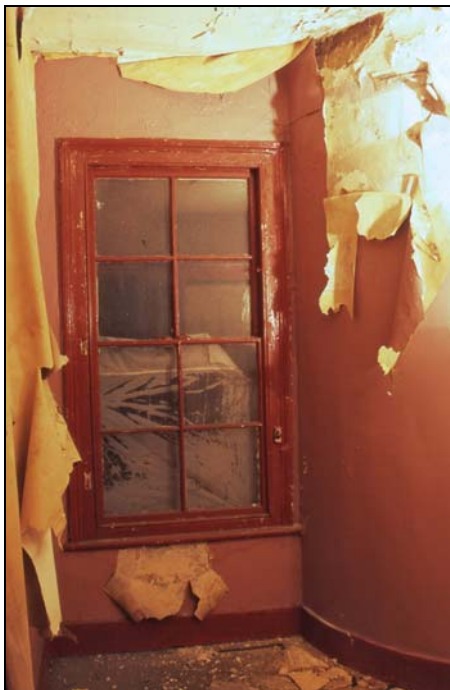
5.3.10 The only exceptions to this window type are those opening onto the balcony, which are original and of a sash construction (fig. 27; plate 16), possibly to provide a more aesthetically pleasing appearance within the communal areas.

Plate 16: Typical balcony sash window

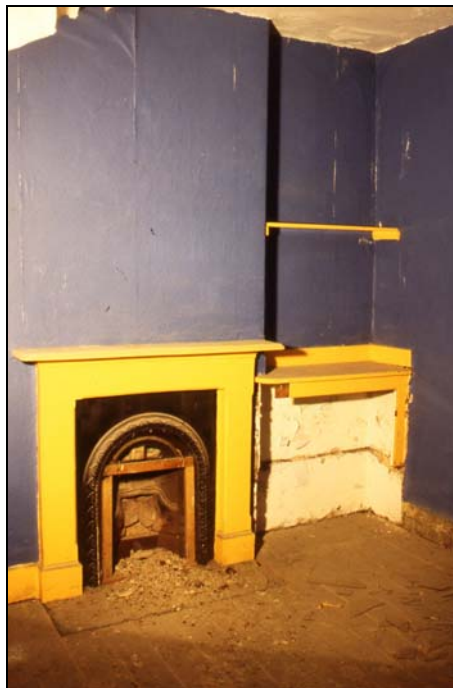
5.3.11 The decorative schemes within the flats contain no immediately apparent elements which could be considered original; neither paint nor wallpaper nor coving or other finishes (although original paint or wallpaper may be present beneath more recent layers). Basic skirting board is present in many rooms, but this is of little historic interest and may be of recent date. The flats have suffered somewhat from the attentions of short-life tenants, who seem to have removed or damaged many of the historic fixtures and fittings and implemented some unusual decorative schemes. However, these influences have also given the building a certain eccentric charm which is reflected in many of the record photographs (plate 17).

Plate 17: Decorative scheme in room SNFo5

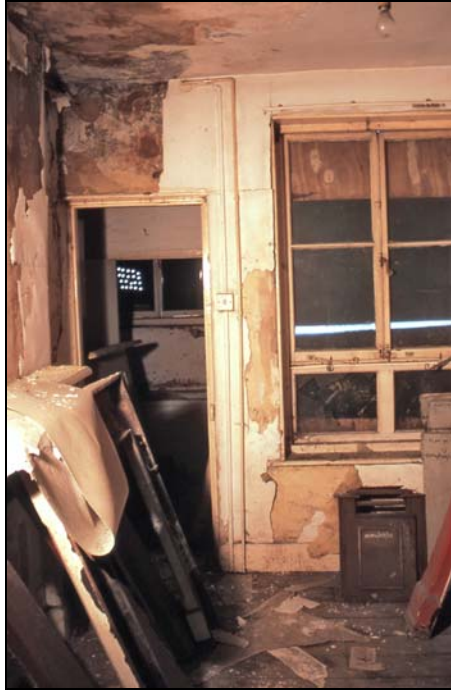
5.3.12 The flats are generally in a poor state of repair (plate 18), with damp leading to peeling wallpaper, ceiling falls and rot. They have, until cleared to allow recording, been used as a storage place for the salvage material from the 2001 demolition of the adjacent third Stanley Building, which initially cluttered and obscured the rooms (plate 19).

Plate 18: General view of room SNFo10, showing poor condition of building

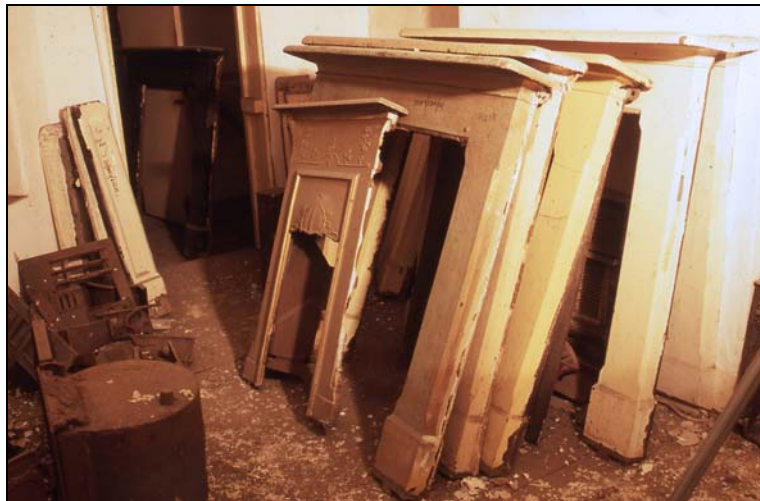
Plate 19: General view of room SNFo3, showing stored salvage materials

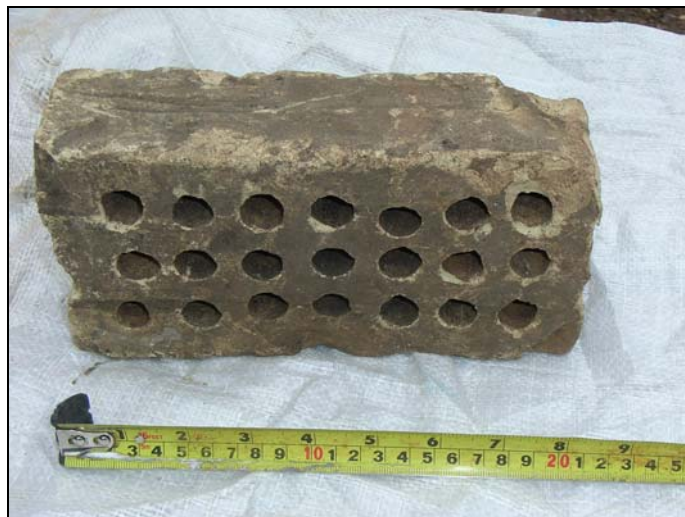
- 6.4 Type 2 bricks (Plate 20), which were used for the foundations, main load-bearing walls and frontage, were pinkish yellow perforated bricks. These were machine made (extruded and wire cut; with perforations introduced by the die), an appearance and fabric consistent with an 1860's date. They were probably new when used in the building. These were cheap bricks; cheaper to produce as they use less clay, and required less fuel to fire; cheaper also to transport and handle. They were of a type typically used for engineering purposes, and were stronger than ordinary bricks of the time.

Plate 20: Type 2 brick

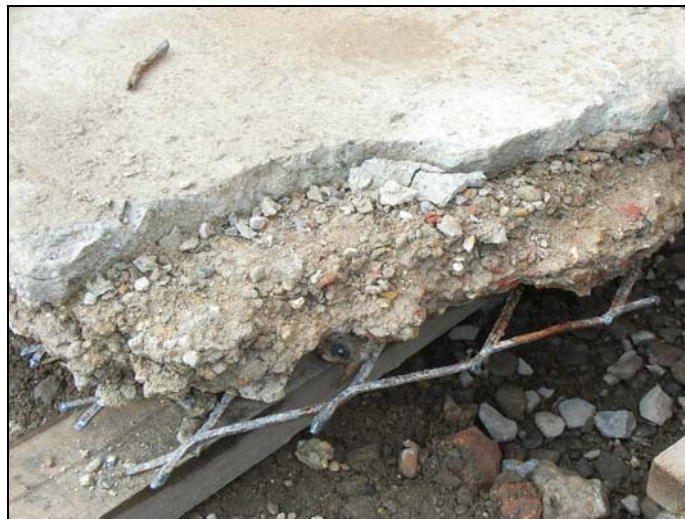
6.7 Sections of the concrete used within the building were also removed and recorded (plate 21). The cross-section of the concrete showed that the balcony and internal concrete floors were created using a similar method of construction to that described in paragraphs 8.2.3 and 8.2.4 for the roof: an iron mesh was fixed in place, shuttered underneath, then a coarse concrete mix including clinker and culm poured over it. Once this set, a finer grade of concrete appears to have been laid over it, to create a smooth surface. This system indicates that the sequence of construction for the balcony at each floor was as follows: the column and C-beam were erected, then the mesh fixed between beam and walls and shuttered underneath. The coarse mixture was poured in. When it had set, the balustrade was bolted in place. Finally, the finer grade concrete was laid over the coarse, anchoring the base of the balustrade to the floor.

Plate 21: cross-section of concrete sample

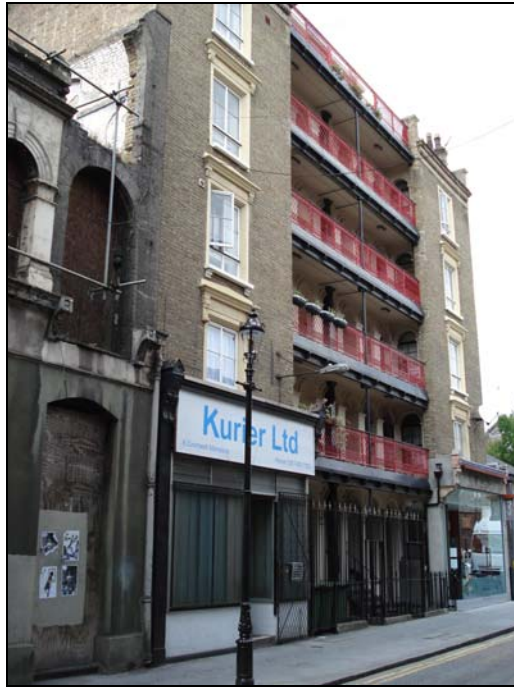
Plate 22: The Cromwell Buildings, New Southwark Street: general view

- 8.1.8 The Stanley Buildings were completed in 1865, which meant that though they were the IIDC's first scheme, they were not the first of its buildings to be occupied. The Cromwell Buildings, New Southwark Street (plates 22 and 23) were occupied in 1864, and the Tower Buildings in Wapping in early 1865. Both buildings are almost identical in design to the Stanley Buildings (and thus, in turn, to the Lagbourn Buildings (Mays, 1863)).

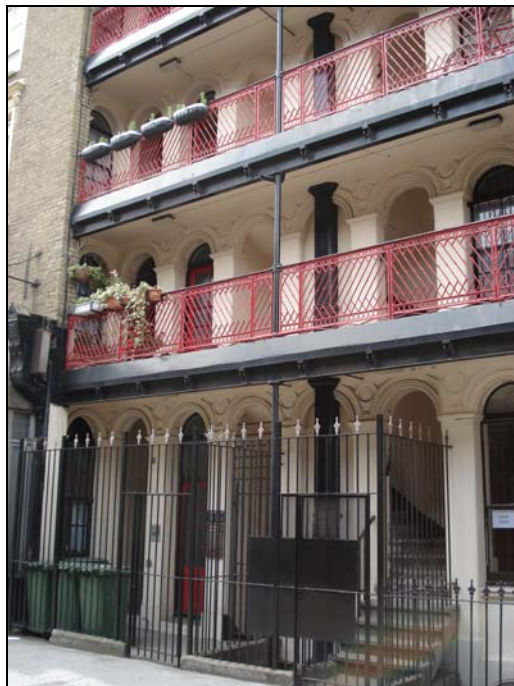
Plate 23: The Cromwell Buildings, New Southwark Street: balcony detailing

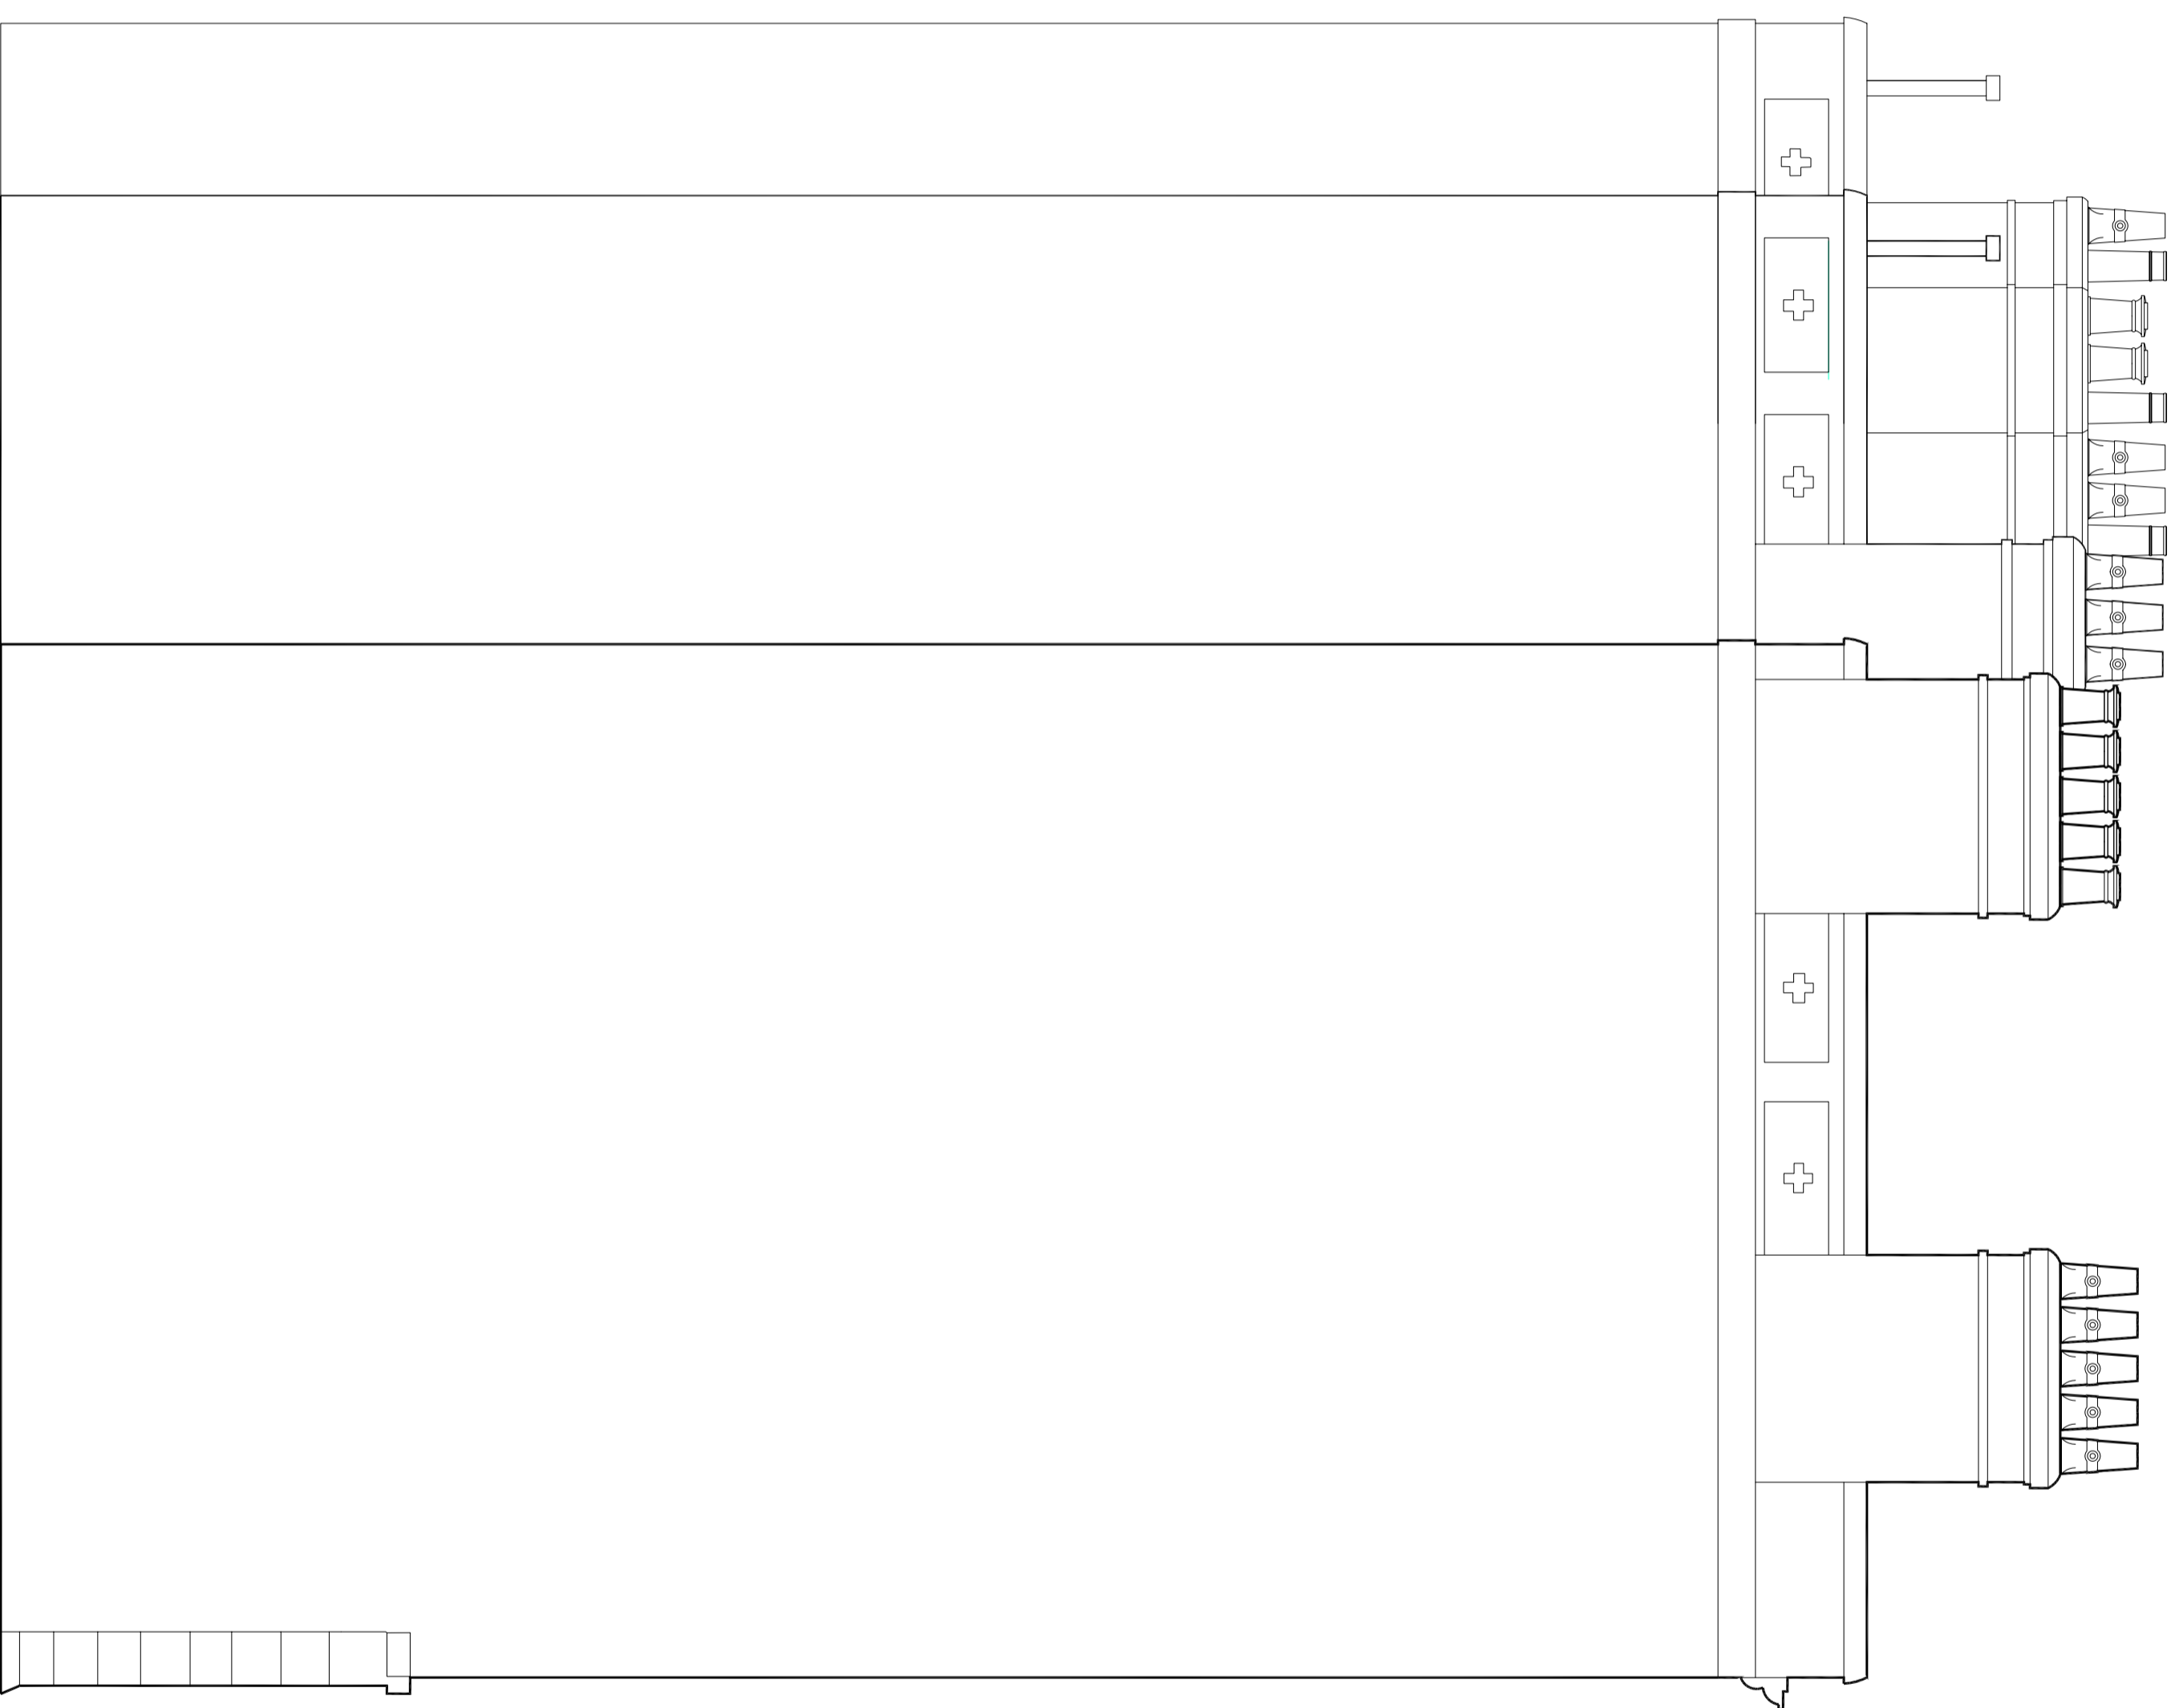
Figure 11
North East elevation
1:50 at A2

5.2.3.1 This elevation (fig. 11) is of original brick in an irregular Flemish bond. The southernmost section is set back from the rest of the elevation, as it forms the
