**THE WORKSHOP SITE, 25
DULWICH VILLAGE, LONDON
BOROUGH OF SOUTHWARK, SE21
7BW:
AN ARCHAEOLOGICAL WATCHING
BRIEF**

**SITE CODE: DCV17
REPORT NO.: R13440**

AN ARCHAEOLOGICAL WATCHING BRIEF
Quality Control

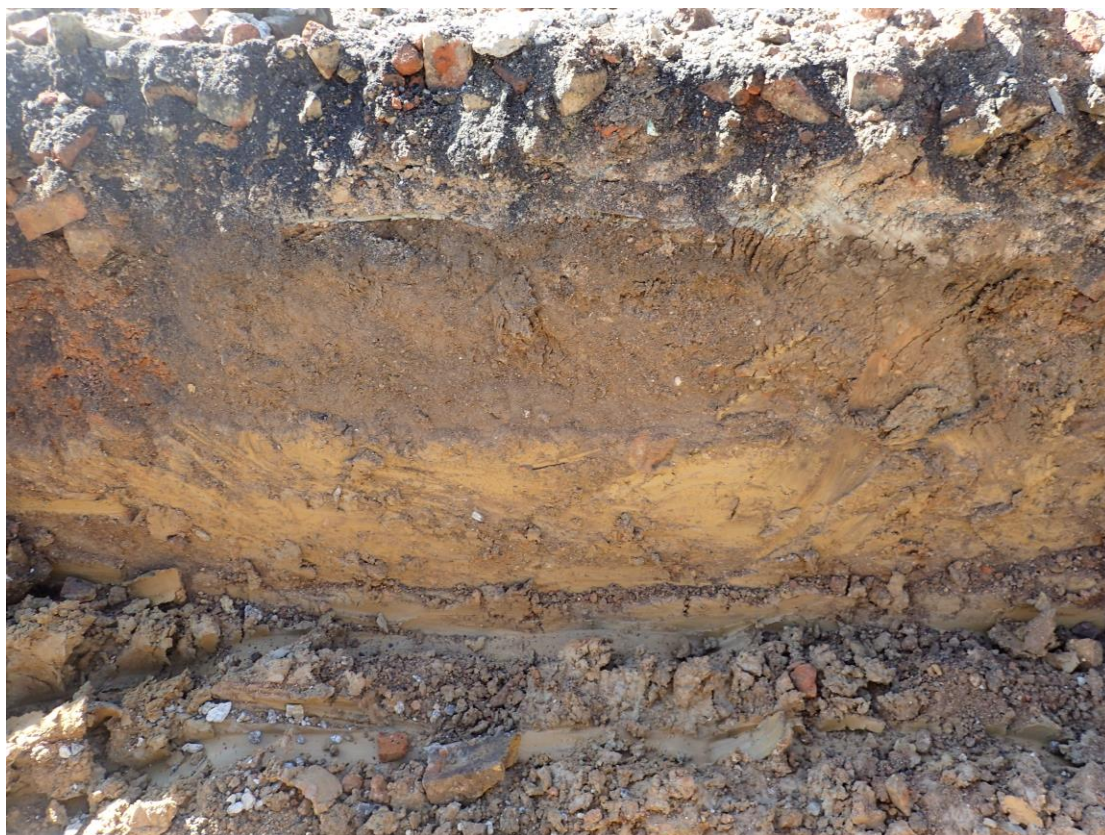
Plate 2 East facing section of Trench 2.

7.2.5 A layer of mottled yellowish clay [102] was observed at 1.40m BGL (c.27.40m OD) and continued along the base of the trench and below the lower limit of excavation.

7.2.6 Overlying the yellowish clay [102] was a layer of silty bluish grey clay 0.20m thick, observed at a maximum height of c.27.60m OD. The latter corresponds well in terms of composition and elevation to natural sequences identified in WS4.

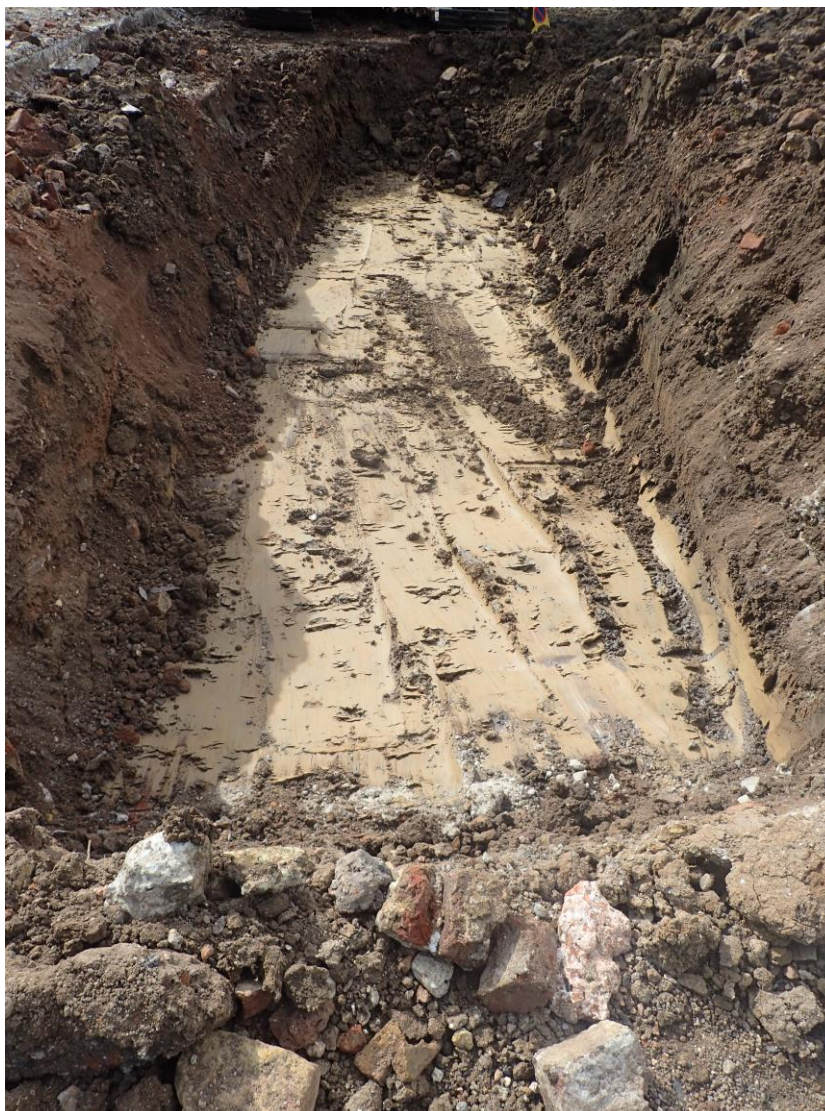
Plate 3: Base of Trench 3 looking west.

7.2.8 At the base of trench 3 a layer of natural mottled yellowish clay [103] was observed at 1.20m BGL (c. 27.60m OD) and continued below the lower limit of excavation. This represents a continuation of [100] as seen in Trench 1 and is likely to correspond to natural horizons identified in WS9 from 27.70m OD.

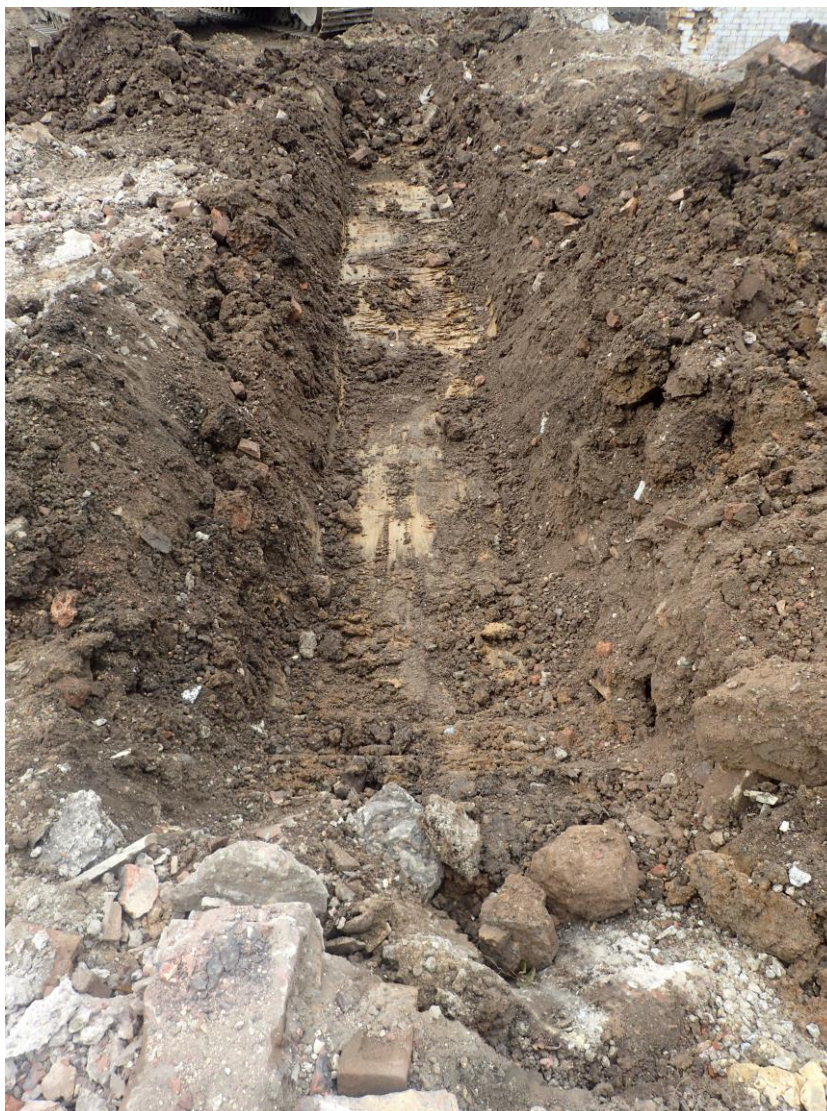
Plate 4: Base of Trench 4 looking west.

7.2.9 Trench 4 was excavated to a maximum depth of 0.80m BGL (c.27.90m OD) where a layer of natural mottled yellowish clay [105] was observed and continued below the lower limit of excavation. This horizon is likely to represent a continuation of natural horizons identified in WS6 and TP3, albeit at a slightly lower elevation indicative of horizontal truncation from modern foundations.

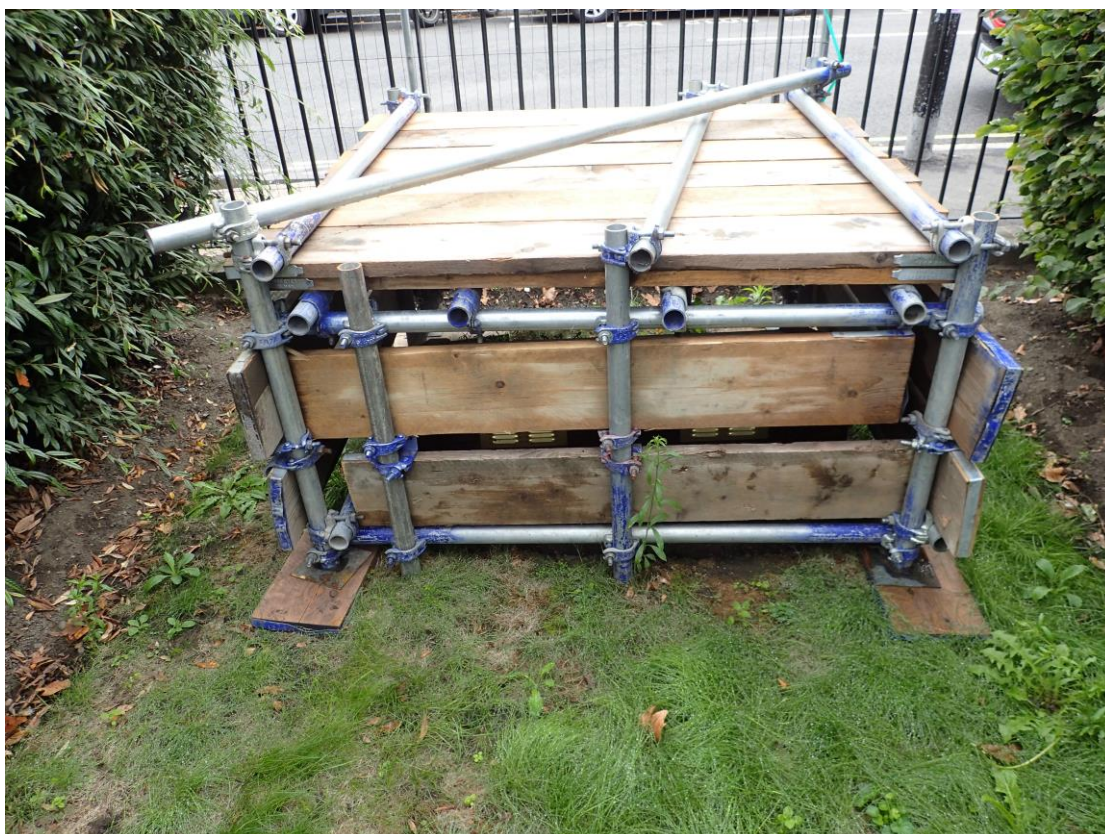
Plate 5: Covered village stocks commemoration plaque.

2.4 A plaque commemorating the village stocks remained protected in scaffolding within the site (plate 5) in a small memorial garden at the time of writing. However, the stocks themselves would have been located to the south-west bordering the current traffic island dividing Carlton Avenue. No remains relating to the stocks were present within the area investigated.

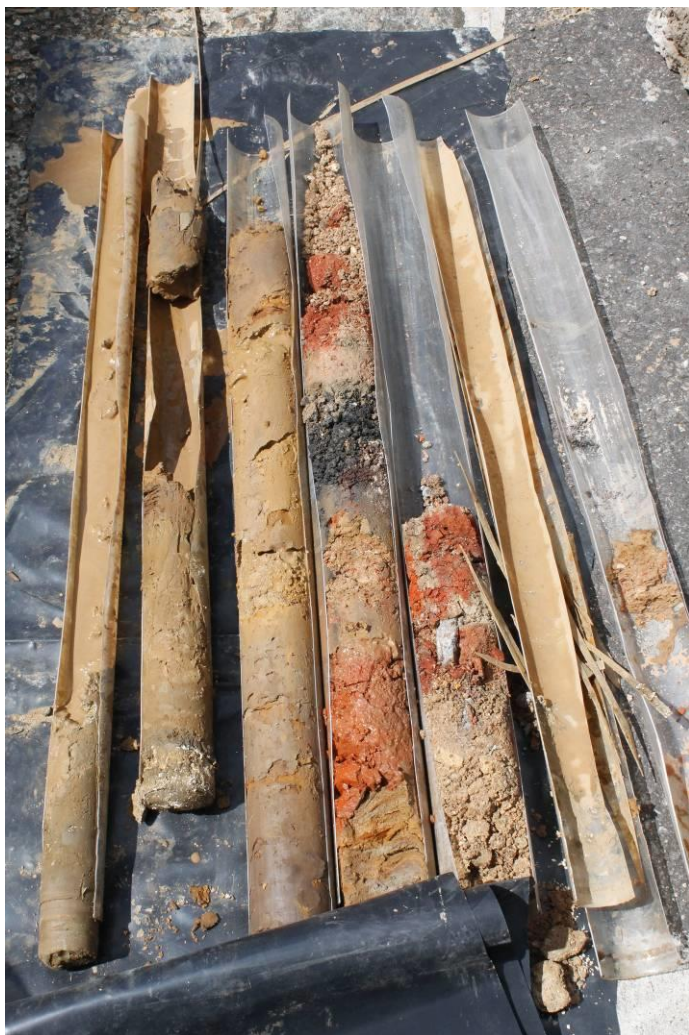
Shot of WS2

Summary: Made ground for upper 1.90m, underlain by soft silty sands from 26.71m OD (1.90m BGL) and firm clays from 25.91m OD (2.70m BGL). A distinctive shell rich horizon was noted at 24.66m OD (3.95m BGL).

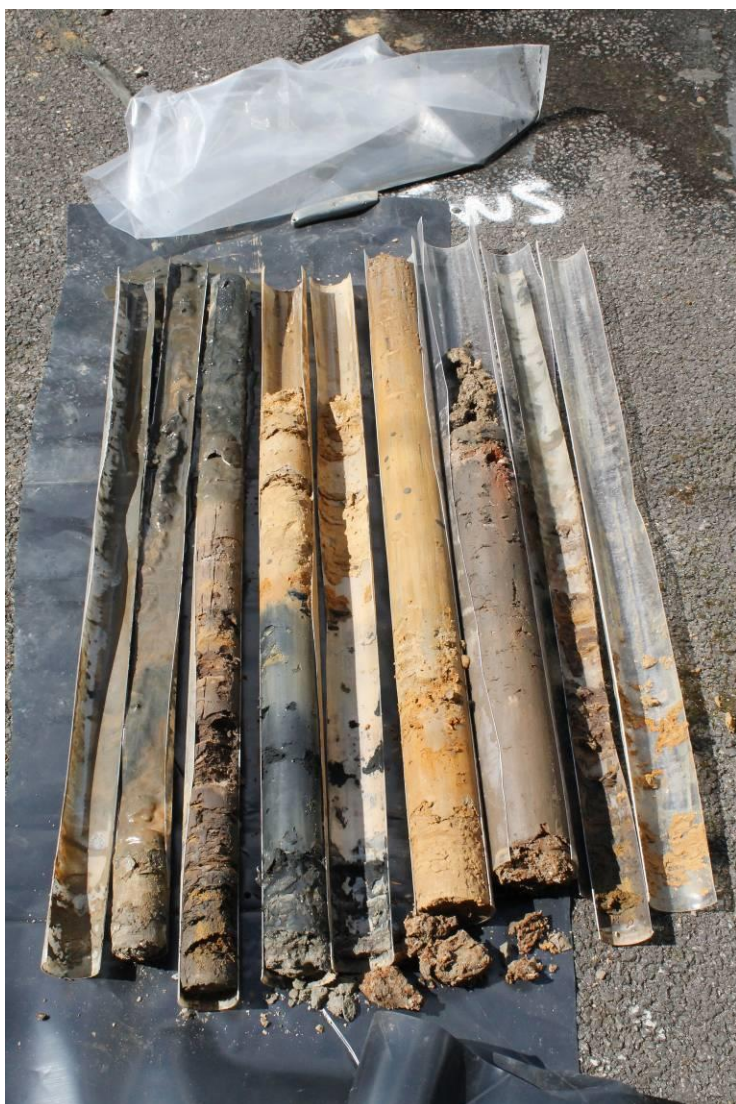
Shot of WS3

This was located in the southern central area of the site and sealed by tarmac. Below this a mid grey-brown sandy clay with red lenses was recorded with brick rubble at the top of the deposit only. This extended to 1.20m BGL and was tentatively interpreted as made ground. At 27.41m OD a soft, light yellow brown clay sand was identified overlying loose, med/coarse grained grey sand to a maximum combined thickness of 1.35m. At 2.55m BGL (26.06m OD) a black sand horizon was identified measuring 0.40m in thickness and overlay a 0.05m thick layer of friable fine grey sand and waterlogged black sand respectively. It is unclear whether the black sand indicates degraded organic material or contamination. At 25.26m OD firm, mottled grey-brown/red-brown clay was recorded with lenses of yellow sand. This extended to 4m BGL and sealed compact grey clay with frequent shell inclusions at 4.90m BGL.

Summary: Made ground for upper 1.20m. Potentially natural sand-rich deposits identified from 27.41m OD (1.20m BGL), becoming waterlogged from 3m BGL. Firm clays identified at 25.26m OD (3.35m BGL) with a distinctive shell rich horizon at 23.71m OD (4.90m BGL).

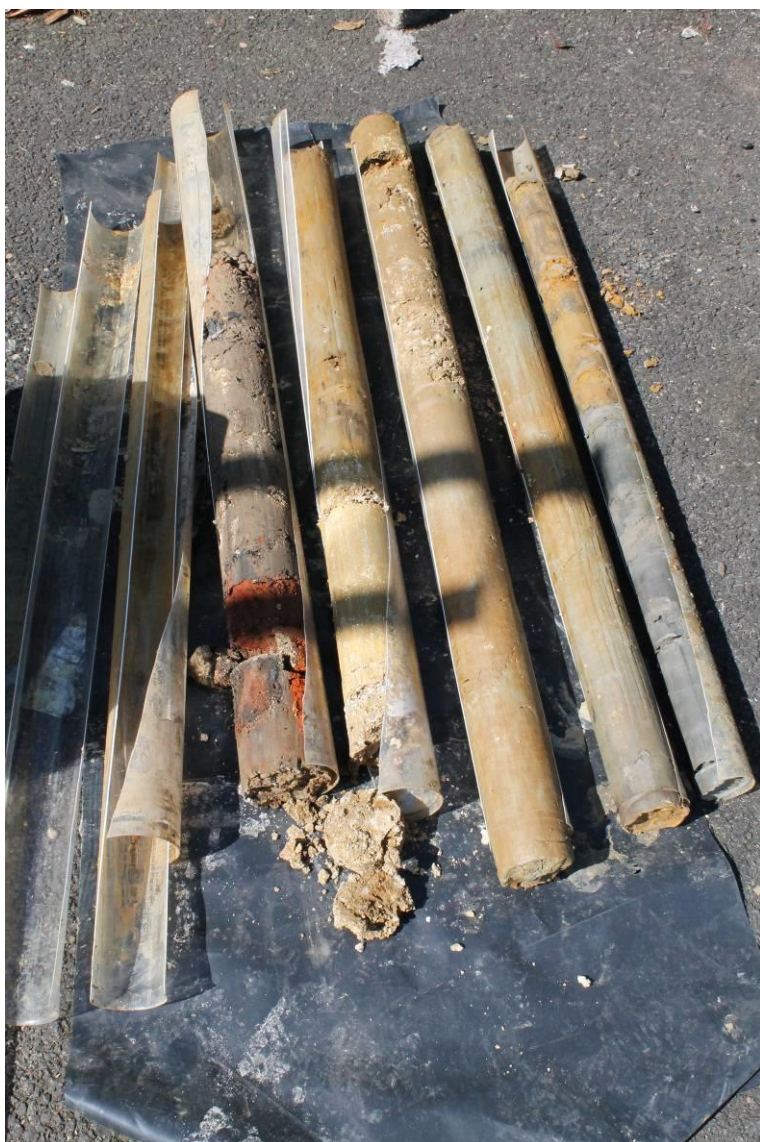
Shot of WS 7

This was located in the southern corner of the site within the extant car park. Made ground of tarmac, concrete, and CBM rubble sealed the upper 1.03m of the sample. These sealed a 0.20m thick layer of compacted masonry, potentially indicating the presence of an *in situ* late post-medieval wall. At 27.58m OD potentially natural stiff, grey-brown and orange mottled silty clay was identified. This extended to 1.83m BGL at which point the clay became increasingly shell rich. Numerous bands/laminations of shelly clay were recorded to a depth of 2.75m BGL. At this point, soft, yellow-grey silty clay was identified. A higher sand content was evident from 4.23m BGL and continued to the base of the sample.

Summary: Made ground sealed the upper 1.03m of the sample, and overlay *in situ* masonry at 27.72m OD. The nature of the masonry remains uncertain but is likely to represent late post-medieval or modern footings associated with a former structure. Natural silty clays were recorded from 27.58m OD (1.23m BGL), and extended to a depth of 26m OD (2.75m BGL) with numerous shell rich laminations. The lower 2.25m of the sample comprised sandy clays and silty sands, clean of any inclusions.

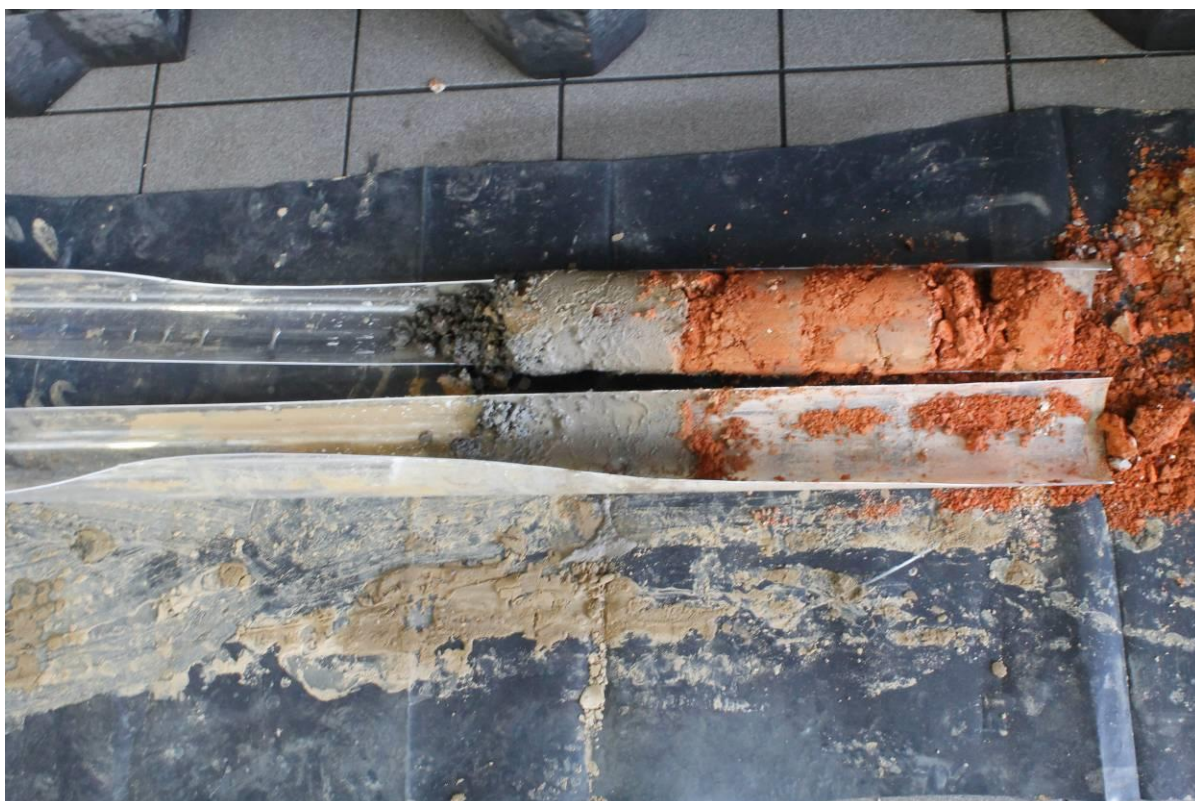
Shot of WS 8

Located in the extant workshop, this sample was abandoned after the first metre due to an obstruction. Only made ground was observed and comprised compacted CBM rubble.

Summary: Made ground only observed and sample abandoned. Possible in situ tanks in area.

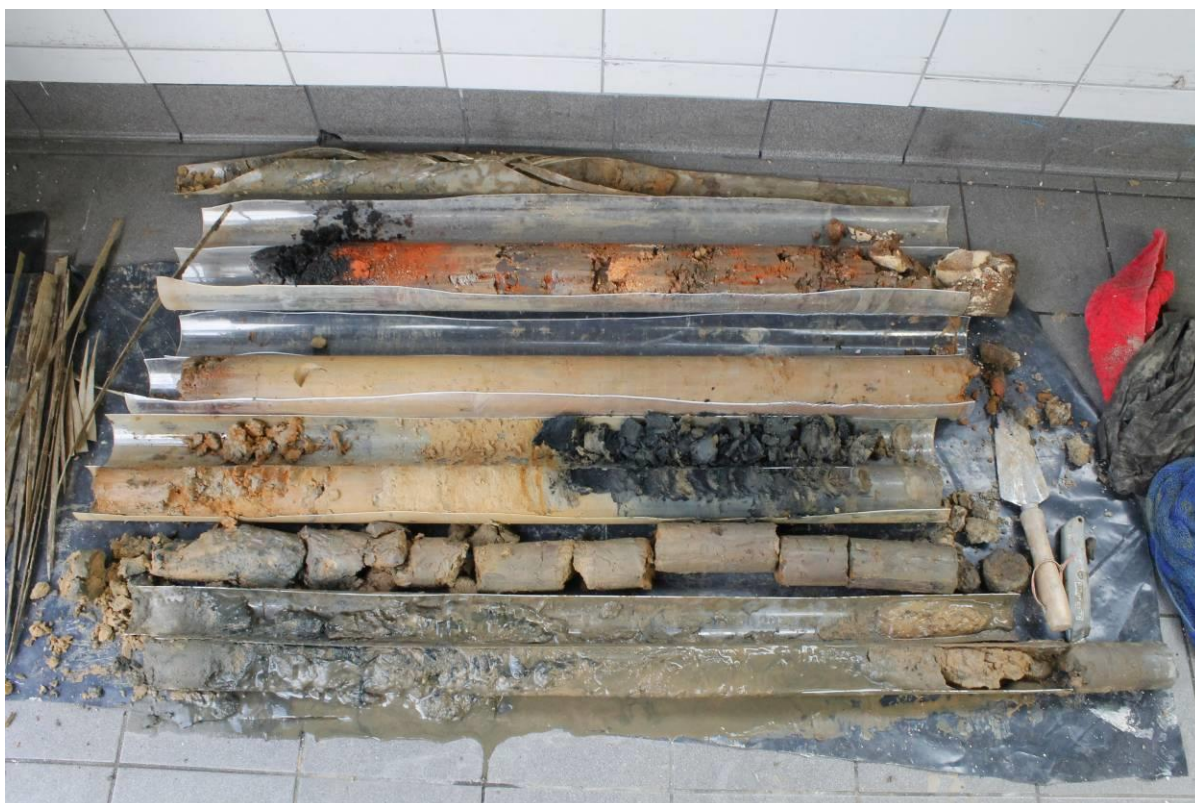
Shot of WS 9

This was located in towards the north-eastern corner of the extant workshop area. The concrete floor slab capped the upper 0.20m of the sequence, and was underlain by loose, black clinker and red CBM crush made ground to 0.37m BGL. At this point a 0.75m thick layer of firm sandy silty-clay containing CBM rubble and large fragments of ceramic drain pipe was identified and interpreted as late post-medieval/modern levelling material. Soft, yellow-brown silty clay with sand lenses was identified at 27.70m OD and extended to a maximum thickness of 0.60m. No anthropogenic inclusions were evident and this was interpreted as natural. From 1.72m BGL the clay became increasingly sand rich with waterlogging apparent from 4.10m BGL. Firm, grey brown silty clay was recorded in the last 0.10m of the sample.

Summary: Made ground sealed the upper 0.37m of the sample, with late post-medieval/early modern levelling material identified at 28.65m OD and thought to represent the demolition of structures pre-dating the extant garage/workshop. Natural horizons of silty clay were recorded from 27.70m OD (1.12m BGL) and became increasingly sand rich from 27.10m OD (1.72m BGL). Waterlogging was apparent from c.4.75m BGL.

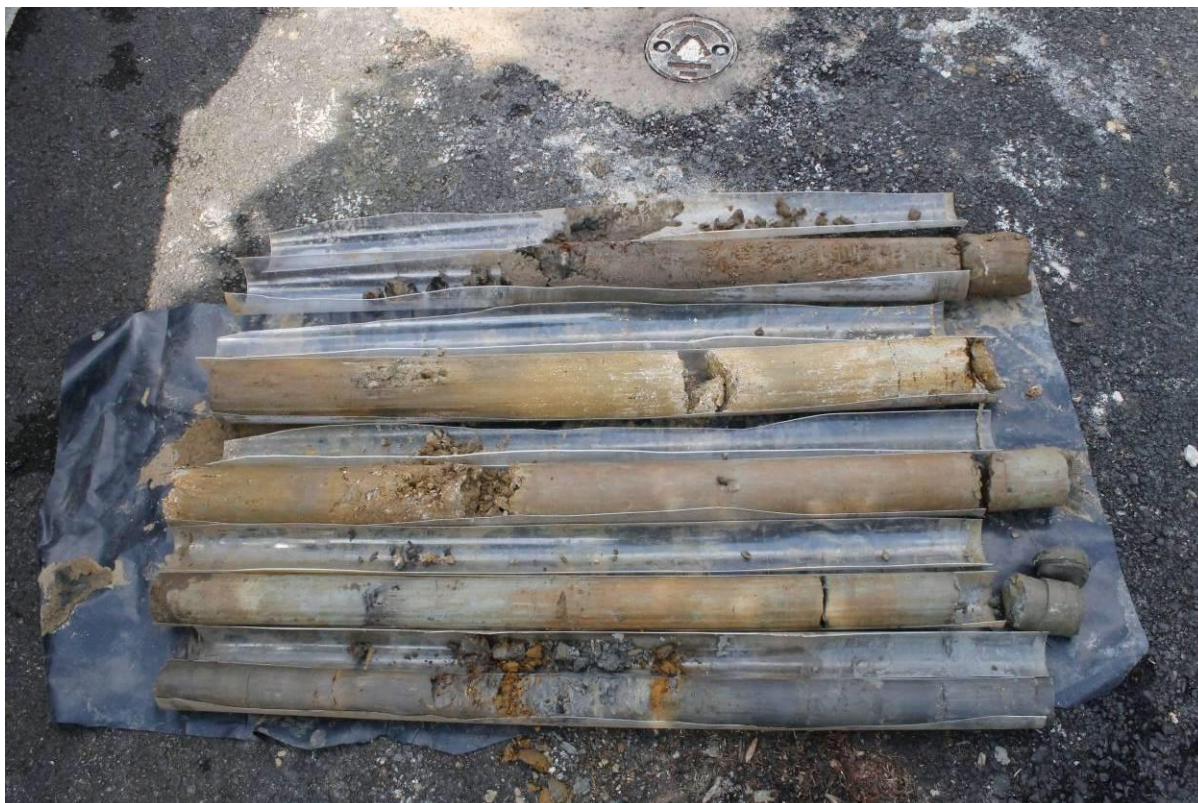
Shot of WS 10

The sample was located at the central south-eastern end of the site, between WS 5 (to the north east) and WS 7 (to the south west). Tarmac and concrete sealed the upper 0.33m of the sample and were underlain by loose, mid brown grey coarse sandy-silt with gravel and CBM flecks. The latter 0.20m thick deposit is likely to represent levelling material, of uncertain date. This was underlain by light grey sandy-silt with red-brown lenses of clay and interpreted as a natural horizon. The sandy silt and clays extended to a depth of 1.30m BGL at which point the layers became increasingly shell-rich with isolated dense accumulations of shell. These shell inclusions extended to a depth of 2.05m BGL. Firm, mid grey-yellow silty clay with no inclusions was recorded at 26.67m OD and extended to the full depth of the sample with variable lenses of sand and gravel.

Summary: Made ground capped the upper 0.33m of the sample with possible levelling material identified below this from 28.39m OD of uncertain date. Below this natural silty clays were recorded from 28.19m OD, with shell inclusions recorded from 27.42m OD (1.30m BGL). The natural became increasingly compact and clay rich from 26.67m OD (2.05m BGL) and extended to the full depth of the sample.

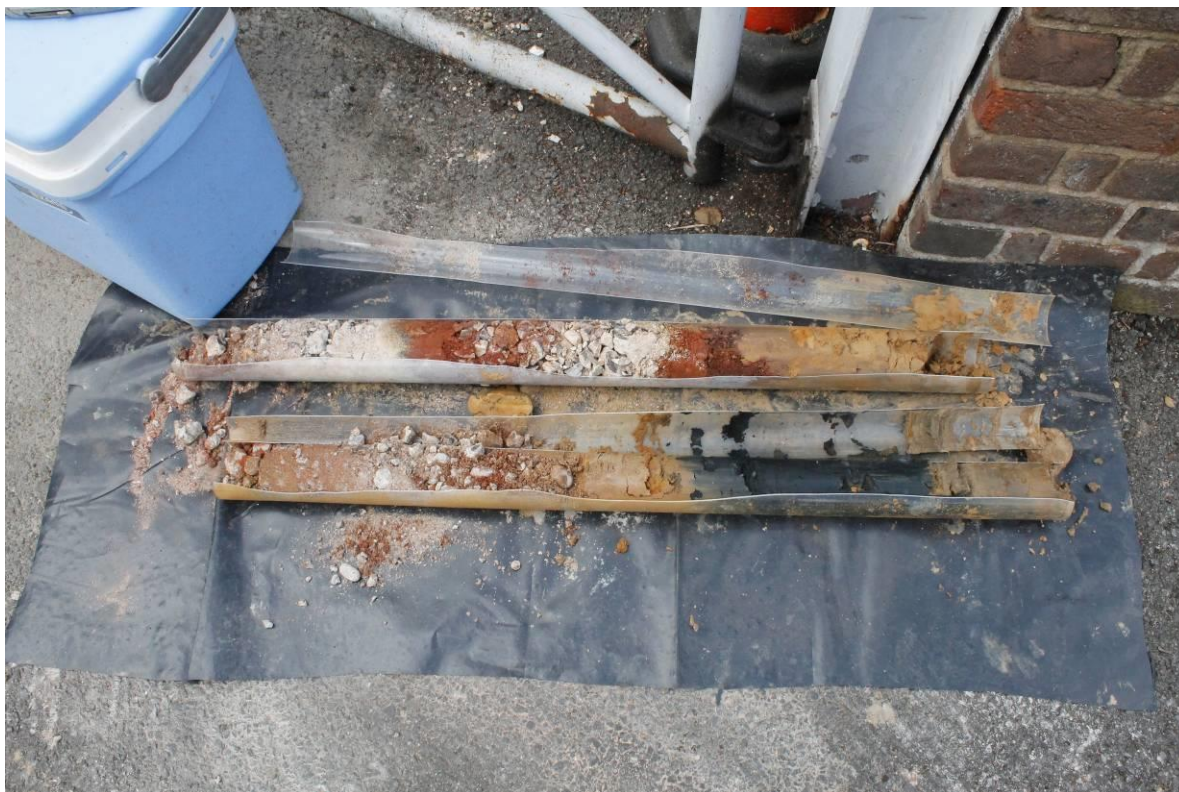
Shot of WS 11

This was located in the north-western limits of the site adjacent to WS1A (to the north) and WS2 (to the south). Due to obstructions, this was not excavated to full depth. Furthermore, obstructions in the upper metre caused compaction and collapse of the second probe, therefore making any depths established for these horizons approximate. Made ground comprising loose, gravel and CBM rubble sealed the upper 1.70m of the sample. This was underlain by loose, mid yellow brown silty sand interpreted as natural. This extended the full depth of the sample, subdivided by a distinctive black sand horizon at c.2.20m BGL. It is unclear whether this c.0.50m thick deposit represents natural staining from organic material or contamination.

Summary: Modern made ground capped the upper 1.70m of the sample, and sealed natural silty sands from 26.90m OD. No evidence of the compact clays or shell horizons as seen in other samples was encountered.
