**182 BURNT OAK BROADWAY,
EDGWARE, LONDON HA8 0AU
AN ARCHAEOLOGICAL
EVALUATION**

AN ARCHAEOLOGICAL EVALUATION

Site Code:	BNO18
Central NGR:	TQ 1995 9072
Local Planning Authority:	LONDON BOROUGH OF BARNET
Planning Application No.:	17/6051/FUL
Historic England (GLAAS) Ref.:	16/5815/FUL dated 07/02/2017
Commissioning Client:	HILL PARTNERSHIPS LIMITED
Written/Researched by:	JAMES LANGTHORNE Pre-Construct Archaeology Limited
Project Manager:	HELEN HAWKINS (MCIfA) Pre-Construct Archaeology Limited

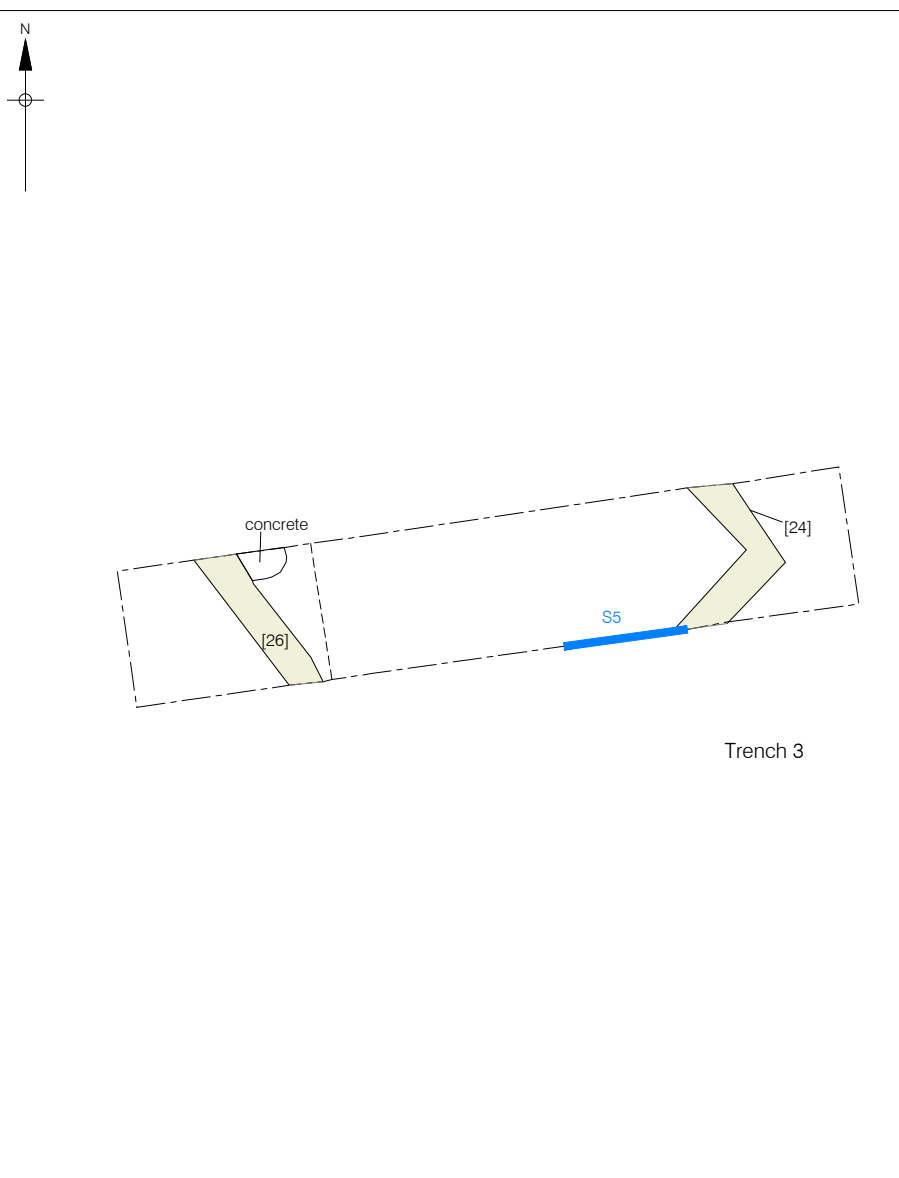
Figure 3
Plan of Trenches 3 and 6
1:100 at A4

7.2.2 Truncating weathered natural clay [28] and [2] in Trenches 3 and 6 respectively were the remains of several 19th and early 20th century wall foundations constructed of frogged red and yellow stock brick and concreted light grey white or grey yellow cement mortar: walls [24] and [26] in Trench 3 and walls [4], [6], and [8] in Trench 6. These late post-medieval structures related to the former Workhouse building present on the site. The walls in Trench 3 had bricks dated to 1875-1900 (Appendix 4). When overlaid on the Ordnance Survey map, they appear to correspond with a building built after 1873 and before 1896 (Figures 5 and 6). The walls in Trench 6 were dated by their bricks to 1875-1925. However, a building is not shown in this location until the Ordnance Survey map of 1937 and so they must have been constructed after 1914 but before 1937 (Figure 7). The details and dimensions of the wall foundations are outlined in the table below:

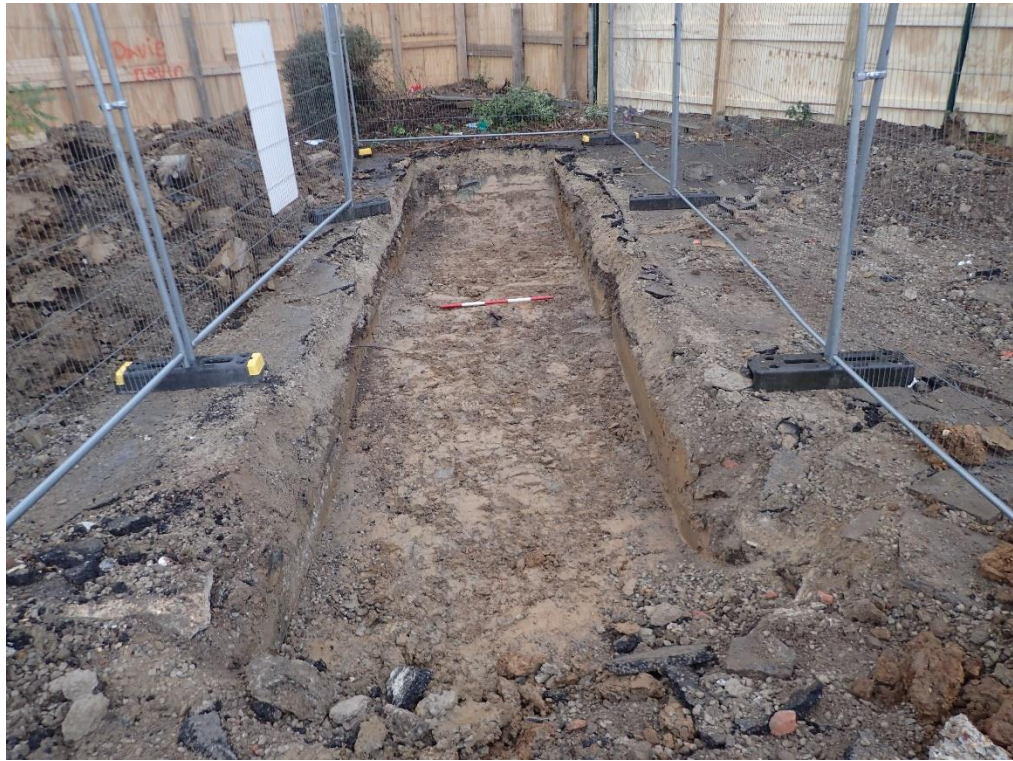
Plate 1: West facing view of Trench 1 (1m scale).

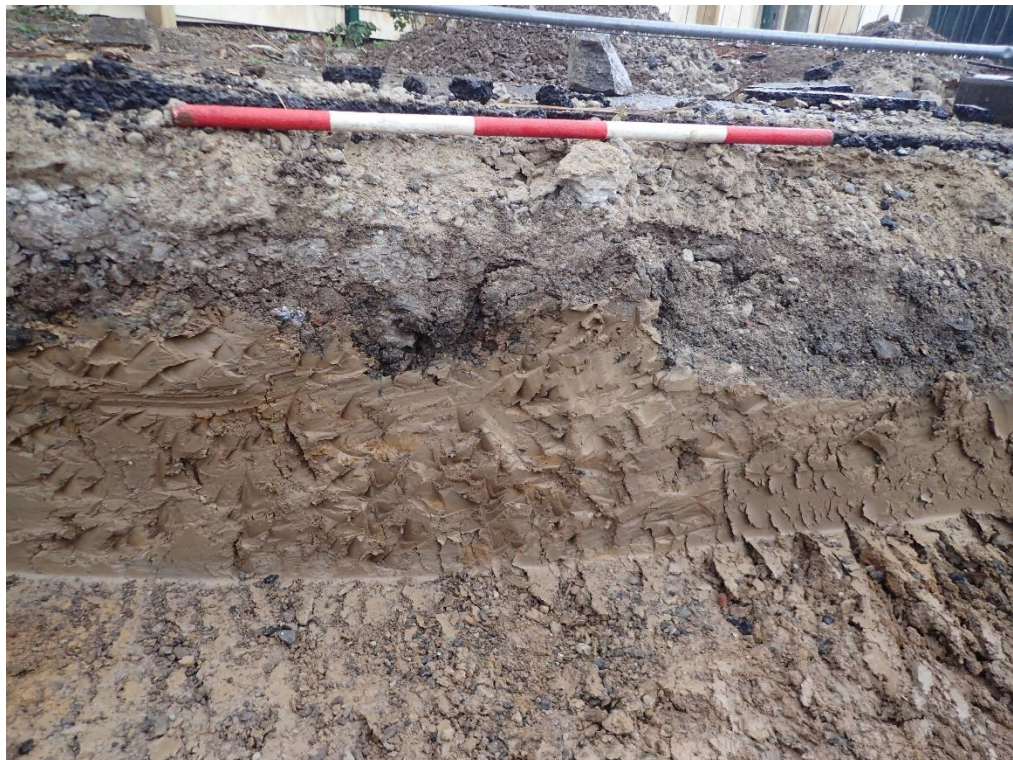
Plate 2: South facing section in Trench 1 (1m scale).

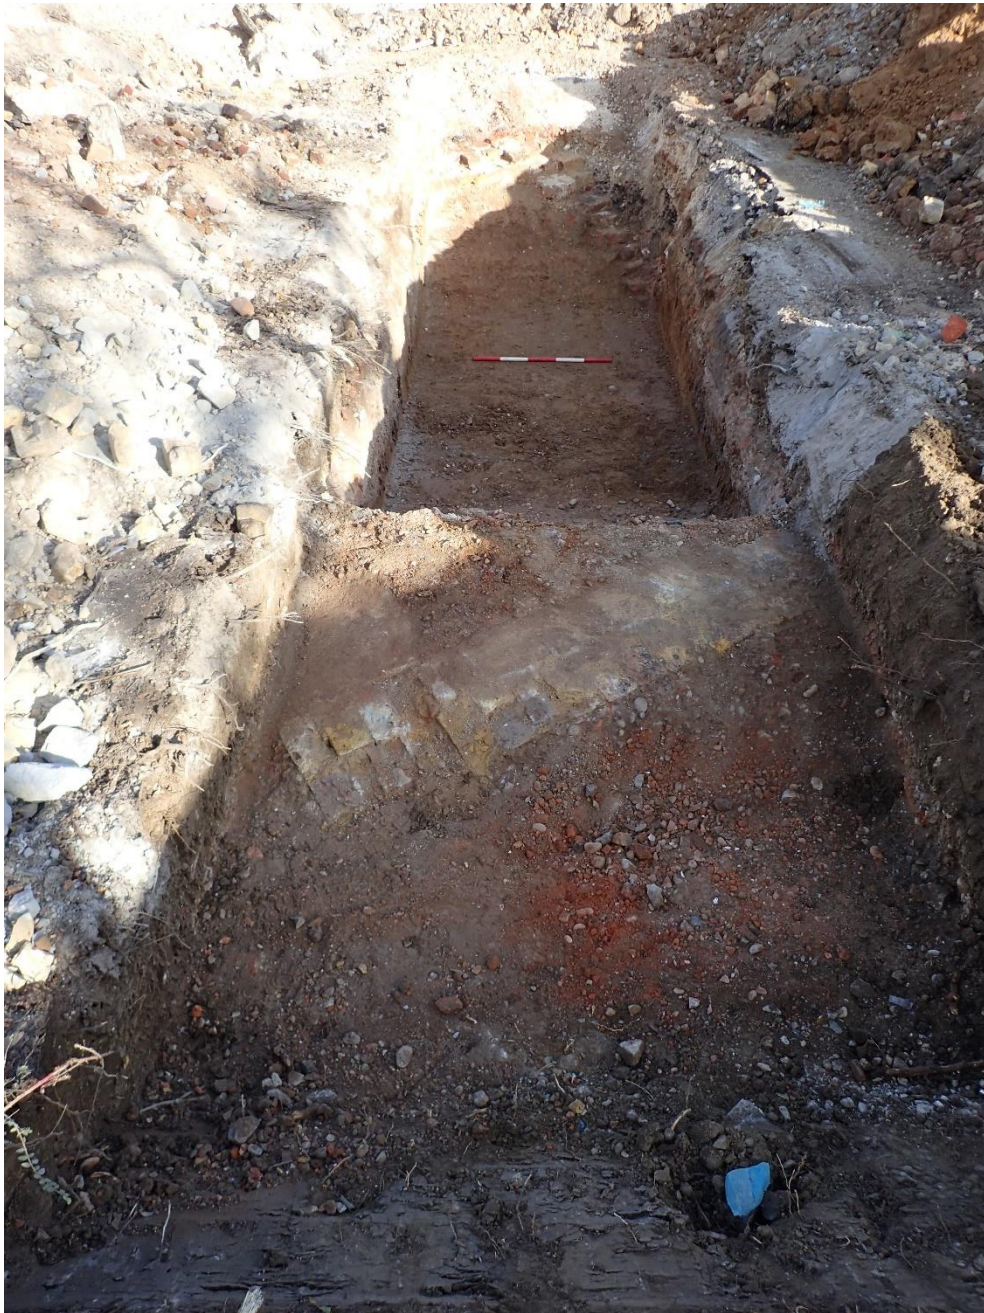
Plate 3: East facing view of Trench 3 (1m scale).

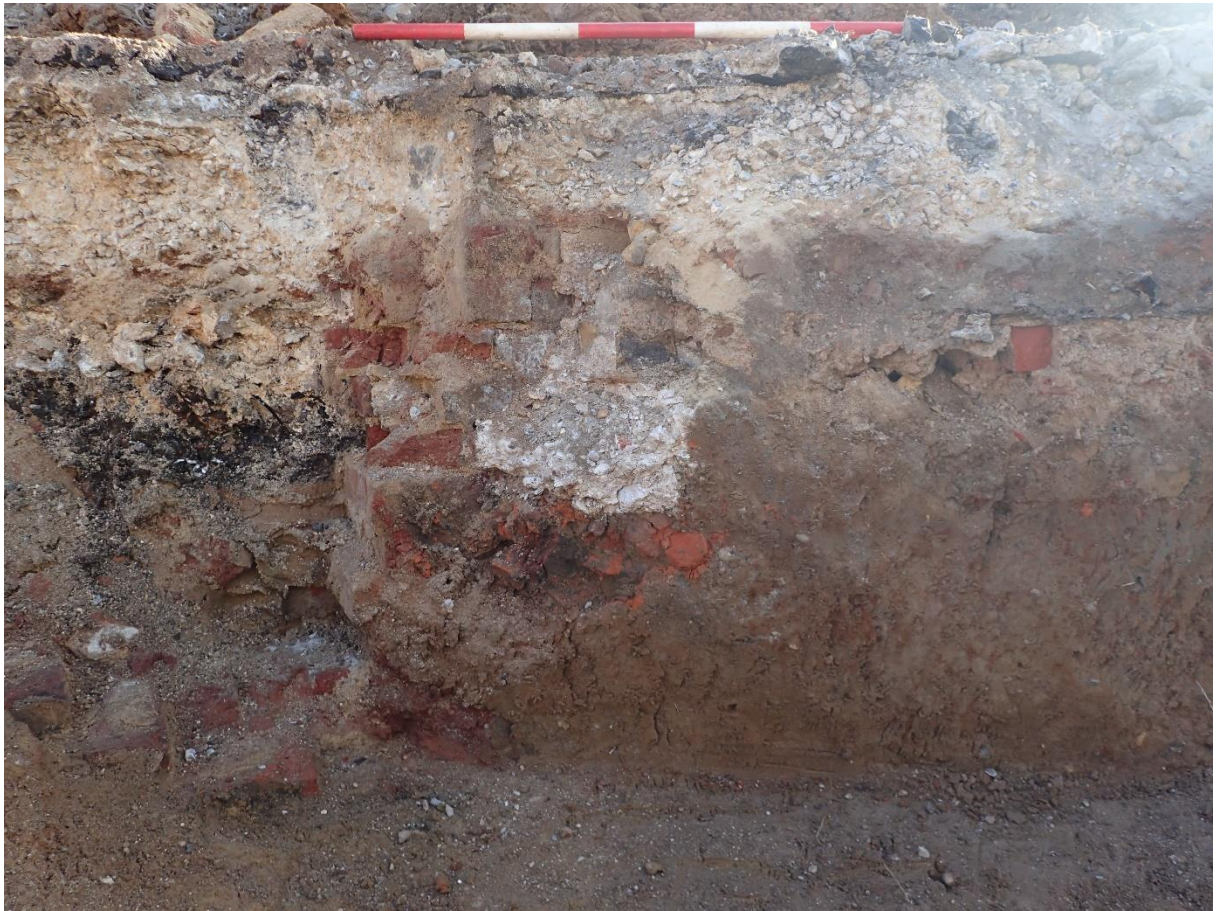
Plate 4: North facing section in Trench 3 (1m scale).

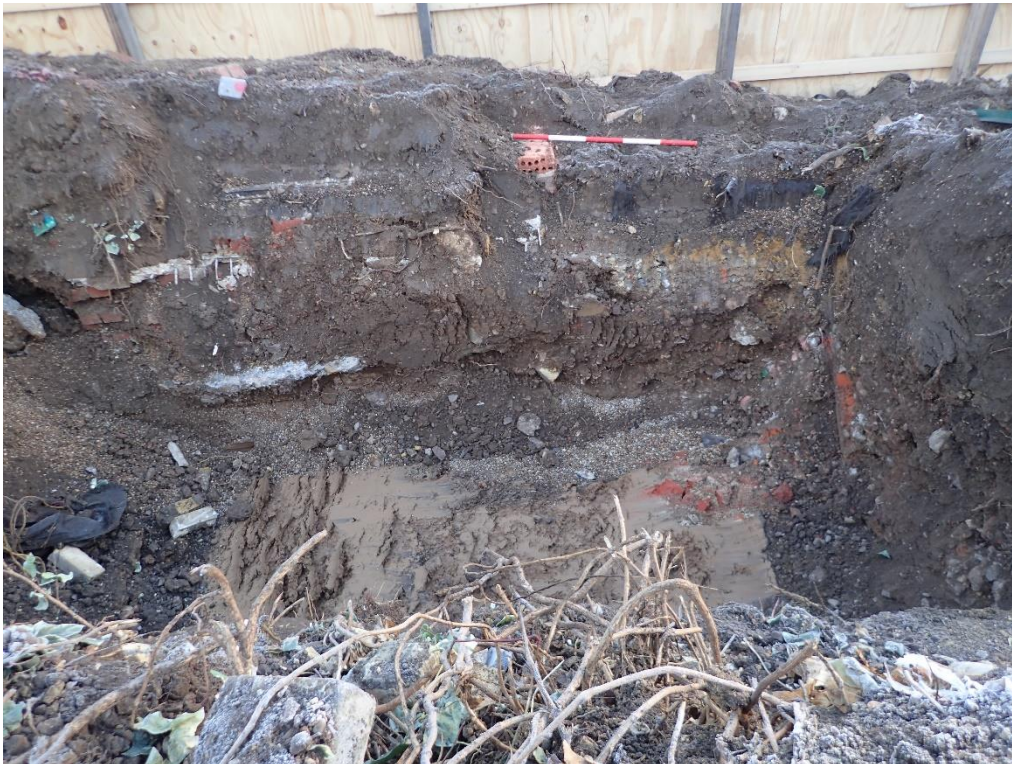
Plate 5: North-East facing section in Trench 5 (1m scale).

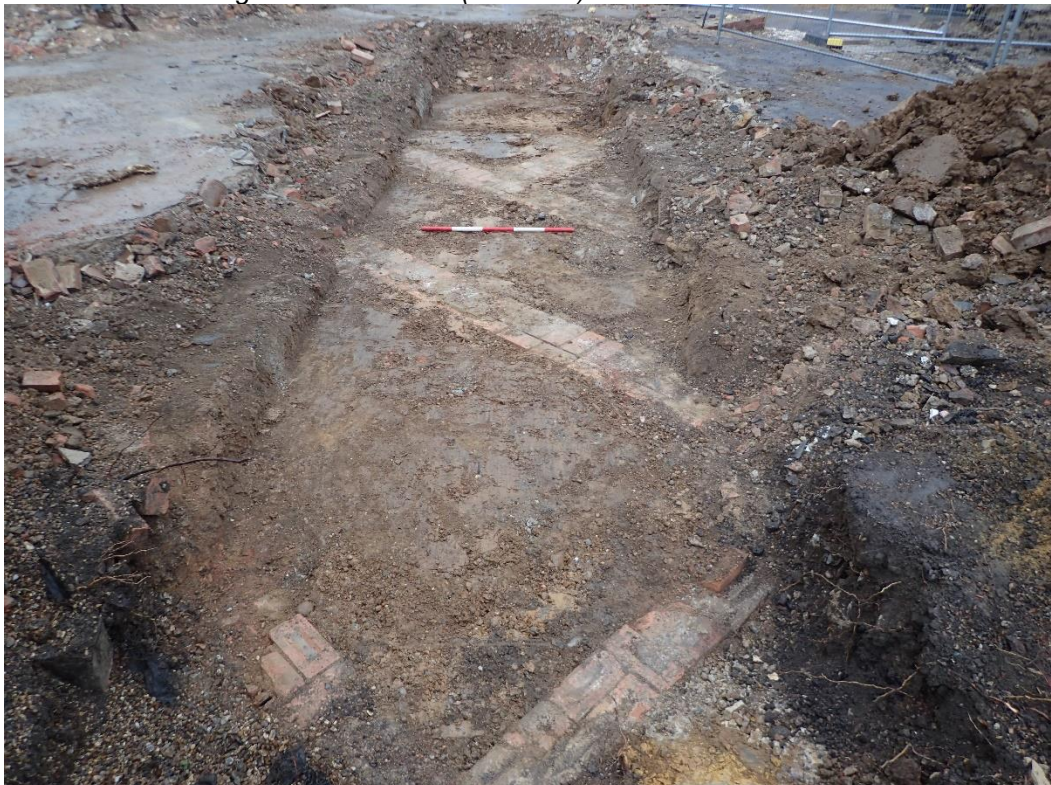
Plate 6: South facing view of Trench 6 (1m scale).
