**LAND BETWEEN KINGS COTTAGE
AND 29 HIGH STREET, THORPE-LE-
SOKEN, ESSEX**

ARCHAEOLOGICAL EVALUATION

PCA REPORT NO: R13515

SITE CODE: TSKC18

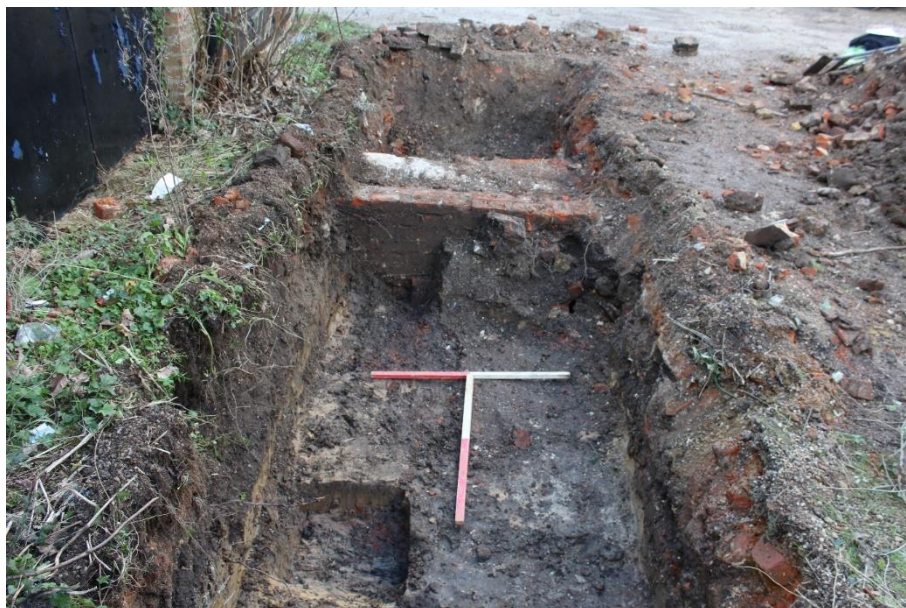
6.2.4 Irregularly bonded wall (12) was c. 0.24m wide (1 brick length thick) and survived to a height of 0.20m below the current ground surface. It was oriented northeast to southwest. Walls (13) and (14) were only partly seen in the edge of the trench. They were both oriented northwest to southeast and survived to a height of 0.25m below the carpark surface (although the upper bricked courses are heavily disturbed).

Plate 5: Trench 1, view northwest with wall (12)

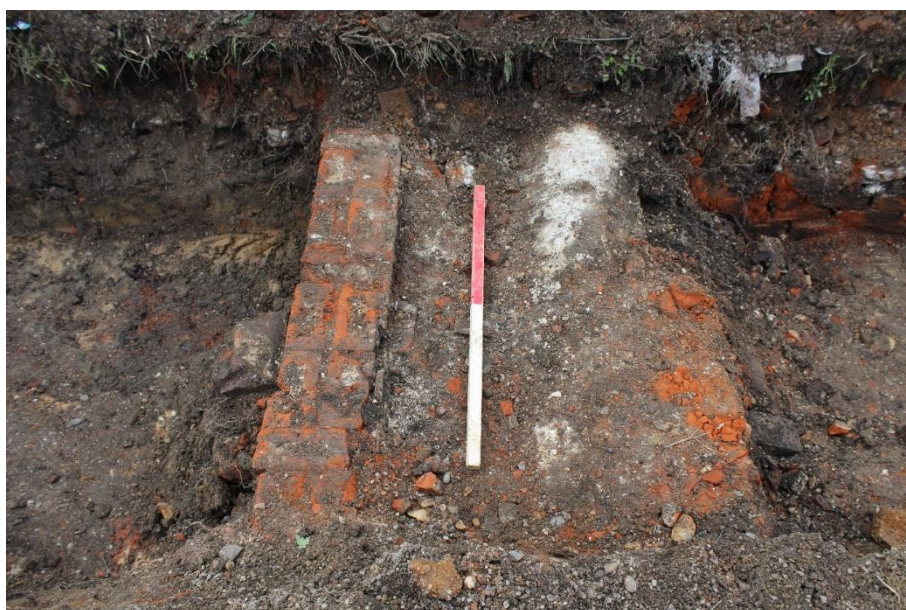
6.2.6 A modern concrete capped drain was recorded running across the middle of Trench 1 just below the modern ground level.

Plate 6: Trench 1, wall (12) and modern concrete drain to right, view southwest

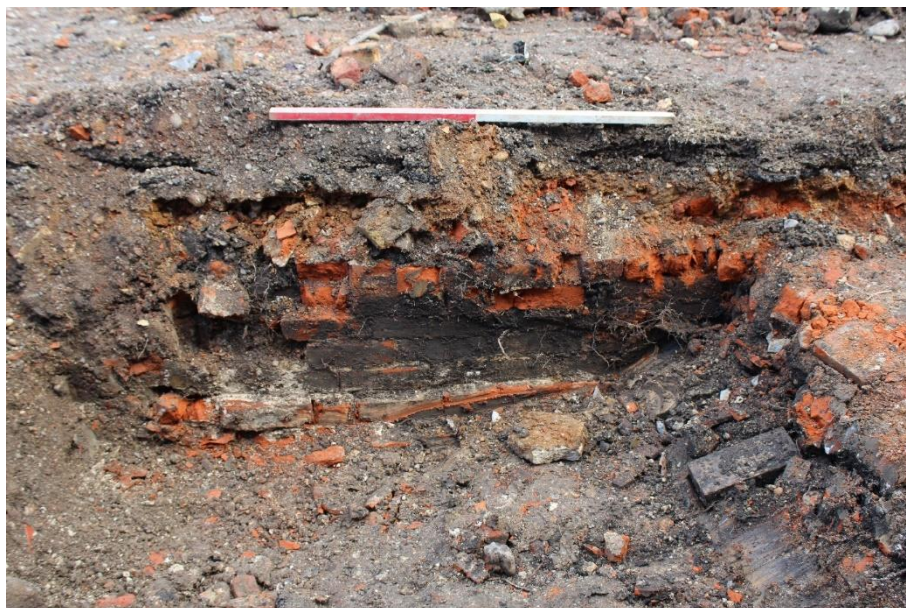
6.2.2 This trench contained three brick walls (112), (113) and (114) which together formed a small cellar apparently contemporary with a phase of the existing building on site. These walls survive to a height of c. 0.6m, above their brick footings. The cellar was 1.9m wide and at least 2m long. Ordnance Survey County Series Map Essex 1874 (1:2,500) shows that the line of the rear of the existing building or a previous building at the same location was stepped out in two places (see Plate 15). The line of the rear of the building was straightened after it was remodelled as a garage in the 20th century (Garwood 2018).

6.2.3 Some shallow bricks were seen concentrated near the base of these walls during machining (although heavily disturbed), indicating the probable former presence of a floor (116). The walls were built of lightly frogged late 18th to 19th century bricks (Adam Garwood pers. com). No construction cuts were observed associated with these walls. A deposit (115) that abutted the footings of walls [113] and [114] was recorded immediately below the level of where the remains of the probable floor were observed. Layer (115) was not excavated.

Plate 7: Trench 1, wall (113), view northeast

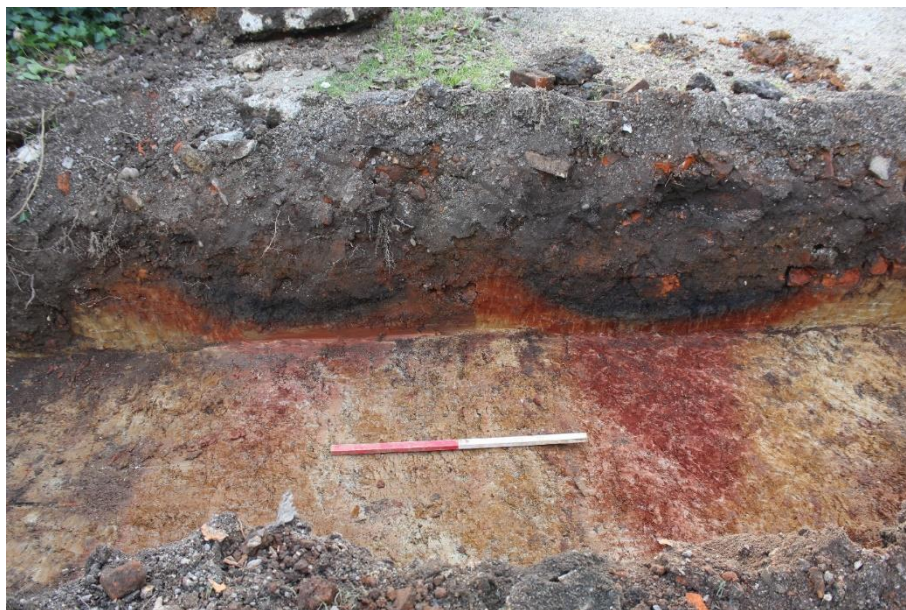
6.3.1 Trench 2 was 9.5 m long and contained the remains of what appear to be furnaces [120] and [123]. These features were heavily truncated and survive to a maximum depth of 0.20m (Fig. 3). Although the reddened and burnt natural was clearly visible during machining, the base of these shallow features was first observed in profile in the southwest side of the trench. A c.2m wide area of modern truncation occupied the southwest of the trench. This truncation was probably linked to demolition activity connected with former building located at the northeast of the site (Garwood 2018).

6.3.5 The furnace features in Trench 2 were overlain by made ground layer (118) which seems to represent a demolition and landscaping of the site. The activity represented by this layer (and equivalent layer 102) seems to be responsible for truncating features [120] and [123]. An area of modern truncation was recorded at the eastern end of the trench.

Plate 9: Trench 2, furnace features [120] & [123], view southwest

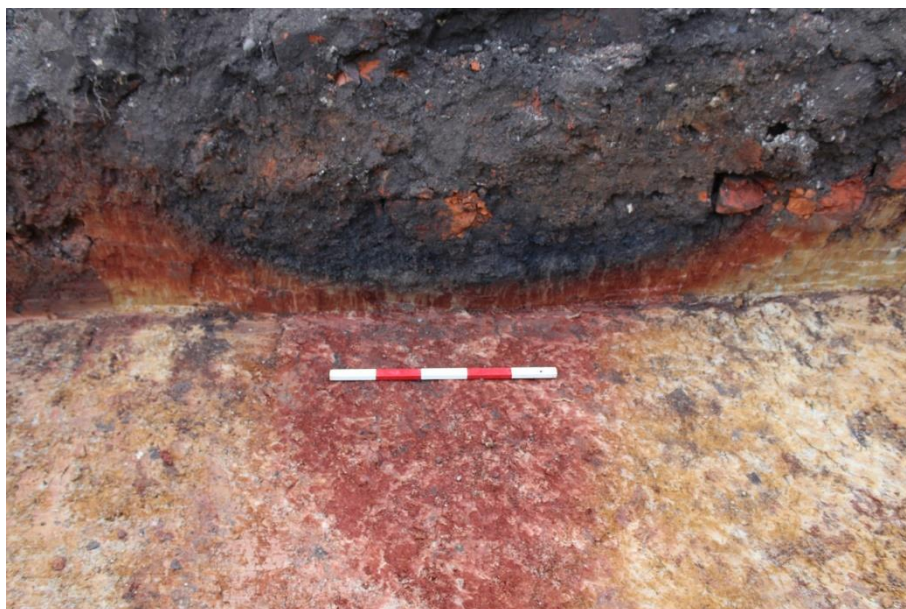
6.3.3 Feature [120] was c. 1.4m long and c. 0.8m wide. It was 0.14m deep. It was filled by (119), a dark fill composed of fragmentary baked clay thought to be refractory material. Underlying [120] was an area of intensely reddened natural ground (121) which can be taken to indicate prolonged high temperature activity associated with this feature. It is thought that this feature is a furnace base related to some small-scale 18th or 19th century industrial activity on site. No dating material was recovered from this feature.

Plate 10: Trench 2, furnace feature [120]

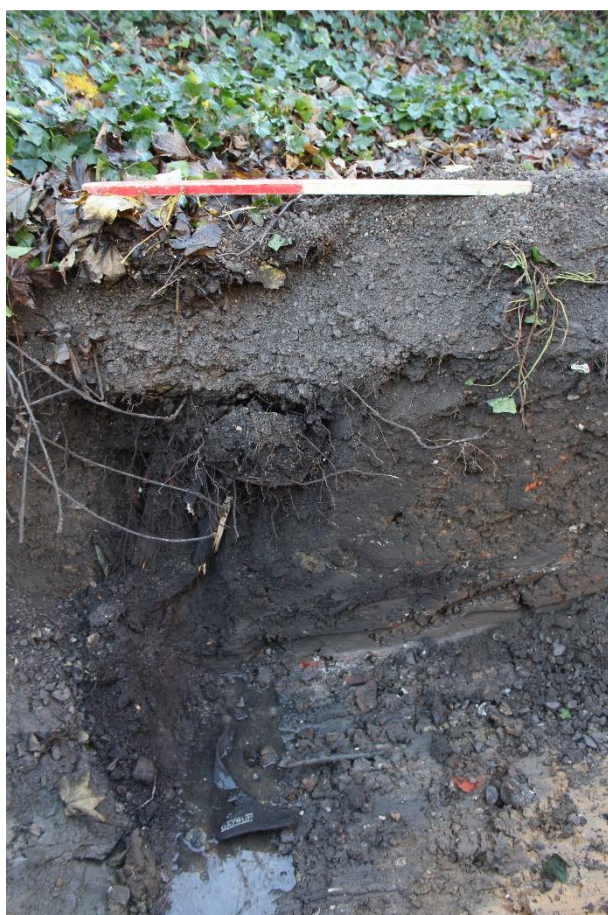
6.4.4 An area of modern truncation [105] was recorded at the eastern end of the trench. This truncation was probably linked to demolition activity connected with former buildings located at the northeast of the site (Garwood 2018).

Plate 12: Trench 3, modern truncation [105], view south

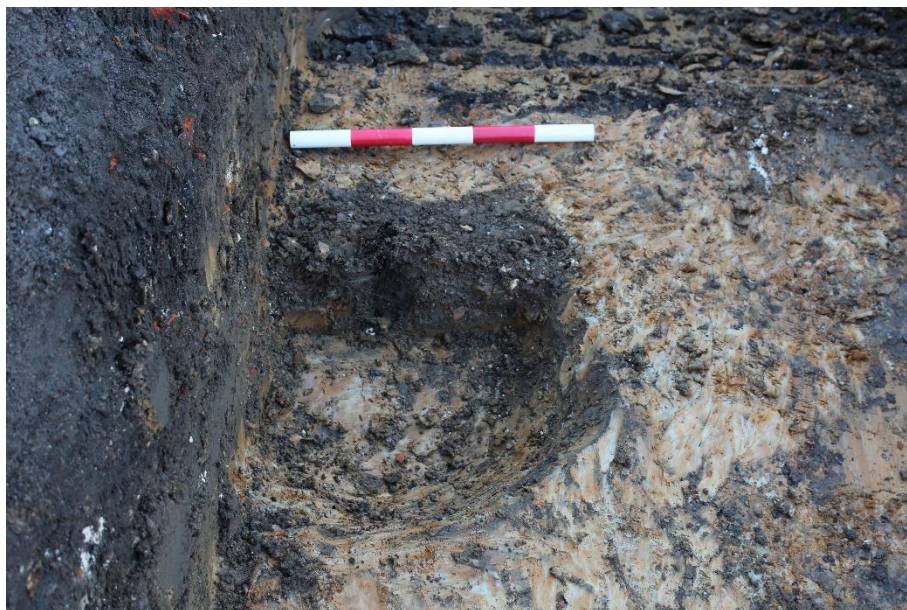
6.4.2 The posthole was 0.9m in diameter and 0.5m deep and contained the remains of a rotting wooden post, suggesting a recent (i.e. 20th century date).

Plate 13: Trench 3, Posthole [107], view east

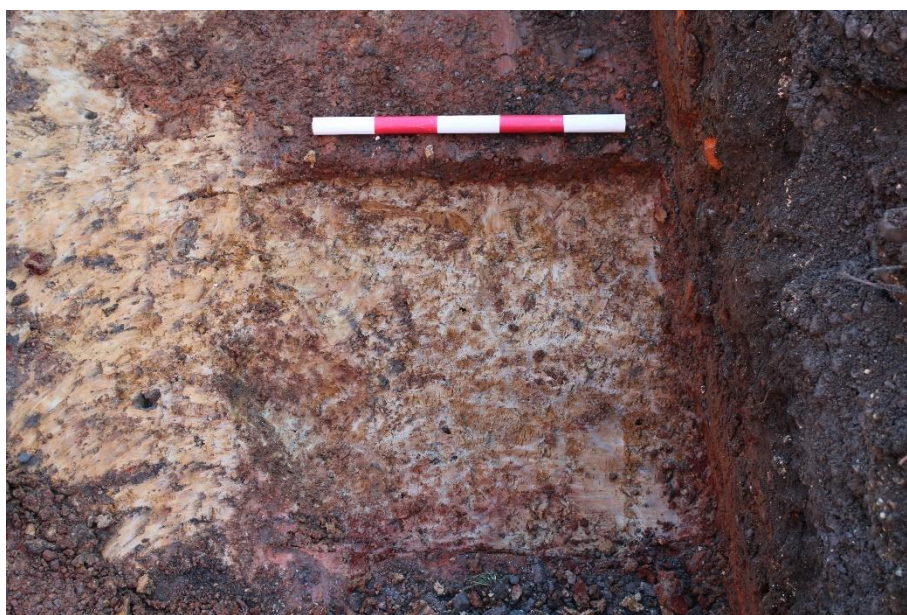
6.4.3 A small irregular feature [109] was excavated towards the west end of Trench 3. Its fill (108) was comprised of fragmentary brick rubble and brick dust and likely represents a feature associated with the 19th/20th century demolition of former buildings on site.

Plate 14: Trench 3, modern demolition feature [109], view east

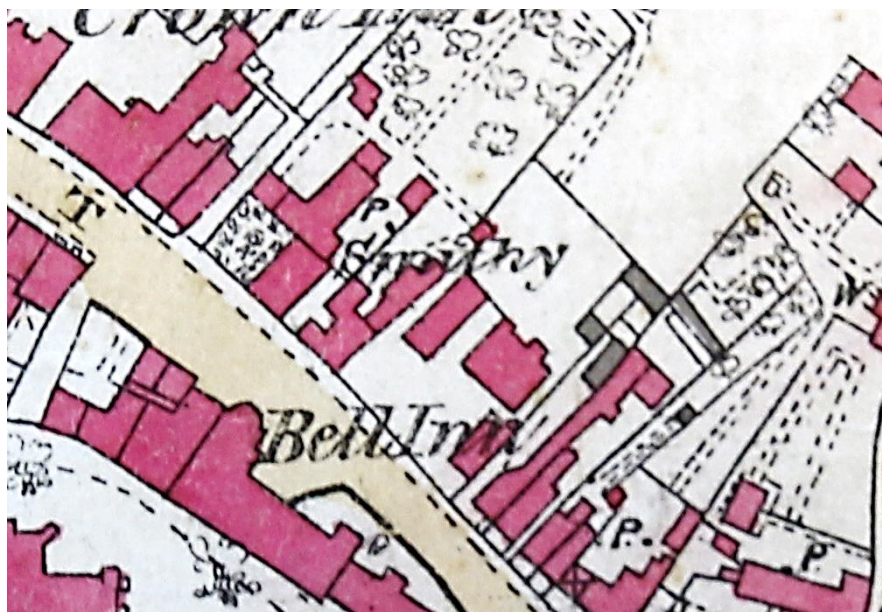
6.3.2 It seems likely that these furnace features were associated with buildings (e.g. workshops) that were formerly located at the northeast of the site (Plate 15).

Plate 15: Detail of OS County Series Map Essex 1874 1:2,500
