OLDCHURCH HOSPITAL,
ROMFORD
LONDON BOROUGH OF HAVERING
PHASES 1-5

EVALUATION

**Archaeological Evaluation (Phases 1 to 5) at Oldchurch Hospital,
Romford, London Borough of Havering**

Site Code: OWH 06

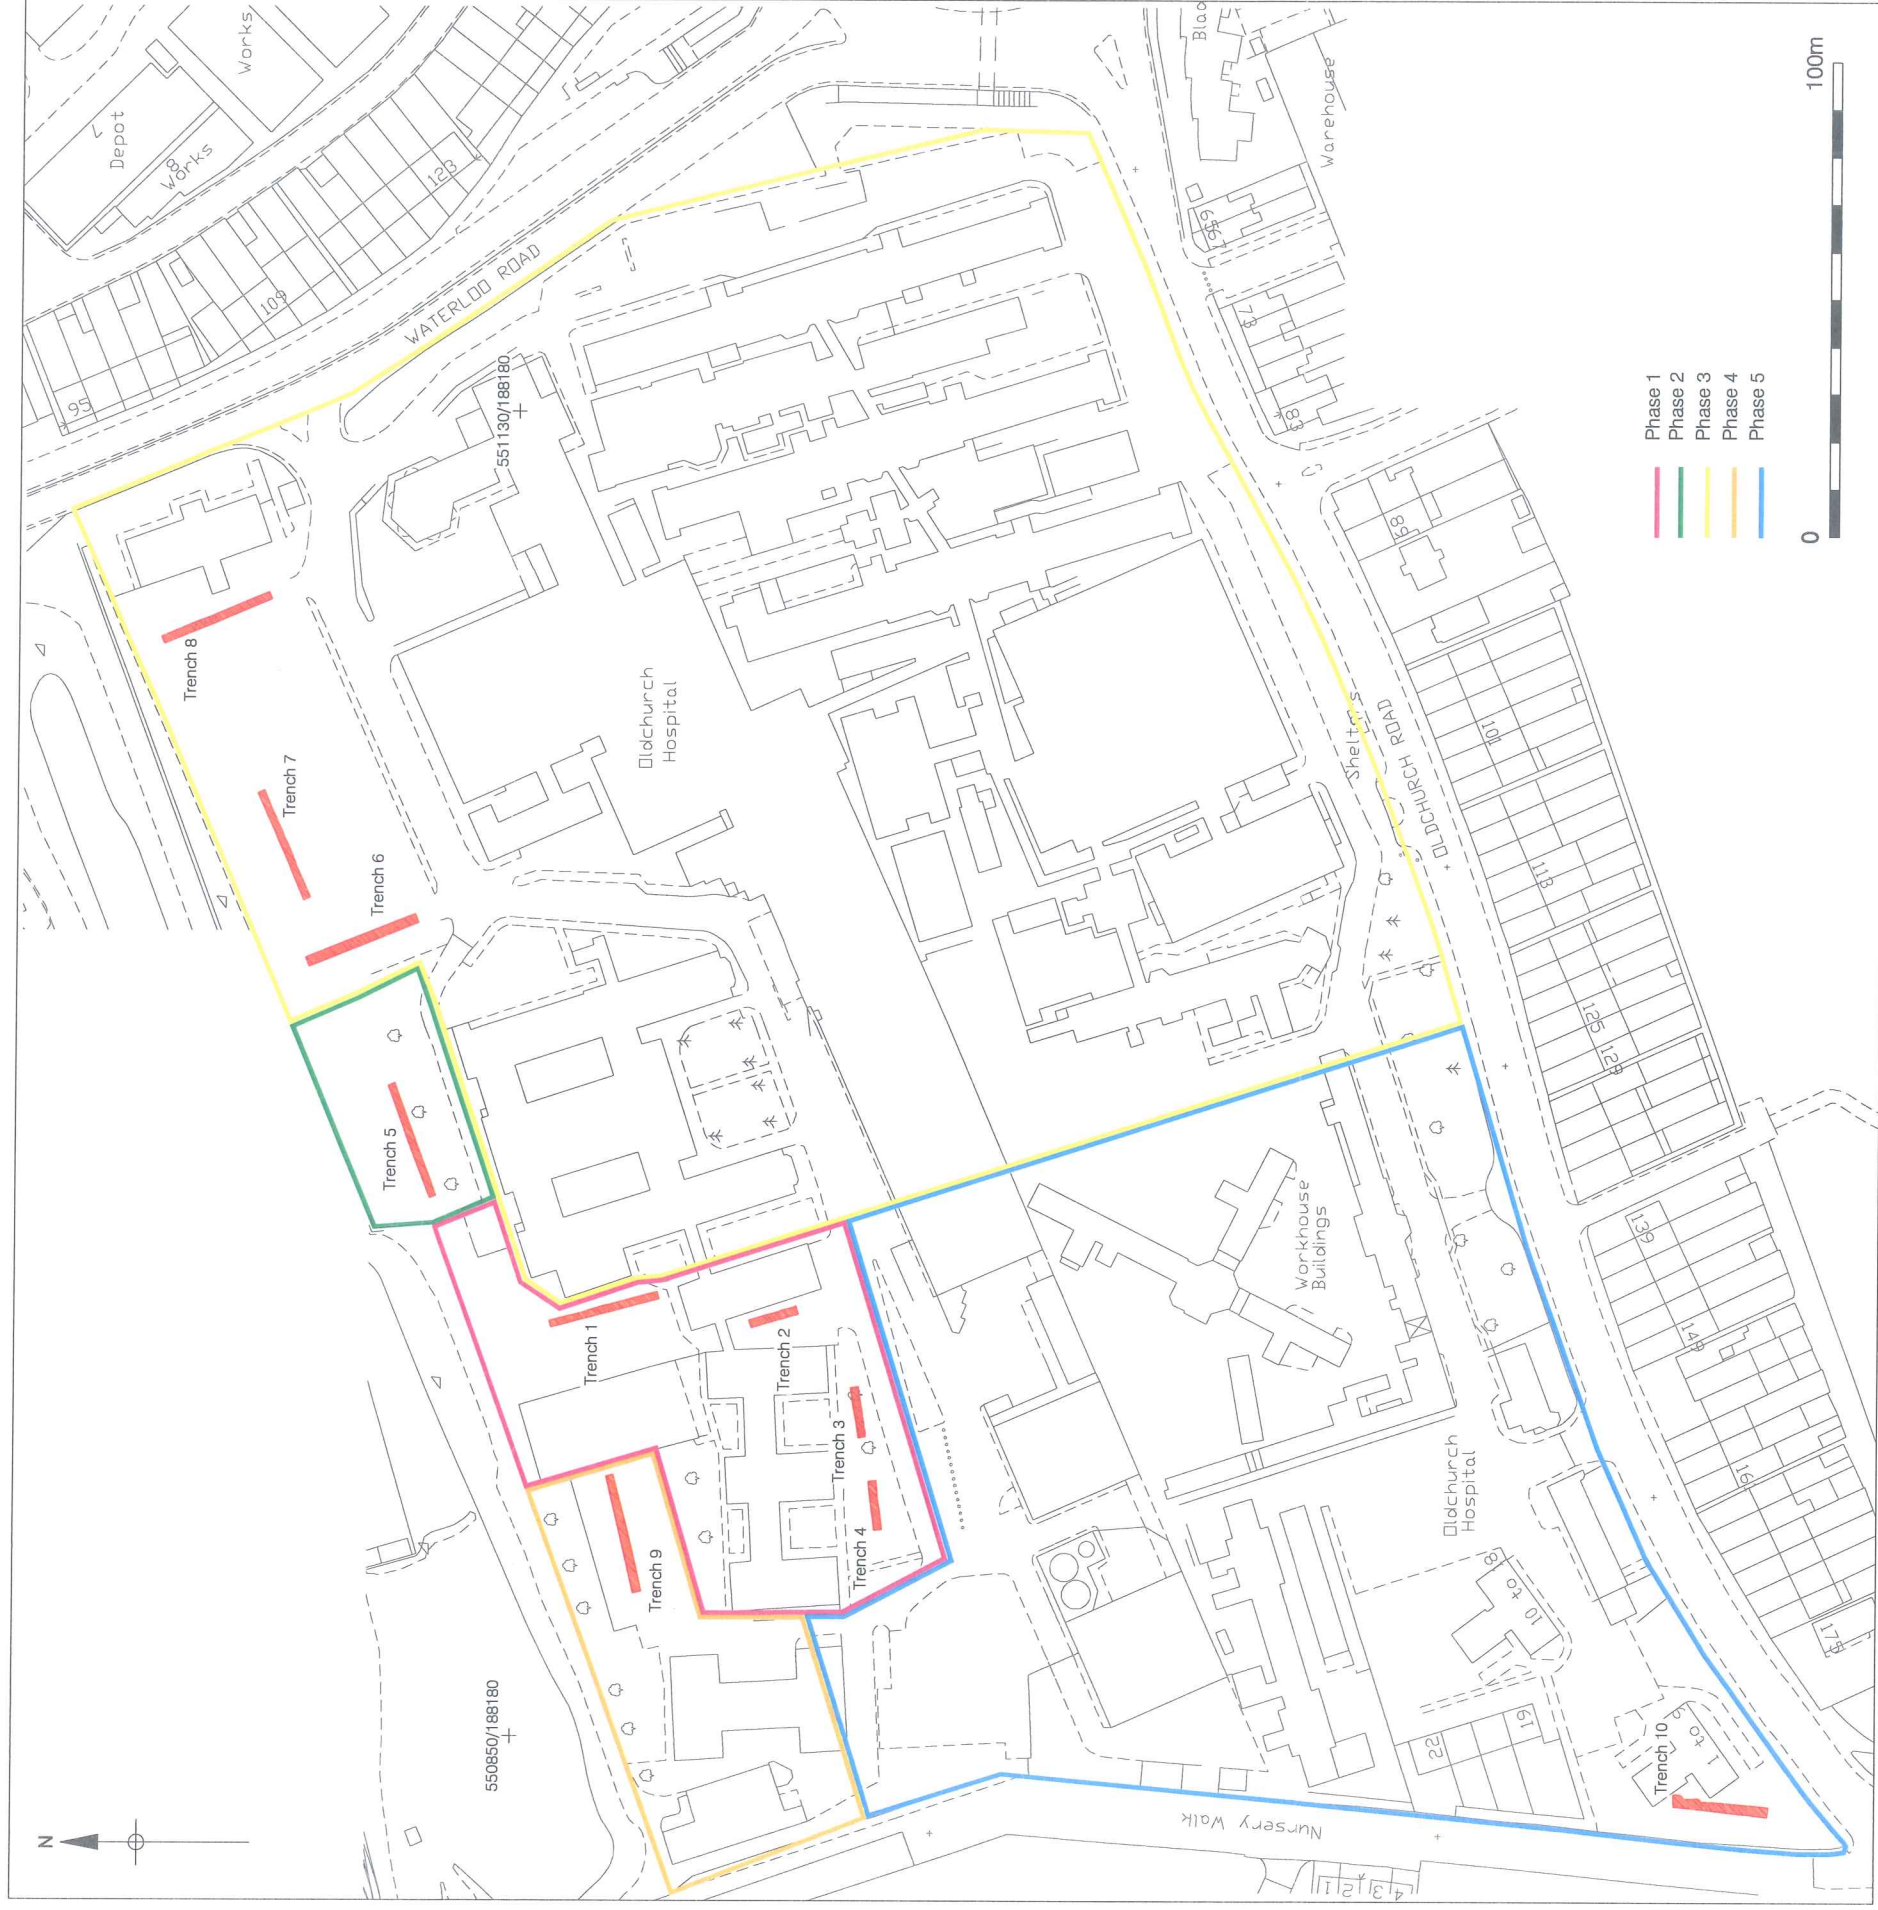
Figure 2
Trench location
1:2,000 at A4

- 1.2 The evaluation consisted of ten trial trenches, undertaken in five phases, aimed at comprehensive coverage of the site (Fig 2). A sequence of natural gravel sealed by brickearth was recorded across the site. A series of late post-medieval features (19th and 20th century date) were recorded across the central and eastern areas of the site which were interpreted as being horticultural in origin. Other features recorded were modern in date and associated with the development of the hospital. The sequence was sealed by ground raising deposits and turf or tarmac.
