37 WEST STREET
EASTON ON THE HILL
NORTHAMPTONSHIRE

A PROGRAMME OF
ARCHAEOLOGICAL MONITORING
AND RECORDING

PCA REPORT NO: R13525

MARCH 2018

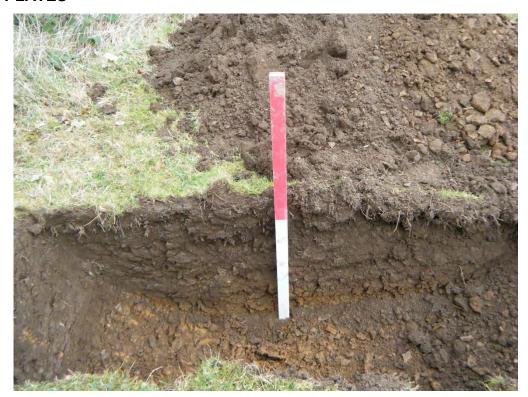
Plate 1: Test pit 3

- 5.1.2 In TP1, 3 and 4 the geological substrate was overlain by subsoil (101), which had an average thickness of *c.* 0.3m and consisted of mid brown clayey silt with a moderate density of angular limestone pebbles (Plate 1 and Plate 2). This was overlain by dark brownish grey organic silt topsoil (100), which had an average thickness of *c.* 0.15m but was noticeably thicker near the back of the main buildings, where it was up to 0.36m thick.

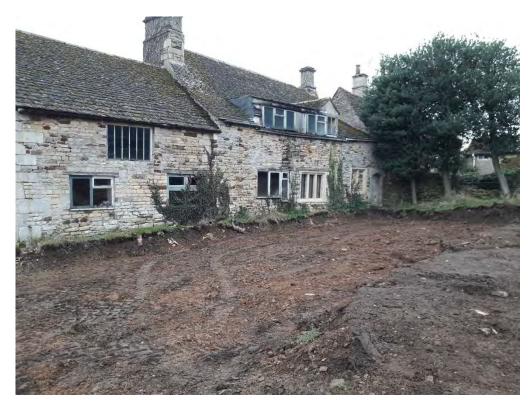
Plate 3: Ground reduction at rear of 37 West Street, looking SSE

- 5.2.2 Prior to the excavation of the foundation trenches, the ground level was reduced to the surface of the geological substrate, comprising a mid-brownish orange, slightly sandy clayey silt with frequent gravel inclusions (102) in both areas, enabling the stripped areas to be inspected by the attending archaeologist for archaeological remains. At the rear of 37 West Street, ground was reduced by a maximum of 0.6m (Plate 3) and to the south of the rear barn by a maximum of 0.3m (Plate 4). No archaeological remains were encountered in these areas, but a small quantity of medieval to post-medieval pottery was retrieved from the subsoil (101) (see Sudds, Section 6.1 below).

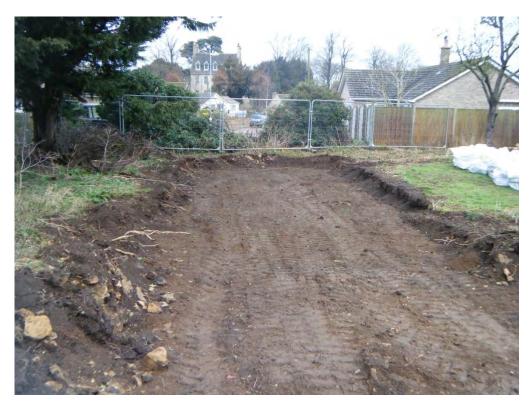
Plate 5: Ground reduction of access road, looking N towards Orchard Way

- 5.2.3 The route of the new access road was stripped of topsoil (100), to a depth of up to 0.3m below modern ground level, exposing the surface of the subsoil (101) at formation level (Plate 5). No archaeological remains were encountered in the road corridor, other than the brick foundations of a recently demolished building to the south of the rear barn. The soils in this area contained a quantity of modern flower pot fragments which were not retained.

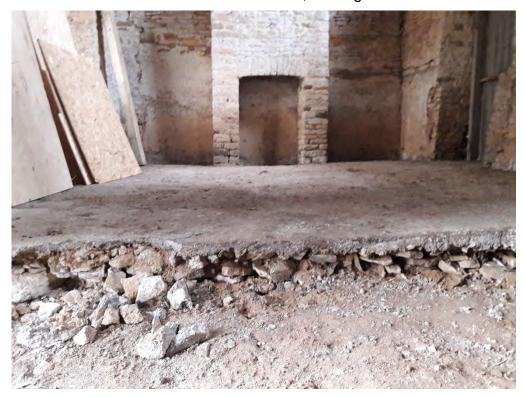
Plate 6: Ground reduction inside front barn, looking N

- 5.2.4 Ground reduction within the front barn comprised the removal of the current concrete floor, c. 0.03m thick, and the underlying hardcore rubble make-up (104), which was c. 0.10m thick (Plate 6).

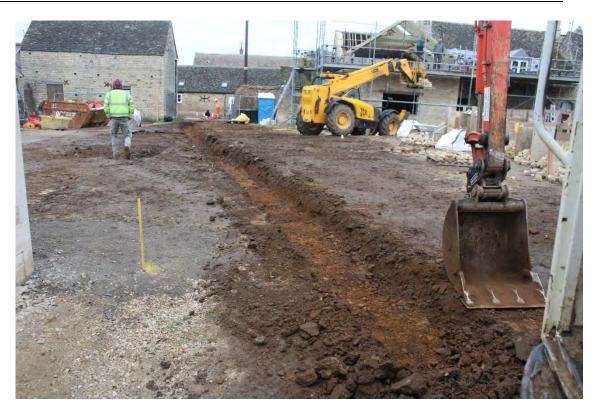
Plate 7: Service trench, looking E

5.3.1 A service trench which was 0.8m wide and up to 0.5m deep was excavated

through the centre of the site from the rear barn to the West Street street frontage (Plate 7). The trench cut trough a homogenous layer of modern made ground which contained fragments of Ceramic Building Material (CBM) and modern plastic flower pot, which was not retained.

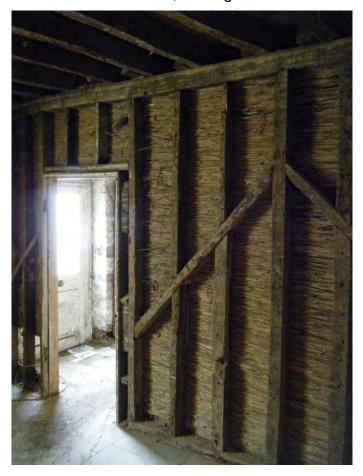
Plate 8: Reed Wall on ground floor

- 5.1.4 Stripping of modern materials revealed some of the previously hidden historical fabric of the building, but no more specific clues as to its chronological development. The fabric of the reed stud wall, indicated in the building survey

- as potentially original (ABRS 2018; Figure 4), was revealed. However, the timbers of the primary bracing seemed to be too well cut and slender to suggest a 17th century date (Plate 8 and Plate 9). A 19th century replacement of the original wall seems more likely.

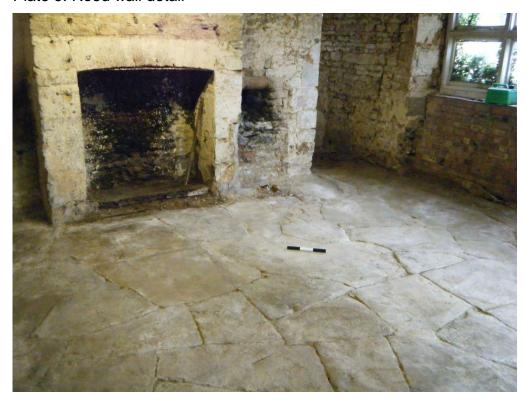
Plate 10: Flagstone floor in northern room of 37 West Street, looking SSW

- 5.1.5 A large flagstone floor was revealed in the northern main room of 37 West Street (Plate 10). This, too, was dated to the 19th century by a 1909 Edward VII penny found in the sub-base below one of the flagstones.

6.2.1 A bronze penny, showing a bare head Edward VII facing right on the obverse, was picked up from the sub-base (105) of the flagstone floor in the northern room of 37 West Street. The reverse of the penny features Britannia, seated left, holding a trident, and the date of 1909. The coin dates the laying of the flagstone floor to the early 20th century.

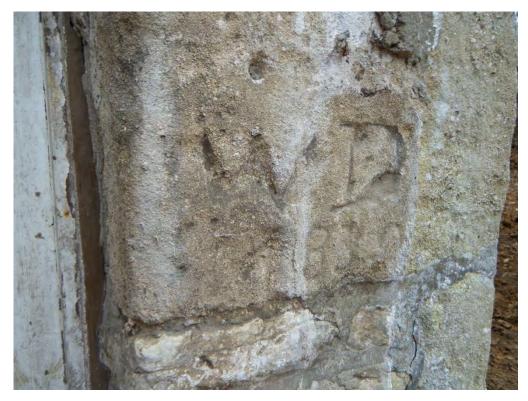
Plate 11: Initials 'WD' and ?1830 date carving adjacent to N doorway

- 5.1.6 An interesting detail was the carving of the initials "WD" in two places near the north-western door into the dwelling (Plate 11). This was revealed after the removal of the modern porch to the door at the north-western corner of 37 West Street. The carving by the door is difficult to make out but could read "WD 83 o", or most likely "WD 1830" (Plate 11). "WD" stands for William Duncomb who is known to have been the owner of the property between 1817-19 and the mid-19th century (see above and ABRS 2015). The layout of the buildings at 37 West Street changed significantly between the Inclosure Map of 1817-19 and the first edition OS map of 1886 (ABRS 2015) and the carving suggests that this remodelling of the buildings took place prior to or in 1830, in a programme undertaken by William Duncomb.
