**WHITE HART INN, EAST COWES, ISLE  
OF WIGHT: HISTORIC BUILDING  
RECORDING REPORT**

**SITE CODE: TWEC18  
MAY 2019**

**Type of project: Historic Building Recording**

**Report: R13573**

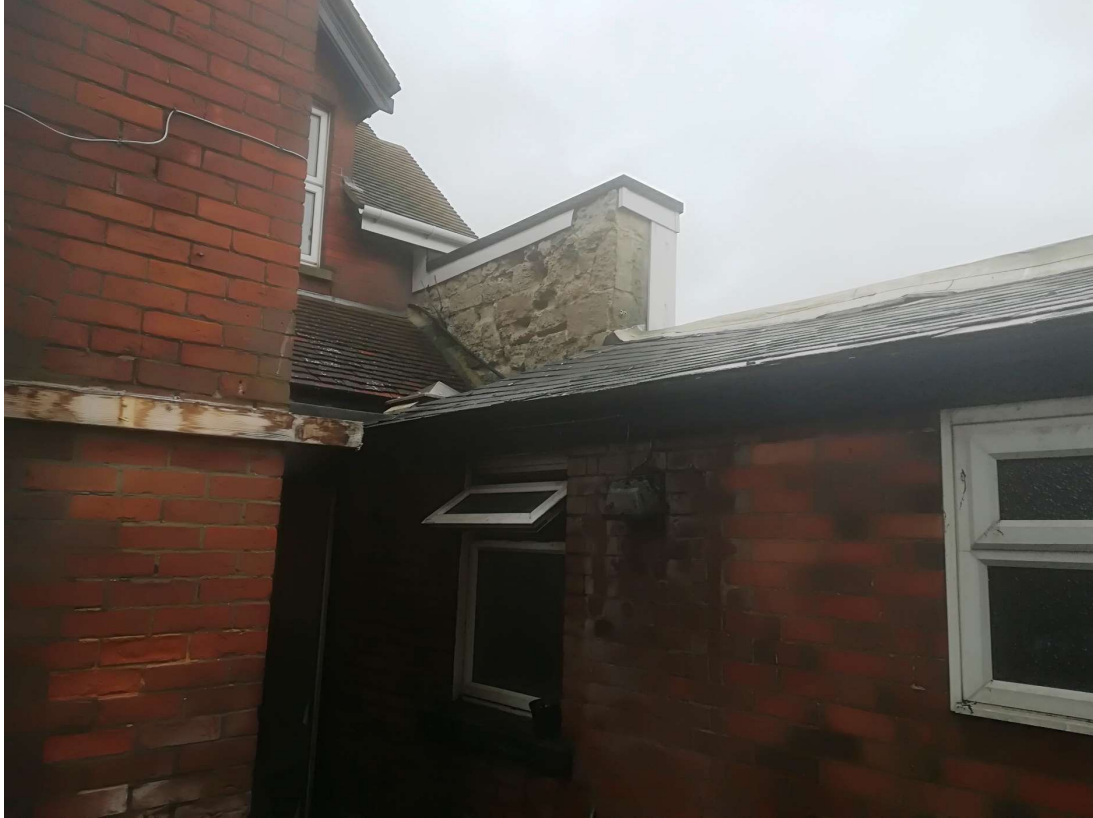
5.1.1.2 The recessed northern end of the elevation is filled by a door giving access to a yard at ground level. Above it is a ceramic tile covered slanted roof and the upper storey is filled by a dormer window containing a uPVC window that is a replacement of the wooden framed original. Part of a masonry wall can be seen at the level of the upper storey. A small brick building abutts this elevation. It is constructed in a similar brick and bond to the main building. It has two windows in its south-facing elevation that are uPVC replacements of the wood framed originals and a single pitch roof.

Plate 1. Recessed external northern end of the eastern elevation of the building. Part of a masonry wall is visible adjacent to the upper storey and a the men's toilets in the foreground. No scale.

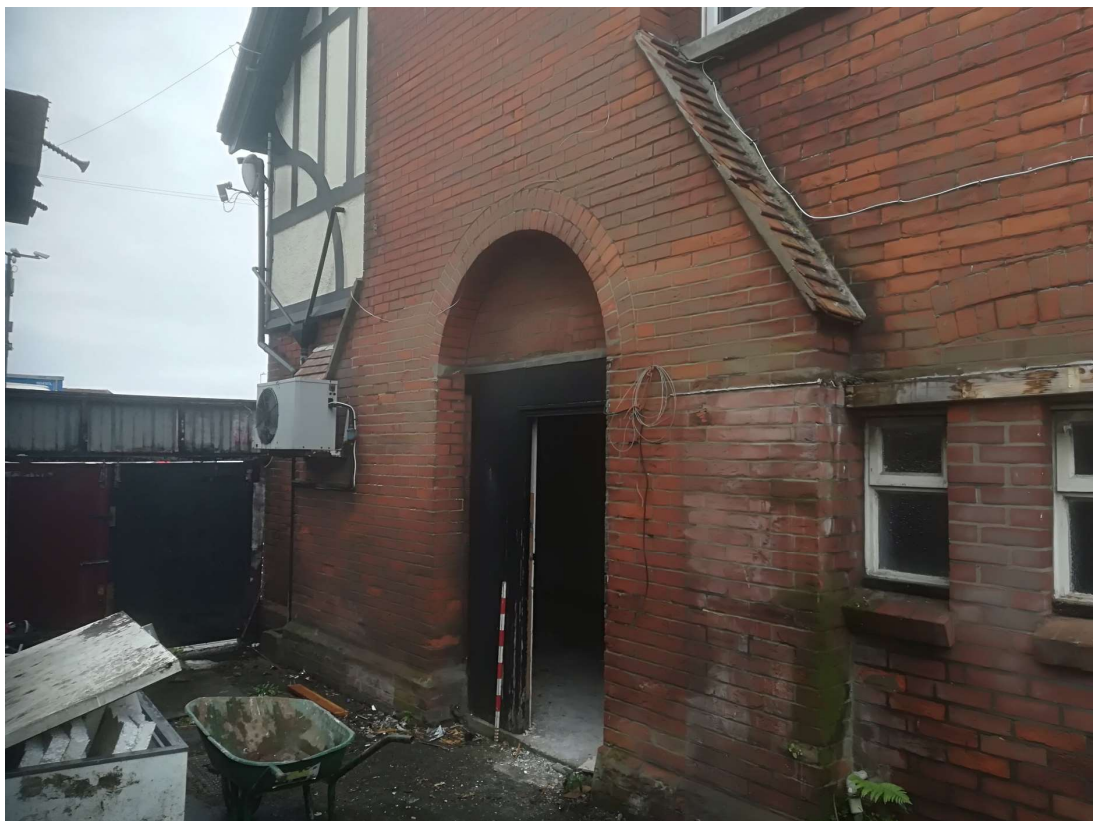
5.1.1.3 A doorway positioned centrally within the southern end of the elevation into the building at ground level is covered by a rounded brick semi-circular arch and is incorporated into a chimney breast that is offset slightly from the wall. The slanted aspects of the chimney breast are covered by tiles. Two awning style wooden frame windows occupy the northern end of the elevation at ground floor level and are surmounted, partially, by a curved segmental arch from a pre-existing window opening which has been infilled to create two smaller windows. A similar awning style window opening (now infilled with brick) occupies the northern end of the elevation at first floor level and has a sloped tiled roof above it. The lowest four courses of the elevation comprise a brick plinth offset one course in thickness which contains air bricks to ventilate the underfloor space of the building.

5.1.1.4 In the upper storey a mock timber frame black-painted with yellow-painted plaster infill covers part of the southern side of the chimney breast. On the elevation to the north of the chimney breast is a window with a segmental arch above. The original wood frame window has been replaced by a uPVC one.

Plate 2. External southern end of the eastern elevation. Scale 1m.

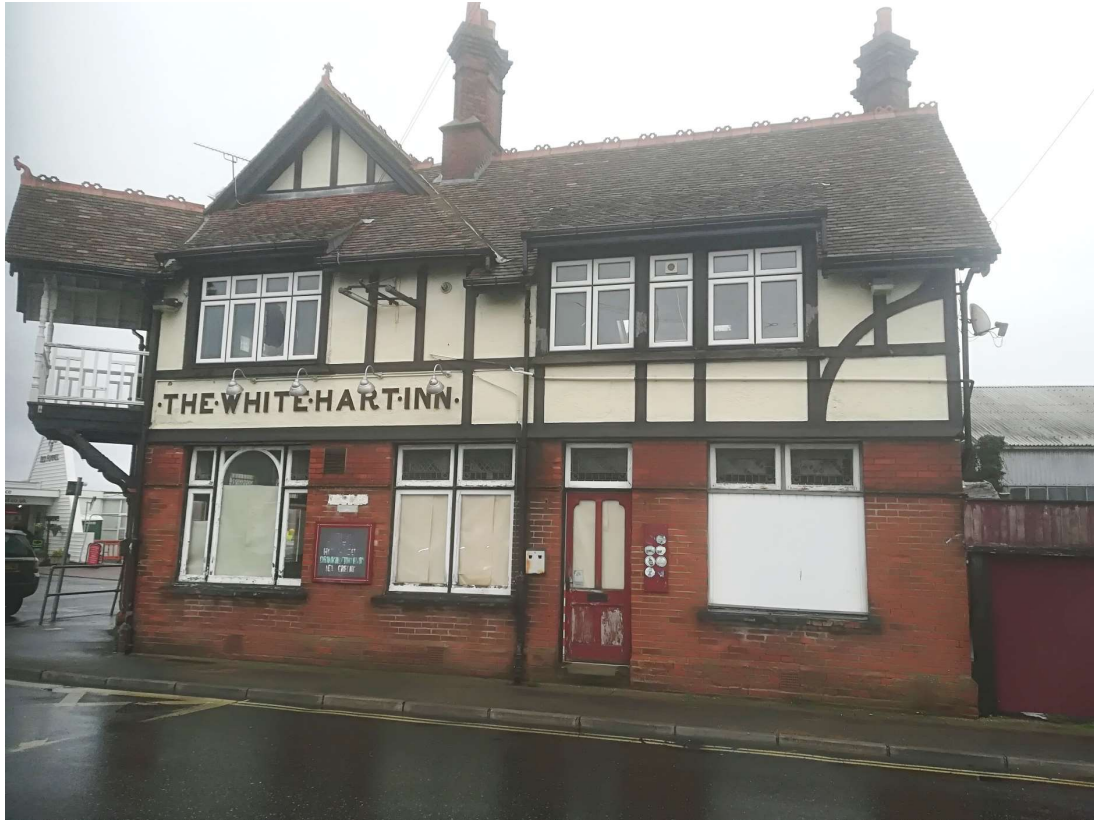
5.1.2.1 The ground floor of the southern elevation is constructed in the same red brick and in the same stretcher bond visible in the eastern elevation. An offset brick plinth (6 courses deep) visible at the base of the east-facing external elevation continued along the base of the southern elevation. The brickwork is quite weathered in appearance and appears to have been repointed in places. It contains three windows and a door, all of which contain their original wooden frames and glass

panes. Brick lintels are present at the base of the window openings. Two of the windows, either side of the door, consist of identical casement windows with smaller, identical fixed leaded, stained-glass windows above. The casement windows in the easternmost window have been removed and boarded-up. The westernmost window is slightly bigger than the other two with a central fixed window set in an arched wooden frame with casement and awning windows either side. A fixed leaded stained glass window is also present above the door and, at the height of the base of the stained glass window, a brick cornice that extends the full length of the wall. The door has two wooden recessed panels in its lower half and two frosted glass windows in its upper half. The door is painted a scarlet/claret colour and is identical to two other doors through which access to the building can in the south-west and western elevations of the building.

- 5.1.2.2 The entire exterior of the upper storey is covered in the same mock timber frame cladding partially covering the upper storey of the eastern elevation. There are two sets of windows contained within the timber framing. All are replacement uPVC casement and awning windows.

Plate 3. The external south-facing elevation of the building. Scale 1m.

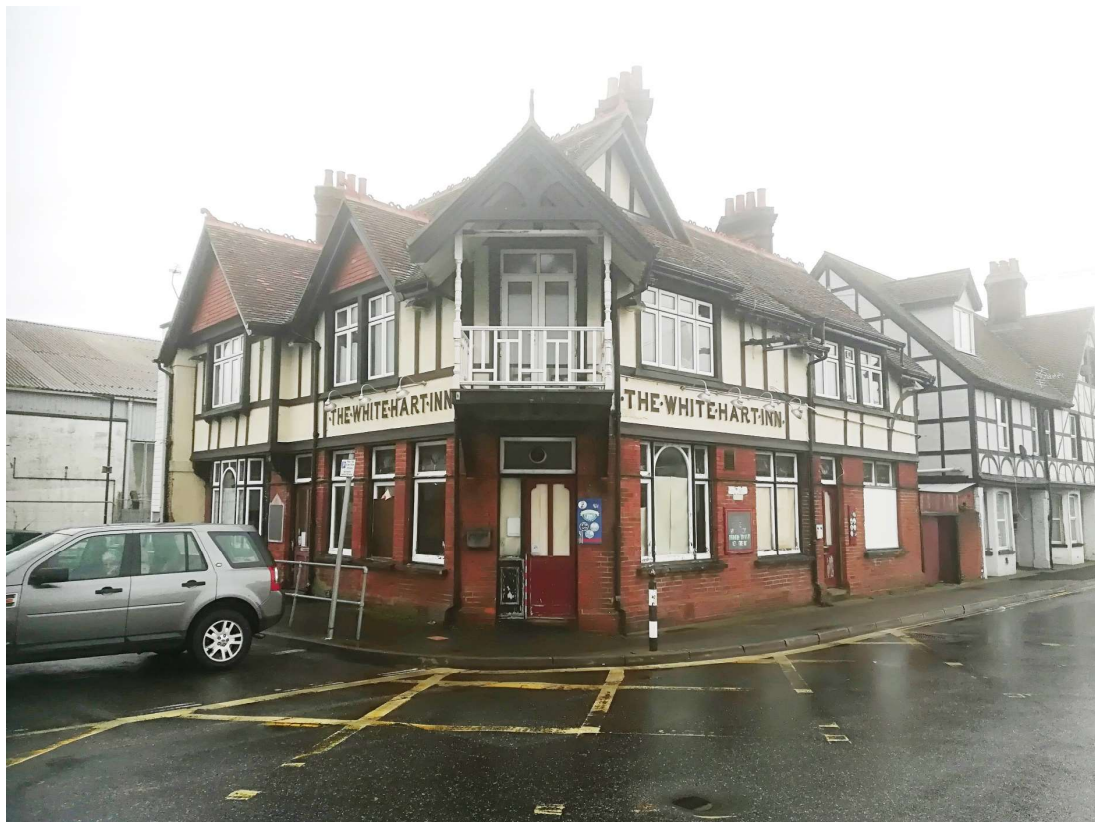
- 5.1.3.1 The south-west facing elevation is very narrow and at ground level contains only an entrance to the building. The door is contained within a wider frame containing a lower wood panel and an upper fixed glass window at its northern side and, above the door, a single window spanning the opening in which an air extractor fan has been incorporated.

- 5.1.3.2 In the upper storey of this elevation uPVC french doors open out on to a balcony. The balcony is edged with white painted timber railings arranged in fretwork. A dual pitched roof covers the balcony.

Plate 4. External south-west facing section of the building. Scale 1m.

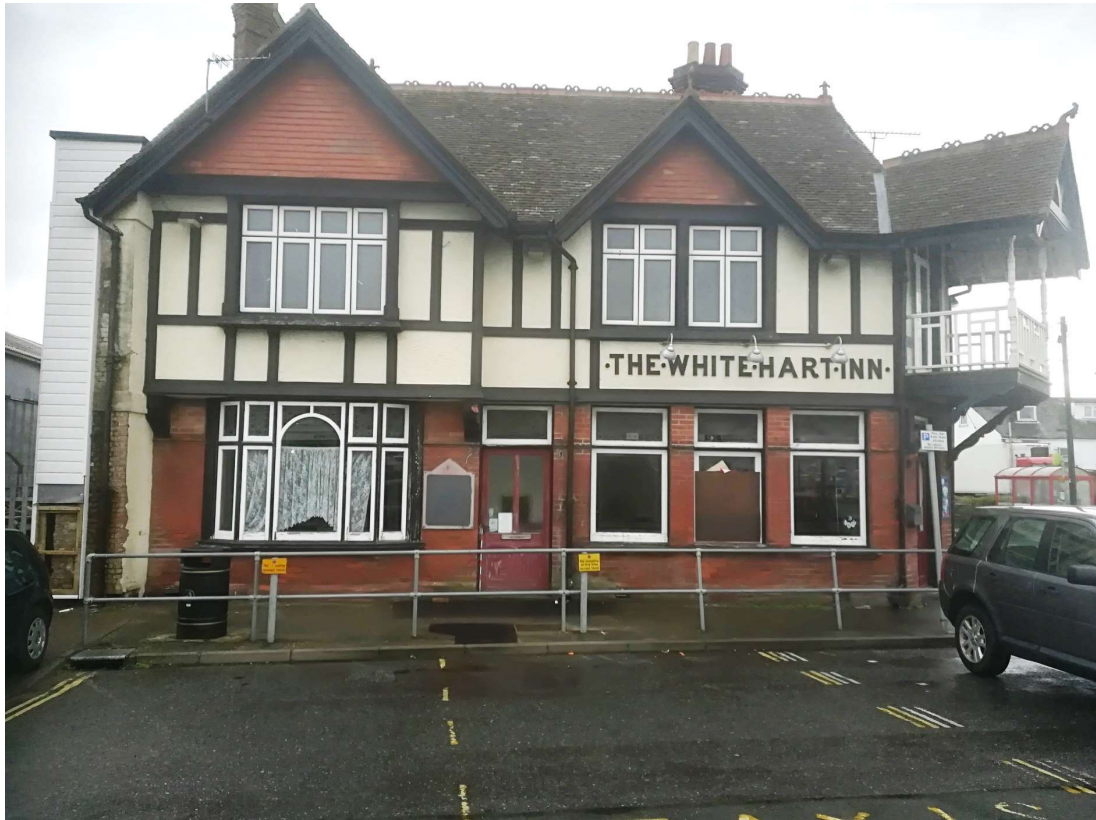
- 5.1.4.1 The west-facing elevation is constructed in red brick laid in stretcher bond. The ground floor contains one large opening for a bay window at its northern end and, at its southern end, three identical adjacent windows. All the windows contain their original wooden frames and glass. The bay window contains a central arched window that appears to be marginally smaller than the arched window present in the east-facing elevation of the building. Stained glass leaded windows occupy the upper part of the window openings and above another doorway in to the building above a cornice visible in the east, south and south-west facing elevations. The door in this elevation differs slightly to the two other doors in the south and south-west elevations and, therefore may not be original.

- 5.1.4.2 Mock timber frame cladding adorns the upper storey of the elevation. There are two sets of windows contained within the timber framing. All are replacement uPVC combination casement windows with awning windows above.

Plate 5. External west-facing elevation of the building. Scale 1m.

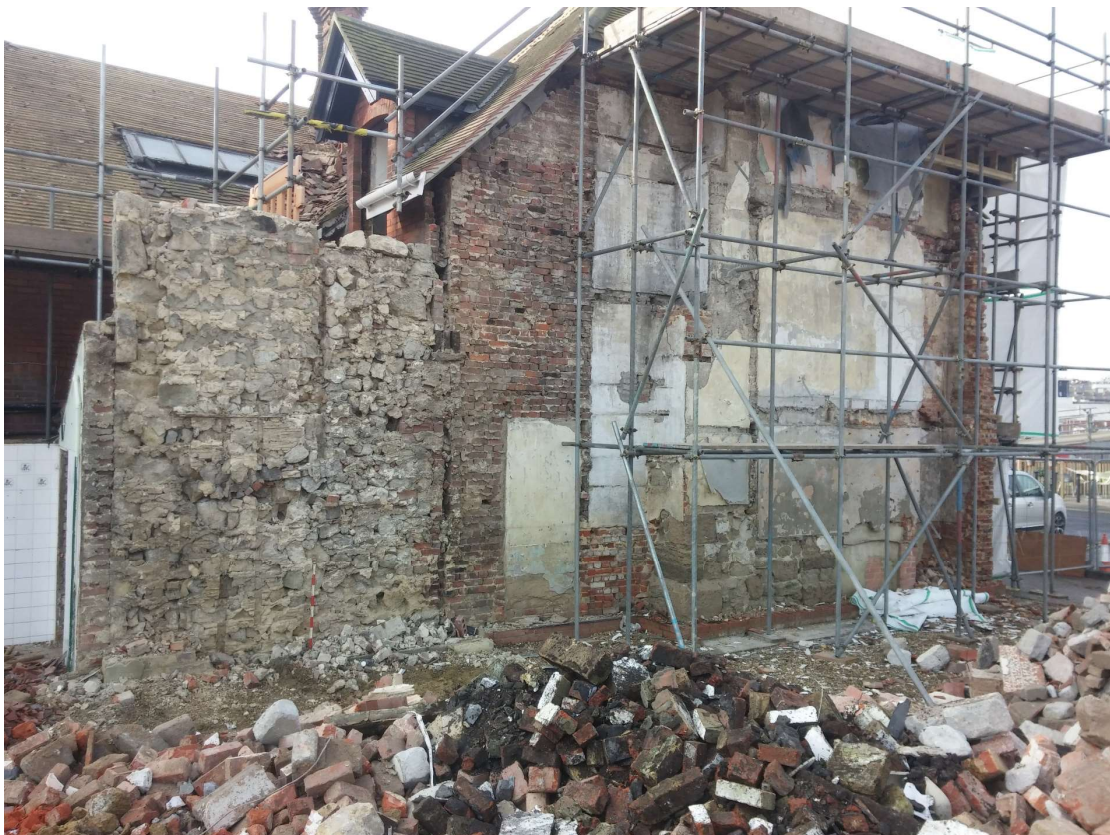
5.1.5.1 The north-facing elevation of the building was removed of its uPVC cladding to reveal a crudely laid brick wall with a central, offset, chimney breast that is constructed in both green glauconitic limestone and red brick. Some large ashlar blocks and a quoin stone were present at the base of the chimney breast. Large areas of the elevation are covered with a plaster render. A small fireplace has been built into the north-west corner of the base of the chimney breast and a doorway, which has been infilled, at ground level at the eastern end of the elevation. Clearly this elevation once formed a party wall with a pre-existing building adjoining it to the north. Part of the demolished wall forming the west-facing façade of the pre-existing building is visible at the north-west corner of the building.

5.1.5.2 A masonry wall situated to the east of the northernmost wall of the building – part of the southern elevation of which is visible from a room at the rear of the upper storey of the building, but covered by wire mesh cladding along its north-facing elevation – was fully exposed to reveal an unfaced limestone rubble wall measuring approximately 3.6m in width and 5m in height, with the occasional red brick incorporated into it. The masonry wall butts both the eastern elevation of the Inn and a brick wall for a building housing men's toilets to the east of it.

- 6.4 The north-facing elevation of the northernmost wall of the building, which was constructed of both red brick and green glauconitic limestone, mostly in rubble form but also in ashlar, represents an internal wall of the pre-existing three storey 'Medina View' building that formed part of a terrace of four buildings including the earlier incarnation of the White Hart Inn, a Customs House and another building, all depicted on an 1841 Tithe Map of East Cowes. The use of masonry within the wall suggests that materials were being sourced from a demolished building pre-existing nearby. On the insertion of Queens Road *circa* 1896 Medina View was the only building within the terrace to survive. The extant White Hart Inn was subsequently built up against it. Medina View was demolished in December 2014 and the then exposed north-facing elevation covered in white plastic cladding.

Plate 6. Exterior northern elevation of the White Hart Inn and limestone infill wall following removal of cladding sheet cladding. Scale 1m.

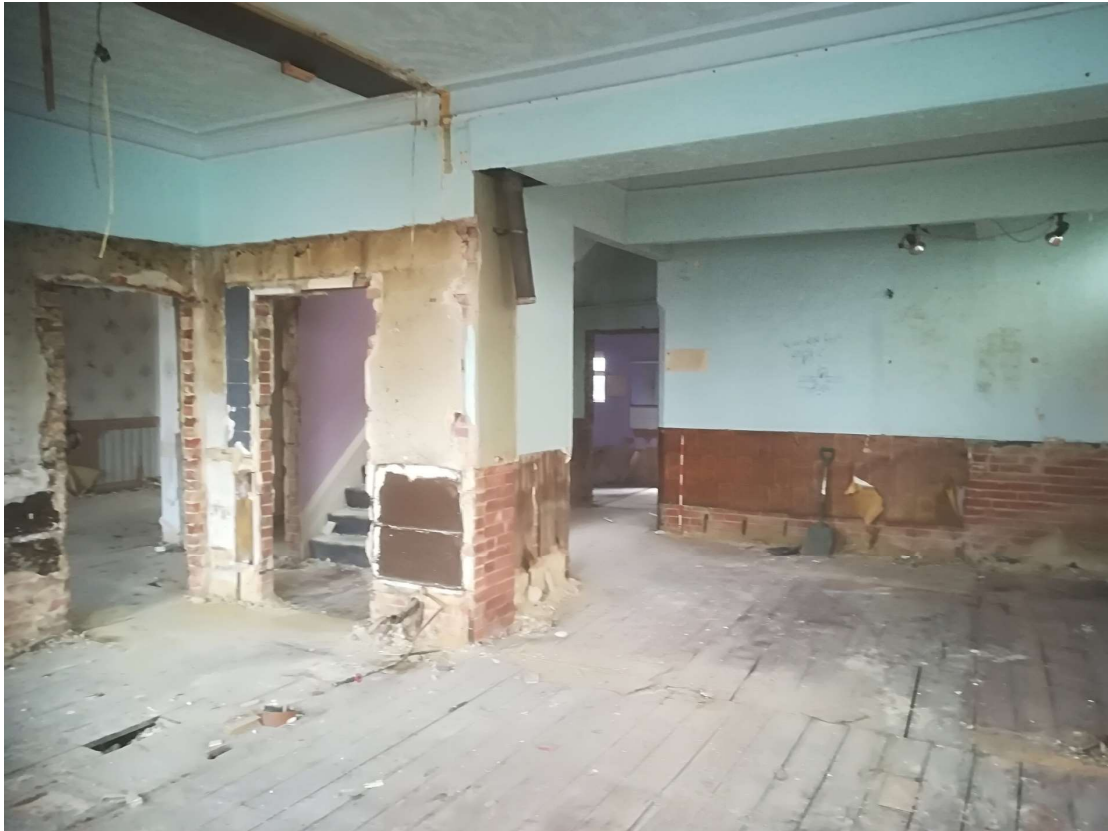
5.2.1.1 The Public Bar: The principal entrance into the building is through the door in the south-west facing elevation of the building, which enters in to what once served as the Public bar of the Inn (**Figure 2; Plates 7, 8 & 9**). The building has been soft stripped to remove any materials containing asbestos exposing the lower 13 courses of the internal skin of brickwork of the building. Above this height the walls and ceiling were covered in a heavily nicotine-stained duck-egg blue colour painted artex. An oblong-shaped area of beige patterned wallpaper pre-dating the application of the paint survives at the western end of the south-facing elevation, presumably where the dart board was previously erected, and gives an indication of an earlier phase of wall decoration for the room. The two bars (now removed) were incorporated into the elevation partitioning rooms 1 (the Public) & 2 (the Lounge).

Plate 7. Room 1: Public bar looking north-east. Scale 1m.

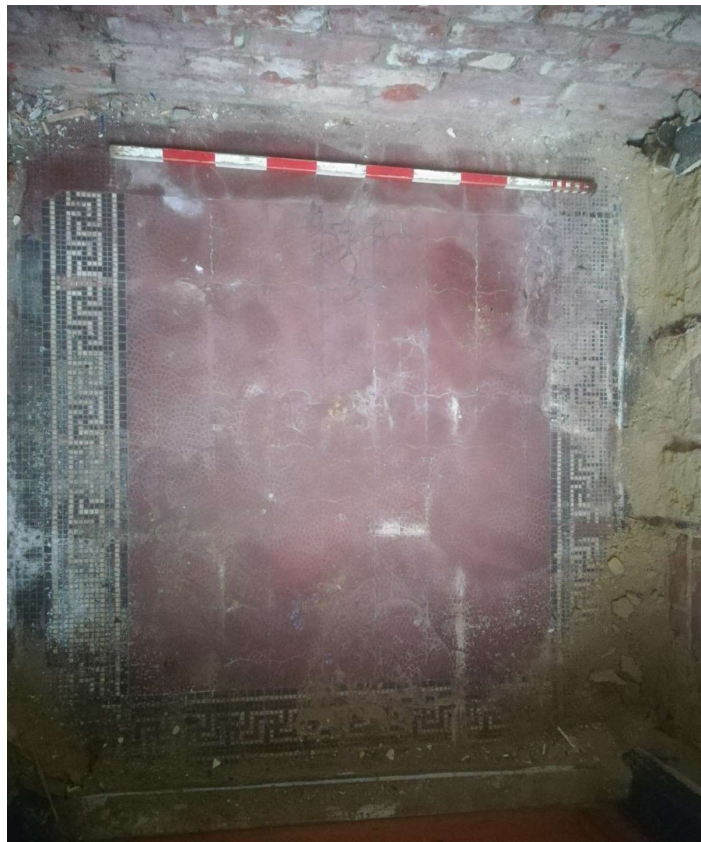
5.2.1.2 The Lounge Bar: The Lounge bar is accessed by an entrance in the western elevation of the building which opens into a square porch, the floor of which contains a red, black and white tile mosaic floor (**Figure 2; Plate 10**). The lower thirteen brick courses of the elevations in this room are covered with a vertical striped wallpaper; the upper portion of the elevations with an 'art patterned' wallpaper. The ceiling, unlike room 1, is not artexed, but smooth and painted white with a blue and white banded coving at its edges (**Figure 2; Plates 11 & 12**). The ceiling directly above the bar contains the same wallpaper visible in the Public bar and is heavily nicotine-

Plate 10. Room 2: Mosaic floor in porch entrance to the Lounge bar. Scale 1m.

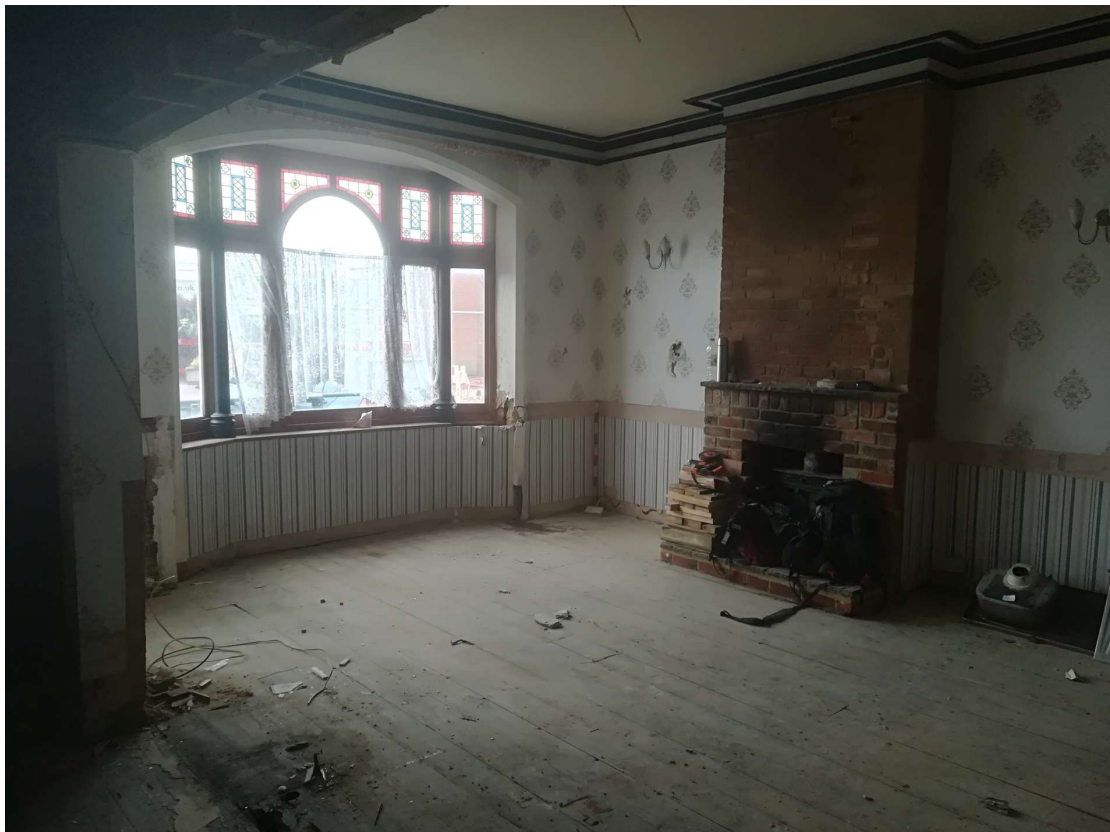
Plate 11. Room 2: The lounge bar looking south towards bar area and Room 3. Scale 1m.

5.2.1.3 Room 3: is a small room white-painted room adjoining the eastern end of the bar that served as a toilet and washroom for the bar staff (**Figure 2; Plate 11**).

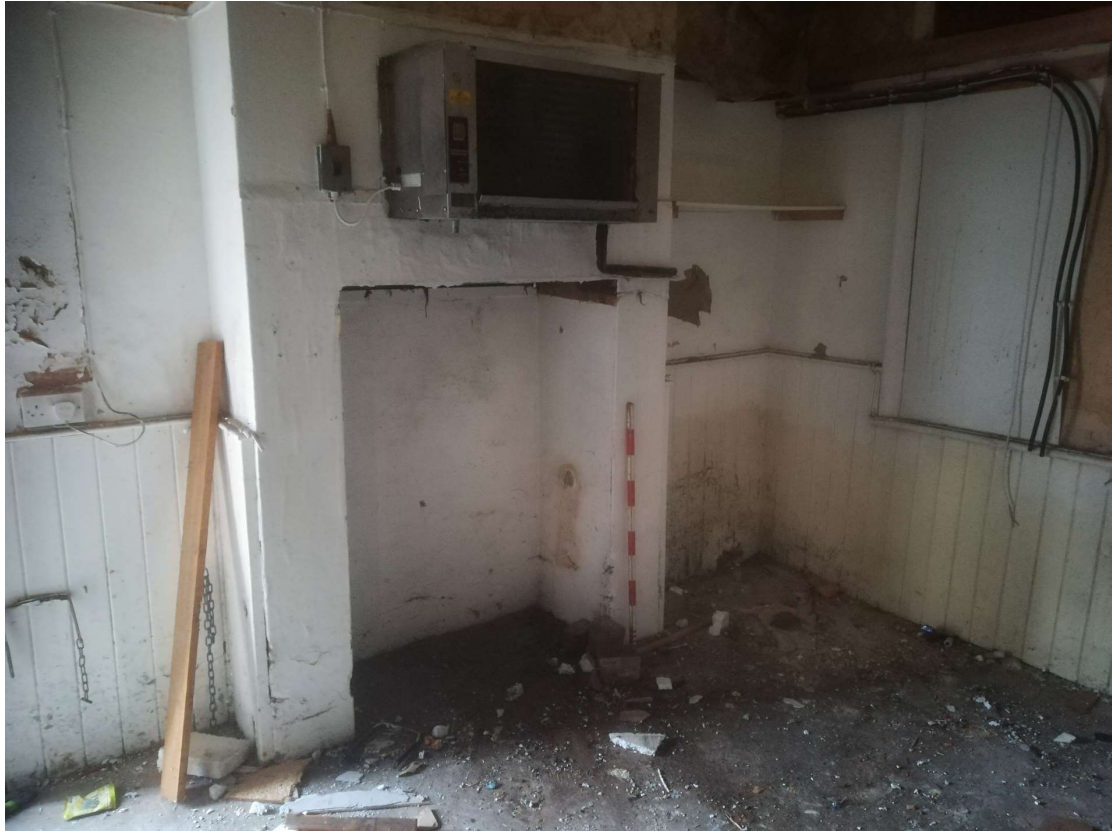
5.2.1.5 Room 5: to the immediate south of room 4 is painted white and contains a fireplace in its west-facing elevation (**Figure 2; Plate 13**). The windows in the southern elevation of this room have been boarded-up.

Plate 13. Room 5: Chimney breast looking south. Scale 1m.

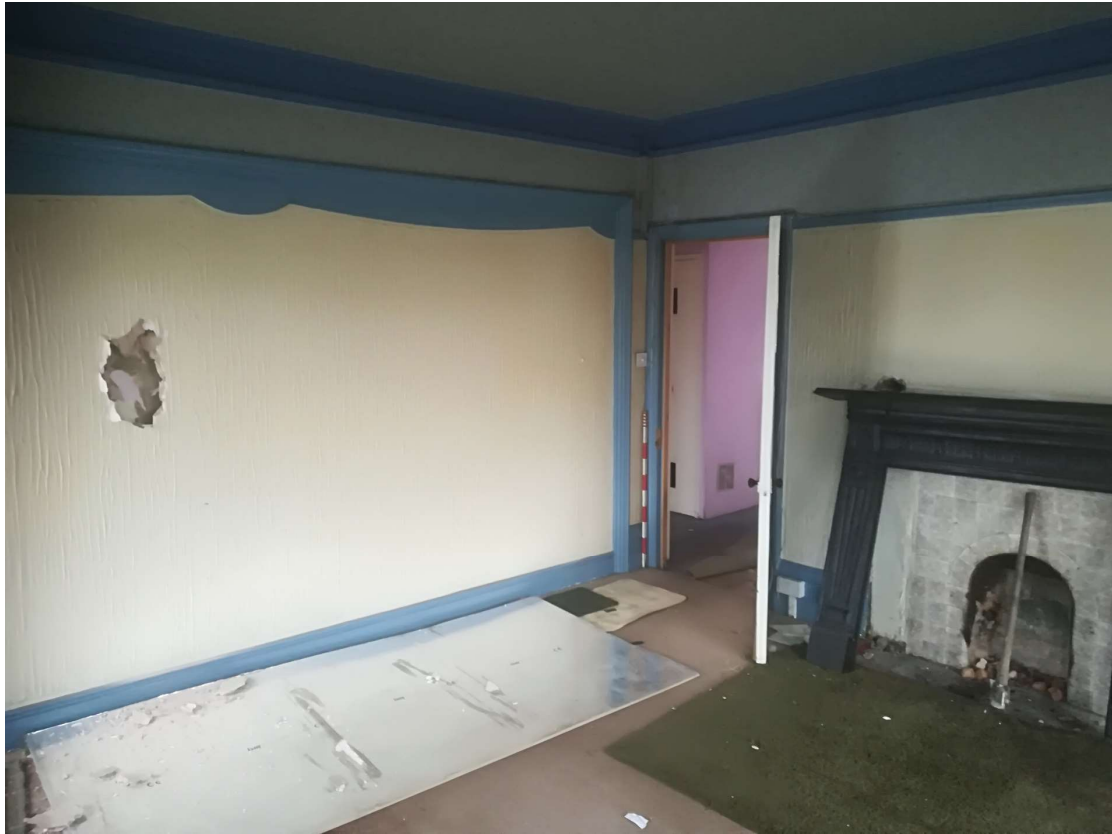
5.2.2.5 Room 9: A cream colour painted room with blue colour painted window frames, door frames and skirting. The northern elevation of the room, separating it from Room 10, contains a plasterboard infill within an Art Nouveau styled wooden frame. The eastern elevation contains a glazed tile and brick fireplace with a cast iron surround (**Figure 3; Plate 19**).

Plate 19. Room 9: Upper storey bedroom, looking east, showing Art Nouveau framing in room division. Scale 1m.
