**DRAINAGE IMPROVEMENT, MILITARY  
ROAD B6318, HEDDON-ON-THE-WALL,  
NORTHUMBERLAND**

**EVALUATION REPORT**

**Archaeological Evaluation**

<b>Pre-Construct Archaeology Limited Quality Control</b>	
<i>Project Number</i>	K5956
<i>Site Code</i>	MRH 19
<i>Report Number</i>	RN11111

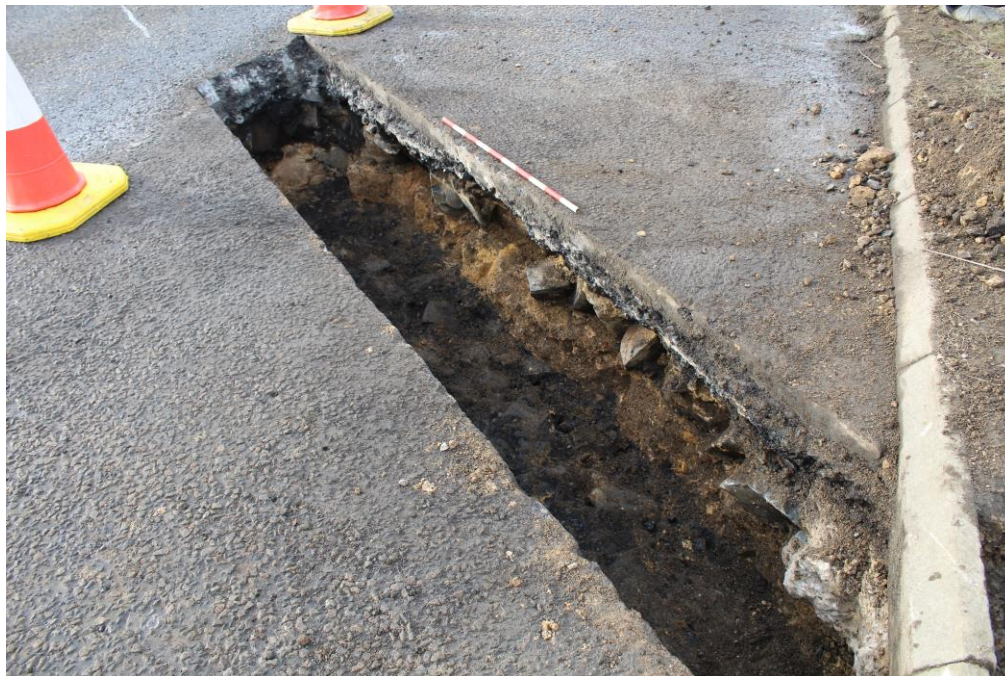
*Plate 1: Overview of Trench 1 (SW-facing direction of view)*

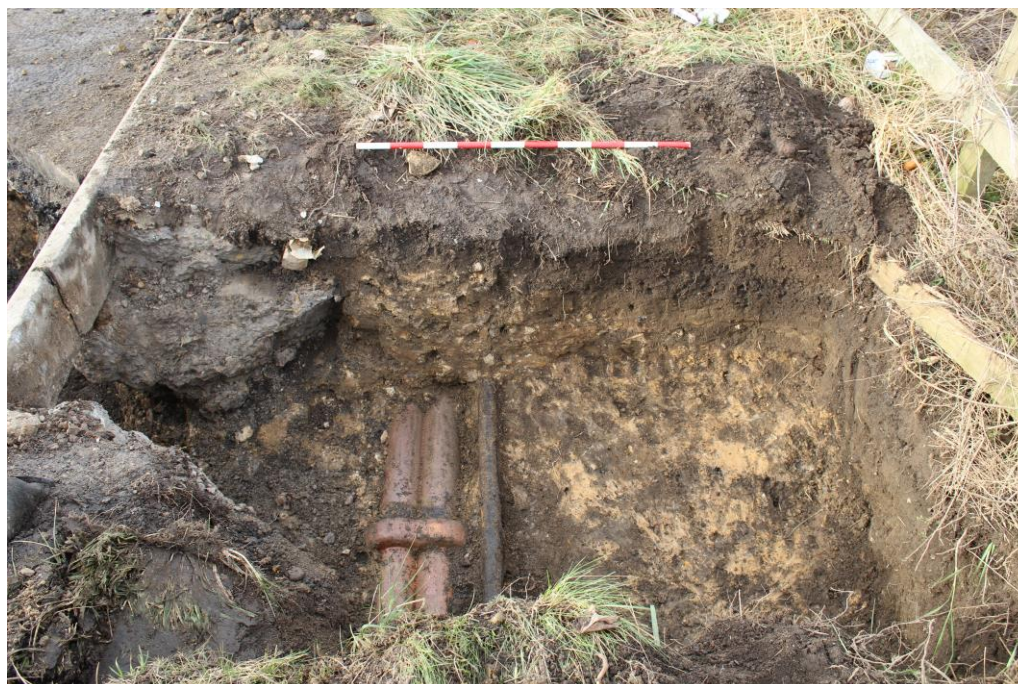
*Plate 2: E-facing section of Trench 1 showing service trench (W-facing direction of view)*

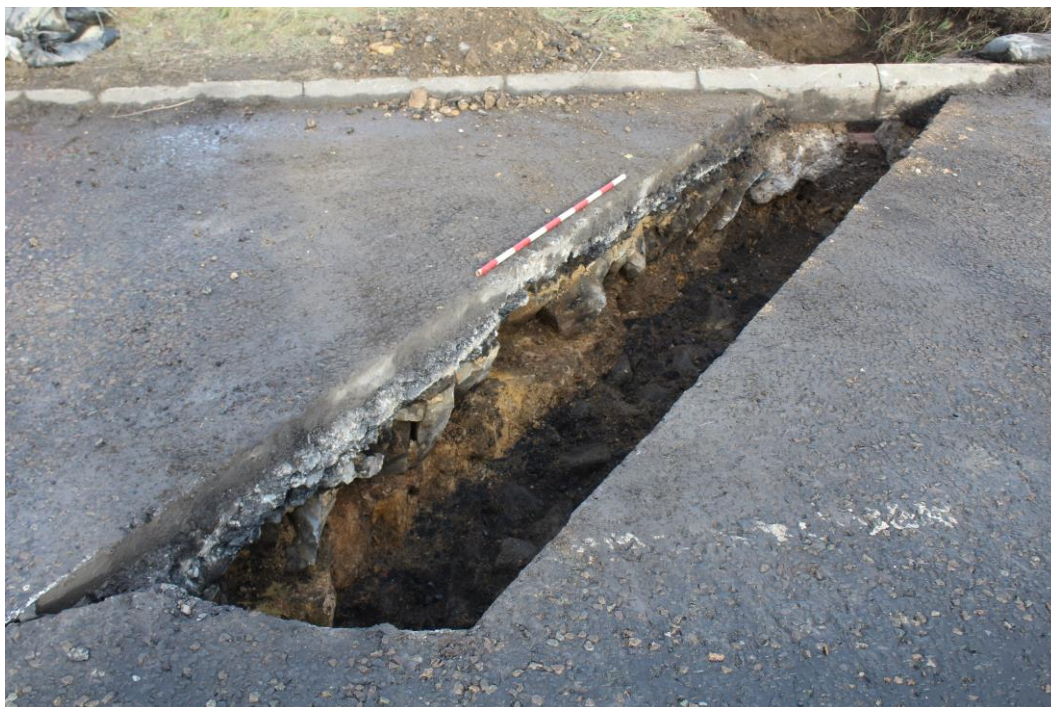
*Plate 3: Oblique view of Trench 1 (N-facing direction of view)*

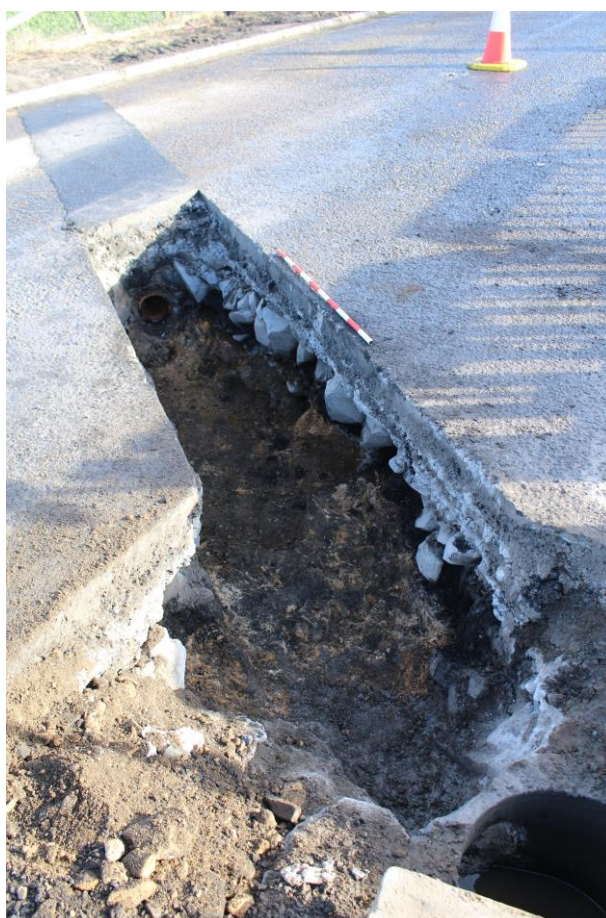
*Plate 4: Oblique view of Trench 2 (NE-facing direction of view)*

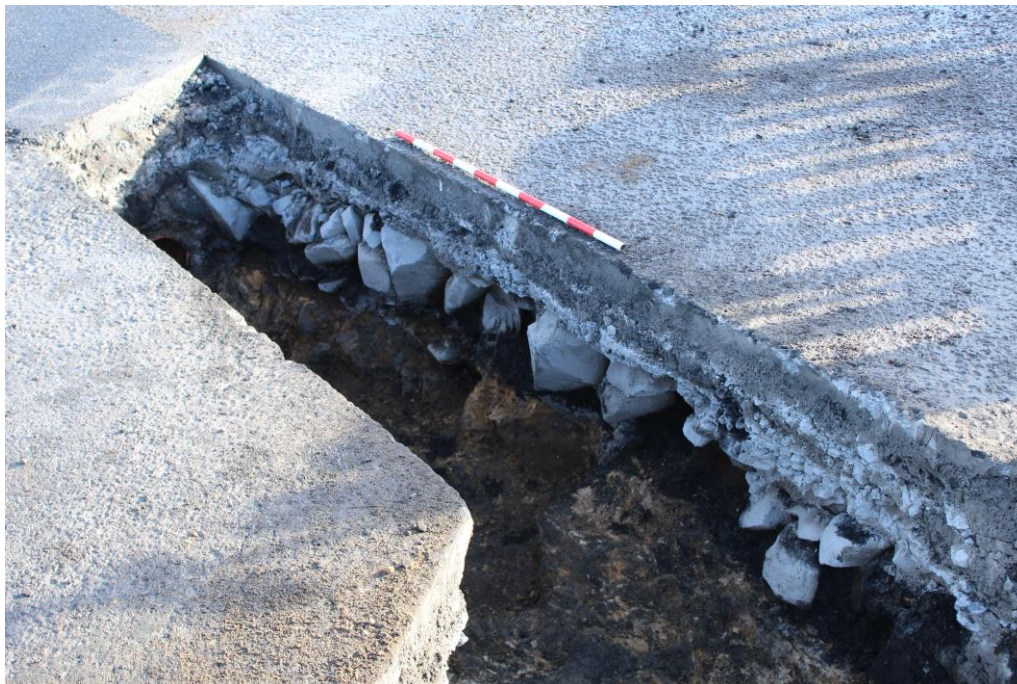
*Plate 5: Oblique view of NW-facing section of Trench 2 (E-facing direction of view)*

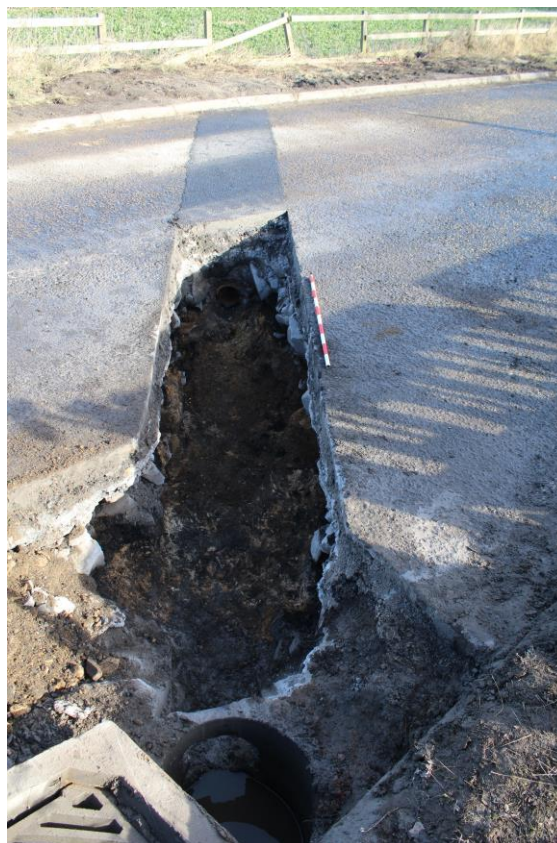
*Plate 6: General view of Trenches 1 & 2 (NE-facing direction of view)*
