**WILSON HOSPITAL, CRANMER
ROAD, MITCHAM CR4 4TP:
AN ARCHAEOLOGICAL
EVALUATION**

SITE CODE: CNM19

**LOCAL PLANNING AUTHORITY:
LONDON BOROUGH OF MERTON**

APRIL 2019

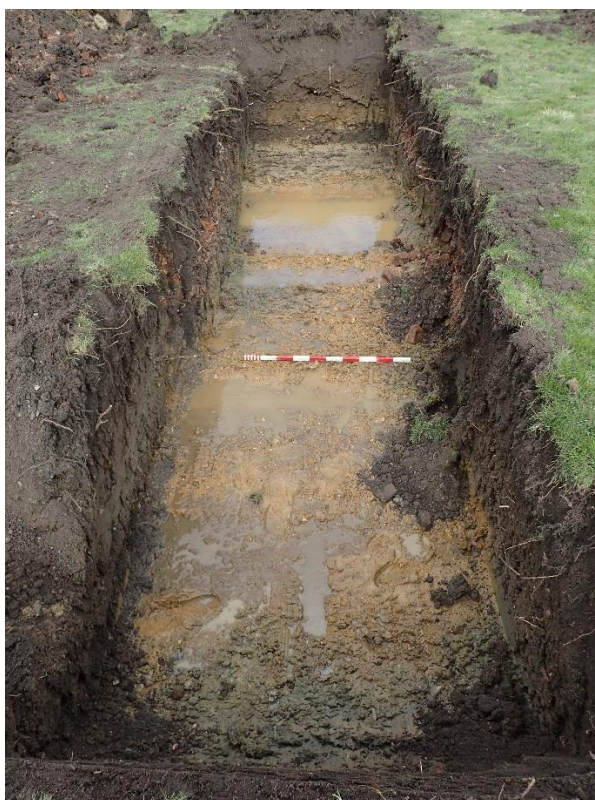
Plates 1: Natural [3] in Trench 3

- 6.1.1 The earliest deposit observed during the archaeological evaluation consisted of a gravelly clay [3] which was seen in the bases of Trenches 1, 3 and 4. The natural was encountered at a height of between 23.01m OD and 21.65m OD and was at least 1m thick. In the sondage in Trench 4, natural clay was identified c. 0.30m below ground level and was at least 2.5m thick.
- 6.1.2 In the north and south of the site in Trenches 1 and 3 the natural [3] was overlain by an undated subsoil [2] and topsoil [1]. The subsoil was 0.25m thick in Trench 3 and 0.70m thick in Trench 1.

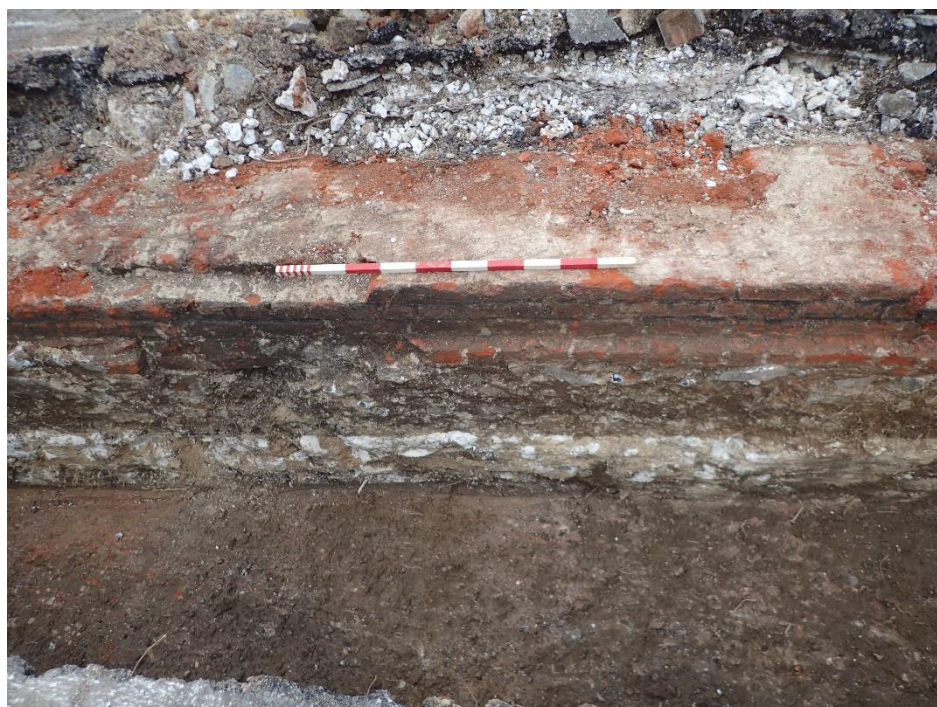
Plate 2: Wall [11] including [12] and [14]

wall [9] was only seen in plan, wall [11] was constructed with a deep foundation which included a chalk base [14], measuring 0.27m (H), which was overlain by a flint and mortar packing [12], measuring 0.31m (H) and capped with the red brick wall [11], measuring 0.3m (H). The walls were constructed of red unfrogged poor quality handmade bricks typically measuring 220mm x 110mm x 60mm and dating to the 17th/18th century (Appendix 5).

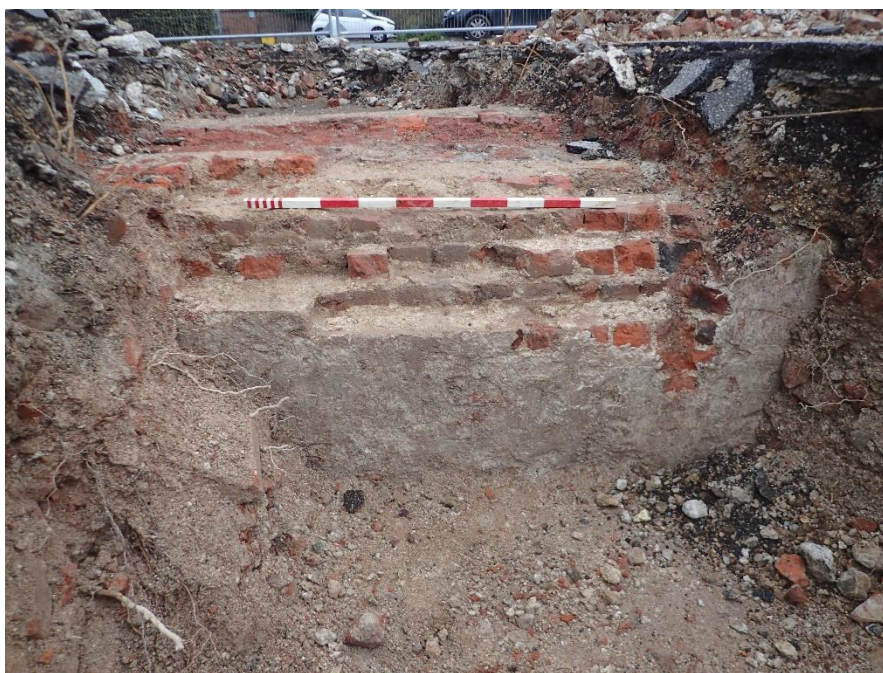
Plate 3: Wall [8]

- 6.2.3 On the north-west end of wall [11] was a L-shaped wall [31] which was possibly a slightly later addition to the original construction of the main house.
- 6.2.4 Internal walls [7] and [8] were identified in Trench 2, which appeared to have mortar or plaster on their inner faces. These walls were likely to have been part of a basement.

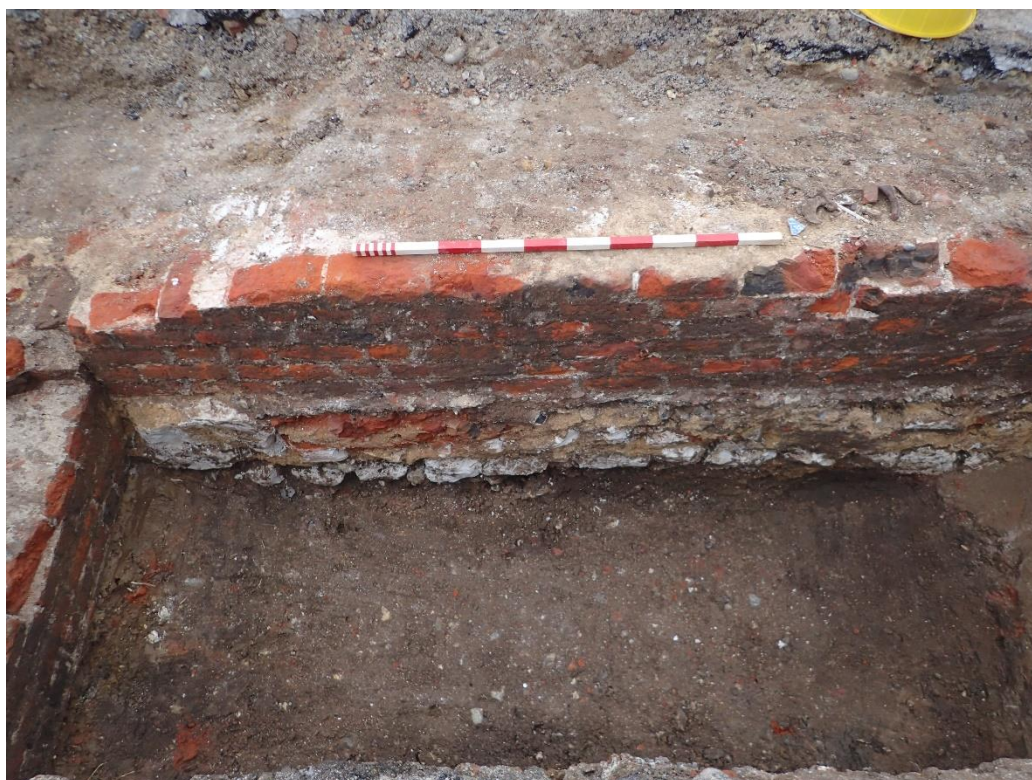
Plates 4: Wall [16] with [18]

6.3.2 Wall [11] appeared to have been extended by the construction of wall [16], measuring 6.30m (L) x 0.35m (W). Wall [16] was constructed using a chalk base [18], measuring 0.33m (H) capped with a red brick wall [16], measuring 0.45m (H).

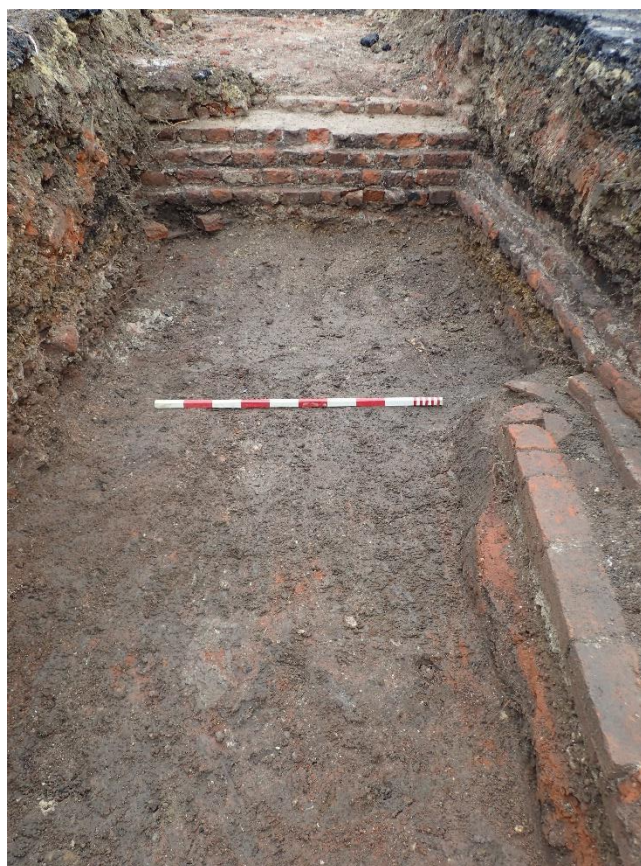
Plate 5: Wall [21] with drain [22]

- 6.3.3 Running along the northern side of wall [9] was a possible drain [10], measuring 1.60m (L) x 0.40m (W) which appeared to be a later addition to the original property.
- 6.3.4 There were a number of walls [27], [28], [41], [42], [43], [44], [48] and [52] that appeared to function as part of the internal structure of the house. All of these walls had a similar date (Appendix 5).
- 6.3.5 A possible external wall [21] with a stepped foundation, measuring 1.60m (L) x 0.62m (W) x 0.40m (H), was identified running across the north-west end of Trench 4 with a return in the north side of the trench. There also appeared to be the remains of a brick drain [22] which ran along the internal edge of wall [21].

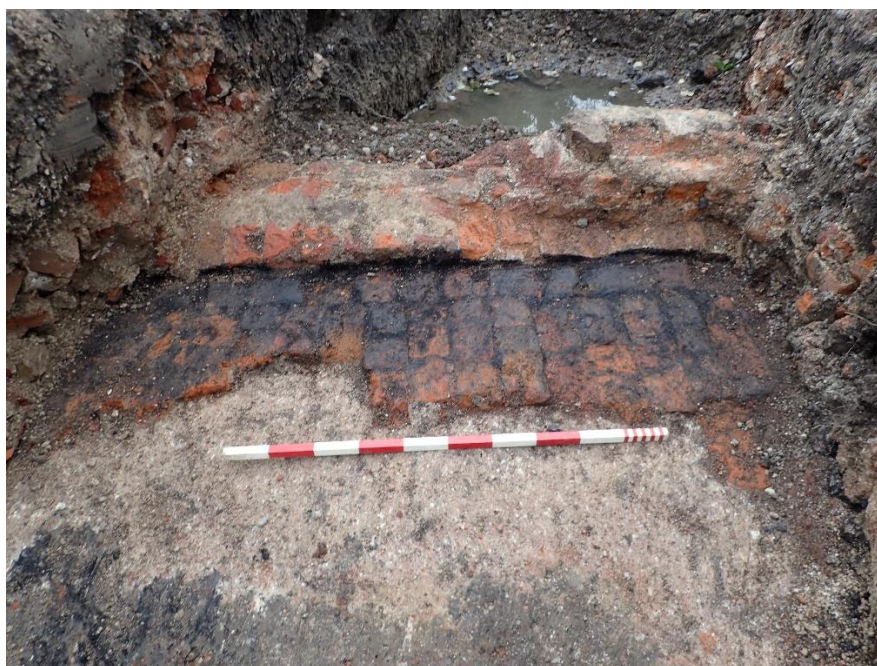
Plate 6: Wall [57] and Floor [39]

- 6.3.6 Walls [50] and [51] in Trench 5 appeared to form a square, measuring 1.80m (N-S) x 1.30m (E-W) that could have been used as a possible drain.
- 6.3.7 Also in Trench 5 walls [55] and [57] were associated with a sunken structure, accessible by the York stone stairs and part of the floor was still preserved. This structure was difficult to assign to the second phase of construction or to the late 18th or mid 19th century. The presence of York stone stairs suggests a 19th century date although the different dimensions of the steps could indicate a re-use of the stone. An outbuilding is shown on the later maps of the site (Figures 5 and 6) which this sunken feature appears to be part of .
