**KENSINGTON PALACE, KING
WILLIAM III LAWN,
LONDON W8 4PX:
AN ARCHAEOLOGICAL WATCHING
BRIEF**

SITE CODE: KEN35

APRIL 2019

AN ARCHAEOLOGICAL WATCHING BRIEF

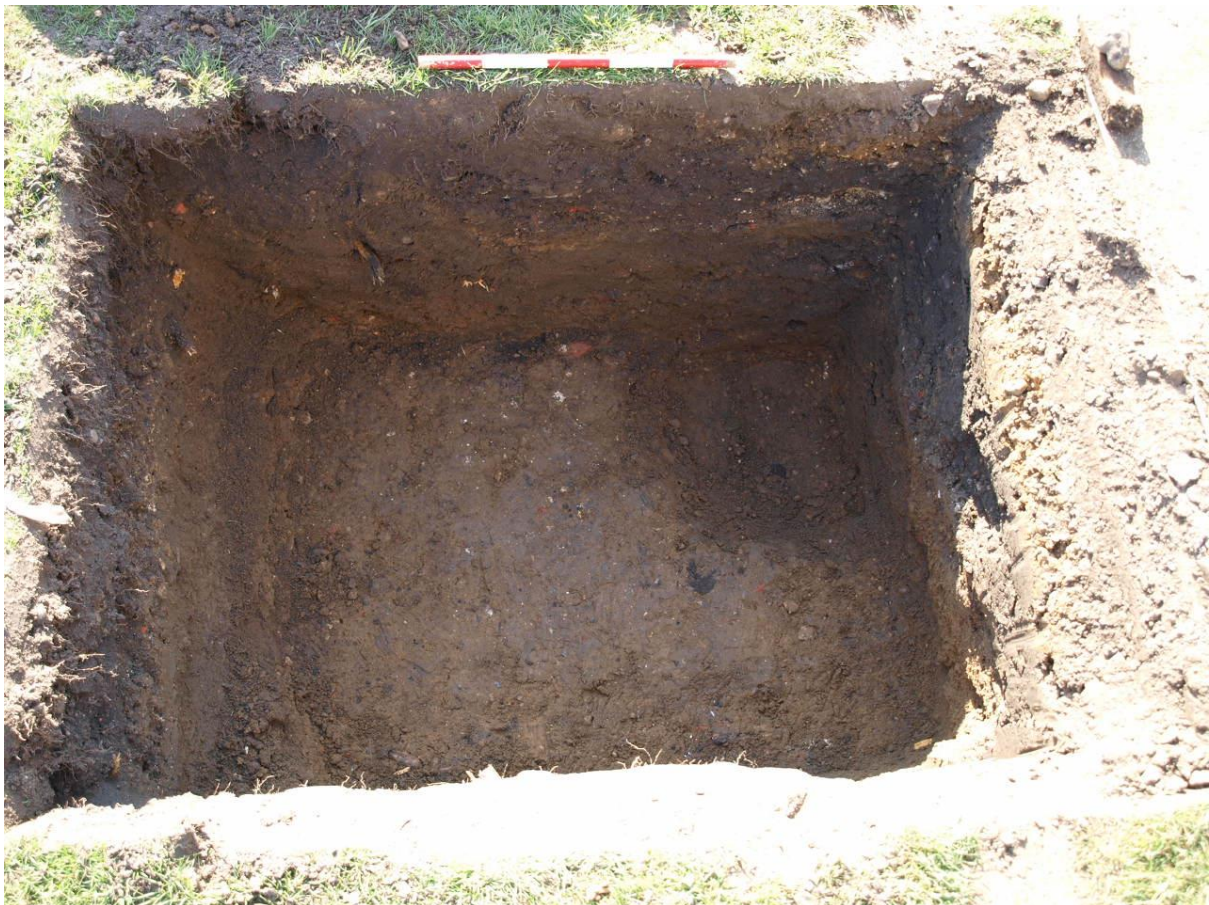
- 7.1.3 In the corner of Pit 4, truncating layer [11] was a small pit [9]. Cut [9] measured 0.40m by 0.50m and was 0.50m deep, extending to 0.95m deep. The cut was backfilled by fill [10] a dark grey brown silt with occasional mixed sand. Cut [9] was most likely a garden feature relating to one of the later phases of gardens. Fill [10] was nearly identical to layer [8] which sealed it.

Figure 1 North facing Section in Pit 4 with cut [9] to the top right.
