**RIVER WALL AT 26-37 CLIVE STREET,
NORTH SHIELDS, TYNE AND WEAR**

**ARCHAEOLOGICAL BUILDING
RECORDING**

Archaeological Building Recording of the River Wall at 26-37 Clive Street, North Shields, Tyne and Wear

PCA Report No. 13676

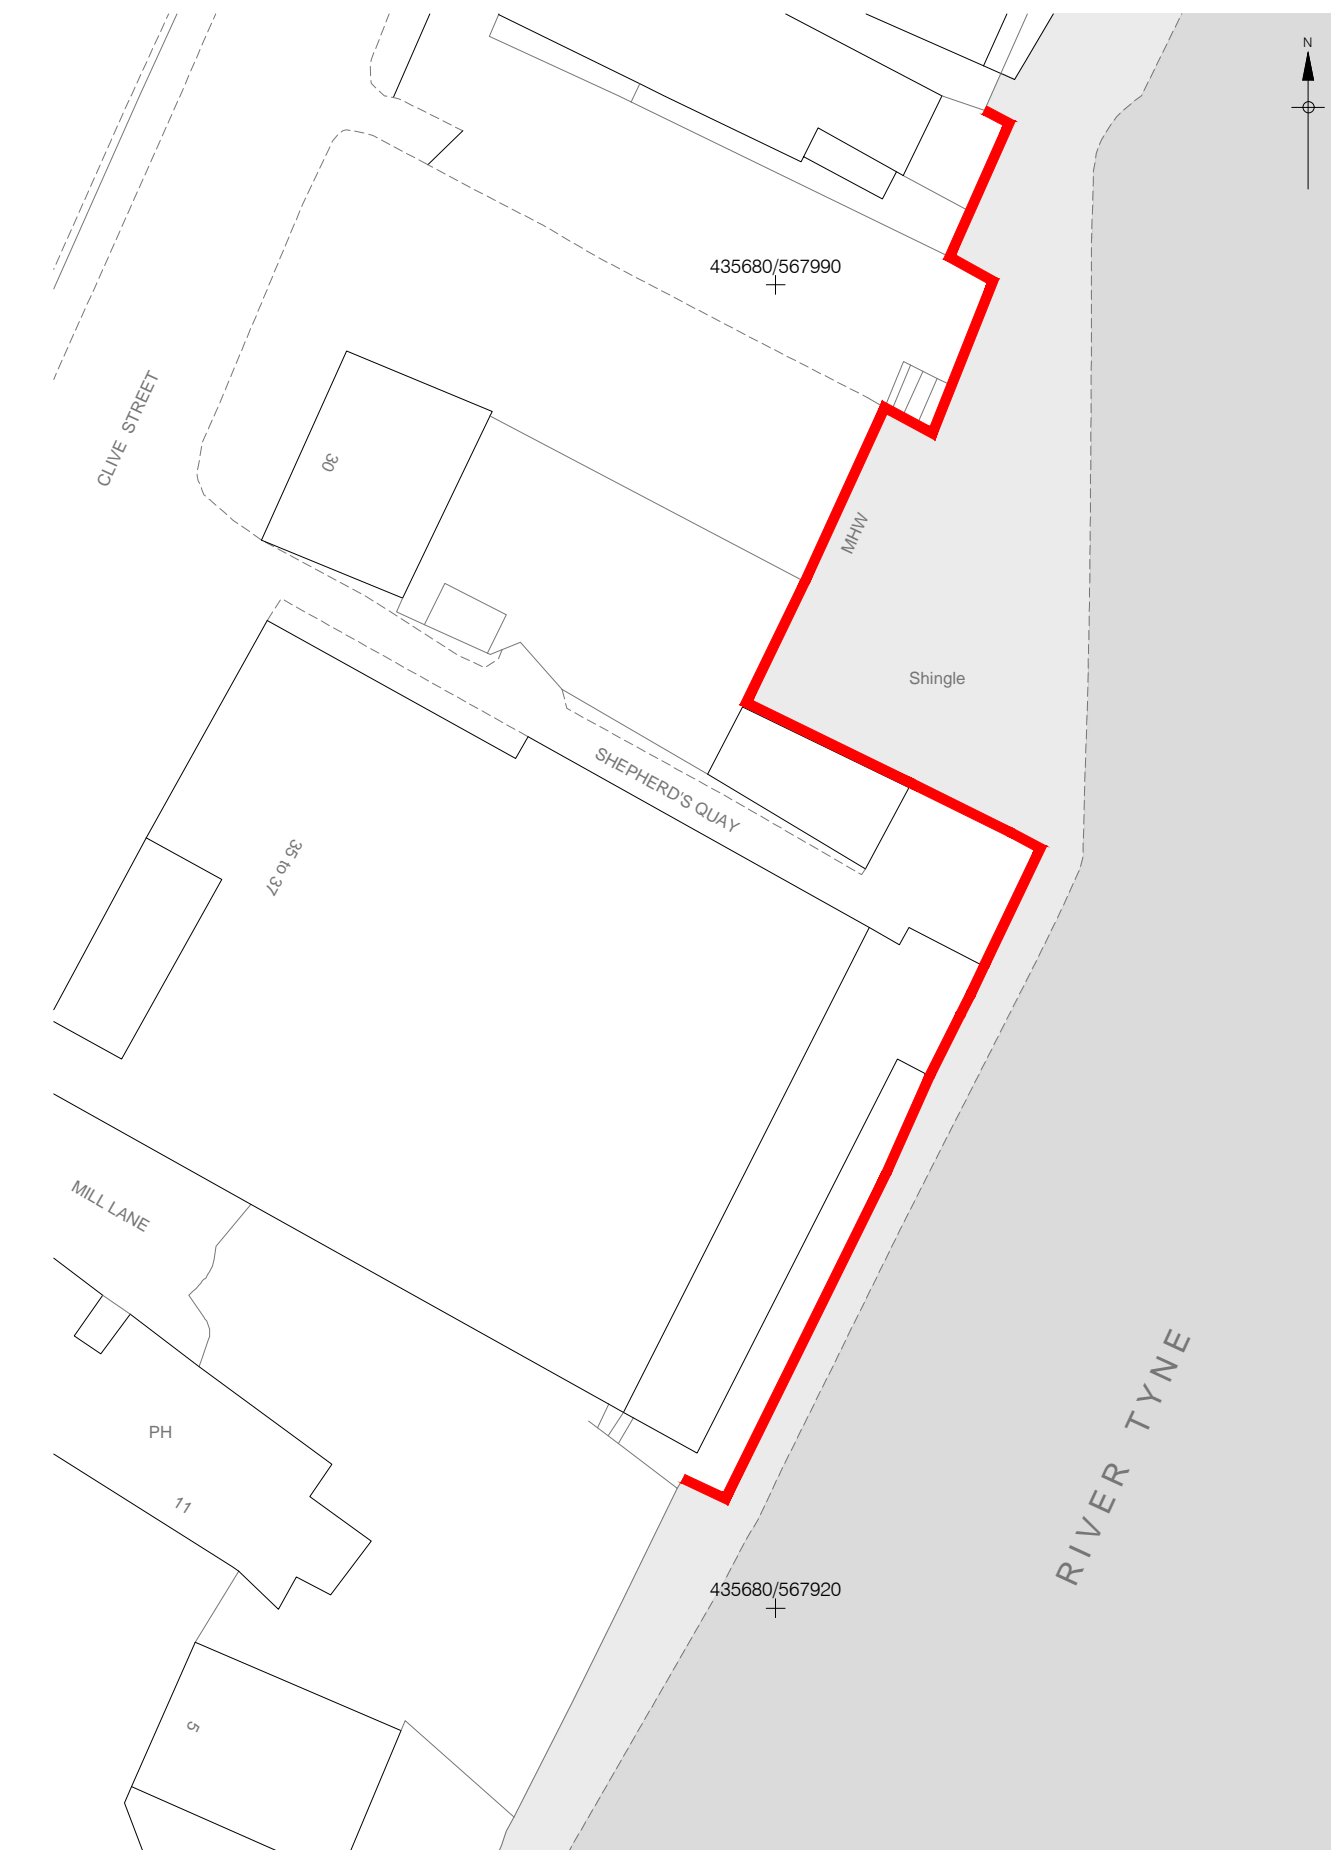
Figure 2
 Detailed Site Location
 1:400 at A4

- 2.2.1 The part of the quayside wall to be repaired is located to the rear of 26–37 Clive Street, North Shields, Tyne and Wear at central National Grid Reference NZ 3568 6796 (Figures 1). The archaeological building recording (photographic survey) involves a c. 90m long section of quayside wall formed by a c. 38m long section of upstream wall aligned NNE-SSW located behind Nos 35-37 Clive Street, a c. 18m long section of wall aligned WNW-ESE and a c.34m long section of downstream wall aligned NNE-SSW located behind Nos 26-30 Clive Street (Figure 2).

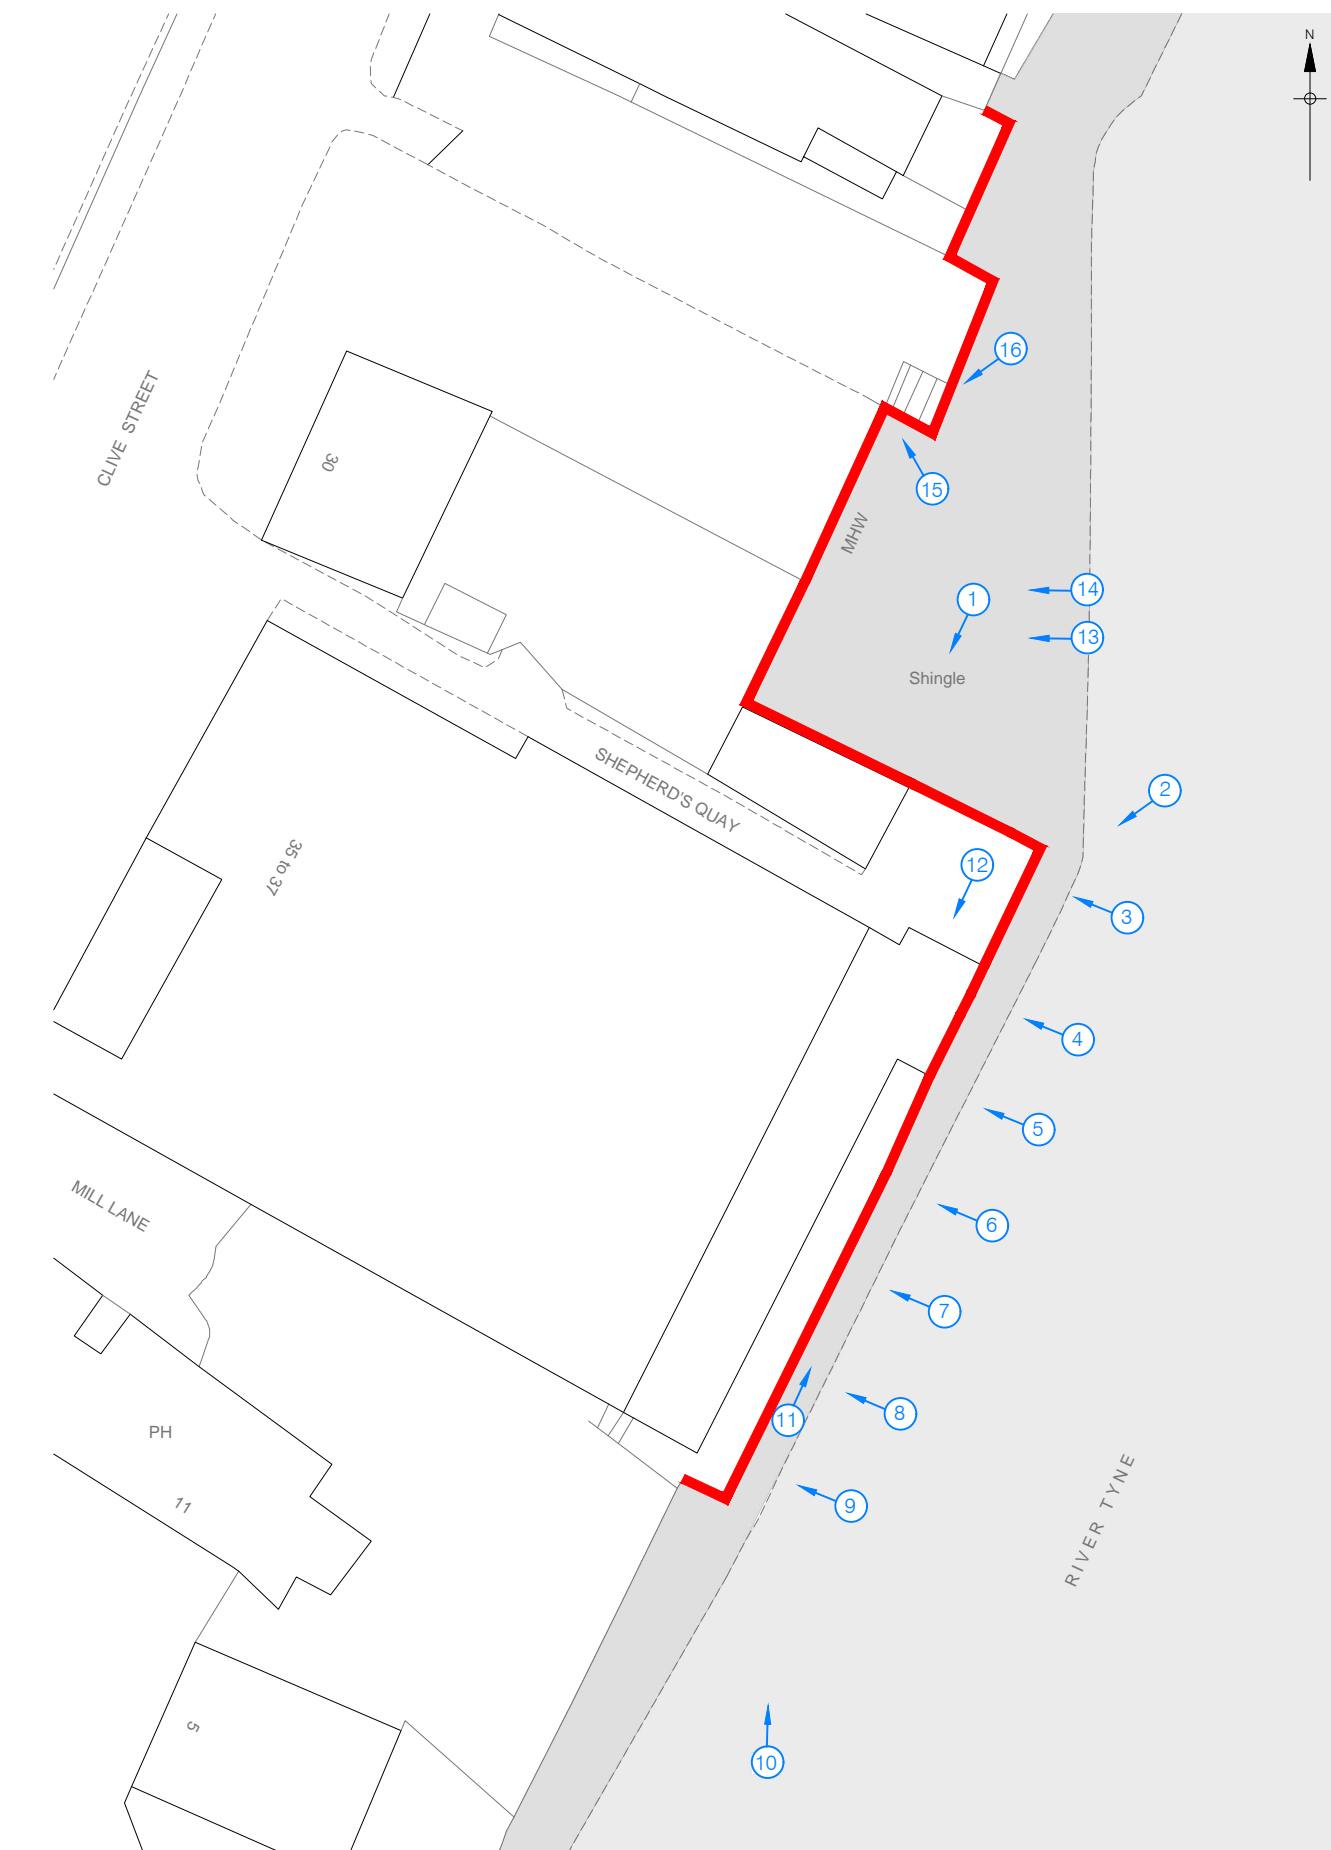
Figure 12
 Plate Locations and Directions
 1:400 at A4

4.3.2 A photographic survey of the quayside wall was undertaken using high quality digital camera. The survey was conducted on 18th April 2018. A selection of photographs is included in this report (Plates 1 to 16) and the location and direction of these plates is shown on Figure 12.

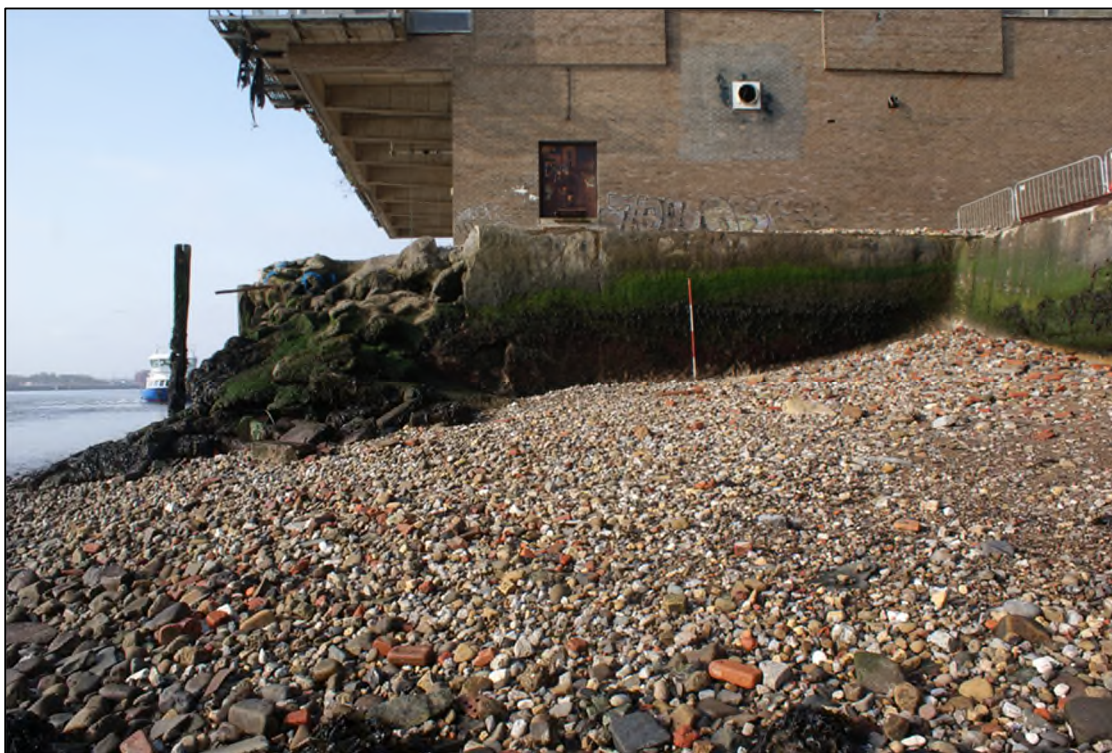
6.1.1 The WNW-ESE aligned section quayside wall measures c. 18m long and was exposed to a maximum height of 3.12m high (Plate 1). Although this section of quayside wall is built in ashlar sandstone blocks it is entirely covered in concrete render reinforced with steel mesh. The underlying masonry was exposed at the north-eastern corner of the wall where it has collapsed (Plate 2) and also within an area of spalling at the ESE extent of the wall.

Plate 1: NNE facing elevation of WNW-ESE aligned quayside wall, view SSW, 2m scale.

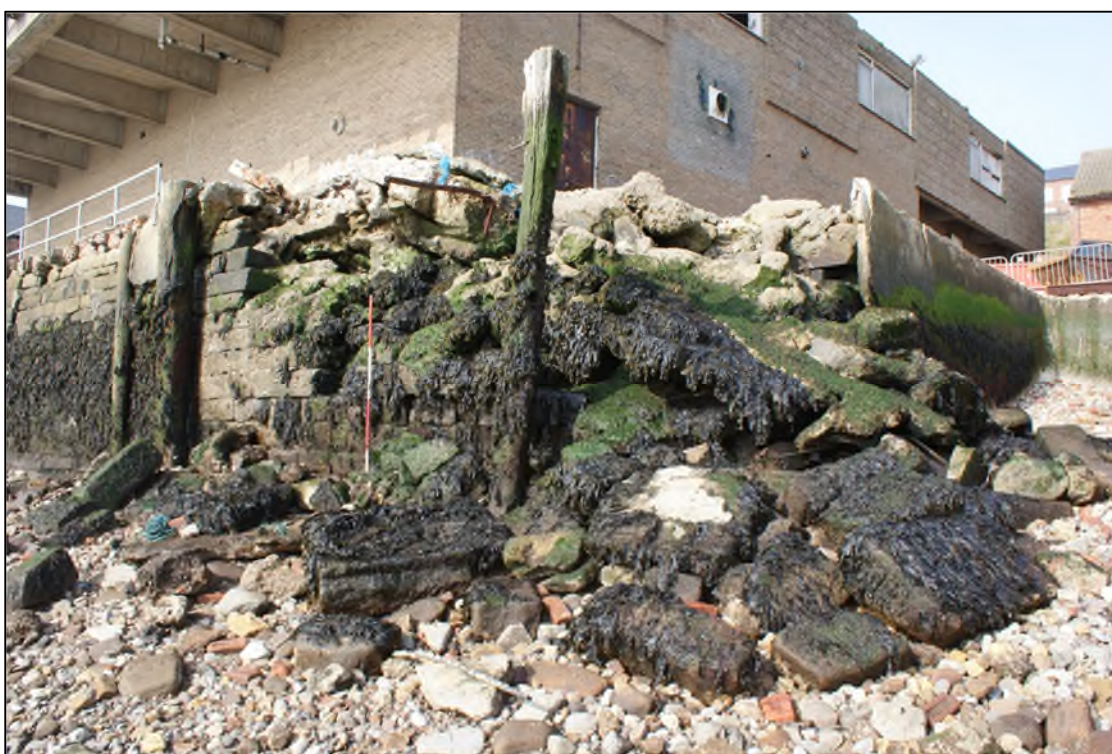
- 1.1.5 A section of the NNE-SSW aligned upstream masonry quayside wall is bulging and at the NNE extent has partially collapsed (Plates 11 & 2). Approximately 40m of the quayside masonry wall will be dismantled and rebuilt using the original materials. The staircase located at the central part of the NNE-SSW aligned downstream quayside wall has partially collapsed and will be dismantled and rebuilt using existing materials where possible. Other work involves the re-pointing of the masonry wall and replacing existing concrete coping where required along all sections of the quayside wall. Loose or hollow sounding concrete facing to be removed along the WNW-ESE aligned section of quayside wall with these areas to be inspected and advice provided for any further repairs that may be required.

6.2.4 The north-eastern corner of the quayside wall has collapsed and has been temporarily stabilised by pouring concrete over the masonry rubble (Plate 2).

Plate 2: North-eastern corner of collapsed quayside wall, view south-west, 2m scale.

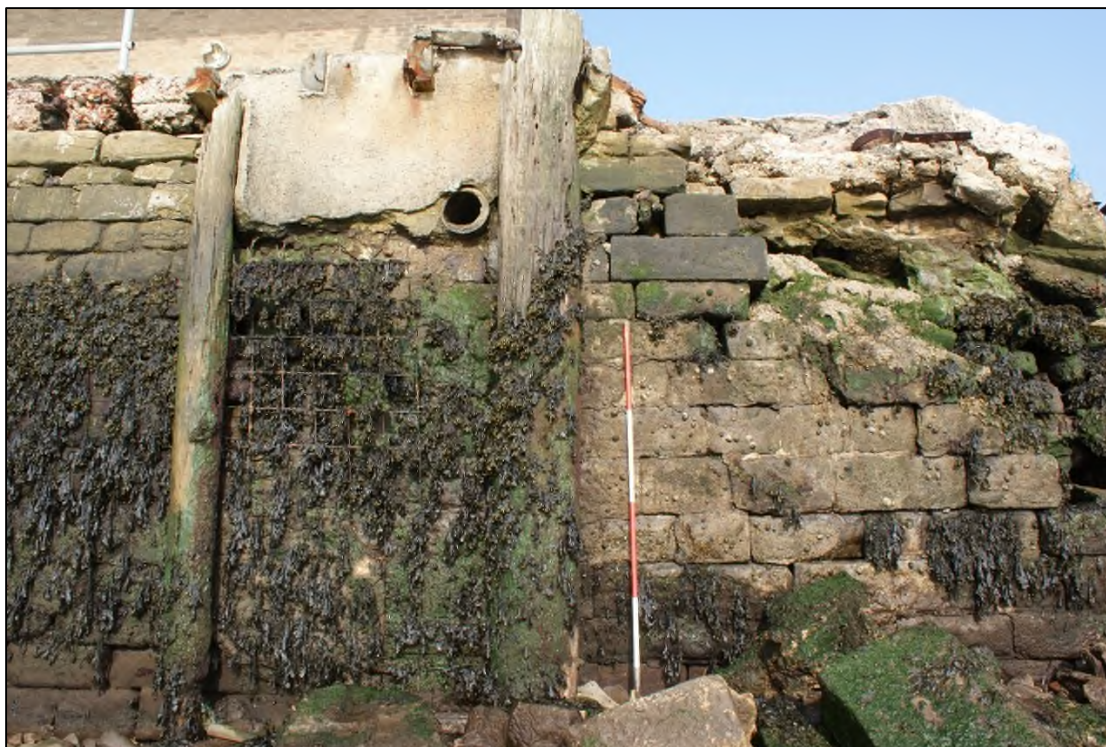
Plate 3: ESE facing elevation of NNE-SSW aligned quayside wall showing timber mooring posts and drain, View WNW, 2m scale.

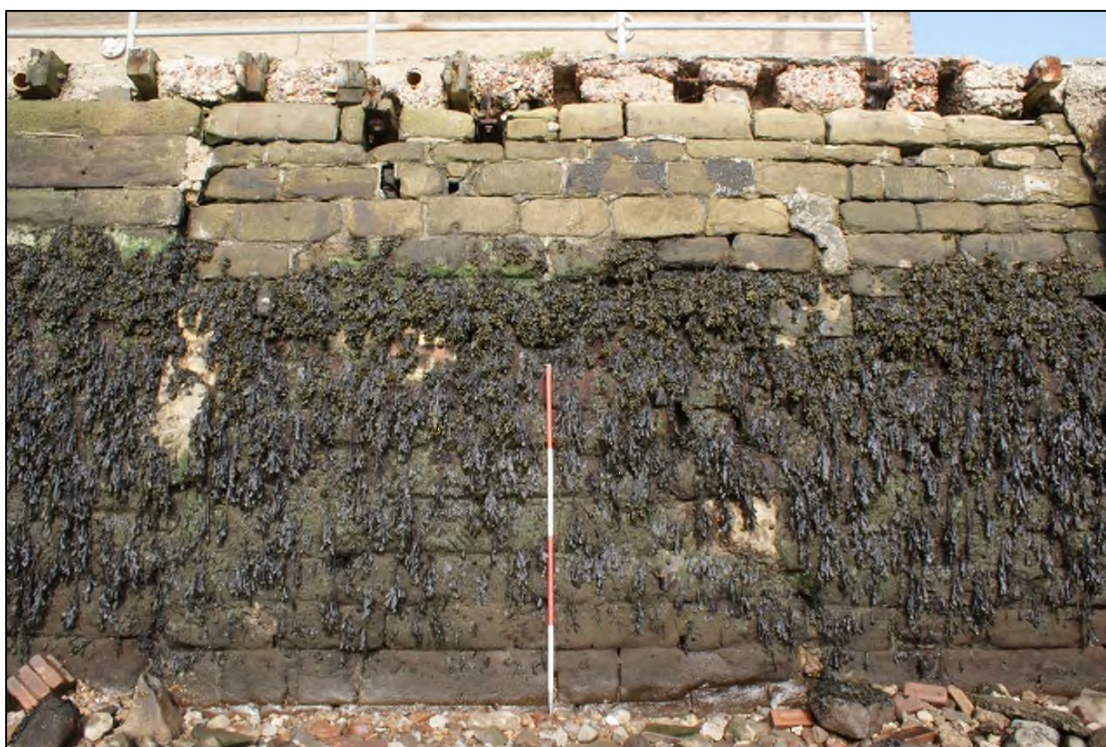
Plate 4: ESE facing elevation of NNE-SSW aligned quayside wall showing concrete and timber deck, View WNW, 2m scale.

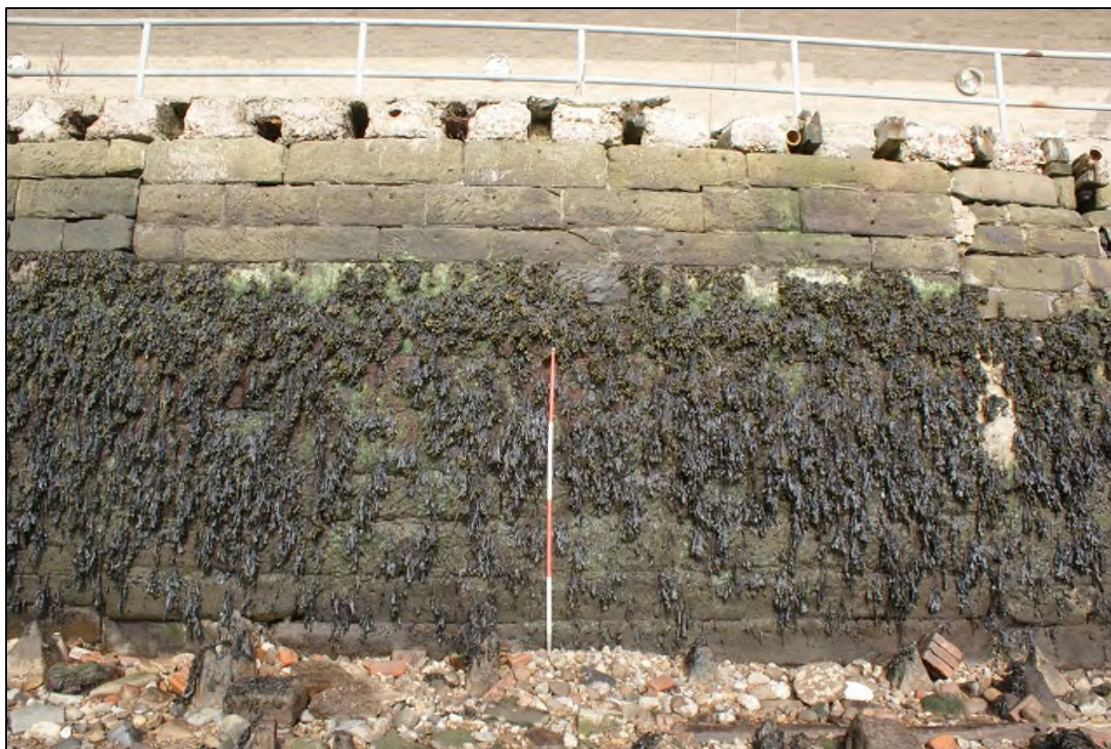
6.2.2 An area of infilled wall with dimensions of c. 6m long by at least 3.70m high was noted at the NNE portion of the quayside wall (Plate 5). The infilled section of wall was built using identical sandstone ashlar masonry as the rest of the wall and may represent a late 19th century or early 20th century repair, possibly reusing masonry from this section of the quayside wall. Alternatively, it may represent a strengthening structure associated with the crane depicted on the 1896 Ordnance Survey (Figure 7).

Plate 5: ESE facing elevation of NNE-SSW aligned quayside wall showing area of masonry infill, View WNW, 2m scale.

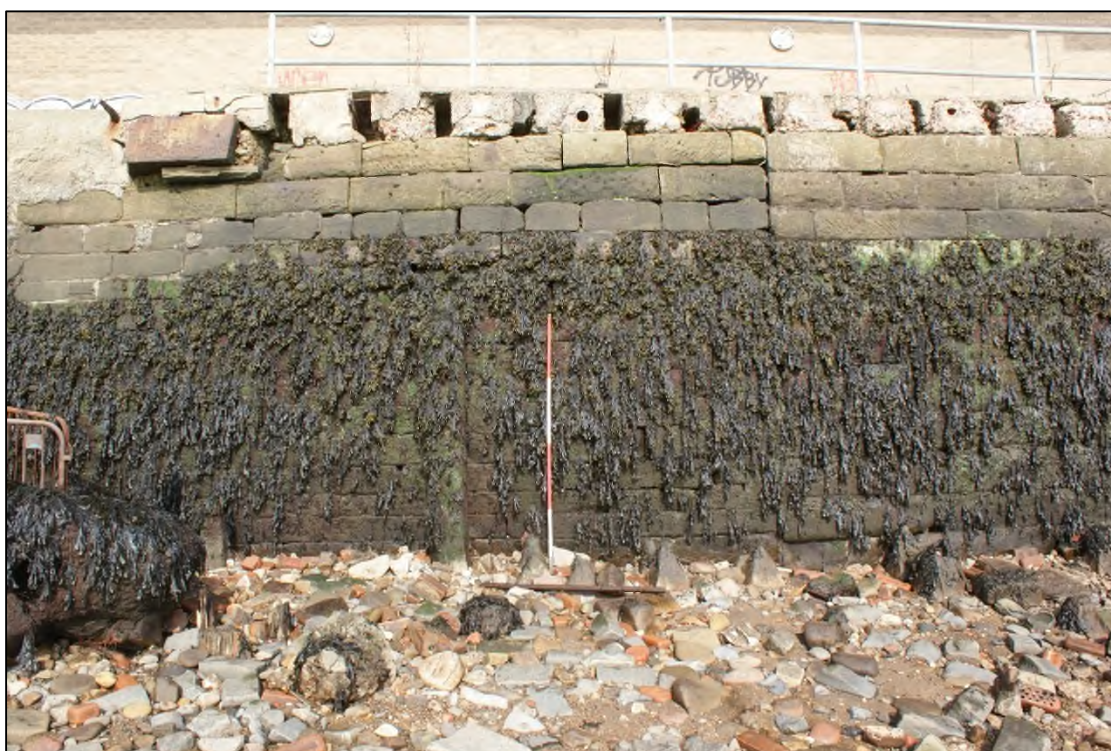
Plate 6: ESE facing elevation of NNE-SSW aligned quayside wall showing timber mooring, View WNW, 2m scale.

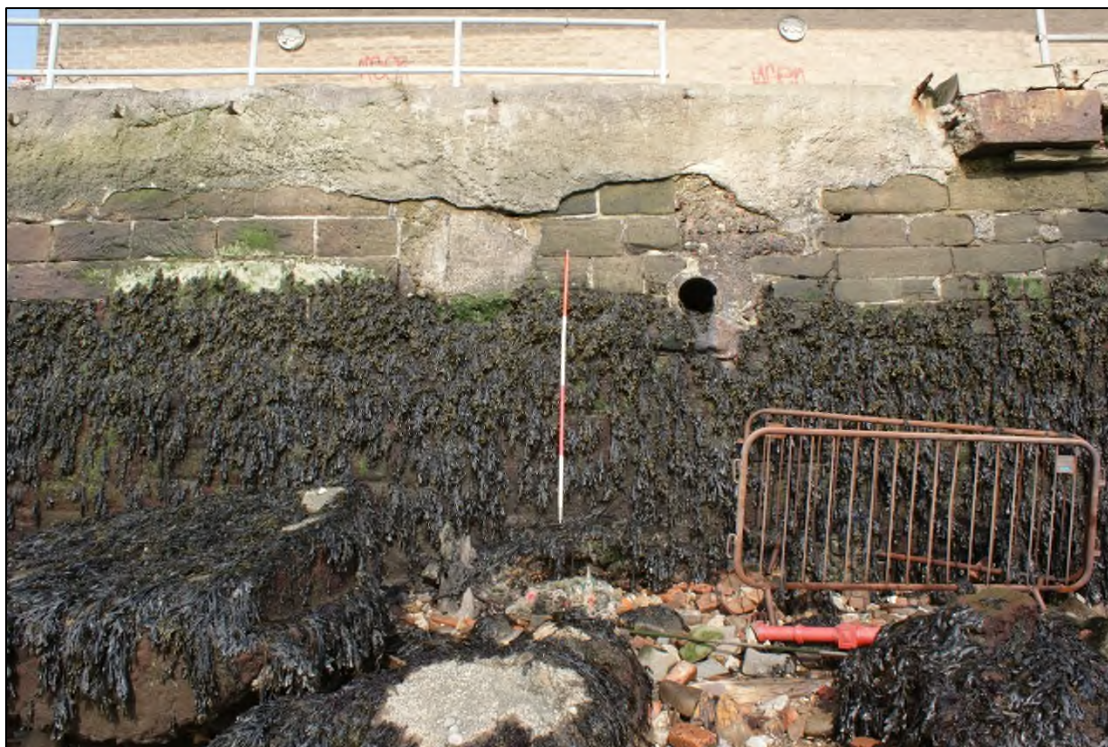
Plate 7: ESE facing elevation of NNE-SSW aligned quayside wall showing concrete render to and drain, View WNW, 2m scale.

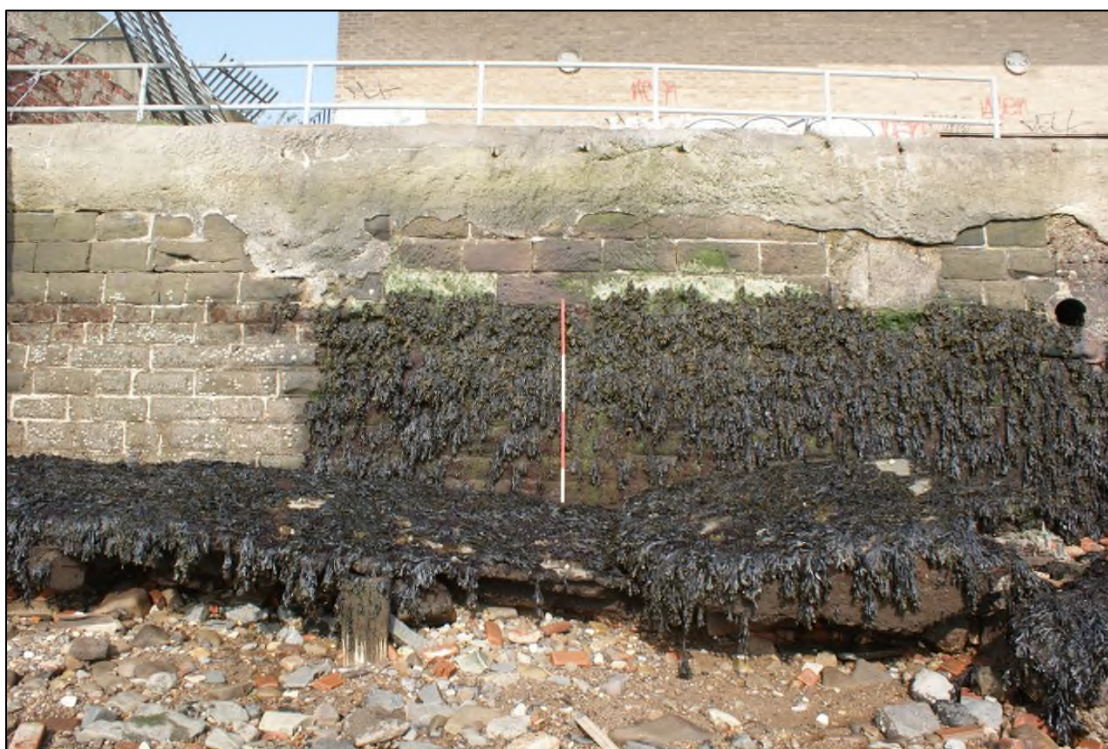
Plate 8: ESE facing elevation of NNE-SSW aligned quayside wall showing collapsed concrete surface in the foreground, View WNW, 2m scale.

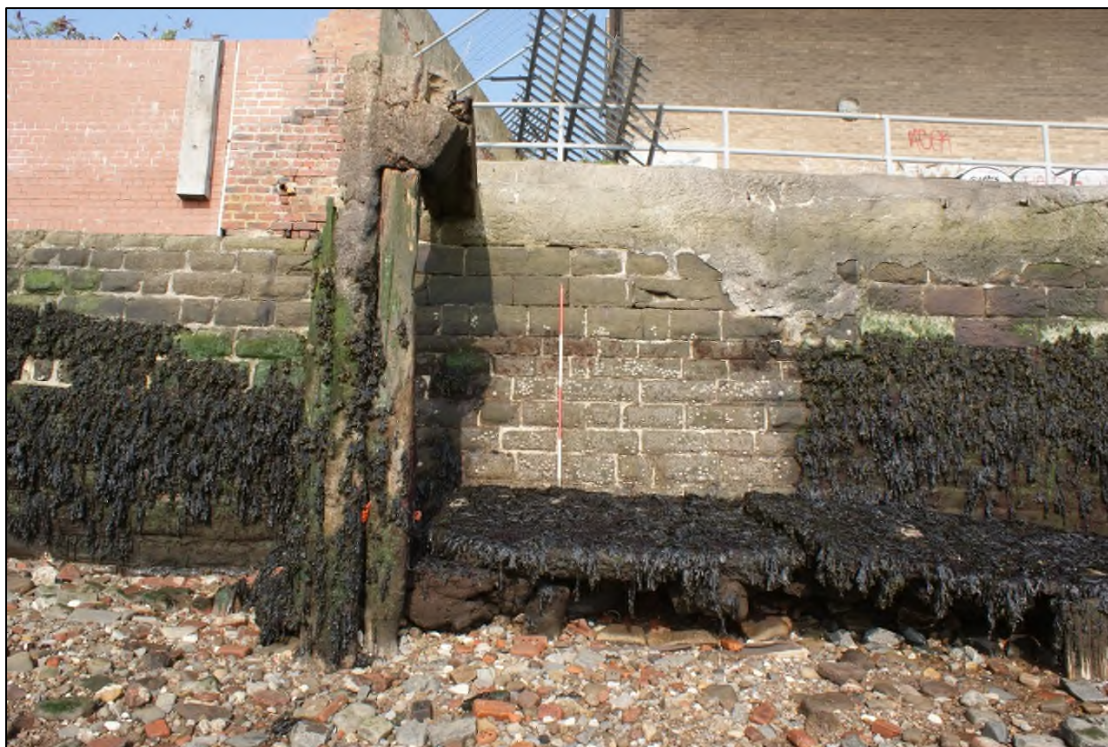
Plate 9: ESE facing elevation of NNE-SSW aligned quayside wall showing collapsed ramp in the foreground, View WNW, 2m scale.

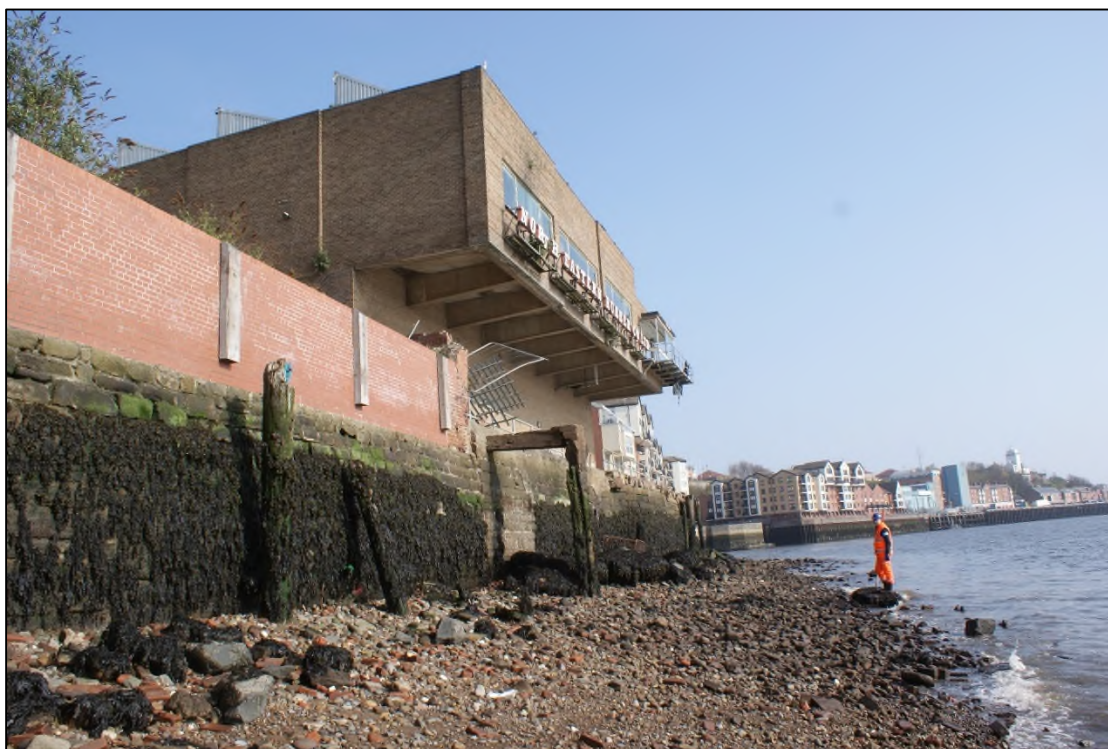
Plate 10: Oblique view of NNE-SSW aligned quayside wall showing collapsed ramp, View north, 2m scale.

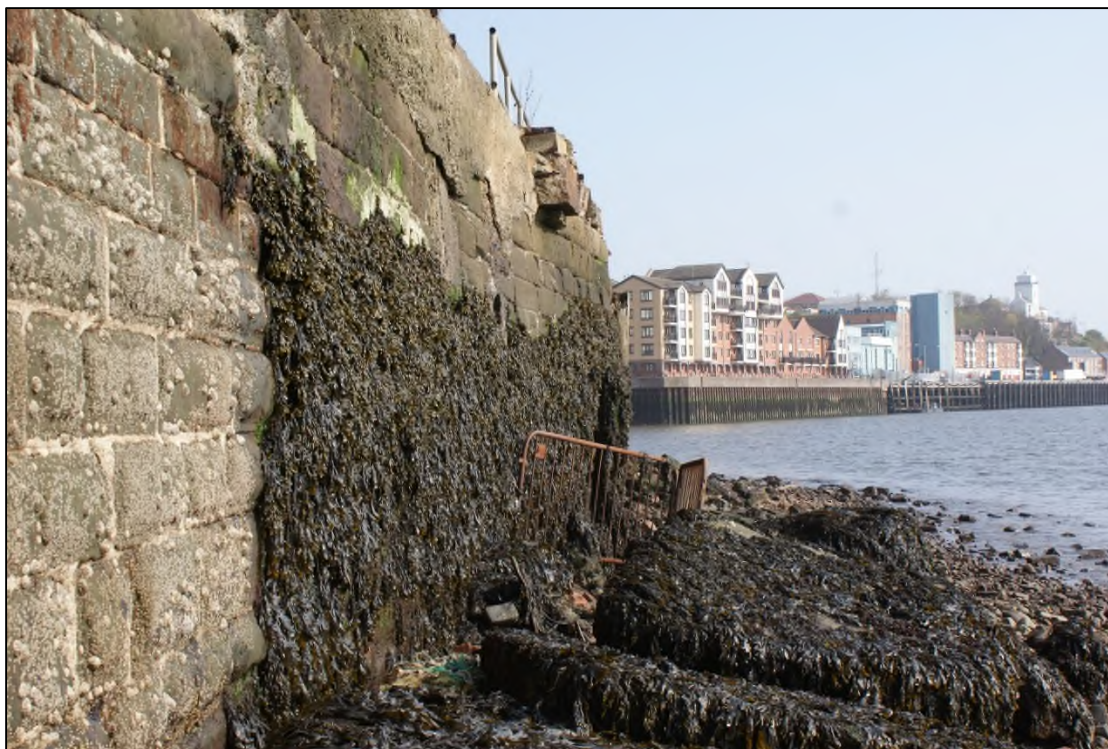
Plate 11: Oblique view of NNE-SSW aligned quayside wall showing area of bulging, View north.

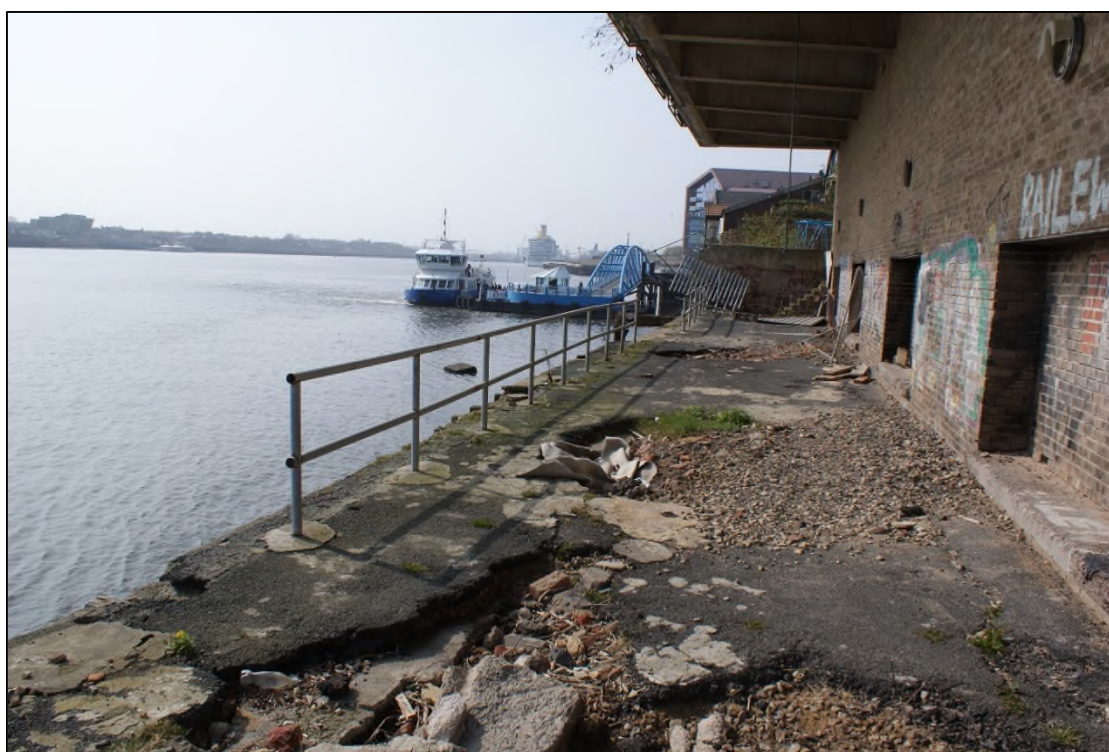
Plate 12: General view from top of NNE-SSW aligned quayside wall, View north.

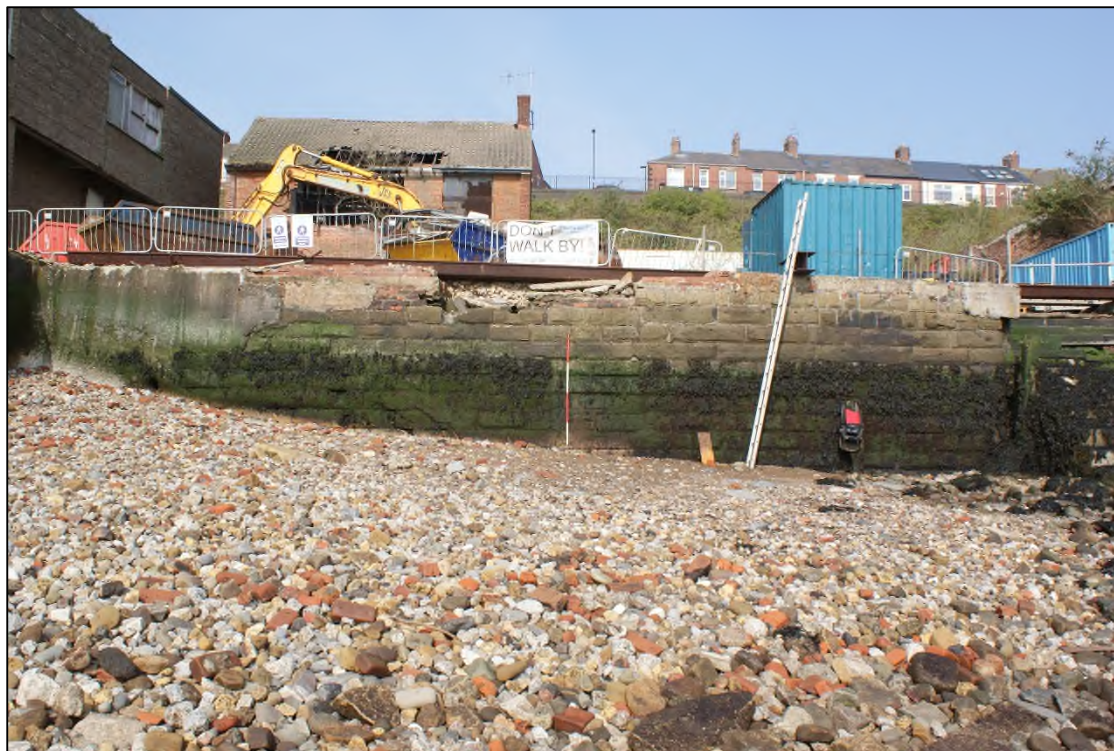
Plate 13: NNE-SSW aligned quayside wall facing property 30, View ENE, 2m scale.

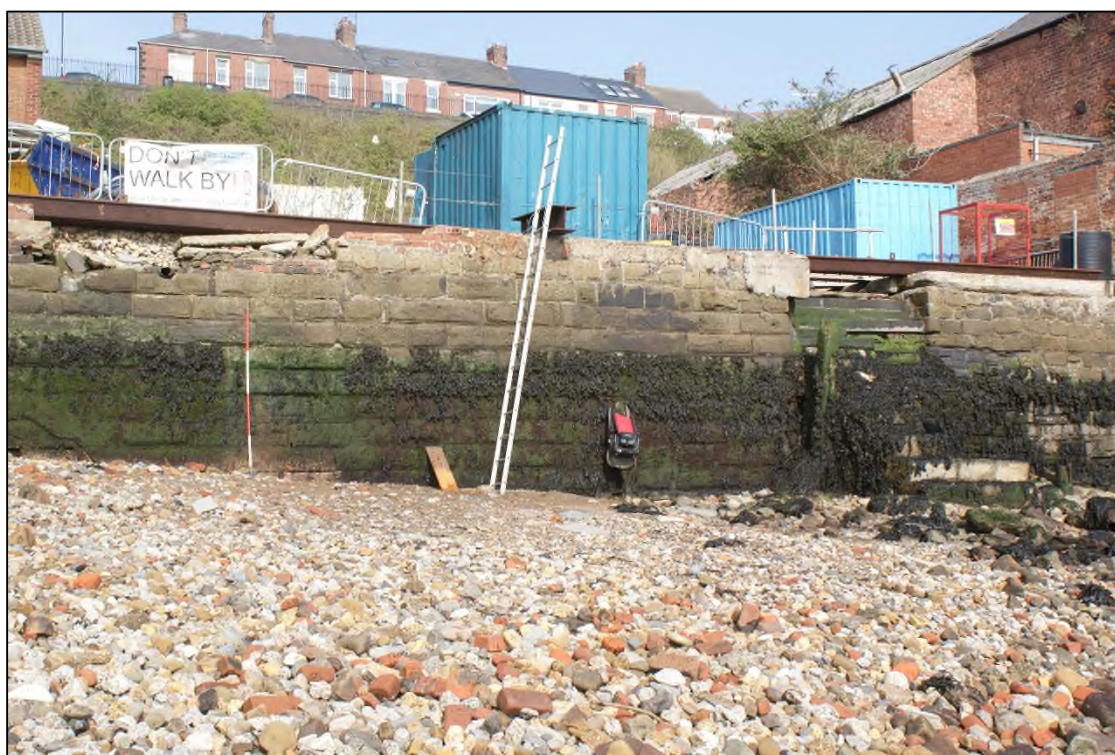
Plate 14: NNE-SSW aligned quayside wall facing property 30, View ENE, 2m scale.

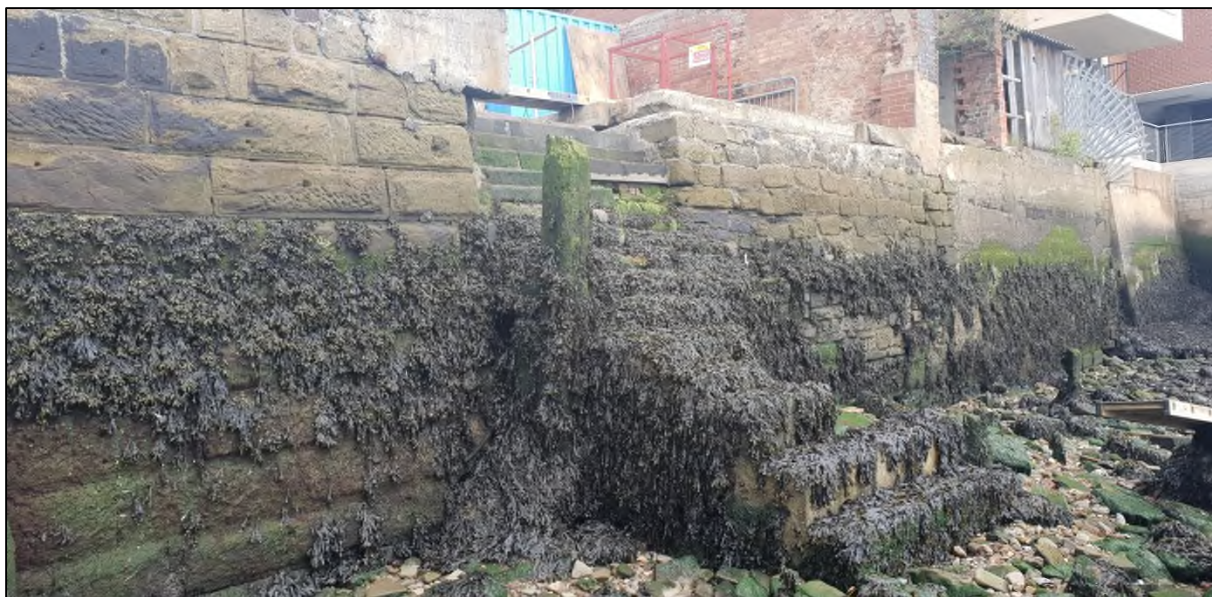
- 6.3.4 The staircase leading to the foreshore is situated in the central part of the quayside wall and is generally in poor condition with the lower seven steps partially collapsed (Plates 15 & 16). The stairs were built with large sandstone ashlar blocks that at the time of this survey was covered in a thick growth of seaweed. The five uppermost steps have been rebuilt, probably in the latter part of the 20th century, using large rectangular stone slabs bonded with concrete. The lower two steps of the rebuilt portion have also partially collapsed. Although the location of the staircase is as depicted on the Ordnance Survey Map of 1896 (Figure 7) it is possible that this has been rebuilt sometime in the 20th century when the original quayside wall was demolished and rebuilt.

Plate 15: Staircase leading to foreshore, View NNW.

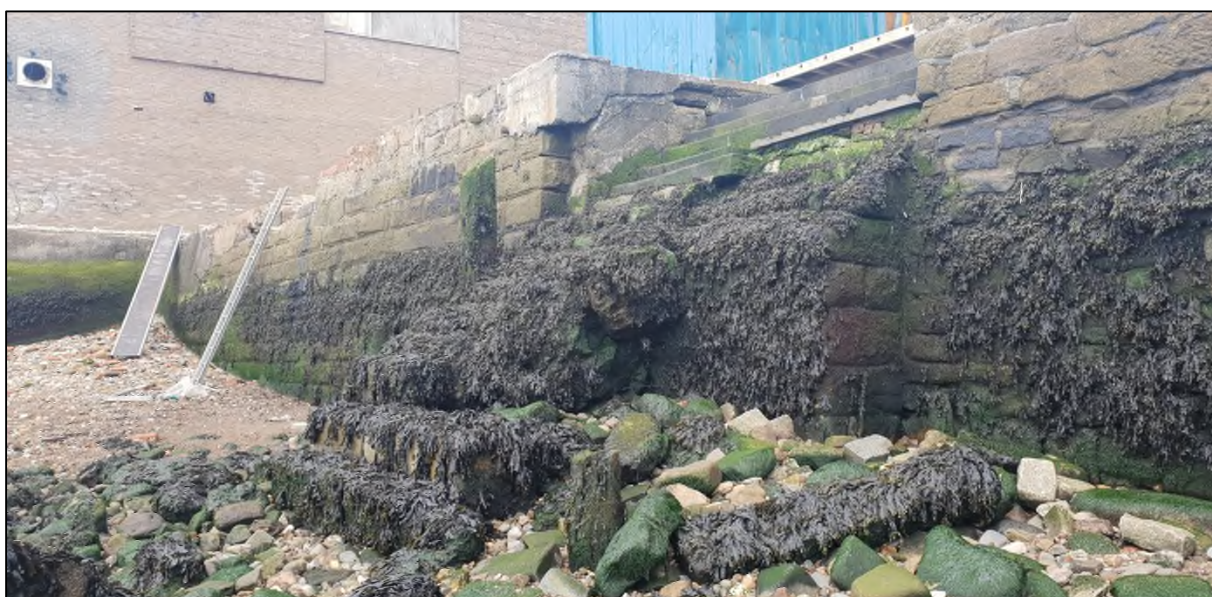
Plate 16: Staircase leading to foreshore, View SW.
