**LAND WEST OF HEAD GARDENERS
COTTAGE,
THE ALNWICK GARDEN,
GREENWELL ROAD,
ALNWICK,
NORTHUMBERLAND**

**ARCHAEOLOGICAL EVALUATION AND
IMPACT ASSESSEMENT REPORT**

JUNE 2019

Pre-Construct Archaeology Limited Quality Control	
<i>Project Number</i>	K6108
<i>Site Code</i>	ACG 19
<i>Report Number</i>	R13711

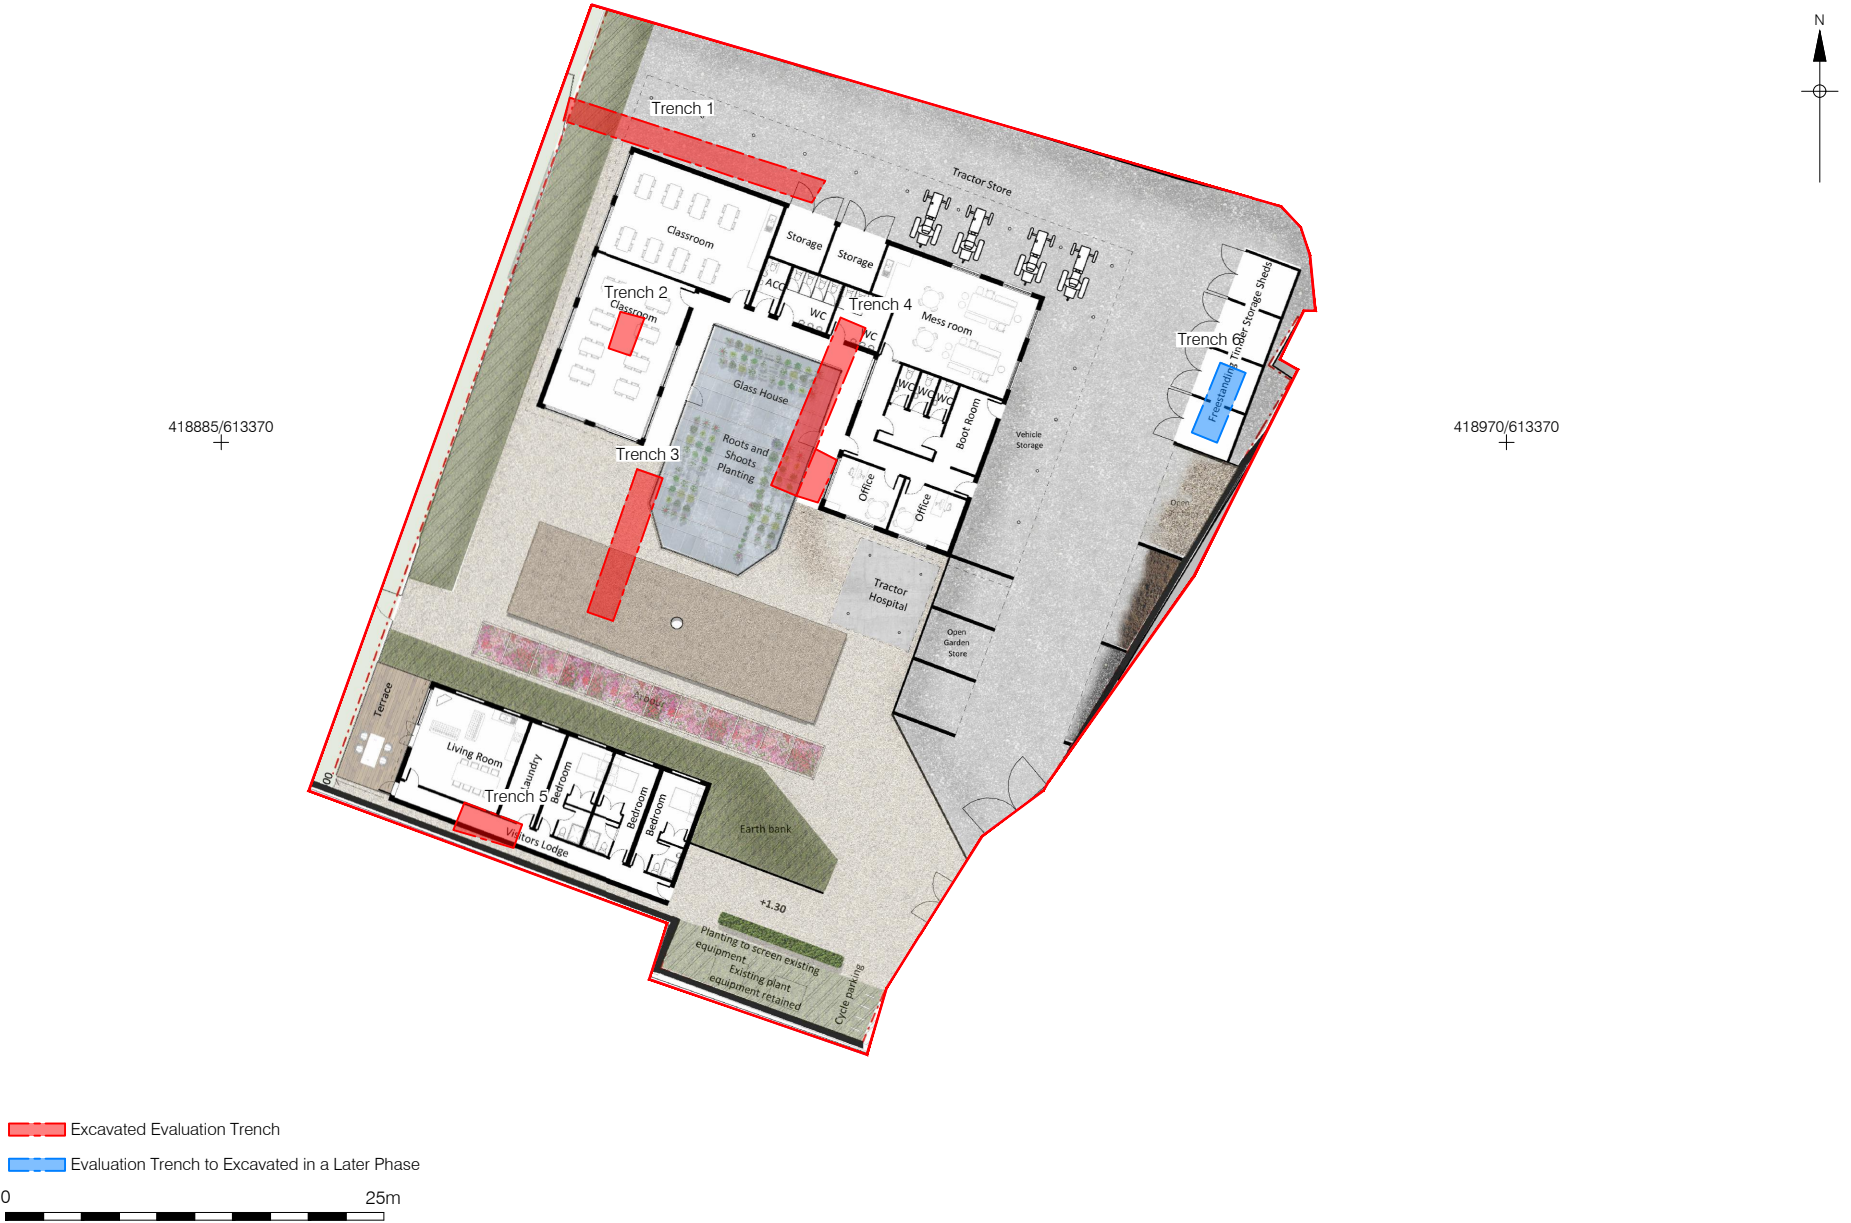
Figure 3A
Evaluation Trenches overlain on Proposed Development
1:500 at A4

- 7.3.1 The proposed scheme of works (discussed in detail in Section 2.4) comprises the demolition of the remaining mid-19th century propagating house and 20th-century stores and offices to be replaced by a central single-storey education centre with classrooms, offices, gardener's welfare facilities and glasshouse; an accommodation block along the southern boundary and northern sheds along the eastern boundary wall (Figure 3A&B).

- 7.3.3 The proposed scheme (Figure 3A&B) comprises a new education centre within the centre of site and accommodation block running along the southern boundary wall. Subsoil deposits were noted at a great depth of approximately 2m below ground level so it is highly unlikely that the construction depth will reach medieval deposits. If foundations and drainage/services are excavated into the Phase 2 deposits it would potentially only have a **low adverse** impact. The upstanding remains of the northern propagating house, as well as the buried remains within Trench 3 are to be demolished/truncated. This will have a **high adverse** impact on the structural remains of the northern propagating house. This can be mitigated with a suitable scheme of historic building recording on the upstanding remains and archaeological excavation of below ground features. The southern propagating house appears to be largely outside of the footprint of the new building, however, services or landscaping may truncate its upper levels resulting in a **low adverse** impact.

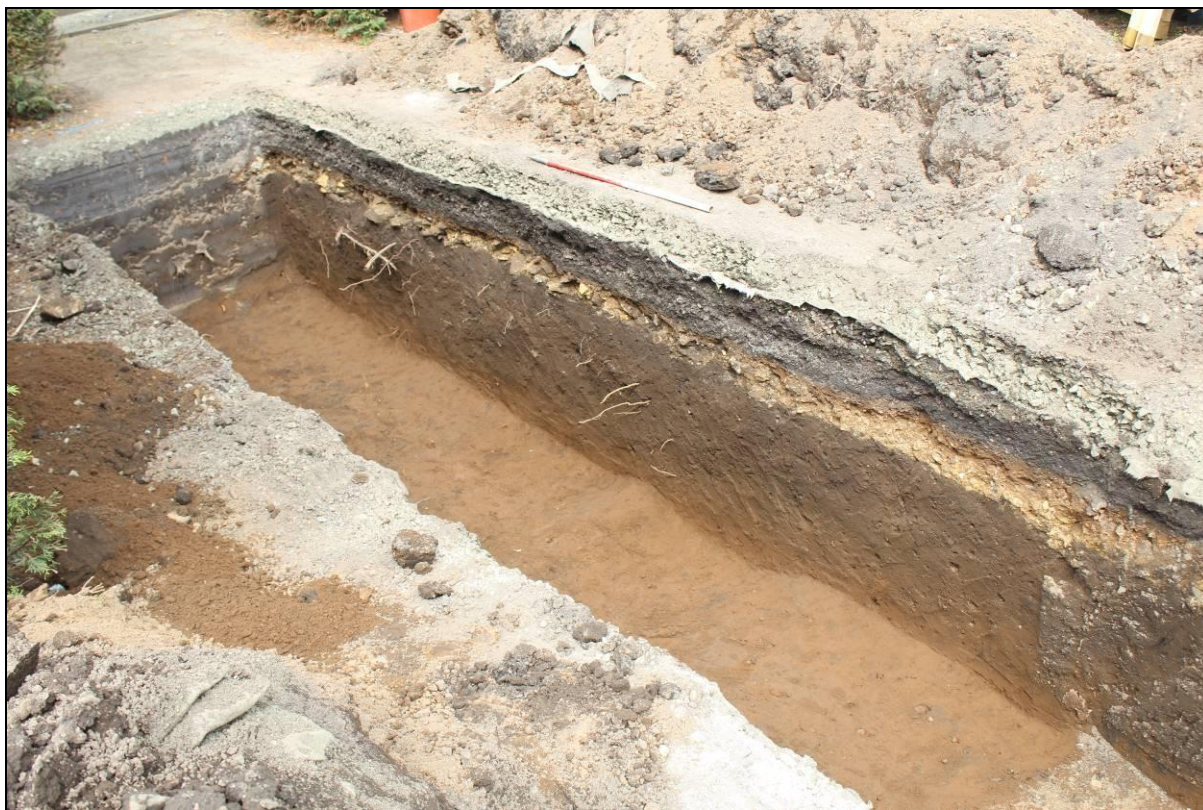
Plate 1: Trench 1 section: view northwest, 1m scale

- 5.2.2 A dark greyish brown sandy silt [103] represented the buried soil within Trench 1. This deposit was noted across the entirety of the trench and was c. 0.70m thick. It was encountered from a depth of 0.30m below ground level at 52.16m AOD (Figure 10: Section 1; Plate 1).

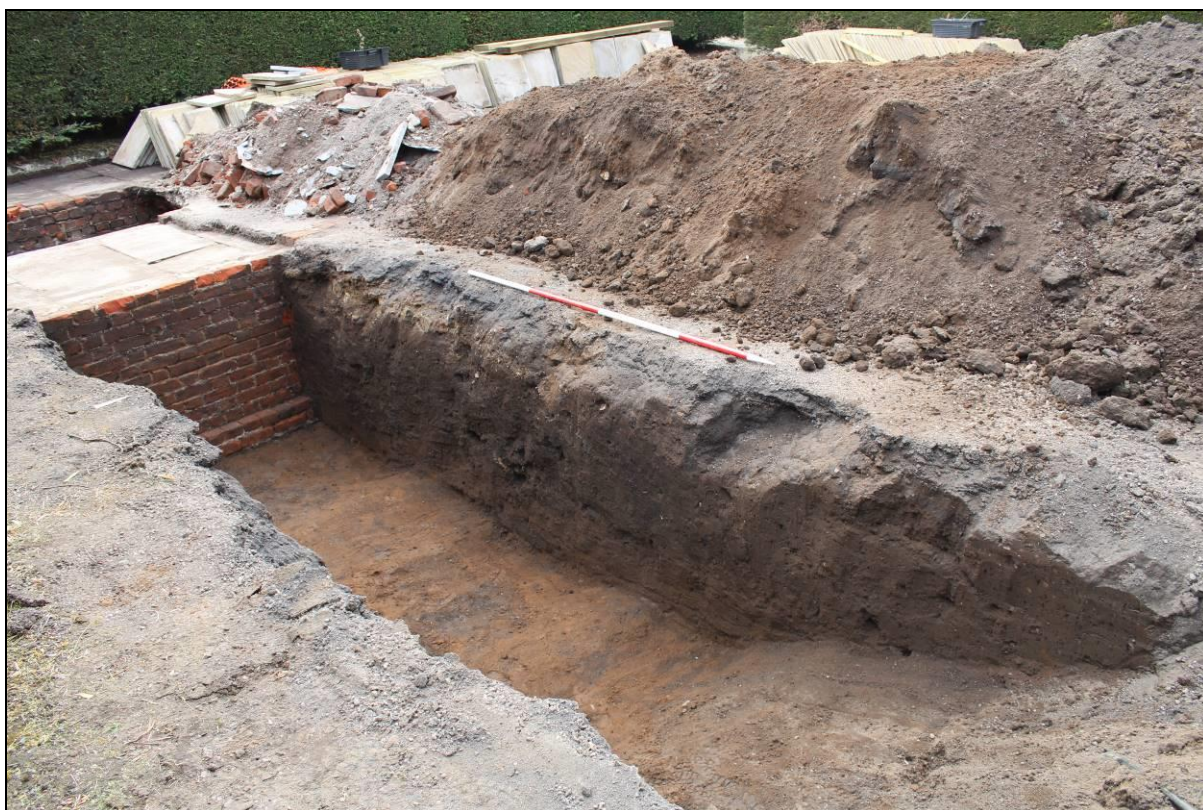
Plate 2: Trench 4 section: view southwest, 2m scale

- 5.2.4 Two buried soil deposits were noted within Trench 4. These comprised: dark greyish brown silty sand [416] c. 0.50m thick at 52.52m AOD and mid reddish-brown silty sand [415] c. 0.30m thick at 52.82m AOD (Figure 9: Section 2; Plate 2). In Trench 5 the buried soil comprised dark greyish brown sandy silt [501] c. 0.38m thick at 53.86m AOD (Figure 10: Section 3; Plate 3).

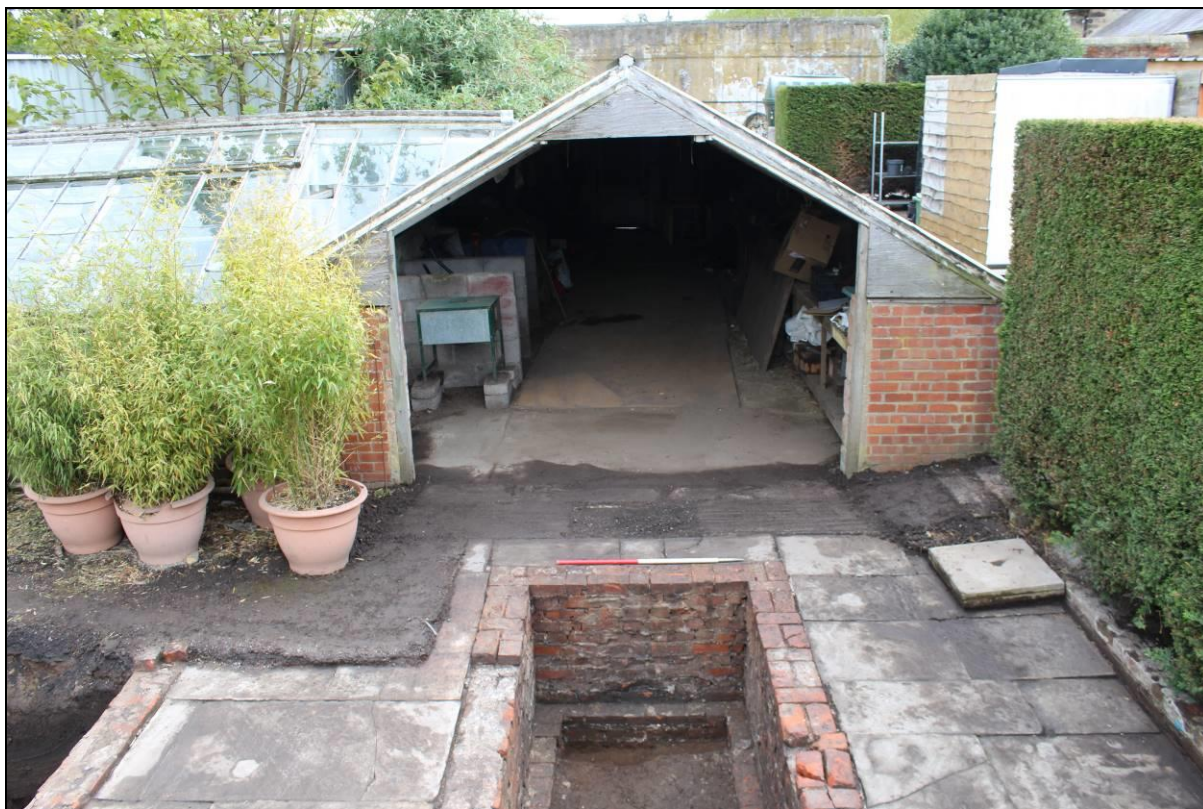
Plate 10: Below ground remains of northern propagating house with upstanding remains to the east: view east, 1m scale

- 6.1.2 Only the eastern half of the northern propagating house survives, c. 15m long (Plate 10). Externally the building comprises an ENE/WSW brick range with a mid-20th century NNE/SSW glasshouse extension. The glass roof of the propagating house has been replaced with corrugated metal sheeting (Plate 11) that has been attached to the original wrought iron roof structure and timber sash bars that may have supported the original glass panes that once covered the structure (Plate 12). At least 14 courses of a red common brick wall in Flemish bond survive along the southern elevation (the northern elevation comprises the greenhouse extension on the western side and is obscured by late 20th-century garden stores on the eastern side). Six original former apertures along the southern elevation comprise a sandstone sill and lintel; these have all been bricked-up during the mid to late 20th century (Plate 11 & 13).

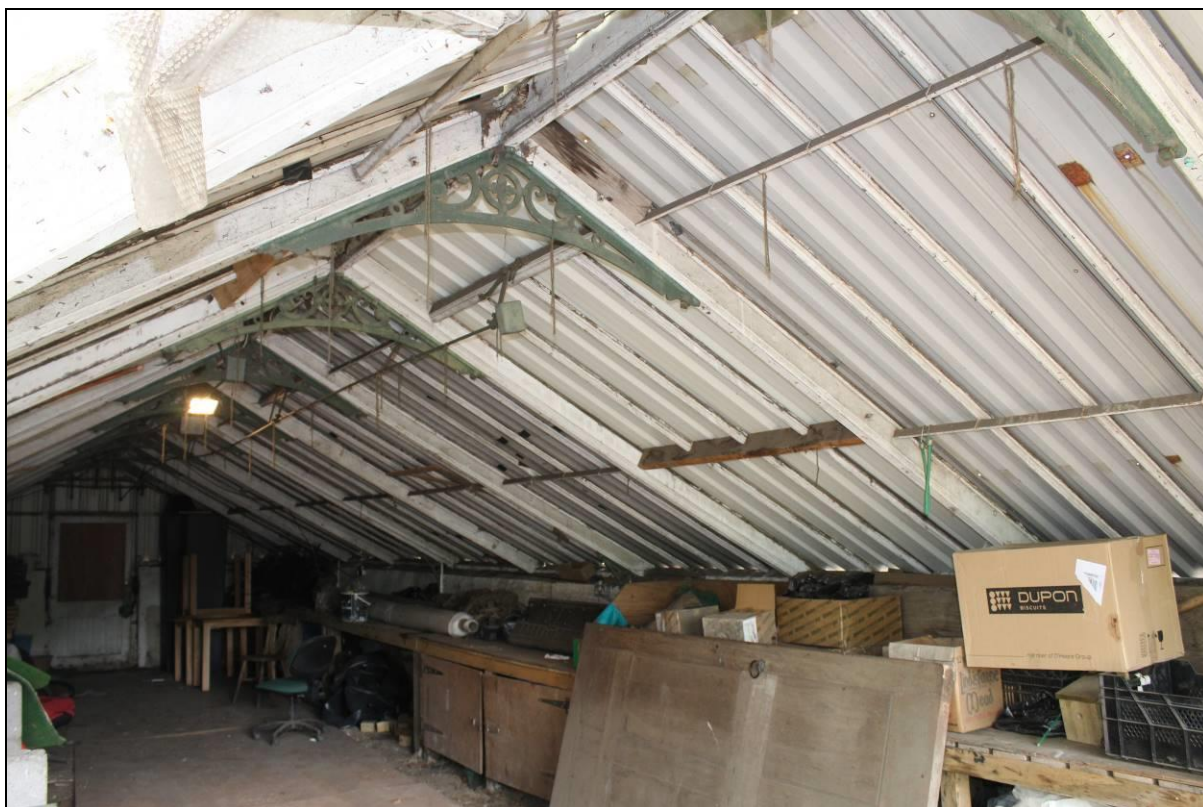
Plate 12: Original roof structure surviving under metal roof of northern propagating house: view southeast

- 6.1.5 Internally, the timber roof structure of the original propagating house survives comprising ridge beam, rafters, sash bars and purlins (Plate 12). Several of the original purlins have been replaced with modern timber. Decorative iron roof ties are present within the apex of the timber rafters (Plate 12 & 16). Sash bars also survive under the metal cladding on the eastern gable end of the structure along with parts of the mechanism for ventilating the propagating house (the control surviving adjacent to the eastern doorway; Plate 17).

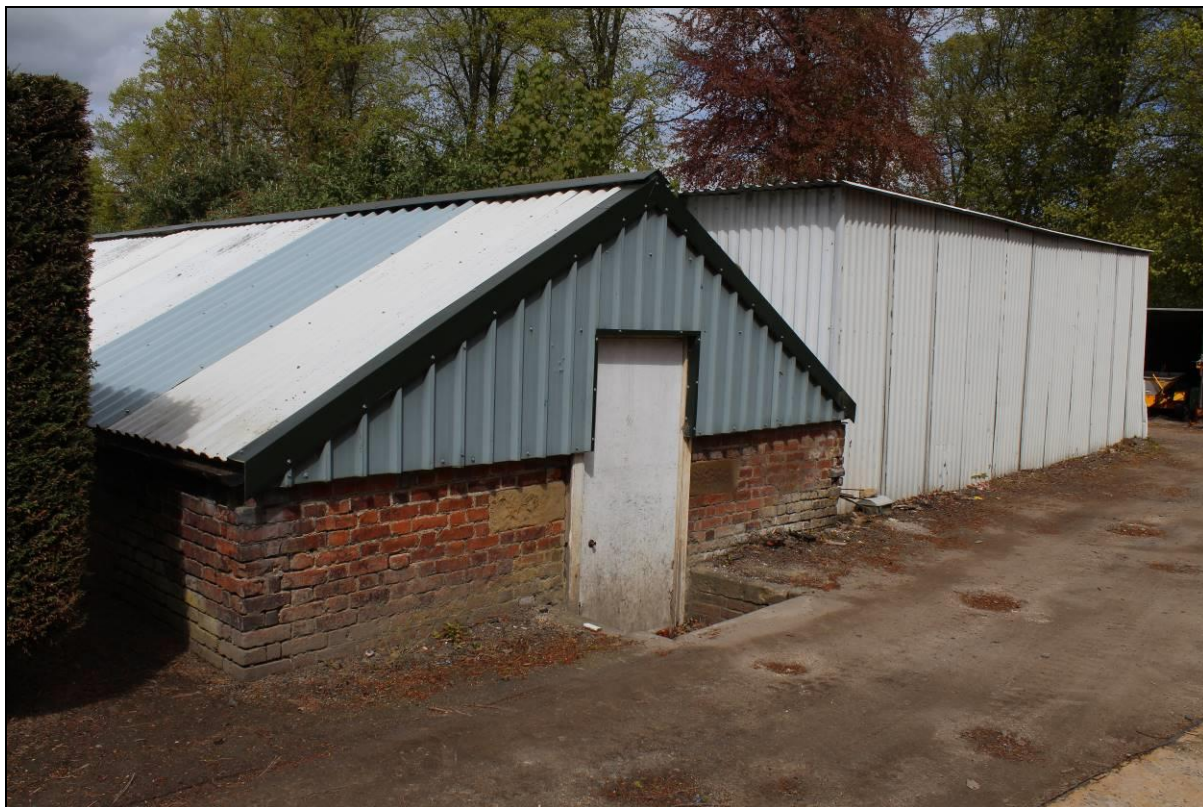
Plate 14: Eastern gable end of upstanding northern propagating house: view northwest

- 6.1.3 The eastern gable end comprises two sandstone lintels either side of a doorway at the base of a sunken stairway (Plate 14). Patches of decayed pointing are noted across the gable end as well as some damage to the northern corner with several loose bricks observed.

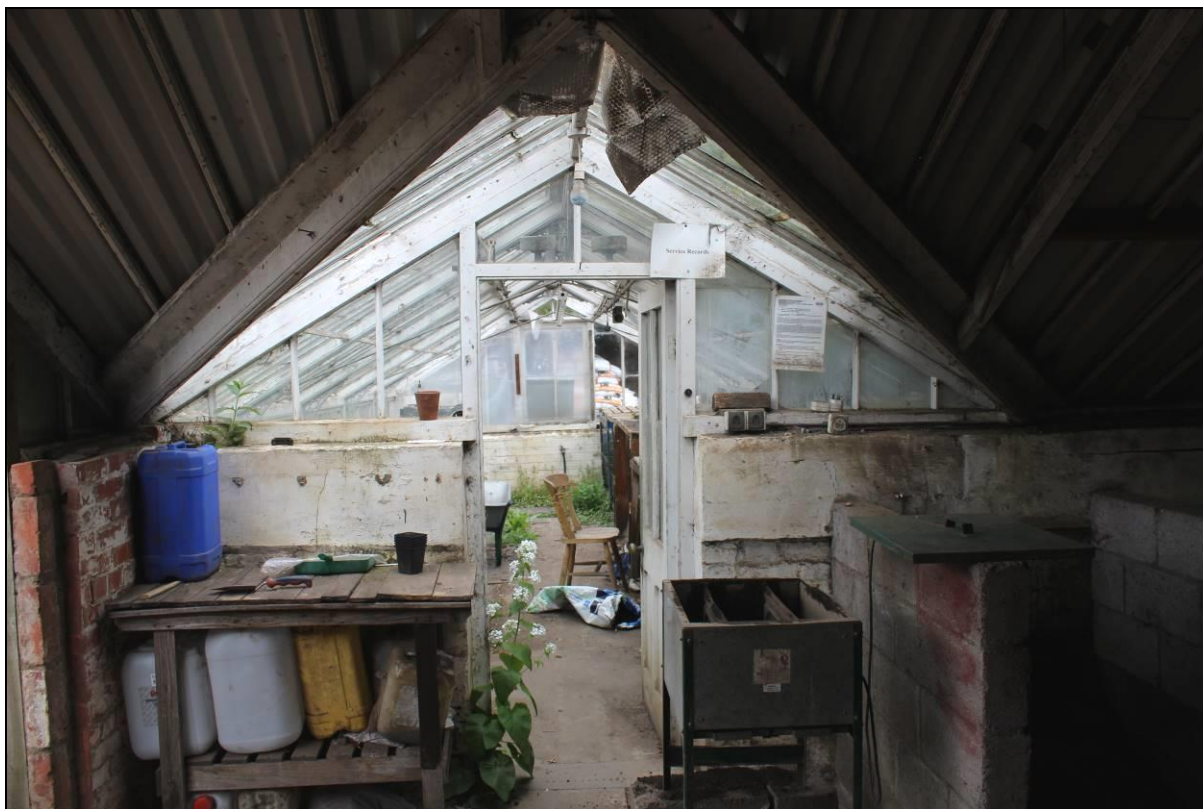
Plate 21: Northern extension to propagating house: view north

- 6.1.6 The northern glasshouse extension was constructed sometime in the late 1960s to early 1970s prior to the western range being demolished. Externally it comprises at least nine courses of buff brick bonded in English Garden Wall style with the mid-20th century glass house surviving above (Plate 18). The extension is nearly structurally complete with windowpanes surviving as well as ventilator at the apex of the roof (Plate 19), controlled by a mechanism housed internally. The brickwork is generally in good condition however a crack was noted within the brickwork on the northern gable end (Plate 20). Internally the ventilator mechanism can be seen along with decorative iron roof ties replicating those observed within the mid-19th century structure (Plate 21, 22 & 23).

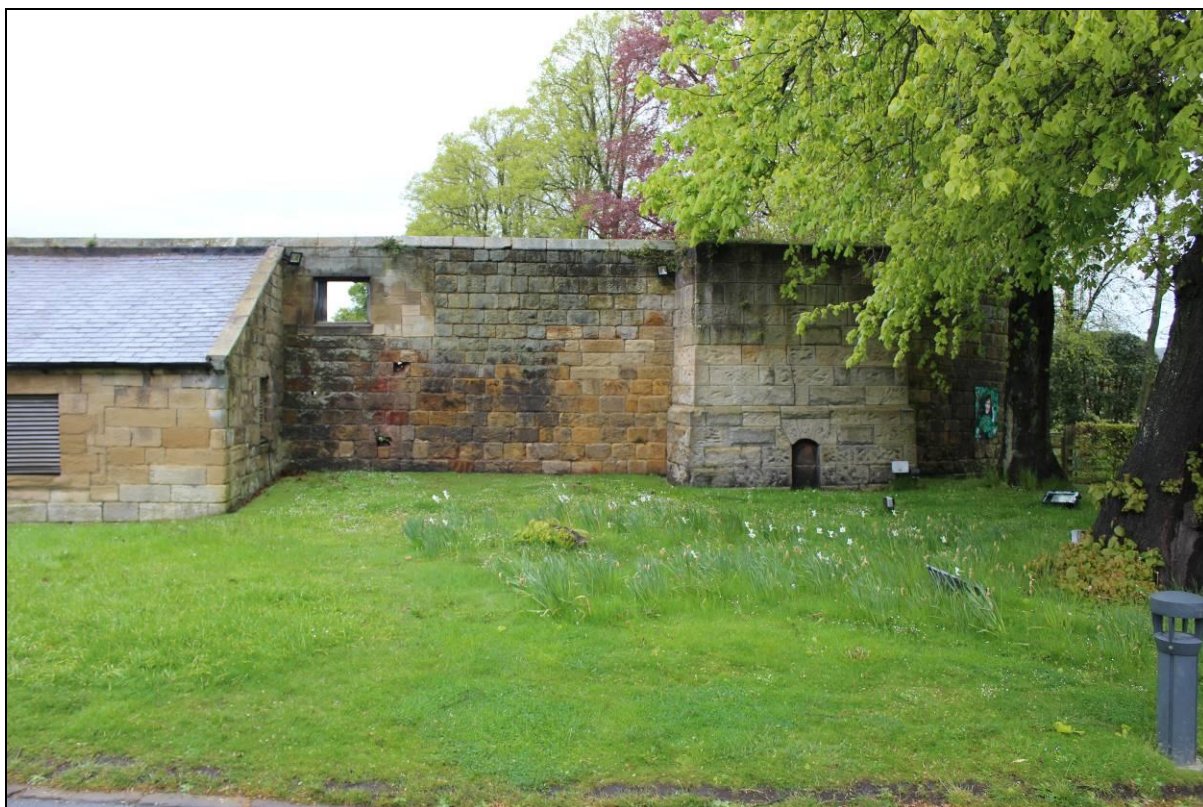
Plate 24: Steam plant building (right) straddling northeast corner of eastern boundary wall: view west

- 6.2.9 The eastern elevation (external to the walled kitchen garden) comprises 13 courses of squared sandstone with an opening at ground level (Plate 24). The opening is slightly recessed with a sandstone arch and lintel above. At the back of the recess, the sandstone appears to be heat affected. A crack was also observed running from the southern side of the arched recess that ran up the structure for approximately three courses (Plate 25). The western elevation of the structure could not be assessed due to the presence of late 20th-

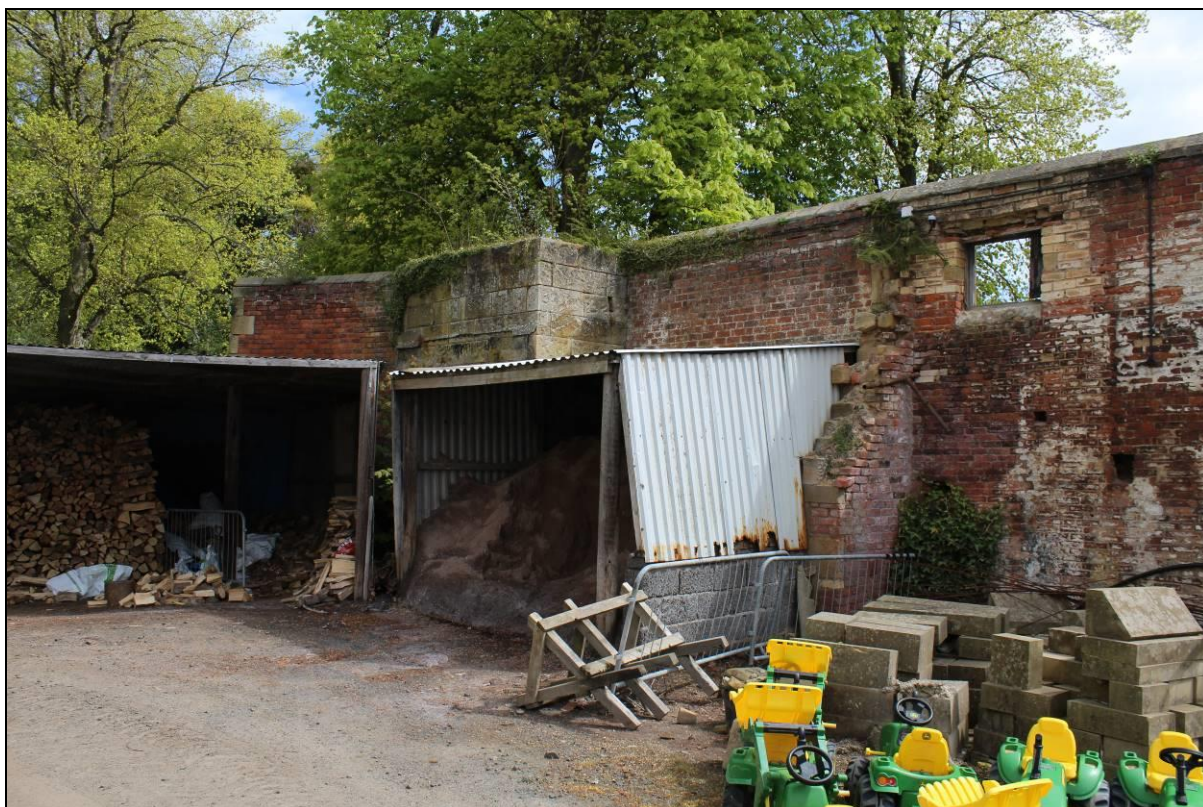
Plate 26: Steam plant building straddling northeast corner of eastern boundary wall: view northeast

century garden stores built adjacent to the former steam plant building (Plate 26). Overall the structure appears to be in good condition.

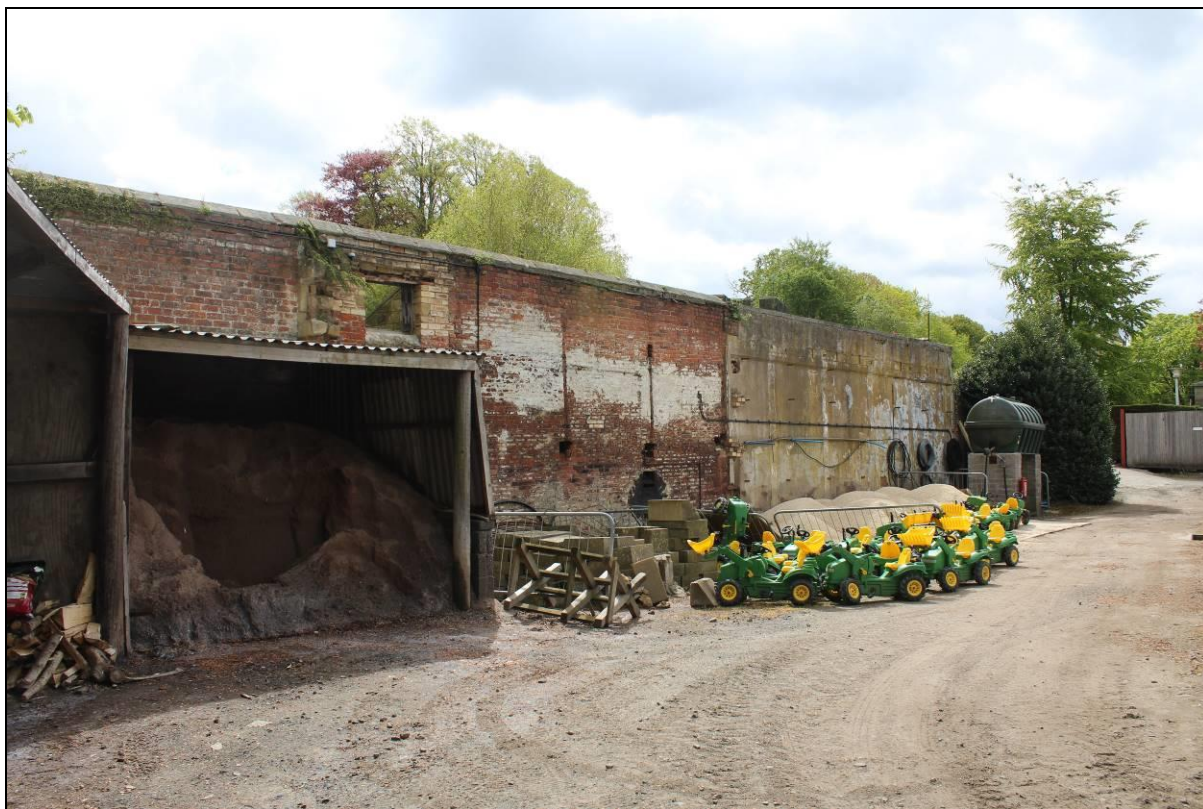
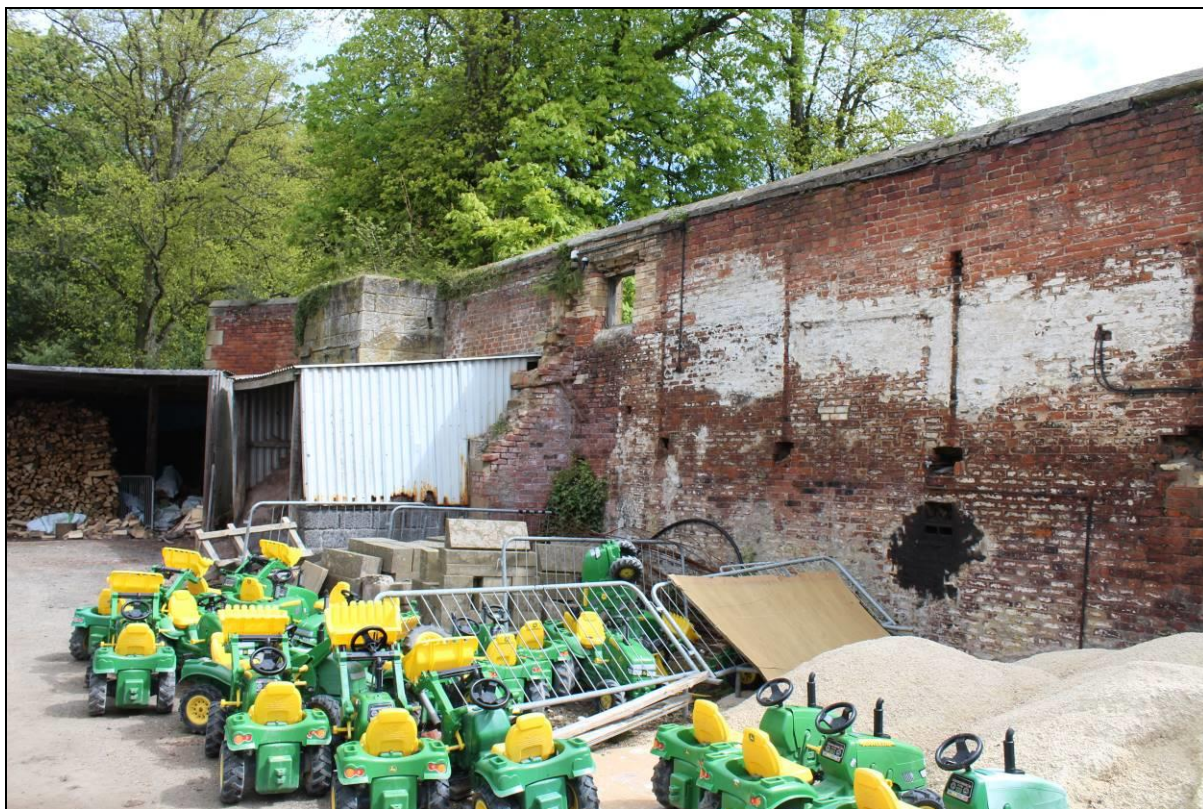
- 6.2.4 The western facing elevation of the boundary wall is brick built, the majority in stretcher bond although courses of headers are noted as well as several headers, half-bats and three-quarter bat bricks within the same courses as the stretchers (Plate 28 & 29).

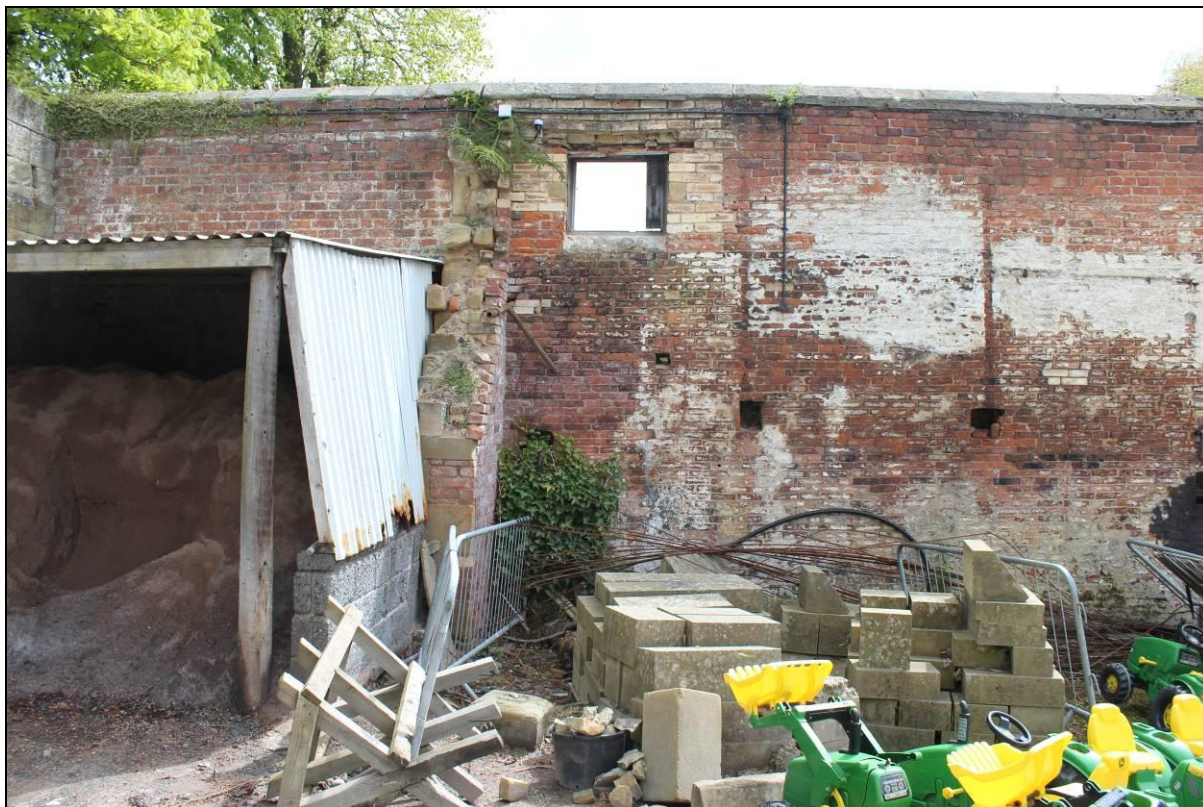
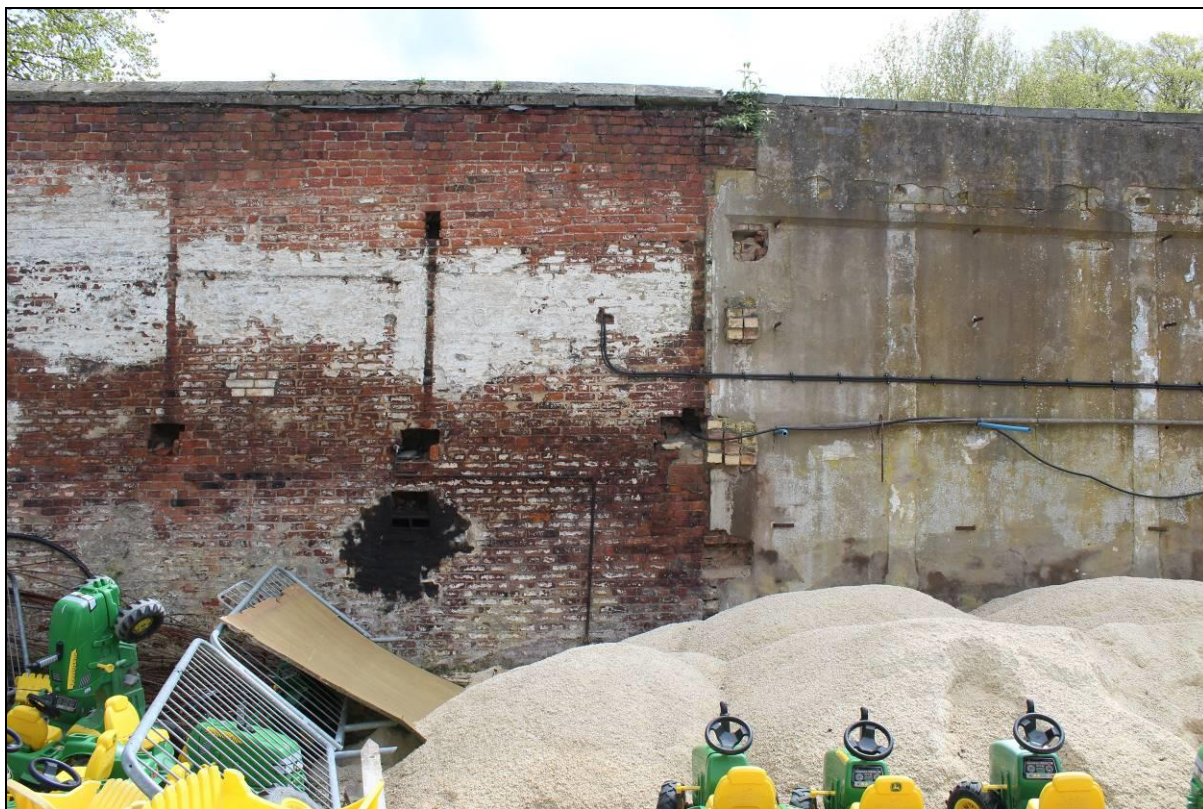
- 6.2.5 Slightly to the south of the north-eastern steam plant is a square timber framed gap near the top of the wall surrounded by firebricks (Plate 30). Numerous brick scars are noted along this section of wall running to the south along with sections protruding out westwards from the boundary wall (Plate 28, 29, 30 & 31). These are perhaps the remnants of the 10m x 8m structure first shown on the Ordnance Survey of 1897. Evidence for heating systems for a demolished vinery structure and glasshouse are also present within the wall with several voids for structural supports and cast-iron pipes noted (Plate 30 & 31).

- 6.2.7 The eastern elevation of the boundary wall is in excellent condition. The western elevation had been altered over the years with numerous historic structures being demolished. Electrical cables have been fed through the wall from the long rectangular lean-to structure on the eastern side as well as three plastic water pipes. Moreover, the southern section has been rendered in cement. It can therefore be considered that the western elevation of the boundary wall is in moderate condition.
