**189 WESTHALL ROAD,
WARLINGHAM CR6 9HL**

**AN ARCHAEOLOGICAL WATCHING
BRIEF**

SITE CODE: SWHR19

JULY 2019

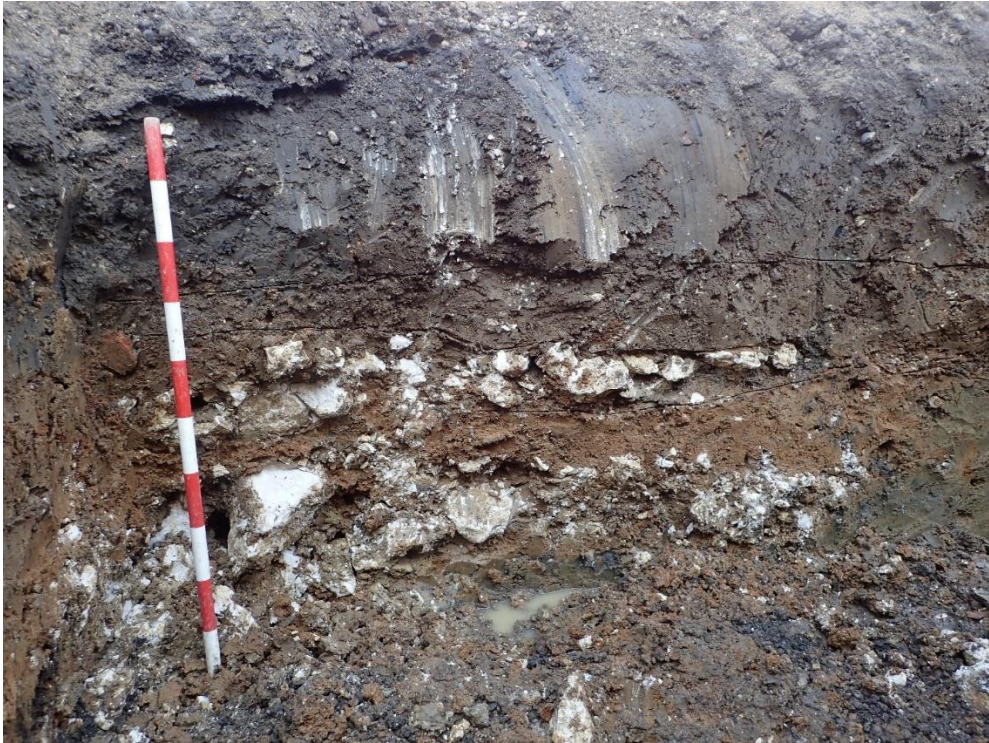
- 7.1.1 The natural bedrock of the Lewis Nodular Chalk Formation [9] was composed of off-white chalk, apparently broken and sandwiched between layers of bright orange silty clay [6, 10] (Figure 3, Plate 1). The chalk was recorded between 183.76m OD and 183.56m OD.

Plate 1: Section 2, view to south-west, scale 1m. Layers of degraded chalk [5,9] alternating with layers of orange clay [6, 10].

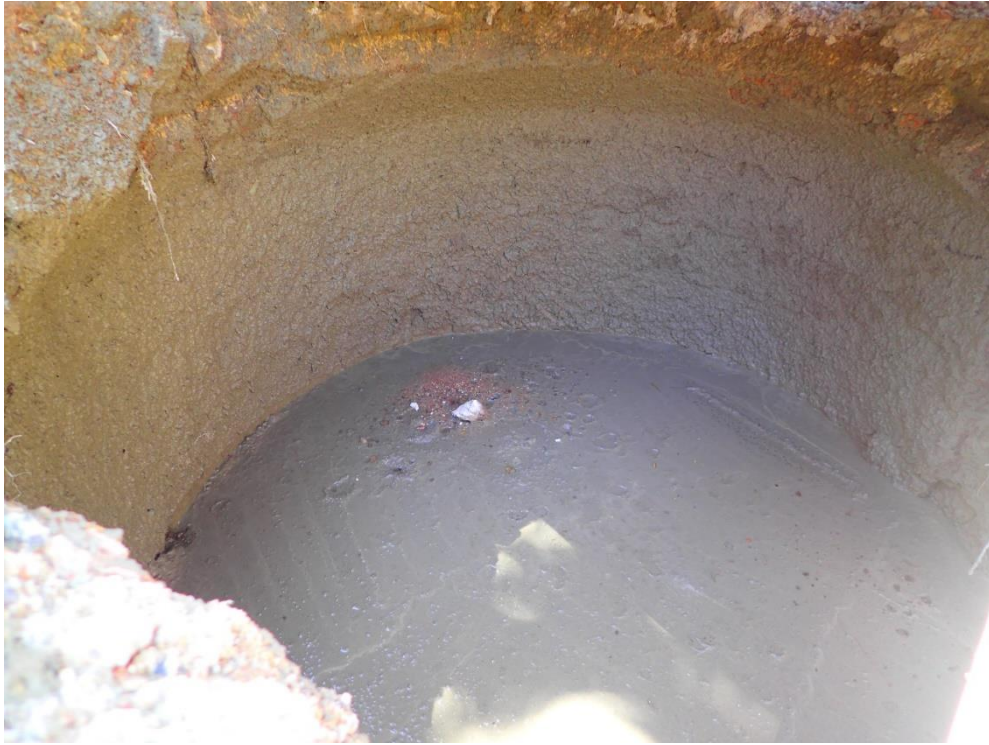
- 7.2.1 In the south-west corner of the foundation trench perimeter a brick-built cistern was exposed which still held water. It was discovered about a metre below the current ground level. Due to the presence of water and unstable ground it was unsafe to try and retrieve a brick sample or to record the cistern in any detail. However, the bricks did not appear to be modern and were unfroged (Plate 2). This suggested that the structure pre-dated the 20th century garage and may have been associated with the three houses and gardens that are depicted on the late 19th century maps (Hudson 2018:12).

Plate 2, view to south-west, no scale but c.2m in diameter: brick-built cistern [11]

- 8.4 A brick-built cistern [11] was discovered in the south-west corner of the development footprint; it still held water but had partially collapsed. It was not possible to retrieve a brick sample although they appeared to be un-frogged. It was clear that the structure pre-dated the 20th century garage and so therefore may have been associated with the three houses and gardens that are depicted on the late 19th century maps (Hudson 2018:12).

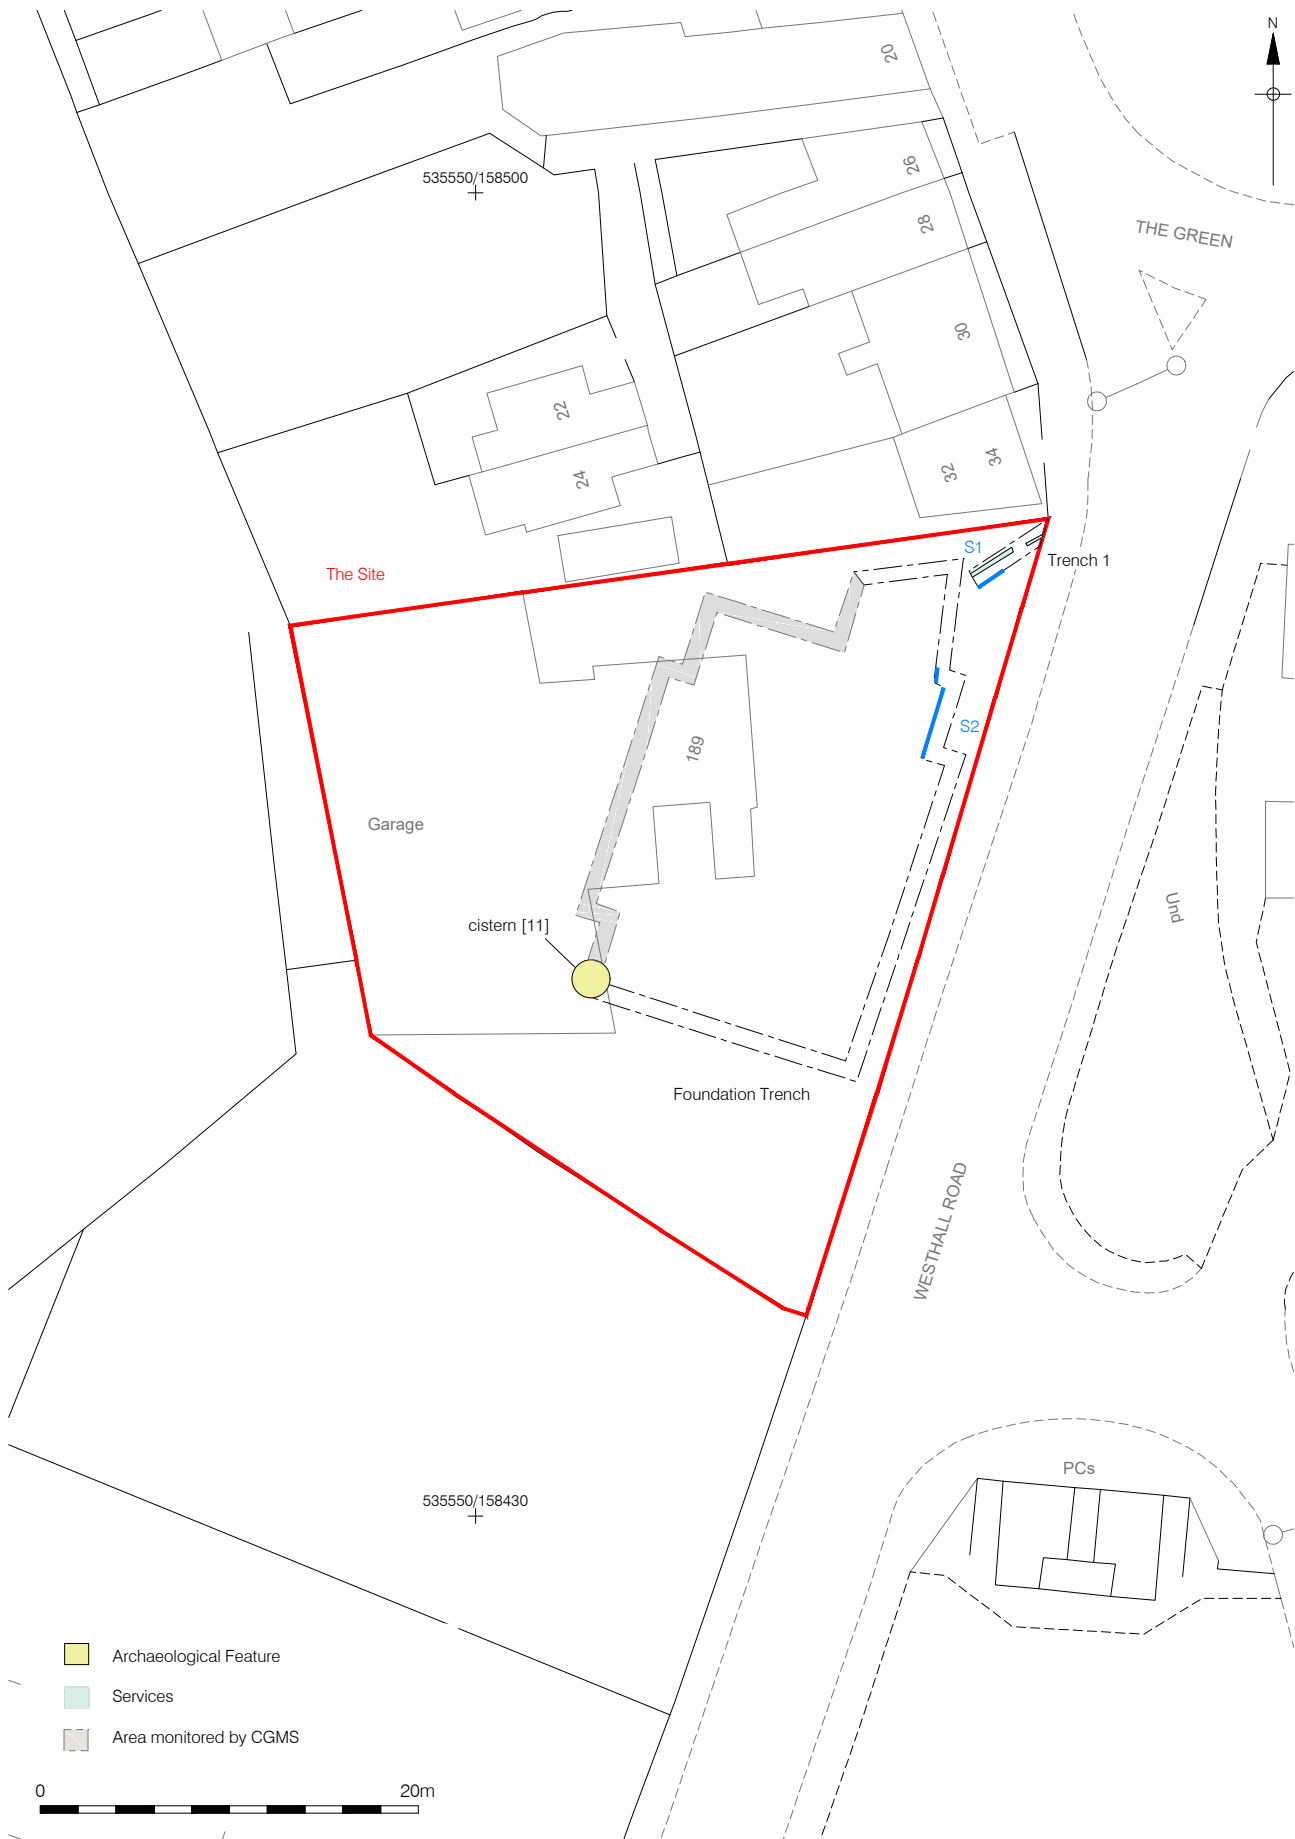
- 7.2.2 In Section 2 a series of made ground layers [3-5] were revealed which appeared to be sealing a large, sub-oval pit [8] whose fill [7] was a dark-greenish colour. The pit measured 2.70m by 0.61m, and was 0.44m deep. Although the trench was too deep to investigate the feature in detail it seemed to pre-date the later made ground layers. It is possible to envisage the pit having been used for the extraction of chalk and then later it was deliberately in-filled or used for cess (Figures 2& 3, and Plate 2).
