**767 – 785 COMMERCIAL ROAD,  
LIMEHOUSE,  
LONDON,  
E14 7HA**

**AN ARCHAEOLOGICAL  
EVALUATION**

**SITE CODE: CMI19**

**JULY 2019**

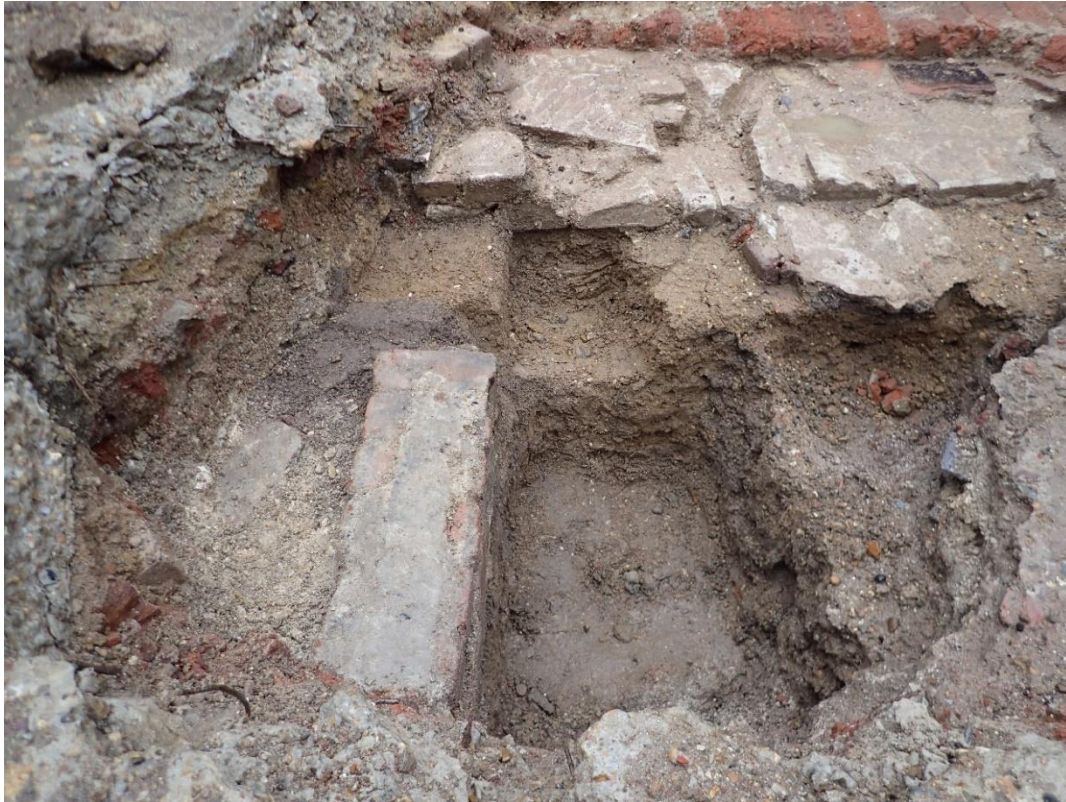
Plate 1: Trench 1, looking west, wall [33] cut into natural gravel [40], truncated by service cut [73] into which was built wall [47]

8.3.1 Within Trench 1, construction cut [40] was seen to cut the natural gravel [72] along the western edge of the trench. Within this cut were white stone walls [33] and [41] (Plate 3), these abutted each other forming a T shape, and were most likely the remnants of an earlier foundation surviving to a height of between 6.88m and 7.01m OD the stone and mortar being dated 1825-1950.

8.3.4 Stone wall foundation [41] was truncated to the east by [73] (Plate 1), a vertical sided cut which continued beyond the northern, southern and eastern LOEs. This cut contained a concrete deposit [74] at a height of 6.31m OD, which was most likely encasing a service. This was backfilled by a soft grey brown silty sand [46] with inclusions of clay tobacco pipe (CTP) and pottery dated 1830-1900.

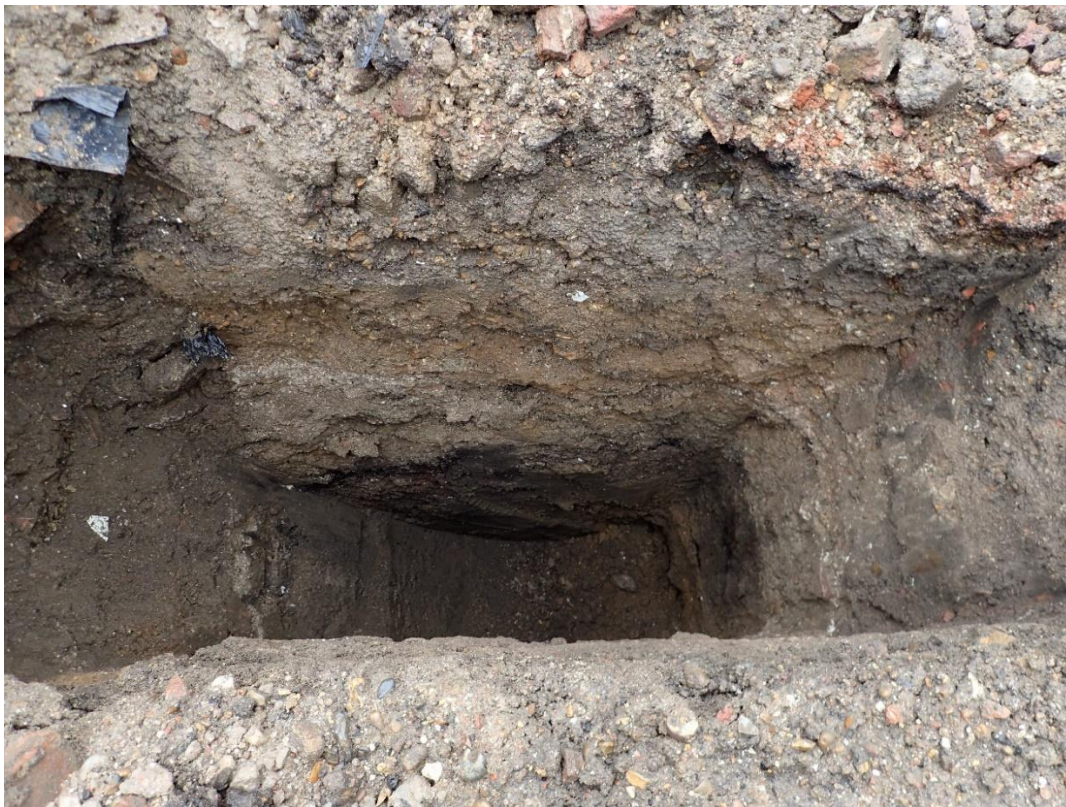
Plate 2: Trench 2, looking west, layers [105], [106], [107], [108] and [109] within southern sondage.

- 8.2.1 Within Trench 2 the natural gravels [111] seen within the southern sondage were overlain by several layers of made ground. These consisted of a layer of firm mid brown sandy silt [109], a 0.22m thick layer of loose black sandy silt [108], a layer of friable yellow white sandy mortar, a layer of soft orange sand [106] and a layer of firm mid brown sandy silt [105] (

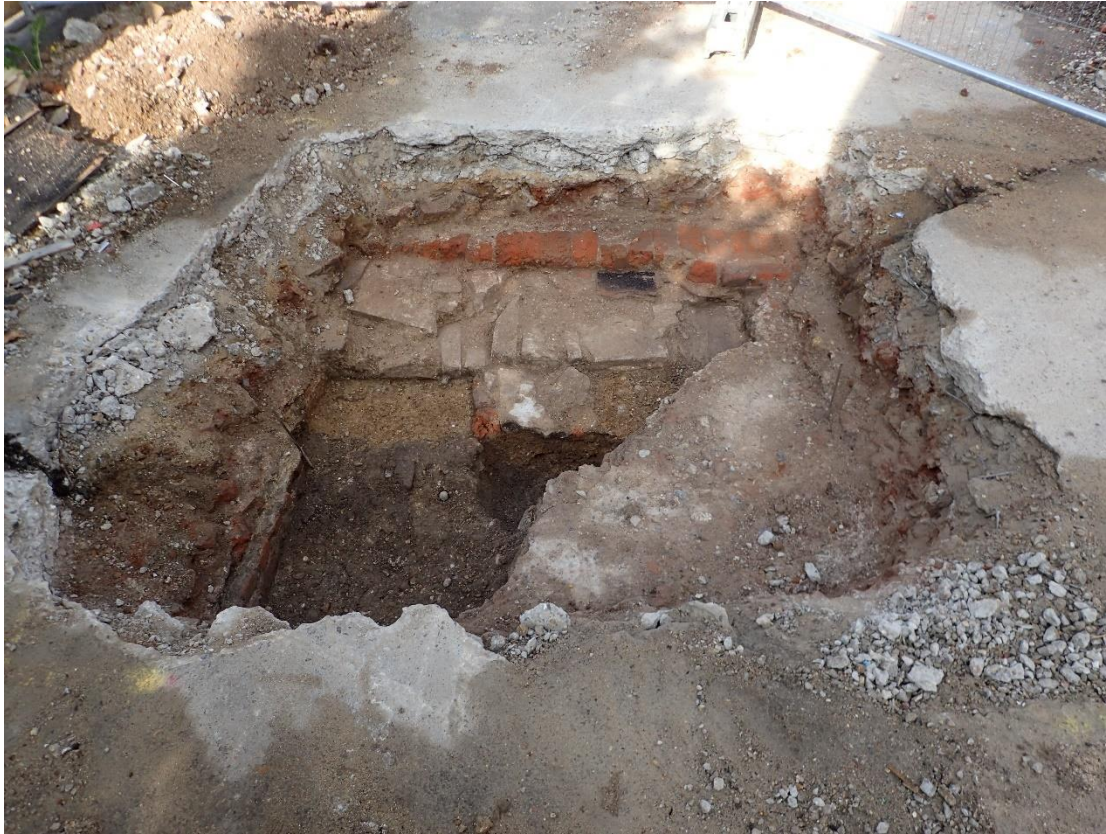
Plate 3: Trench 1, looking south, walls [31], [33] and [41]

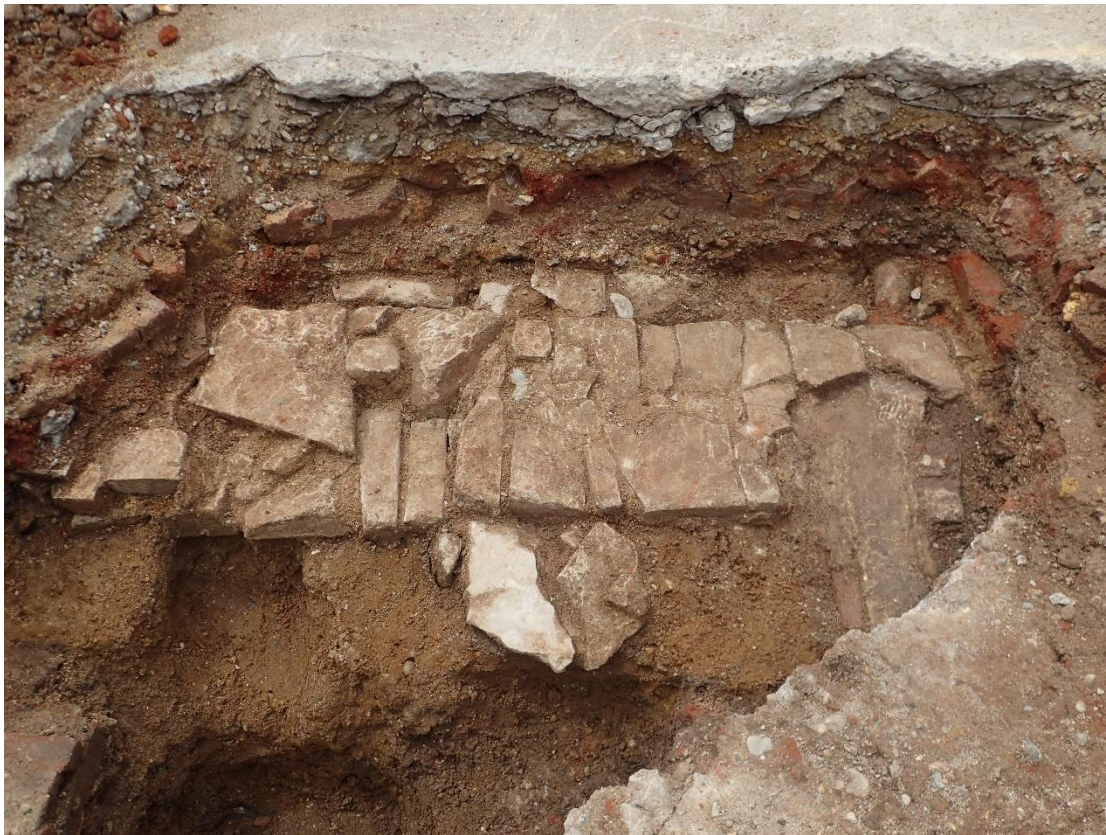
Plate 4: Trench 1, looking west, walls [31] and [68]

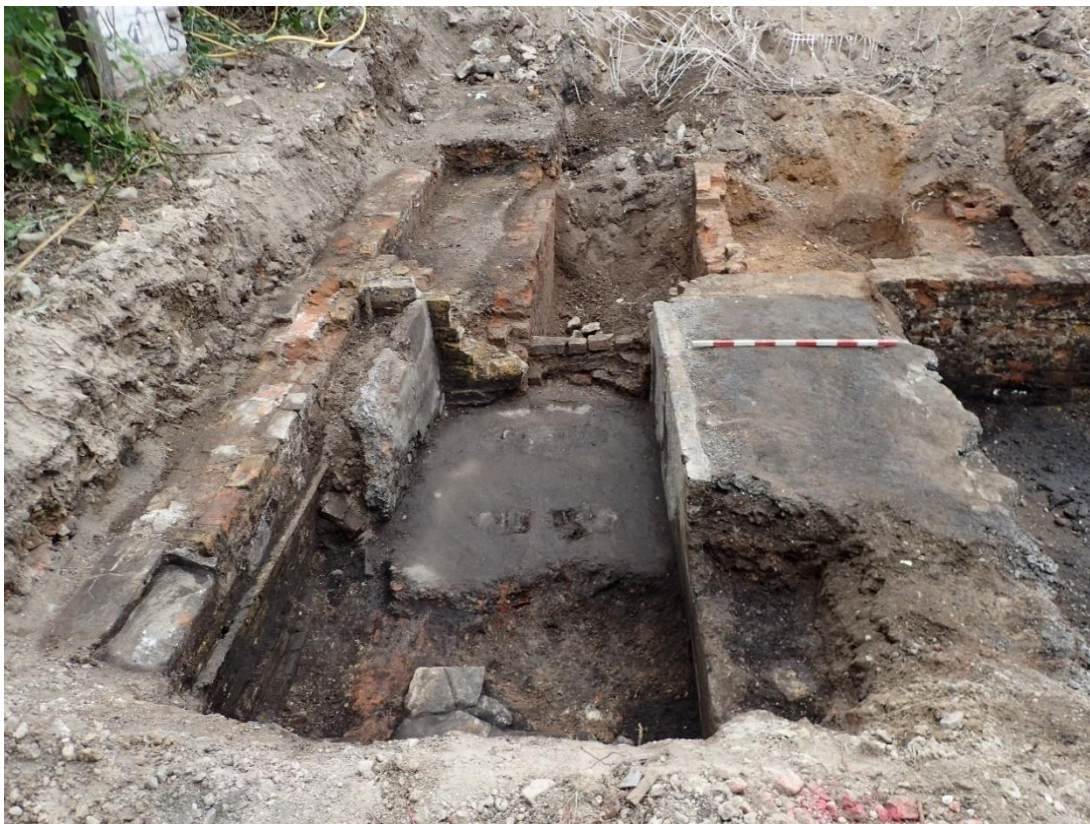
Plate 6: Trench 2, looking south, north-south brick walls [3], [2] and [1] (from left to right), cast concrete walls [8] and [10] and floors [7] and [9] in the foreground.

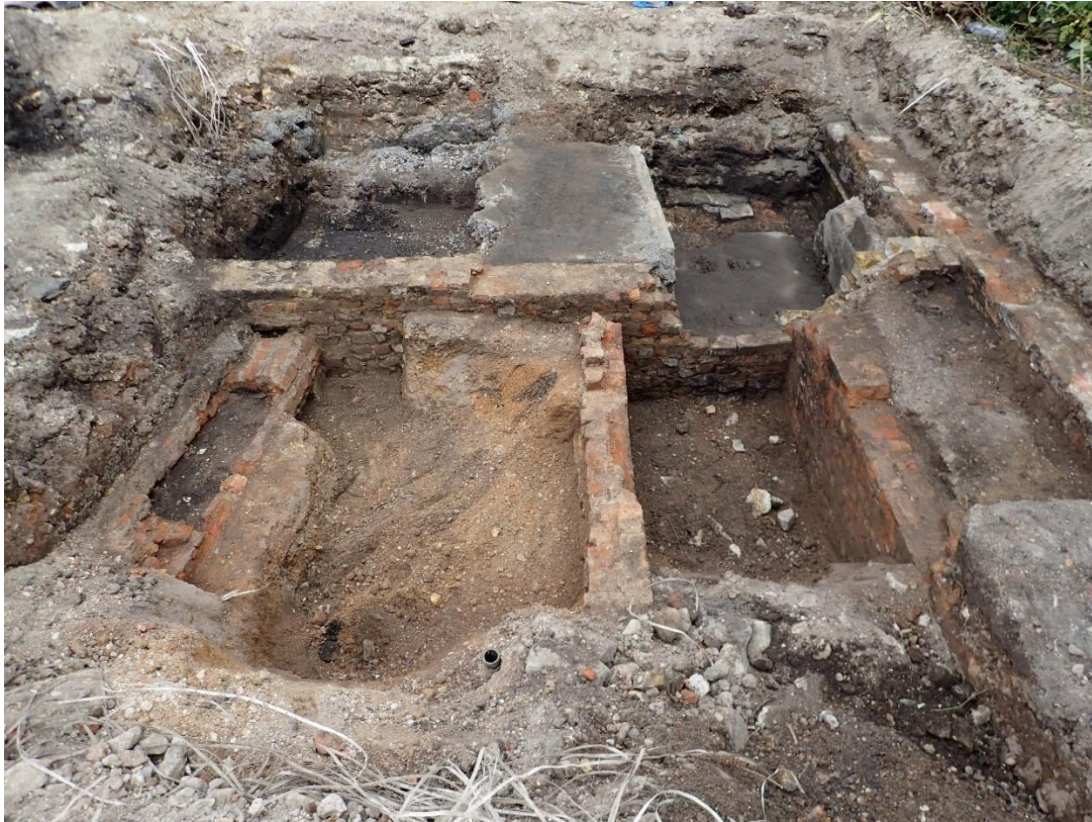
Plate 7: Trench 2, looking north, from left to right drain [63], walls [1] and [2] cut by east-west wall [5].

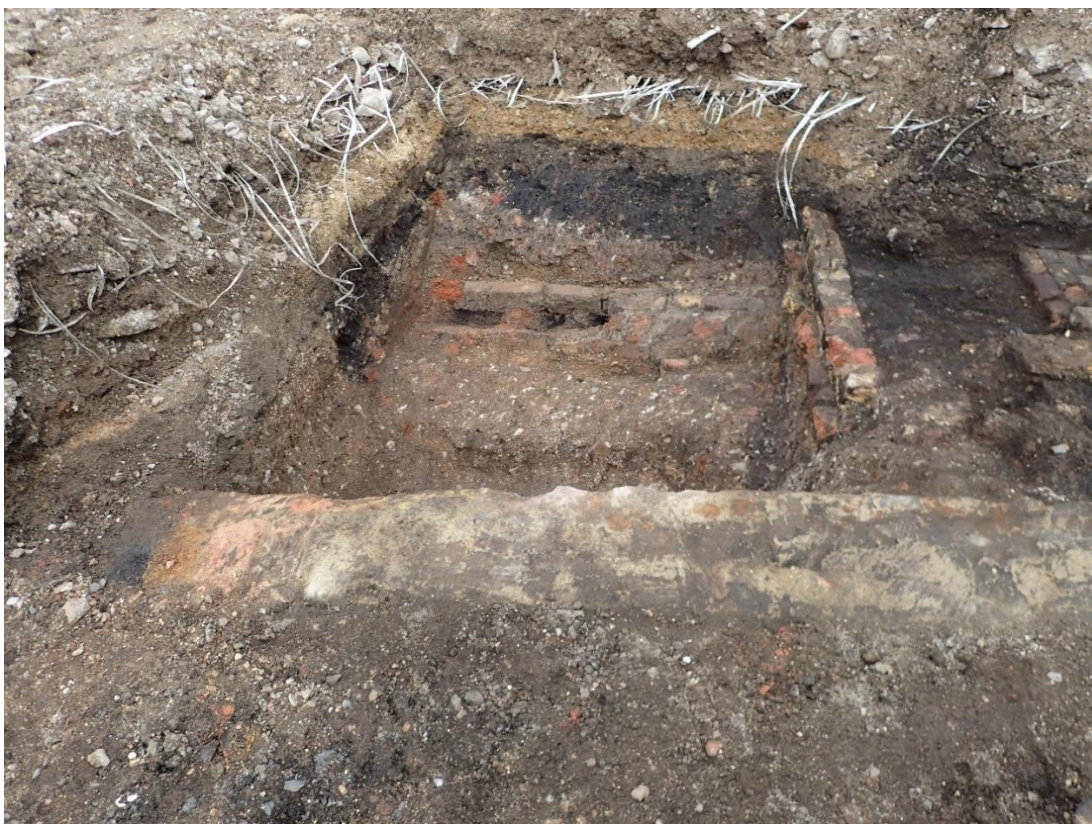
Plate 8: Trench 2, looking east, southern extent of drain [63] with east-west wall [79] and wall [76] in the foreground.

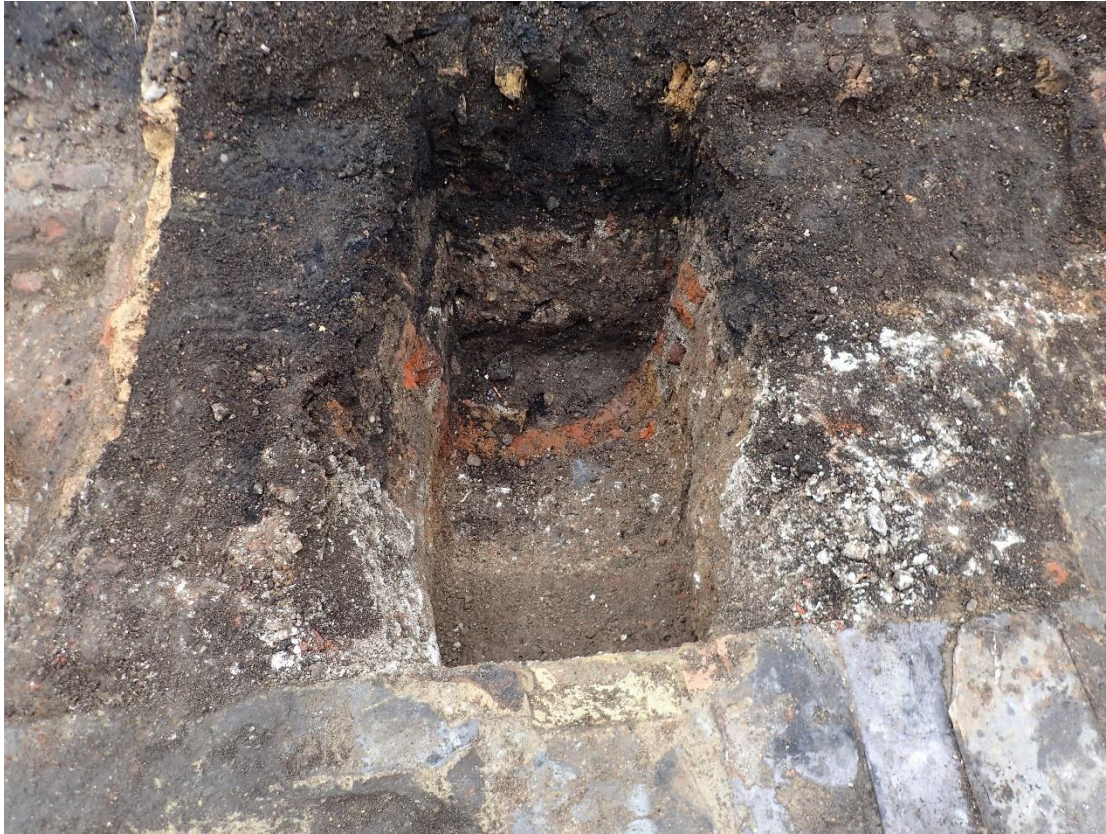
Plate 9: Trench 2, looking east, soak away [96] and construction cut [77] within eastern sondage

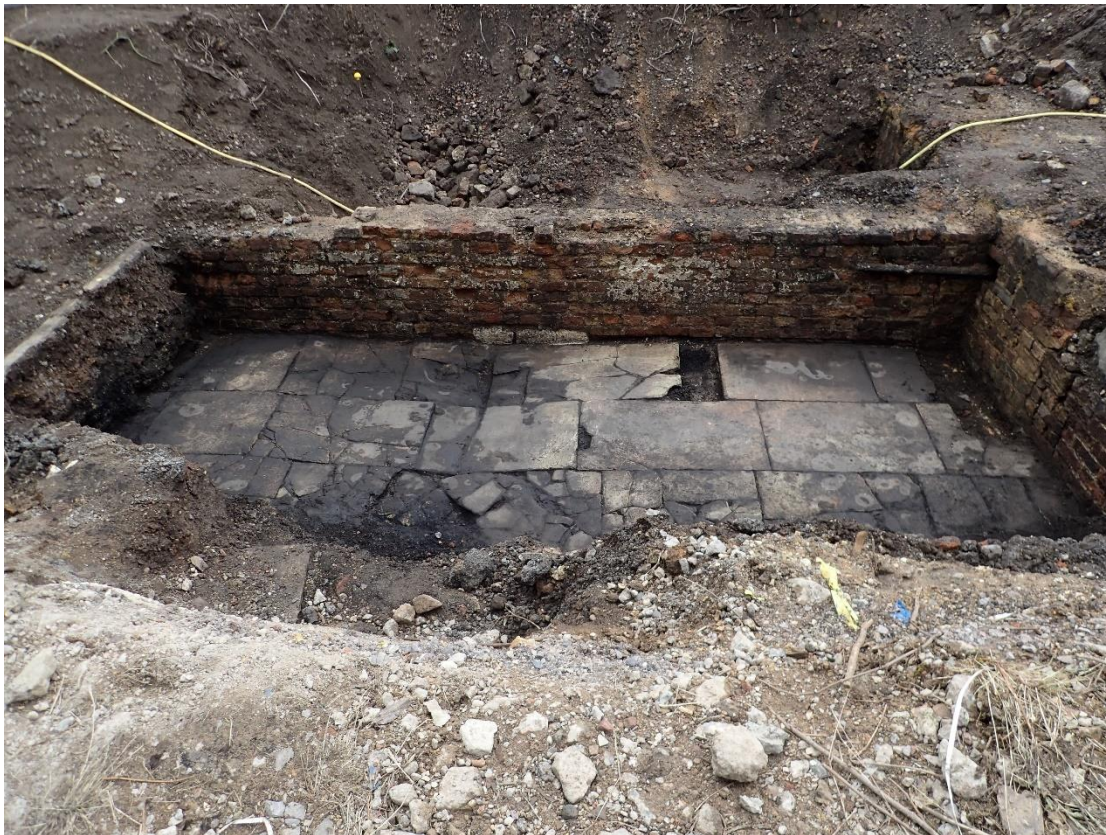
Plate 10: Trench 2, looking south, stone floor surface [48] with brick wall [5] in the background

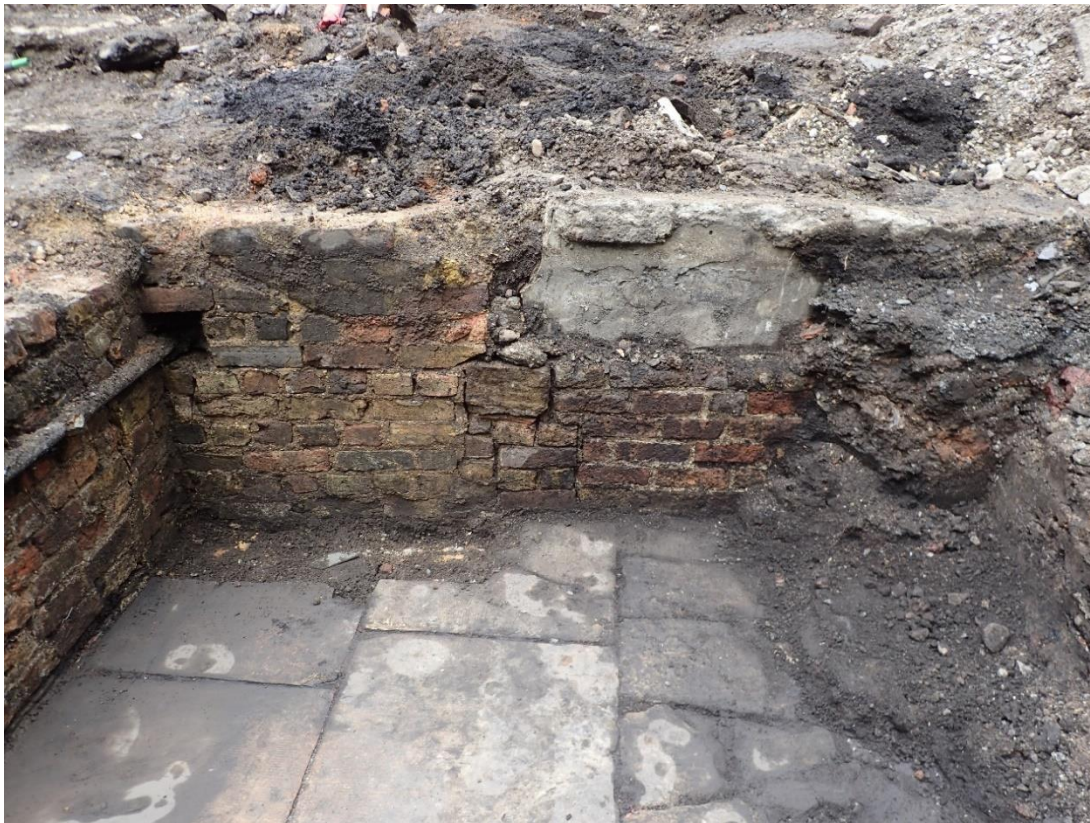
Plate 11: Trench 2, looking west, wall rebuilds and repairs [49], [51], [53] and [55]

- 8.3.23 To the north of wall [49] there appeared to have been a number of changes (Plate 11). A section of wall [51] was constructed from red brick (dated 1892-1940) and continued beyond the northern LOE. Between wall [49] and [51] an area of masonry appears to have been truncated [52] with a repair of red brick and stone [53]. Truncating the tops of both [51] and [53] a rectangular cut [54] contained a cast concrete repair [55].

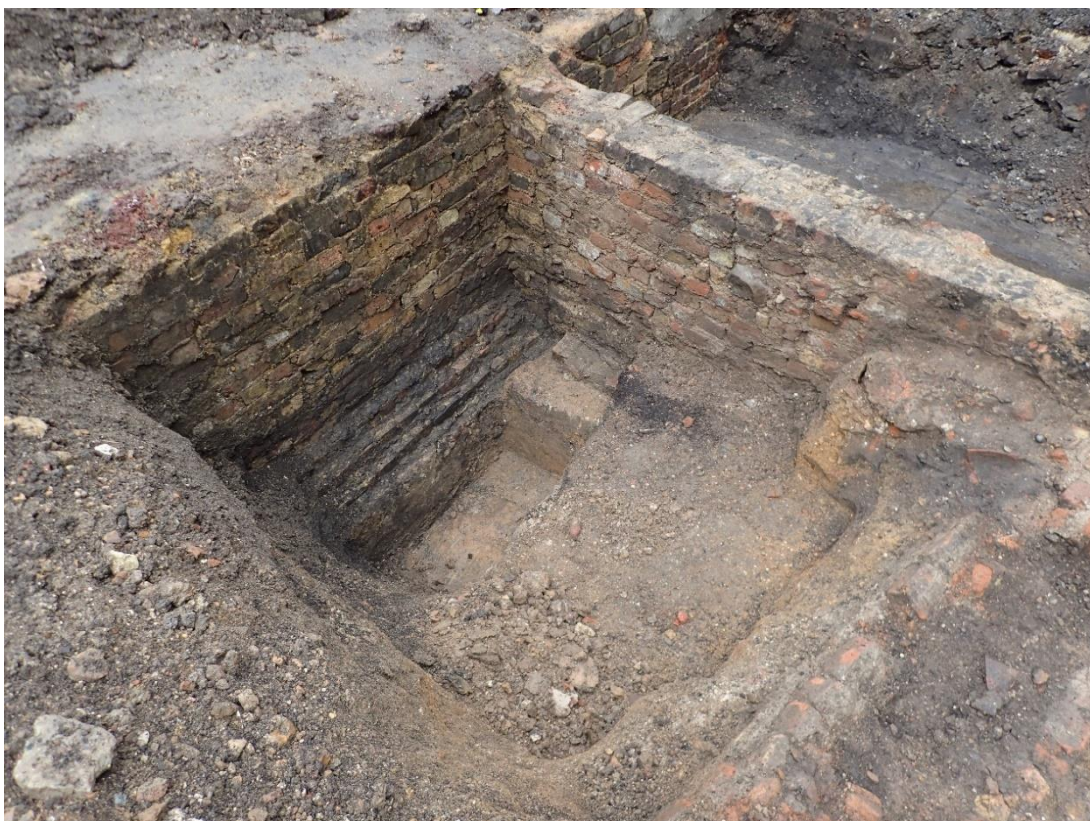
Plate 12: Trench 2, looking northwest, wall [5] cut by construction cut [57] for concrete foundation [65] and brick wall [49]

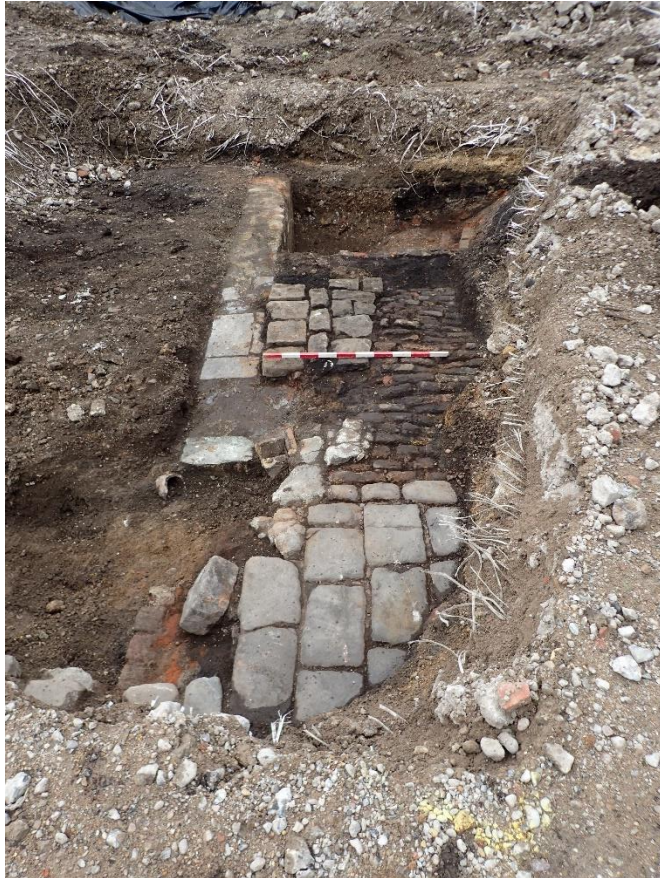
Plate 13: Trench 2, looking north, surfaces [80] and [88]

- 8.3.36 Layer [86] and [88] appeared very similar, although it was not possible to establish if they were the same layer due to limitations on excavation within this area. These two deposits form bedding layers for a brick and stone set surface across the south-eastern part of Trench 2. Overlaying the eastern extent of layer [86] was a red and yellow brick surface [81], and overlaying layer [88] was a stone set surface [82]. A further area of stone sets [80] was seen to seal the backfill [85] of construction cut [77] which cuts the bedding layer, suggesting that this was a later repair. A date of 1800-1900 was obtained for brick floor [81], although it is impossible to determine if this is due to the use of reused bricks, or if this is an earlier yard surface reused as an internal floor surface for the structure seen on historic maps from 1870 until 1830. The presence of several different materials within this surface would support this being a frequently repaired and long lived surface.

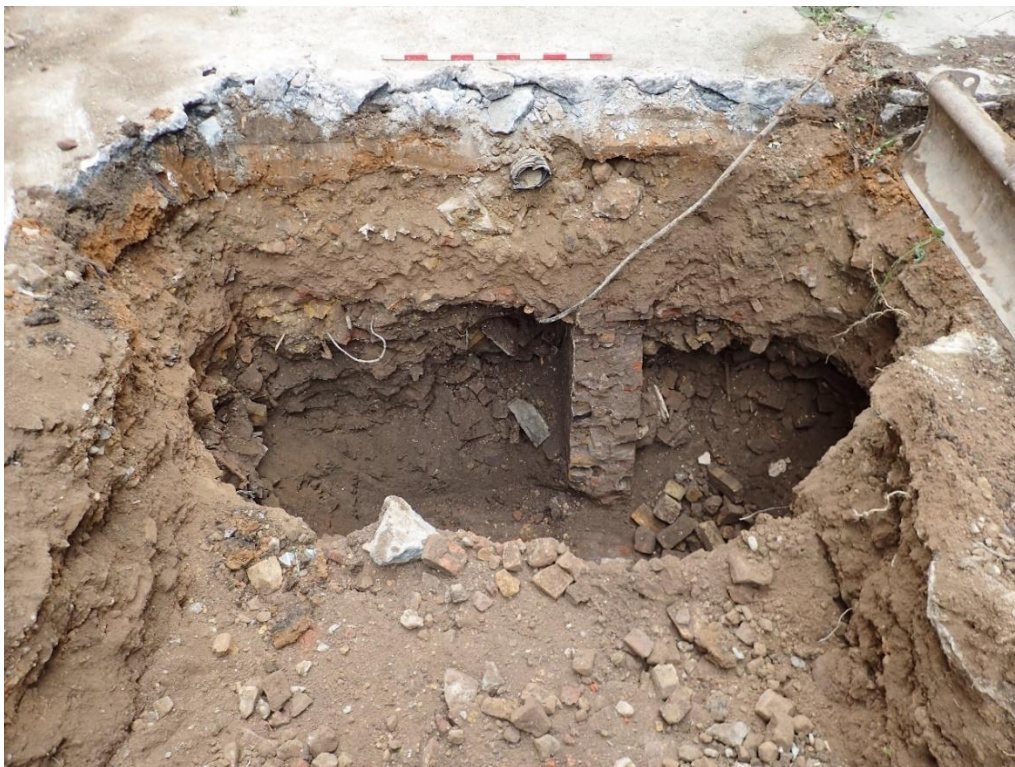
Plate 14: Trench 3, looking south, basement wall [102] with backfill deposit [100] and [101] overlain by layer [99]

- 8.3.38 A north-south wall [102] (Plate 14) was seen within the southwest of Trench 3, surviving to a height of 5.68m OD there was evidence of white paint on the eastern facing side of this wall. Historic maps show a wall within the location of this wall from 1870 until 1951, with bomb damage maps showing this part of the site to have suffered from blast damage during the war.

8.4.2 Backfilling the space to the east and west of wall [102] was a loose rubble fill with yellow brown silty sand [100] and [101] (Plate 14). The only find from this trench was from the deposit to the east [100] and it was an iron draw with copper-alloy components most likely from a filing cabinet.

8.4.3 Sealing the backfill deposits was a layer of compacted mid yellow grey brick rubble and silty sand [99] (Plate 14). This layer was seen to a height of 6.14m OD across the entire trench.
