**HAM HOUSE, HAM STREET,
RICHMOND UPON THAMES, TW10
7RS
AN ARCHAEOLOGICAL WATCHING
BRIEF**

SITE CODE: PIG19

JULY 2019

**AN ARCHAEOLOGICAL WATCHING BRIEF OVER AN I.T. CABLE
TRENCH ON THE WEST SIDE OF THE WESTERN FORECOURT**

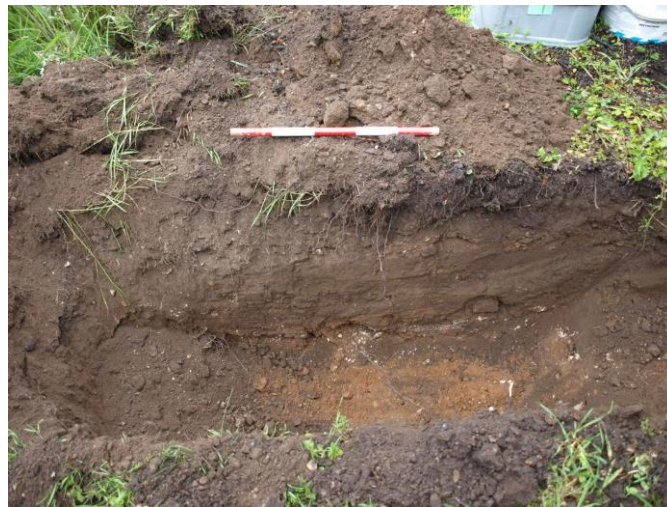
7.1.1 The earliest deposits encountered were layers [4] and [8] seen within Inspection Chambers 1 and 2 (Sections 1 and 3) at 0.75m and 0.50m BGL respectively. These consisted of either a light orange brown or a light grey brown soil made up of a slightly silty fine sand. Within both the only inclusions seen were small red and black flecking likely placed there through an action of bioturbation such as worm action.

Plate 1. West facing section (Section 1 Figure 3) within inspection chamber 1 (0.50m scale)

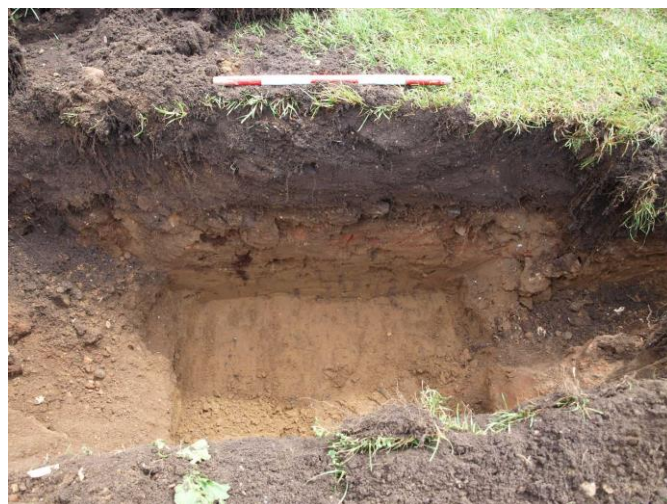
Plate 2. West facing section (Section 3 Figure 5) within Inspection Chamber 2 (0.50m scale)

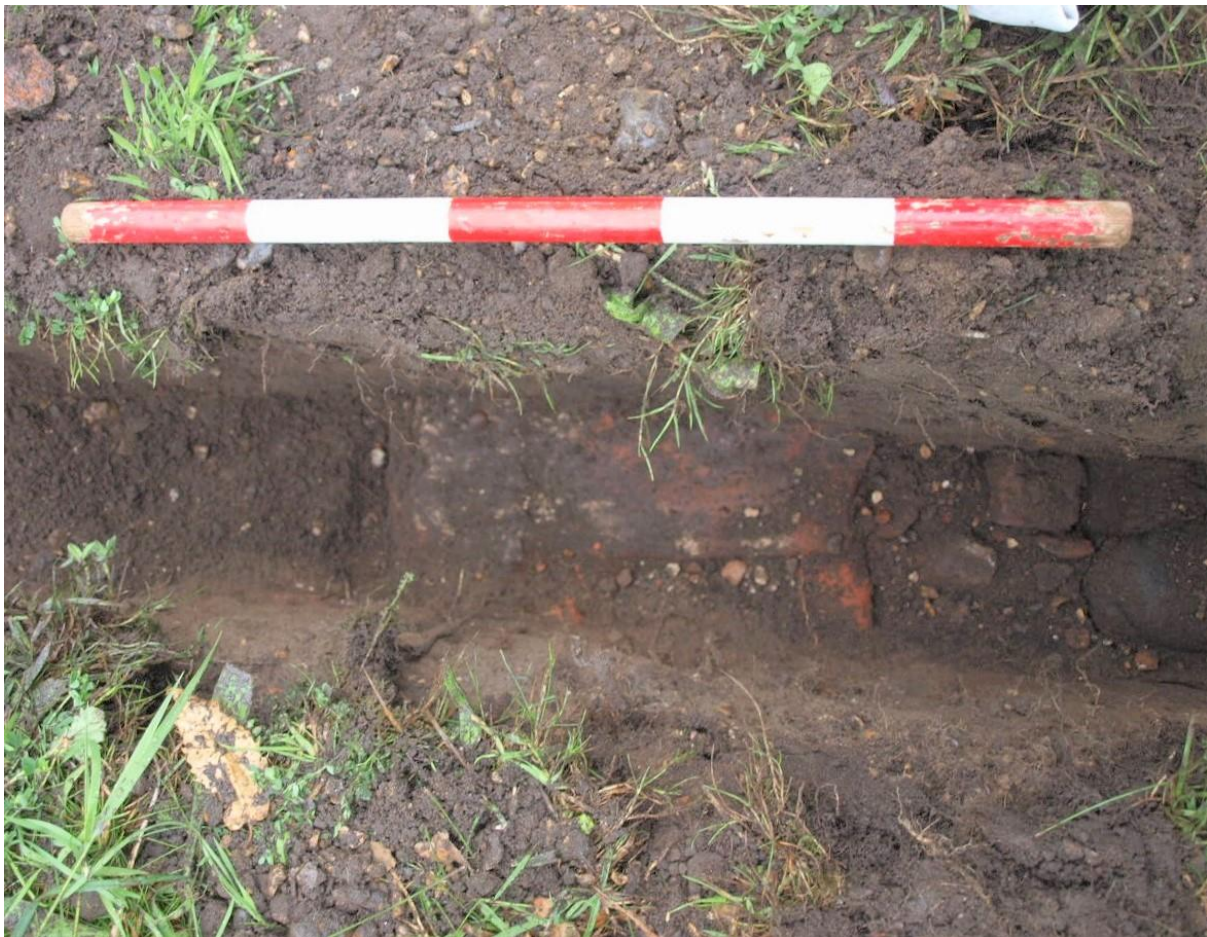
- 7.2.1 An east-west running wall [5] was encountered just below the dig depth for the ducting located just north of Inspection Chamber 1 (Figure 3). What was visible in plan comprised three red unfrogged red bricks (Plate 3) laid in 9 inch bond measuring 250mm long by 120mm wide with an unknown thickness. The bricks were located at 0.40m BGL and ran east-west. The mortar used was a hard yellow lime based mortar with small charcoal inclusions.

- 7.2.2 It was possible that wall [5] was related to the currently standing north-south wall to the east of the works trench, however, no scar was visible within the currently standing wall to suggest wall [5] ran east to join the current wall. No samples were taken from wall [5] as it was fully preserved in situ. The wall was located in the Back Courts area as shown on the 1620 Robert Smythson plan. A number of buildings are shown in the vicinity of Wall [5] on the Slezer and Wyck plan of 1671 and on the Helmingham plan pre-dating the 1730s (Howes 1992/93).

Plate 3. East-west running wall [5] seen near Inspection Chamber 1 (0.50m scale)

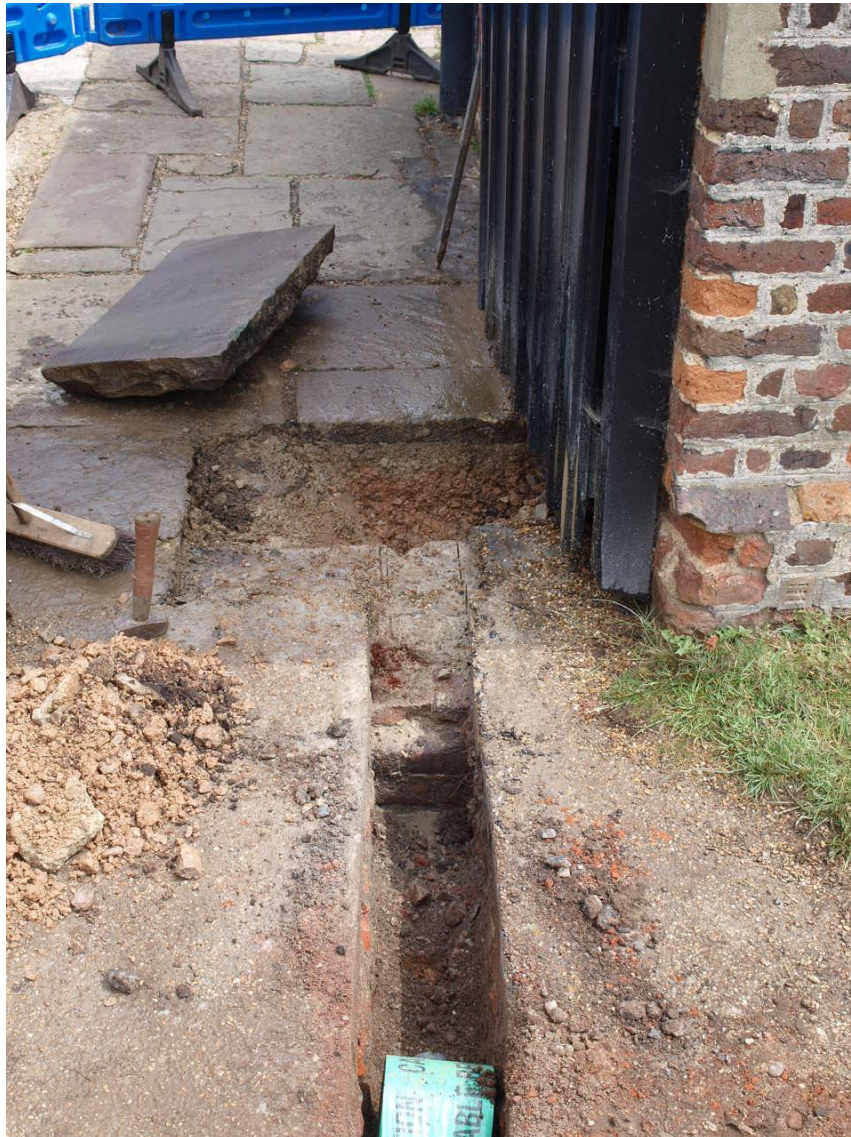
- 7.2.3 Possibly contemporary to wall [5] was wall [9], located to the very north of the ducting trench. Wall [9] ran along the same alignment as the current standing north-south running wall, underneath a doorway leading to the public toilets and shops. It is likely that this was the foundation to the current wall, before the doorway was formed in c. 1948 (Cooper 2009). The

wall was laid in stretcher bond where it was exposed, although it could also have been garden wall bond as only three courses were excavated.

Plate 4. East facing photo showing wall [9] within the current doorway leading to the public toilets

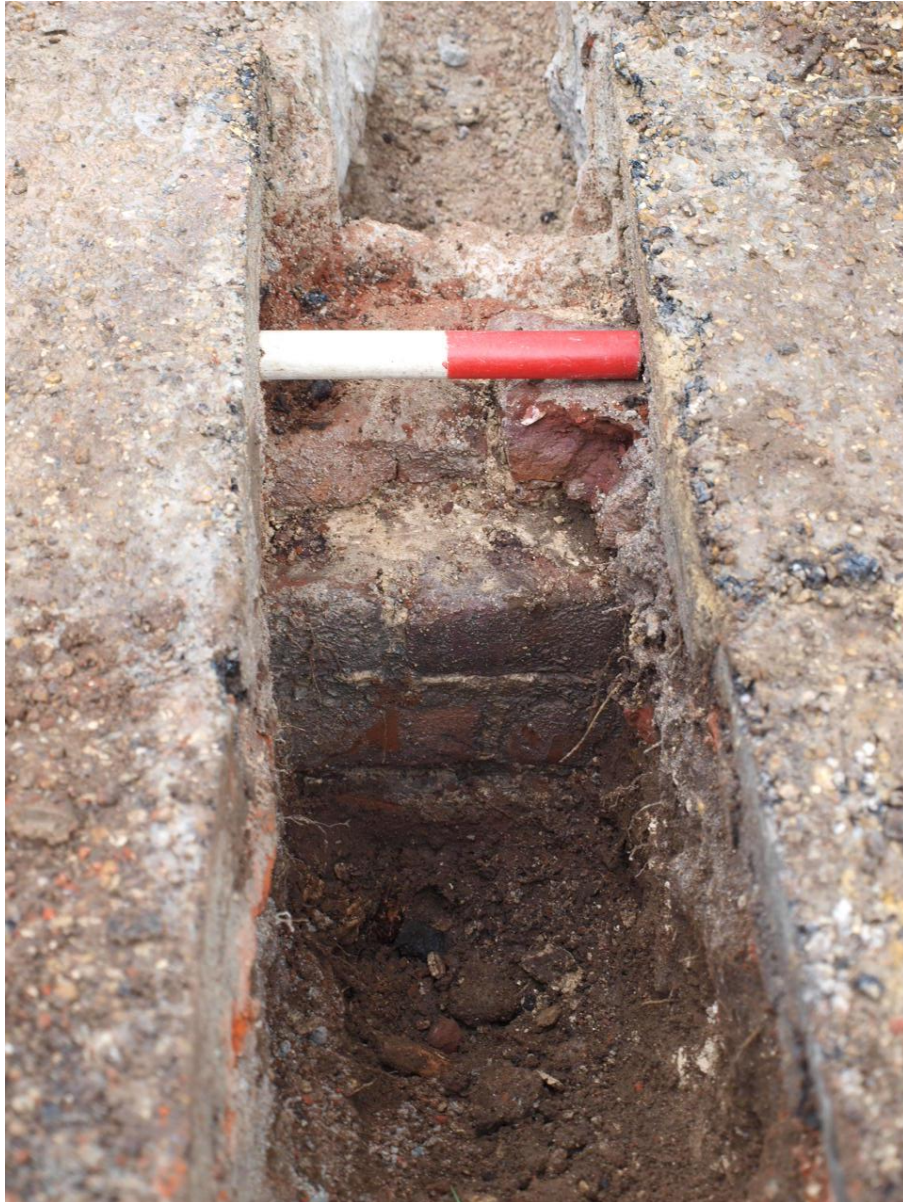
- 7.2.4 Wall [9] measured 0.25m long, 0.25m wide and 0.30m down to the limit of excavation. Two red handmade bricks were recovered measuring 250mm by 110mm and 55mm thick. As with wall [5] the mortar used comprised a hard yellow lime mortar with small charcoal inclusions.
- 7.2.5 The bricks recovered from wall [9] had a possible date range of 1600-1800 AD and they showed evidence of vitrification due to possible proximity to a fire or fireplace. No evidence was seen within the soil around wall [5] that suggested either a fire or a fireplace.
- 7.2.6 The upper two courses of wall [9] were removed to enable the passage of the plastic ducting works. In places wall [9] had been previously truncated and damaged by the modern concrete bedding layer for the stone slabs above it.

Plate 5. East facing closeup shot of wall [9] (0.20m scale)

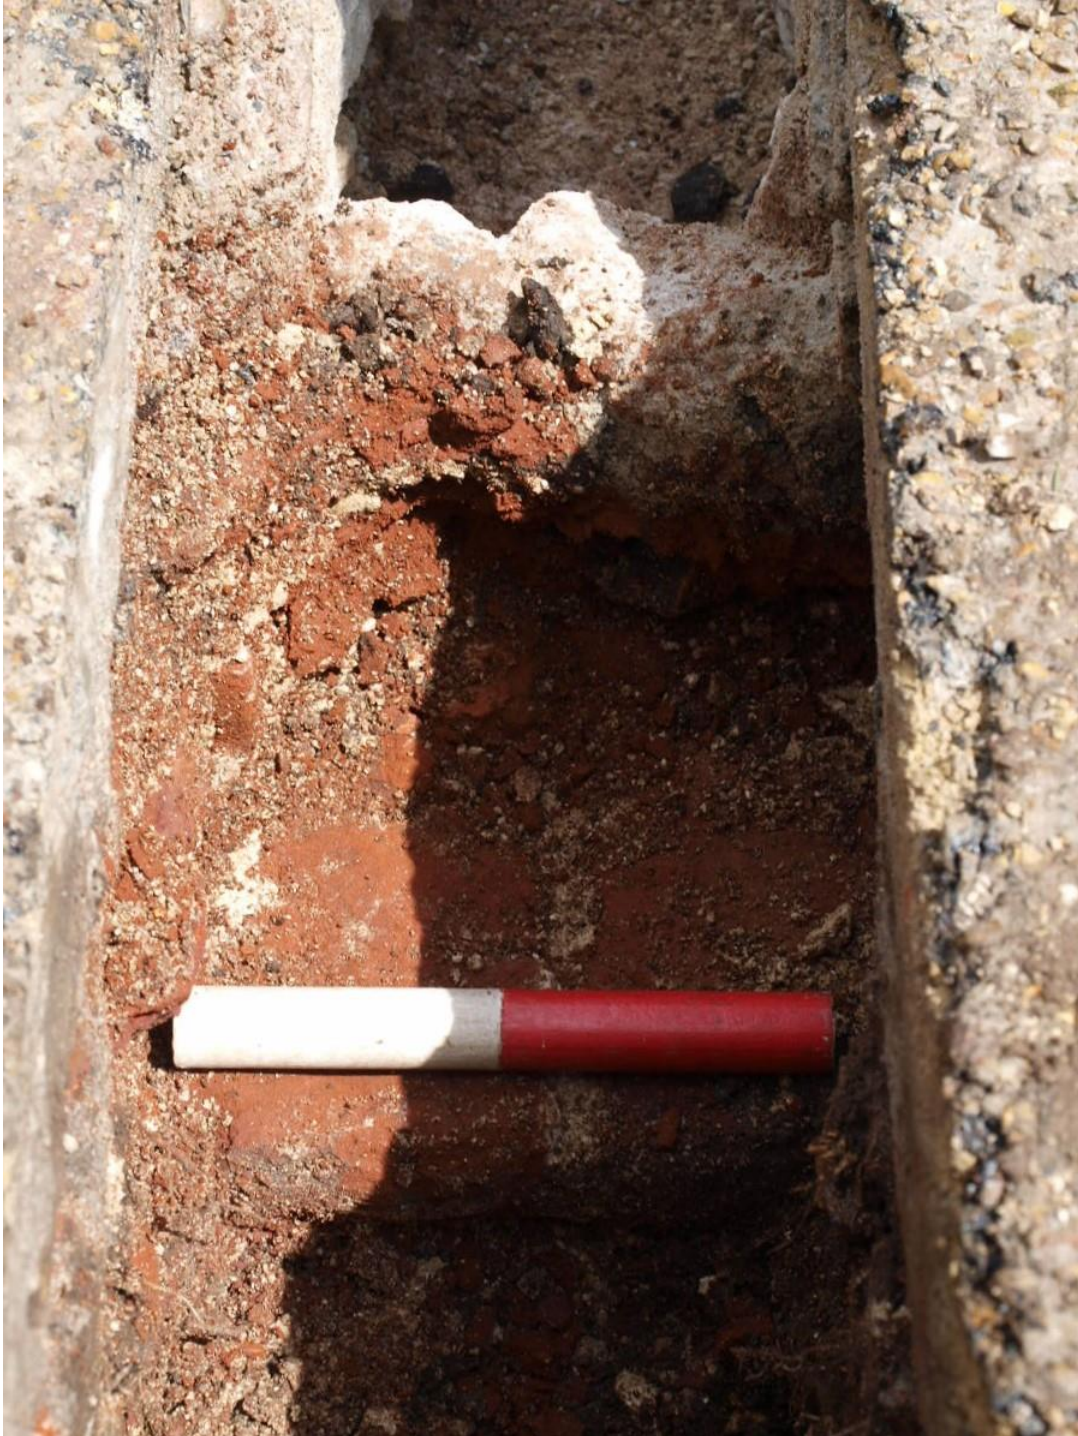
Plate 6. Wall [9] post-removal of two brick courses (0.20m scale)

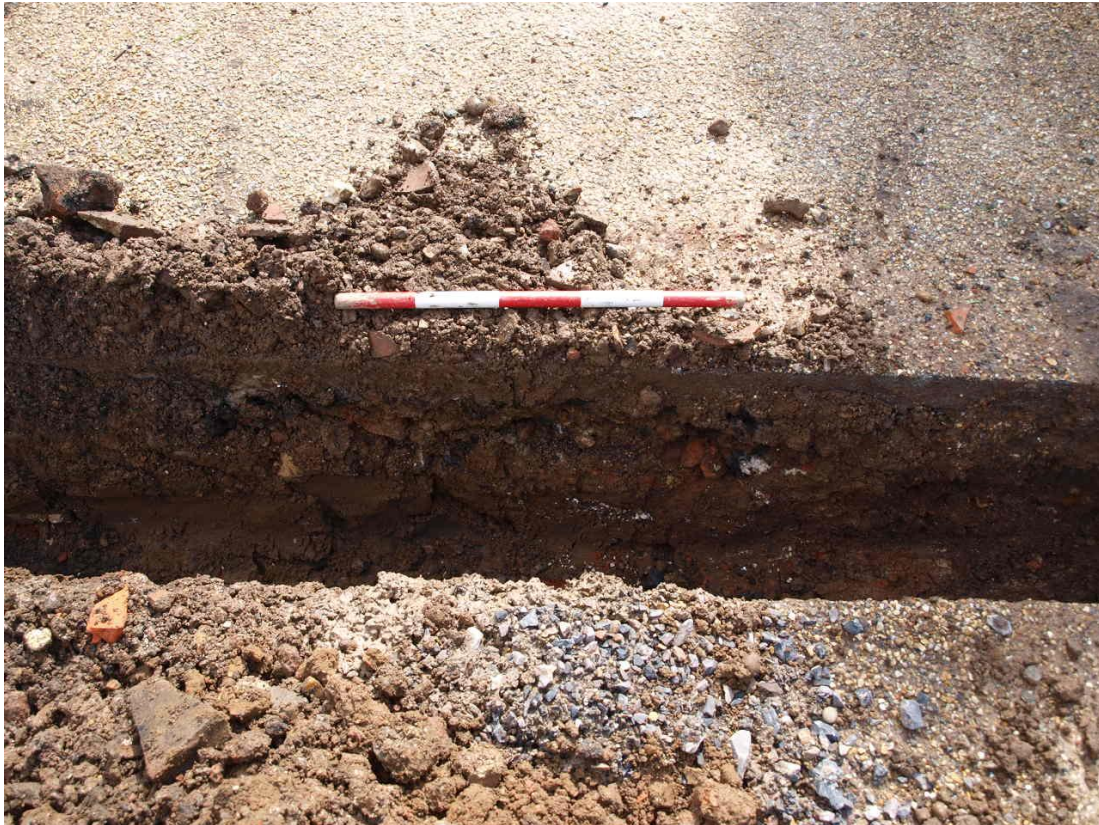
7.4.1 In the middle of the site, in Section 2 (Figures 2 and 4), was deposit [6]. This ran underneath the eastern garden entrance into Ham House directly beneath the current tarmac road. Layer [6] consisted of a silty rubble made up of crushed red and yellow frogged brick, some crushed peg tile, plastic and modern cable.

Plate 7. West facing section (Section 2, Figure 4) showing layer (6) under the tarmac road leading into Ham House (0.50m scale)

7.4.2 Layer [6] was interpreted as a bedding layer for the current road which reused material similar to layers [3] and [7] seen within the post-medieval construction horizon. A sample of the peg tiles were recovered for dating and these were identical to those recovered from layer [7].
