**THE MOAT SCHOOL, BISHOP'S
AVENUE, FULHAM, LONDON SW6
6EG
AN ARCHAEOLOGICAL WATCHING
BRIEF**

SITE CODE: BOP19

An Archaeological Watching Brief

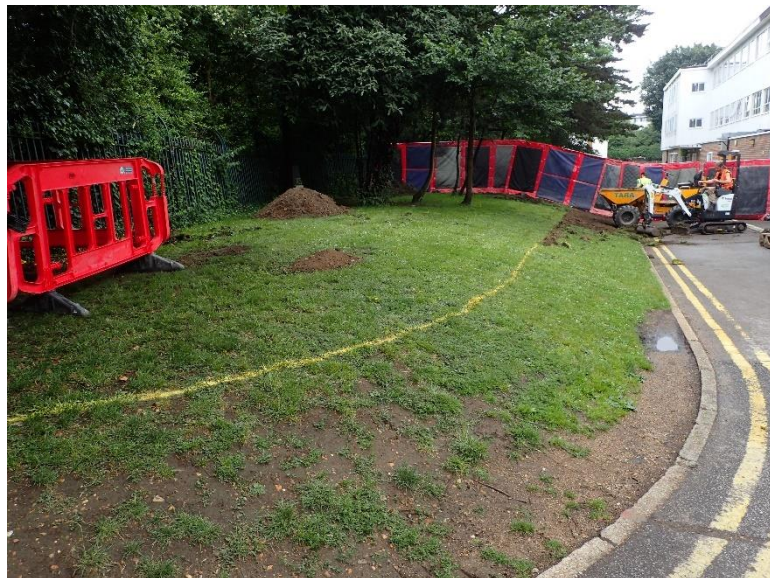
Plate 1: view of bank facing east

- 3.2.3 One feature of the site was a north-west to south-east aligned earth bank located directly south of, and parallel to, the filled-in moat that bordered the south side of Bishop's Avenue to the north. The bank follows the line of the current road and comprised a 20th century landscaped feature, constructed at the same time as the school.

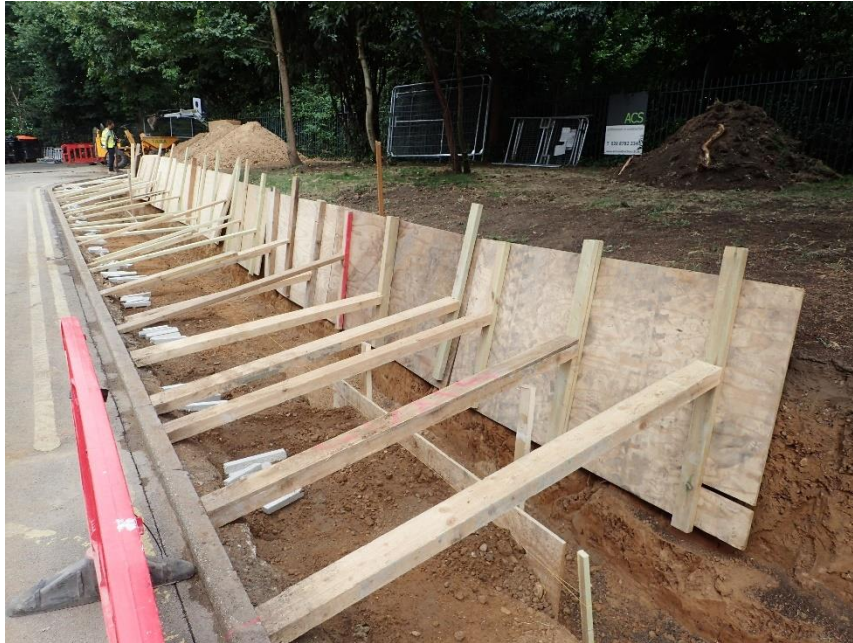
Plate 2: View of bank facing west, post-excavation

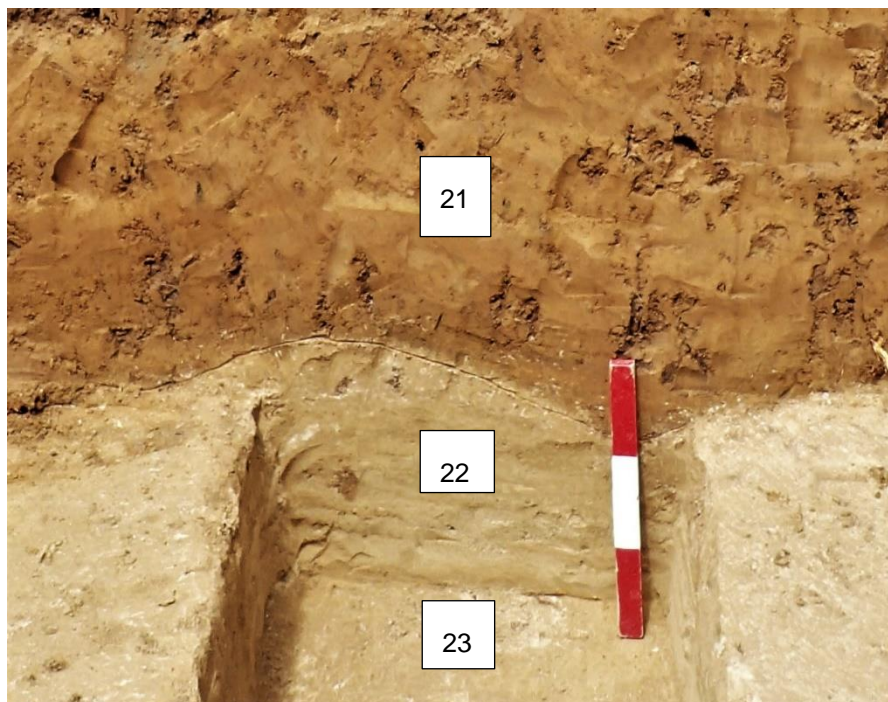
Plate 3: Trench 2, Section 4, view to north-west, scale 0.3m. Sand layer [23] was sealed by a thin layer of sandy-clay [22].

7.2.1 Evidence for the Kempton Park Gravel Formation was represented by a layer of soft, yellowish-white sand [23], which contained alternating laminations of clay, recorded at a height of 3.02m OD. It was sealed by a layer of friable, whiteish-yellow sandy clay [22], 0.09m thick and recorded at 3.11 m OD (Figure 3, Section 4, Plate 3).

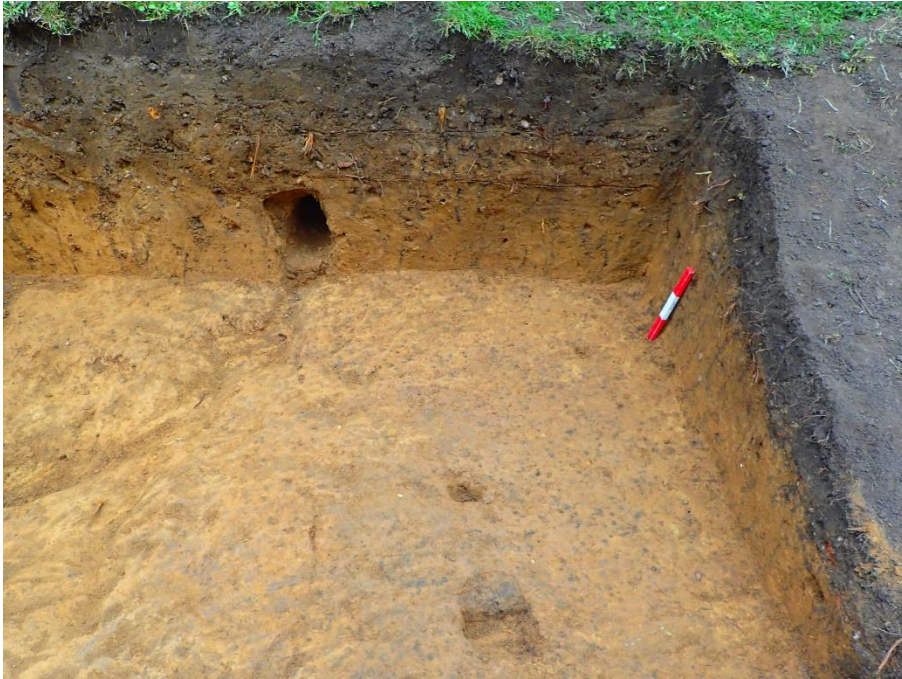
Plate 4: Trench 2, Section 2, view to north-west, scale 0.3m. Bioturbation and animal burrowing in brickearth layer [21]

7.4.1 The sand layers were sealed by a layer of compact, reddish mid-brown sandy clay or brickearth [7/ 17 /21] which contained occasional rounded pebbles and sub-rounded flint fragment inclusions. The layer was recorded at 4.60m at the west falling to 3.76m OD at the east although this was an artificial slope created by later landscaping. It had been subject to bioturbation and animal burrowing (Plates 3-5, Figure 3 Section 4).

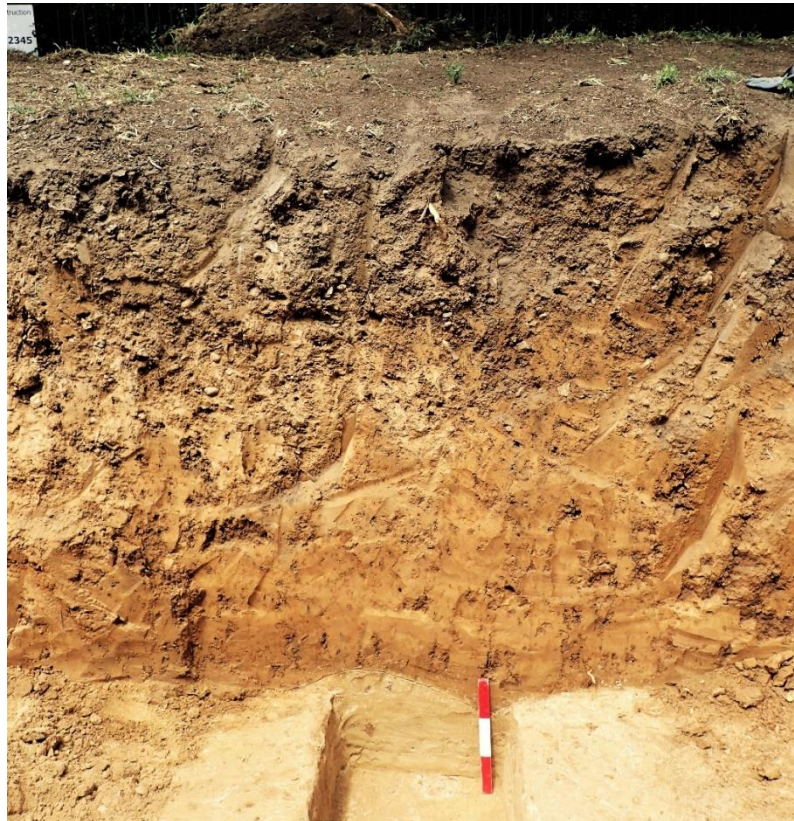
Plate 5: Trench 2, Section 4, scale 0.3m. The whole sequence from sands and clays [23] & [22] at the base, sealed by brickearth [21], made ground 20] and landscaping [19].

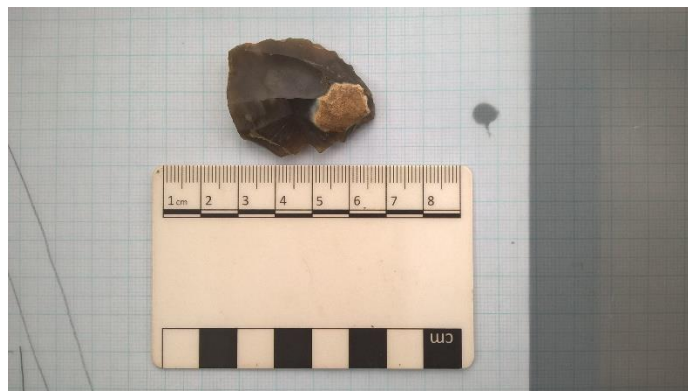
Plate 6: Neolithic flint retrieved from the basal strata of brickearth layer [7/17/21].

7.4.2 During ground reduction a small amount of burnt flint was recovered from the brickearth layer as well as a struck flint of probable Neolithic date (Figure 3, Section 4, Plate 6). This indicated that the brickearth layer [7/ 17 /21] was redeposited. The dearth of other finds suggested that the reworking may have taken place at an early date, or it may relate to upcast from the moat.

8.2.2 During the ground reduction of the brickearth layer, burnt flint was recovered at regular intervals although the finds were not related to any feature such as a hearth or a knapping floor. Towards the base of the deposit, a worked flint of the Neolithic period was recovered. This indicated that the brickearth layer was redeposited or reworked, possibly in the prehistoric period or that it represented upcast from the construction of the moat directly to the north.

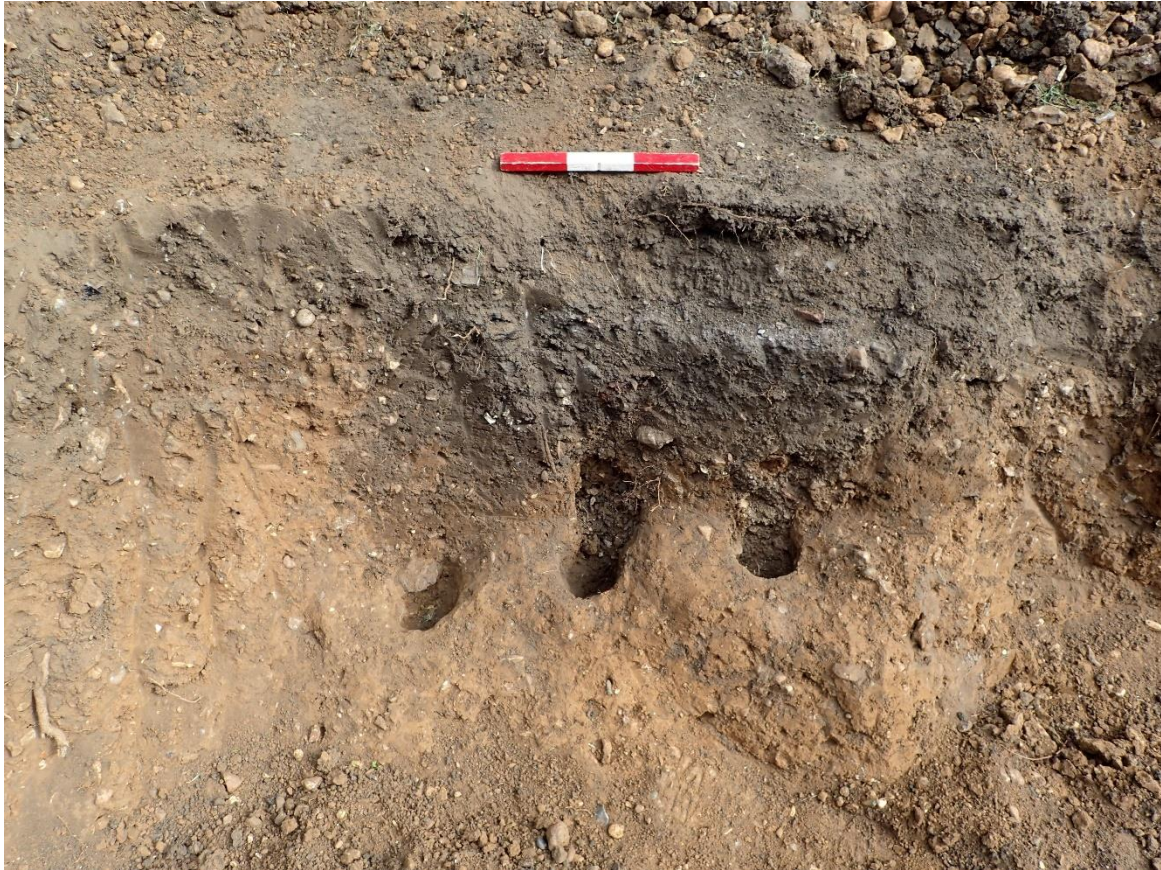
Plate 7, Trench 2, Section 3, view to the north, scale 0.3m. Pit [9] with postholes (L to R) [15], [13] & [11].

7.5.2 Pit [9] was 1.07m wide and 0.35m deep with straight sides but with a slanting or sloped base from east to west. Its relationship to the postholes [11], [13] and [15] was not clear but it is possible the structures were contemporary and that the posts had been introduced to create some stability. However, there were no vestiges of post pipes in the fills [10, 12 and 15] (which would have indicated where the timbers had rotted away *in situ*) but in fact appeared to be voids into which the fill of the pit had fallen. This would suggest that either the timbers had been removed (creating the voids) or, in fact, there was no longer any trace of the timbers and the wood had rotted away completely (Figure 3, Section 3, Plates 7 and 8).

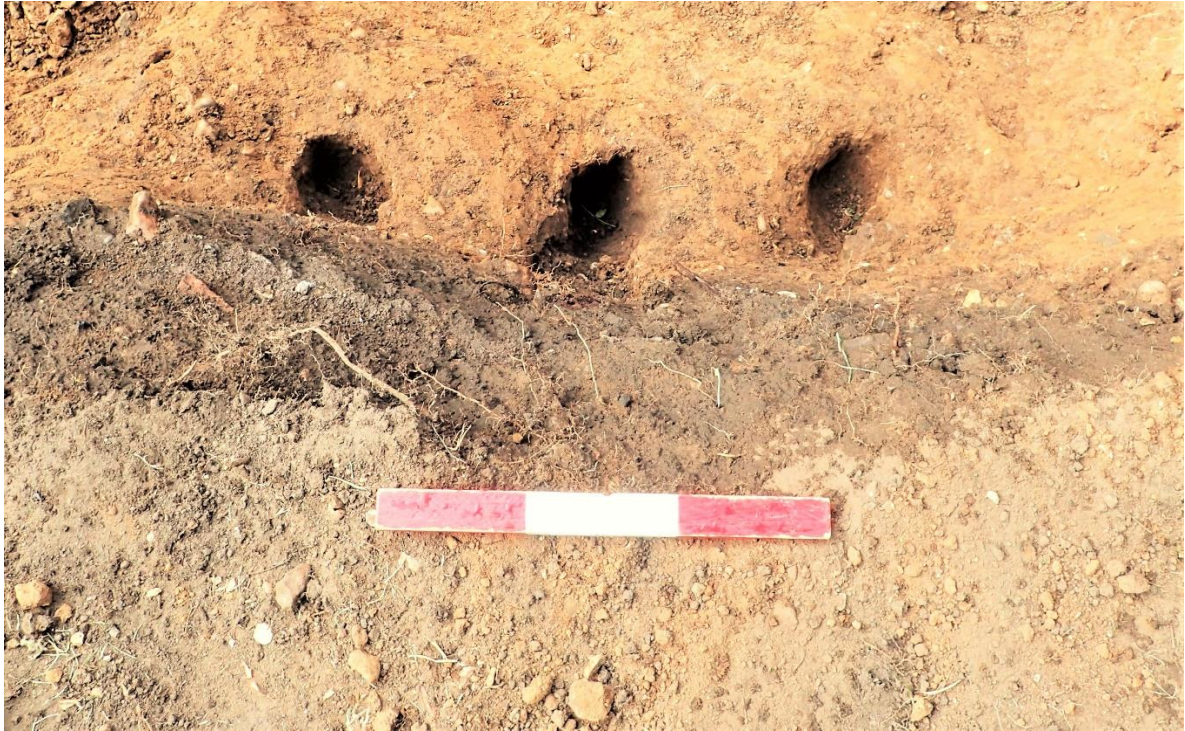
Plate 8: Trench 2, Section 4, scale 0.30m, view to south. Plan (left to right) view of postholes [11], [13] & [15].

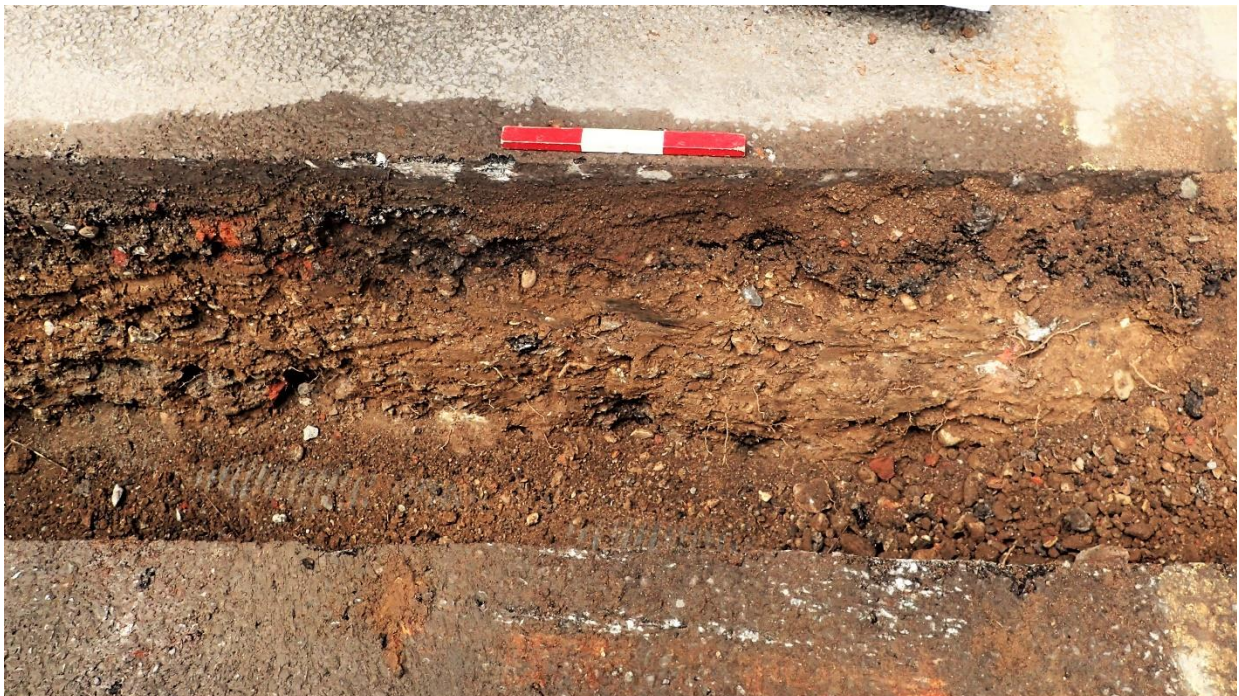
Plate 9: Trench 3, Section 5, view to north-west, scale 0.30m. Made ground and black plastic conduit containing live electrical services.

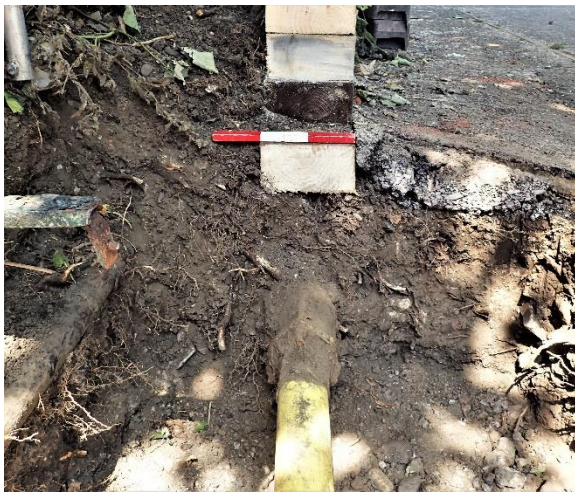
Plate 10: Trench 4, Section 6, view to north-west, scale 0.30m. Made ground [25] and gas main.

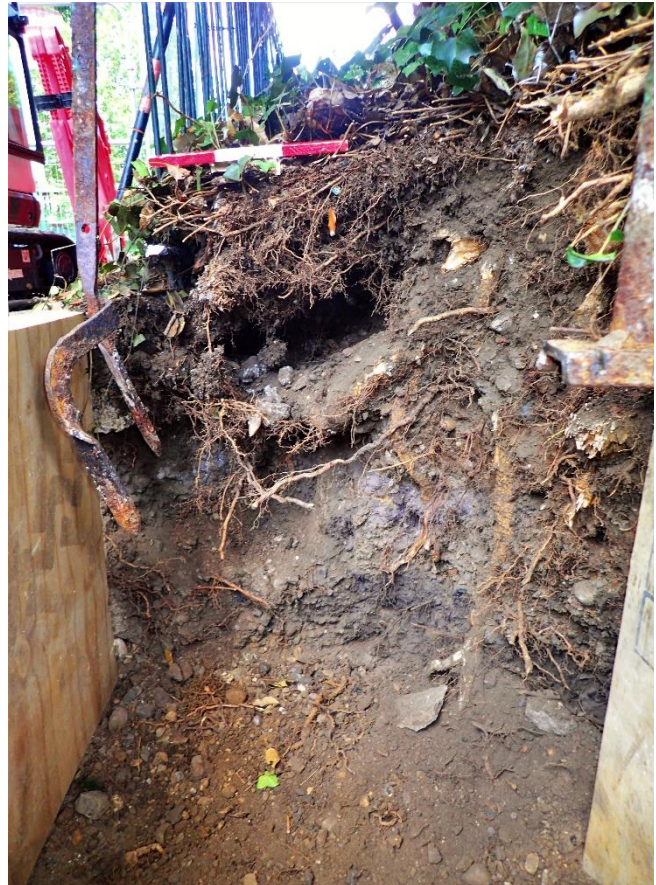
Plate 11: Trench 5, Section 7, view to north-west, scale 0.30m. made ground [26].

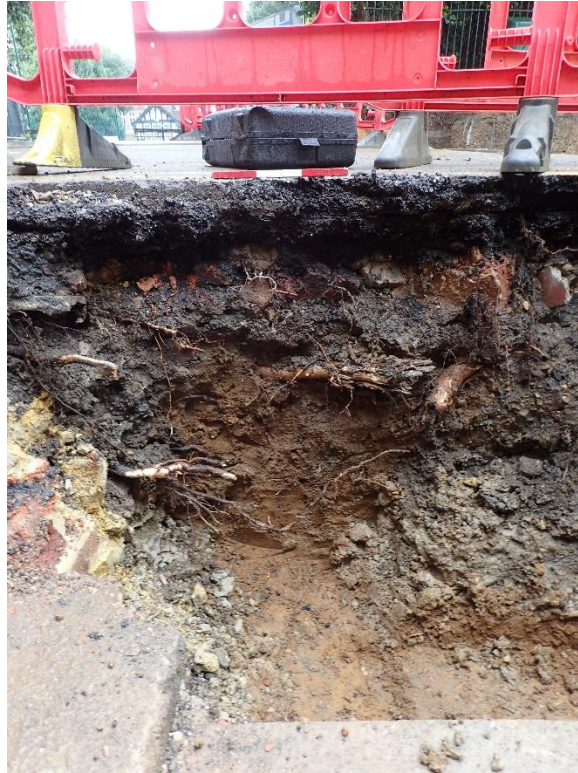
Plate 12: Trench 6, Section 9, view to north-west, scale 0.30m. Made ground and truncated brickearth [31].

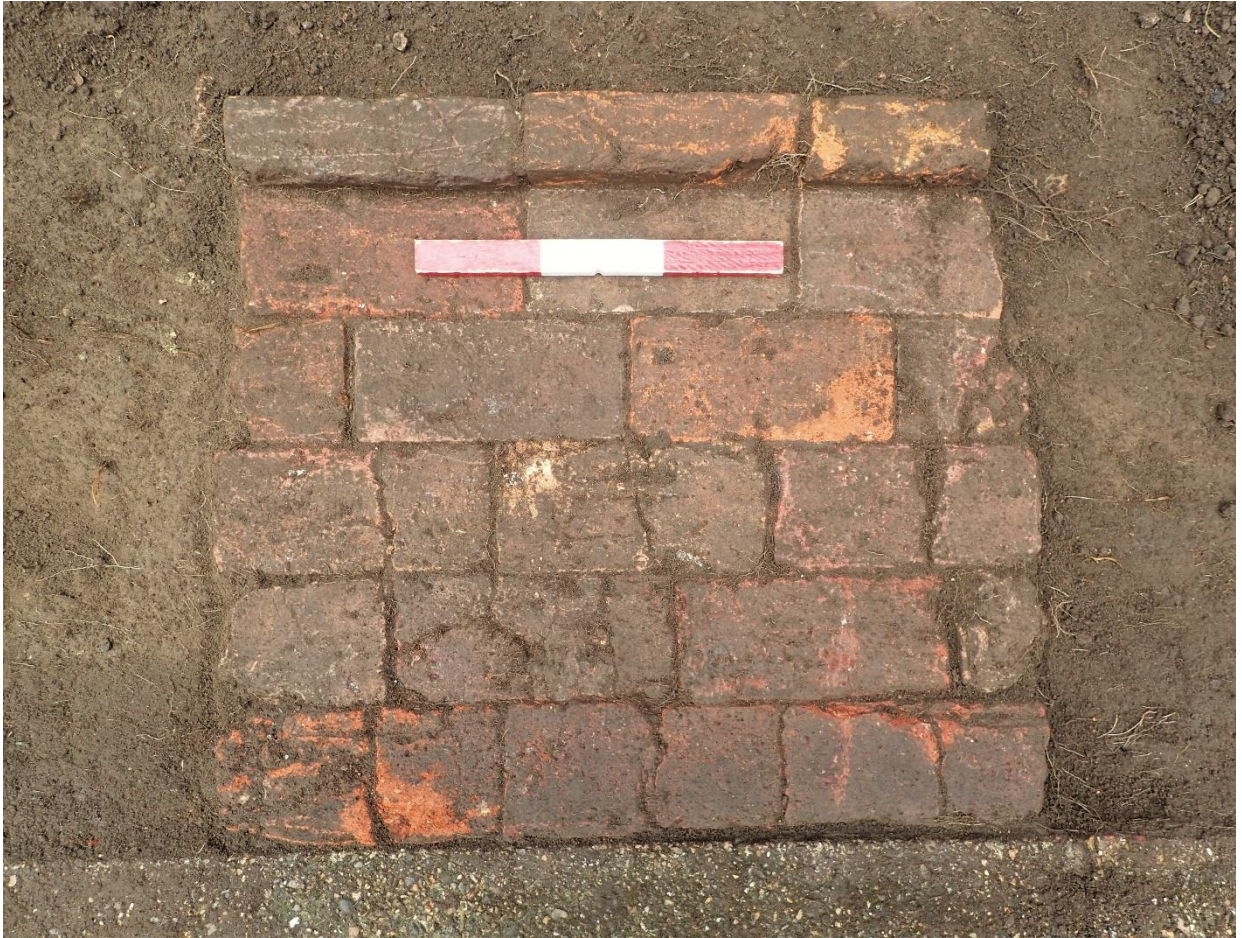
Plate 13: Trench 2, View to north, scale 0.30m. Step [4], constructed of re-used, frogged bricks.

- 7.7.2 A small step of re-used bricks was recorded as masonry [4] which measured 0.60m by 0.56m and had been cut (Cut [5]) through the turf and laid directly onto the made ground below [6] without mortar. It comprised modern, froged bricks.

8.5.1 A small 'step' of re-used bricks [4] were recorded as having been cut directly through the turf and laid directly onto the underlying made ground [6] without any mortar, creating an 'ad-hoc' step up onto the east-west oriented earthen bank.
