**POND RESTORATION AT
WANDLEBURY COUNTRY PARK,
STAPLEFORD, CAMBRIDGESHIRE**

ARCHAEOLOGICAL MONITORING

PCA REPORT NO: 13983

SITE CODE: ECB6008

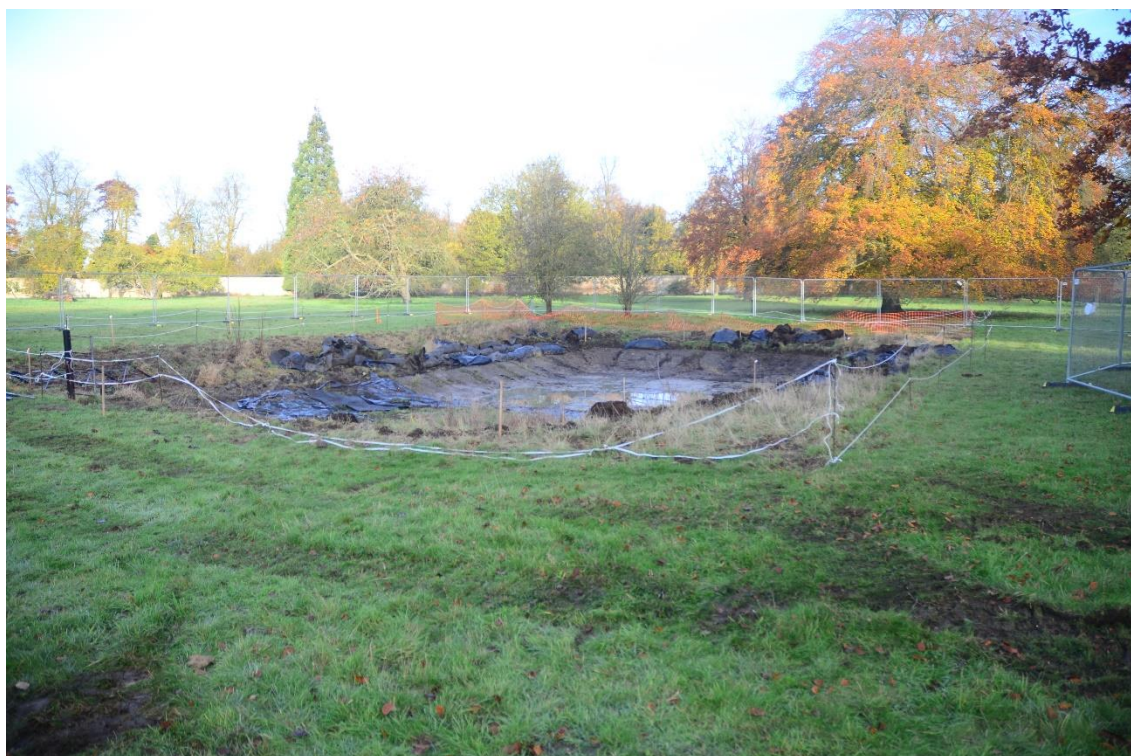
Plate 1: The pond area pre-excitation, view north-west

- 1.3 The scheme involved the restoration and enlargement of the existing but at that time dry pond (Plate 1), and the digging of a relatively shallow c. 70m-long pipe trench from the south, providing the pond with a supply of runoff rainwater (Figure 2). The aim was to restore the pond and its immediate surroundings to the status of a significant landscape, ecological, learning and recreational focal point within the country park. Prior to enlargement, the ‘Inner Ring Pond’ had a footprint of approximately 10m x 15m. The total area of landscaping required for the pond restoration was approximately 30m x 30m (900m²), in addition to the excavation of the new pipe trench.

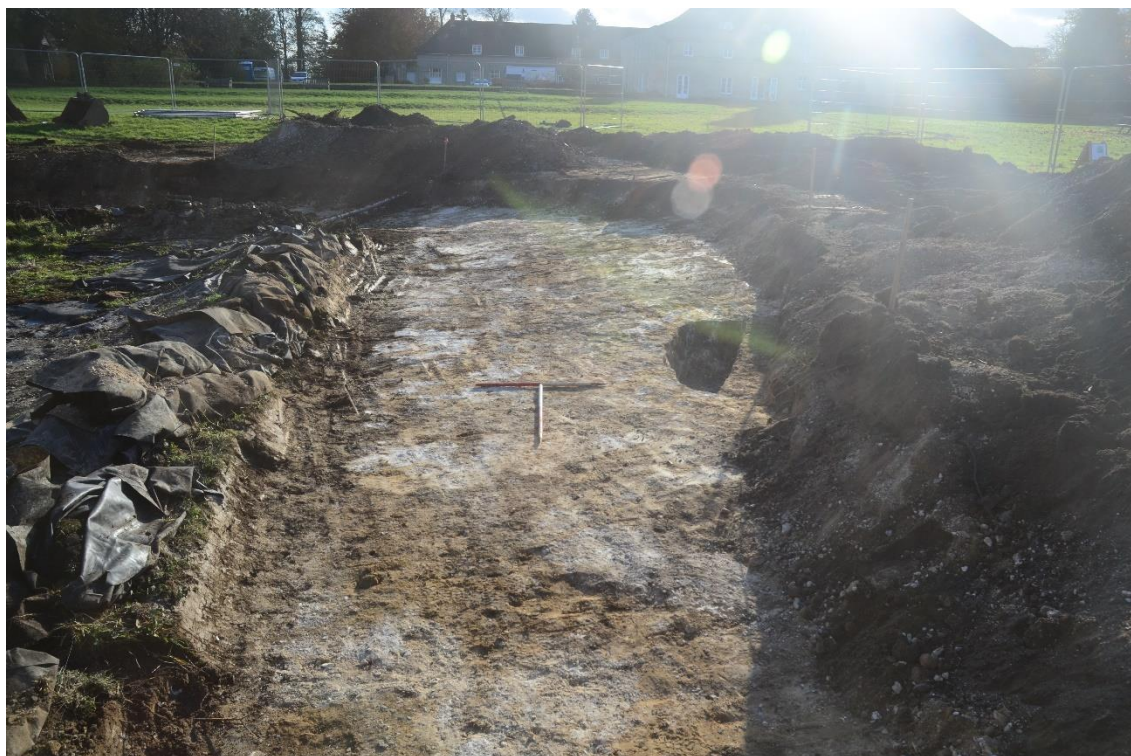
Plate 3: The pond area, west side, view south

5.2 The Pond Area (Figures 4 & 6; Plate 3)

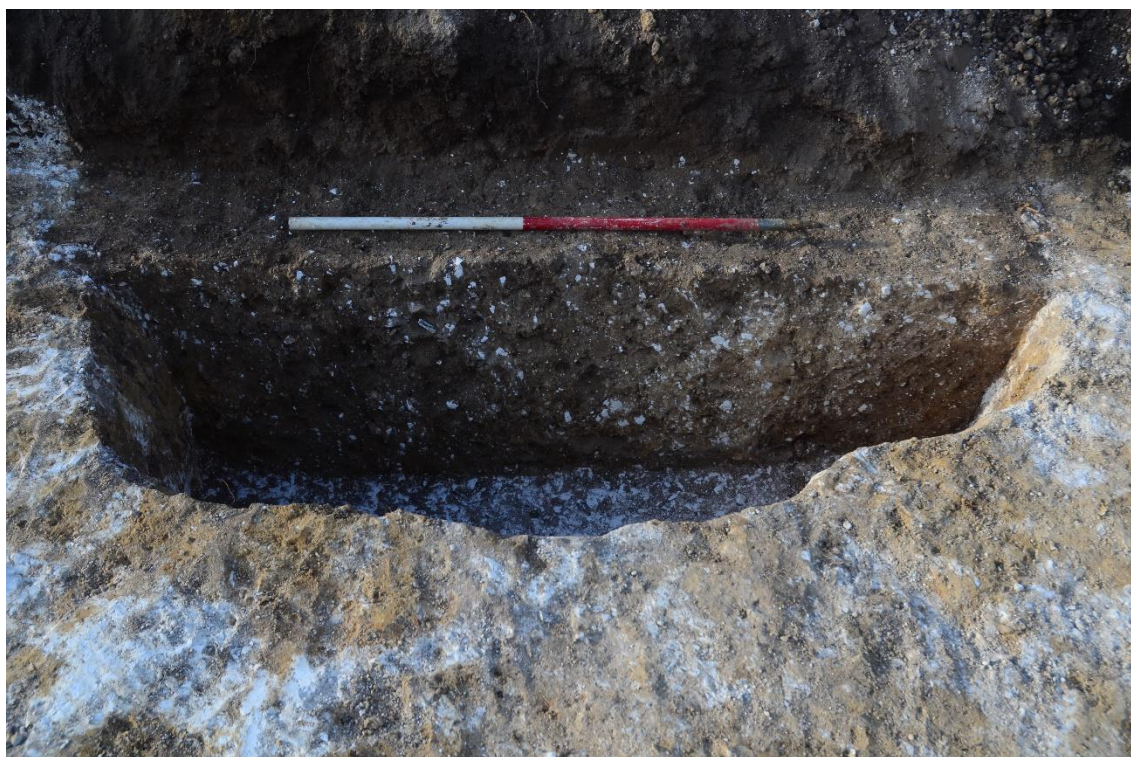
Plate 4: Pits [108] & [122], view west

5.2.1 Pit [108] (Figure 6, Section 2; Plate 4) was located on the west side of the pond footprint and appeared to be circular, although it was not fully visible in plan (c. 2.03m wide by 0.62m deep). It had two fills: a lower fill (107) of mid- to dark greyish-brown silty sand, which contained two residual pieces of earlier prehistoric struck flint, as well a single sherd (3g) of calcined-flint-and-sand-tempered handmade pottery dating to the Late Bronze Age to Early Iron Age. The fill also contained five fragments of animal bone, mainly sheep/goat, as well as a mouse or vole femur. A bulk soil sample <1000> taken from this fill contained small fragments of wood charcoal, a small assemblage of

carbonized wheat (*Triticum* spp.) grains and further unidentifiable grains. The feature also had an upper fill (106), a moderate to firm light yellowish-grey silty clay which contained no finds. The feature was cut/ recut by Pit [122].

5.2.2 Pit [122] (Figure 6, Section 2; Plate 4) was located on the west side of the pond footprint and appeared to be circular, although it was not fully visible in plan (c. 1.48m wide by 0.57m deep). It had a single fill (105) of mid-brownish-grey silty sand which contained three sarsen stone pot-boiler fragments and a single sherd (4g) of pottery of probable Late Bronze Age to Early Iron Age date. The fill also contained six fragments of animal bone, comprising a horse tooth and bones deriving from sheep and cattle-sized animals. The feature may have been a recut of Pit [108].

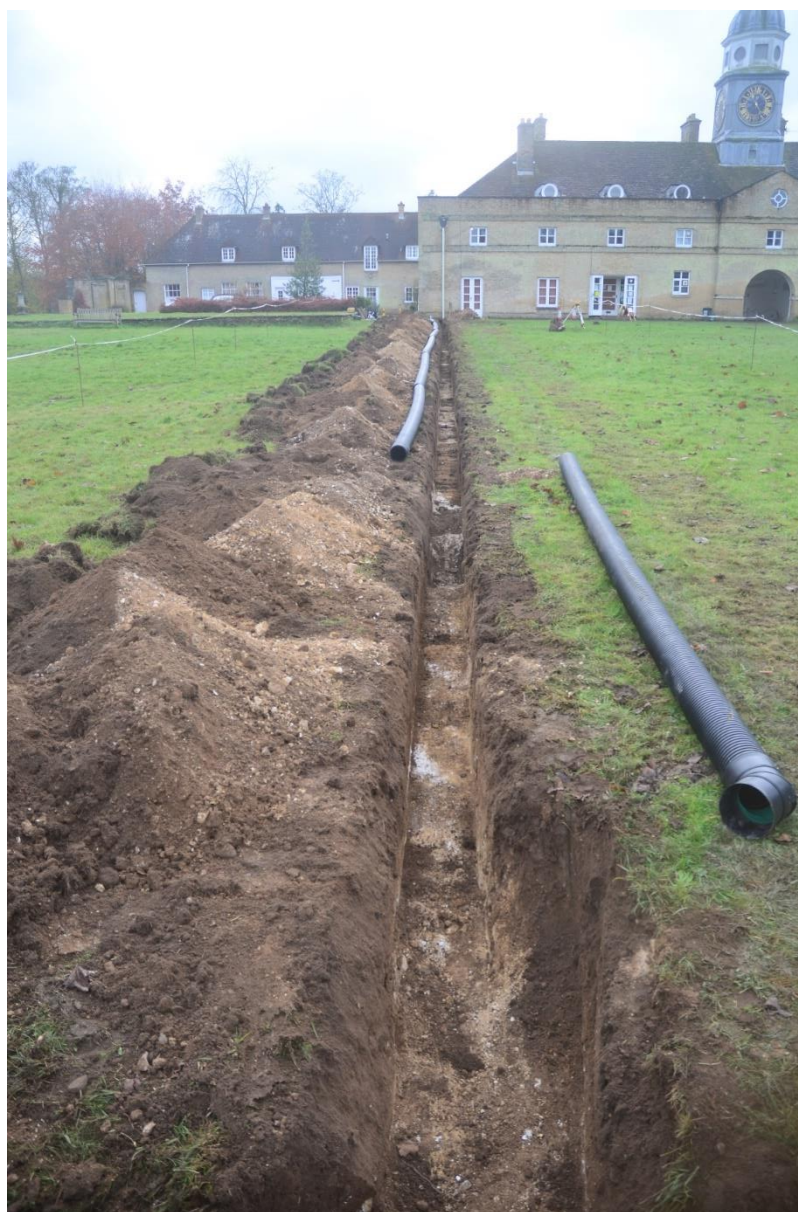
Plate 6: Pipe trench, view south

5.3 The Pipe Trench (Figures 5 & 6; Plate 6)
