**An Archaeological Watching Brief at the Great Northern Hotel,
King's Cross Central, London Borough of Camden**

Site Code: KXB07

Written and Researched by Shane Maher

**Pre-Construct Archaeology Limited,
January 2008**

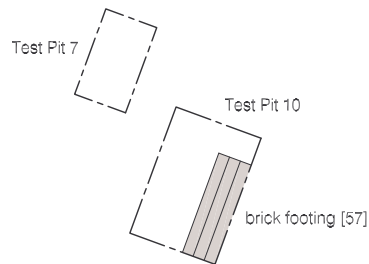
Test Pits 7 & 10

- 7.7.1 Trial pit 7 (fig 2) was located outside the hotel, in the lightwell and was excavated to a depth of 0.62m.
- 7.7.2 A concrete surface [38] was observed at 13.67m OD. It was decided that no further excavation was necessary.

- 7.10.1 Trial pit 10 (fig 2) was located in a vault outside the hotel and was excavated to a depth of 0.84m.
- 7.10.2 The earliest deposit was a dark blue brown clay [55] , observed at 12.63m OD. This was probably redeposited, but too little was exposed to make a true assessment.
- 7.10.3 Above this layer a stock brick wall footing [57] was observed at 13.08m OD which was 0.51m deep. The wall footing was aligned NNE-SSW and had three steps.
- 7.10.4 A deposit of sandy gravels [54], measuring 0.54m thick, was observed at 13.14m OD immediately above the footing.
- 7.10.5 A light yellowy brown bedding sand [53], measuring 0.17m thick, was observed at 13.31m OD, sealing the sandy gravel layer.
- 7.10.6 Sealing the bedding sand layer was a red brick floor [52] which measured 0.1m thick and was observed at 13.41m OD.

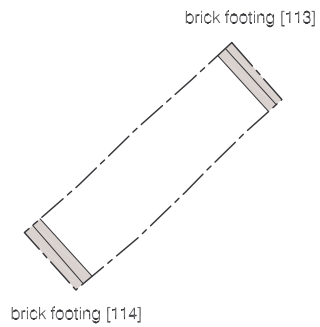
Test Pit 22

7.22.2 A deposit of dark bluey brown clay [115] was observed at 12.96m OD.

7.22.3 Two stock brick wall footings [113] and [114] aligned NW-SE were observed. Footing [113], belonging to an exterior store wall, was observed at 13.26m OD and measured 0.28m deep. Footing [114], belonging to the exterior wall of the hotel, was observed at 13.26m OD and measured 0.3m deep. Both footings had two steps.

7.22.4 Above these footings a silty sand [112] deposit with frequent brick rubble inclusions, was observed at 13.76m OD and measured 0.8m thick.

7.22.5 Sealing the silty sand a concrete surface [111] was observed at 13.96m OD to be 0.2m thick.

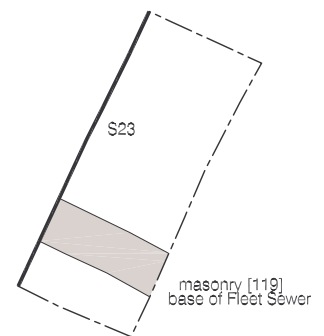
Test Pit 23

7.23.2 A red brick culvert [119] (the Fleet Sewer) was observed at 13.99m OD to be aligned NW-SE. The culvert appeared curved.

7.23.3 Above the Fleet sewer was a mid to dark grey brown deposit of silty sand [118], observed at 14.09m OD and recorded to a depth of 2.34m.

7.23.4 Immediately above the silty sand was a concrete slab [117] 0.14m thick, was observed at 16.23m OD. The slab sealed the silty sand deposit.

7.23.5 Above the concrete slab a tarmac surface [116], was observed at 16.29m OD which was 0.06m thick.

- 8.3 The north-eastern limit of the Fleet Sewer was identified in Trial Pits 11 and 23. The brick and steel reinforcements, observed in Trial Pit 11, were built to support the weight of the extension to the hotel built c.1900. Outside the building footprint no reinforcements were needed.

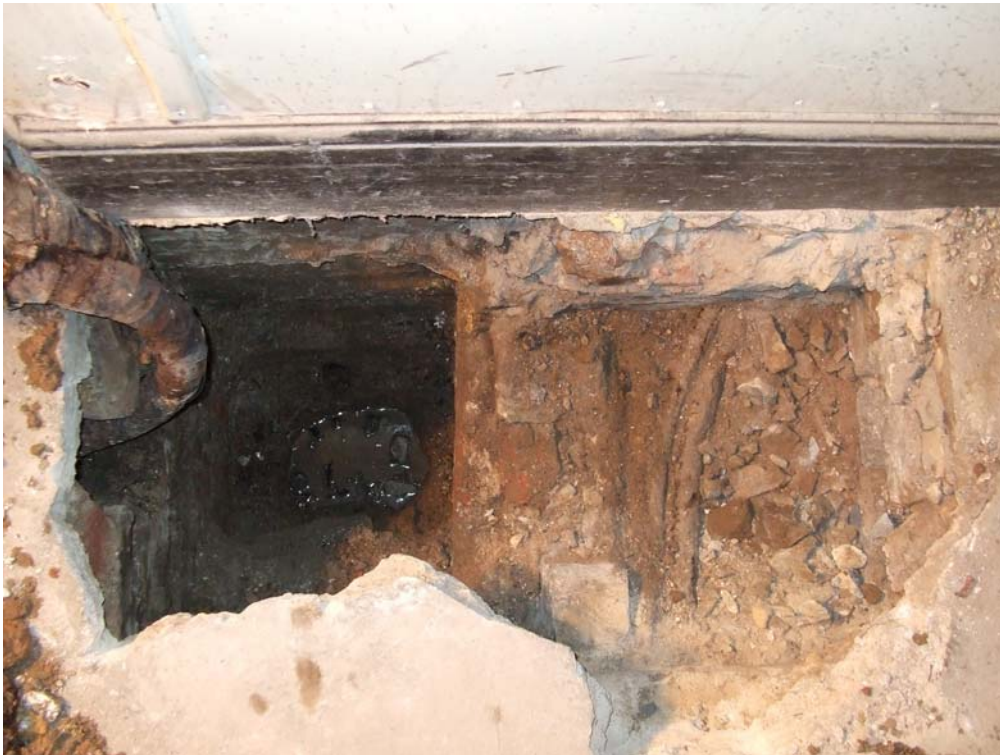
Plate 2 Trial Pit 21

7.21.2 A mid grey brown silty sand [110] deposit was observed at 16.00m OD and recorded to a depth of 2.0m.

7.21.3 Sealing the silty sand a concrete surface [109] measuring 0.2m thick, was observed at 16.20m OD.
