# LAND AT WALDEN CASTLE, SAFFRON WALDEN, ESSEX

# AN ARCHAEOLOGICAL WATCHING BRIEF

**PCA REPORT NO: R13904**

**SITE CODE: HWCS19**

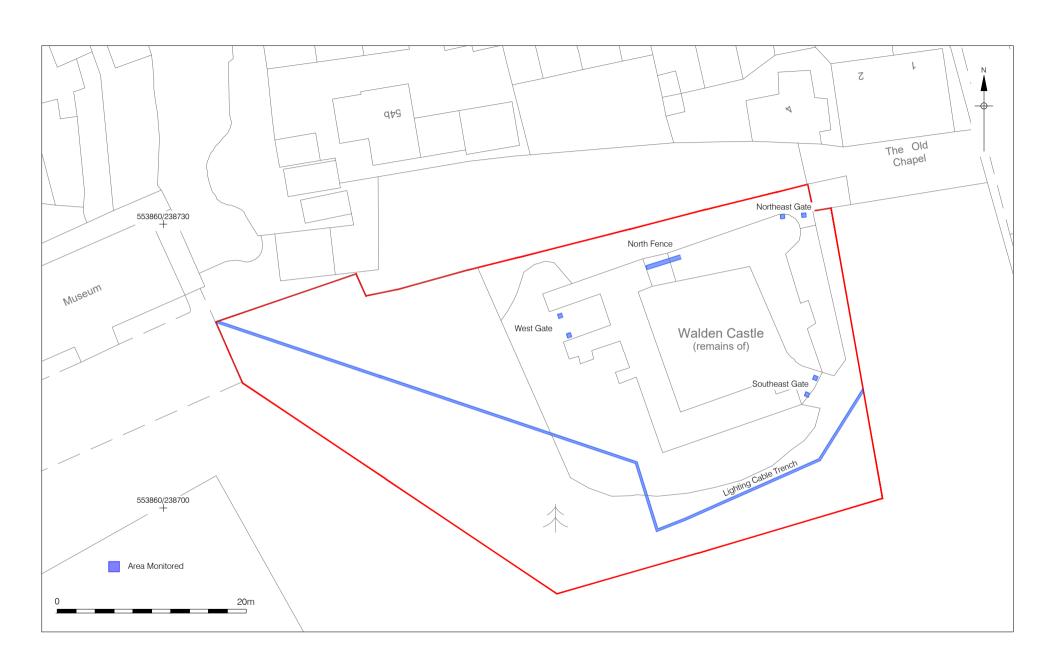
4.2.1 Two postholes were excavated at the south-east gate on 23<sup>rd</sup> September 2019 (Figure 2), the postholes measured 0.45m square and 0.45m deep. It became clear when excavating the two postholes at the south-east entrance that the planned position of the posts would impact the castle walls. Permission was subsequently granted to impact the walls for this purpose and the postholes were further monitored on 3<sup>rd</sup> October 2019. Apart from the flint and mortar of the castle structure itself, deposits removed from these postholes abutting the castle walls were modern (102) and consisted of a semi-compact, grey silt with modern inclusions (green bottle glass and screws). This material comes from the site of the 1980s excavation that recorded the 'stairs' (see Bassett 1982 in Place Services - Medlycott 2017).

4.6.1 This trench was 0.25m wide and c. 0.45m deep. It ran from the eastern end of the museum to near the south-west corner of the castle where it turned south and then eastwards parallel to the south wall of the keep before turning north-east just beyond the south-east entrance (Figure 2). No archaeological features were observed in the trench. Apart from the modern topsoil, deposits comprised late post-medieval/19th century levelling material (108).

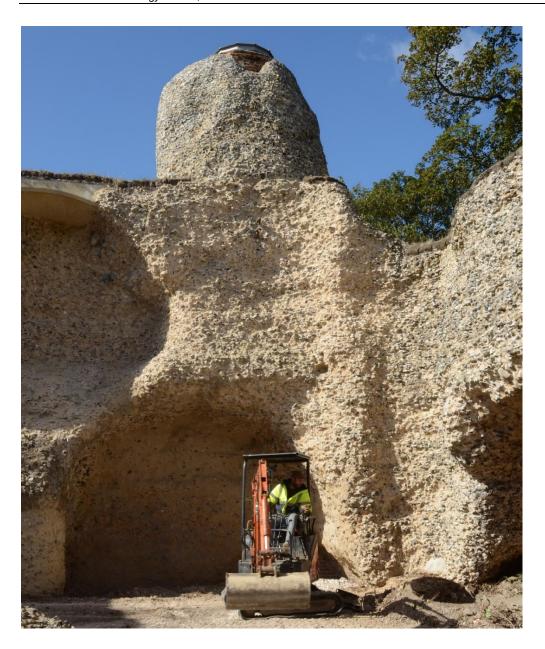
4.1.1 This work was monitored on 17<sup>th</sup> September 2019. Some very minor adjustment (<100mm depth) of the modern surface (101) inside the keep and at the entrance was undertaken before geotextile and type 1 crush was laid down. The modern surface comprised modern rubbish and weed growth on a very dry silty deposit. At the south-east entrance to the keep the machine scraped the ground to a depth not exceeding 100mm. It was decided in order to create a gentler access slope the ground immediately to the interior of the south-east entrance would be built up rather than reduced further. No archaeological features or deposits were identified.</p>

Plate 3: view south, levelling the ground inside the keep

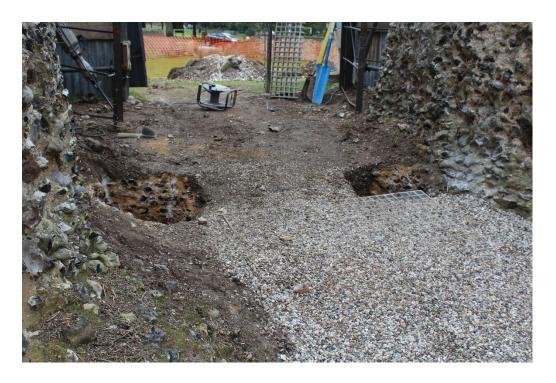
Plate 4: view south-east, postholes for the new gate at the south-east entrance

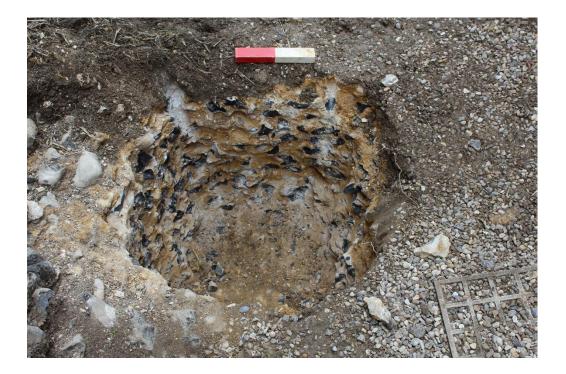
Plate 5: view south-east, detail of new posthole excavated through the castle wall

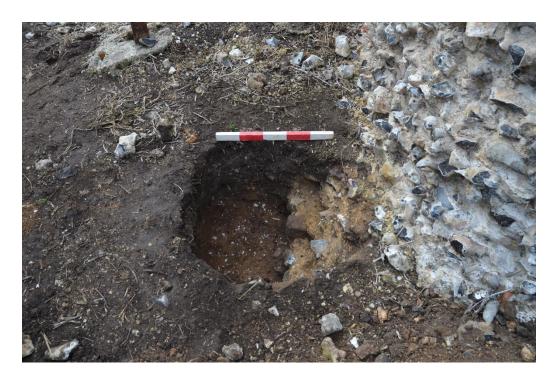
4.3.1 Two 0.45m square and 0.45m deep postholes were excavated at the north-east gate on 27<sup>th</sup> September 2019. One of these abutted the residential property to the north-east of the keep. Here deposits consisted of a modern topsoil and made-ground deposits relating to the construction of the adjacent property. The western of these postholes, abutting the castle, revealed the original line of the castle wall. Here, below the topsoil (c. 0.30m), a layer of what could be original

(105) mound material (i.e. thought to have been built up against the lower keep) was recorded abutting the castle wall. Layer (105) was a compact reddish-brown sandy silt with chalk flecks. No finds were recovered from this layer.

- 5.1 The monitored works were of a minimal impact. Nothing new of particular archaeological significance was recorded during this watching brief. The castle walls exposed by the south-east gate postholes were recorded in the 1982 excavation.
- 5.2 Layer (105) seen in the north-east gate postholes may represent part of the original mound laid against the castle walls.
- 5.3 Layer (108) was a post-medieval levelling layer seen in the trench for the lighting cable.

Plate 6: view south, north-east gate posthole with possible mound material (105) base

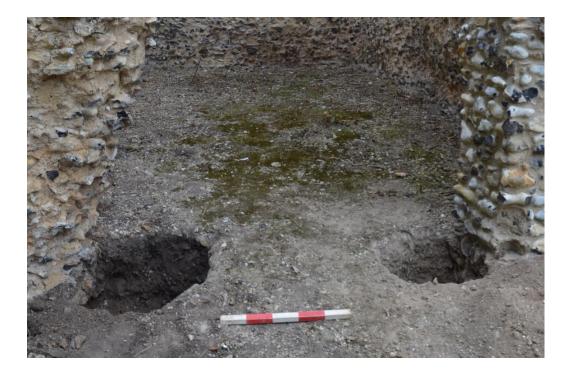
4.4.1 Two square postholes (0.45m x 0.45m x 0.45m) were monitored at the entrance to the building on 23<sup>rd</sup> September 2019. Disturbed modern layers associated with modern renovations were observed.

Plate 7: view east, west gate (forebuilding)

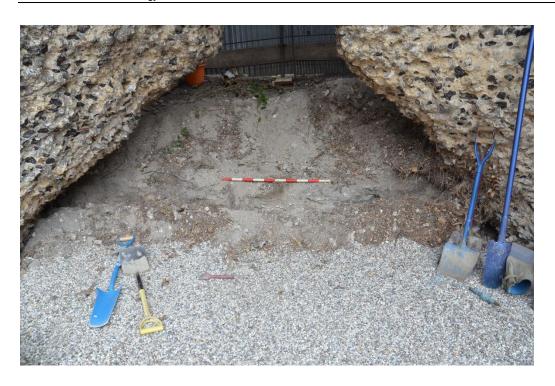
4.5.1 A shallow trench for railings within the north wall was monitored on 27<sup>th</sup> September 2019. This trench was hand excavated to a depth of 0.20m through modern silty material. No archaeological finds or features were recorded.

Plate 8: view north, trench for north fence (in front of scale)

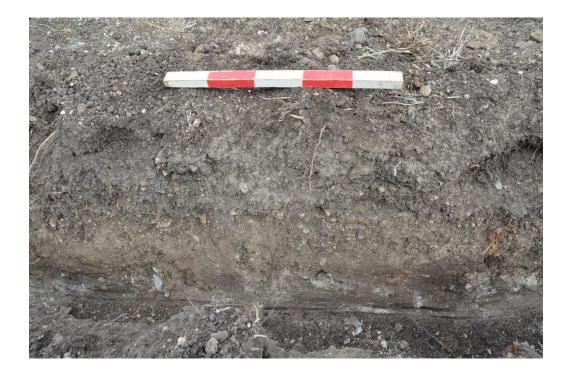
Plate 9: view north-east, late post-med deposits (108) and topsoil in section of trench for electric cable
