**HILL HOUSE FARM,
NEWTON AYCLIFFE,
COUNTY DURHAM,**

**HISTORIC BUILDING RECORDING
REPORT**

NOVEMBER 2019

Site Code: HHN19

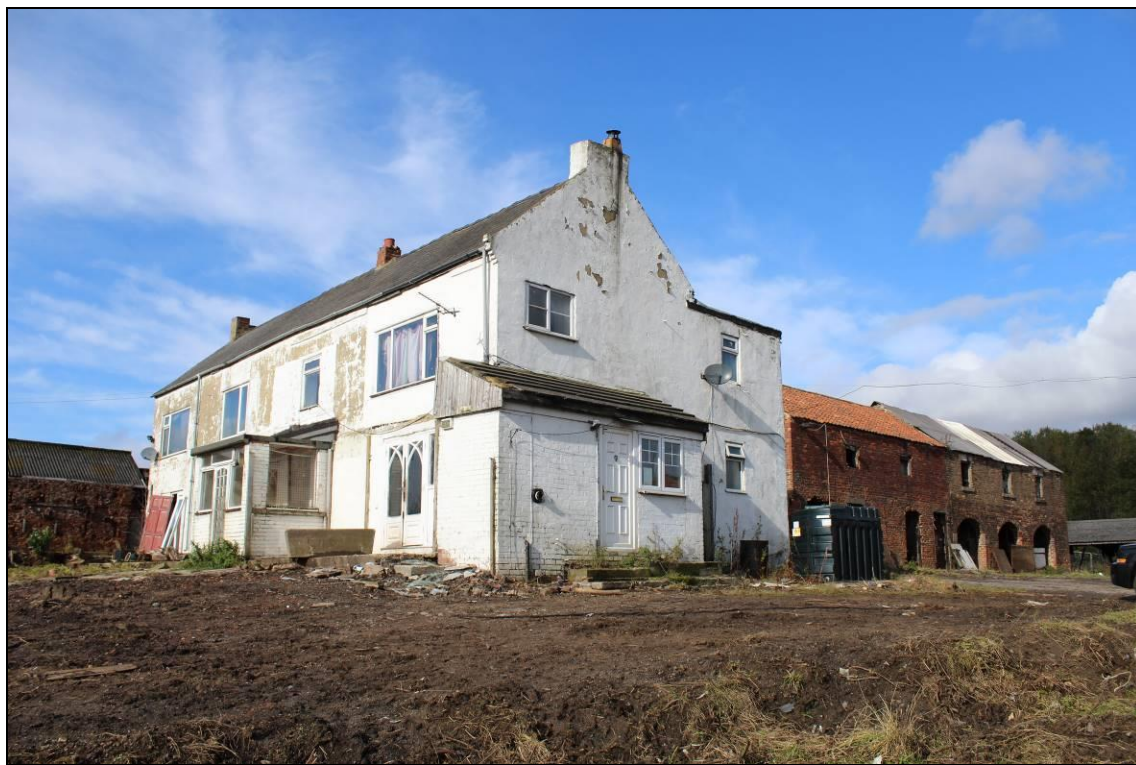
Plate 2: Building A: Farmhouse: view southwest, 2m scale

- 6.2.2 The northern elevation can be split into two parts. The eastern part of the elevation had a flat felt roof extension with modern porch at the front (Plate 2). The porch was constructed in brick with uPVC sliding doors. Four uPVC windows were also noted on the eastern side; one at ground level and three on the first floor. The structure was rendered so further architectural details could not be ascertained.

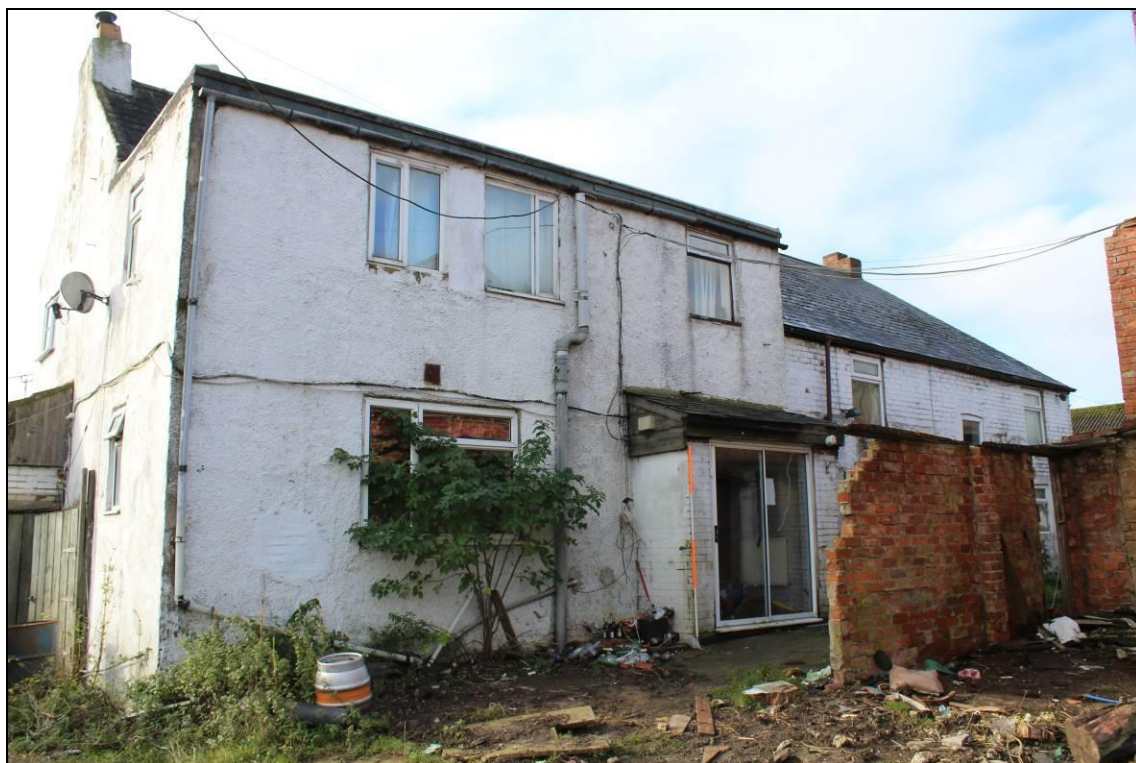
Plate 3: Building A: Farmhouse: view southeast, 2m scale

- 6.2.3 The western part of the elevation of the northern elevation did not have a flat roofed extension with the slate roof continuing to the edge of the structure. The lower courses of brick at ground floor level were partially rendered therefore the bonding was not observed. No render was present across the upper course of brick which were in English Garden Wall bond (Plate 3). A uPVC door and window were observed at ground level with an additional three uPVC windows on the first floor. The central window comprised a double brick arch above.

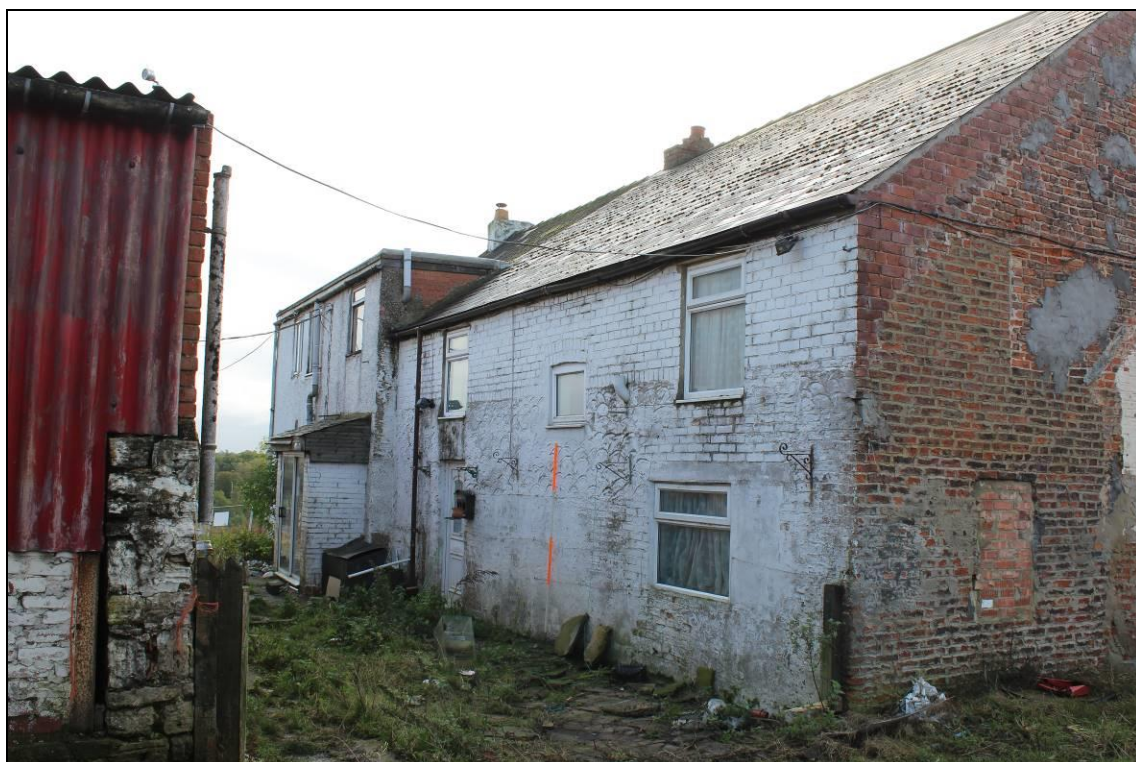
Plate 4: Building A: Farmhouse: view west, 2m scale

- 6.2.4 A modern porch was noted on the eastern extension c. 4.6m north/south by 1.40m east/west (Plate 4). The structure was comprised of brick with uPVC door and window and cement tiles on the lean-to roof. Additional uPVC windows were also noted; one on the ground floor and two on the first floor. On the ground floor a recess was observed adjacent to the porch within the original build of the property. This store was approximately 0.6m deep with timber doors.

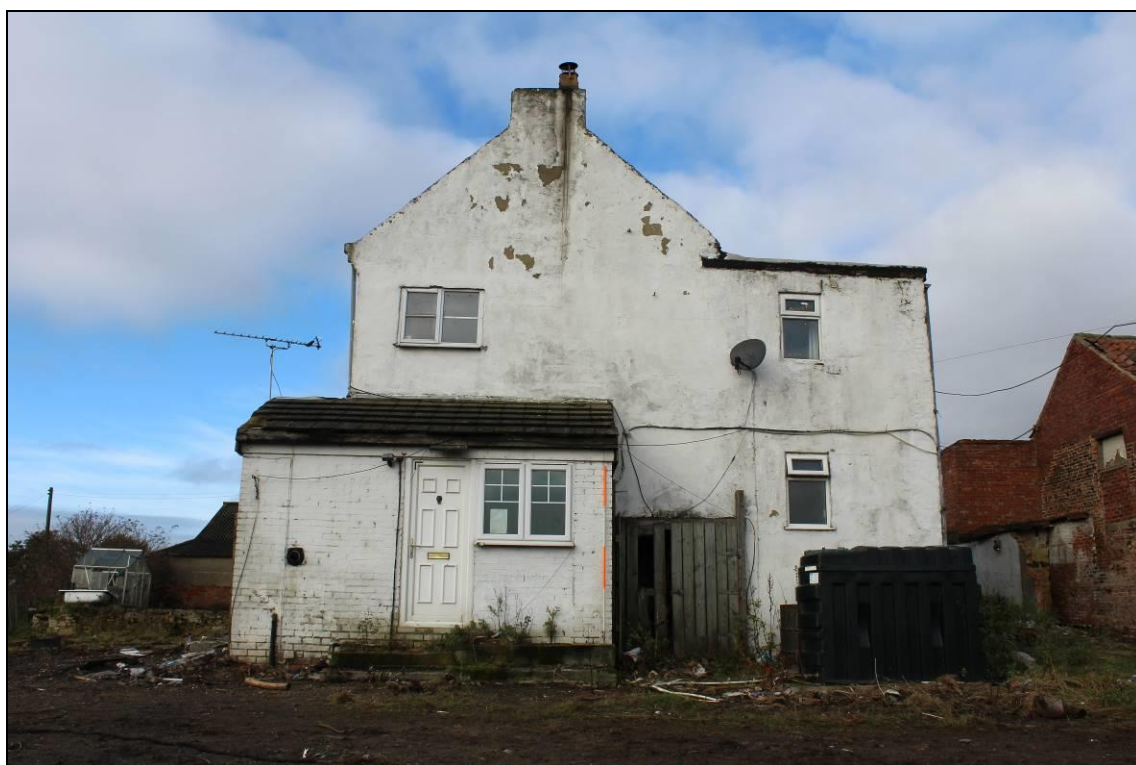
Plate 5: Building A: Farmhouse: view north, 2m scale

- 6.2.5 The southern elevation also featured a modern porch extension located centrally that was brick-built with a flat felt roof (Plate 5). The porch had a wooden door and several timber framed windows. Double doors leading into the eastern part of the house was located at the eastern end of the southern elevation. An additional entrance was also observed at the western end comprising a uPVC double door leading to the end property. Several uPVC windows were noted on the ground floor with an additional four uPVC windows on the first floor.

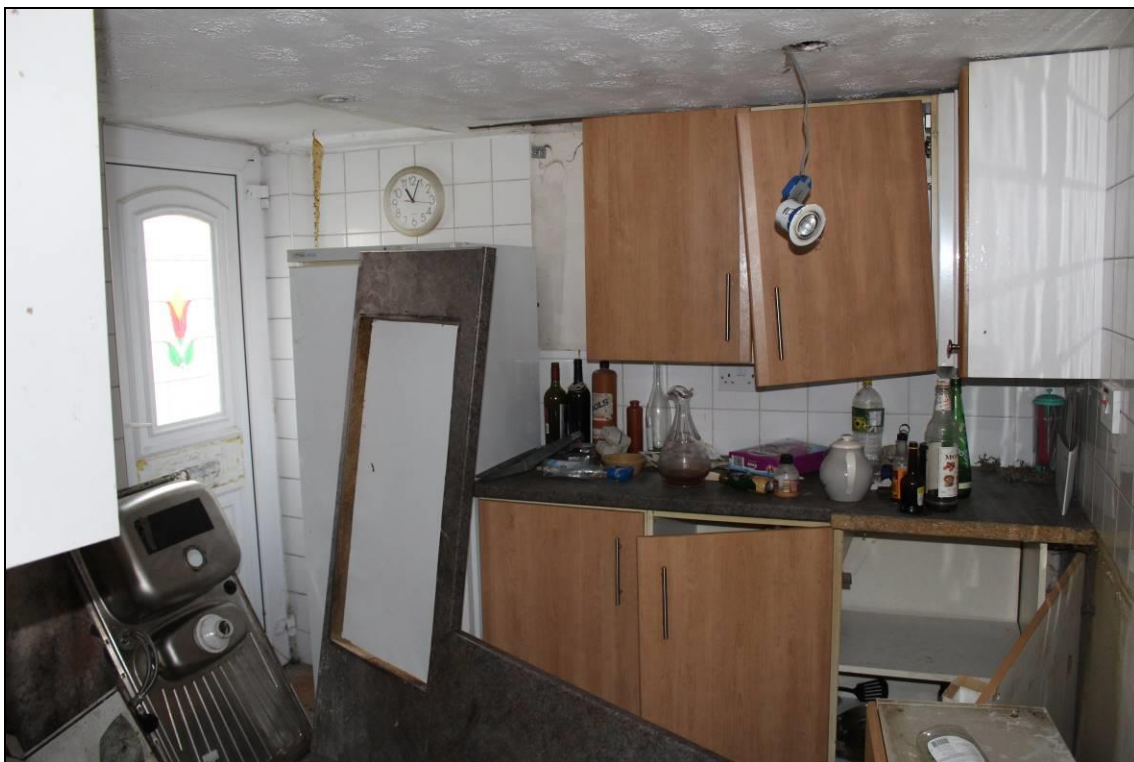
Plate 8: Building A: Room A1.2: view west, 1m scale

6.2.9 Room A1.2 was located in the northwest corner of the property. This featured a small 2.97m east/west by 2.51m north/south room (Plate 8). No original features were observed as the last tenants to the property had installed insulation panels across every wall and ceilings. This was a recurring problem in the western section of the building.

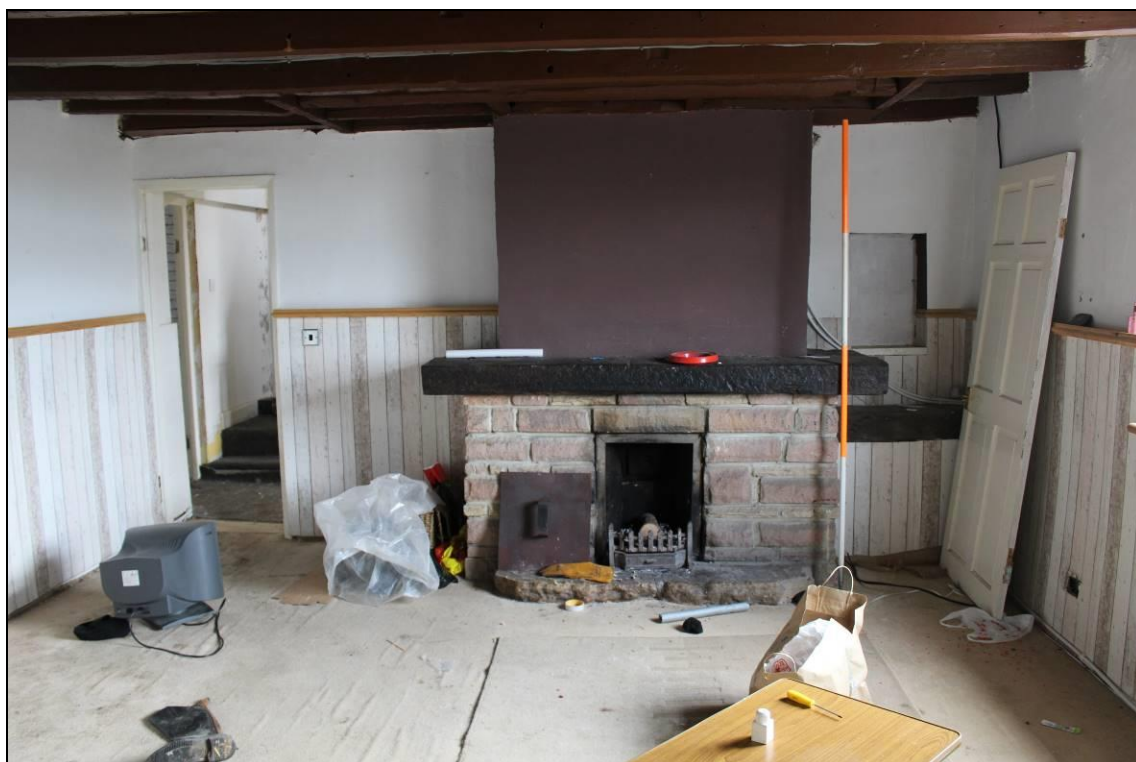
Plate 15: Building A: Room A1.9: view south, 2m scale

6.2.16 Room A1.9 was in the southeast corner of the farmhouse. The square room was approximately 4.7m north/south by 4.9m east/west (Plate 15). A small alcove was noted along the eastern wall that represented the former location of a fireplace (Plate 16). Along the western wall of the room was a staircase that led to the rooms on the first floor. A set of double doors were also noted along the southern wall granting access to the gardens to the south of the property.

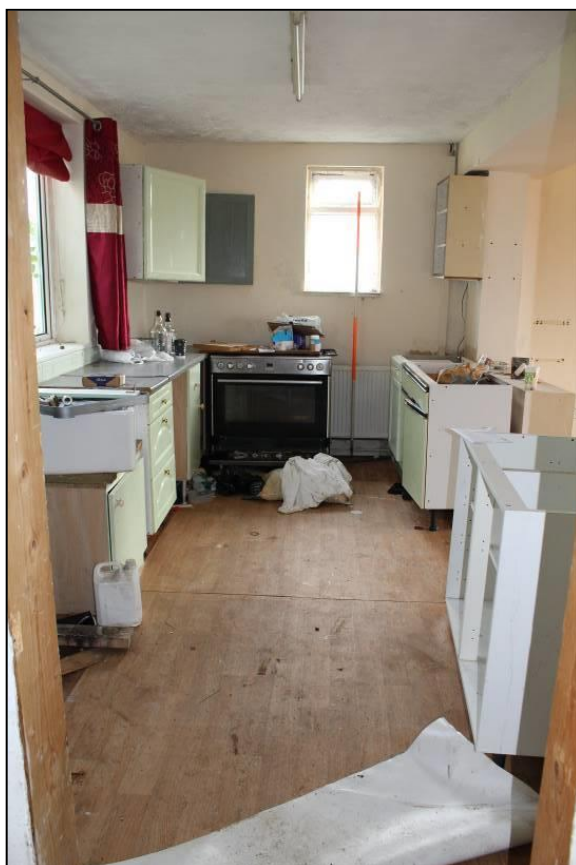
Plate 18: Building A Room A2.1 stairwell: view northeast

6.2.18 Room A2.1 was located above Room A1.1 and comprised a small square landing c. 2.5m east/west by 2.61m north/south (Plate 18). A window was noted in the stairwell with Room A2.2 to the east, Room A2.3 to the west and Room A2.4 to the south.

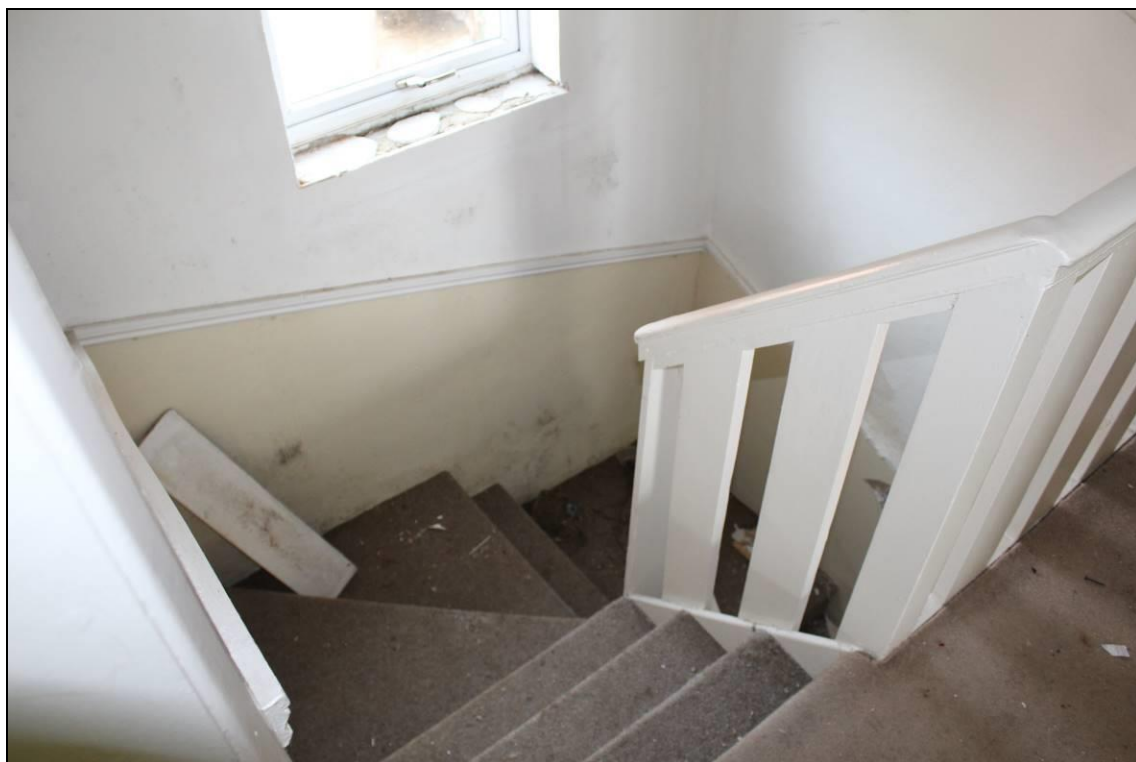
Plate 19: Building A: Room A2.2: view northeast

6.2.19 This room was located along the northern central section of the farmhouse and comprised a rectangular room c. 4.45m east/west by 2.5m north/south (Plate 19). A modern uPVC window was noted on the northern wall.

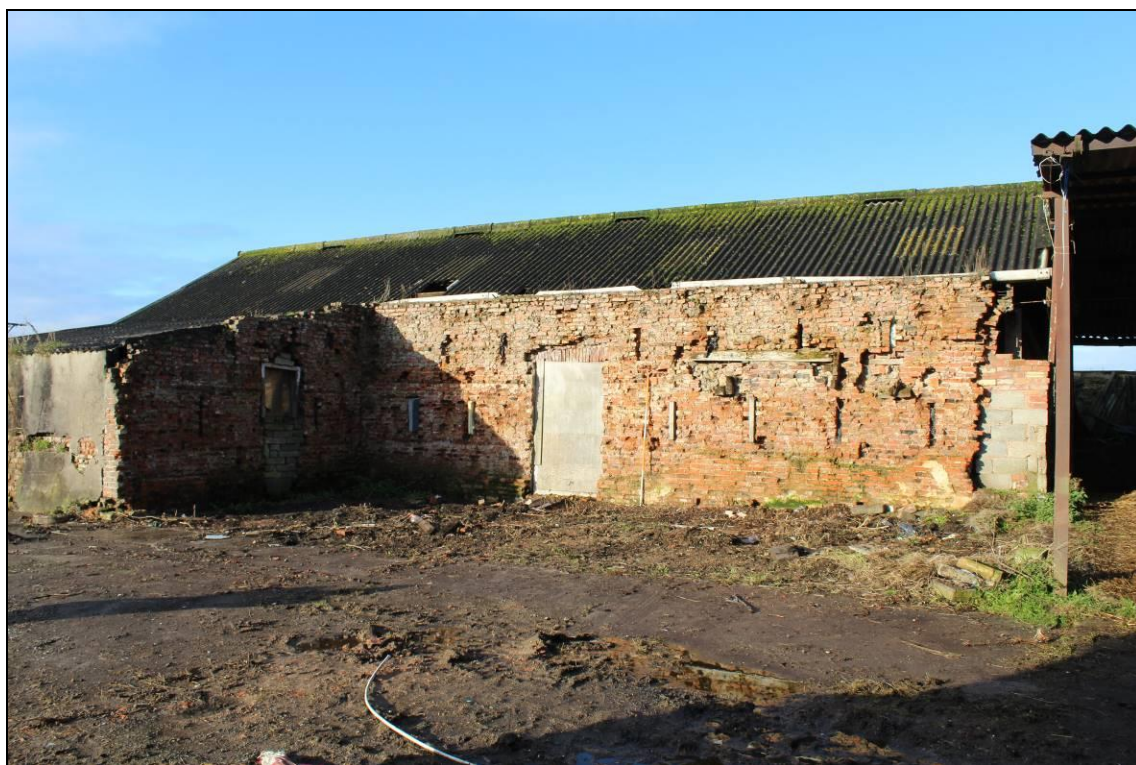
Plate 31: Building B1, southern elevation: view south, 2m scale

- 6.3.3 The southern wall was in a poor condition and as observed was 5.5m long (east/west) and c. 0.36m thick (Plate 31). The bricks forming the inner face of the structure had for the most part collapsed with only the core of the wall remaining. Based on the surviving masonry elements observed it is likely that the wall was built in English Garden wall bond and was bonded with a light greyish pink lime mortar. Four ventilation slits were apparent within the southern elevation however the central section had been truncated and infilled with concrete blocks (this measured approximately 1m wide by c. 2.5m high).

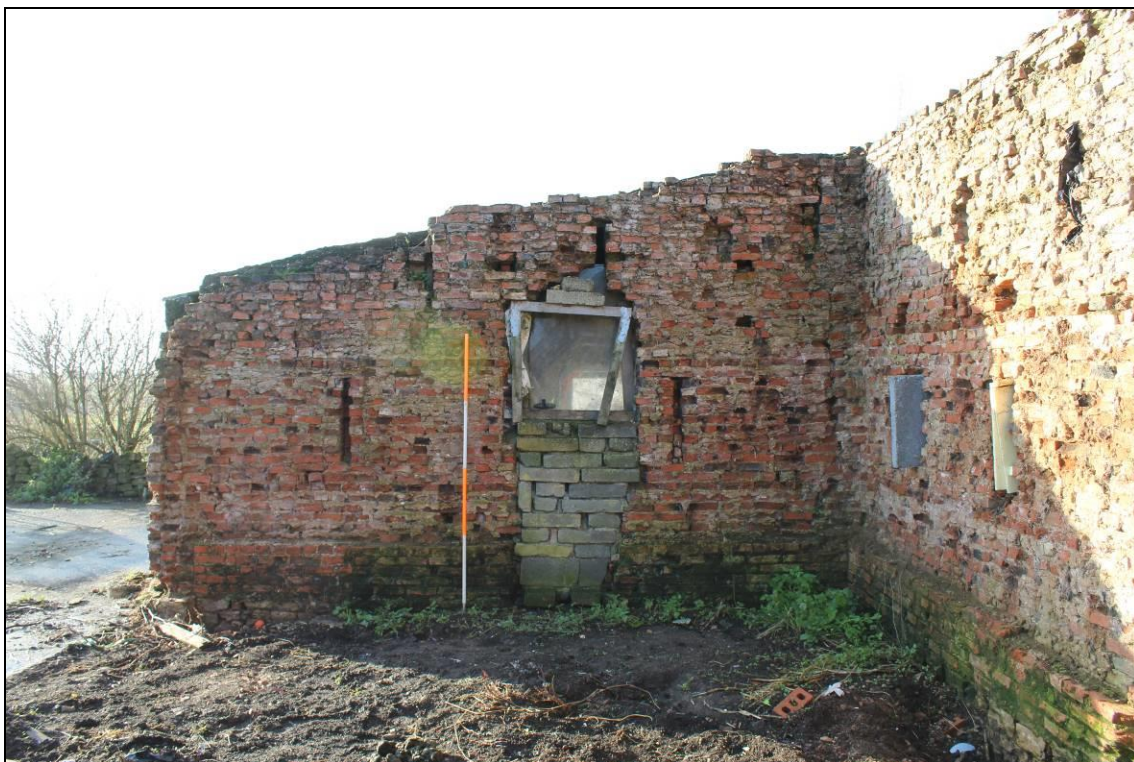
Plate 32: Building B1, western elevation: View west, 2m scale

- 6.3.4 The western wall survived for 10.69m north/south (Plate 32). Twelve ventilation slits were noted in the wall although the majority of these were blocked up with either foam insulation board or wooden batons. Within the central section of the wall was a large blocked up doorway approximately 1.3m wide and 2.2m high. Above the blocked-up doorway was a flat segmental brick arch.

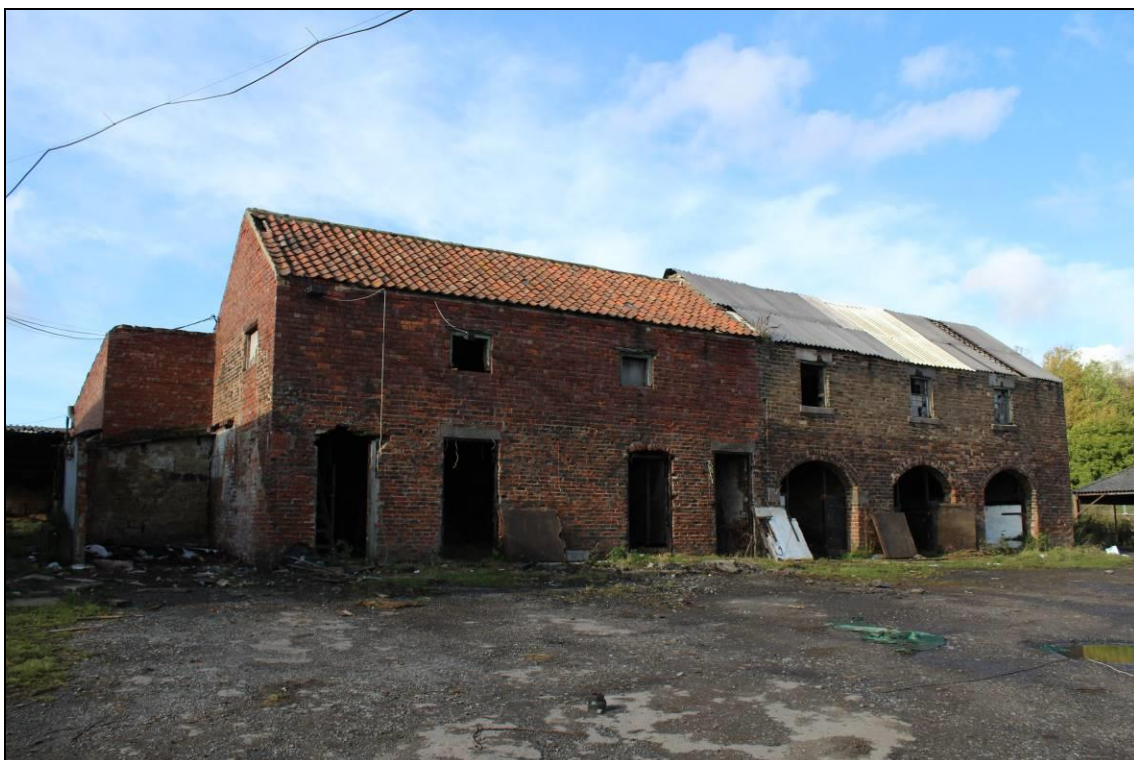
Plate 41: Building C1: stable block with hay loft above. Note brick scar and use of different bricks just above lintels of each doorway: view west, 2m scale

- 6.4.3 On the ground floor four doorways were observed each measuring c.1m wide. The lintel from the southernmost entrance has been removed with concrete lintels present in the 2nd and 4th doorways (from south to north). The third doorway retains its original segmental brick arch (Plate 41). An iron doorjamb was observed in all doorways that housed the stable doors that are no longer present. On the first floor two square timber framed openings were observed.

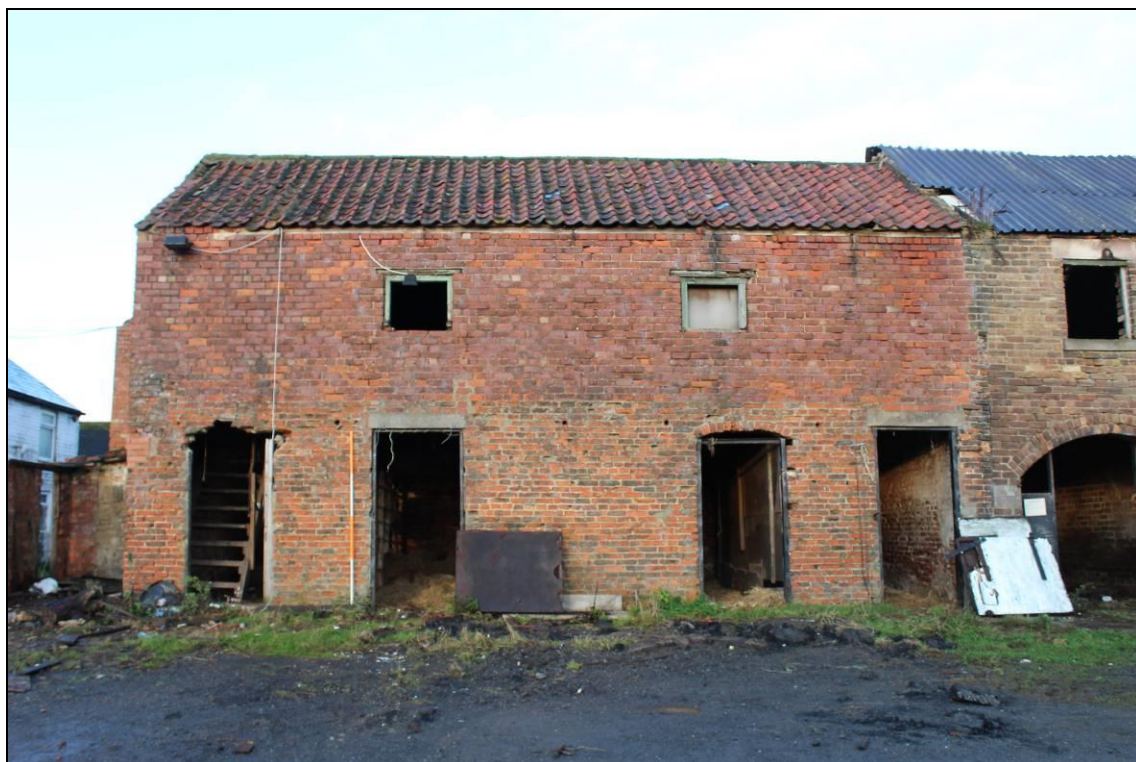
- 6.4.4 A change in the brick building material was observed approximately 34 courses above ground level with larger bricks used for the upper 24 courses. This suggests either the structure was originally a single-storey building and was extended upwards adding a first floor or alternatively the upper floor collapsed and the change in the brick building material represents the rebuilt section. Based on the material used it is likely the uppermost part of this building was constructed sometime during the 19th century. To the north of Building C1 is the later addition of Building C2 that has been keyed into the original masonry of Building C1. The internal elevation of Building C2 shows clearly that Building C2 is butting up against the earlier Building C1.

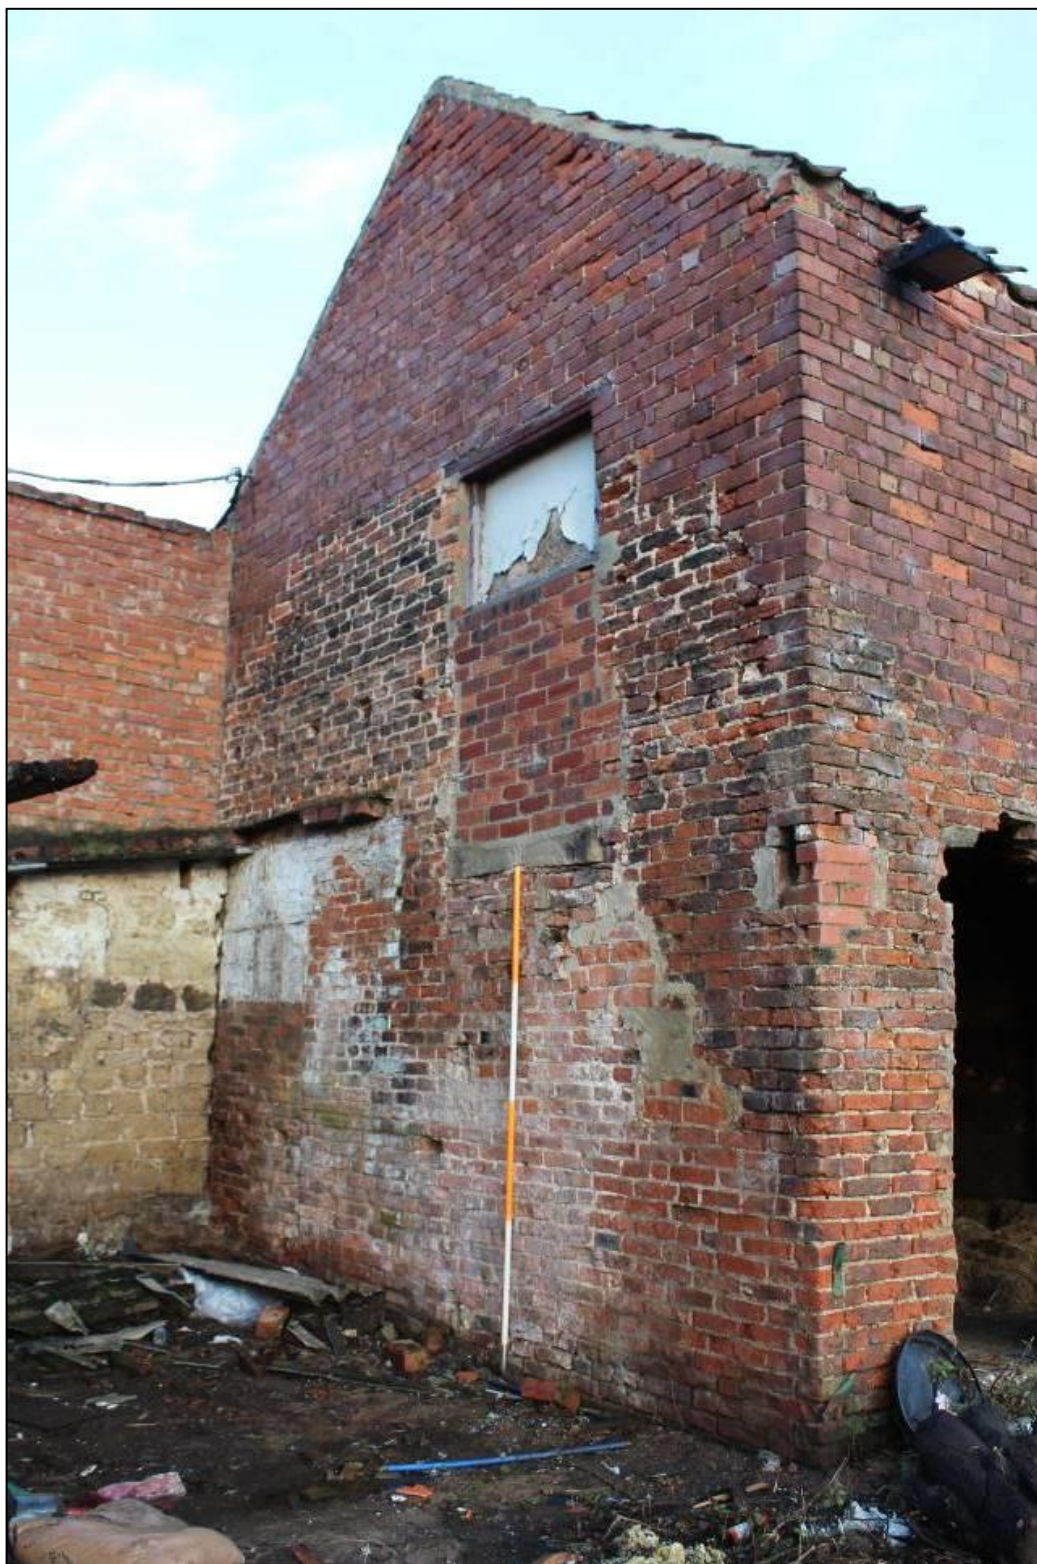
Plate 43: Northern elevation of Building C1: view southeast, 2m scale

- 6.4.6 The northern elevation of building C1 was mostly obscured by Building C2 (Plate 43) although a lime render was noted in one area. The western elevation was obscured by render on its

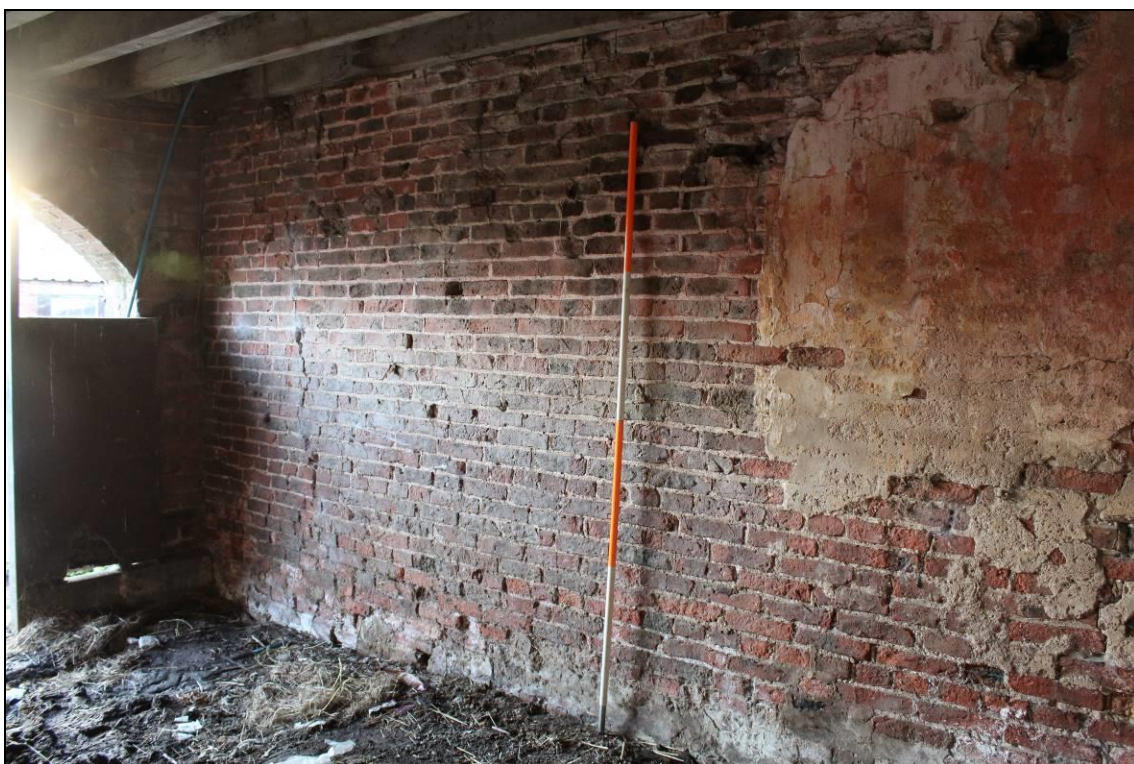
Plate 44: Building C1 western elevation (taken from inside Building C4). Note first floor pitching hole into hay loft: view southeast, 2m scale

lower courses however, a second pitching hole was recorded on the first floor as well as a blocked-up window (Plate 44).

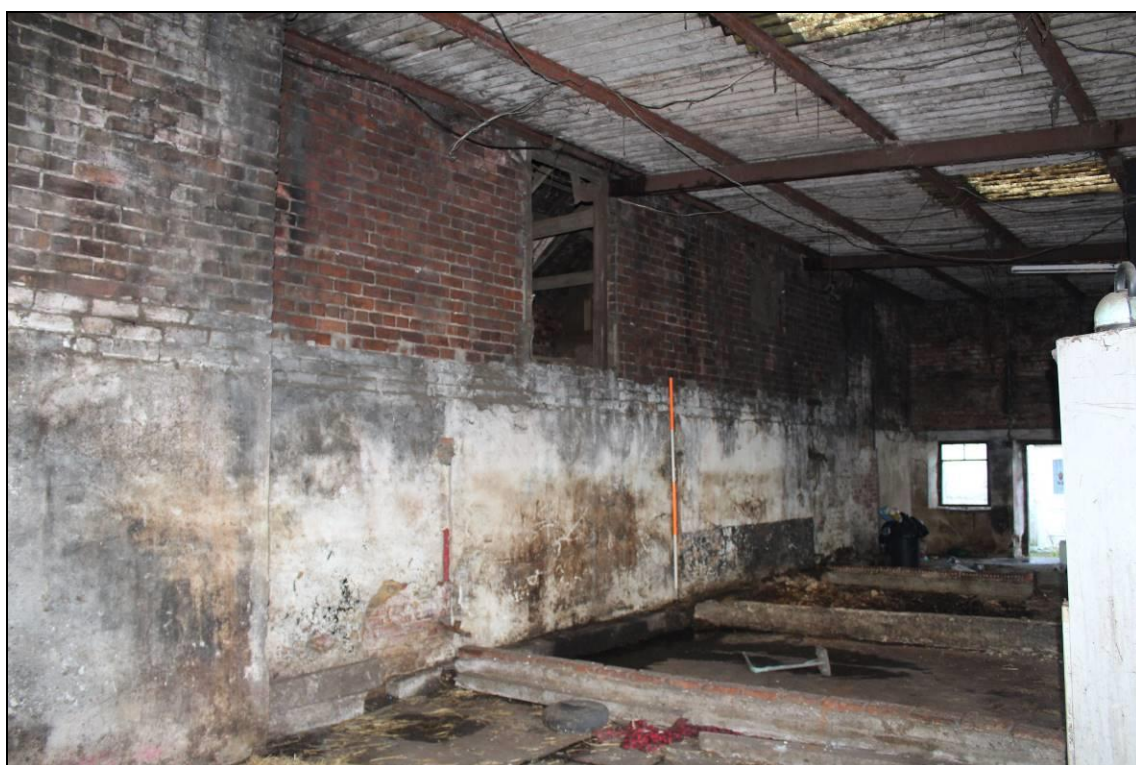
Plate 45: Building C1 internal: view southeast, 2m scale

6.4.7 Internally, the floor was mostly obscured by mounds of hay however small patches could be seen at the southern end comprising imprinted concrete with drainage lines (Plate 45). A timber staircase was observed at the southern end of Building C1 however, the timbers were heavily degraded and due to health and safety constraints the first floor of the building (including Building C2) could not be accessed.

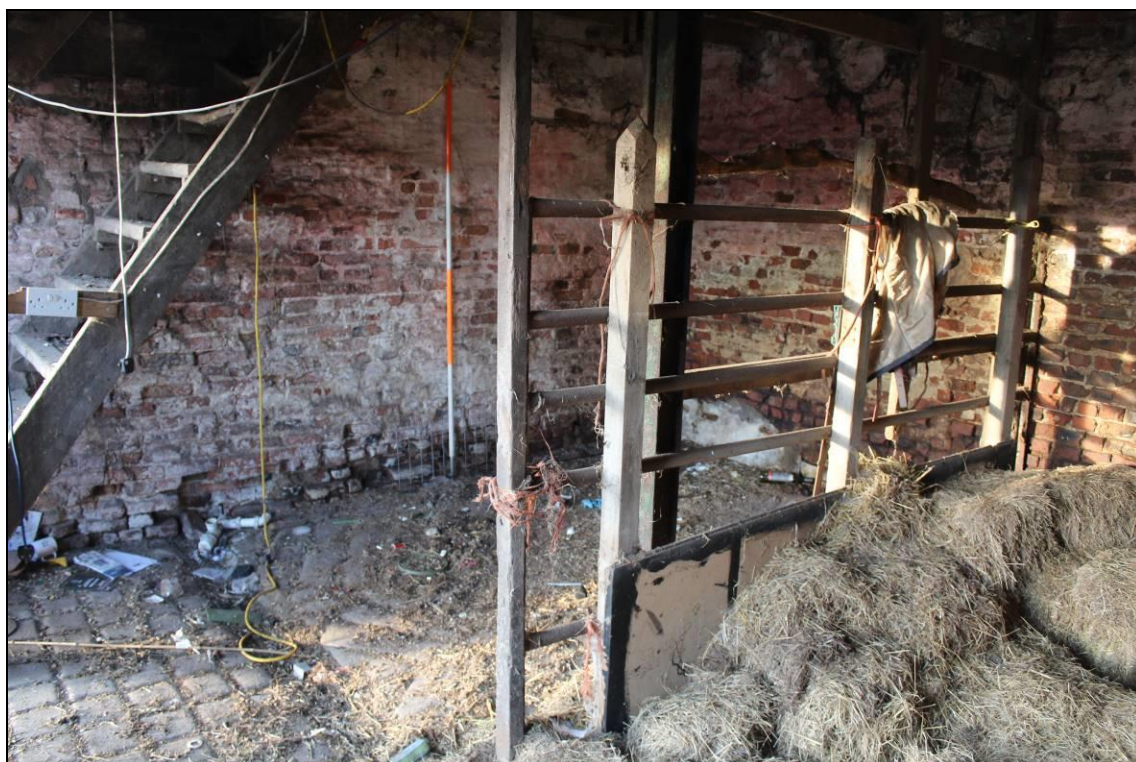
Plate 46: Building C2, hemmel/shelter shed with hay loft above: view west, 2m scale 2m

6.4.9 Building C2 was located to the north of Building C1 and comprised a brick built hemmel/shelter shed with a corrugated metal roof approximately 12.2m north/south by 5.65m east/west (Plate 46). The structure first appeared on the Ordnance Survey of 1897 (Figure 7) so must have been constructed between 1895 to 1896 (when the 1897 OS map was surveyed) as it does not appear on the 1895 edition.

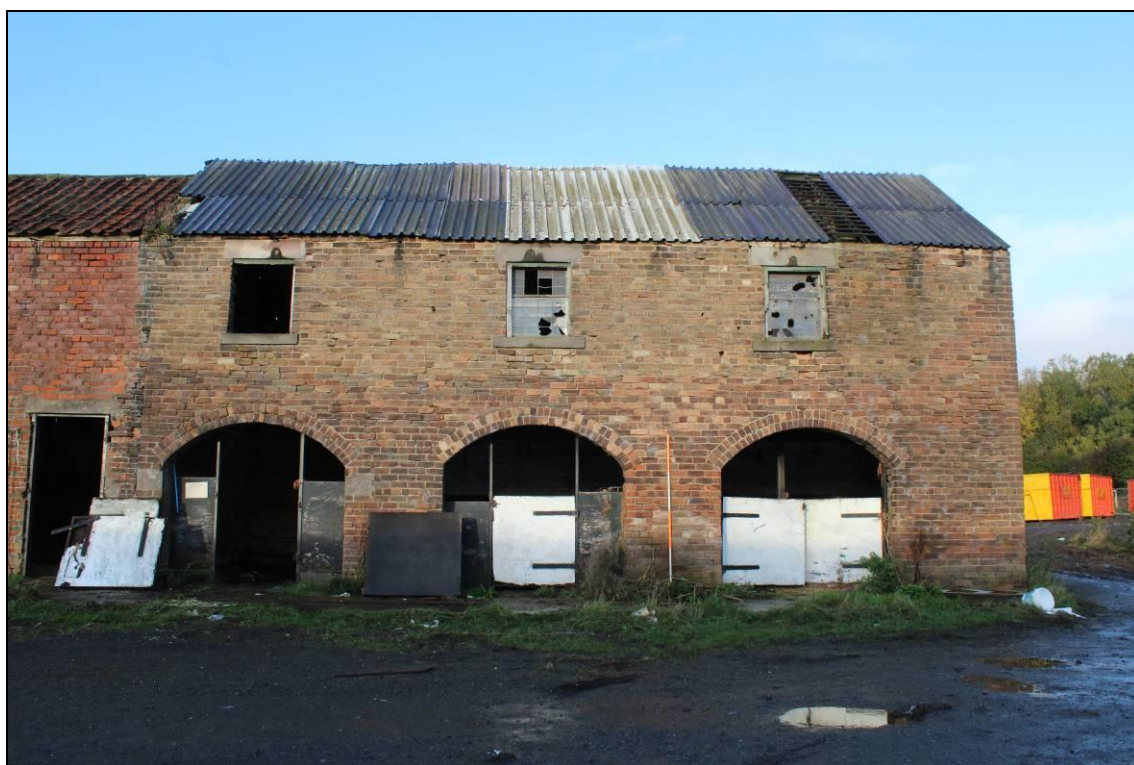
Plate 47: Building C2, northern elevation: view south, scale: 2m

6.4.12 The northern elevation of Building C2 featured a window with concrete sill and lintel however, the original sash window did not survive (Plate 47). The western elevation was partially obscured by Building C4 however, a blocked-up pitching hole was noted on the first floor into the hayloft and a boarded-up window (Plate 48).

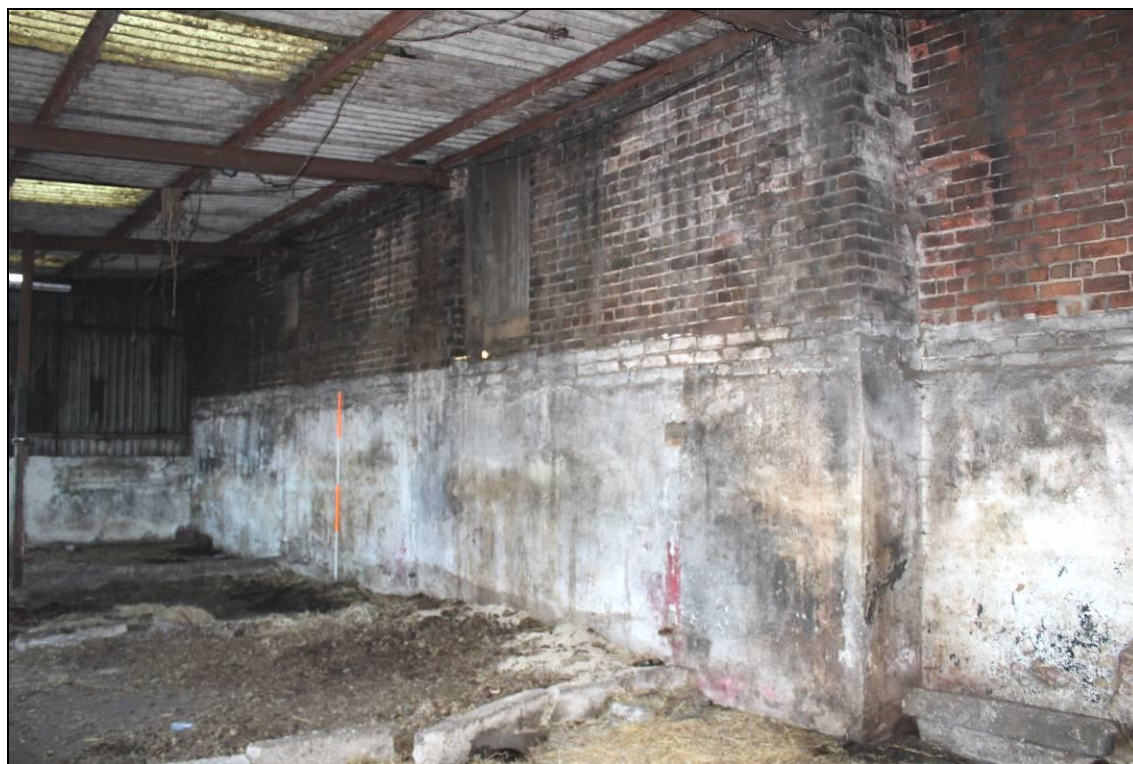
Plate 49: Building C2 interior (southern archway): view west, 2m scale

6.4.13 As mentioned above, the first floor of Building C4 could not be accessed due to the poor condition of the timber staircase in Building C1. On the ground floor the southern archway on the eastern elevation led into a 317m north/south by 4.96m east/west stable with dirt floor (Plate 49). The central and northern archways led into a larger stable area with central

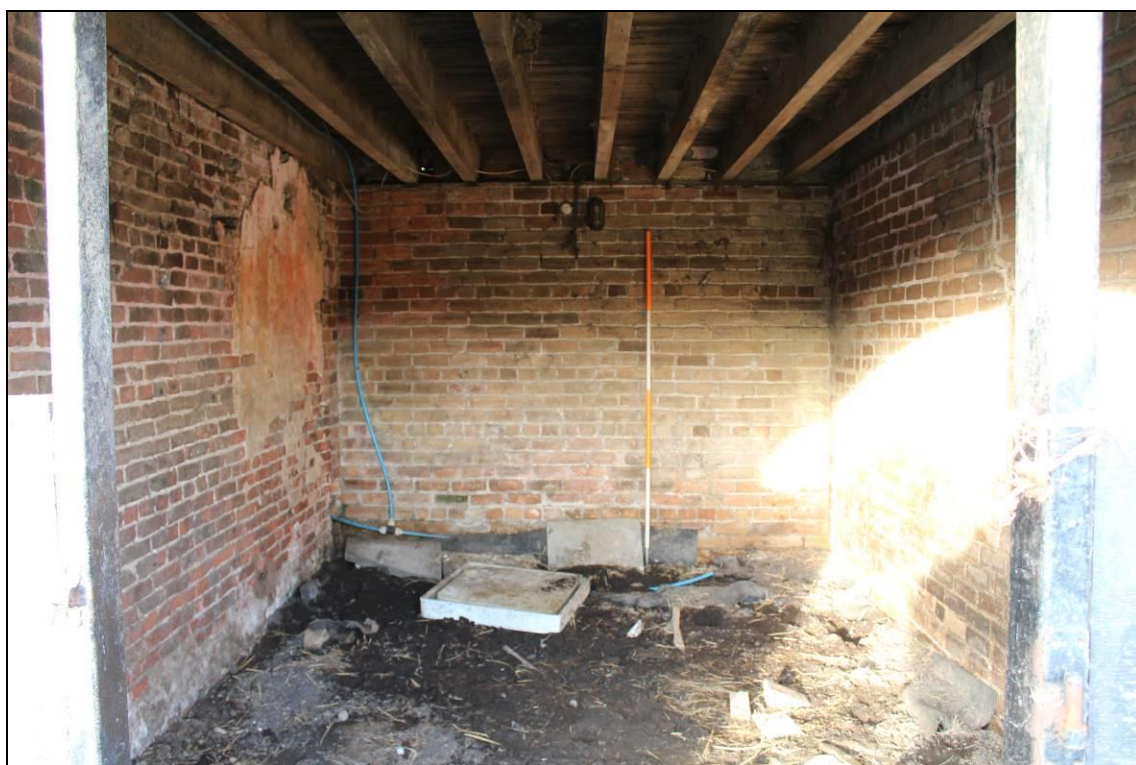
Plate 50: Building C2 interior (central archway and northern): view north, 2m scale

partition approximately 8.51m north/south by 4.96m east/west with a compact dirt floor noted throughout (Plate 50).

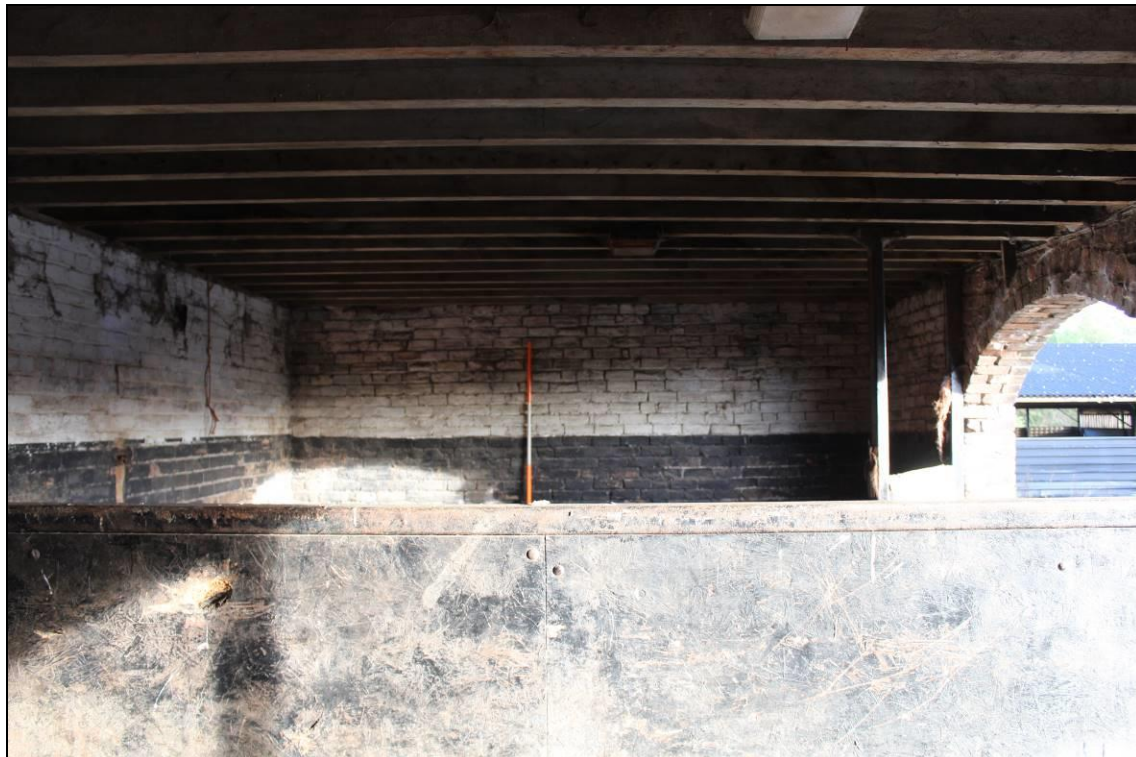
Plate 51: Building C3, (note original sandstone wall of Building C4 at rear): view west, scale: 2m

- 6.4.14 Building C3 was a small ancillary structure added to the southern elevation of Building C1 approximately 4.7m east/west by 2.7m north/south (Plate 51). Historic map regression suggested that this structure appeared at the end of the 19th century (Ordnance Survey of 1897; Figure 4). The roof has long since collapsed and only the southern wall survived (the northern wall formed by Building C1 and the western by C4). The sandstone wall of Building C4 (that can be seen in Plate 51) was part of an original farm structure and is discussed within the description of Building C4 below.

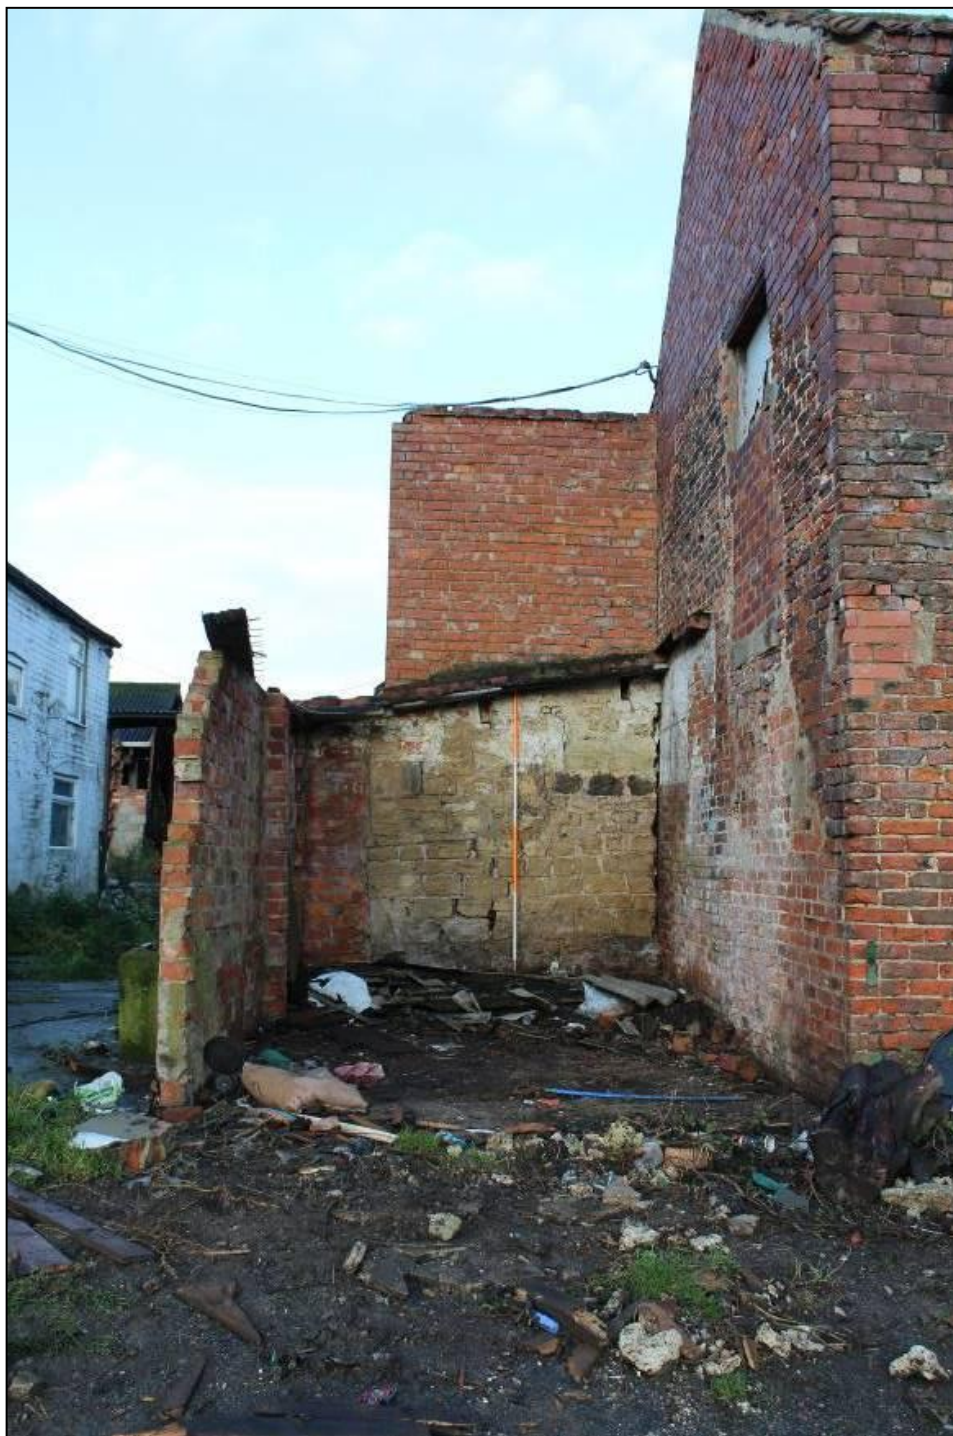
Plate 52: Building C4, west facing elevation: view southeast, 2m scale

- 6.4.15 Building C4 was located on the western side of Buildings C1 and C2 and first appeared on the Ordnance Survey of 1967 (Figure 7). The structure was roughly L-shaped and had been used as a stable block. As the structure was modern it was not recorded in detail with only areas containing parts of the earlier farmstead being noted (Plate 52 & 53).

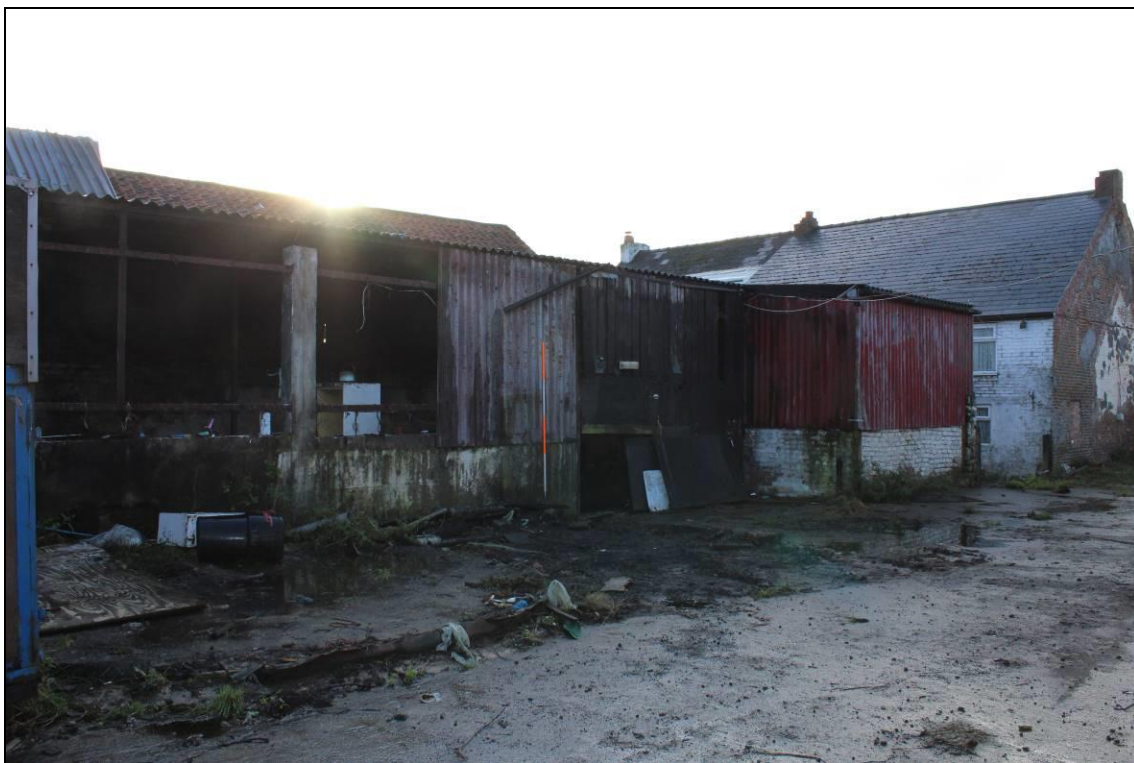
Plate 53: Building C4 interior: view north, 2m scale
