**HILL HOUSE FARM,
NEWTON AYCLIFFE,
COUNTY DURHAM,**

**HISTORIC BUILDING RECORDING
REPORT**

NOVEMBER 2019

Site Code: HHN19

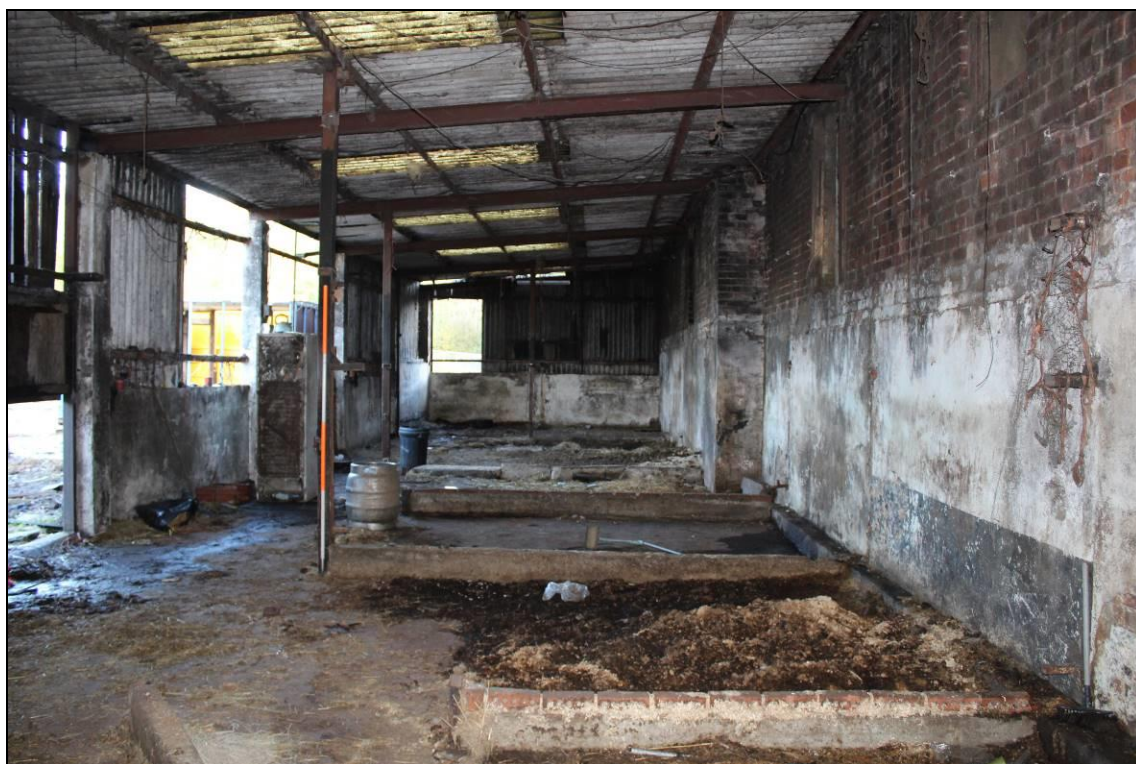
Plate 54: Building C4, south facing elevation (note original sandstone building fabric on lower courses): view northwest, 2m scale

- 6.4.16 Along the southern exterior wall of the stable block was a section of sandstone wall with doorway and window in the south-eastern corner (Plate 54, 55 & 56). It would appear that this was part of an earlier working building that was depicted on the tithe map of 1838 and the Ordnance Survey of 1858 (Figure 3) and survived until the Ordnance Survey of 1967 (Figure 7). The wall was 0.40m thick, 2.29m high and survived for 9.06m east/west. It was reused as part of the new stable block with the western and northern walls demolished during the construction of Building C4.

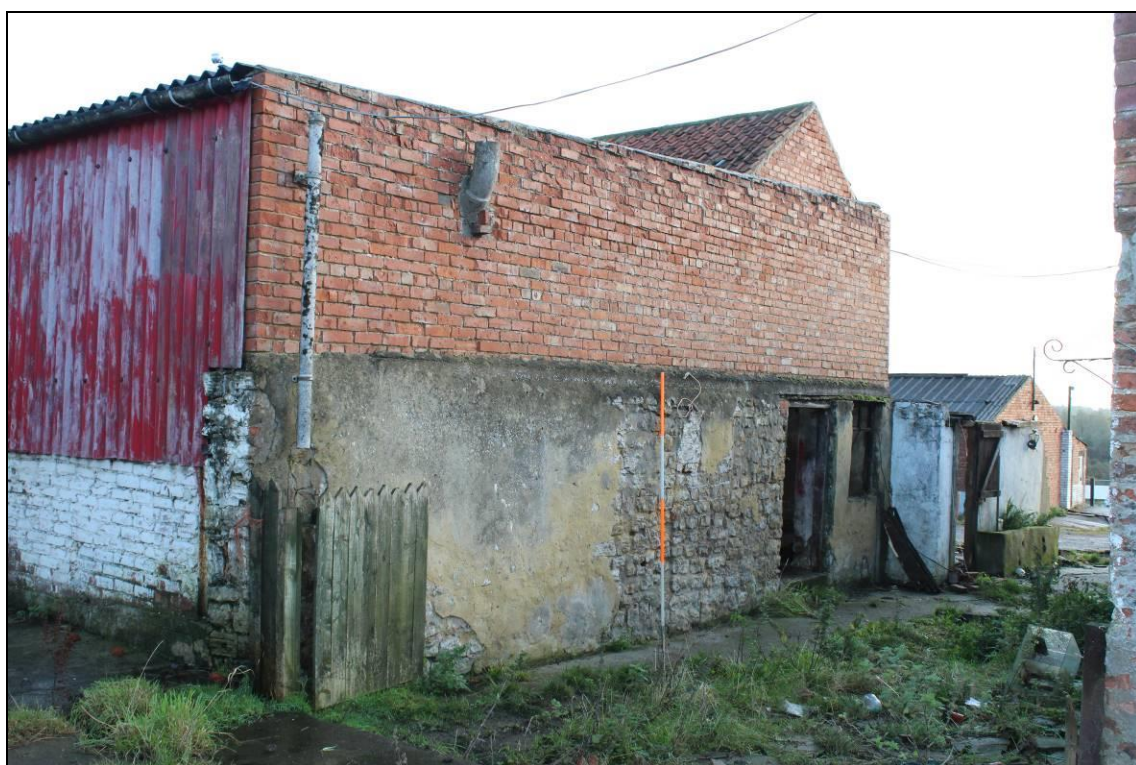
Plate 55: Building C4, southern elevation. Original doorway and window: view north, 2m scale

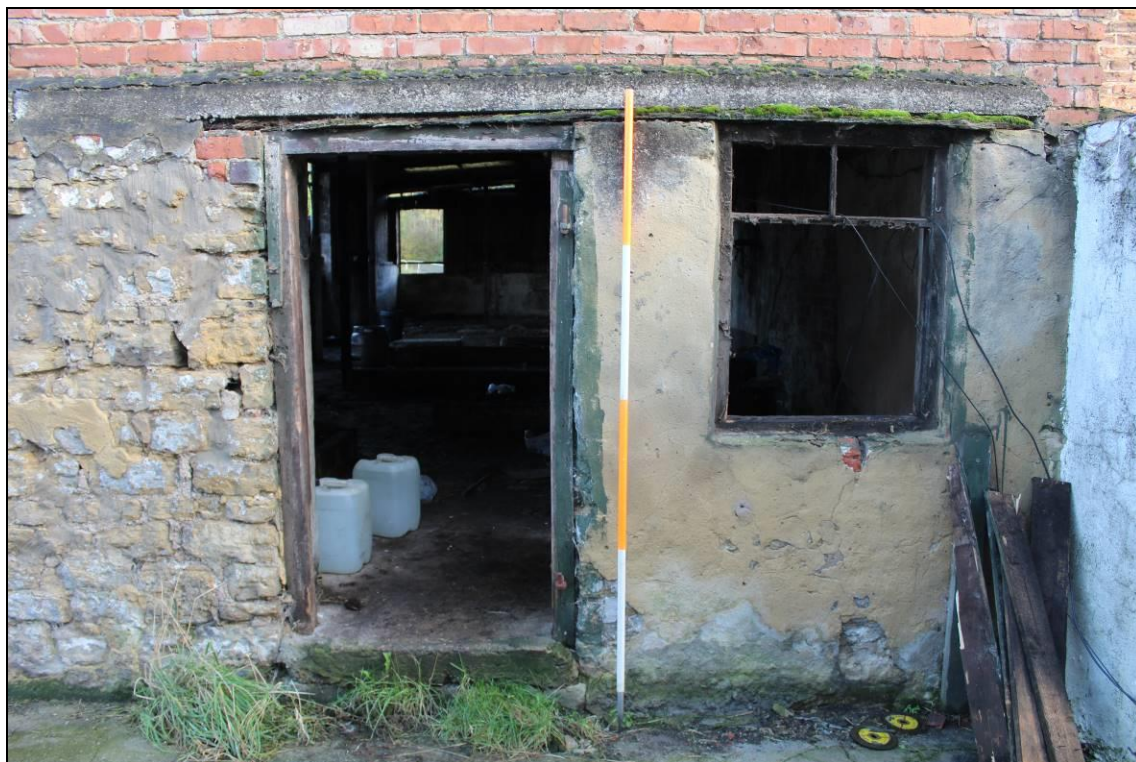
Plate 56: Building C4, internal, southern exterior wall: view south, 2m scale

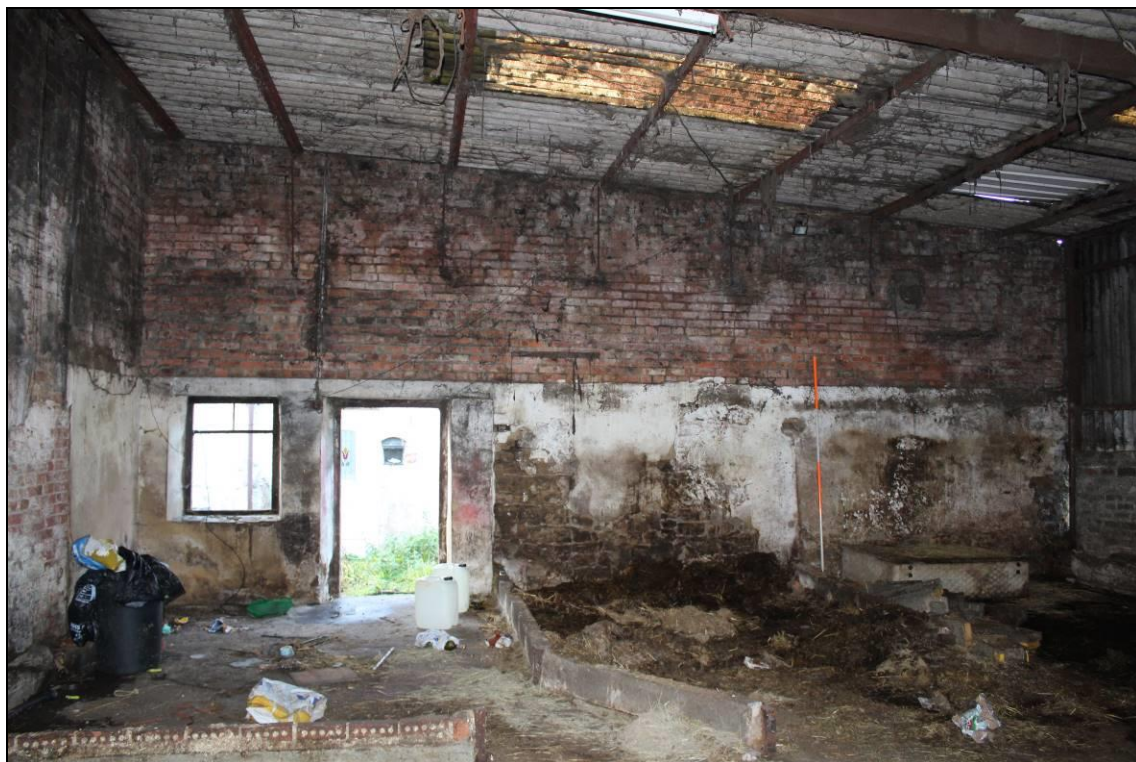
Plate 57: Building D: steel portal frame shed, view northeast

- 6.5.1 At the north-eastern corner of Hill House Farm were two steel portal frame shed comprising steel frame and asbestos sheeting roof. The sheds were constructed in the late 20th century and first appeared on the Ordnance Survey of 1992 (not reproduced in the figures). As they were of modern origin, they were not included in the historic building recording (Plate 57).

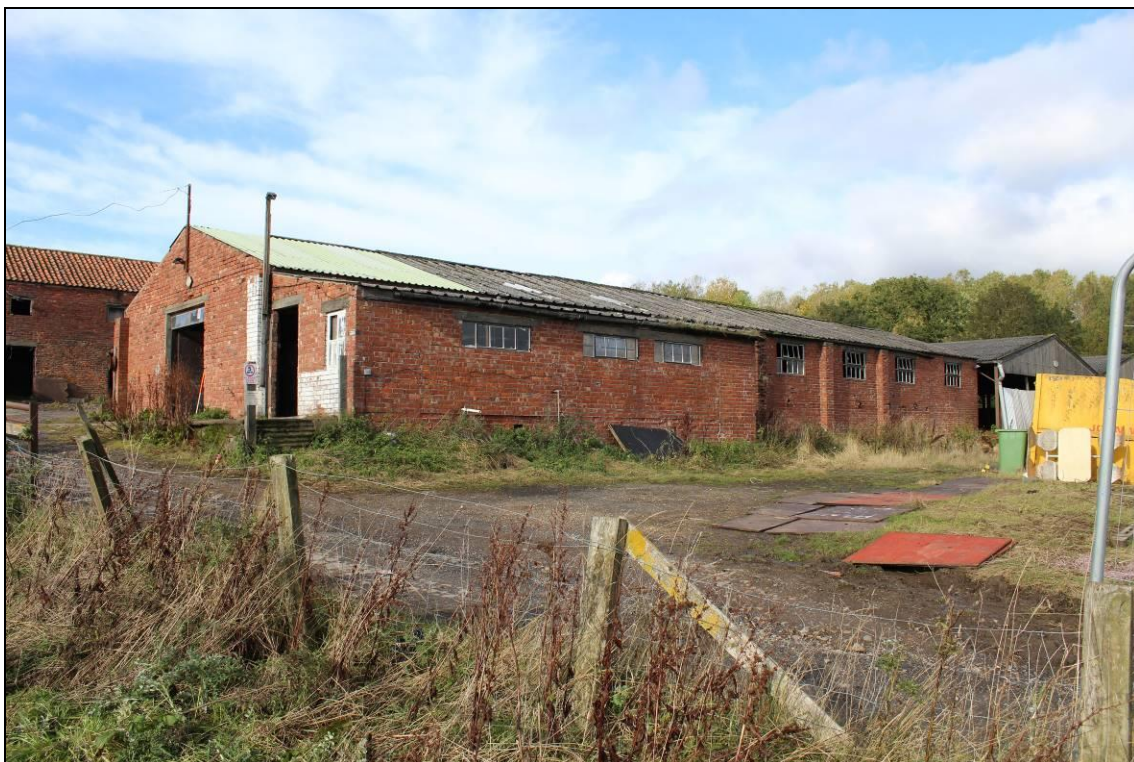
Plate 59: Building E: stable block. Western elevation: view northeast, 2m scale

- 6.6.1 Building E was a stable block located on the eastern side of Hill House Farm (Figure 2; Plate 58). It was constructed between 1939 to 1953 and first appeared on the Ordnance Survey of 1954 (Figure 6) therefore does not fall within the remit of this historic building recording survey. The building was constructed in brick stretcher bond with an asbestos sheet roof. A large double door was noted on the southern and northern walls with windows on the western and eastern elevations (Plate 59 & 60). Internally, the main section of the stable block comprised stalls for horses (Plate 61; the wooden partitions had been removed prior to the survey and stacked in the corner of the building). At the south-eastern corner of the structure

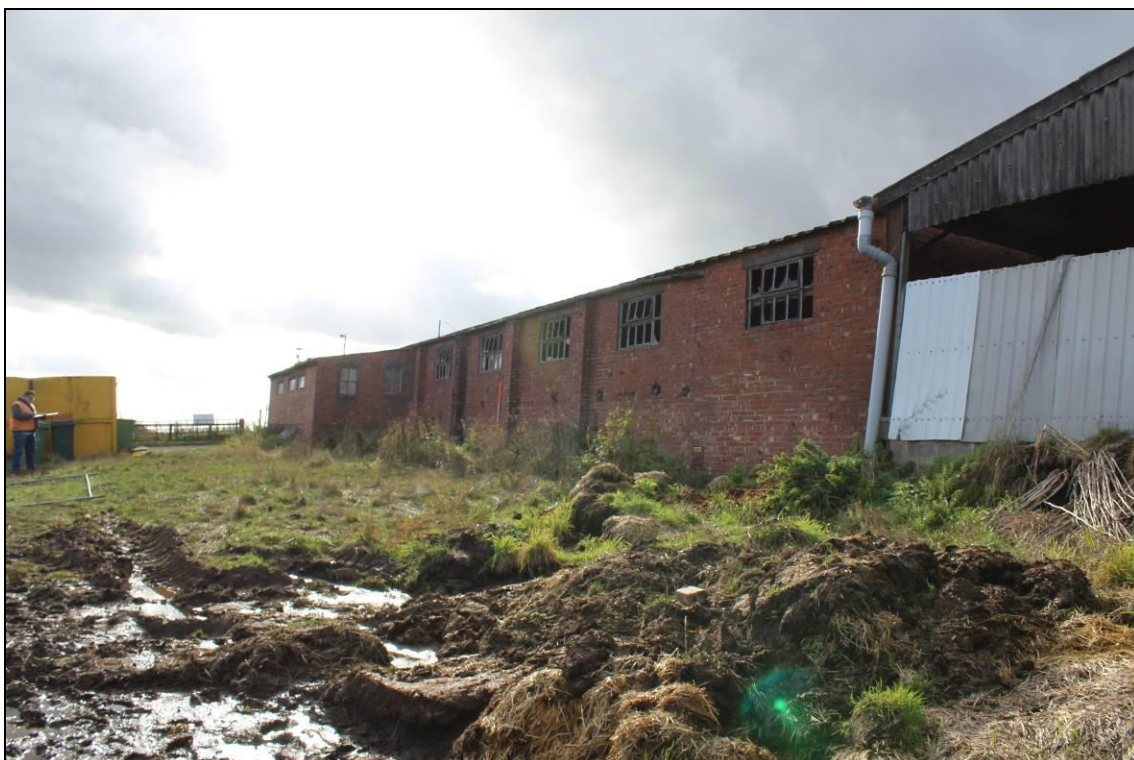
Plate 60: Building E: view southeast, 2m scale

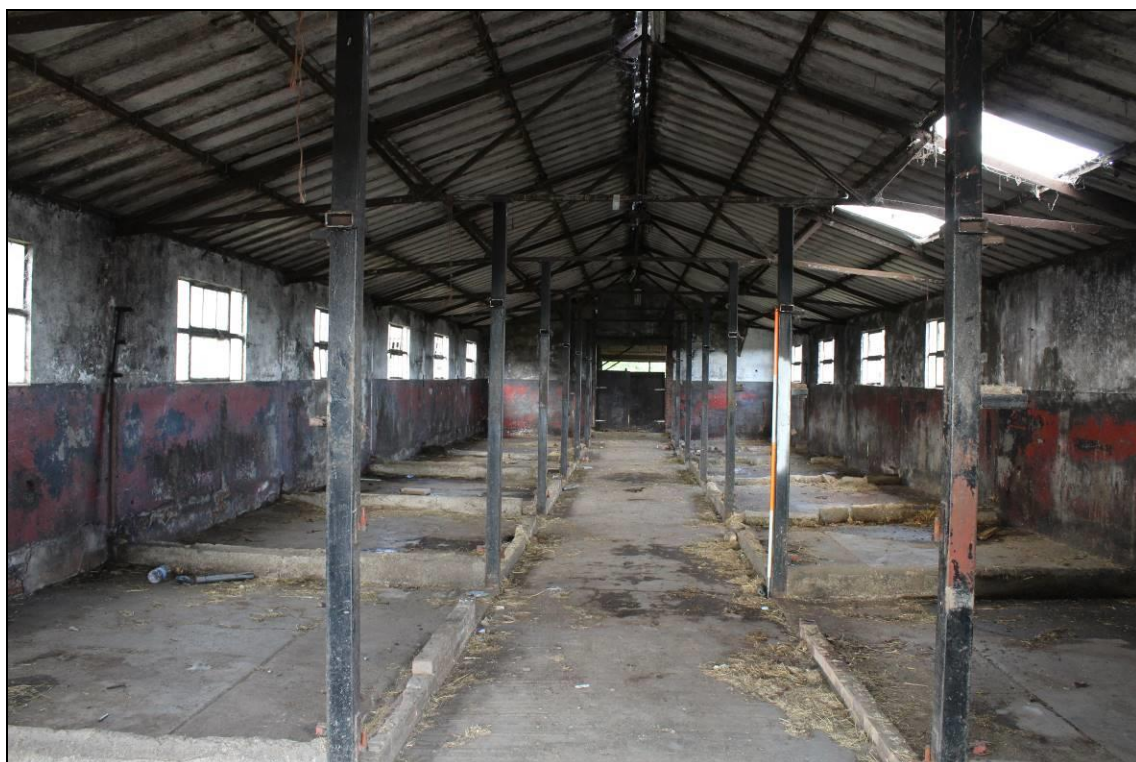
Plate 61: Building E: interior stable block: view north, 2m scale

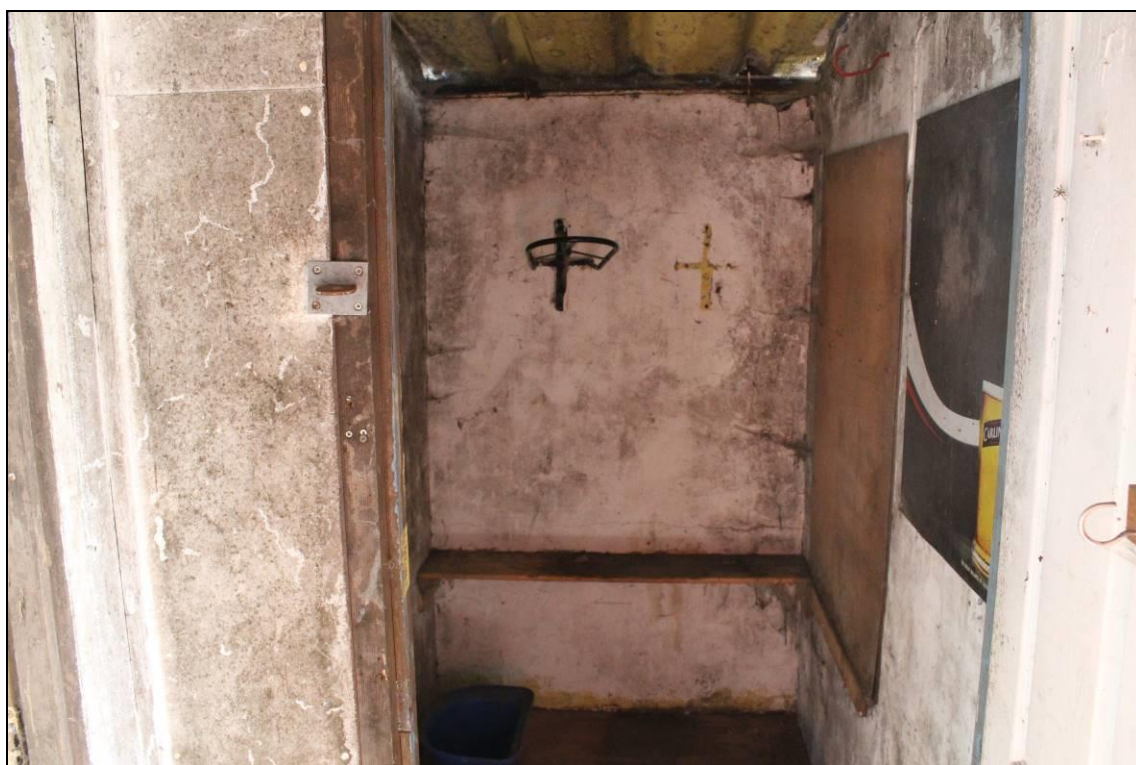
were four rooms. These comprised a storage area (Plate 62); two workshops/storage rooms (Plate 63 & 64) and an additional store at the rear (Plate 65).

Plate 62: Building E: Small storage room: view east

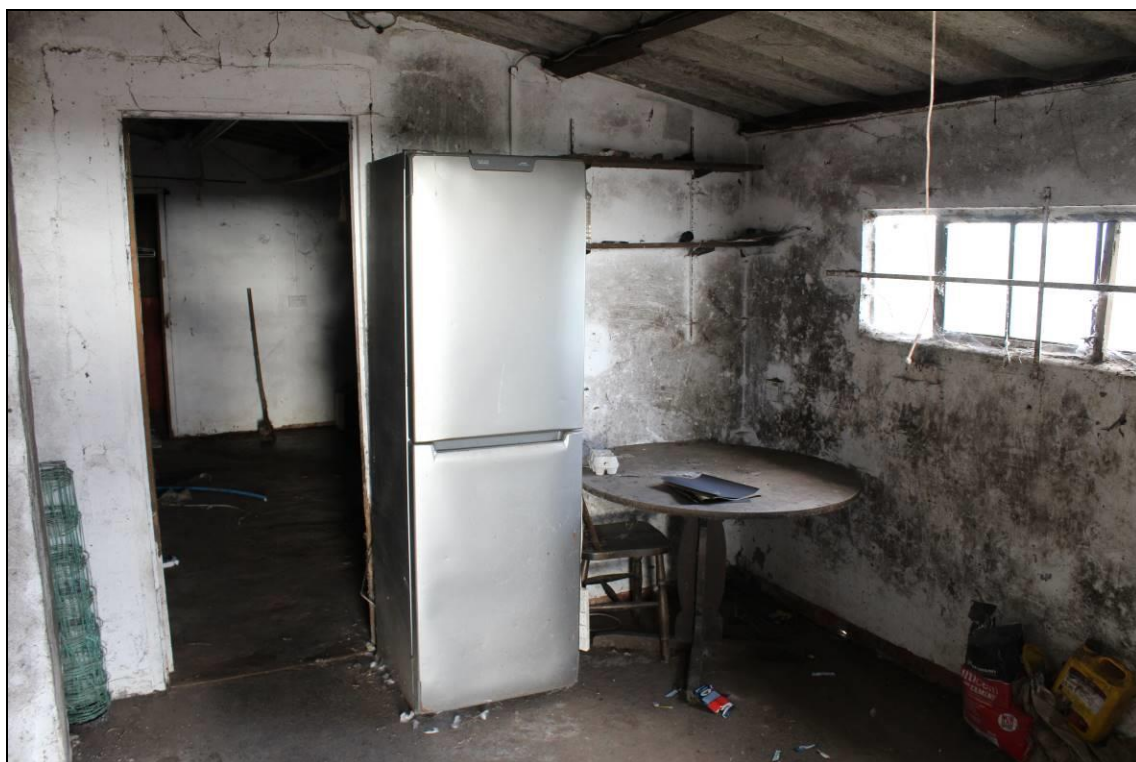
Plate 63: Building E: Room on eastern side: view northeast

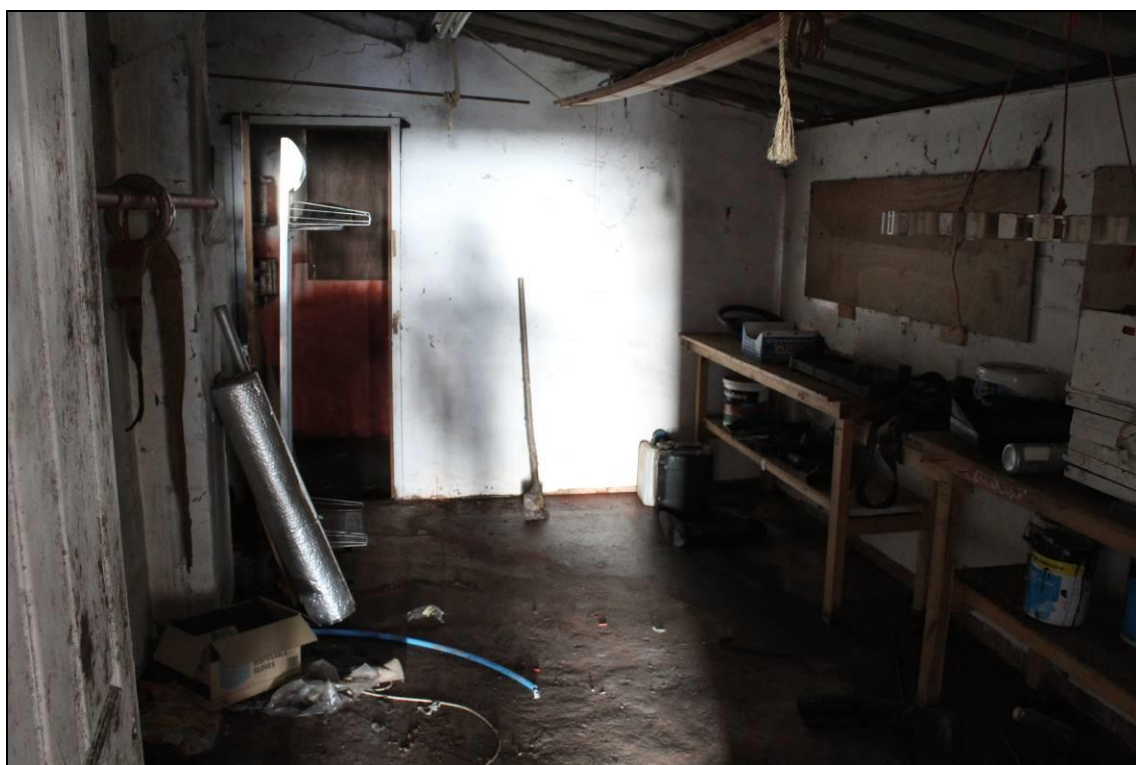
Plate 64: Building E: interior eastern room: view north

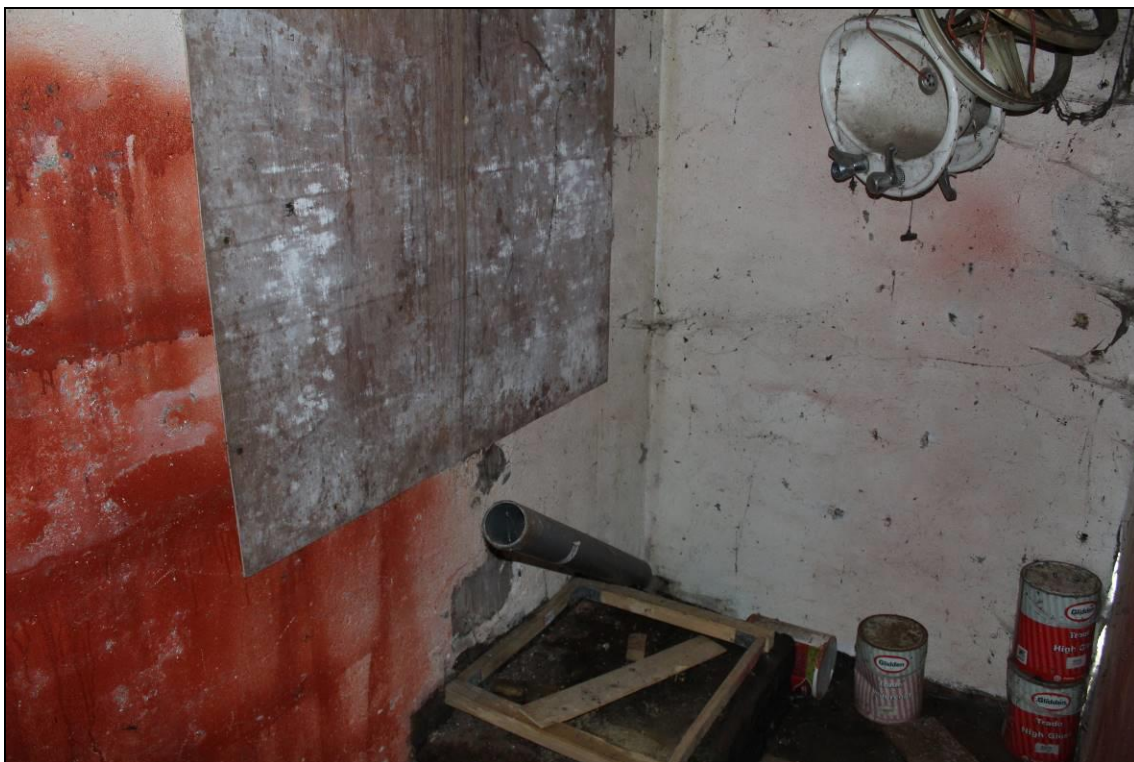
Plate 65: Building E: storage room: view northeast
