Land at Redrose Farm, Redrose Lane, Blackmore, Essex, CM4 0SA

An Archaeological Watching Brief on Geotechnical Site Investigation

Planning reference19/01013/FULLocal planning authorityBrentwood Borough CouncilPCA report no.R13891Site CodeBLARRF19PCA project noK6362DateOctober 19

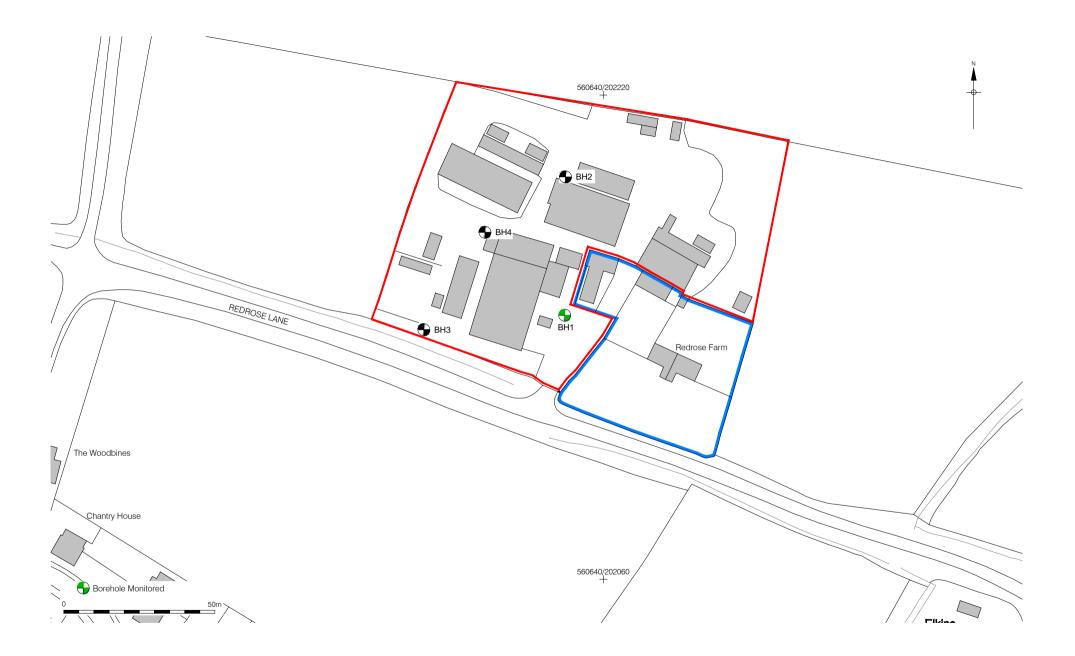
Ordnance Survey © Crown copyright 2019. All rights reserved. License number 100022432 © Pre-Construct Archaeology Ltd 2019 11/10/19 RM Figure 2 Detailed Site and Borehole Location 1:1,250 at A4 Site photographs

- 6.1 The proposed methodology of the archaeological work comprised the archaeological monitoring of geotechnical boreholes (Figure 2). A one day monitoring visit was agreed by Archaeology Collective and ECC.
- 6.2 One geotechnical borehole was monitored (BH1). The borehole was located on the southern portion of the site (Figure 2).
- 6.3 The investigation of the potential archaeological features and deposits was restricted due to a nature of borehole.
- 6.4 All recording systems adopted during the investigation were fully compatible with those most widely used elsewhere in Essex; presented in PCAs Operations Manual 1 (Taylor & Brown 2009, updated 2018). A series of digital photographs recording the encountered deposits a written record of each deposit was also produced. The boreholes were located by offsetting from the internal walls and plotted onto OS mapping data by CAD.

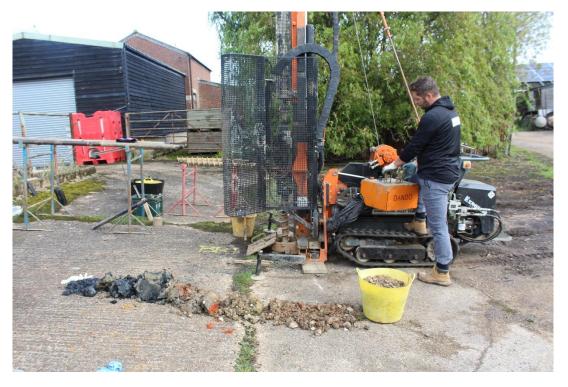
Plate 1: Borehole 1 drilling, looking north

- 7.1 A sequence of two made ground deposits was revealed beneath thick concrete slab (0.30m). The upper layer [1] was a compacted demolition layer containing CBM rubble and contaminated by fuel. It was 0.30m thick). Below was [2], a dark silt with frequent CBM and also contaminated. Layer [2] was 0.40m thick.
- 7.2 The natural geology was present at 1.00m below ground level and comprised a compact greyish blue clay.
- 7.3 No archaeological remains could be identified within Borehole 1. The nature of the borehole allowed only a very limited observation but in the extent of BH1 no deposits other than modern were recorded.
- 7.4 It is possible that another form of investigation might reveal deposits and remains of archaeological value.

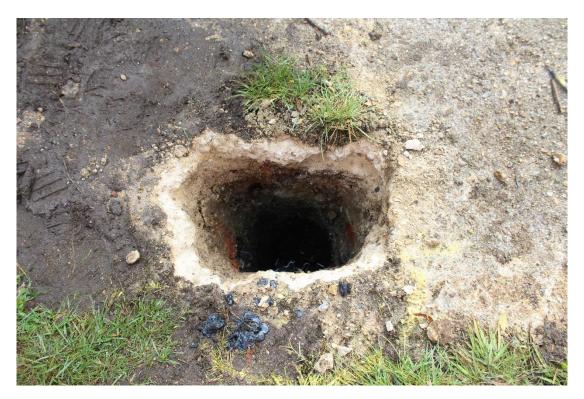
Plate 2: Borehole 1
