**RAVENSBURY ESTATE,  
RAVENSBURY GROVE, MITCHAM,  
MORDEN, LONDON BOROUGH OF  
MERTON:  
AN ARCHAEOLOGICAL  
ASSESSMENT**

**Assessment of an Archaeological Excavation at the Ravensbury Estate, Ravensbury Grove, Mitcham, Morden, London Borough of Merton CR4 4DU**

**Site Code: RVG19**

**Pre-Construct Archaeology Limited, November 2019**

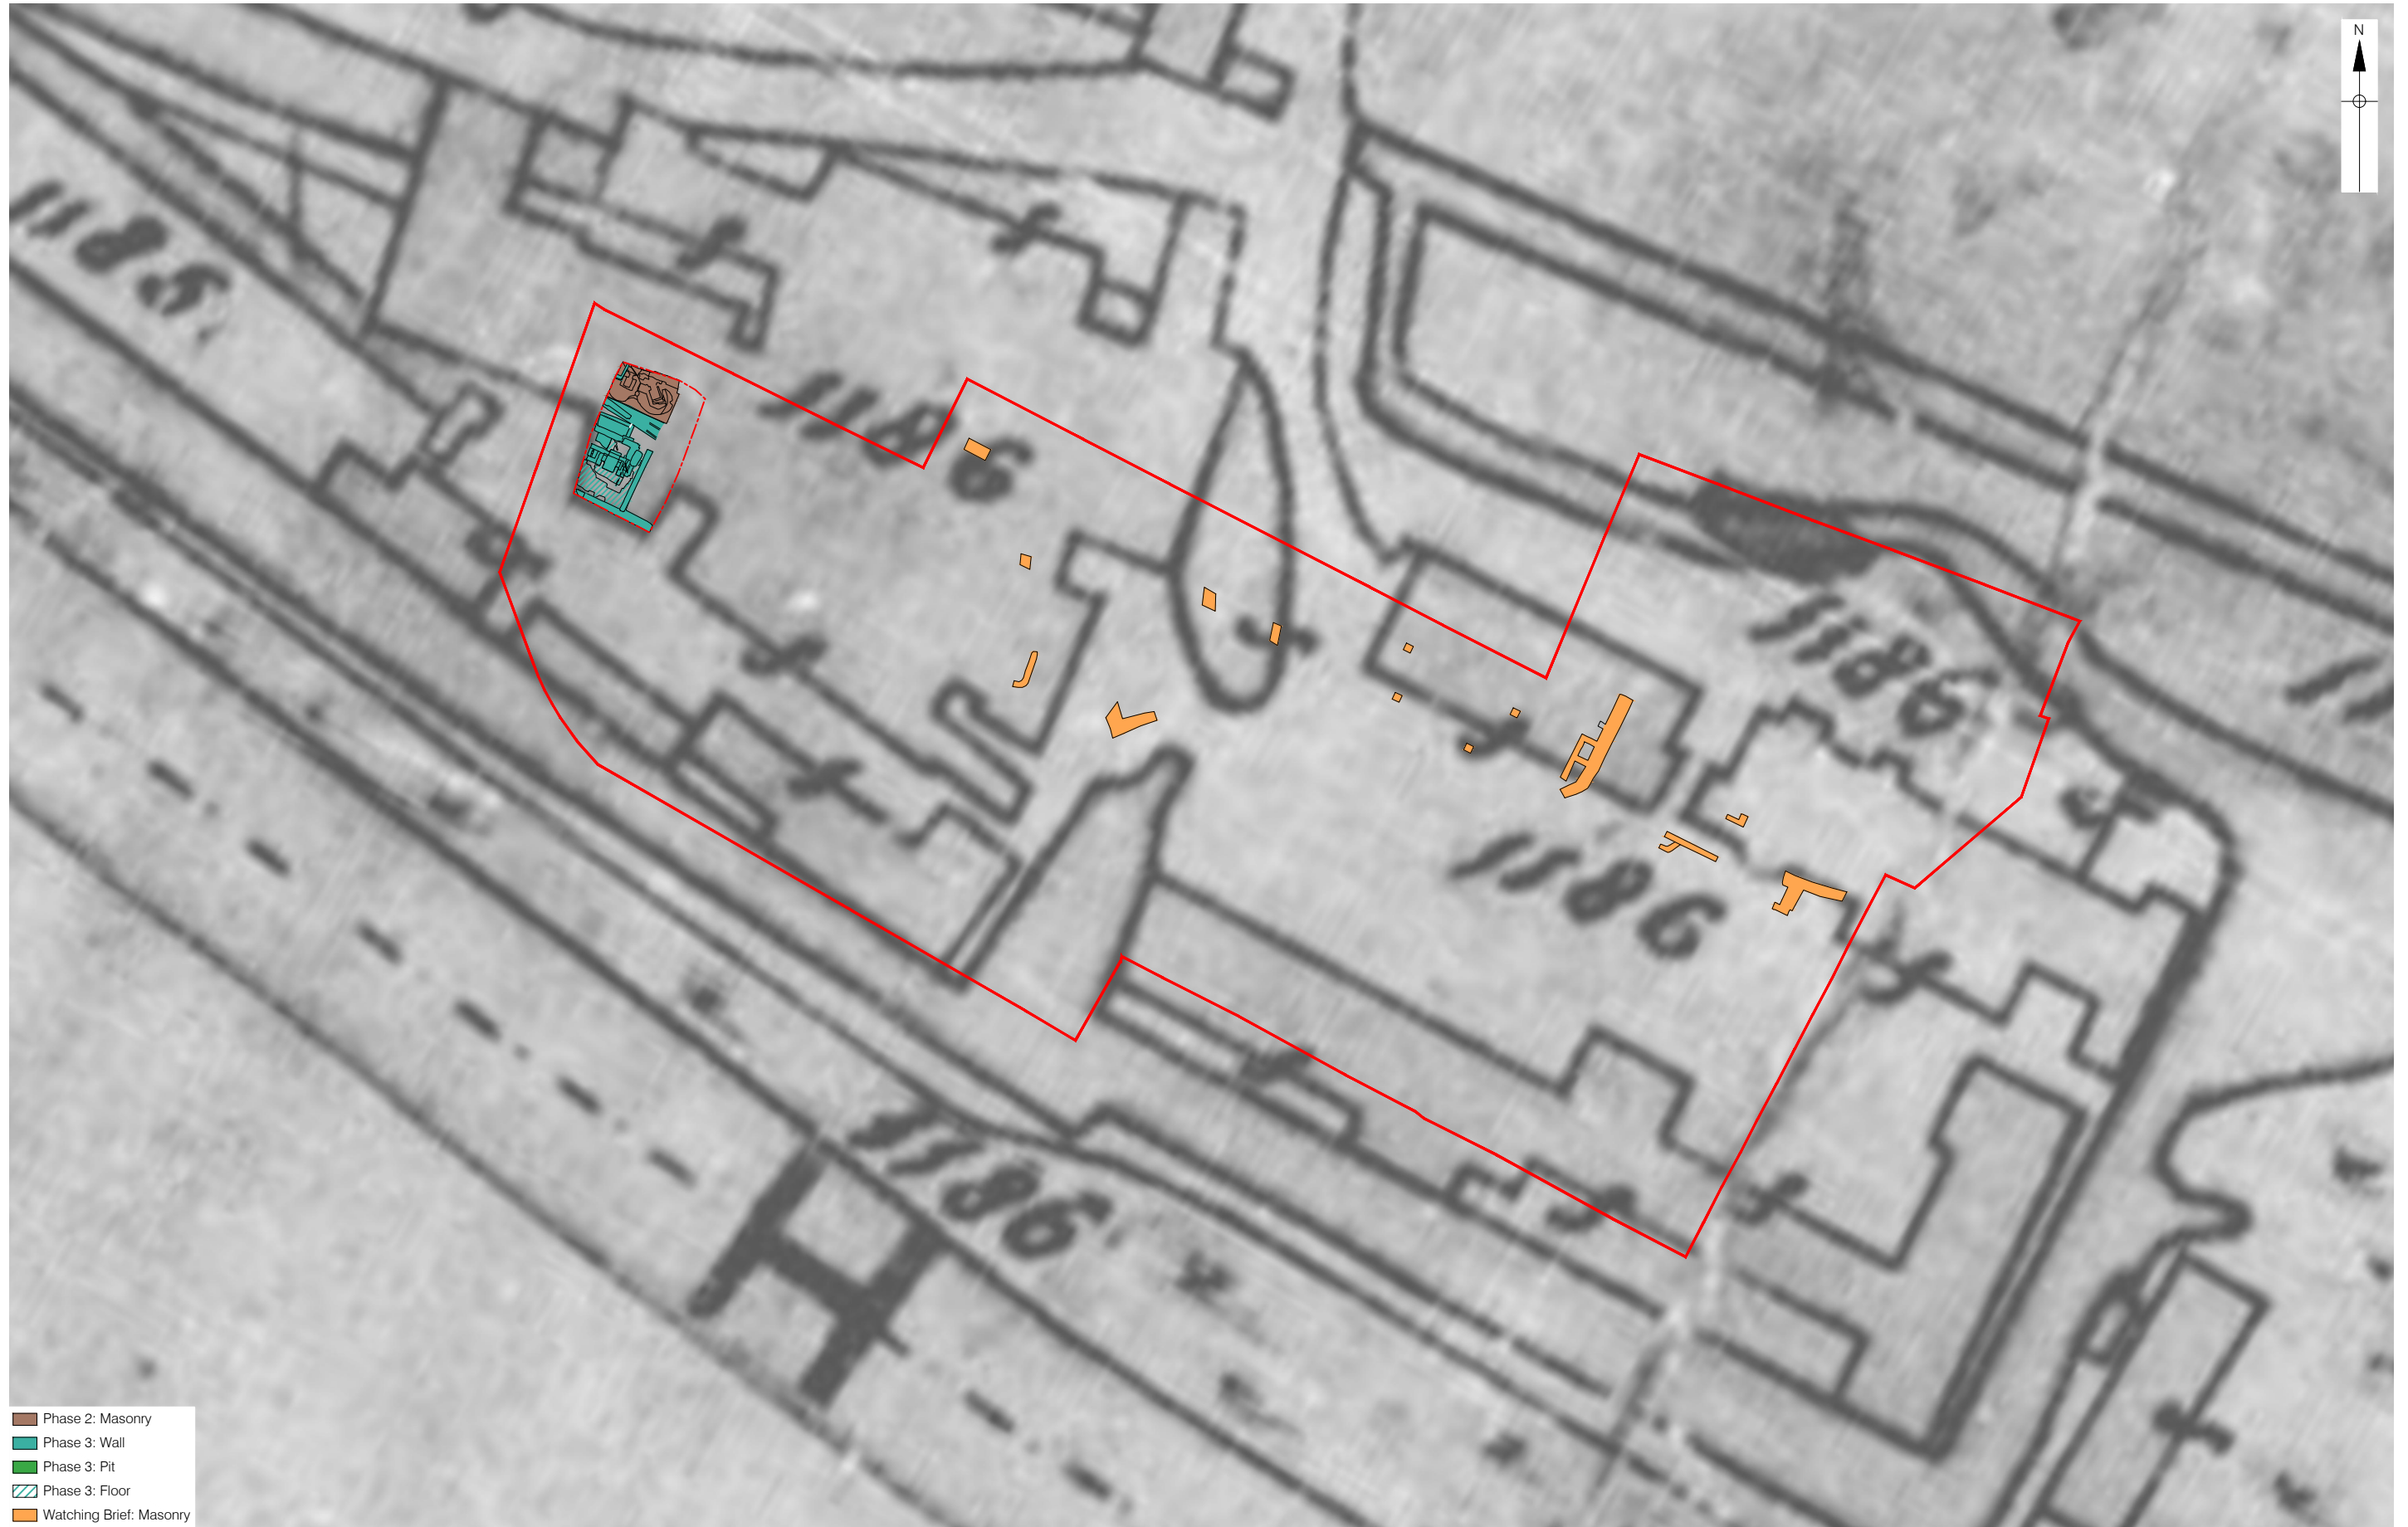
Figure 3  
All Features Plan  
1:250 at A3

- Phase 2: Masonry
- Phase 3: Wall
- Phase 3: Pit
- Phase 3: Floor
- Watching Brief: Masonry

### **7.2 Phase 2: Mid-Late 18th Century (Figures 3 and 4)**

### **8.1 Phase 1: Natural (Figure 3)**

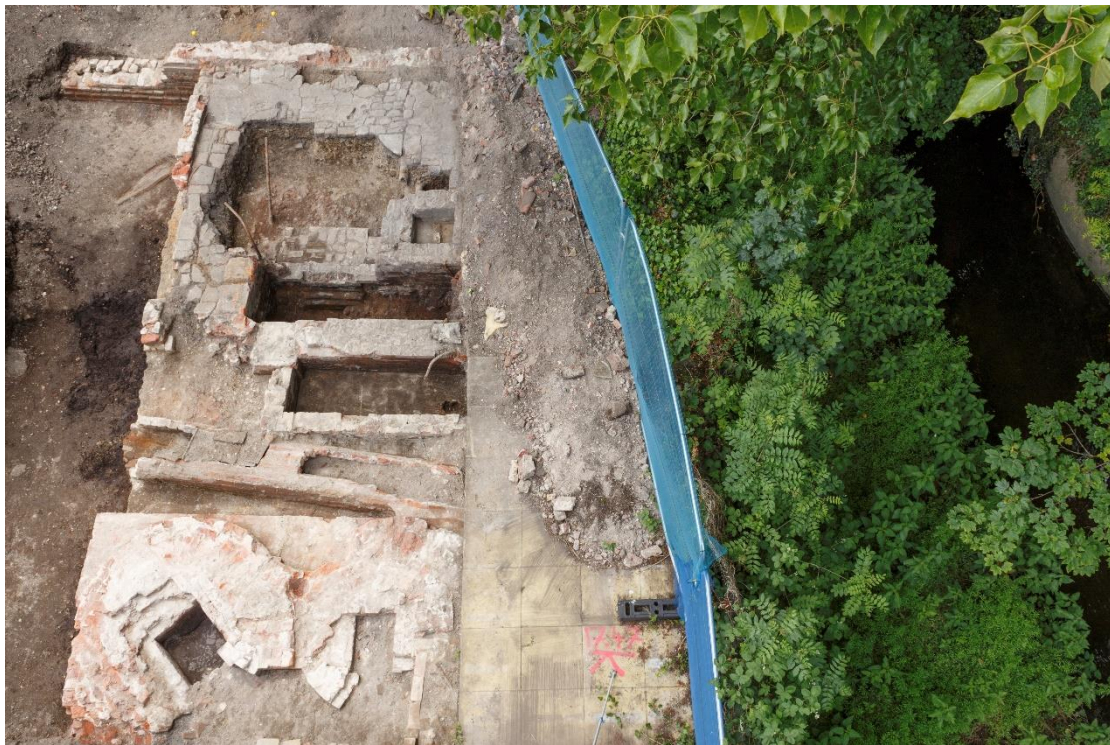
Plate 1: Overview of the excavation area showing the late 18th and 19th -century remains of the Mill from the Calico printing works, looking south-west.

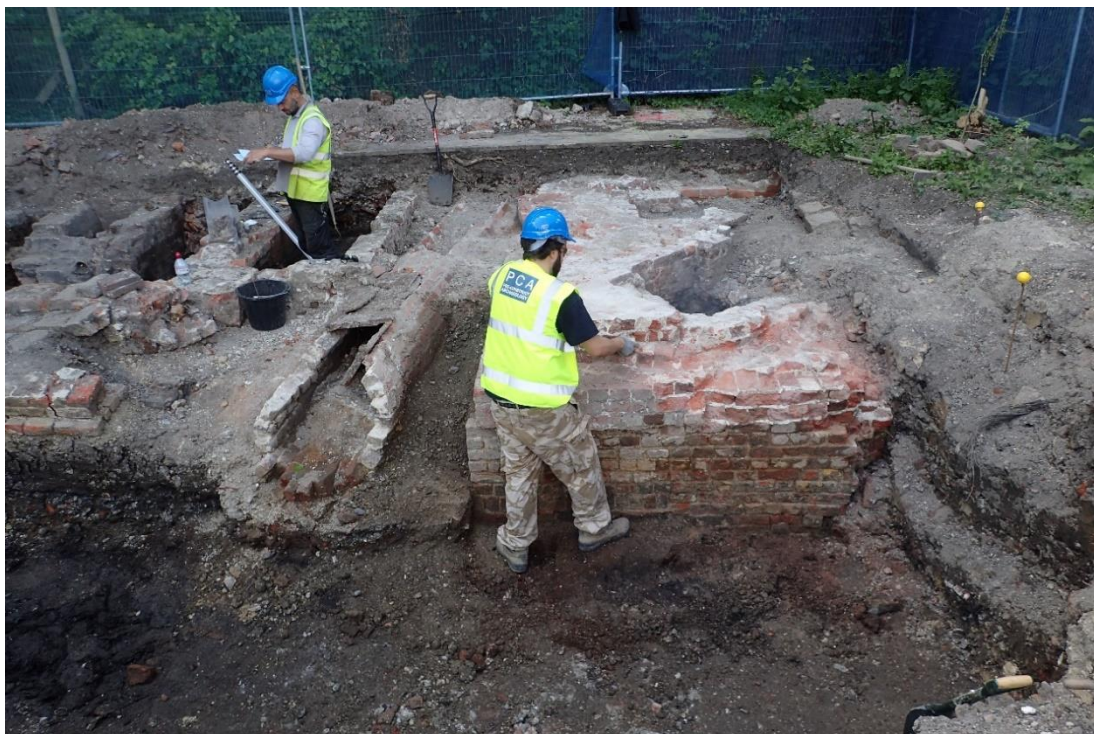
Plate 2: Phase 2 brick base foundation [140] and [126] to the dye furnaces, showing the slightly different alignment of the two parts of this structure, looking north-west.

7.2.1 The earliest feature in the north-west corner of the excavation site was a large solid red brick structure [140]/[126] which appeared to have two separate phases of construction. These appeared to have been built within a short timeframe as both were parts of the same feature which acted as a brick foundation to the dye furnaces. The lower part of the brick base [140] was 2.32m x 4.20m+ and 0.75m high and overlain by a second phase of solid brick construction [126] of similar size on a slightly different alignment (Plate 2). The handmade bricks used in the construction of this feature dated from between 1700–1900 using post great fire bricks and RVG1 indicative of a later 18th century date (Appendix 4)

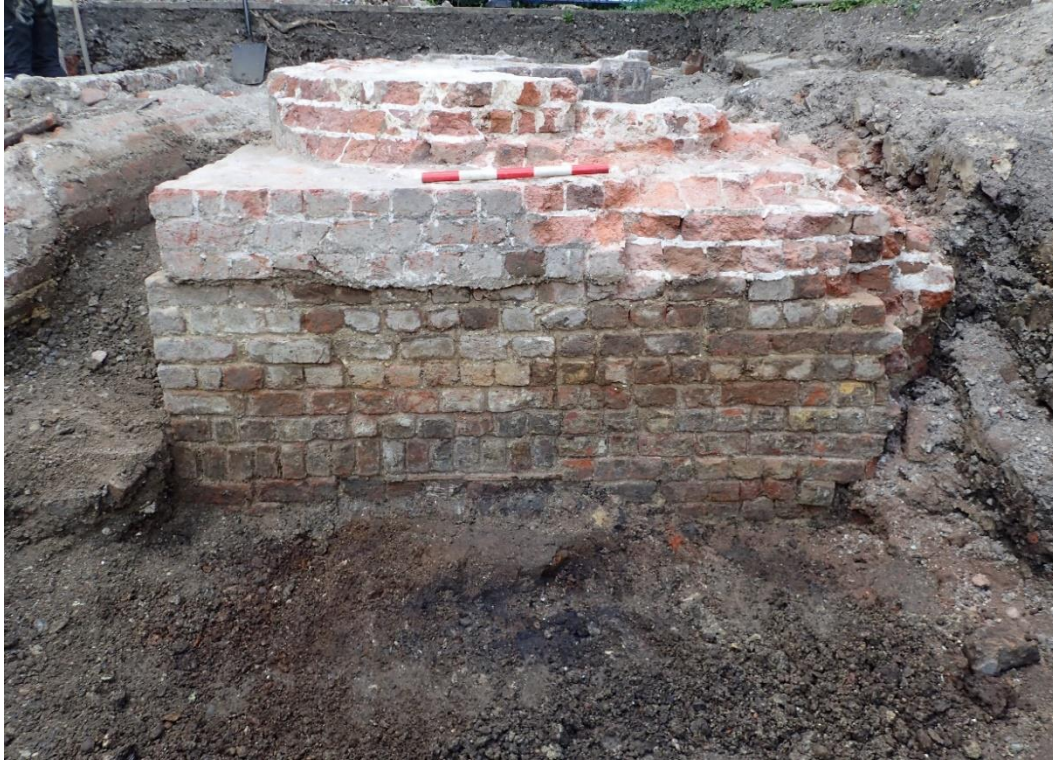
Plate 3: Detail of brick foundation [140] overlain by brick base [126] on a slightly different alignment and brick furnace [106]. Looking north-west. (0.5m scale)

7.2.2 Overlying the brick foundation base [140] were two brick floors [163] and [164] (Plate 3) which, due to being on the edge of the excavation area, were not investigated to their full extent. These floors were constructed of frogged post-great fire brick (fabric 3032) indicative of a later 18th -century date (Appendix 4).

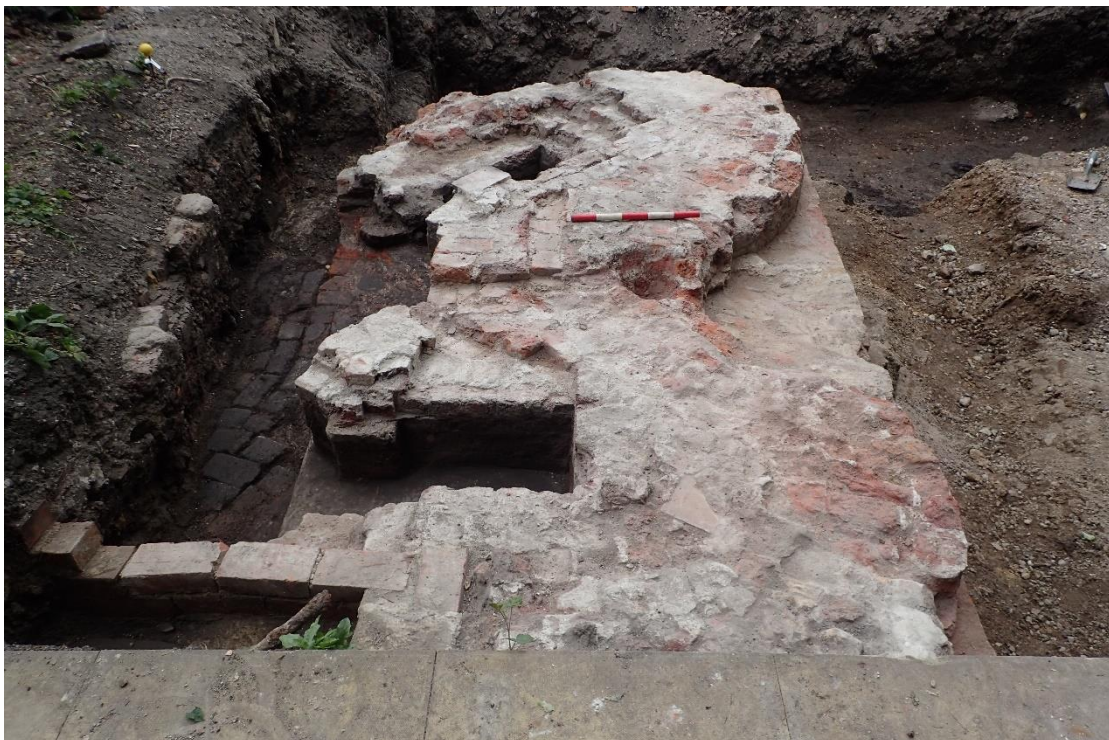
Plate 4: Overview of the two furnaces [105] and [106] used to extract dye for the printing works. Looking south-east. (0.5m scale)

7.2.3 Partially overlying brick floors [163] and [164] the second phase of the brick foundation/structure [126] incorporated two circular 'furnaces' [105] and [106] as part of the same structure (Plate 4), again likely to be later 18th century in date, constructed of gently frogged brick (fabric 3032, Appendix 4). Thought likely to be dye furnaces they were both constructed slightly differently. Base [105] was constructed entirely of brick with a rectangular insert facing in a north-west direction with a brick floor. Base [106] was also constructed of brick but with a stone base included at the time of construction. The alignment of the insert in furnace [106] faced directly north but both inserts fed into a brick-lined channel or path [163/164] used to gain access to the furnaces (Plate 3). The full extent of this path/channel was not investigated as it ran beyond the LOE.

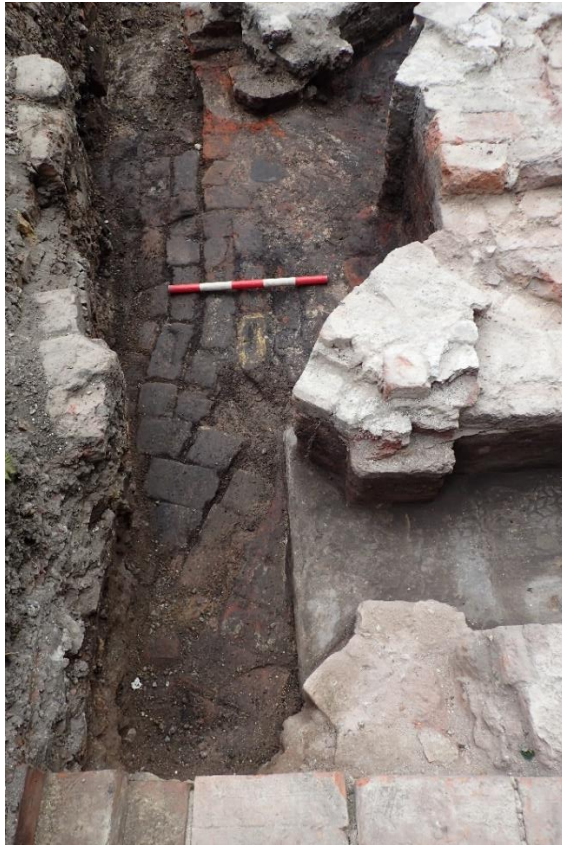
Plate 5: Dye furnaces [106] showing the brick buttresses at the entrance to the flue/rake-out pit, leading to a brick-lined floor [163/164]. Looking south-east. (0.5m scale).

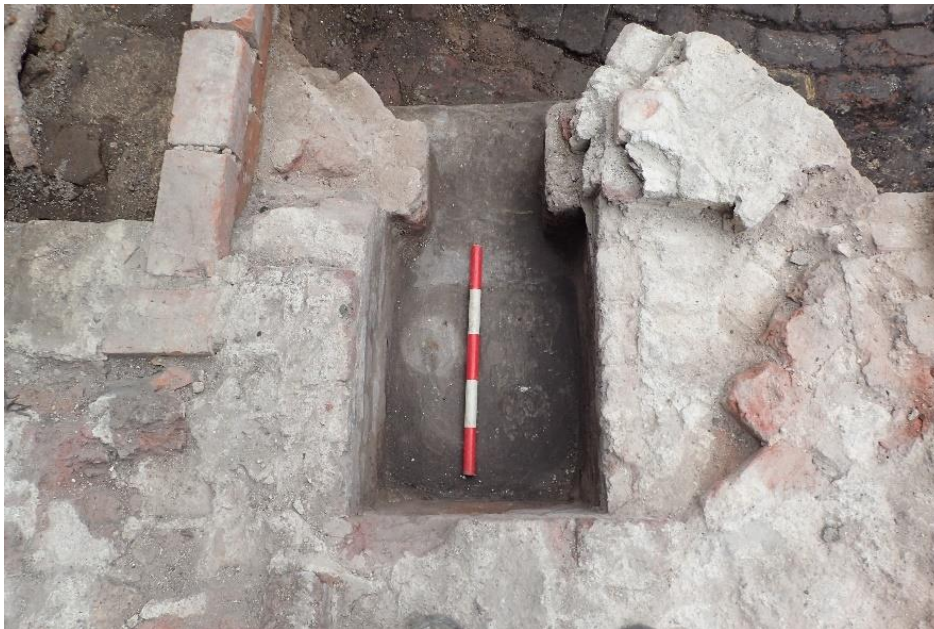
Plate 6: Dye furnace [106] showing the stone slab floor and buttressed brickwork at the entrance to the flue/rake-out pit. Looking north-east. (0.5m scale).

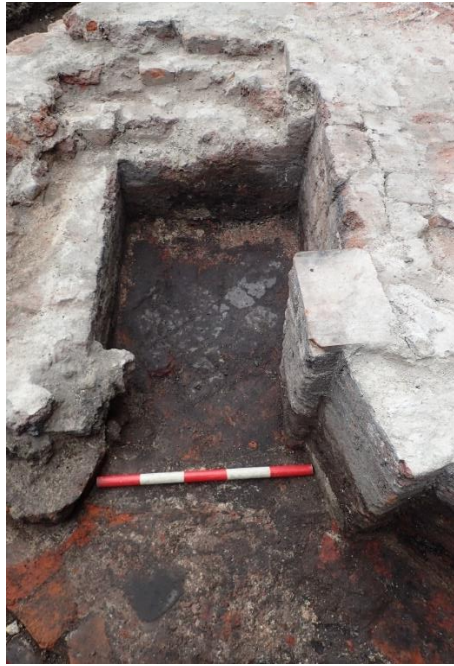
Plate 7 Dye furnace [105] showing the brick floor and buttressed brickwork at the entrance to the flue/rake-out pit. Looking south-east. (0.5m scale)

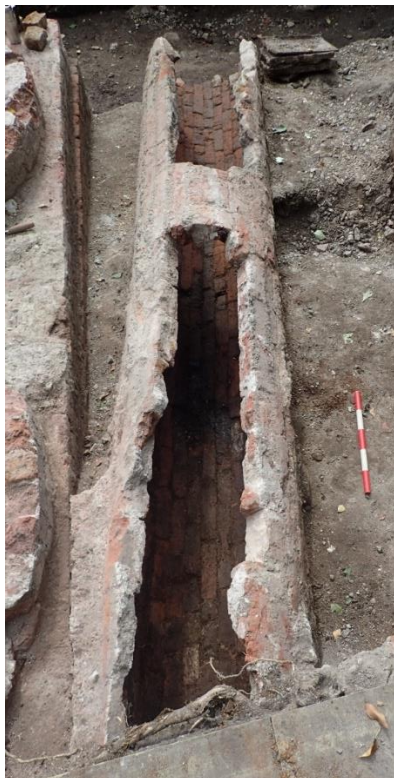
Plate 8: Brick culvert [103] (Phase 2) from the late 18th century Calico Printing works, looking south-east. (0.5m scale)

- 7.3.1 To the south and alongside the brick foundation base [126] for the dye furnaces an east-west brick culvert [103] sloped away from the river and was likely part of the water management system for the mill. Brick samples taken from this culvert were identified as locally made frogged sandy bricks dated as between 1750 and 1850 (fabric 3032, Appendix 4). This culvert respected the layout of brick structure [126] and therefore post-dated it. Pottery associated with the construction cut for culvert [103] was of an early post-medieval character (PMR; 1600-1800, Appendix 3). The continued use of this feature into the 19th century is shown by a collection of finds found in sediments collected from within the culvert (bulk samples <2> and <3>, Appendix 10), producing well-dated finds. Of note were a George III halfpenny (SF 2) minted in Birmingham in 1806 or 1807, a small pottery assemblage dated 1820–1900 and a clay tobacco pipe stamped Smith and in a style typical of the 1830s (Appendix 5). The construction of this culvert in similar bricks to the dye furnaces might have been in the late 18th century but appears to have been in use in the early 19th century.

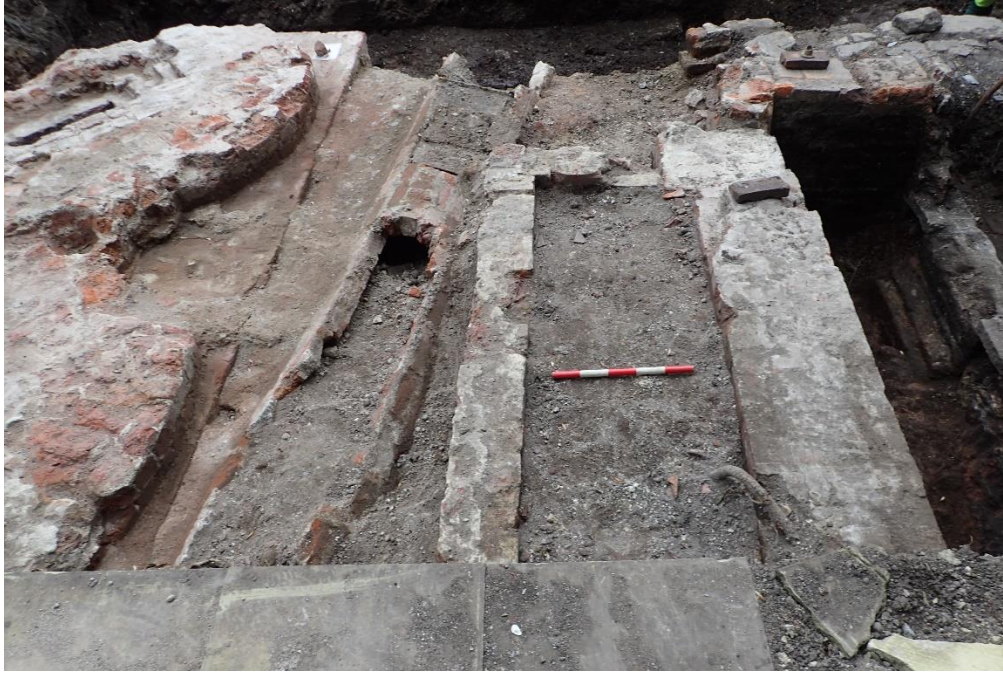
Plate 9: small ?washroom or tank created from L-shaped walls [121] and [131] abutting the wheel-pit wall [102]. Looking south-east. (0.5m scale)

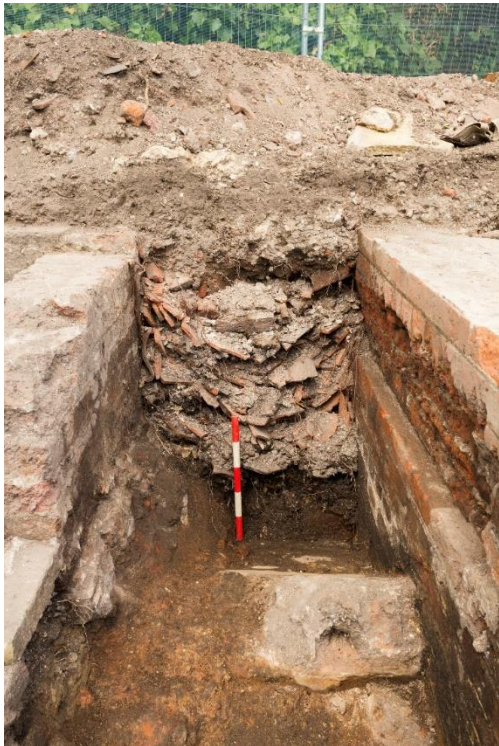
Plate 10: The chamfered base of wheel pit [123] showing the water channel sloping away to the north-west. (0.5m scale)

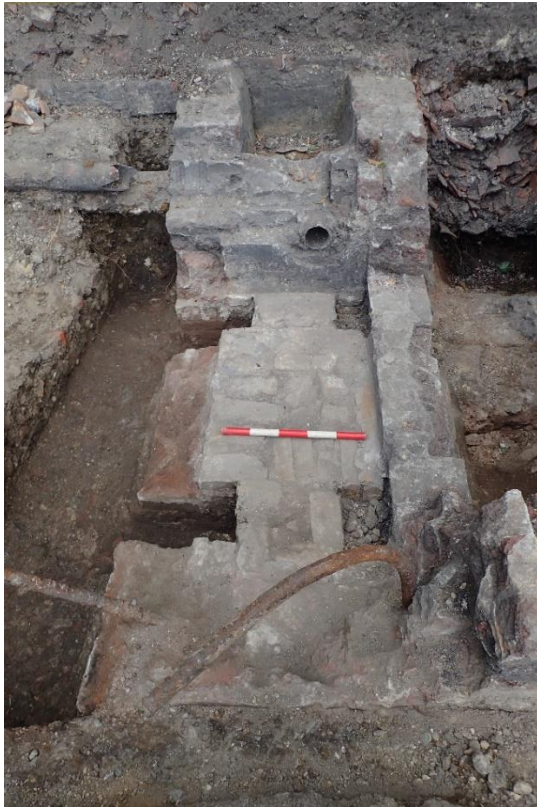
Plate 11: Brick tank [118] with pipes leading into a missing structure supported on brick base [119] to the south-east. Note the pipes leading out of tank [118] to the south-west and under floor [101]. Looking north-west (0.5m scale)

- 7.3.4 The south wall of the wheel pit was used to create brick structure [118] which appeared to contain a cistern/tank from which iron pipes ran into a missing structure on brick base [119] and out southwards below the stone floor surface [101] (Plates 11 and 12). The function of the iron pipes is unknown but may have carried steam generated by the wheel pit around the building to drive other machinery. Adjacent to the wheel pit and

8.3.2 Evidence of iron piping may be associated with the transporting of steam for power around the premises and various iron bars found close to brick structure [119] (Plates 11 and 12) maybe associated with 19th -century industrial machinery.

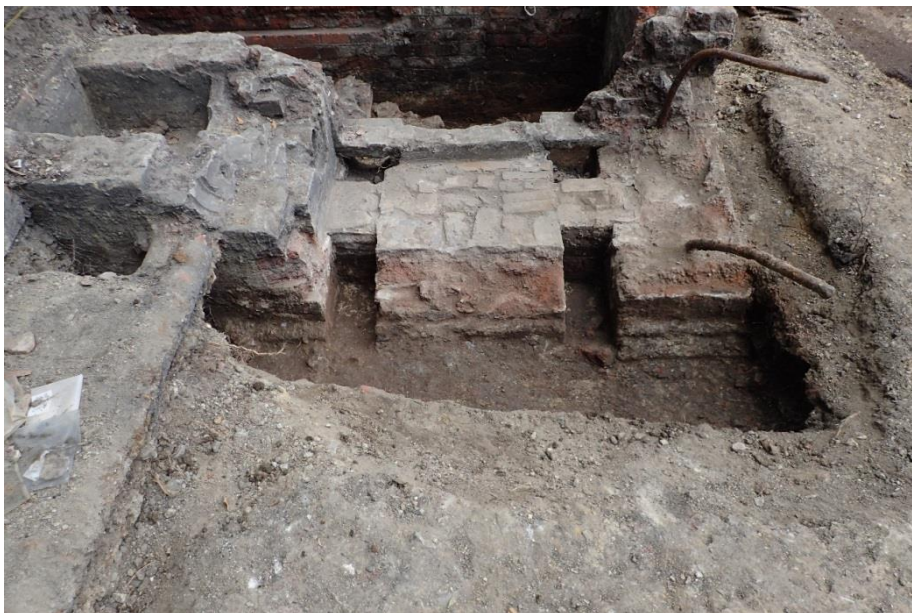
Plate 12: Brick structure [119] with flues leading into the wheel pit to the north-east and onto floor [162] to the south-east. Looking north-east (0.5m scale)

cistern/tank [118] a brick base [119] had been constructed to support ?machinery (now missing) and contained Fletton bricks date 1850—1950 (Appendix 4). At each end of brick base [119] were two short channels leading out into the wheel pit on the north side and on the south side, created two indents leading down to compacted rubble floor/mortar surface [162] .
