**AN ARCHAEOLOGICAL
EVALUATION AT LAND AT FORMER
QUEENS HOSPITAL
QUEENS ROAD
CROYDON
SURREY**

**CENTRAL NATIONAL GRID
REFERENCE: TQ 3210 6740**

SITE CODE: QHQ 04

AUGUST 2004

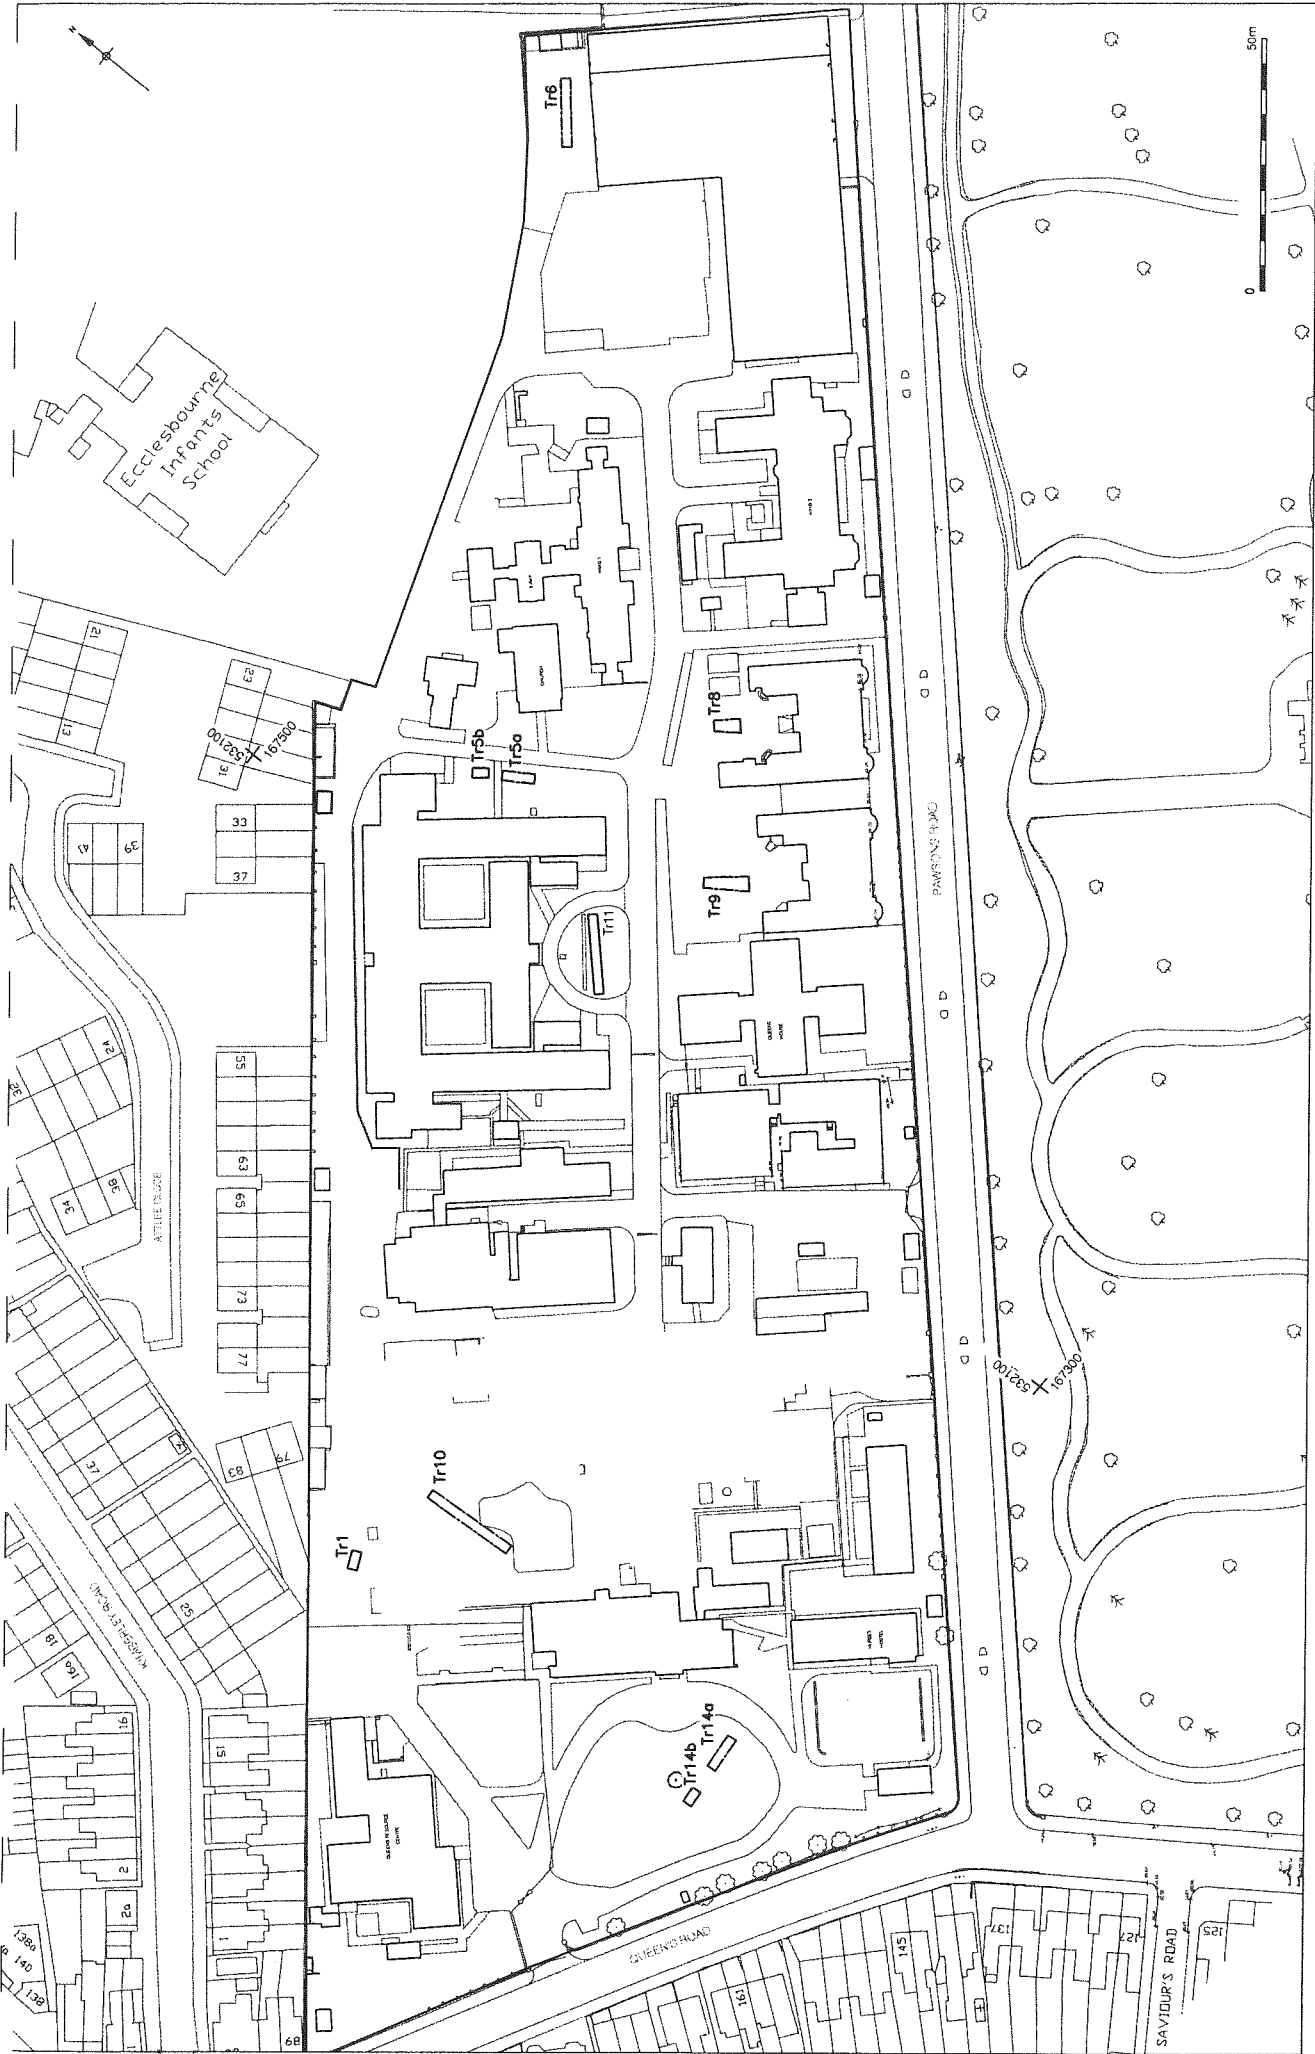
Figure 2
Trench Locations
1:1500

- 6.1 The proposal⁵ located sixteen trenches to provide coverage across the Site. However the Site was found to contain numerous live services, both subterranean and overhead, which made the excavation of six of these impossible. A further two positioned in the northwest corner of the Site could not be excavated as the buildings in that location were still occupied. Therefore only eight were undertaken (Figure 2). Furthermore, some of these had to be reduced drastically in size to avoid service runs. The dimensions of the trenches, intended and actual, are shown in Table 1. Trenches 5 and 14 were separated into two parts each for the same reason, creating Trenches 5a, 5b, 14a and 14b.
