MOCK-ELIZABETHAN COTTAGE (BH79) AND TOWPATH WALL E3

London Borough of Newham

A standing building survey report

February 2008

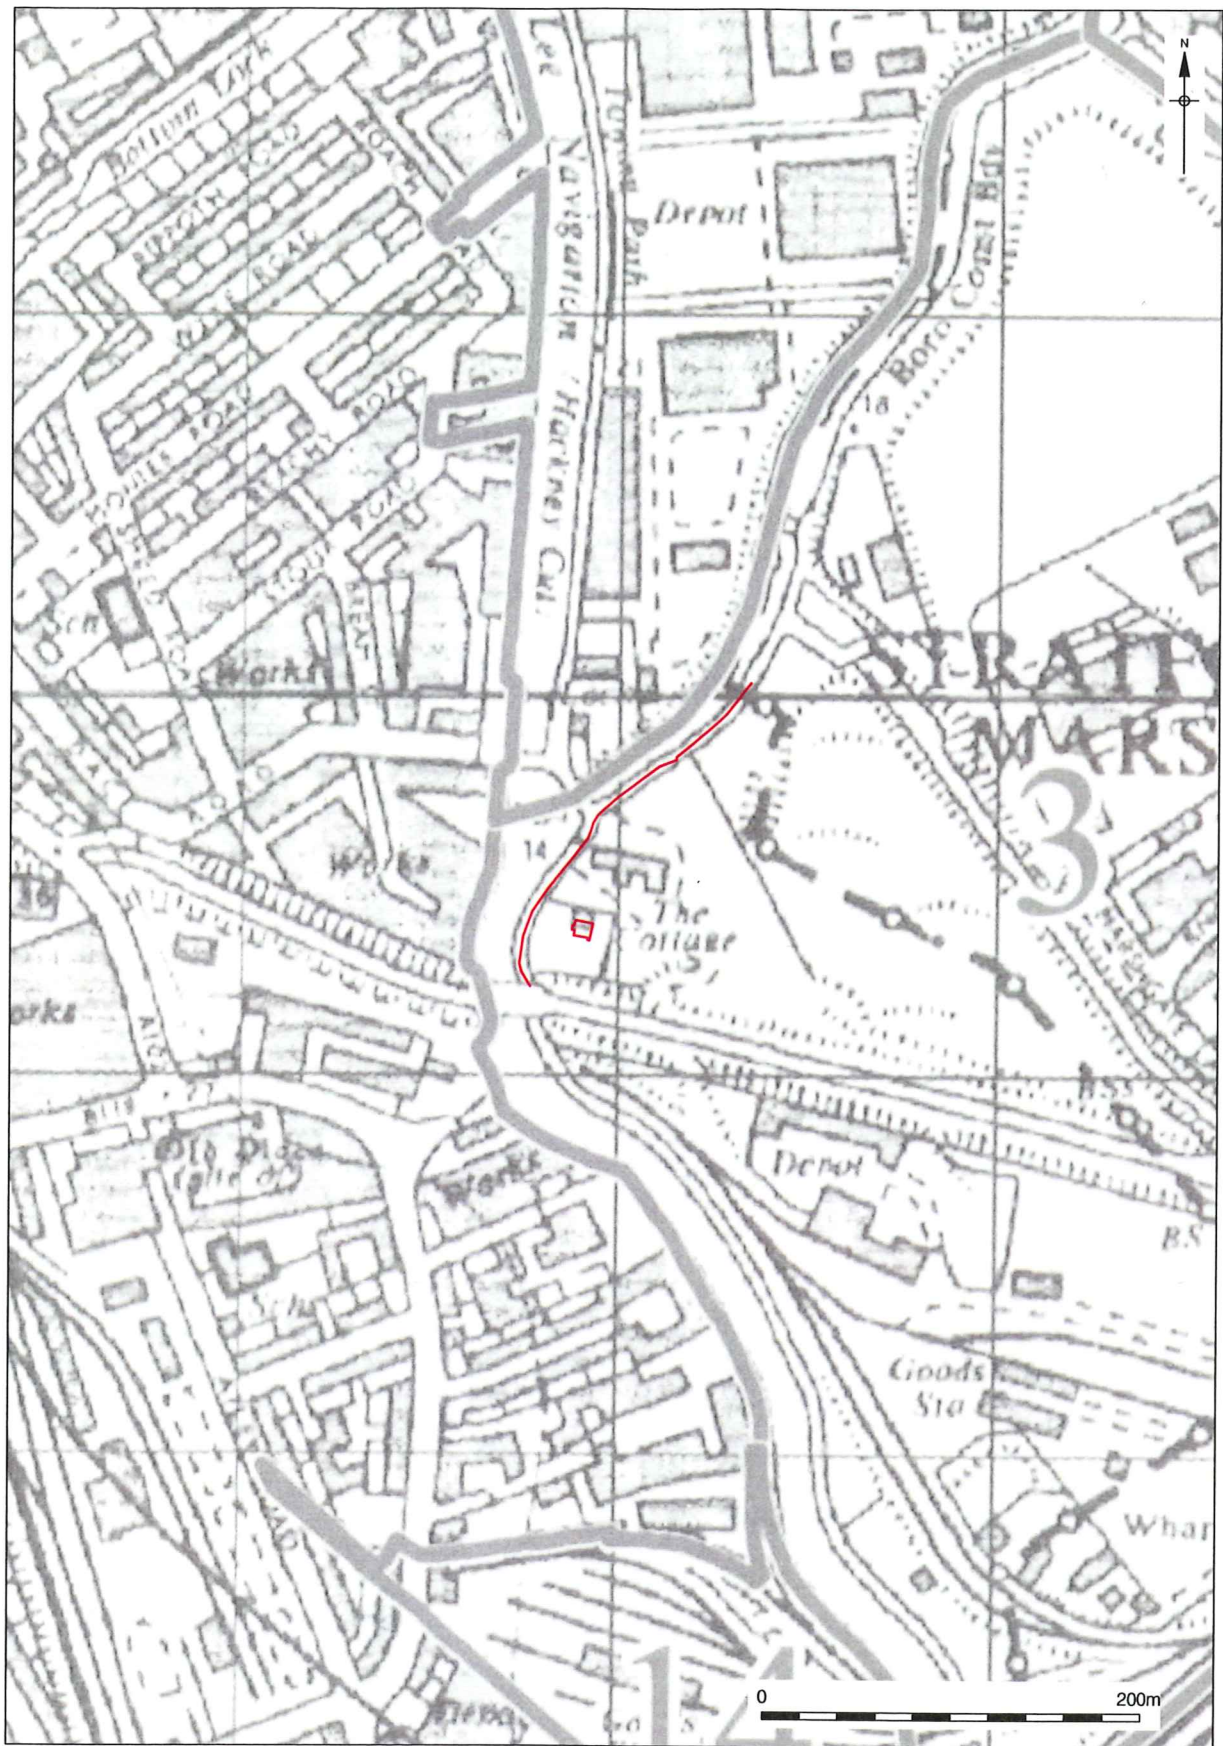
Figure 10
Ordnance Survey 1965
1:4,000 at A4

By 1965 the connecting paths between the cottage and pumping station had gone, and the cottage was enclosed by a boundary wall to the north and east (Figure 10). It is possible that this development marks the date by which the cottage ceased to be the foreman's house or an ancillary structure to the pumping station.

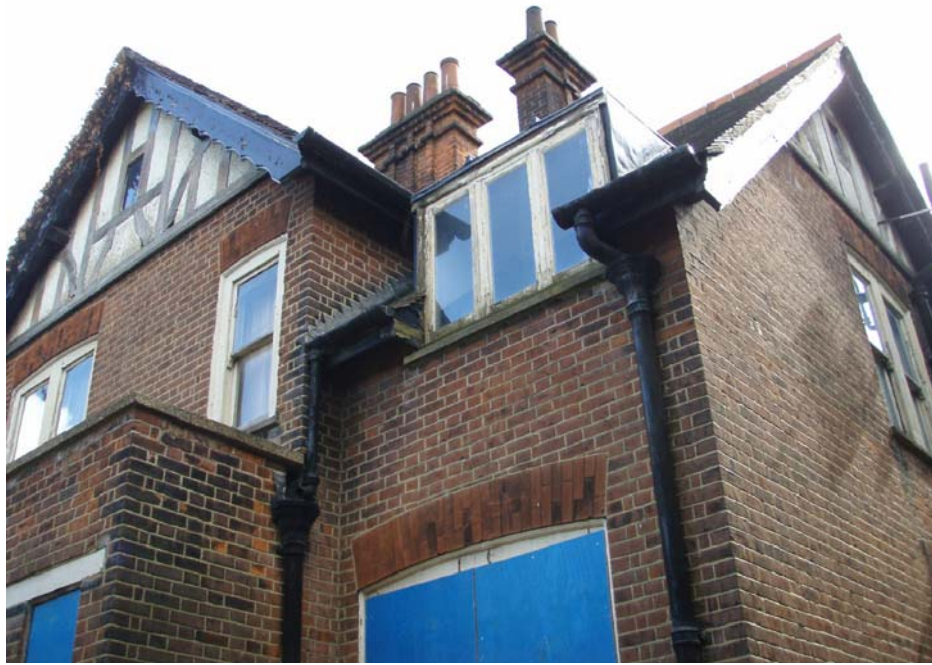
Plate 1 View of cottage from south-west, showing roof form and half-timbered gables

To the north, above the northernmost window and the porch, the elevation rises to a half-timbered gable end with inset window and decorative wooden bargeboards (see Plate 1). At first floor level are two sash windows: one double timber-framed window, with a second single timber-framed window to the south.

To the south, the elevation rises to the eaves of the north-south roof ridge. A three-pane dormer window with a wooden lintel and concrete sill, probably a later insertion, is set into the roof pitch (see Plate 1).

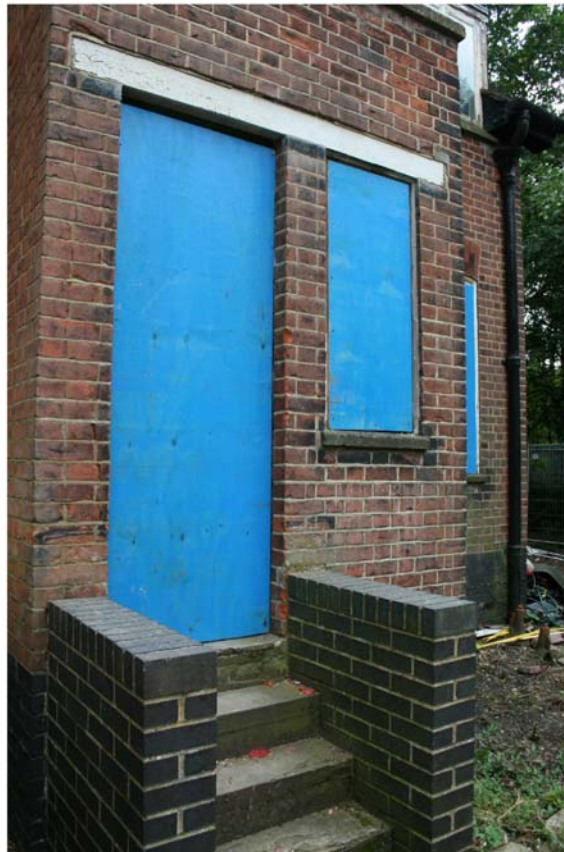
Plate 2 Front door of cottage, western elevation

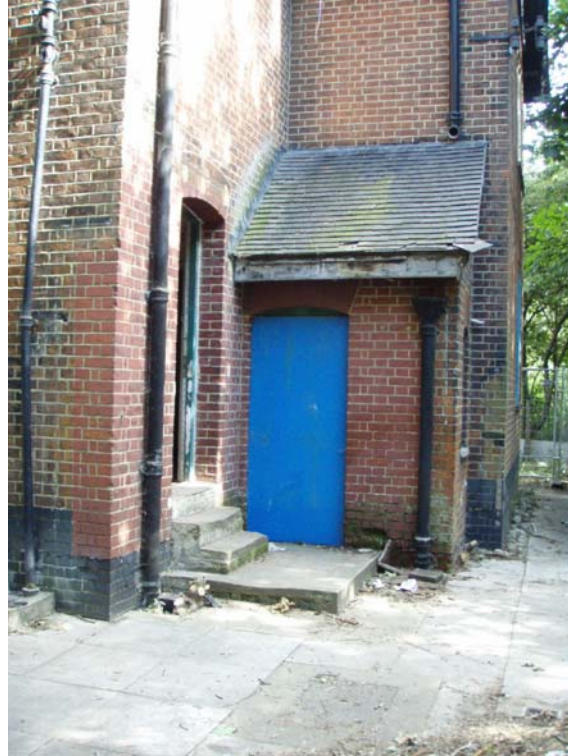
Within the roof are attic rooms, with windows set into the gable ends. The principal elevation is to the west, and access is gained via a porch and front door at the centre of the ground floor (Plate 2). To the rear is a back door and lean-to toilet block (Plate 3).

Plate 3 Back door and outhouse, eastern elevation

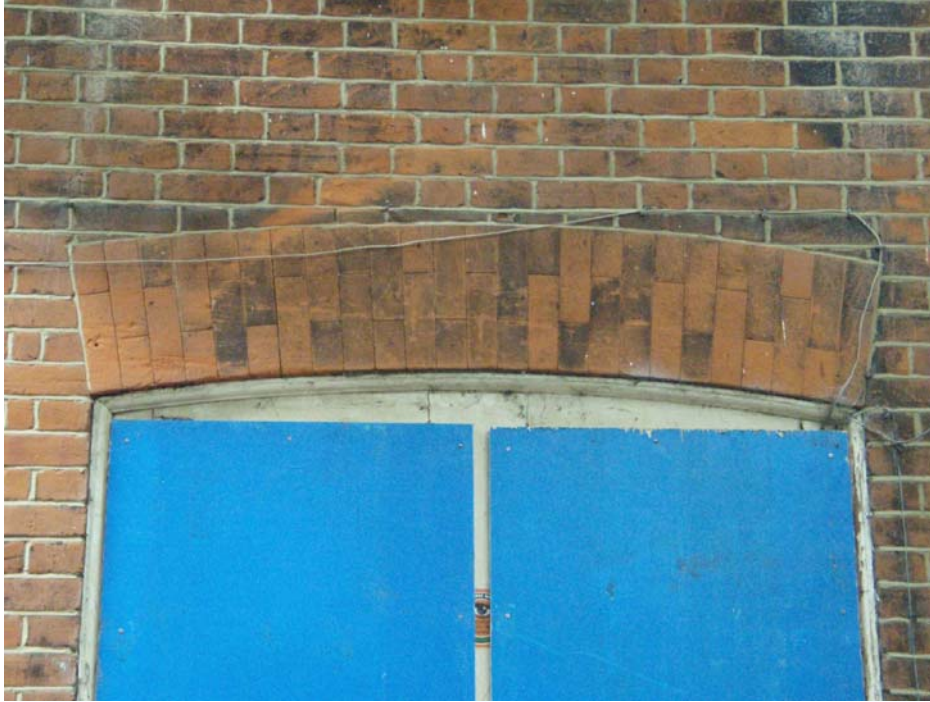
Plate 4 Typical brick-arched window head

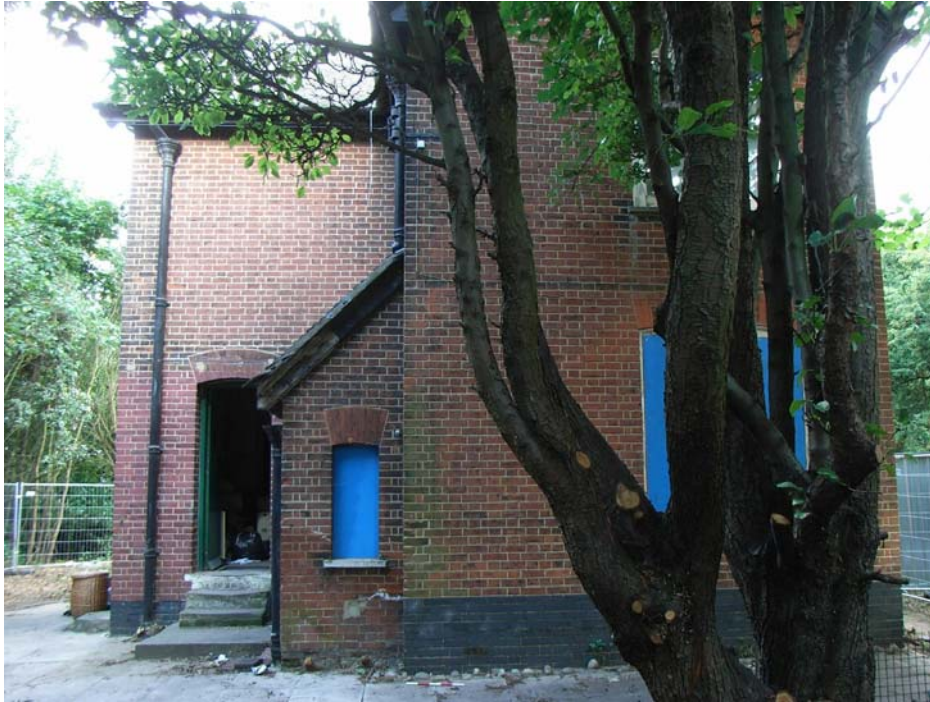
To the north, the east elevation (Plate 5) contains two large double sash windows, and rises to a half-timbered gable end with small inset window. To the south, it is set back and rises to the eaves of the north-south roof ridge. This section contains only the back

Plate 5 East elevation of cottage

The ground and first floor windows in the northern section were boarded at the time of recording, but were visible from the inside. Both windows are timber-framed double sashes with soldier-set gauged brick arched heads and concrete block sills.

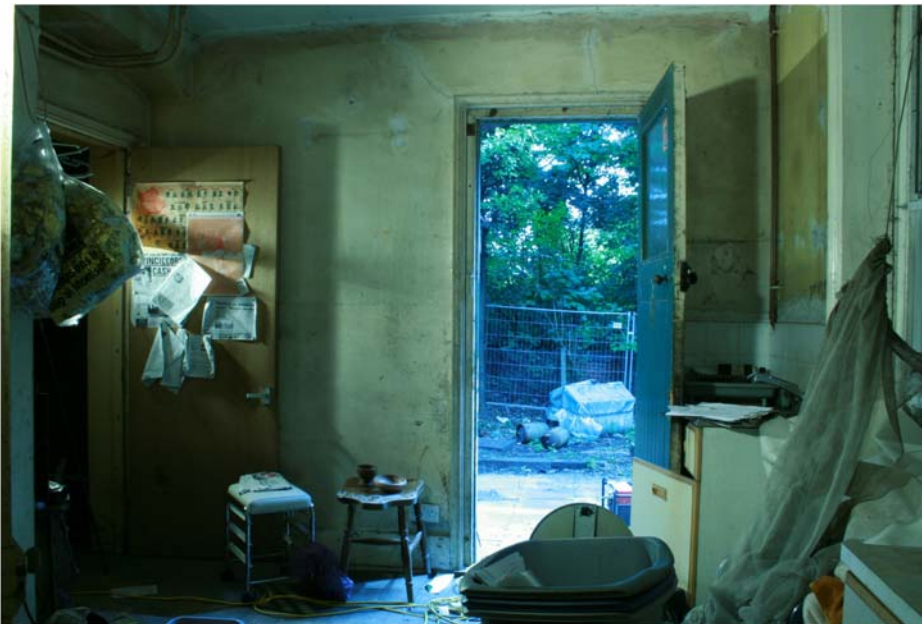
The back door of the cottage leads directly into the kitchen (Plate 6). The floors are timber planking, and a low skirting-board is present. The east wall contains the back door. In the south wall is a centrally placed double sash timber-framed window, below which is a modern kitchen unit. At the east end of this wall is a modern kitchen sink with white tiled splashback.

Plate 6 Kitchen, looking east

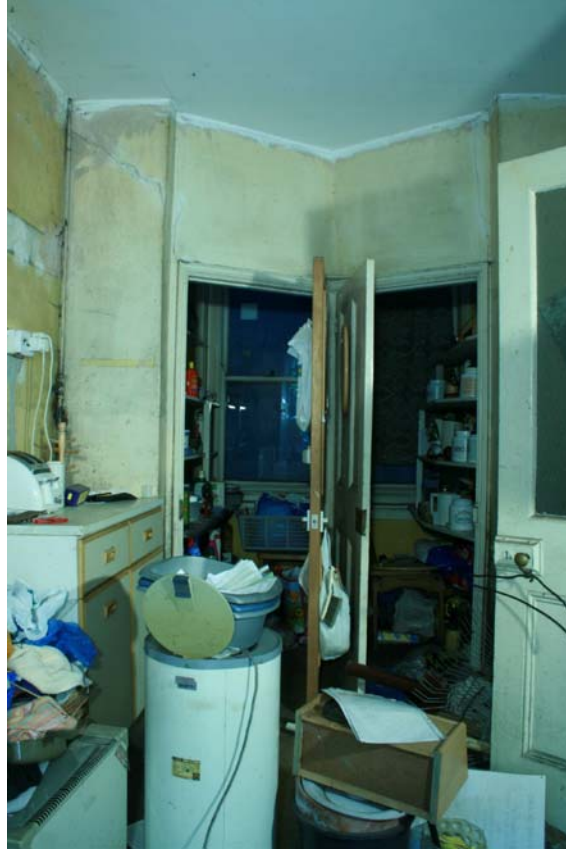
The west wall contains two angled doorways, set in such a way as to form a 'V' shaped indent leading off the kitchen. The two doors lead into equally-sized pantries (see Figure 12 and Plate 7), which have been created by the insertion of an east-west wooden partition and the two angled doorways. They contain substantial wooden shelving units.

Plate 7 Pantries, looking west

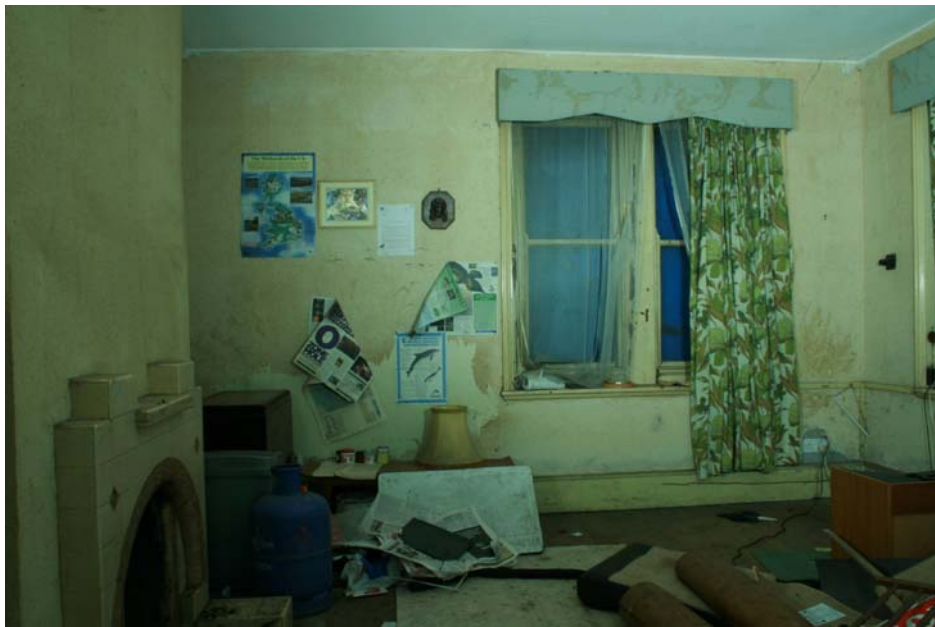
Plate 9 Dining/living room at north-east of cottage, looking north

This eastern doorway gives access to the dining/living room in the north-east corner of the house (Plate 9). The floor is timber planking, and a skirting board is present. The south wall contains only the access door to the kitchen. The east and north walls contain original timber-framed double sash windows, which have wooden pelmets (Plate 10). The west wall has a centrally placed original chimneybreast, into which is set a 1940s/1950s ceramic tiled fireplace. Immediately south of the chimneybreast is an original timber-framed doorway with a modern door, which gives access into the main entrance hallway.

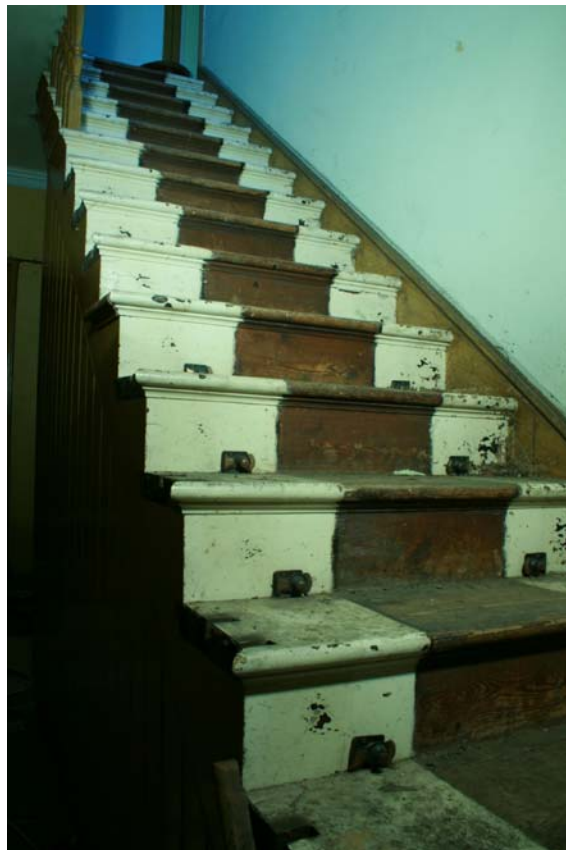
Plate 11 Staircase, looking south-east

The floor of the hallway is timber planking, with skirting board present on all walls. Original coving is also present. The timber floor has a painted strip on the northern and southern extremities, indicating that at one time the central area of the room was covered by carpet.

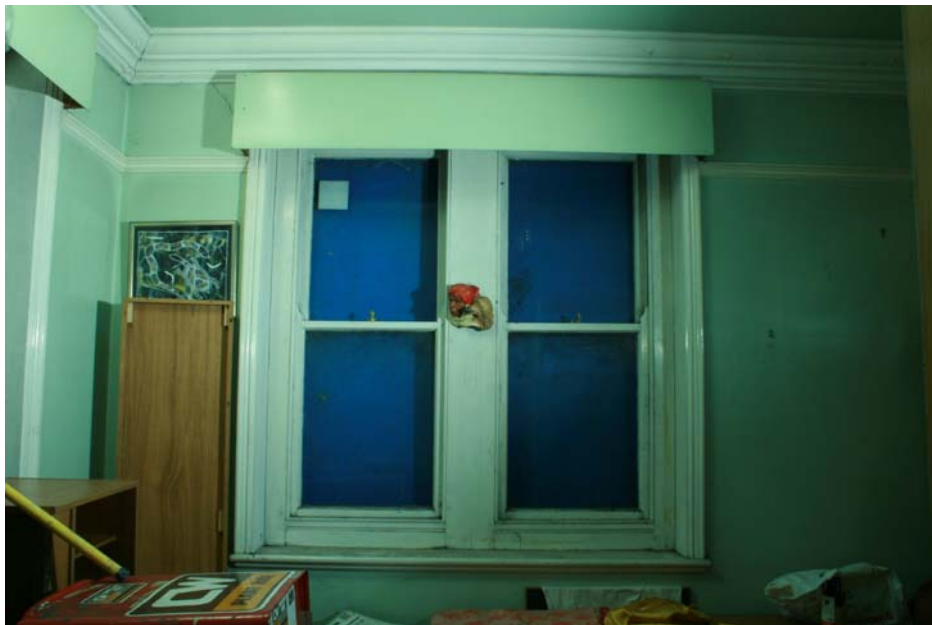
The south wall contains the doorway giving access to the hallway. On the east wall is a centrally-placed chimneybreast, containing a 1940s/1950s ceramic fire surround. The north and west walls both have centrally placed timber framed double sash windows with timber pelmets (Plate 12).

Plate 12 Window in room at north-west of cottage, looking north

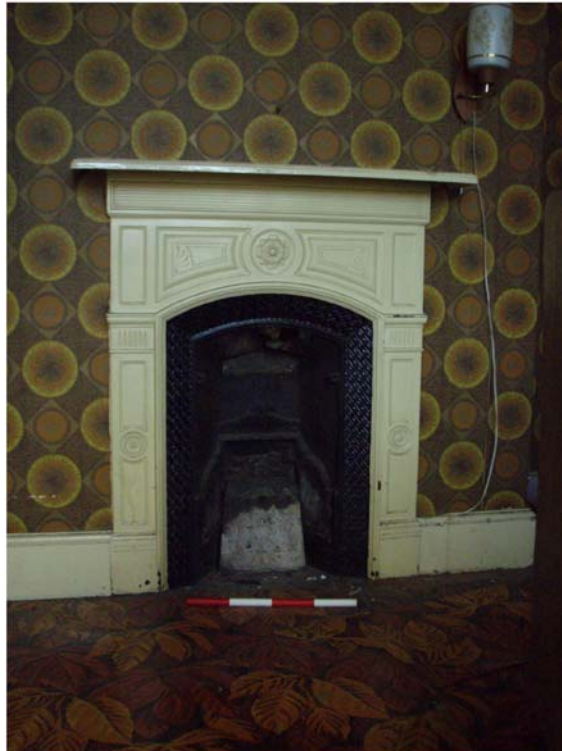
The first bedroom, located in the north-west corner of the first floor and accessed via the northern landing door, has a timber planking floor and original skirting-boards. The ceiling is of painted plaster, and original coving is present on all walls. The west wall contains an original timber-framed double sash window, with plywood pelmet. The east wall has an original chimney-breast and fireplace with a cream-painted original cast-iron decorative fire surround (Plate 13). To the north of the chimneybreast is an original fitted cupboard.

Plate 13 Original fireplace in east wall of north-west bedroom, looking east. Scale 5x100mm

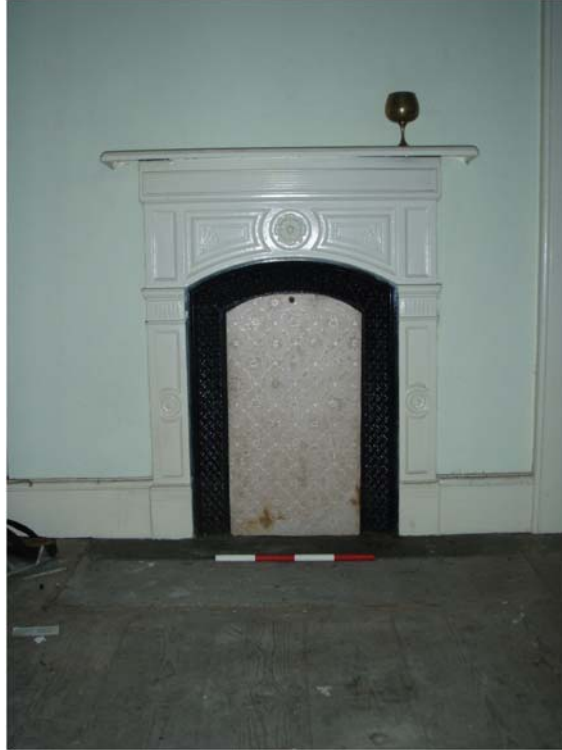
Plate 14 Original fireplace in west wall of north-east bedroom, looking west. Scale 5x100mm

The second bedroom, located in the north-east corner of the first floor and accessed via the east landing door, has a timber planking floor with original skirting-boards. The ceiling is plastered and has been covered with wood-chip wallpaper. The original coving is still present. The east wall contains original timber-framed double sash windows with plywood pelmets, and the north wall also contains an original timber-framed sash window. On the west wall is a centrally placed chimney-breast, with boarded fireplace (Plate 14). Though boarded, the cast-iron fireplace surround is still visible and is of the same design as that in the north-west bedroom. To the north of the chimneybreast is an original fitted timber cupboard.

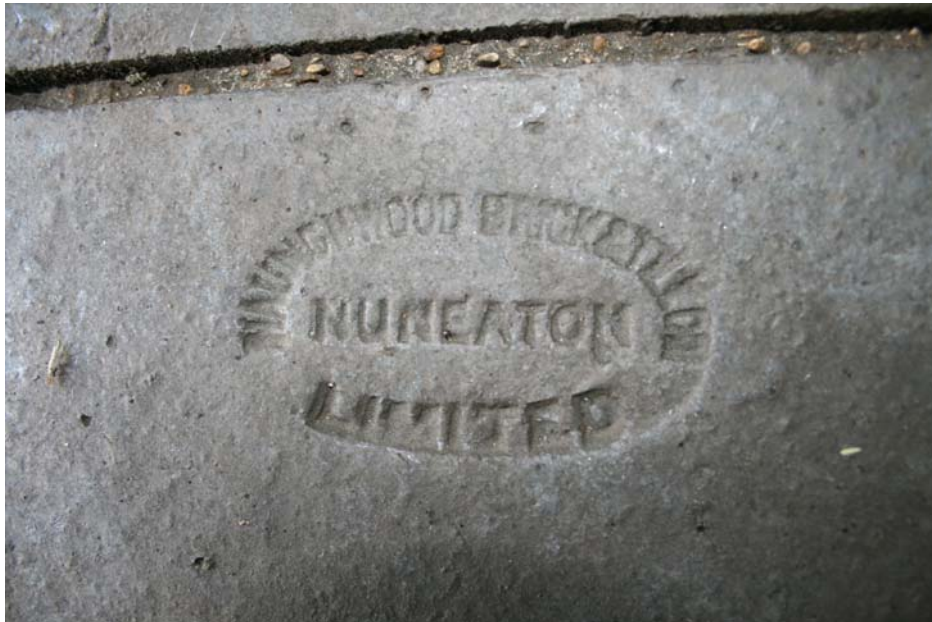
The foundation of the wall is constructed of poured concrete, with the wall itself built from yellow stock brick, laid in Flemish bond and finished with blue bull-nosed capping bricks. One of the capping bricks has a visible maker's imprint, which reads: 'Haunchwood Brick and Tile Company Limited'. The frog is stamped 'Nuneaton' (Plate 15).

Plate 15 Stamped capping brick

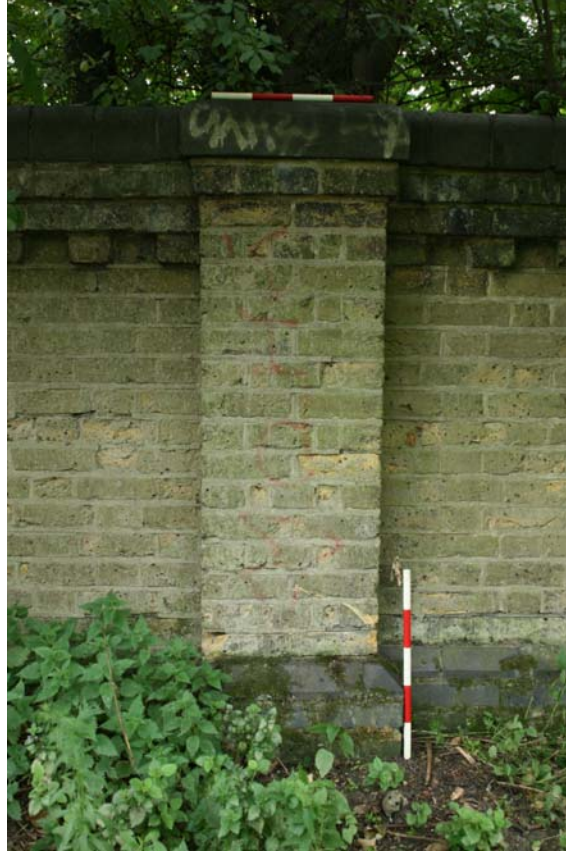
Plate 16 Typical buttress showing brick detailing, west side of wall. Scale 5x100mm

Evenly-spaced buttresses, with strengthening queen closer brick sets on either of them, are present on both sides of the wall for its full length. Each buttress has an individual blue bull-nosed brick capstone (see Plate 16).

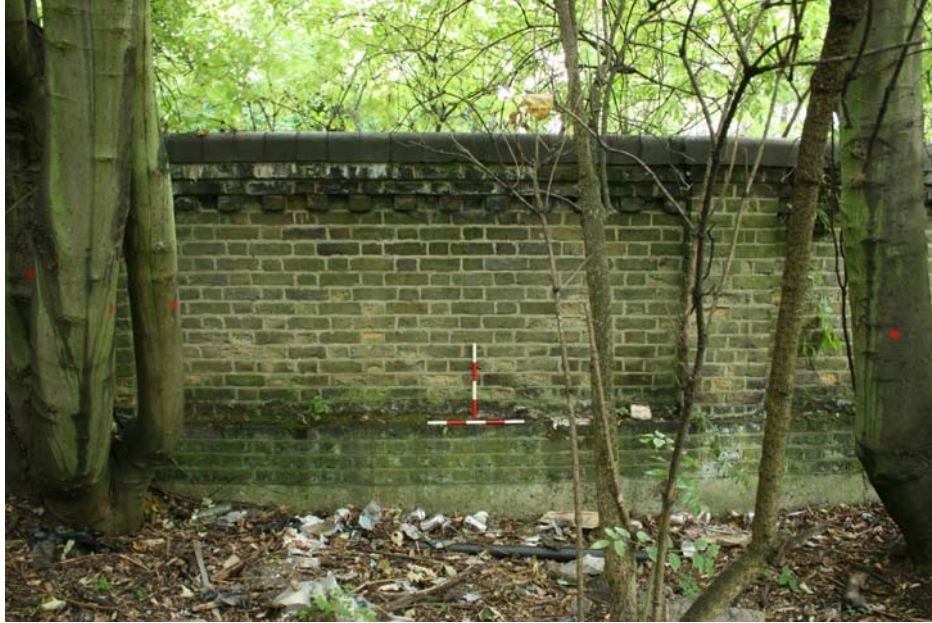
Directly beneath the capping bricks are two courses of corbelling, with a course of dentillated brickwork below, and at the base of the western side of the wall is a projecting brick plinth capped with blue cant bricks (Plate 16). There is also a plinth on the eastern side of the wall, constructed of yellow stock bricks with no blue brick capping (Plate 17). This plinth gradually increases in height as the wall nears Old Ford Locks, until there are only two brick courses between the plinth and the dentil motif.

Plate 17 Typical section of wall, east side. Scale 5x100mm

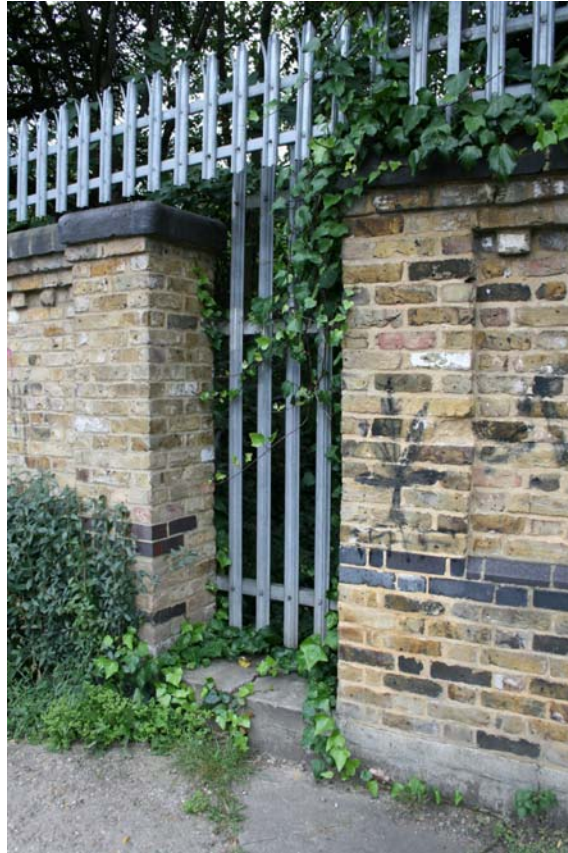
There are three points of access through the wall. The first (Plate 18) is a pedestrian entrance located at the south end of the wall, and houses a modern metal security gate. This gives access to a set of poured concrete steps and associated inclines with metal stanchions and handrails, which lead to a metal bridge over the River Lee (see Figure 2). The opening appears to be a later insertion. The design of the stanchions and handrails on the steps are similar in design to the ones present on the Greenway, first visible on the 1982 OS map.

Plate 18 Southernmost opening in wall

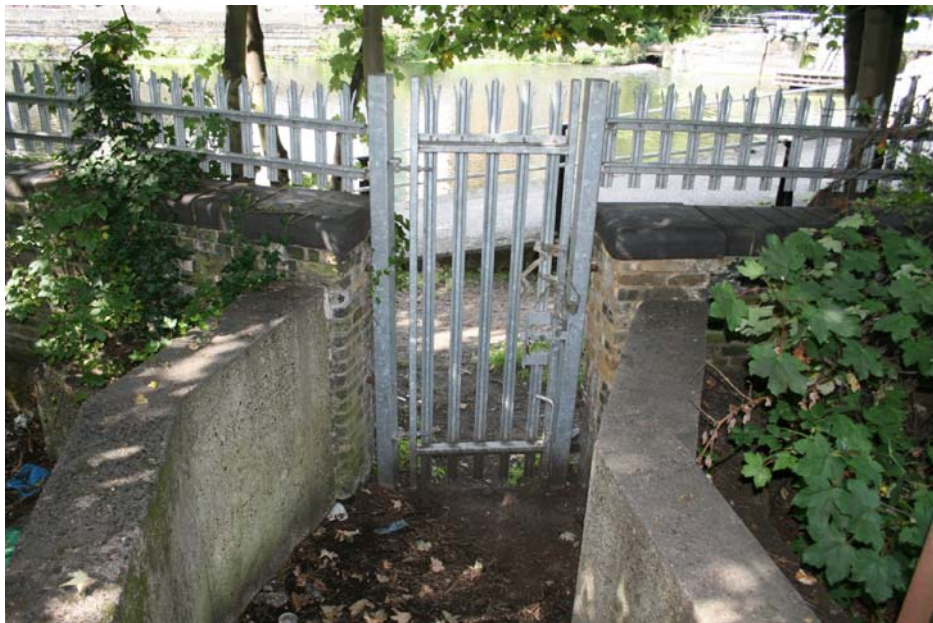
Plate 19 Midpoint opening in wall

A second pedestrian access point (Plate 19) occurs just south of the footbridge over the River Lea next to Old Ford Locks, and appears to be original. Although some rebuilding of the wall around it has occurred, this was probably caused by the installation of the

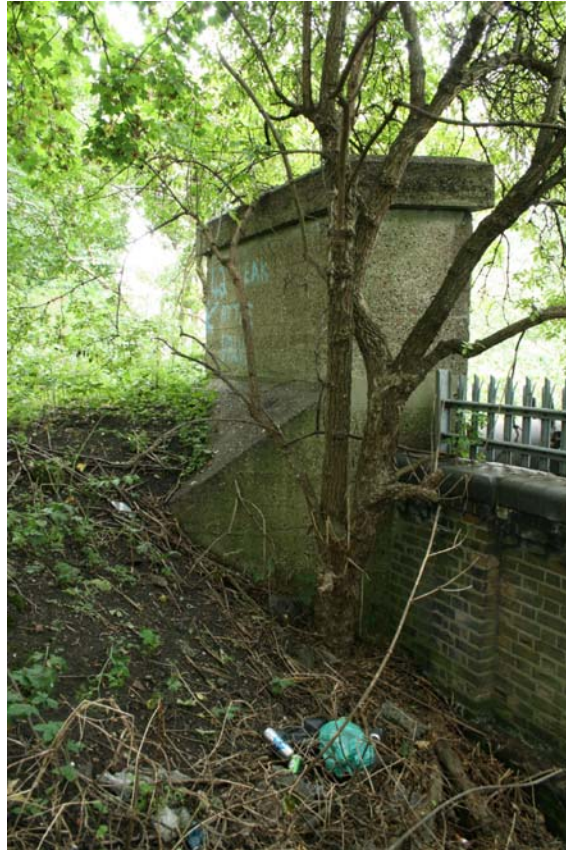
modern gate. The gate is a metal security gate, giving access to a series of poured concrete steps leading to a concrete structure containing a number of metal access hatches. Similar concrete 'blocks' with access hatches appear close to or abutting the wall in the immediate vicinity. These structures are part of the water management system associated with the Mock-Elizabethan cottage site, and are related to two large metal pipes which cross the River Lea from the southern end of the Bow Industrial Estate (Plate 20). These breach the wall immediately south of its junction with the modern security fence.

Plate 20 Concrete structure containing pipes extending over River Lea

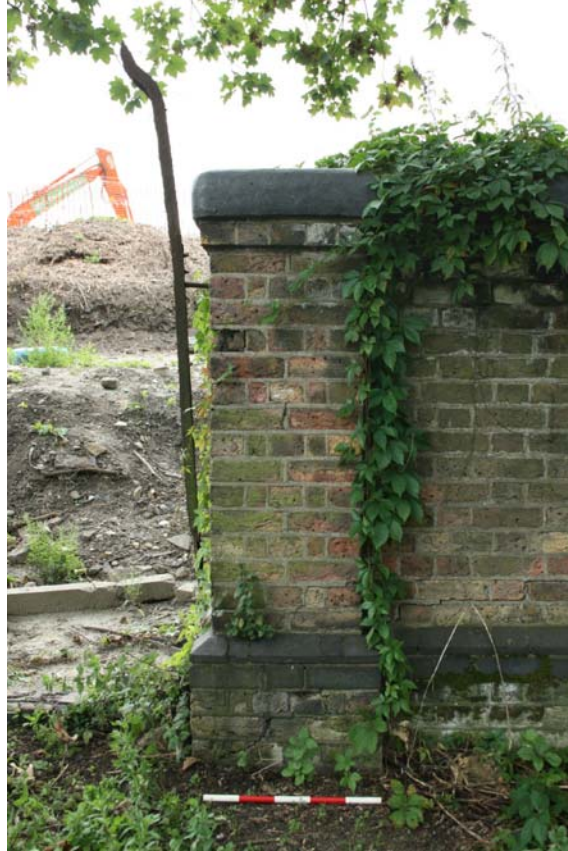
Plate 21 Northernmost opening in wall, showing truncated metal gatepost. Scale 5x100mm

Beyond this point to the north-east, the wall is mostly obscured by undergrowth and the debris of earlier tree clearance. The third access point is at the northernmost end of the wall. The wall ends in a buttress, against which stands an I-section metal stanchion, possibly a gatepost (Plate 21). Beyond this point the wall is still extant, but barely reaches one or two courses in height. It is capped with blue bull-nosed bricks, some of which have been damaged, revealing the underlying yellow frogged stock bricks. This third access point to the pumping station site from the towpath was larger than the other two, and may have been a gate used for bringing in materials transported by river. It appears to be original.
