**AN ARCHAEOLOGICAL WATCHING
BRIEF AT HOLY TRINITY CHURCH,
SUNDERLAND, TYNE AND WEAR**

**WATCHING BRIEF AND OSTEOLOGICAL
ANALYSIS REPORT**

February 2020

Site Code: HTC19

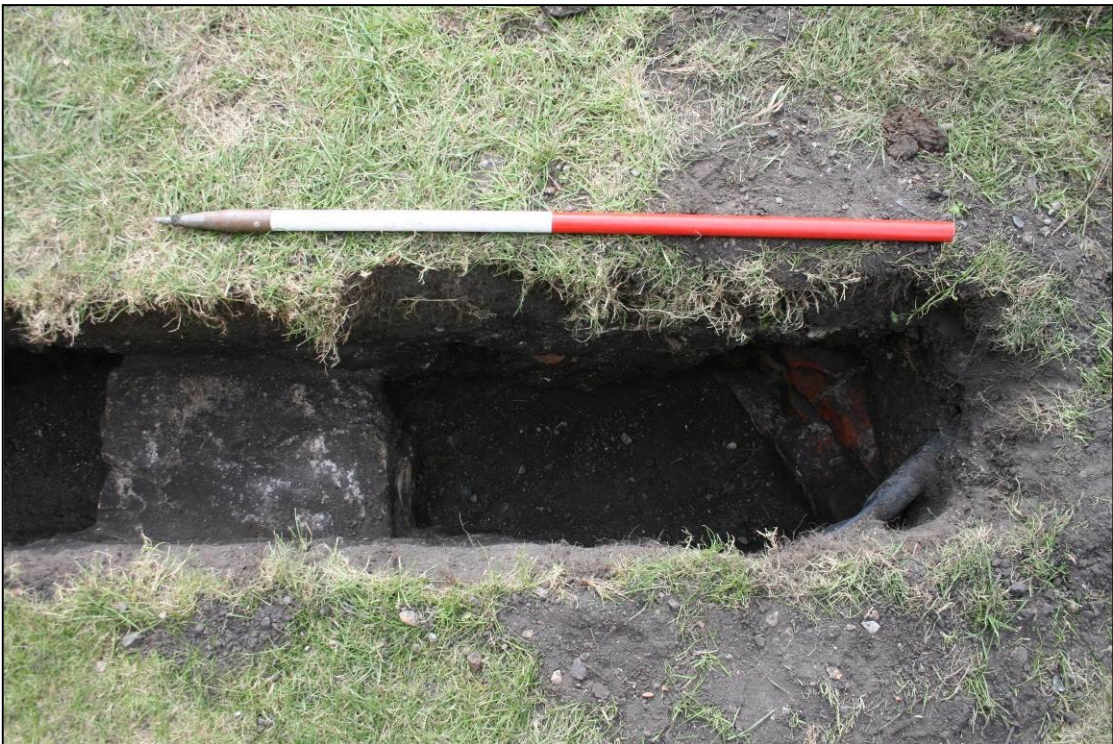
Plate 2: Walls [116] (right) and [115] (left) in drainage trench west end, view south, scale: 1m

- 6.3 The stone wall foundation [115] aligned with the western elevation of the church likely represents the original cemetery wall. It was probably a stone foundation but with red brick upper course. This is the style of construction used throughout the church. The purpose of the other walls is unclear, but it is possible that [116] may have been associated with the introduction of the modern-day cemetery gate. Wall [136] was conceivably associated with the old boiler house.

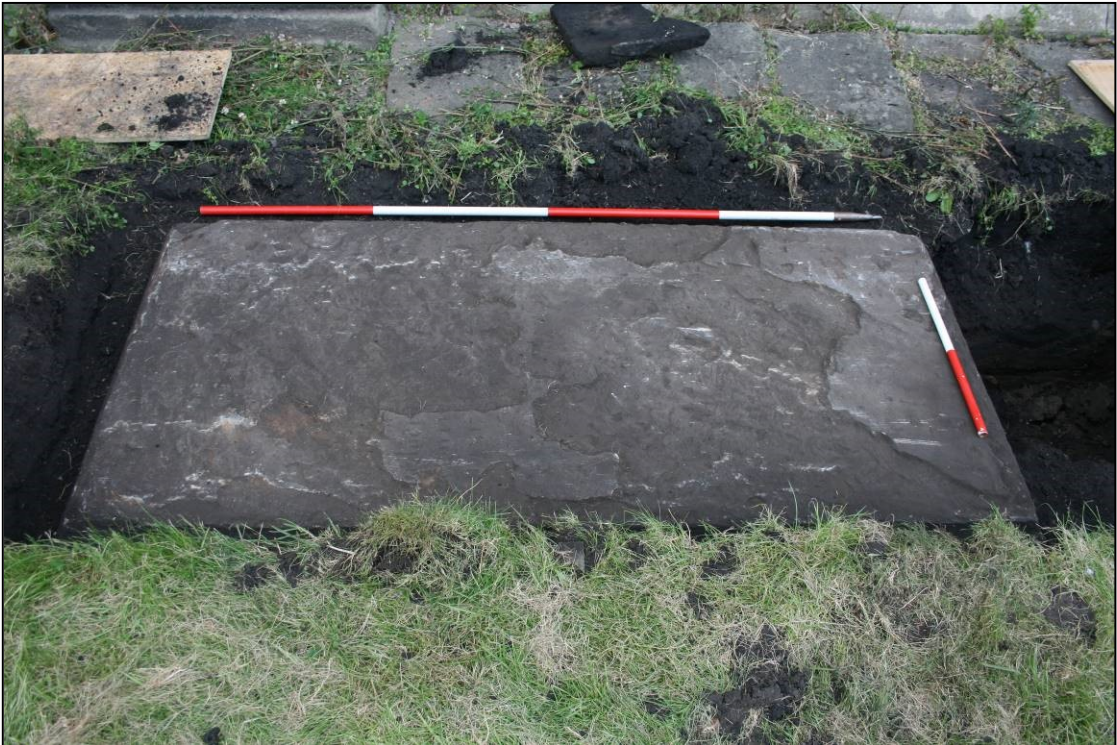
Plate 4: Burial vault [106], view north, scale: 2m and 0.5m

- 5.1.9 To the south of the church was an intact burial vault [106] aligned east-west within grave cut [110]. The cut measured > 2.27m east/west by >0.62m north/south and >0.58m deep. The burial vault was comprised of a brick structure [106] and stone sealing slab [105] (Plate 3 and 4). The stone slab was recorded at a height of 15.72m AOD and the brick vault at a height of 15.50m AOD. The vault was constructed using common bricks a single brick thick (Figure 5). The structure in its entirety measured 2.27m east/west by 0.98m wide and 0.58m high with the internal section being 2.02m east/west and 0.72m wide. The western end of the vault had been damaged and the body badly disturbed by burrowing animals. This led to a mixed infilling deposit [109] accumulating within the vault.

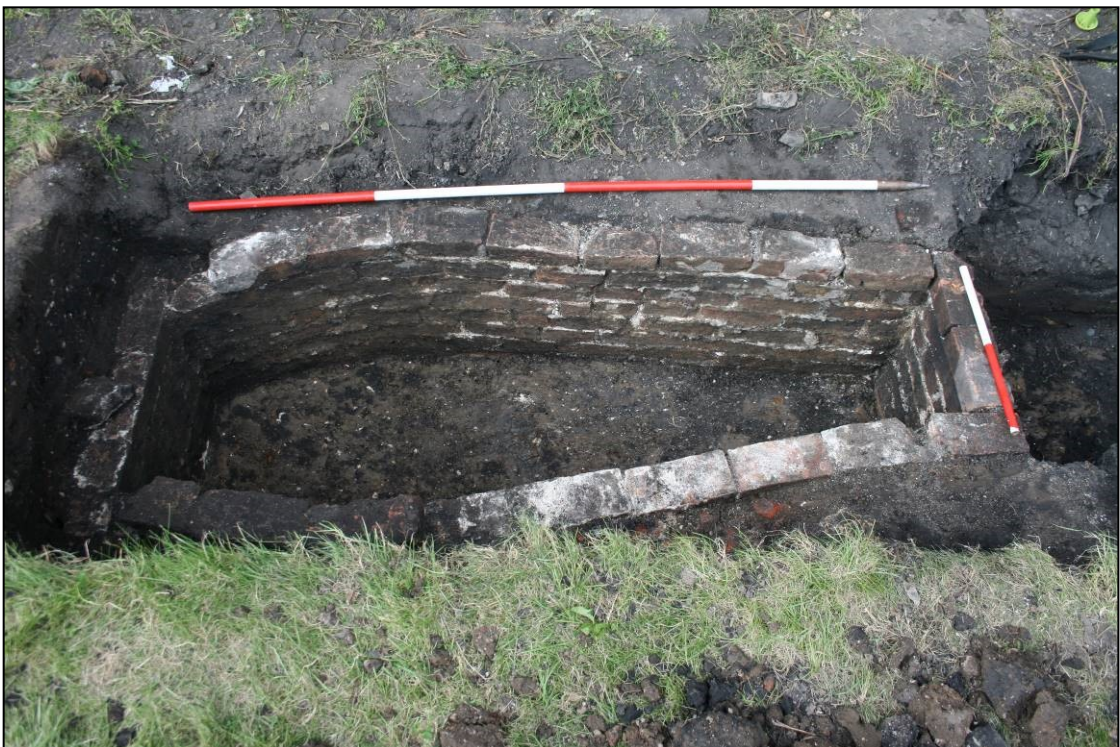
Plate 5: Surviving inscription on [105], scale: 0.5m

- 5.1.11 On top of the stone slab [105], a small portion of an inscription survived (Plate 5). This was barely legible but appears to refer to *January 17??*. It is not known whether this was a birth date or the date the person died.

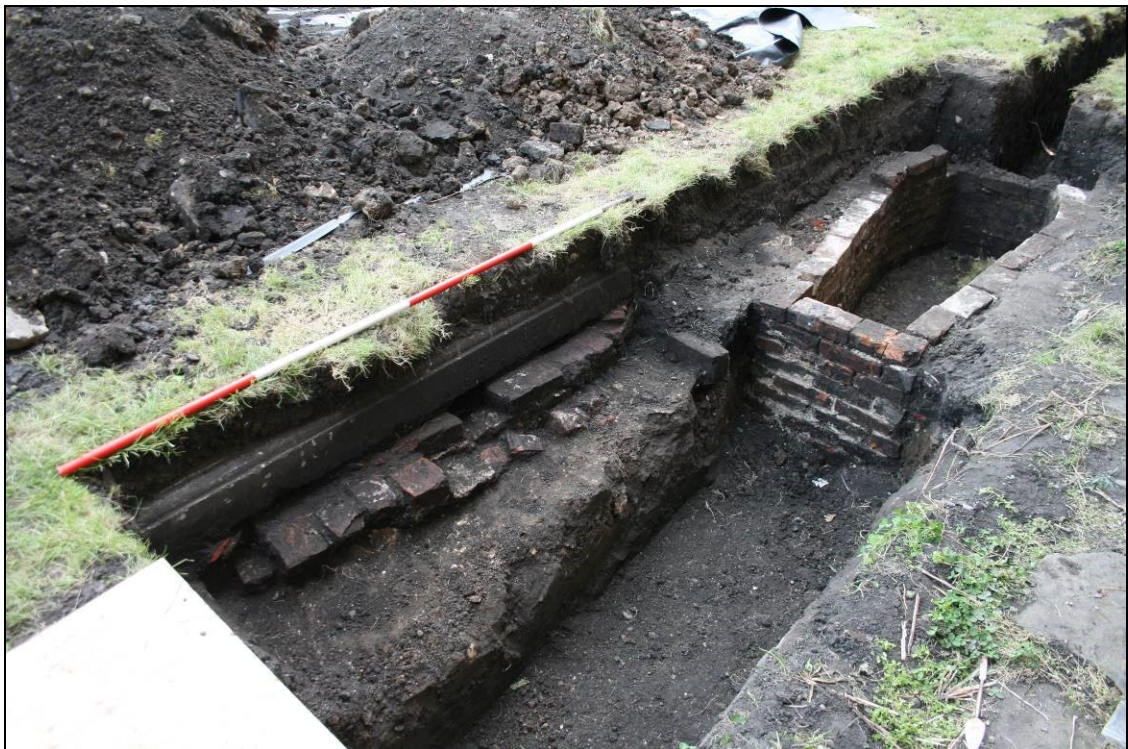
- 5.1.12 An additional two burial vaults were also exposed within the edge of the southern drainage trench (Plate 6). Vault [113], within grave cut [148] was recorded at a height of 15.46m AOD and was covered by stone slab [112] at a height of 15.64m AOD. The burial was only partially within section of the trench so exact dimensions could not be ascertained (Figure 5). Although [113] was not excavated, there was damage to the brickwork, and it did appear to have been infilled similar to [106]. It is likely that this vault has also been disturbed by burrowing animals.

Plate 6: Burial slab [112] with vaults [113] in section with partially demolished vault [114] and burial vault [106] (right), view southwest, scale: 2m

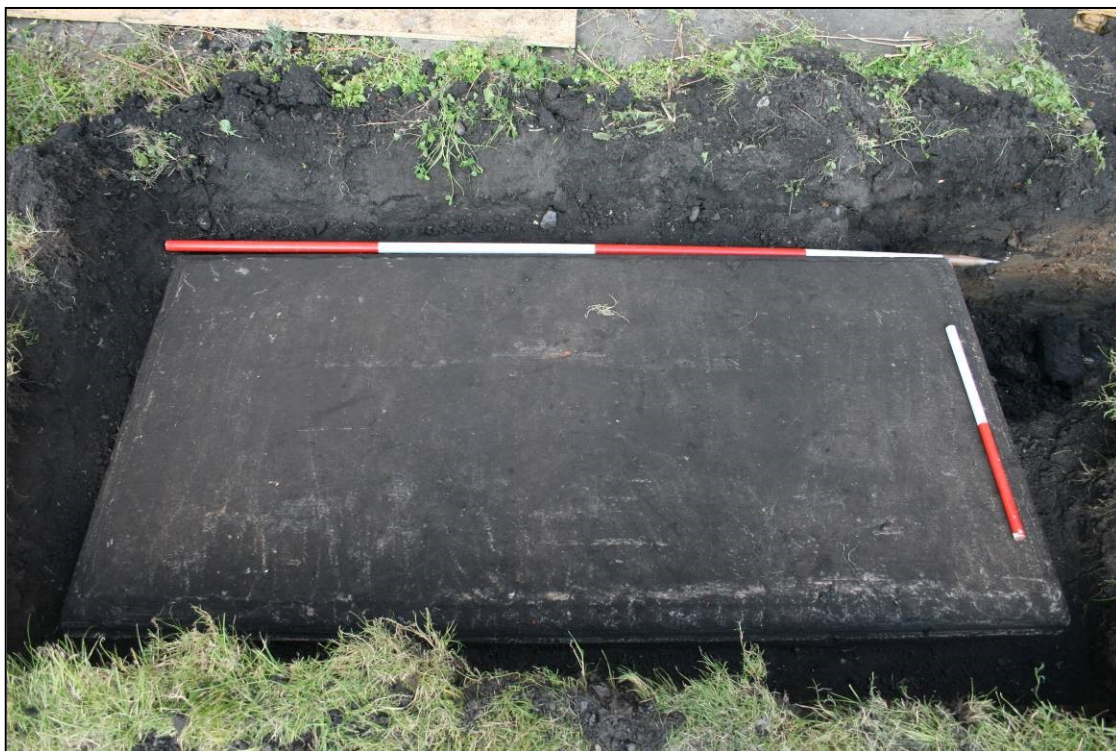
- 5.1.13 To the north of grave cut [148] was demolished vault [114] within grave cut [147]. On top of the vault was stone slab [104] that was encountered just below the topsoil and measured 1.83m by 0.92m and 0.13m thick (Plate 7). A faint inscription was noted on top of the slab however it was too badly worn to be legible. The burial vault below had already been truncated with only a short stretch of vault [114] surviving for 1.4m by 0.11m wide and 0.15m high (Plate 6). As no skeleton was observed within the grave it is conceivable that the vault would have stood above ground level originally but was demolished when the cemetery was cleared of grave monuments. The stone slab would have been reburied below ground level.

Plate 7: Vault slab [104] above [114], view north, scale: 2m and 0.5m

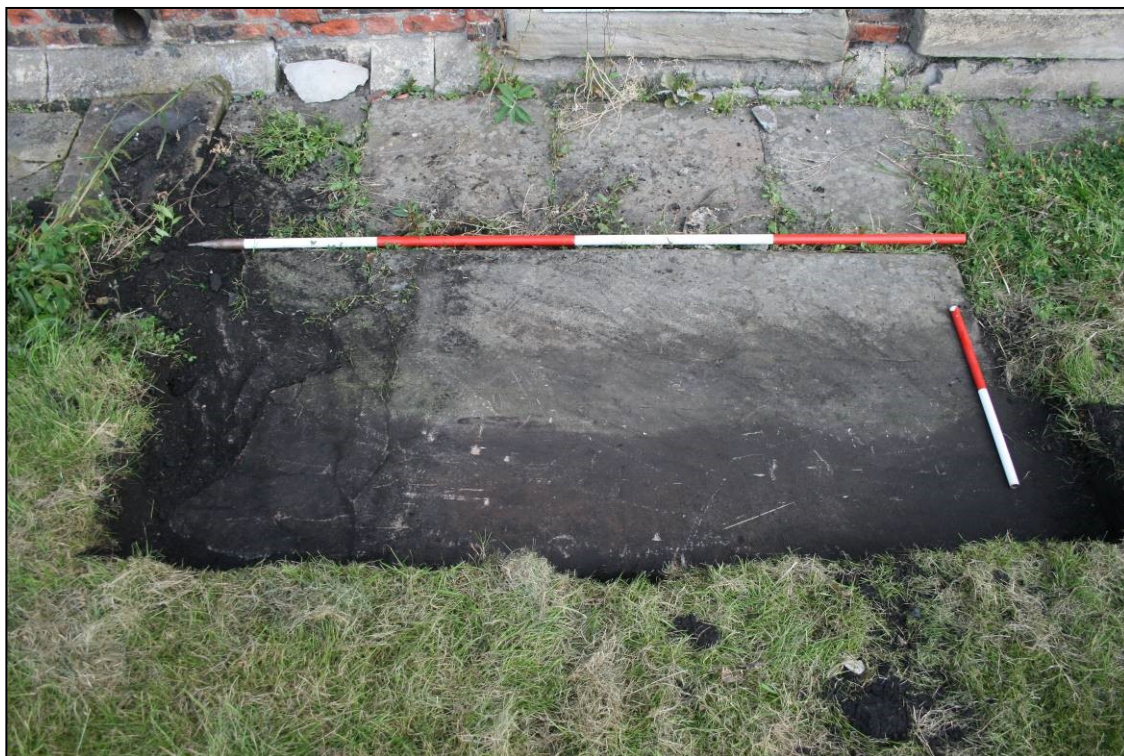
- 5.1.14 Two more redeposited stone slabs were also noted during the works without associated burial vaults or human remains. These comprised [103] (Plate 8) and [108] (Figure 4).

Plate 8: Burial slab [103]: view north scale: 2m & 0.5m

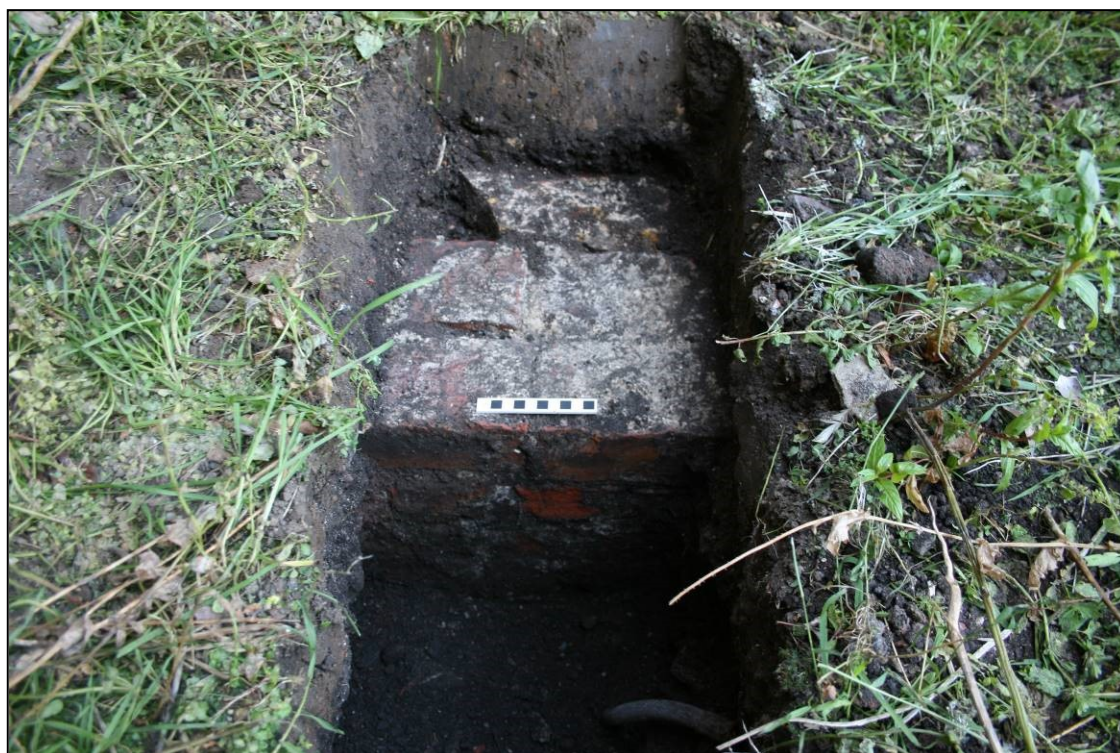
Plate 11: Church floor test pit, view south, scale: 1m

- 5.1.20 A test pit located in the choir area of Holy Trinity Church was monitored, this measured c. 1m by 0.5m (Figure 2; Plate 11). The earliest deposit encountered comprised a friable mid brownish grey silty clay [123] that represented post-medieval levelling activity to raise the floor level within the church.

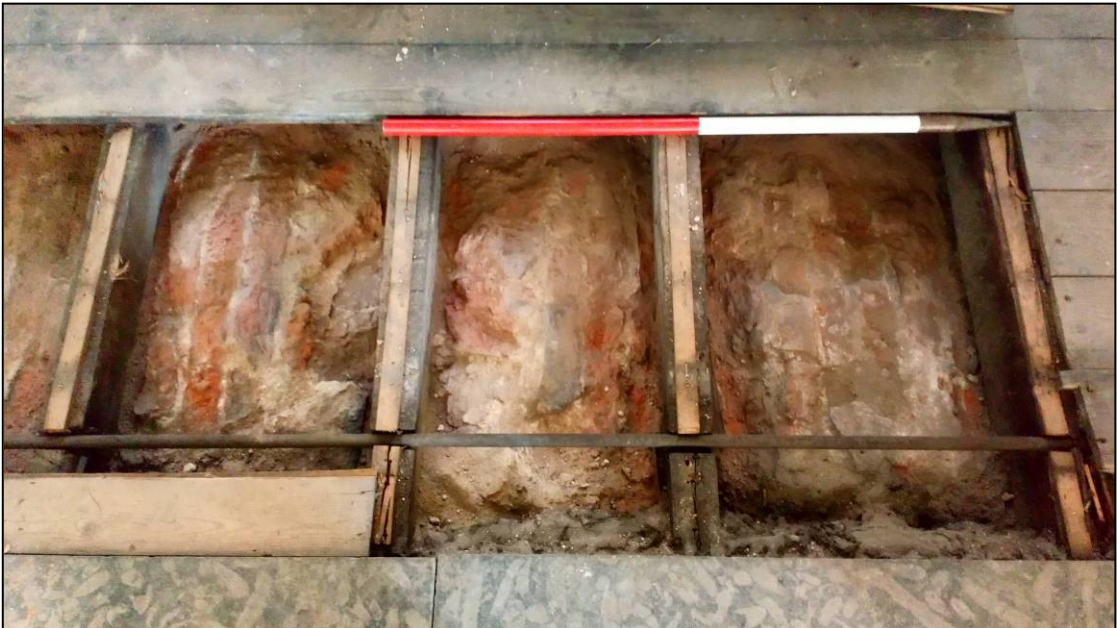
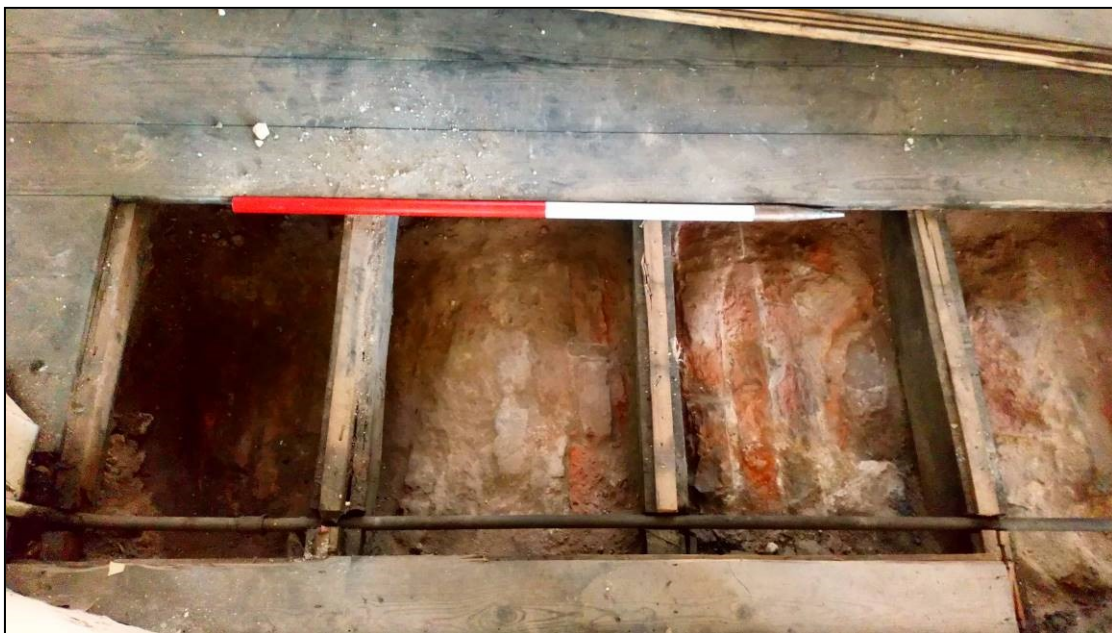
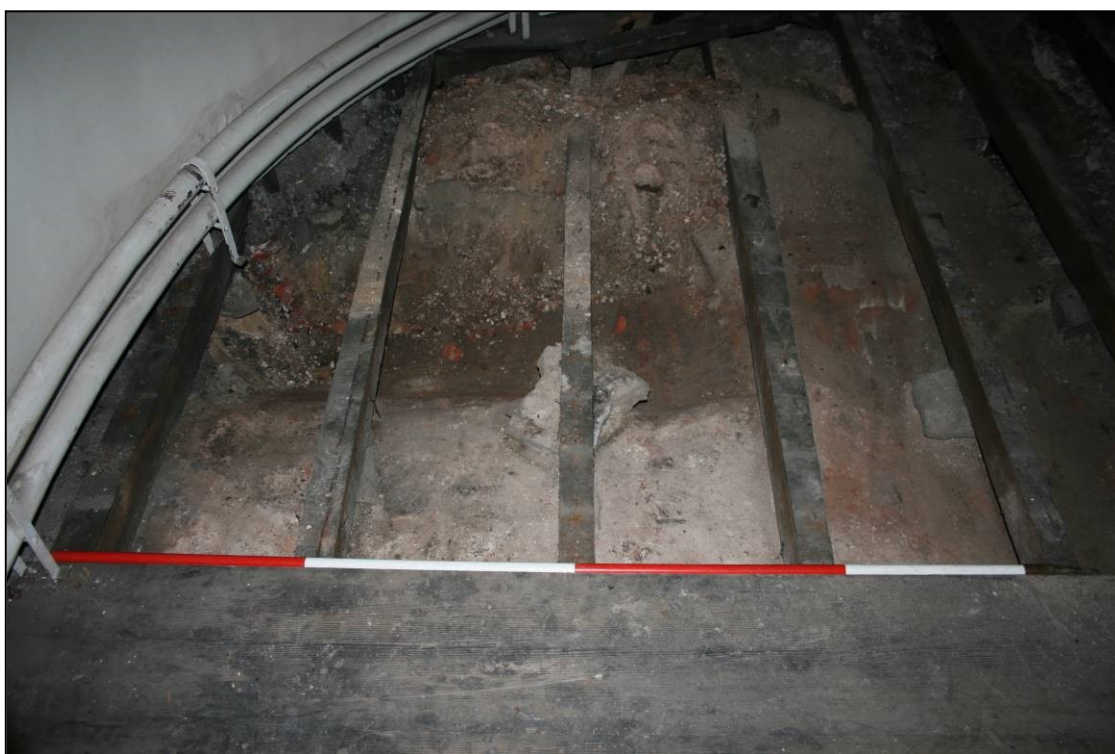
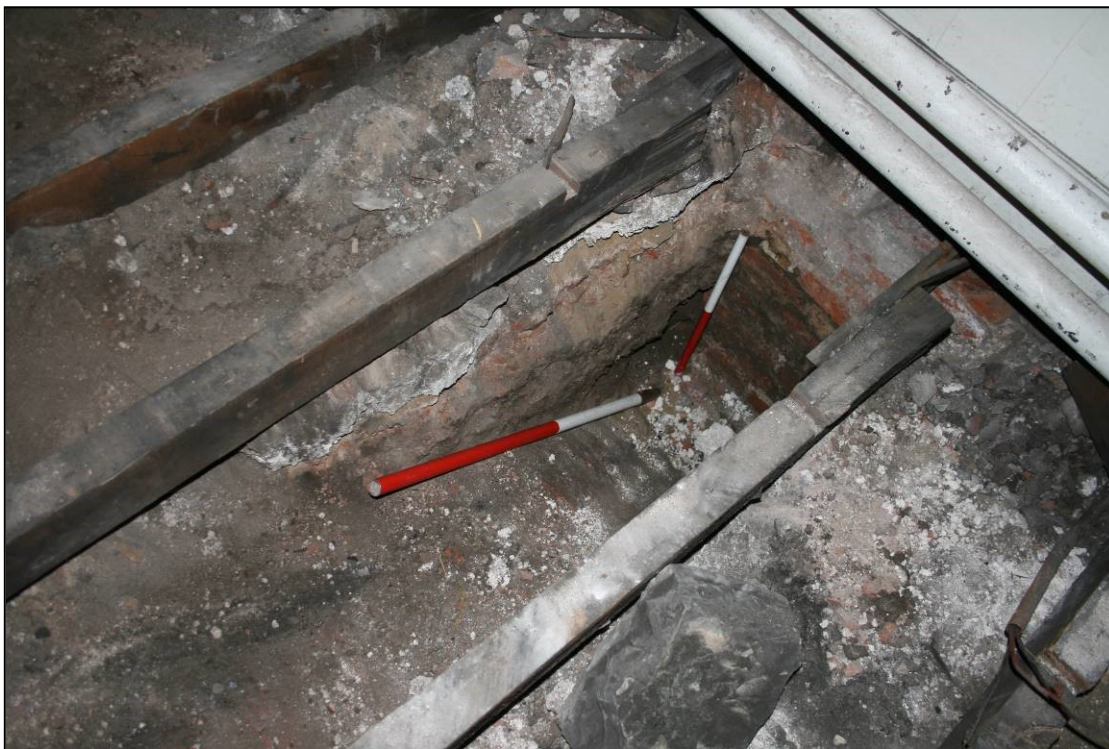
- 5.1.19 The condition of the rector's burial vault [119] below the eastern apse was monitored during removal of the floorboards (Plates 12-15). The roof of the vault was covered in a sandy deposit [120] with occasional stones used to support the floor joists. A service trench [125] for heating pipes had been installed that truncated the upper courses of the burial vault (Plate 16). Through this hole, it was possible to observe the inside of the vault (Plates 17-19). Human bones, presumably the skeletal remains of the rectors known to have been interred within the vault, were observed however, it was clear that some disturbance had occurred as the bones were scattered. It was not possible to ascertain when this had occurred, but anecdotal evidence suggests that the vault floods to such an extent during heavy rain that the bones would be disturbed. There was also what appeared to be a brick ossuary box which likely contained the remains of at least one individual (Plate 19). The vault was not entered, and no human remains were removed from it.

Plate 12: Burial vault [119] below apse, view east, scale: 1m

Plate 13: Burial vault [119] below apse, view east, scale: 1m

Plate 14: Burial vault [119], view east, scale: 2m

Plate 15: Arched roof of burial vault [119], view northeast, scale: 1m and 0.5m

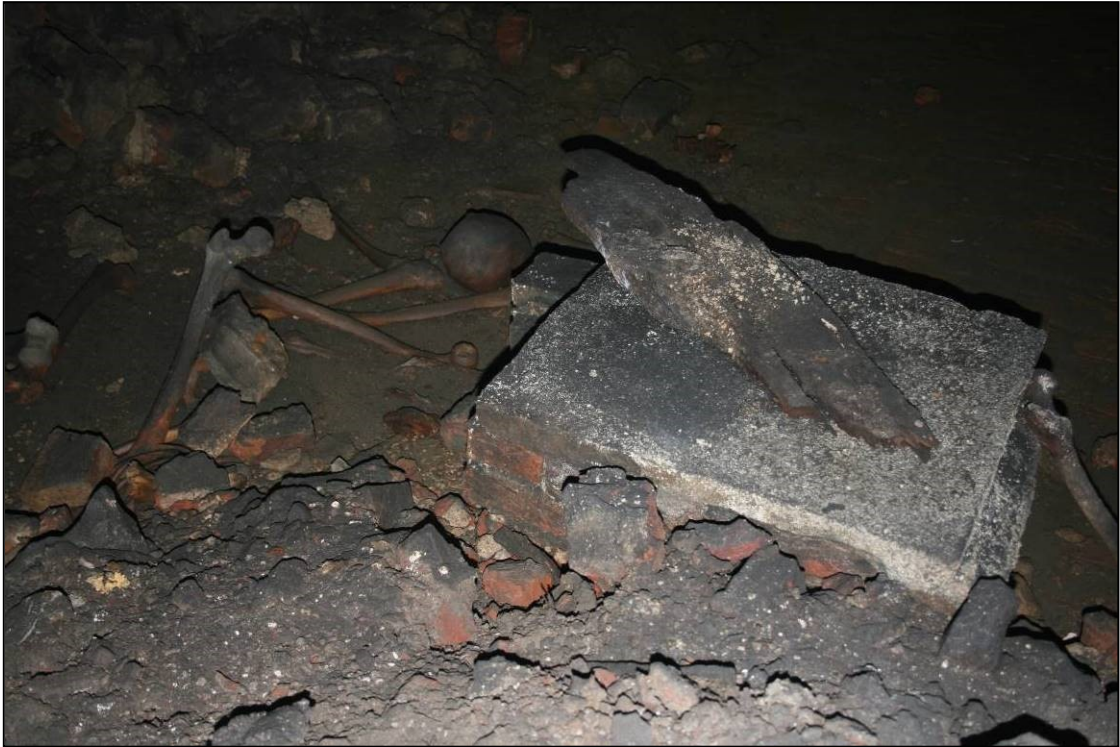
- 6.4 It was not expected that burials would be found within the main body of the church and that has proven to be the case in the areas monitored. The only internal structure known to hold human remains is the burial vault [119] located below the church apse. The burial vault was constructed below the apse for the rectors of the church (CCT 2010, 6 & 8). This archaeological monitoring work has confirmed that the vault still contains the remains of an unknown number of individuals. Although it was not possible to access the vault, a hole on the roof allowed the interior to be viewed and human skeletal remains were visible scattered around the chamber along with a brick structure which probably represents an ossuary box. It is not clear if this occurred during the heating works which created the hole in the roof or during the interment of later burials. Anecdotal evidence also suggests that the vault floods to such an extent during heavy rain that the bones would be disturbed. There was also what appeared to be a brick ossuary box which likely contained the remains of at least one individual (Plate 19). The vault was not entered, and no human remains were removed.

Plate 19: Ossuary box within Rector's vault and scattered human remains, view northeast

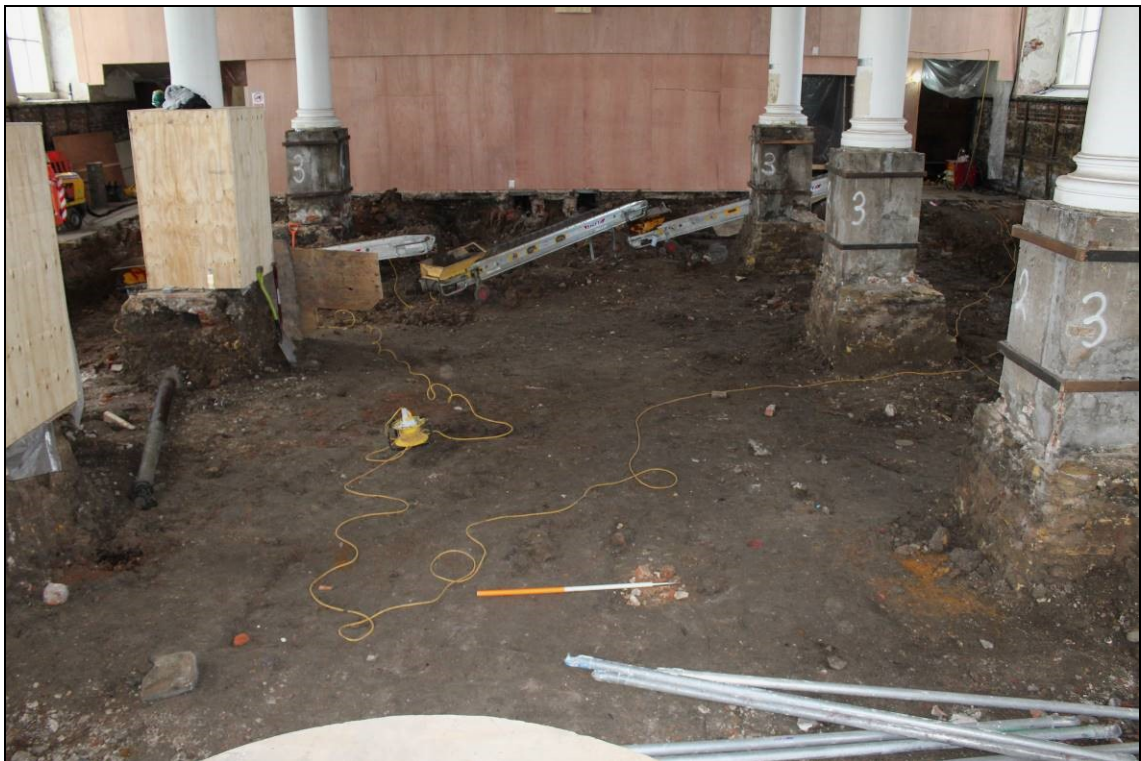
- 5.1.21 Work within the dais and chancel was also monitored during the installation of underground heating within the eastern end of the church (Figure 2). The area monitored measured c. 7.5m north/south by 4.56m east/west; this area was reduced to 1.04m below ground level. The earliest deposit encountered comprised loose black coarse sand [143] and rubble c. 1.04m thick. This represented a ground raising dump/infill below the former floor level of the church and is equivalent to deposit [123] noted in the test pit (Plate 20).

Plate 20: Nave after ground reduction: view southwest, scale: 1m

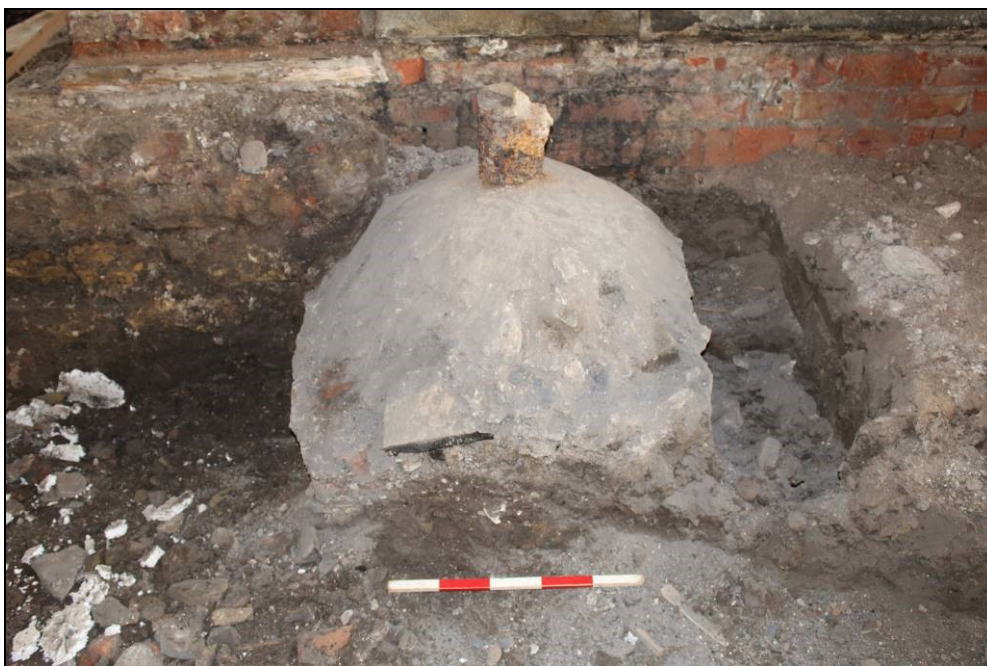
- 5.1.22 Cut into the ground raising dumps was a square construction cut [142] c. 0.91m by 0.90m and >0.64m deep. It was located along the western limit of the dais at the north-west corner and contained a circular cast-iron support beam [140] c. 0.14m in diameter and concrete foundation [141]. The structure perhaps represents the foundations of a pulpit with the metal support continuing above floor level into the base of a wooden pulpit (Plate 21). Historic photographs of the interior of the church show a pulpit within this location.

Plate 21: Pulpit foundations [140] and [141] in cut [141]: view northeast, scale: 0.5m

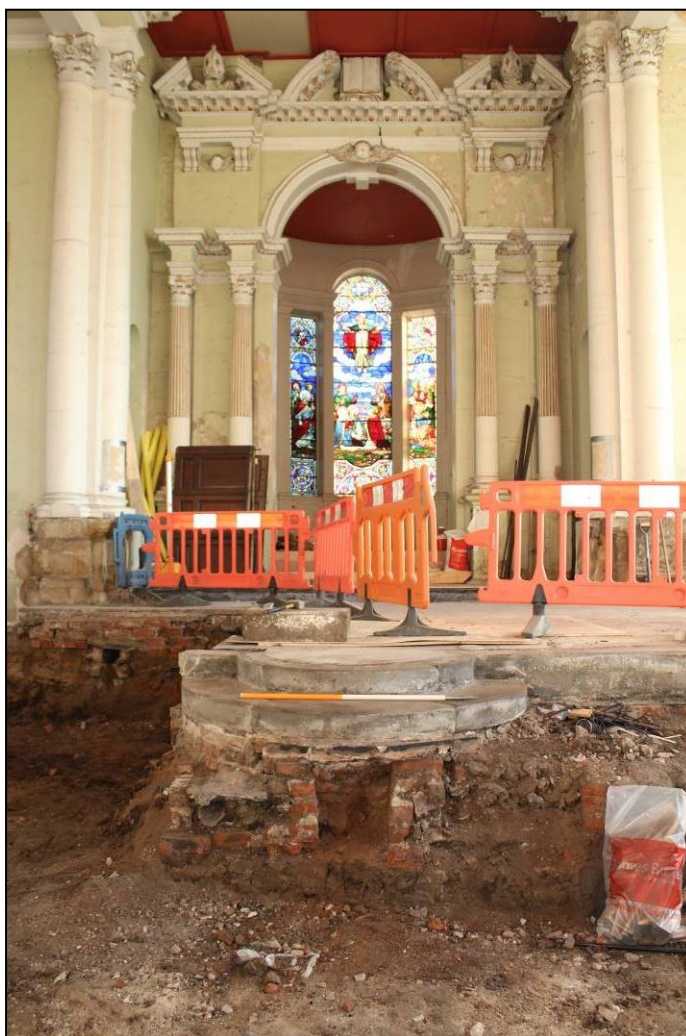
- 5.2.2 The construction cut [206] for the dais was rectangular in shape and cut earlier ground raising deposit [143]. The construction cut was 7.5m north/south by 4.56m east/west and 1m deep. Several brick heating ducts [203] c. 0.50m wide and 0.75m high were observed below the dais which contained cast iron pipes that would have led to the now demolished boiler house on the northern side of the apse. Each heating duct was sealed with a sandstone slab c. 500mm by 600mm and 40mm thick (Plate 22).

Plate 22: Heating duct [203] below dais: view northeast, scale: 1m

- 6.2 The construction date for the dais has been placed within Phase 2 due to 20th-century bricks being used in some areas however it may have been installed earlier during the 1887 works. The modern bricks could represent spot repairs to the masonry. Further research into the installation of the boiler house and therefore the heating ducts may elucidate when it was constructed.

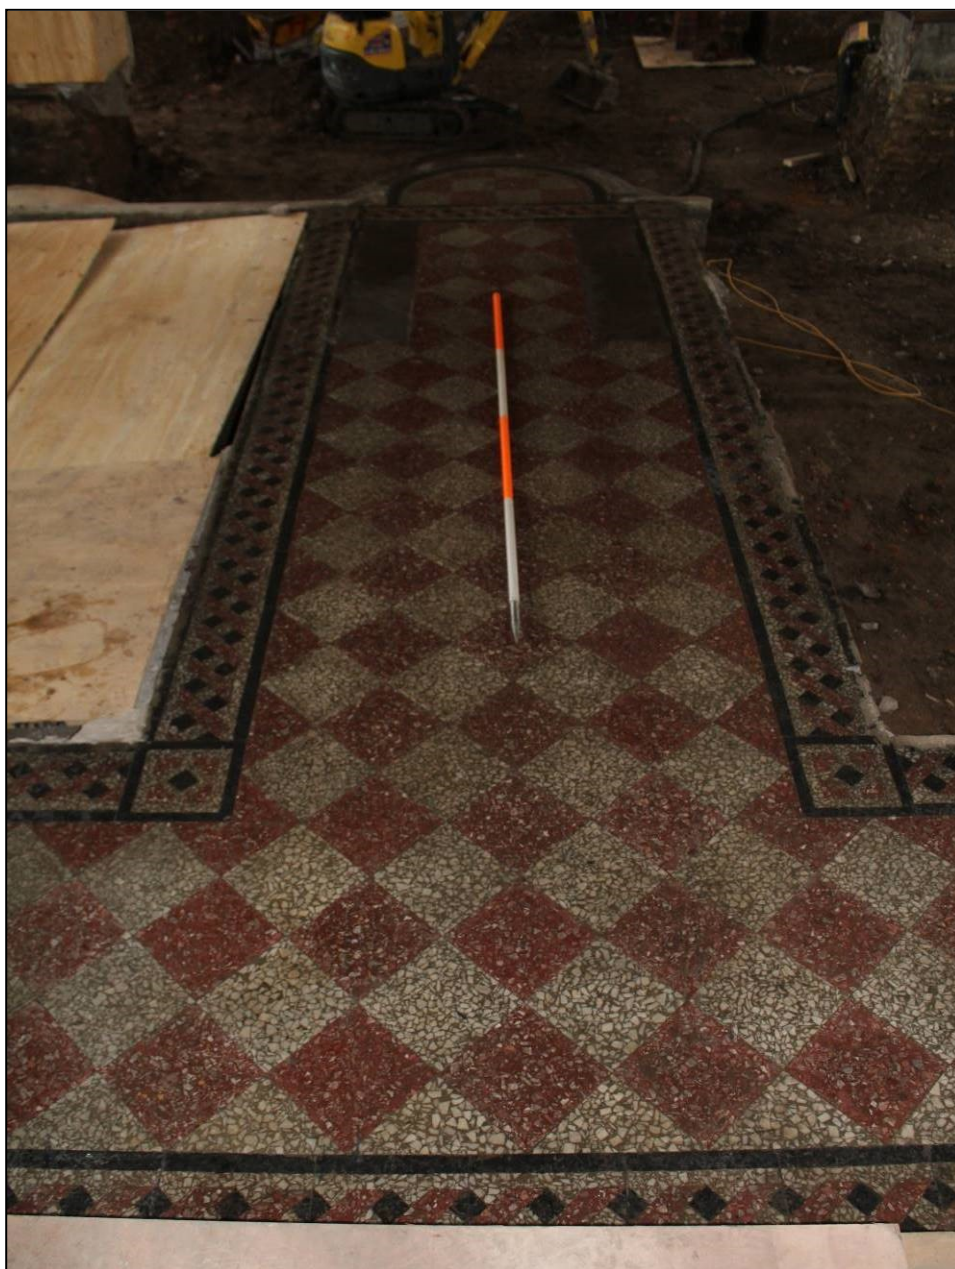
- 5.2.3 The outer limits of the dais (northern, western and southern) were comprised of brick walls [205] in stretcher bond that measured 4.56m east/west, 7.5m north/south, 0.36m wide and 0.88m high. The outer wall was capped with sandstone edging stones [202] that measured c. 6.03m north/south by 3.82m east/west, 0.12m wide and 0.25m thick. The ground level within the dais area was raised by loose black coarse sand and rubble [204] c. 0.42m thick and loose black coarse sand and rubble [201] c. 0.46m thick. The floor level comprised concrete and black and red floor tiles (Plate 23).

Plate 23: Tiled floor surface [200] within dais/chancel: view southwest, scale: 2m
