**Land at The Broadway, Rainham,
London Borough of Havering, RM13
9YW**

An Archaeological Evaluation

| <i>PCA report no.</i> | R14126 | <i>Site Code</i> | BWY20 |

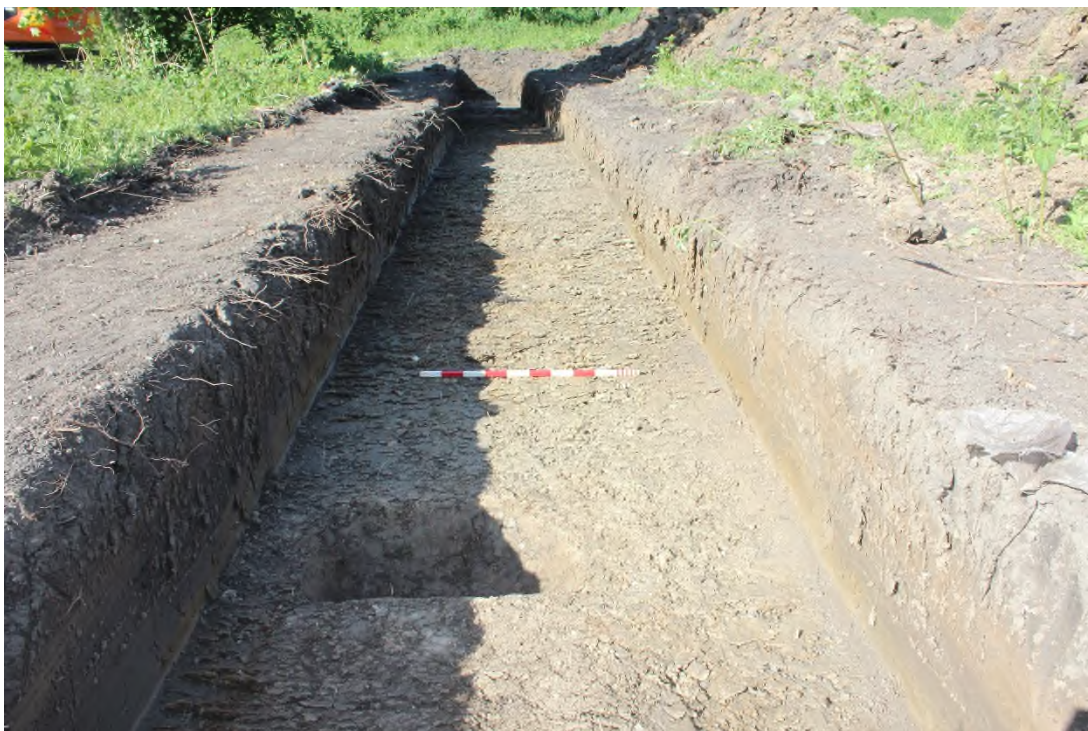
Plate 10: Trench 7, Looking Southwest, Showing Pit [116].

- 6.2.3 A small, undated pit [116], was recorded in Trench 7. It had a surface height of 1.32m OD, appeared sub-rectangular in plan, continuing beyond the northeastern LOE, measuring 1.52m+ NE-SW by 0.78m NW-SE and had a depth of 0.30m. The single fill, [115], was firmly compacted, mid greyish brown clay with mottles of light yellow and reddish brown and had occasional inclusions of small sub-rounded stones and evidenced significant bioturbation via rooting.

- 7.6.4 Pit [116], recorded in Trench 7 showed signs of extensive bioturbation through rooting and is possibly the remains of a tree-planter to the rear of the vicarage fronting on to Broadway.

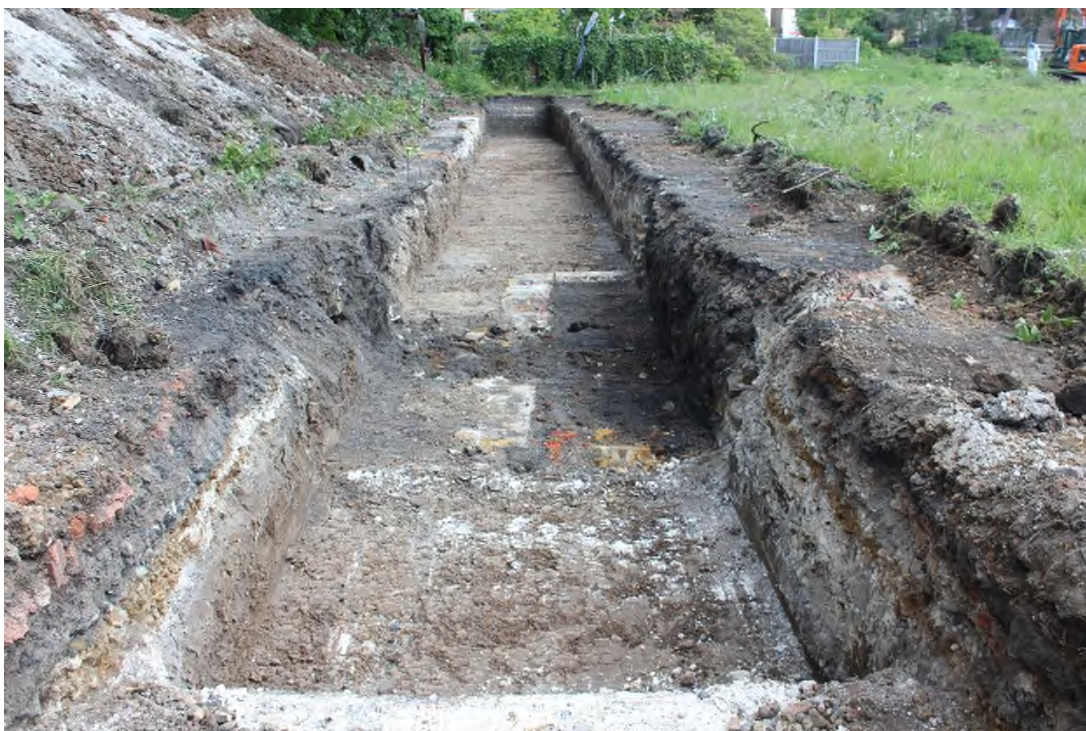
Plate 1: Trench 5, Structure [102], Looking Northeast.

- 6.2.1 To the western end of Trench 4 at 1.18m OD the natural deposits were cut by construction cut [103] for brick structure [102]. The structure was constructed from machine made, red and yellow frogged bricks measuring 220mm/100mm/70mm, dating to AD1850-1950. The bricks appeared to be laid in a stretcher bond, with a light grey, concrete mortar. The structure looked to be sub-square in plan, measuring 3.90m east-west by 1.10m+ north-south, with a probable entrance on the northern side.

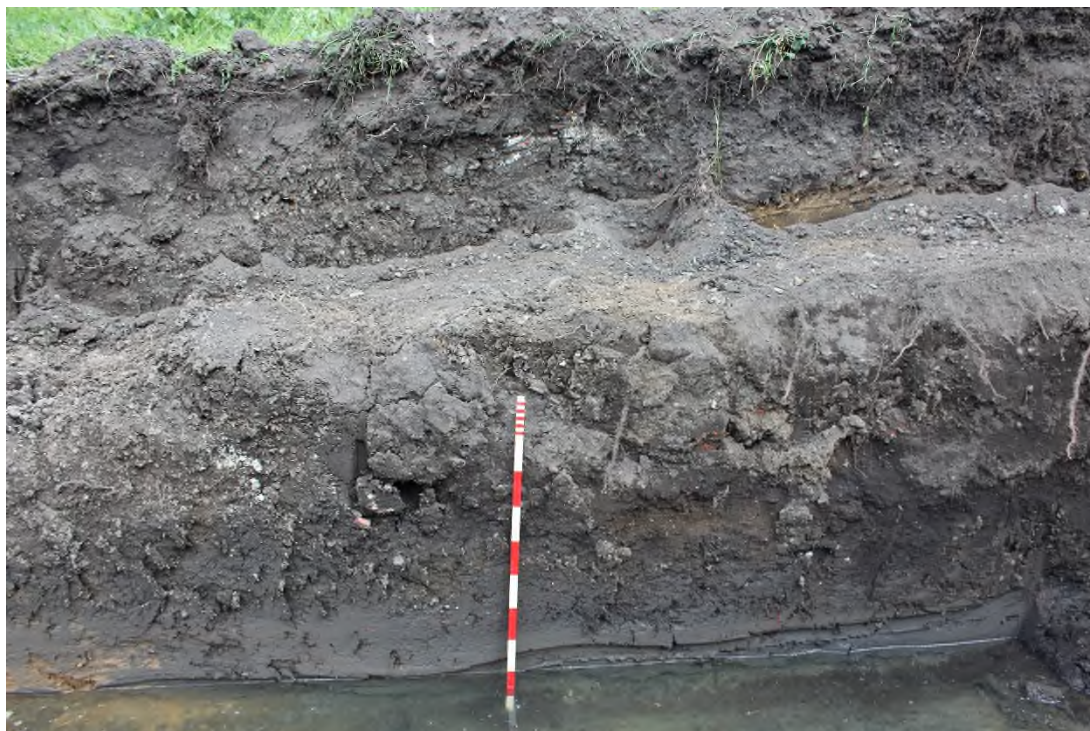
Plate 8: Section 6, Trench 6, Showing Linear Feature [111] and ground-water.

- 6.2.2 In Trench 6, at 1.04m OD linear feature [111] ran on a north-south alignment for 3.17m+, continuing beyond both the northern and southern LOE of the trench. The feature had a width of 1.80m and a depth of over 0.73m, not being fully excavated due to continuing beyond a safe depth and filling with ground water. The feature contained a single fill [110], comprising firmly compacted, dark greyish brown silty clay, with occasional inclusions of sub-rounded stones.

- 7.6.3 The linear feature in Trench 6 corresponds with a property boundary that is visible on both the 1867 (Figure 5) and 1897 Ordnance Survey maps, running behind the buildings that front onto Broadway. Given the susceptibility of the area for flooding, this boundary also probably acted as a drainage ditch that emptied into Rainham Creek, near the Wharf.

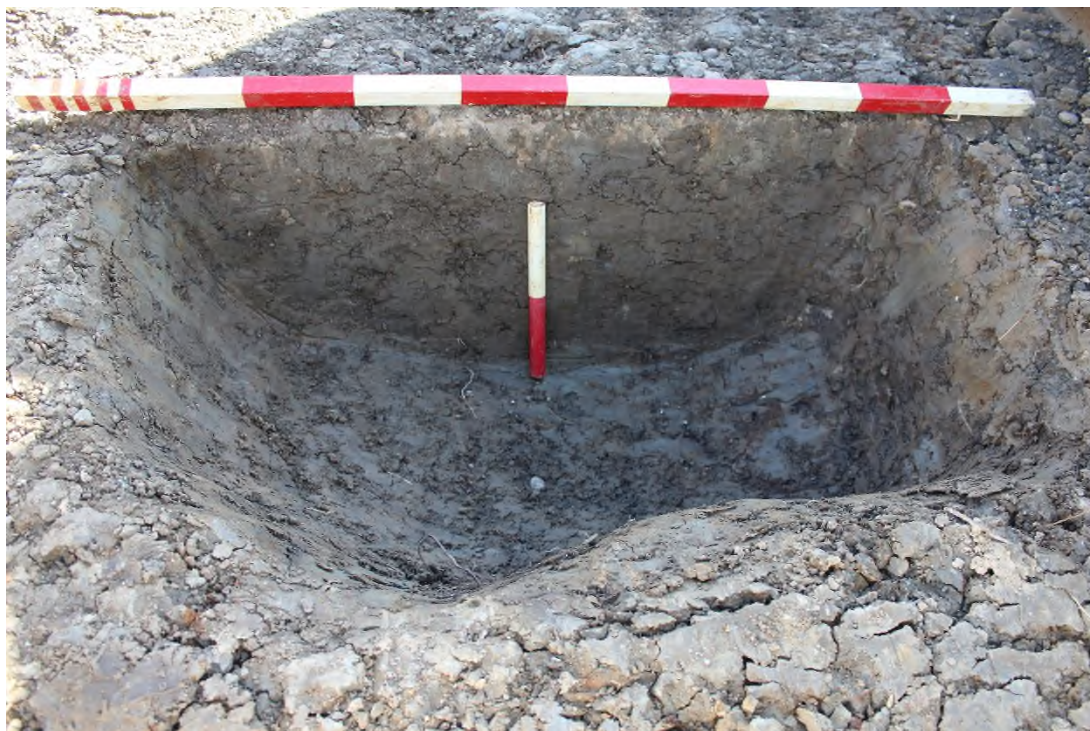
Plate 11: Section 9, Pit [116], Trench 7.
