INDUSTRIAL SHED AND ADJACENT BUILDING (BH146)
Marshgate Centre
Marshgate Lane
E15

Standing building survey report

Site Code: OL-03907
National Grid Reference: 537845 183806

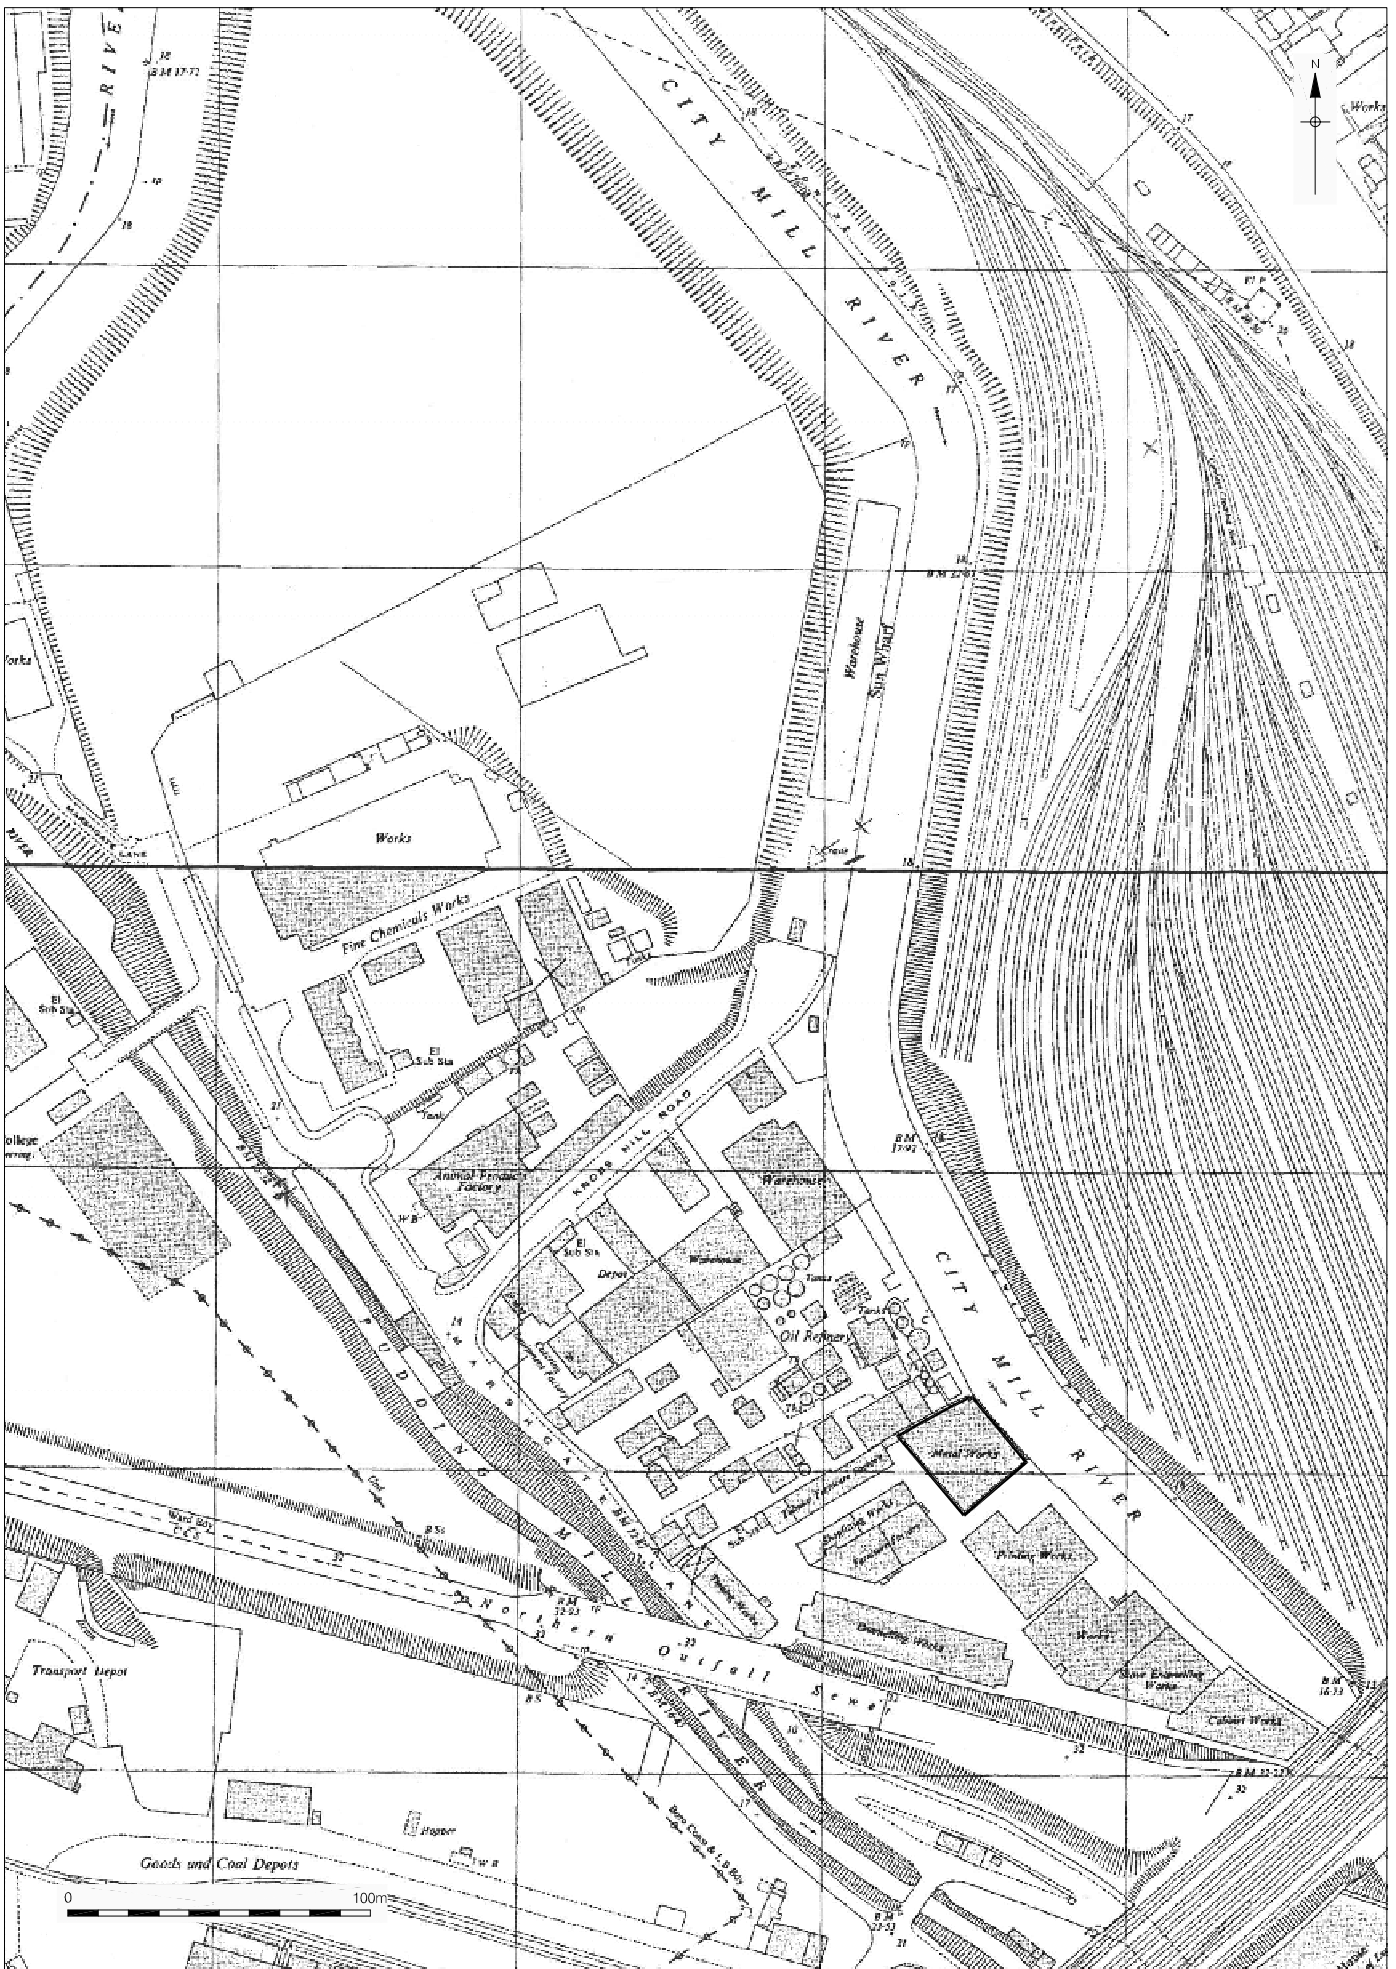
Figure 8
1968 OS map
1:2,500 at A4

The 1968 OS map (Figure 8) shows the area densely populated with structures and heavy industry. The plot in which Buildings 1 and 2 are situated is no longer named 'Marshgate Works', and the structures are individually labelled. Buildings 1 and 2 are recorded as 'Metal Works'. The structures to the southwest are in use as a 'Tubular Furniture Factory', 'Shopfitting Works', and 'Furniture Factory'. To the southeast are 'Printing Works', 'Works', 'Stove Enamelling Works' and 'Cabinet Works'. Running parallel to the Northern Outfall Sewer is an 'Enamelling Works'.

The form of Buildings 1 and 2 has changed slightly; the projection on the south-east elevation has gone, as has the covered walkway and the footbridge. The small space between the north-west elevation of Building 1 and the boundary wall is shown infilled, although as this space was open at the time of survey it is likely that this can be put down to cartographic error.

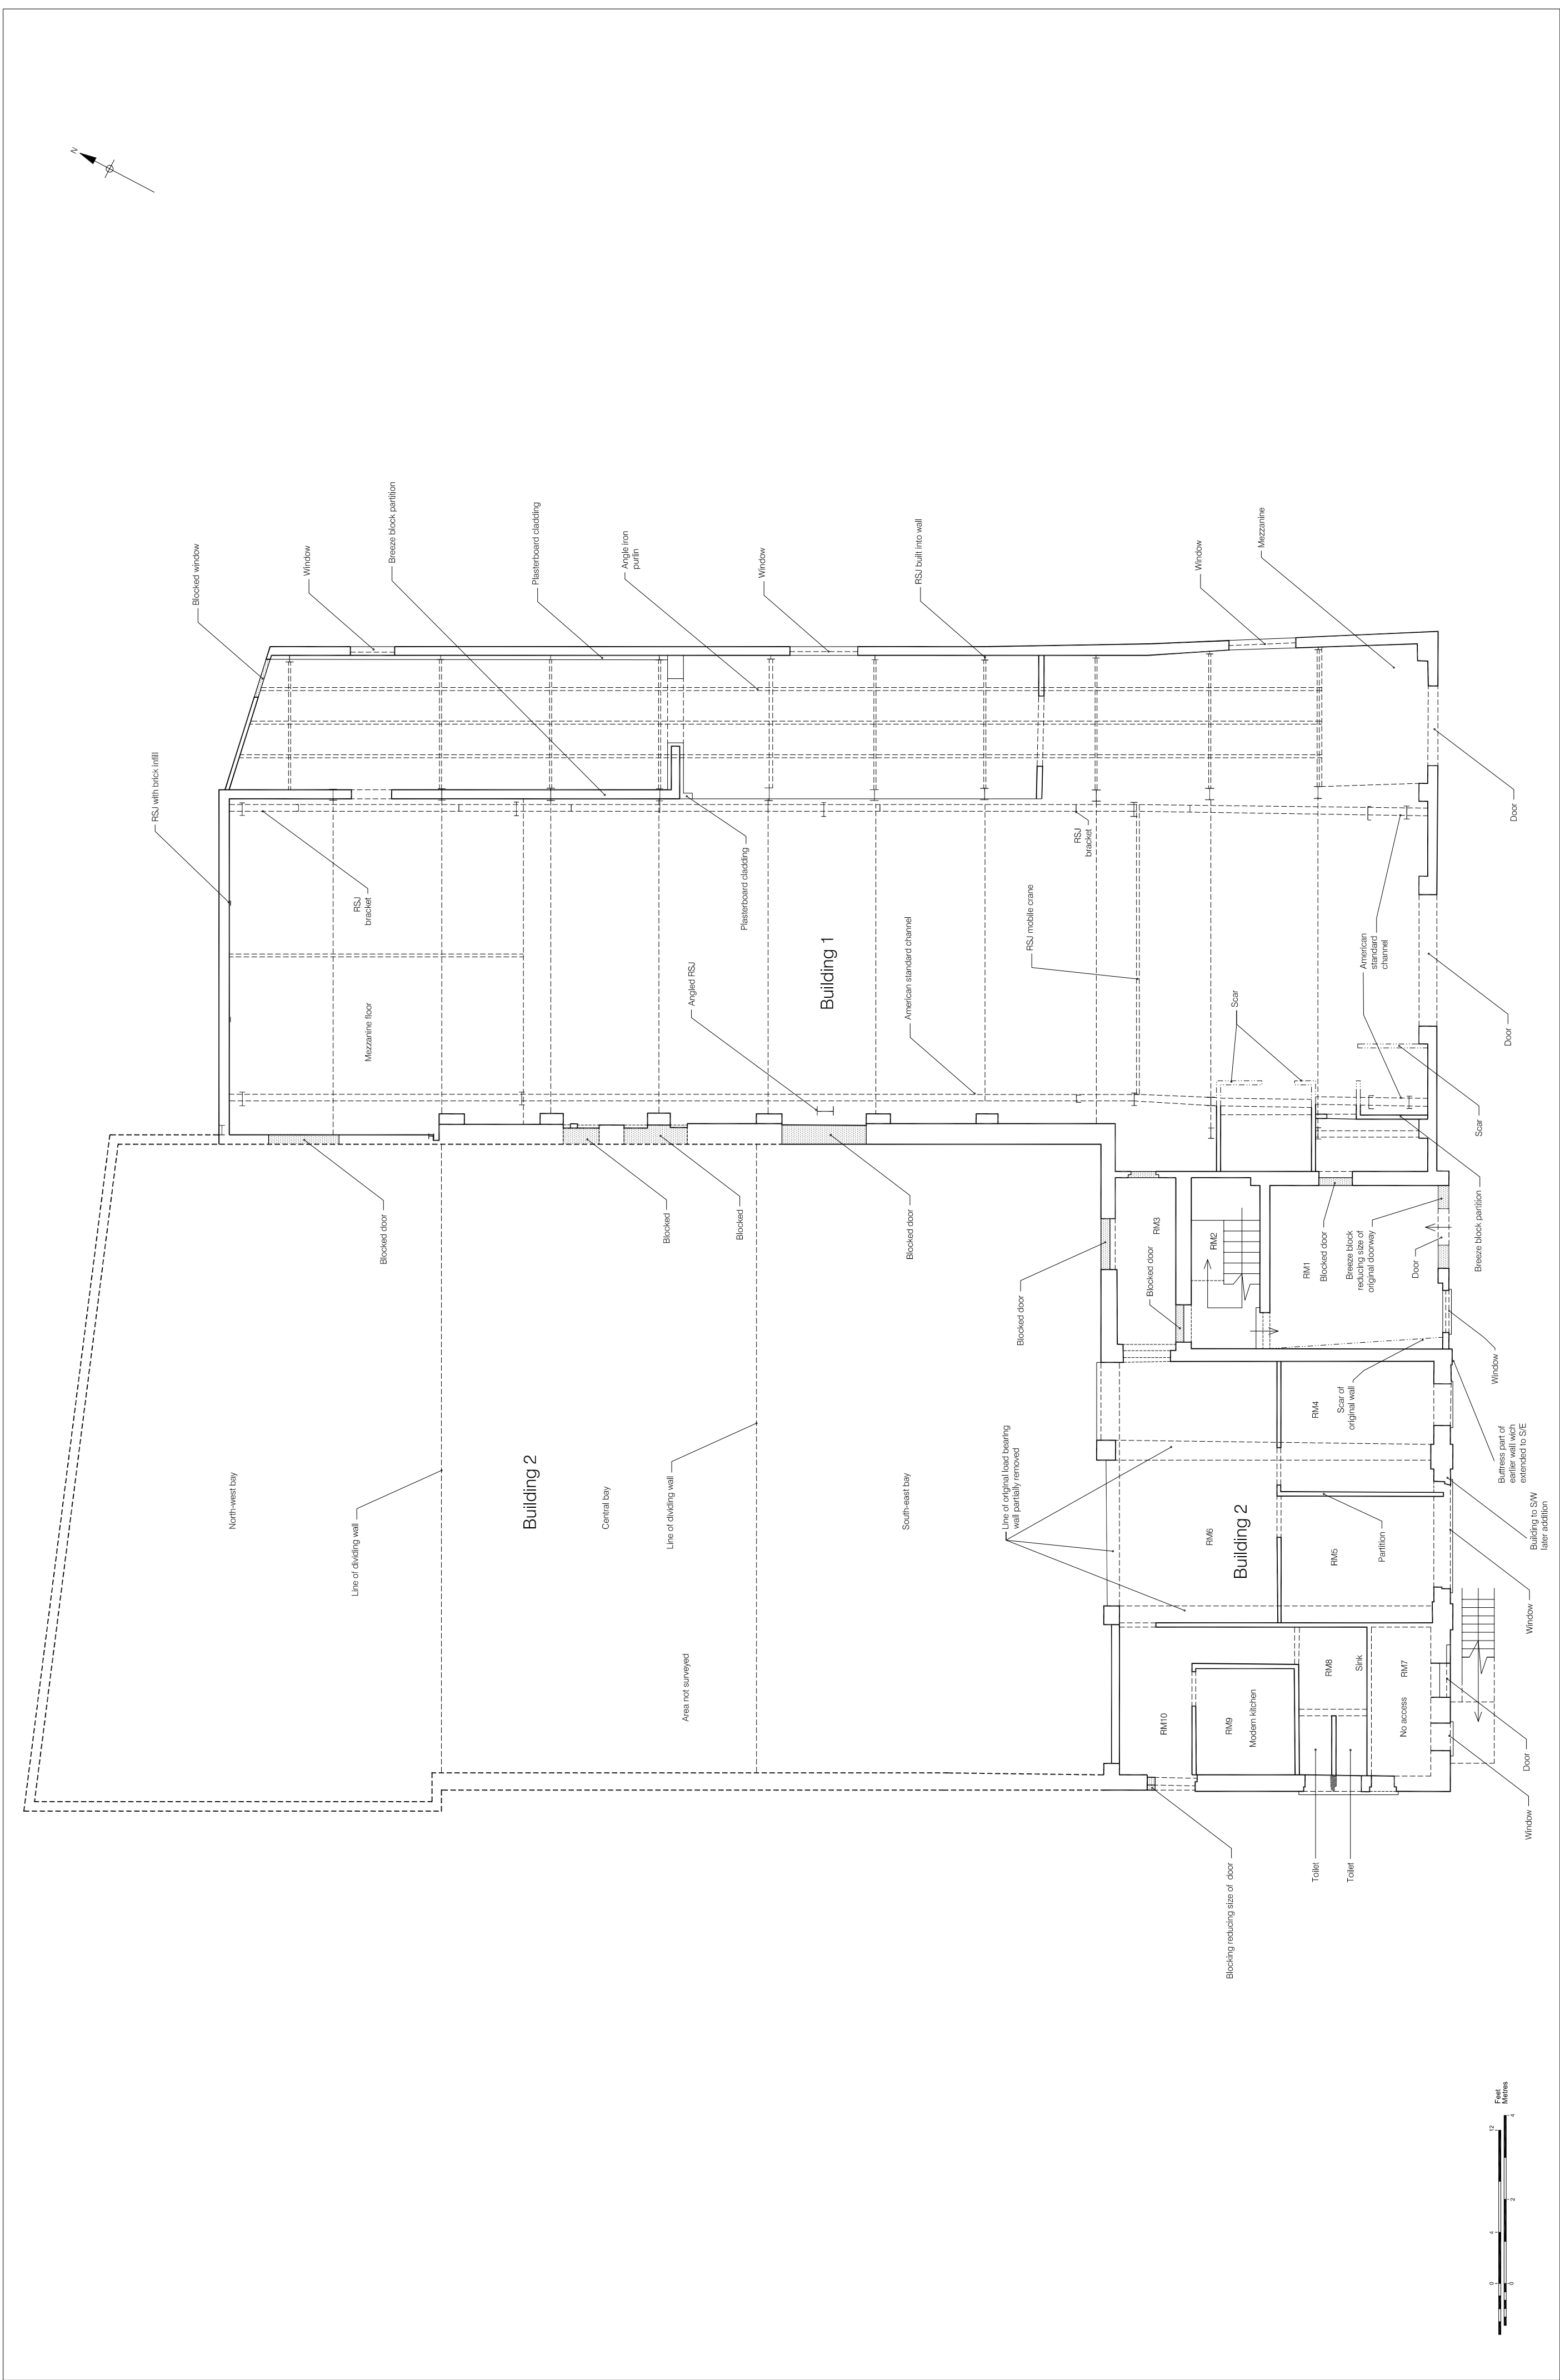
Based on these site drawings, one plan (Figure 9) has been drawn, positioned so as to demonstrate the construction and layout of the building as clearly as possible.

The original plot is at a scale of 1:100.

The following outline description should be read in conjunction with the plan (Figure 9) and selected photographs taken in November 2007.

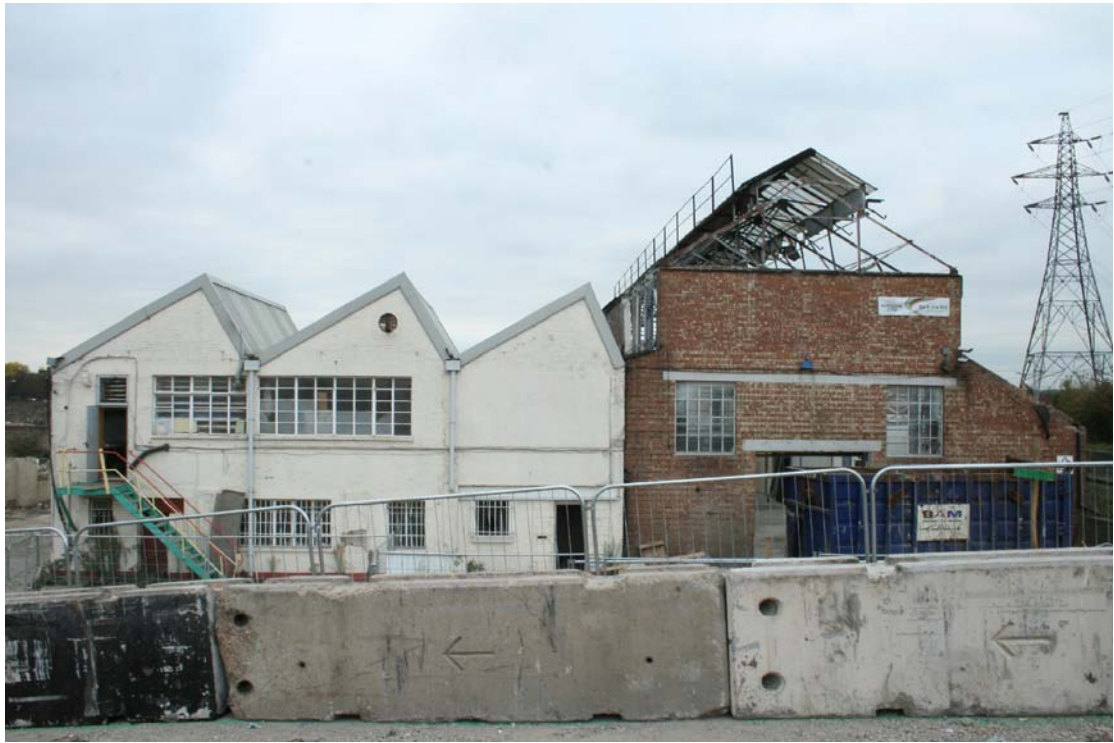
Plate 4 View of Buildings 1 and 2, looking north-west

At ground floor level are a series of steel-framed casement windows with vertical bars, and several phases of brick and breeze-block blockings (Plate 4). At the north-east end of the elevation is a wide modern RSJ between ground and first floor level, below which brick and breeze-block infill has been used to create a doorway and window opening. It appears that this section of the elevation, below the profile of the north-easternmost roof, originally extended further south-east than the rest of this face. To either side of the modern RSJ is evidence of scarring caused by truncated walls which formerly extended outwards to form a small projection.

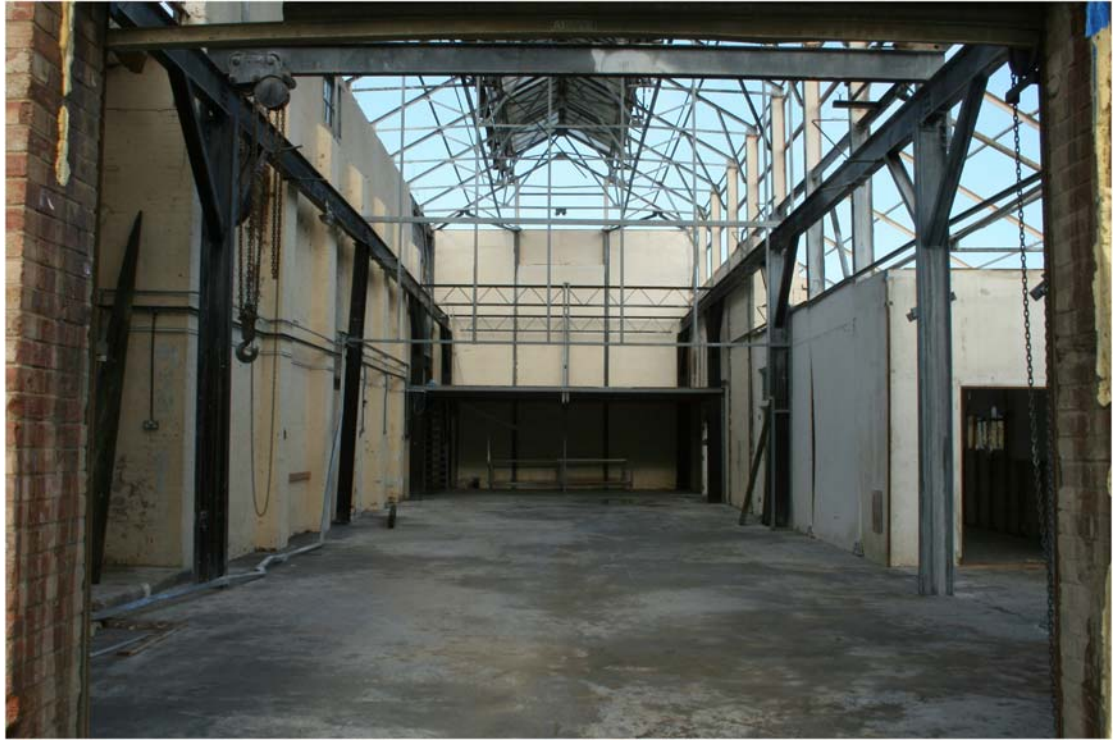
Plate 6 Internal view of Building 1 looking north-west, showing principal space, frame and roof trusses

An older metal frame remains in situ (Plate 6), no longer load-bearing. Modern RSJ replacement stanchions on the north-east side and a series of modern buttresses on the south-west side now support the roof trusses.

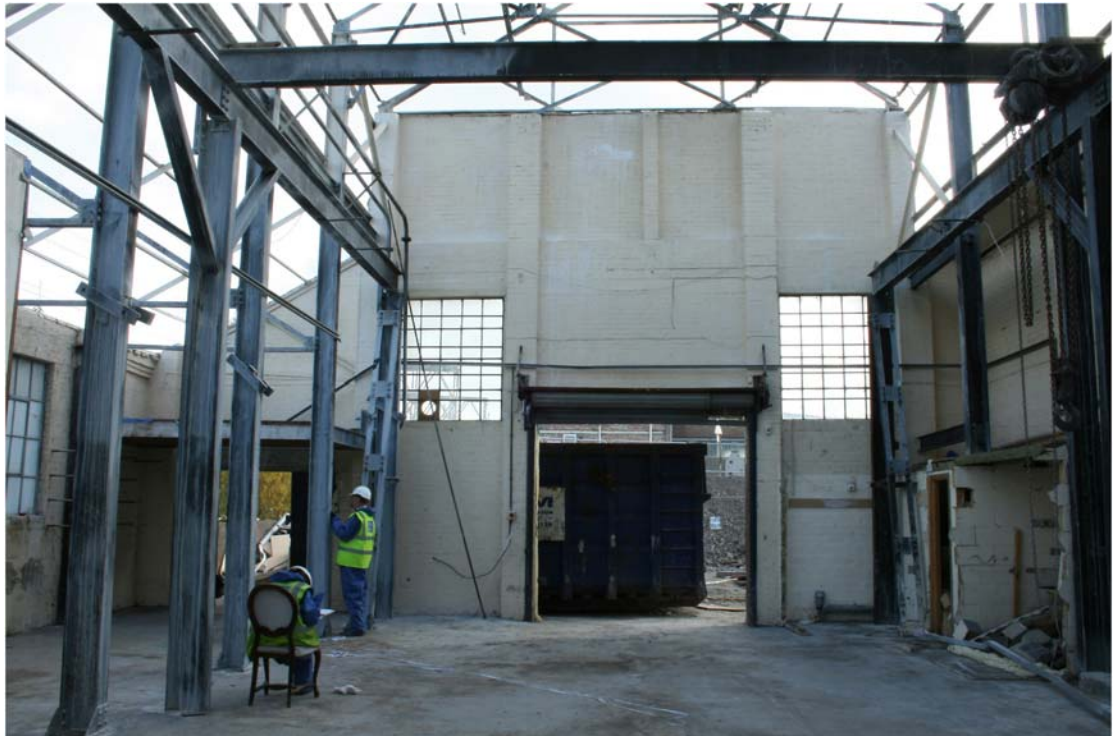
Plate 7 Internal view of Building 1 looking south-east, showing south-east wall and frame

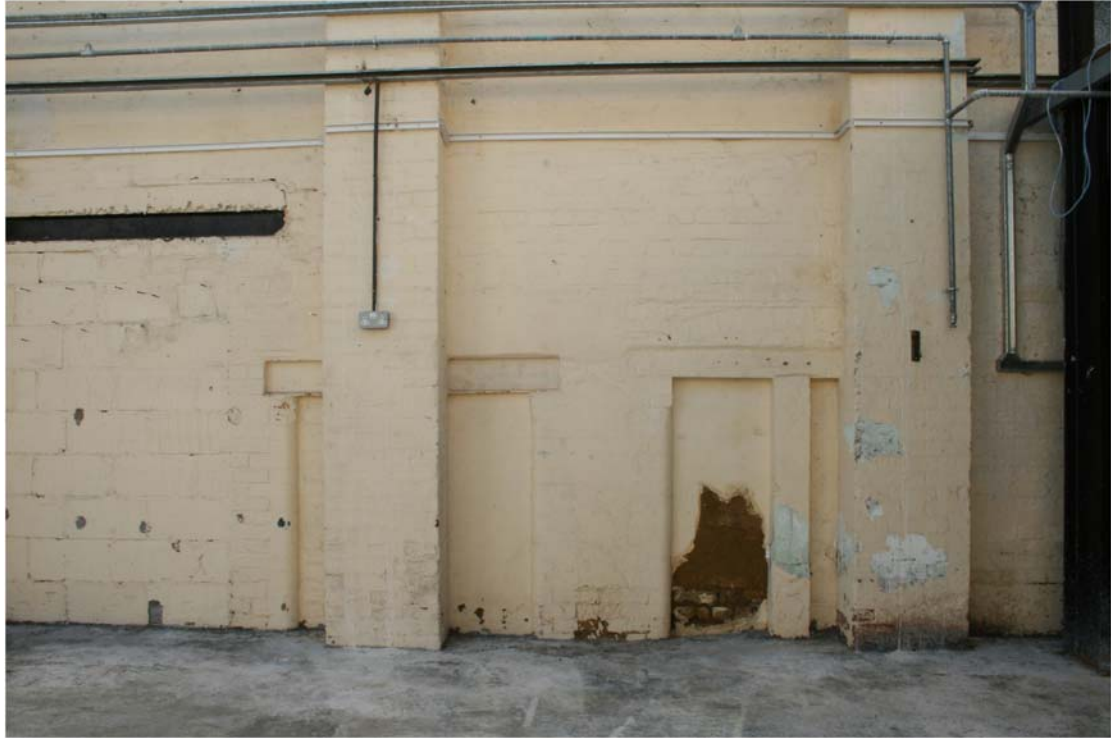
Plate 8 Blockings in south-west wall of Building 1, looking south-west

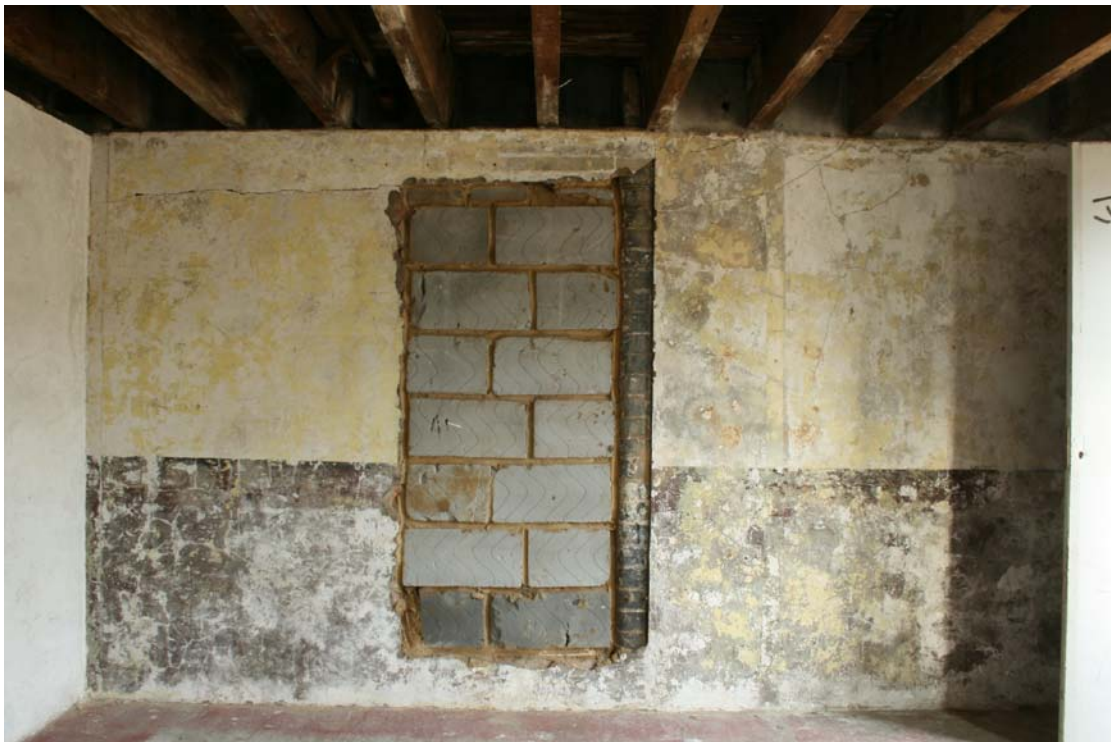
Plate 9 Blocked doorway in north-east wall of Building 2, looking north-east

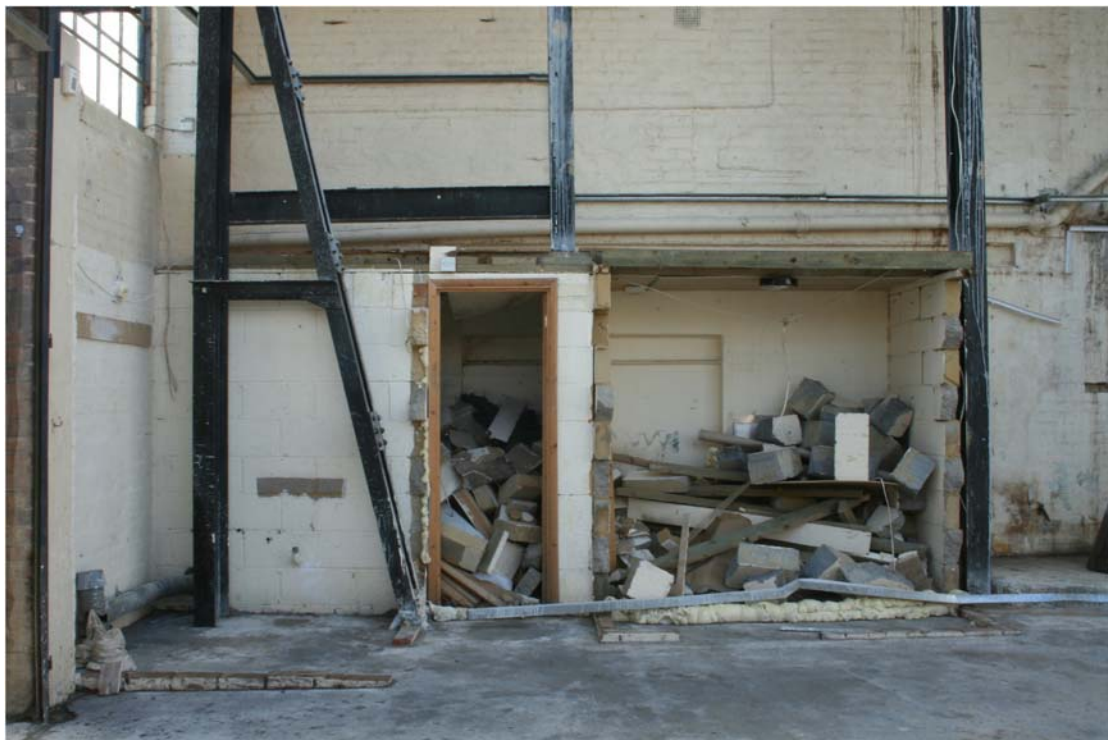
Plate 11 Partially demolished partitioned rooms in south-west corner of Building 1, looking south-west

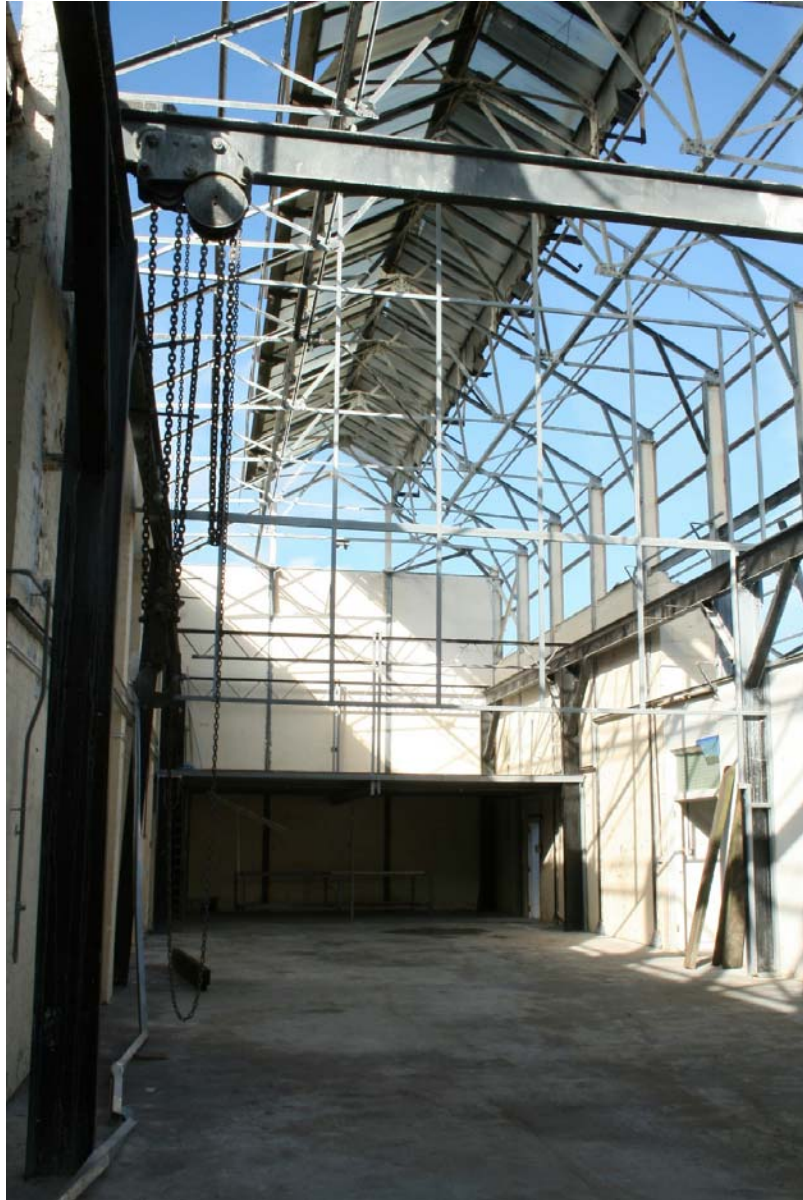
Plate 12 Internal view of Building 1 showing detail of lifting tackle and frame, looking north-east

Within the main space is a RSJ-framed running block and tackle, with fixed gantry and safe working load of 5 tons, still with pulley, hook and tackle and raising and lowering chains attached (Plate 12).

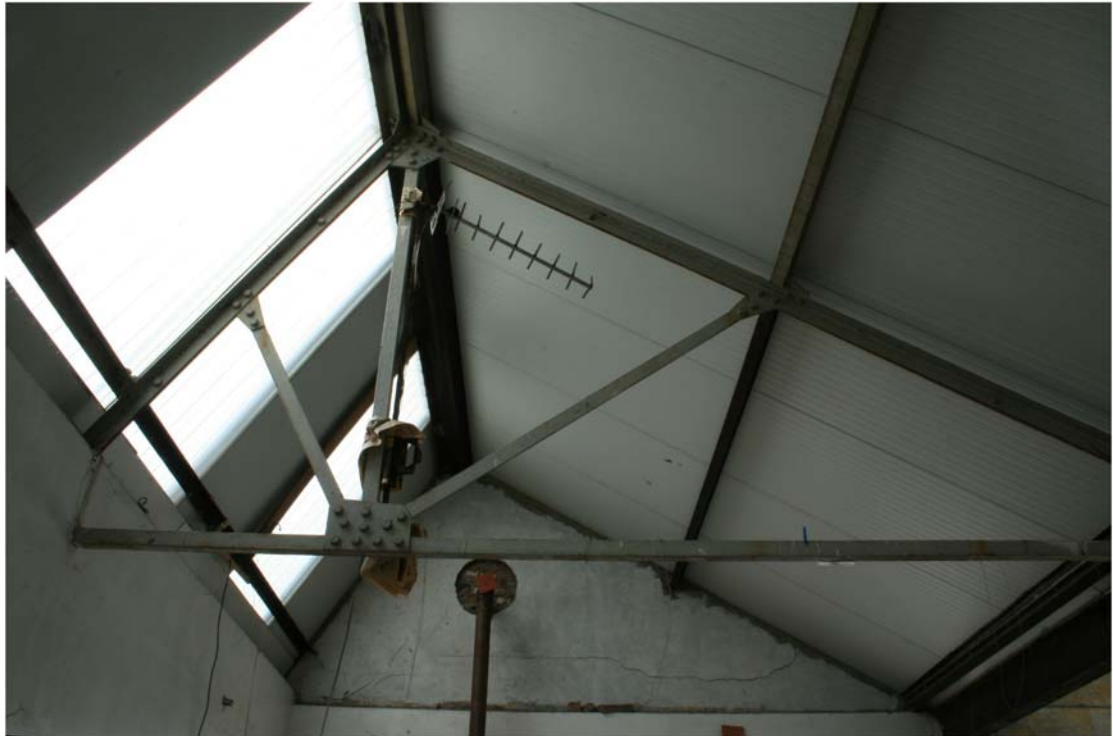
Plate 13 Truss supporting sawtooth-roofed section of Building 2, looking south-east

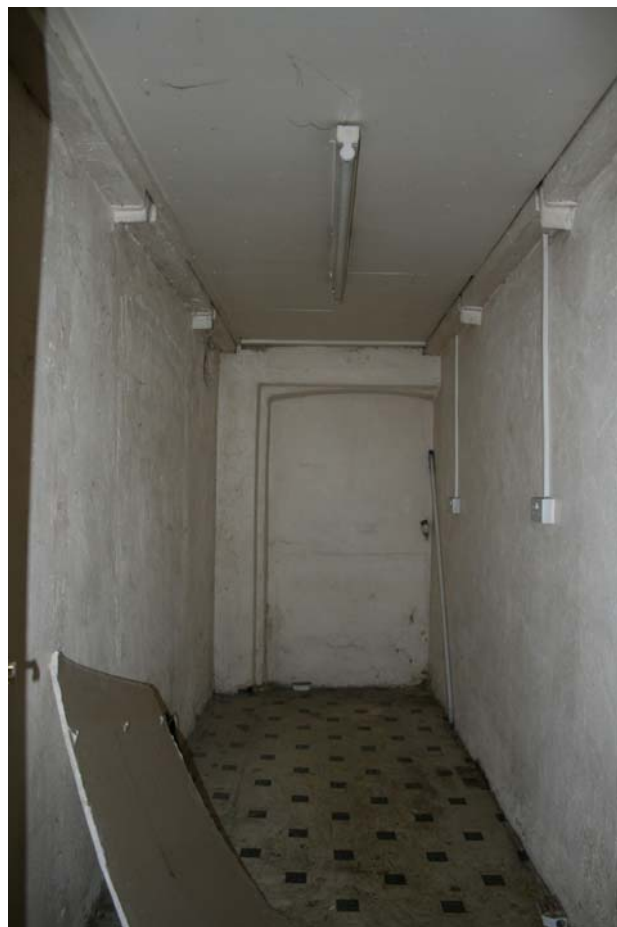
Plate 16 Room 3, Building 2, showing blocked doorways, looking north-east

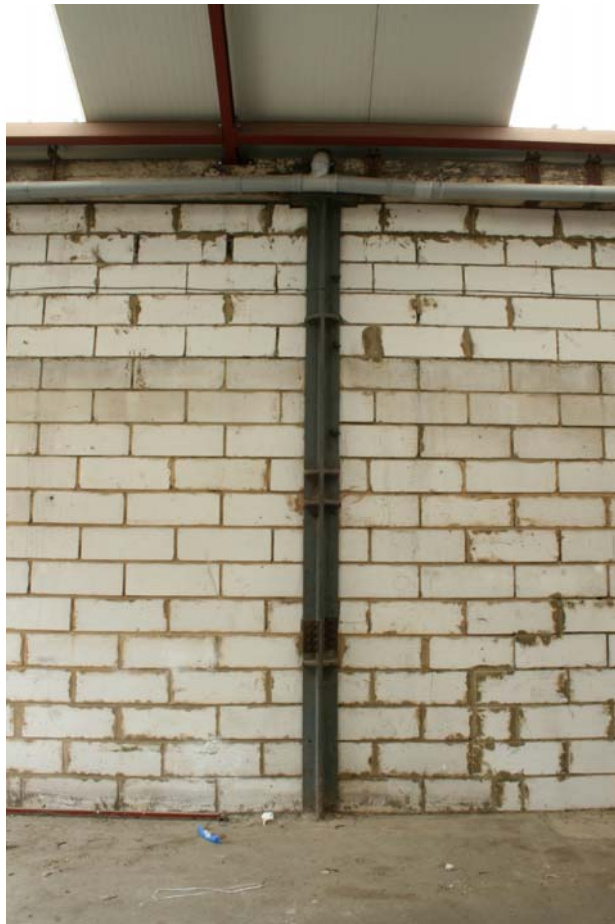
Plate 20 Detail of 19th-century cruciform cast iron stanchions supporting timber beam in central bay of Building 2, looking south-east

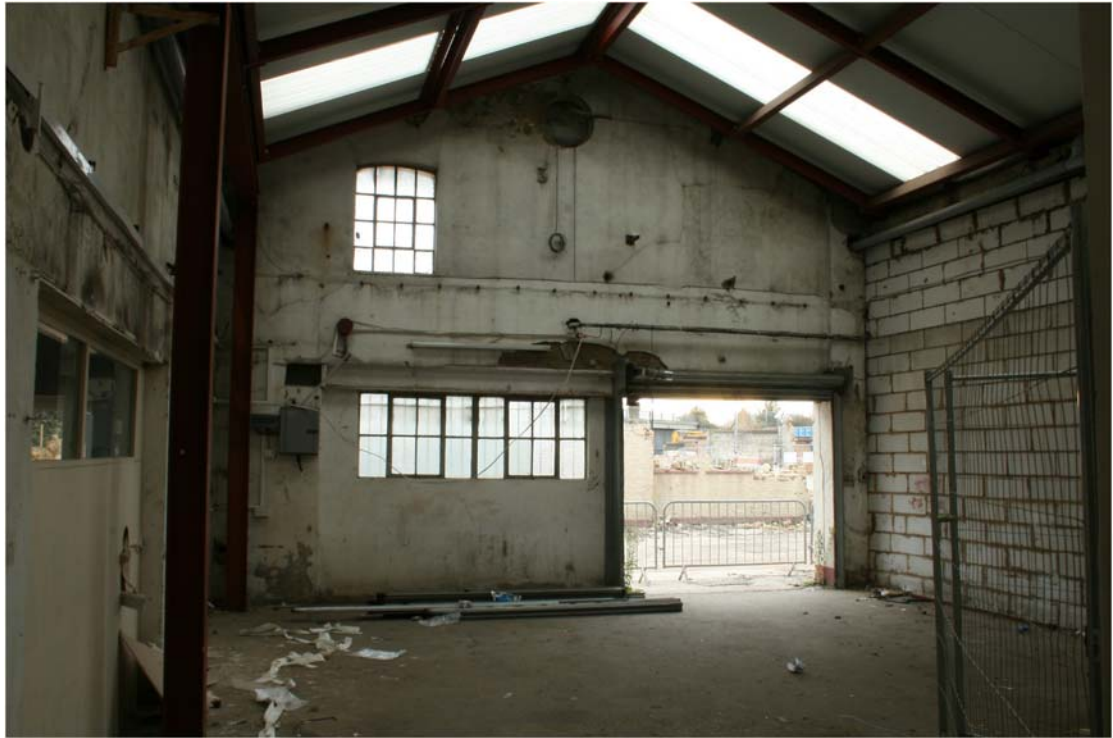
Plate 21 General view of south-east bay, Building 2, looking west

The south-east bay is open plan (Plate 21). Similarly to the central bay, it is likely that there was originally a first floor. The roof is modern sheeting supported by a simple metal truss on a modern RSJ frame. The north-west wall is formed of breeze-block infill between three mid 19th-century cruciform cast iron stanchions supporting a substantial timber beam that runs the length of the building (Plate 20). The south-east wall is built of brick, with numerous alterations is breeze-block or plasterboard. Several openings lead through into the sawtooth-roofed section of Building 2. Located to the rear of the bay is a modern two-storey office structure built against the framework of the bay (Plate 22).
