LAND AT 37-39 HIGH STREET SOUTH, DUNSTABLE, BEDFORDSHIRE, LU6 3HD

# **ARCHAEOLOGICAL MONITORING**

**REPORT NO: R13582**

# 37-39 High Street South, Dunstable, Bedfordshire, LU6 3HD: Archaeological Monitoring

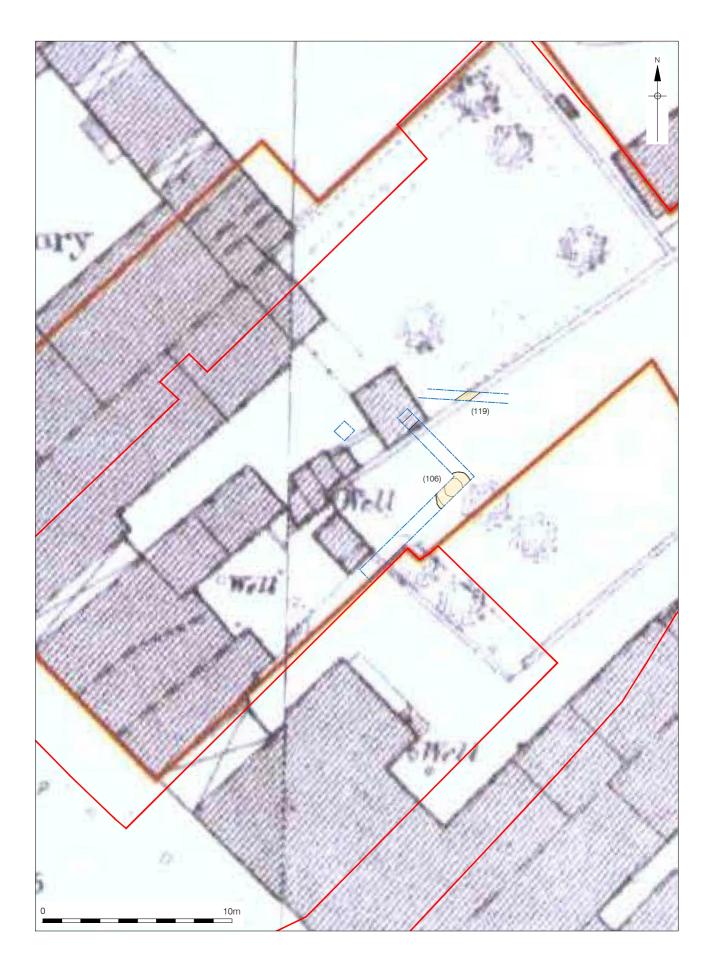
1880 OS Map reproduced from CgMs Desk Based Assessment 35 - 39 High Street South, Dunstable, Bedfordshire © Pre-Construct Archaeology Ltd 2020 02/12/2020 RS

- 8.2 The 1880 OS Map (Figure 6) shows the site being associated with a 'Hat Factory' which occupied part of the western portion of the site. Four buildings, identified on the earlier Tithe Map (1840), occupy the street frontage; these were associated with ancillary buildings including two wells. Rather than being medieval, the well (106) recorded in the footings of the proposed development may be a post-medieval structure re-using stones from earlier priory buildings.

- 8.4 Wall (119) recorded in the new service trench matches with a 19<sup>th</sup> century property boundary, first shown on the 1840 Dunstable tithe map and again on the 1880 OS map (Figure 6).

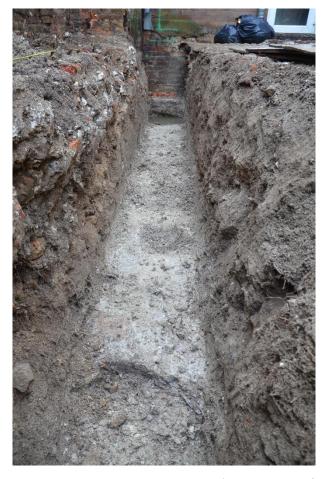
Plate 2: northeast-southwest footing, well (106) in foreground

- 6.4.2 At the intersection of the footing trenches a well, thought to be medieval in date (although it is not possible to confirm this), was recorded, cut into the geological chalk layer (Plate 2, Plate 3, Plate 4). The full extent of this feature was not seen. The construction cut for this well [107] was 2.2m in diameter and apparently circular. The well lining (106) was of clunch stones (c.200mm in diameter) and large tile fragments. It was circular externally and roughly octagonal internally. The internal dimension of the well was 0.9m in width. Prior to the excavation of the footings the well lining had survived to 1.10m below ground level.

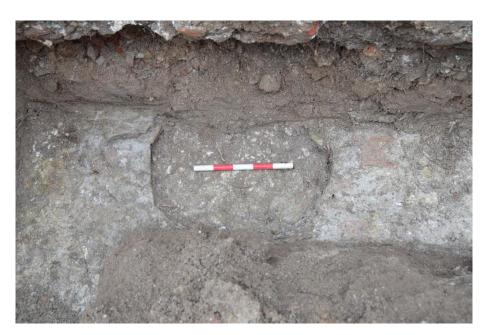
Plate 3: Well (106) view down and to southwest

- 6.4.3 On the south side of the well, between the exterior of the well lining and construction cut [107], a small area of tightly packed clean chalk stones measuring c. 150mm diameter, probably construction cut backfill, was visible (105).

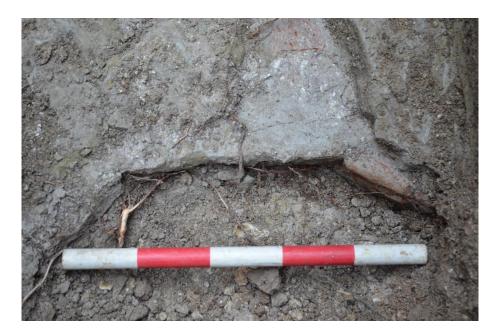
Plate 4: Detail of well (106) view northeast

- 6.4.5 The well structure appeared to have been truncated historically just above the level of the natural ground and therefore, fortunately, suffered limited impact during the excavation of the footings. The truncation of the well may have been in phase with its deliberate backfilling.

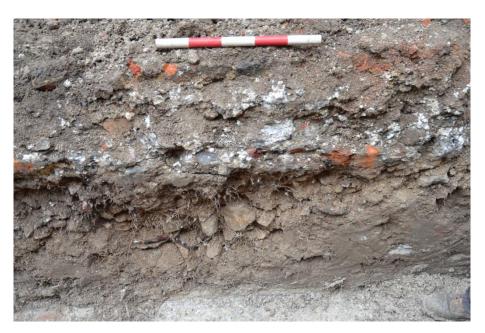
Plate 5: Deposits (101), (102) and (103) view southwest

- 6.4.6 The well was directly overlain by a 0.4m thick brown silty layer (103) containing

occasional clunch cobbles and tile. This deposit may represent a heavily disturbed or redeposited subsoil. Directly overlying (103) was a c. 0.6m thick layer of clunch rubble and tile (102) (Plate 5). This deposit presumably represents the demolition of a nearby building (possibly associated with the well itself). Without further investigation it is not possible to establish whether this demolition material derived directly from a medieval building or a post-medieval building that was re-using the clunch as an architectural material.

6.4.7 Overlying layer (102) was layer (101), a 0.3m thick layer containing 19<sup>th</sup> century brick rubble and mortar. Directly overlying (101) was concrete forming the modern ground surface.

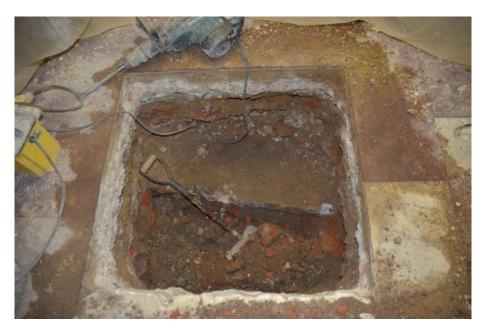
Plate 6: Pad foundation under excavation

- 6.5.2 The deposits encountered were very similar to those of the strip foundations, c. 2m to the east and comprised a series of layers of made ground (110), (111) and (112). A disused service pipe encased in concrete was encountered partway through the excavation and had to be removed with a breaker (Plate 6).

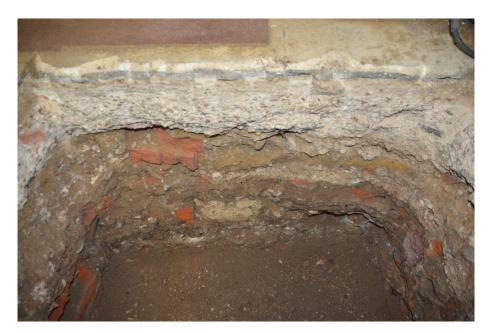
Plate 7: Pad foundation fully excavated. Layer (113) in base.

- 6.5.3 Below the make-up layers lay a dark brown silty soil with moderate flecks of chalk and charcoal (113) (Plate 7). This layer was excavated to a depth of 0.2m and its base was not reached. No archaeological features were revealed. This layer is probably similar to layer (103) excavated in the strip foundations, which was present at a similar depth of c. 0.9m below present ground level. The layer yielded four sherds of pottery which were 17<sup>th</sup> century in date (see Jarrett below).

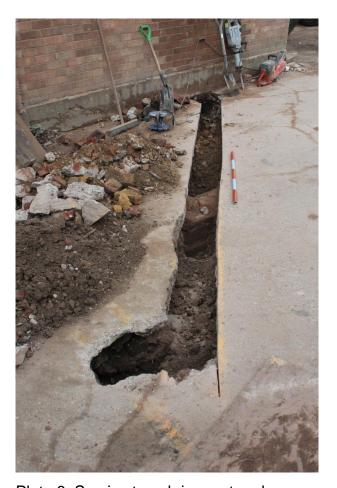
Plate 8: Service trench in courtyard

November 2020 (Figure 5). Only a short service run, on an alignment different to that of the original service plans, was excavated by hand by the client's groundworkers, after cutting of the concrete by hand using a concrete cutter. (Figure 5, Plate 8). This was c. 3.5m long, 0.3m wide and 0.4m deep. Deposits encountered were a layer of brick rubble (115) below the concrete courtyard floor. No finds were present within the layer.

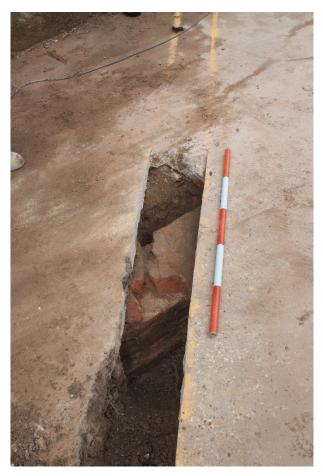
Plate 9: Wall foundation (119)

6.6.2 The trench also revealed a segment of a brick wall foundation (119) directly below the concrete surface to a surviving height of 4 courses of bricks (Plate 9). The wall was 0.3m wide and exposed to a depth of 0.4m. It was built of modern machine-made bricks and bonded with a creamy white cement mortar. It is likely that the wall represents the foundation for a former property boundary (Figure 6).
