## **NEGATIVE WATCHING BRIEF REPORT**

### **Former Pattern Shop, Sussex Street, Stephenson Quarter Newcastle upon Tyne Tyne and Wear**

**PCA Report Number:** R14534

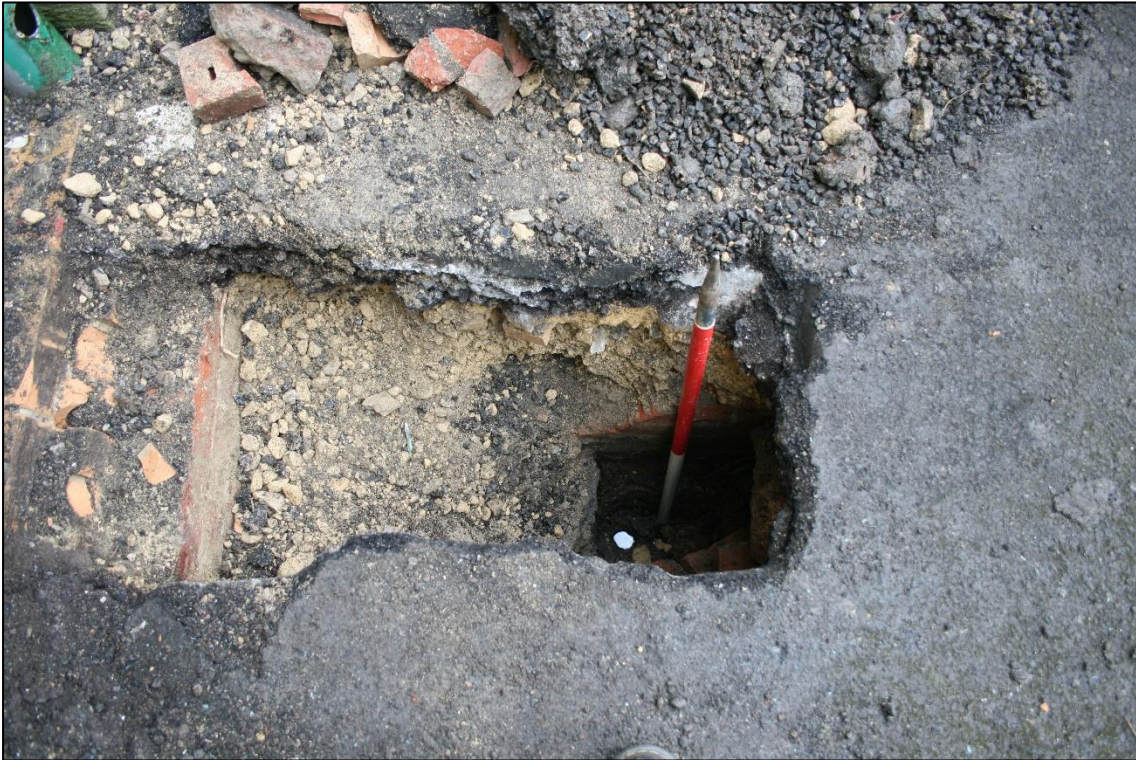
*Plate 1- Test Pit 01 showing walls [006] and [010]. Facing southwest, 1m scale.*

Test Pits 1 and 2 each encountered two skins of modern brick [006] that was exposed to a maximum depth of 0.45m, abutting the outer face of the Pattern Shop wall. The brick structure [006] represents the lower courses of a modern brick facade that would have extended across the whole of the Pattern Shop external wall. In Test Pit 2 the modern brick façade wall [006] had been built directly onto concrete pad [002]. The modern asphalt surface [001] and associated sub-base dolomite crushed rock [003] in test Pit 2 directly overlay compact light brown grey stony sand [007] up to 0.15m thick that contained CBM fragments throughout. This deposit represents a modern made ground deposit that directly overlay concrete pad [002].

In Test Pit 1 the modern brick façade wall [006] had been built onto c. 0.15m compact brick and stone rubble levelling and consolidation deposit [008]. Deposit [008] in turn overlay c. 0.10m thick concrete pad [002]. The concrete pad [002] directly overlay friable dark brown grey sandy clay [009] and gravel [011] at least 0.10m thick that probably represents modern or early 20th century levelling deposits. Located within the south-west corner of Test Pit 1 a short length of an ENE-WSW aligned brick wall [010] was exposed for a maximum distance 0.40m (Plate 1). The wall itself was exposed to a height of at least 0.60m and was built using red brick bonded by light yellowish brown cement mortar. Based on the cement composition of the walls mortar it is likely to be of 20th century construction rather than forming part of the former workshops of the Robert Stephenson & Company Engineering Works.
