39 MARSHGATE LANE, 41 MARSHGATE LANE
43–45 MARSHGATE LANE and
ASSOCIATED WAREHOUSE

A standing building survey report

Site Code: OL-031907, OL-032907, OL-033907
and OL-034907

Project Manager	Alex Rose-Deacon
Author	Helen Robertson

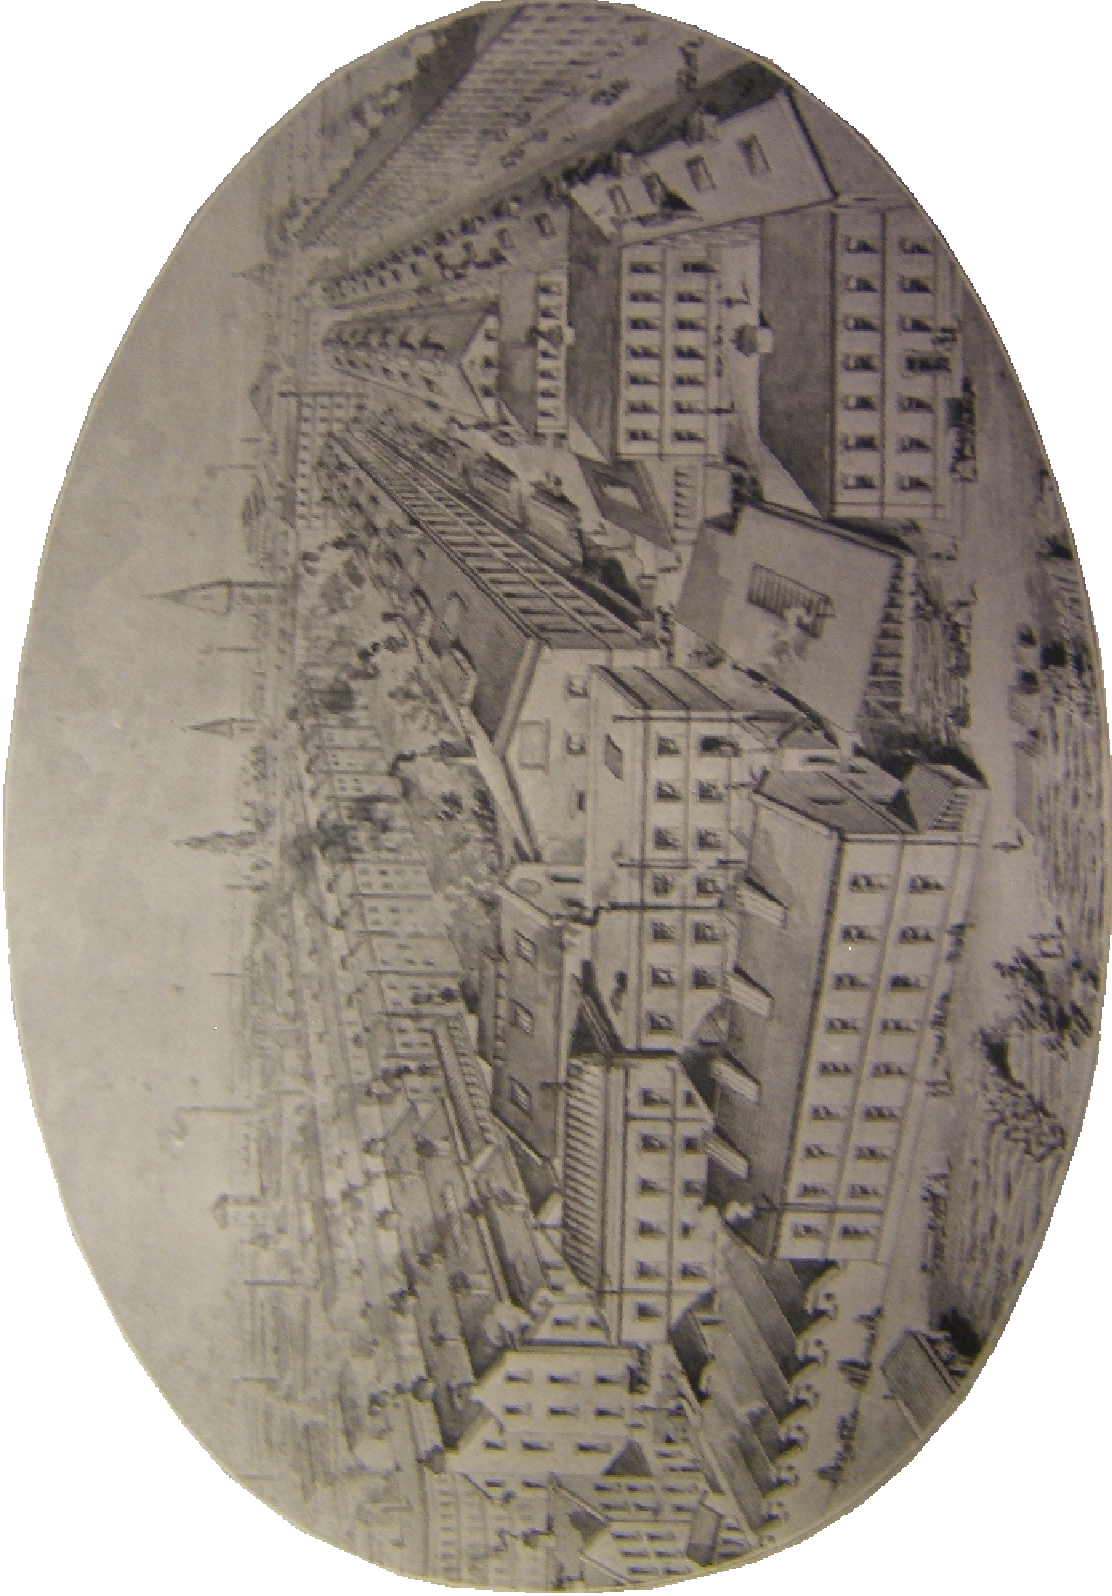
Figure 10
Illustration of Messrs G.B. Kent and Sons' Brush Factories, Victoria Park, London (reproduced from
Columbus, L. 1894: Commerce : an Illustrated Weekly Journal: 693)

Columbus visited Victoria Park Brush Factories and commented on his findings (Figure 10). The factory set up in Marshgate Lane was likely to have had a similar layout to the Victoria Park factory, if a little smaller, and to have gone through the same processes.

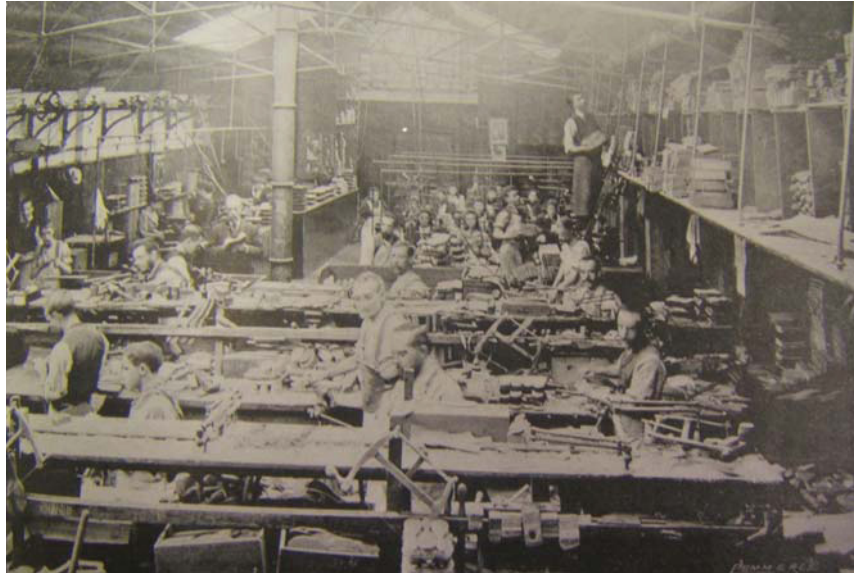
Plate 1 View of ‘Workshop in Main Factory, Victoria Park’ Brush and Mat Factory (reproduced from Columbus, L.1894: Commerce: an Illustrated Weekly Journal: 695)

The machinery that was used for the manufacturing of the brushes were often contracted on site and therefore, an engineering shop was also required within the establishment (Plate 1).

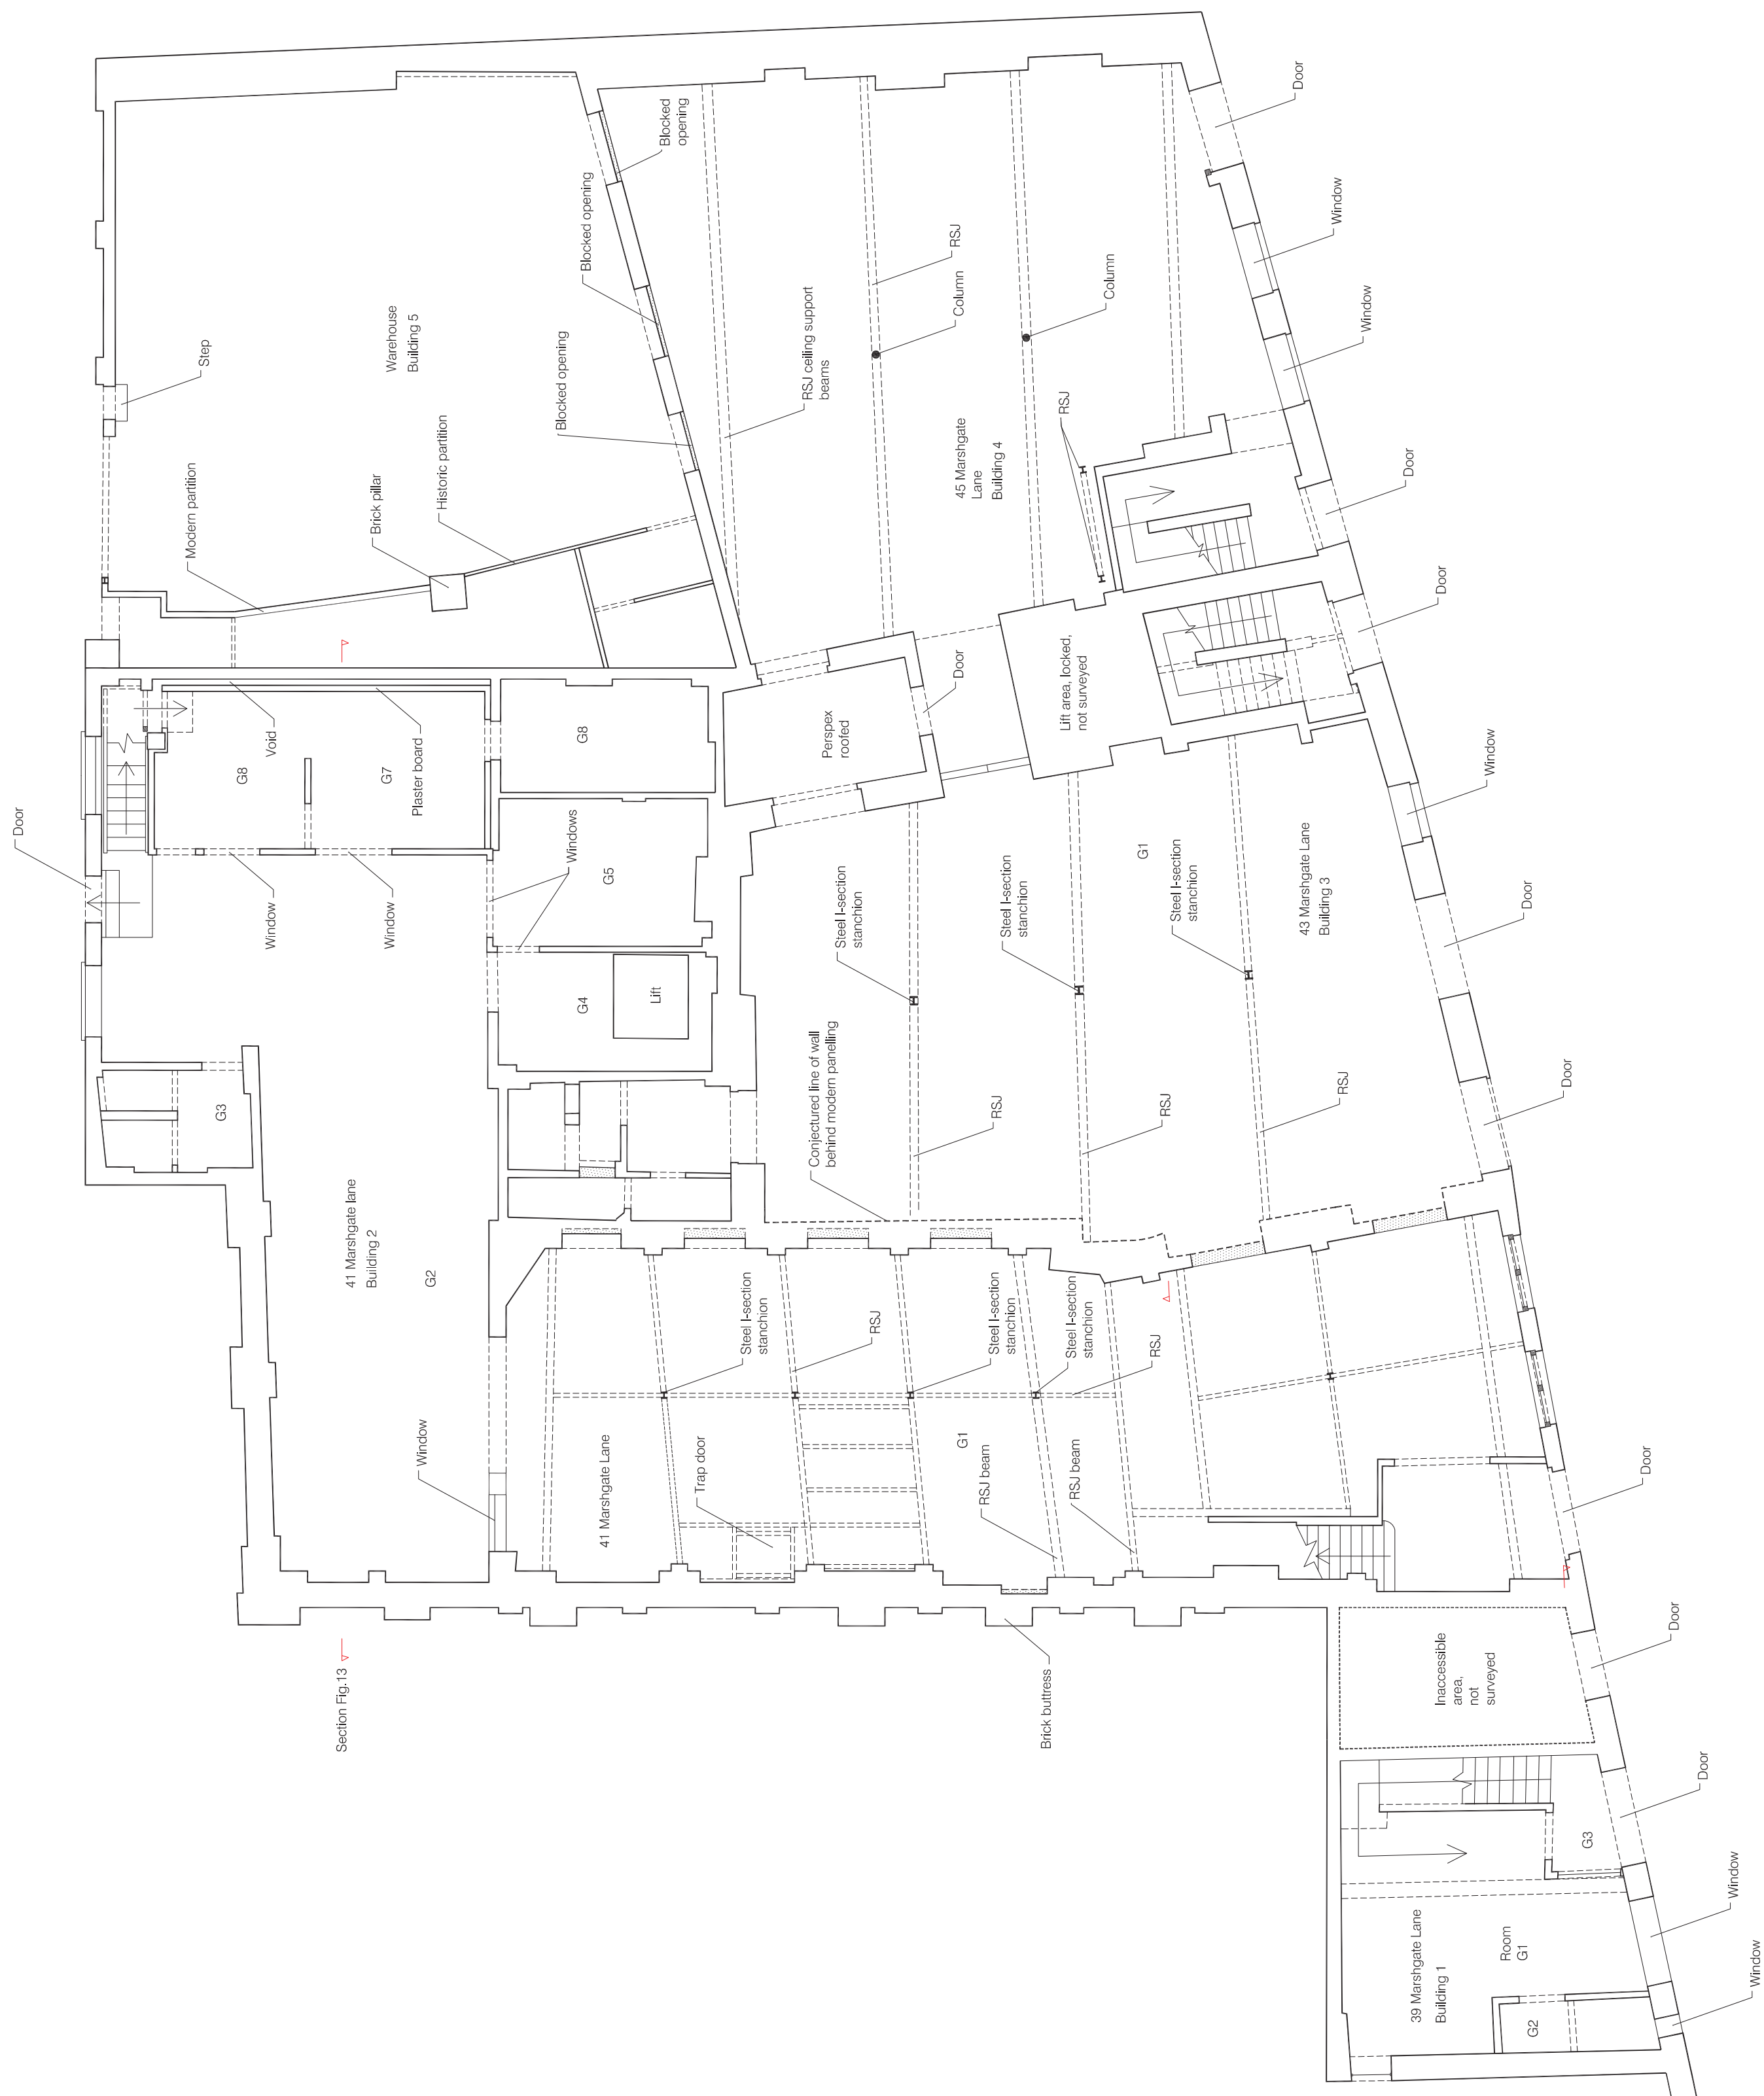
The location and exterior of the standing buildings was determined in outline on the modern Ordnance Survey plan. A plan of Buildings 1, 2, 3, 4 and 5 (Figure 11), transverse sections through Building 1 (Figure 12), Building 2 (Figure 13), Buildings 3 and 4 (Figure 14) and a photographic survey was undertaken. A written description of the structures' construction, development and function was also undertaken.

Based on these site drawings, one plan (Figure 11) has been drawn, positioned so as to demonstrate the construction and layout of the buildings as clearly as possible. Sections have also been drawn of Building 1, 2, 3 and 4 (Figure 12–Figure 14) and their locations can be seen on the plan.

The original plot is at a scale of 1:100.

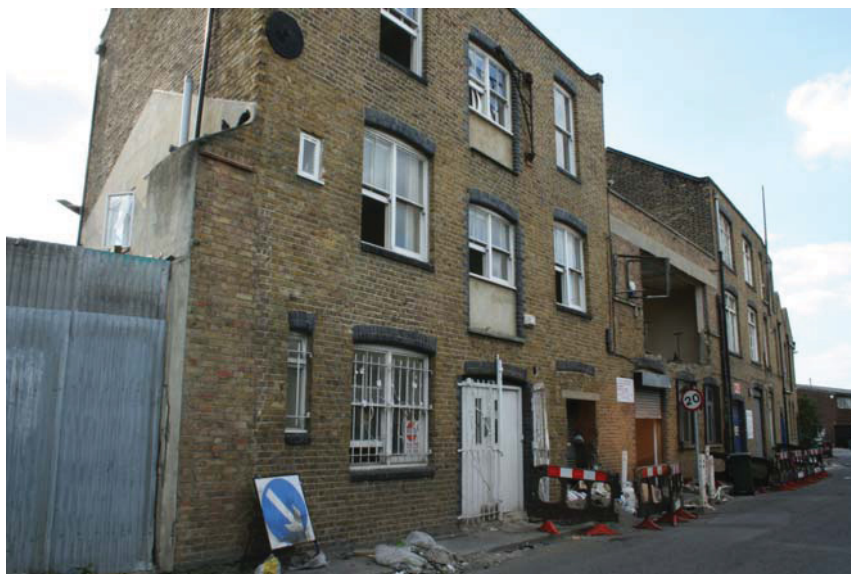
Plate 2 View of Building 1 in foreground and Buildings 2, 3 and 4 in background, looking north-west

In plan, the general area occupied by the buildings measures roughly 43.6m north to south by 29m east to west (Figure 2). The buildings consist of three two-storey, one three-storey and a single storey industrial brick-built structures adjoining one another along the western side of Marshgate Lane (Figure 11) (Plate 2).

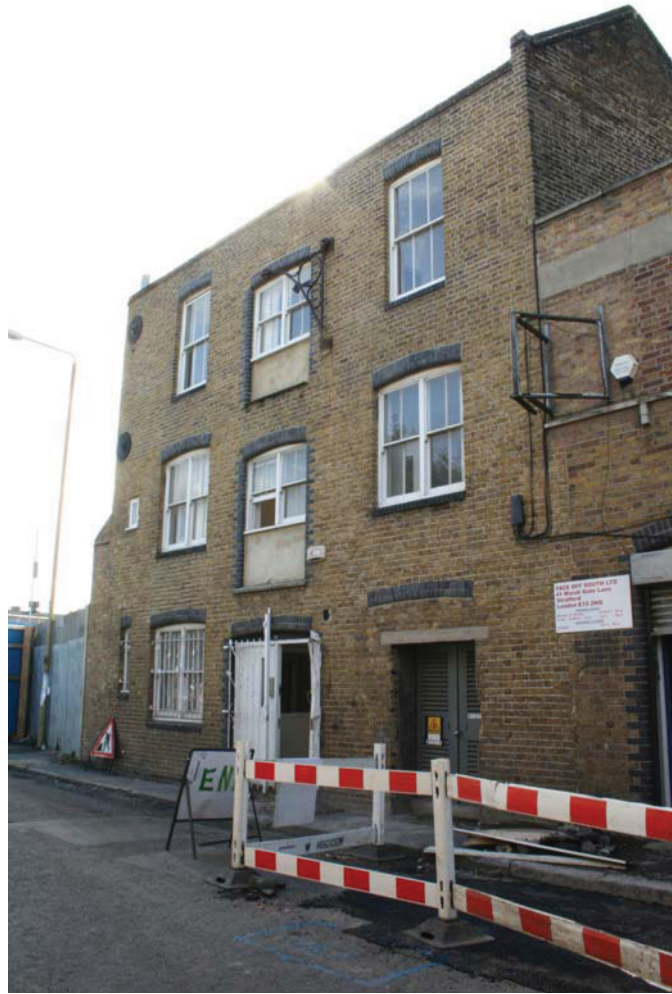
Plate 3 View of Building 1, looking south

Building 1 (Figure 11, Figure 12) (Plate 3) is a three-storey yellow stock brick building, rectilinear in plan and supporting a slate-lined gable roof. The building is the southernmost of four adjacent properties fronting onto the western side of Marshgate Lane. The building lies on a northwest–southeast alignment, fronting onto Marshgate Lane.

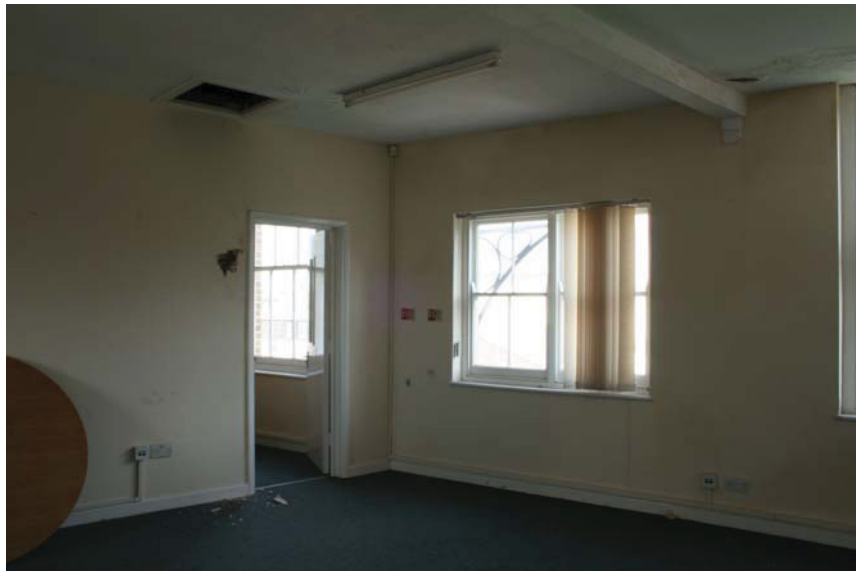
Plate 7 Internal view of Building 1, showing second floor diagonal of first room, looking north-east

The stairwell in the centre leads up to the first and second floors. These spaces have recently been renovated to create offices and any original features have been removed or hidden under the modern plaster and paint. First and second floors have been divided into two large rooms apiece, separated by modern plasterboard partitioning. They also possess boxed RSJ ceiling supports which span the length of the ceiling, running east-west (Plate 7).

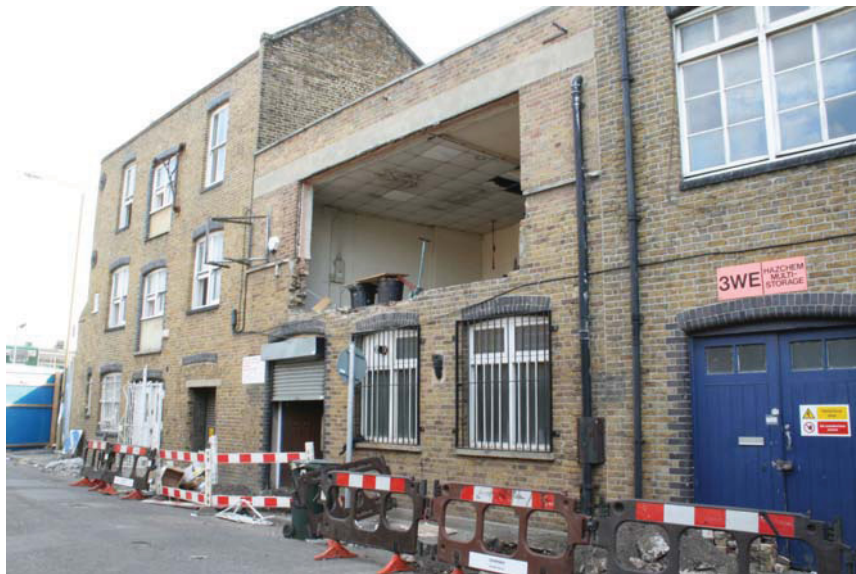
Plate 8 View of Building 2 in foreground and Building 1 in background, looking south-east

The north-eastern elevation is constructed of yellow stock bricks in English cross bond (Plate 8). A low concrete plinth runs from the northern corner of the elevation to the main access point at the south. The access consists of a double-leaf pedestrian door with arched lintel formed of two courses of blue engineering brick, the lower course bull-nosed. The jambs either side of the door are formed of blue bull-nosed engineering bricks. A modern roller door is located above the exterior of the door.

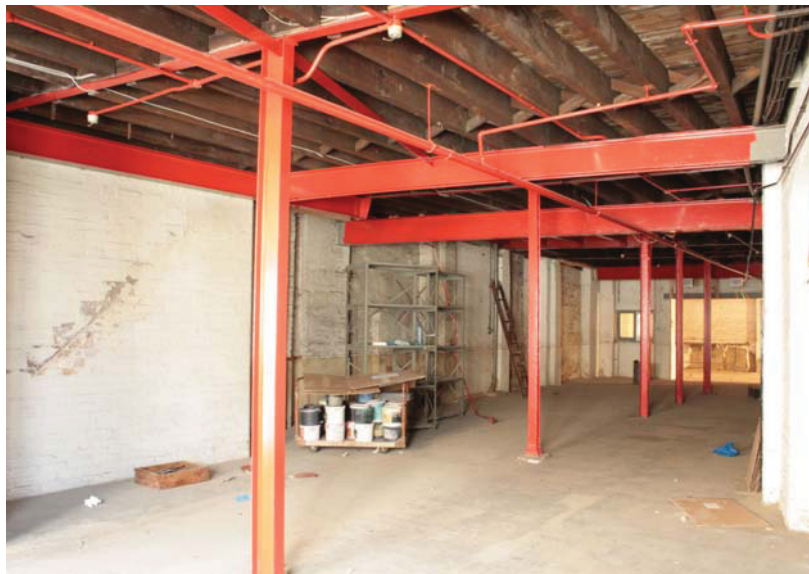
Plate 11 Internal view of Building 2, showing general layout of ground floor and the I-section stanchion frame, looking south

The structure is supported by a frame of centrally aligned I-section stanchions under a series of transverse RSJs. The first floor is supported on timber beams, with timber planking above (Plate 11).

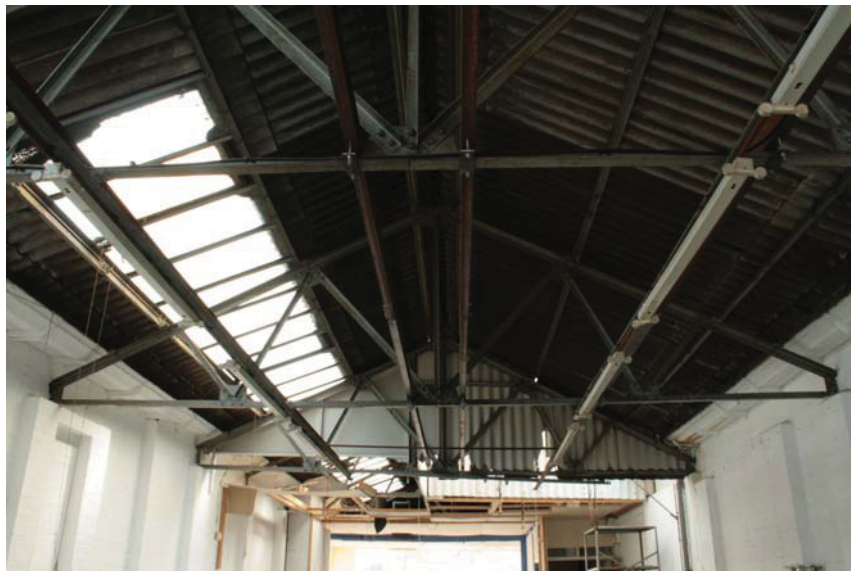
Plate 12 Internal view of Building 2, showing fink truss, looking north-east

To the north-east corner of the first floor is a false plasterboard ceiling. Along the south-east wall in the centre is a lightwell. The trusses are visible in the rest of the first floor; fink trusses clad in corrugated sheeting and resting on a number of buttresses (Plate 12). Running the length of the north wall are a series of opaque deadlights. The area to the north-west has a gable roof.

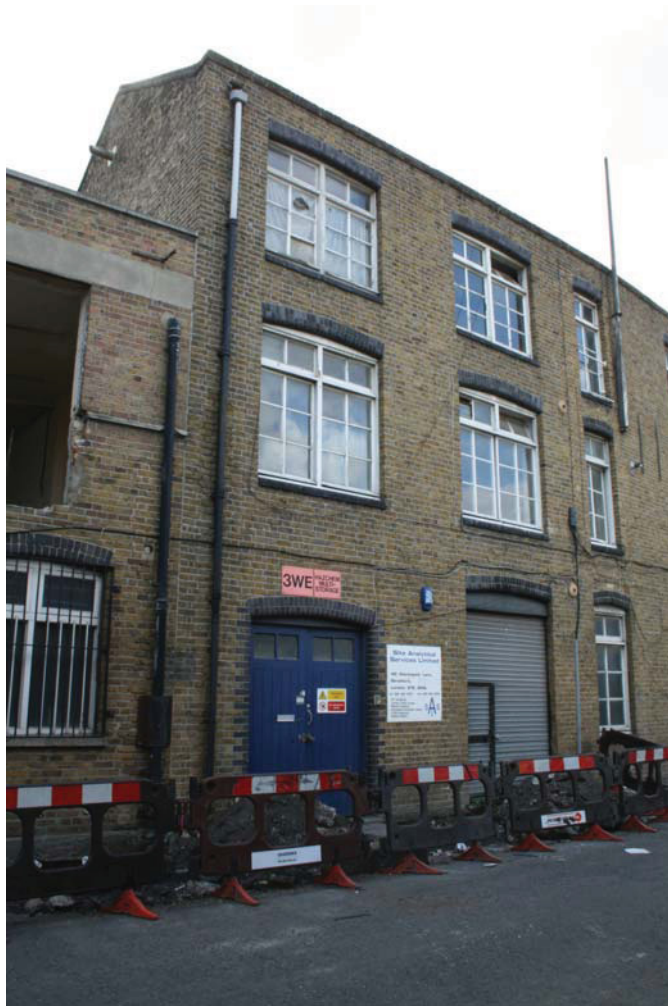
Plate 13 View of Building 3, looking north-west

Building 3 (Figure 11, Figure 14) (Plate 13) is a three-storey yellow stock brick building, rectangular in plan and supporting a gable roof, aligned northwest-southeast. The gable end faces the street and is dressed with two courses of blue bull-nosed engineering bricks.

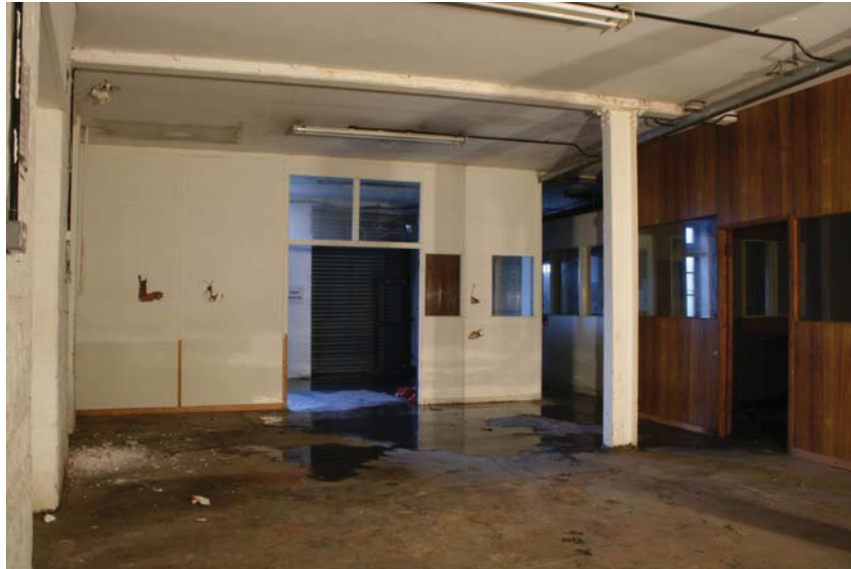
Plate 14 Internal view of Building 3, showing general layout and partitioning of ground floor, looking east

The interior of the ground floor is largely open-plan. There is a series of partitioned rooms against the south-east wall. These obscure the wall, and therefore no original fixtures or fittings are visible along its length. A further partition is located along the north-east wall providing a porch area, used as a reception (Plate 14).

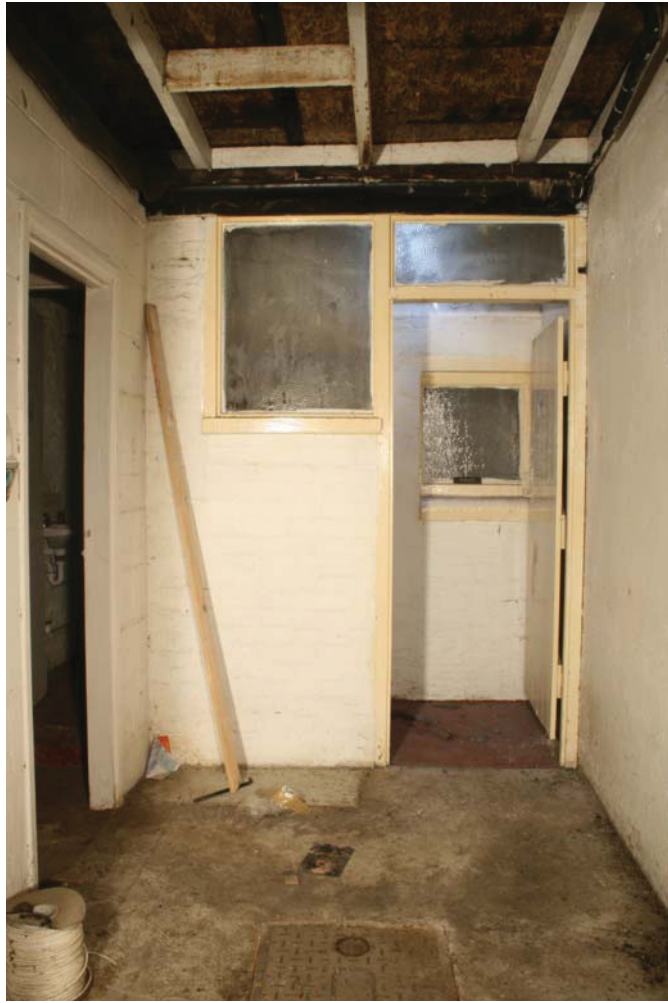
Plate 15 Internal view of Building 3, showing temporary roofed area with WC, looking south-west

The rear of the property (south-west) has a small courtyard which has been roofed over and used for WCs (Plate 15).

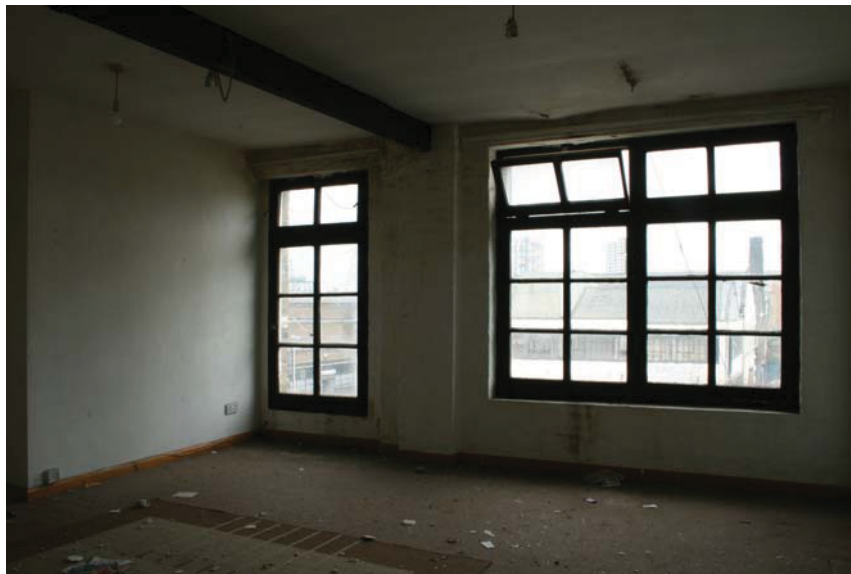
Plate 16 Internal view of Building 3, showing general layout of second floor rooms with original timber beams

On the second floor a series of timber beams are visible, running northeast-southwest (Plate 16). There is a small hall at the top of the stairwell, which has two doors on either side. The north-west door gives access to soil sampling offices and the south-east door would have accessed Building 4 but has been blocked off. The stairwell appears to continue upwards; however, access has been blocked by the introduction of a large safe.

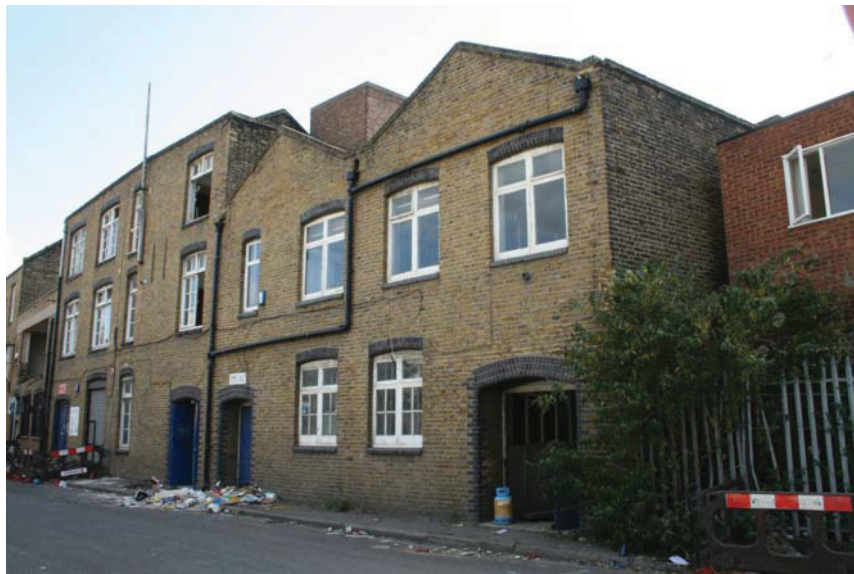
Plate 17 View of Building 4 in foreground and Buildings 3 and 2 in background, looking south-east

The roof is double-pitched, clad in slate with no parapet and is aligned east-west. The roof ridges have dressed ceramic tiles, a common feature of industrial gothic Victorian buildings.

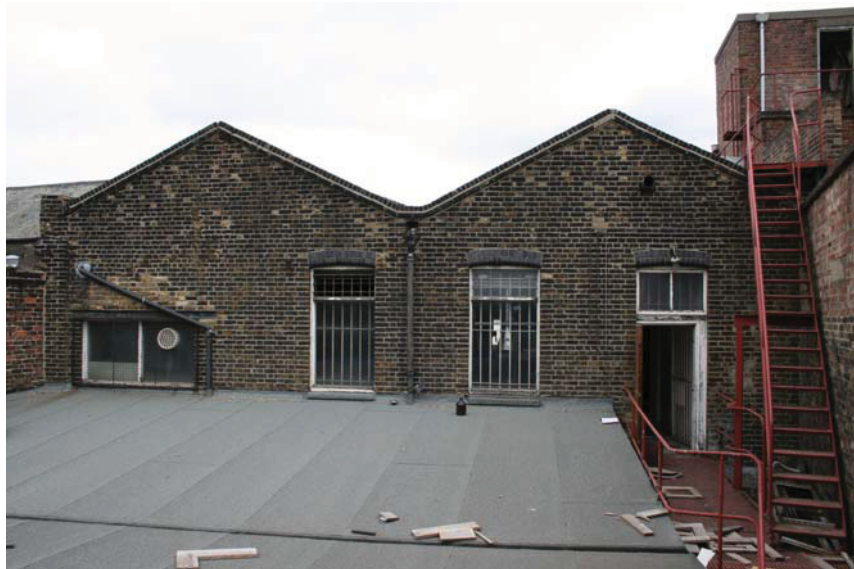
Plate 18 View of rear of Building 4 and roof of Building 5, looking north-east

The south-west elevation is a gable and shares a ground floor with Building 5, the warehouse behind 45 Marshgate Lane. The first floor is formed of Fletton brick in English cross bond (Plate 18). There is a fire escape to the south-east of the elevation leading to a metal platform with stairs up to Building 3 to the south. The lintel of this door is formed of two courses of blue engineering brick, the lower course bull-nosed. Fenestration consists of two original barrel windows in the centre of the elevation, their lintels are formed of two courses of blue engineering brick, the lower course bull-nosed. The sills are formed of concrete and fixed vertical bars have been inserted on the inside of the windows. A modern

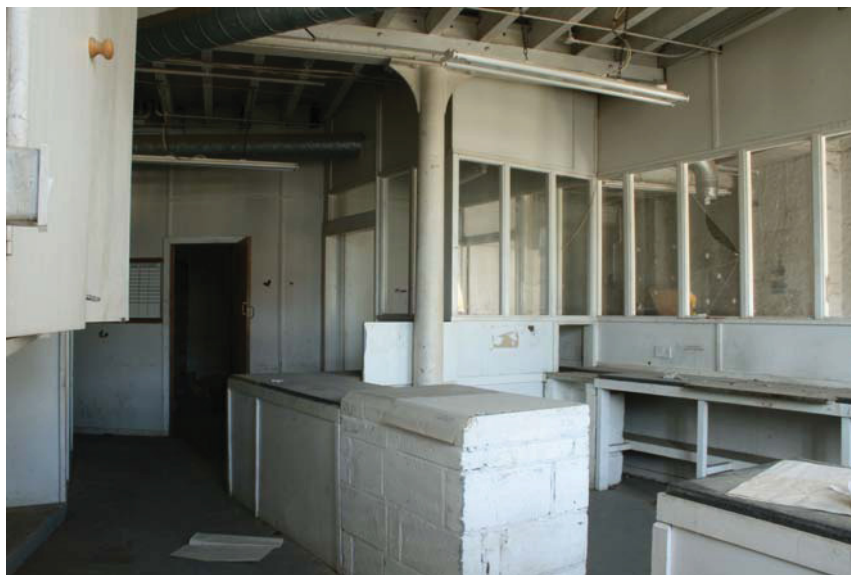
Plate 19 Internal view of Building 4, showing general layout and partitioning, looking south-west

The interior of the ground floor is divided into a series of partitioned rooms, some used as storage, some as offices (Plate 19). Visible on the south-west wall are a number of modern breeze-block blockings. These were originally doorways leading to Building 5 (warehouse behind 45 Marshgate Lane). To the south-east are several breeze-block benches.

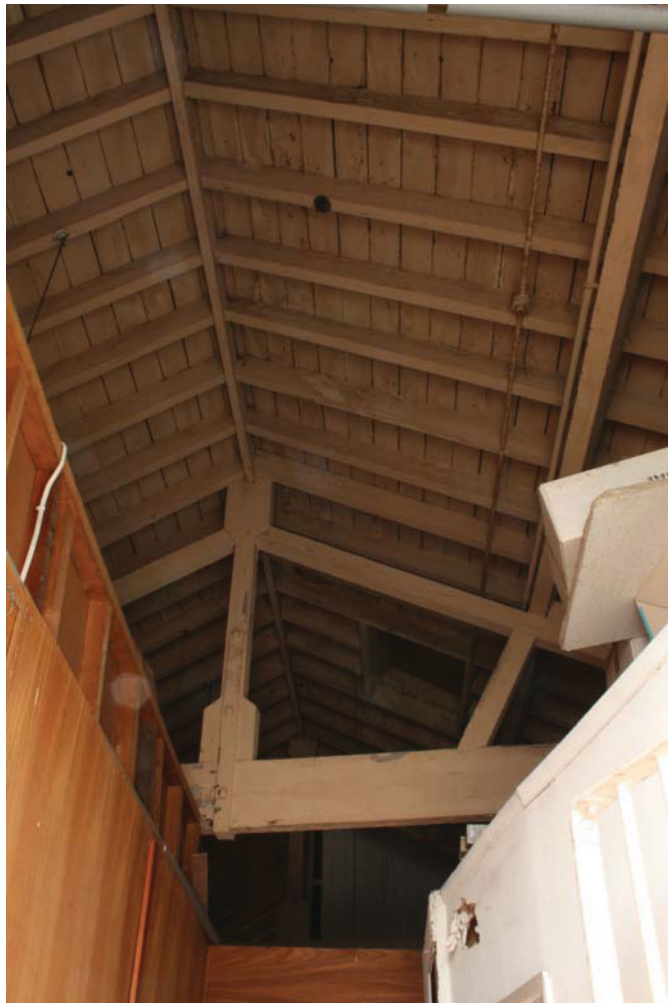
Plate 20 Internal view of Building 4, showing king-post roof truss, looking north-east

formed of timber boards laid over timber joists. There is a false ceiling in place to cover the timber king post trusses (Plate 20).

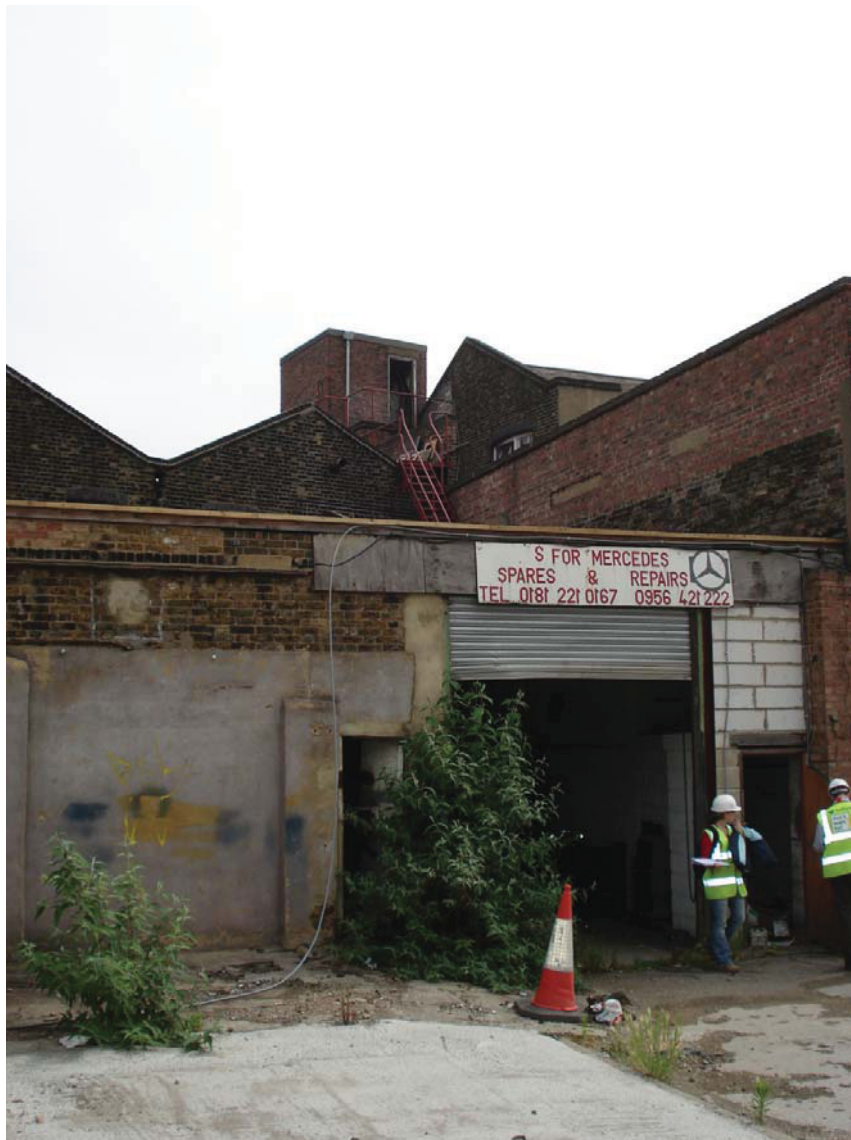
Plate 21 View of Building 5, looking east

Building 5 (Figure 11) (Plate 21) is a single-storey Fletton brick structure in English cross bond, rectangular in plan and supporting a butterfly roof.

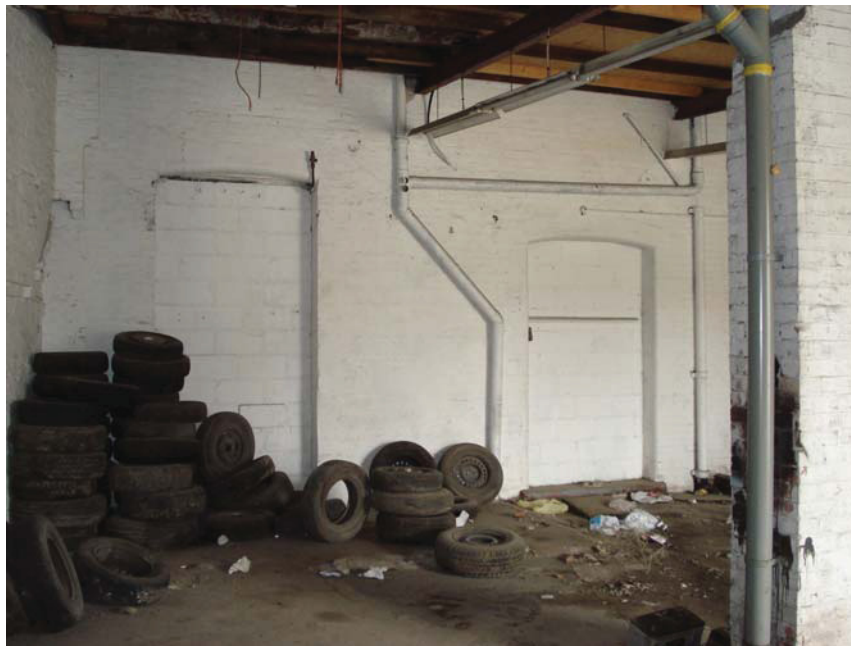
Plate 22 Internal view of Building 5, showing blockings on the adjoining wall of Building 4, looking north-east

There are a series of blocked doorways on the north-east wall coinciding with those found in Building 4 (45 Marshgate Lane, OL-03307) (Plate 22). One-skin thick buttresses are located on the north-west wall and evidence of corbelling to support a first floor can be found on the south-west wall. The floor is formed of poured concrete.

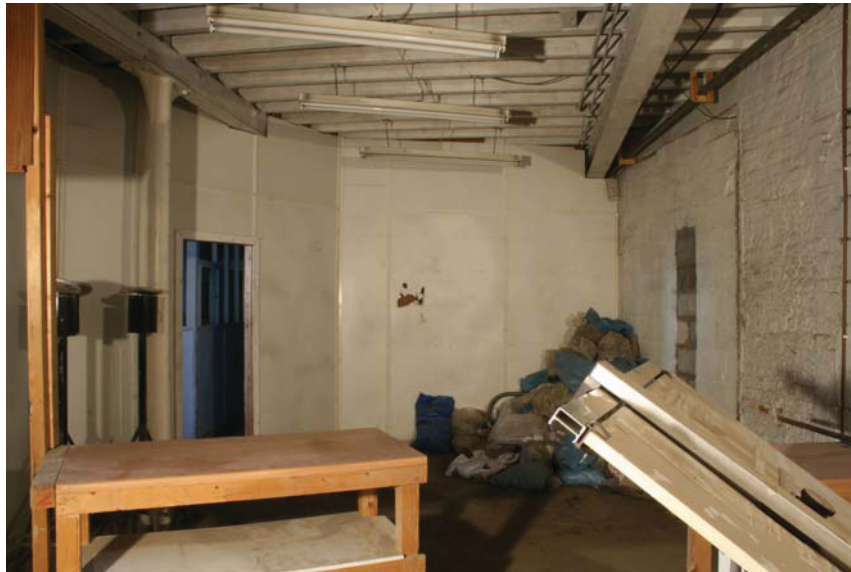
Plate 23 Internal view of Building 4, showing alterations and blockings on the ground floor, looking south-southeast

alterations that took place within the site throughout its lifetime. The number of companies that occupied the structures over time is demonstrated by the evidence of constant repair, alteration and augmentation that can be seen in the physical scars of Buildings 1, 2, 3, 4 and 5 (Plate 23).
