Historic Building Recording.

98 Cheyne Walk, London, SW10 0DQ.

Site Code: CEJ08

Pre-Construct Archaeology Limited, November 2008

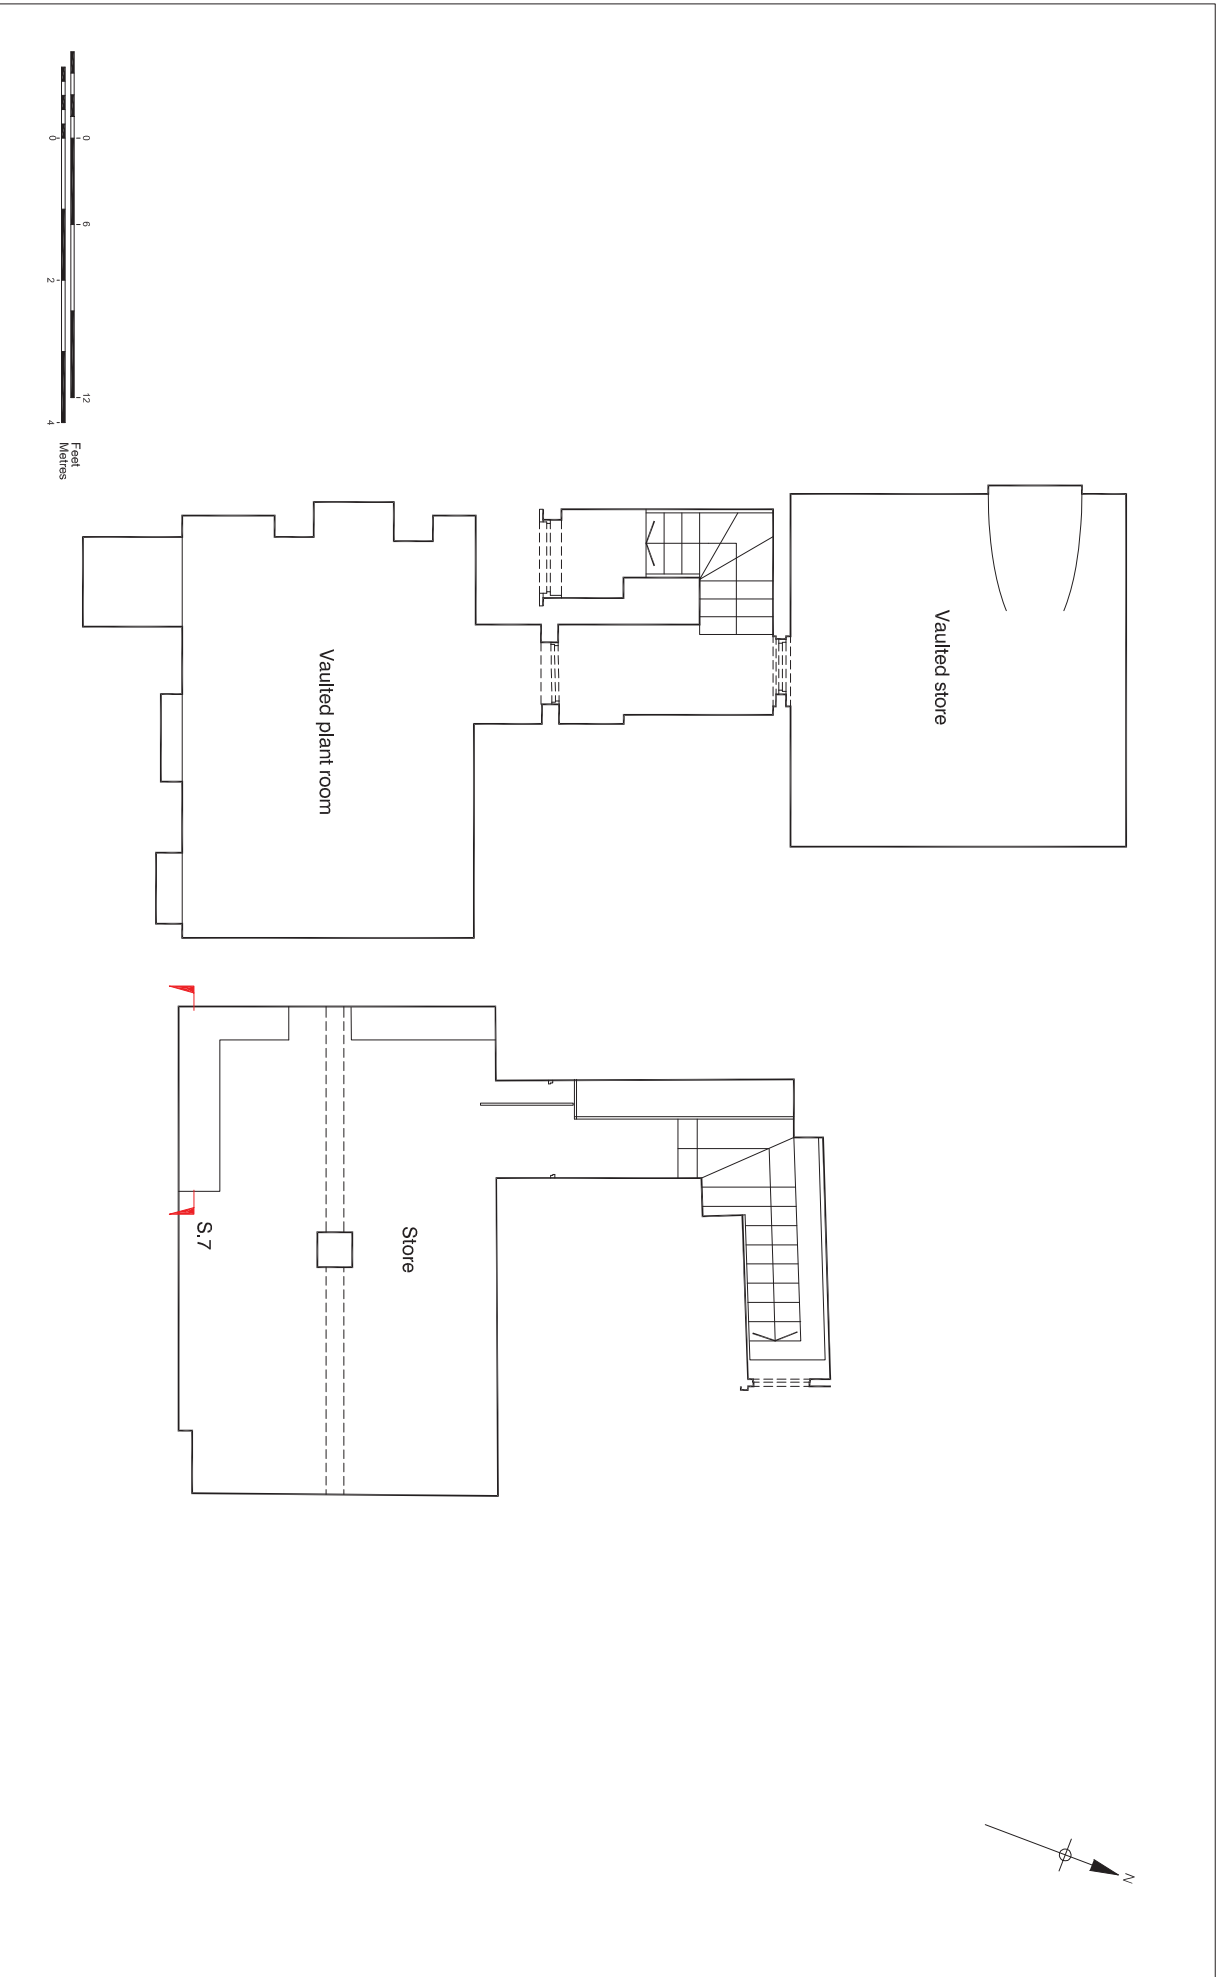
Figure 10

Basement room plan showing location of elevation S.7

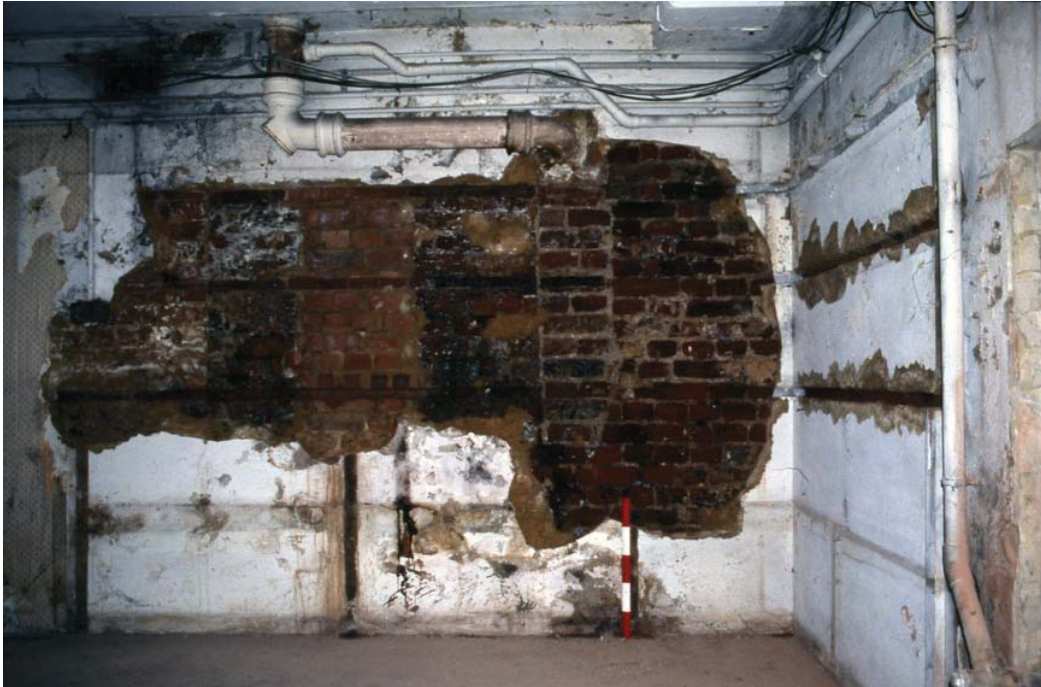
- 4.3.1 The Basement Store is located below ground in the central southern portion of the building.
- 4.3.2 Work to reinstate the light well to the basement involved the removal of modern cement render on the southern mass wall prior to opening up an area of brickwork. The work revealed a section of century (1950s) brickwork [22] blocking a century coal chute This in turn had been inserted into an earlier century blocking of the light well [21]. The light well construction [20] had in turn been inserted in the century into the original century exterior wall [19]. This small exposed area of brickwork in effect revealed a microcosm of all the phases of the buildings history, given the structure number [23].

Plate 1. Basement Store, looking south. Wall [23]. Scale is 0.50m.

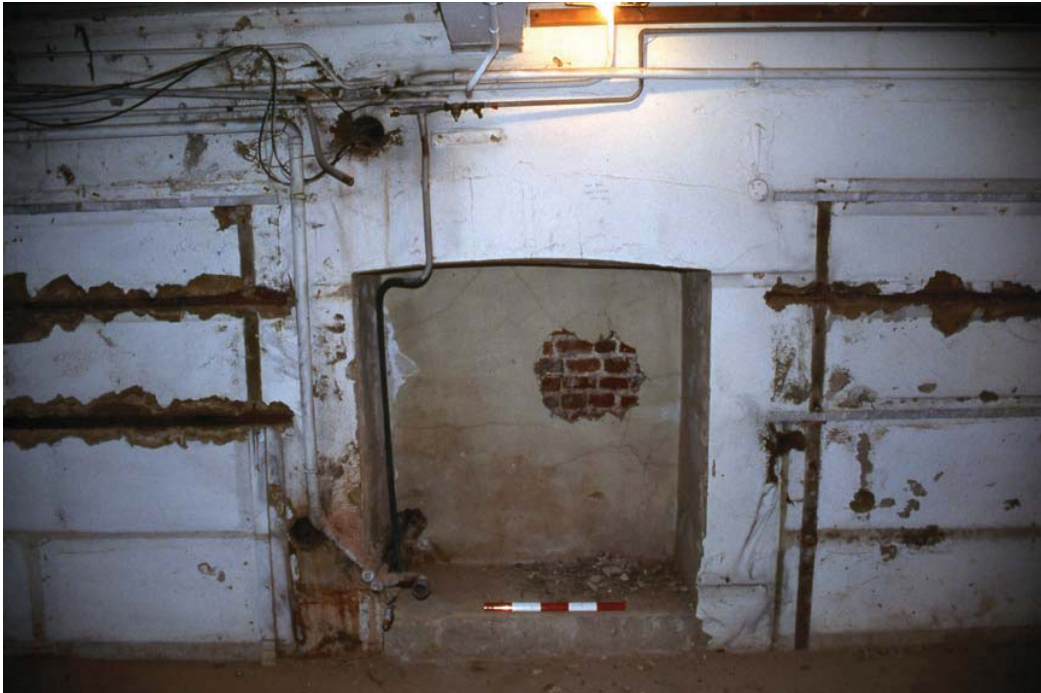
- 4.3.3 A fireplace located on the western side of the internal wall of the basement was thought to be a survivor of the century farmhouse, but further examination revealed the exposed brick fabric to date from the century (Plate 2).

- 5.1.3 Examination of a blocked up fireplace located on the western side of the internal wall of the Basement Store established that it dated to the 18th century, and was not related to the 16th century farmhouse, as initially thought.

Plate 2. Fireplace in western wall of Basement Store. Scale is 0.50m

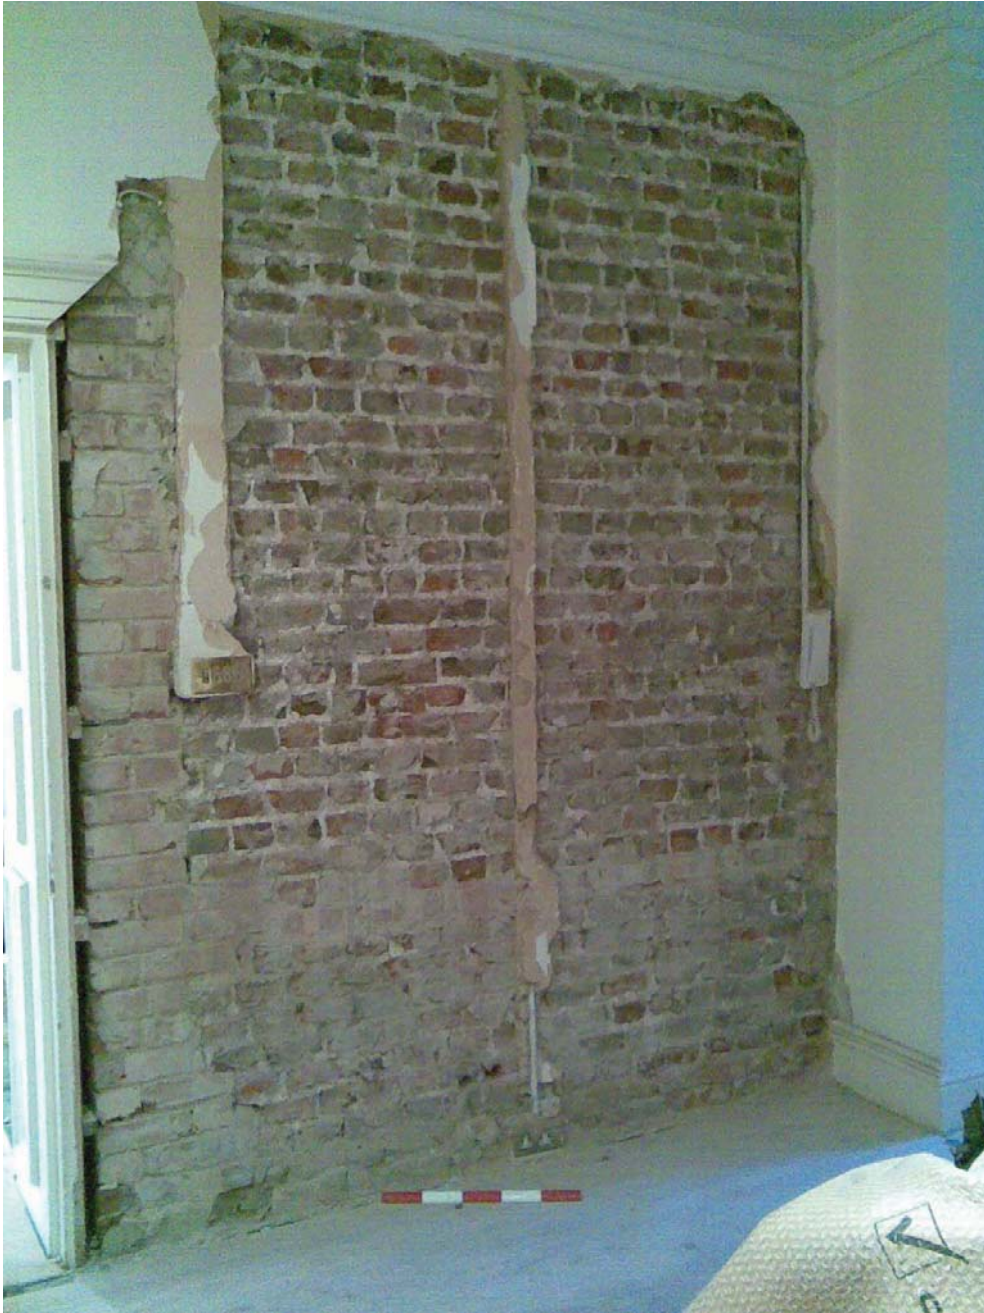
- 4.4.2 The exposed brickwork was observed to be constructed in an irregular English Bond pattern from a mixture of brick fabric types including: c. 60% stock moulded red brick (fabric type 3032-3034), spot dated to between 1660 and the century, c. 30% purple/maroon brick (fabric type 3032 transitional 3033, spot dated to pre- century and c. 10% Classic 'Tudor' red brick with a date range of 1400-1700. The mortar used was a brittle off white lime mortar, laid in thick, irregular beds, giving the impression of a relatively crudely built wall.
- 4.4.3 The broad range of dates is indicative of the re-use of earlier bricks in a wall that is known to have been built in the mid century.

Plate 3. Ground Floor, Inner Hall, wall [11]. Scale is 0.50m

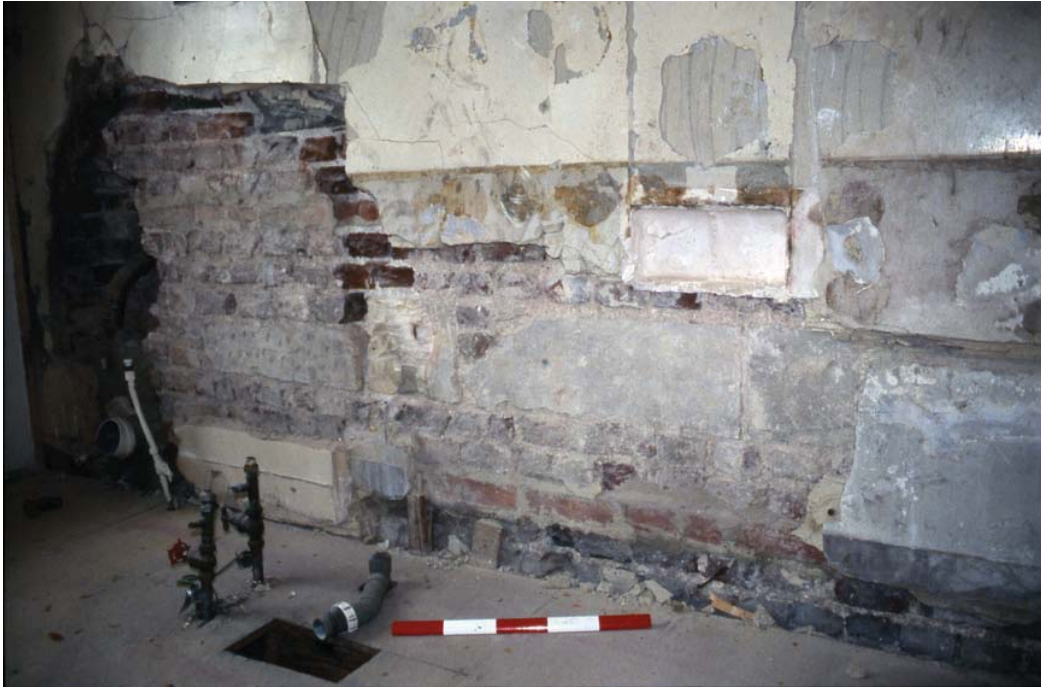
- 4.5.2 The exposed brickwork [18] has a similar make up to that already described above, i.e. the majority being century stock moulded red brick (fabric type 3032-3034), fewer pre- century purple/maroon brick (fabric type 3032 transitional 3033, and occasional Classic 'Tudor' red brick with a date range of 1400-1700.

Plate 4. Second Floor, North Bathroom, wall [18]. Scale is 0.50m

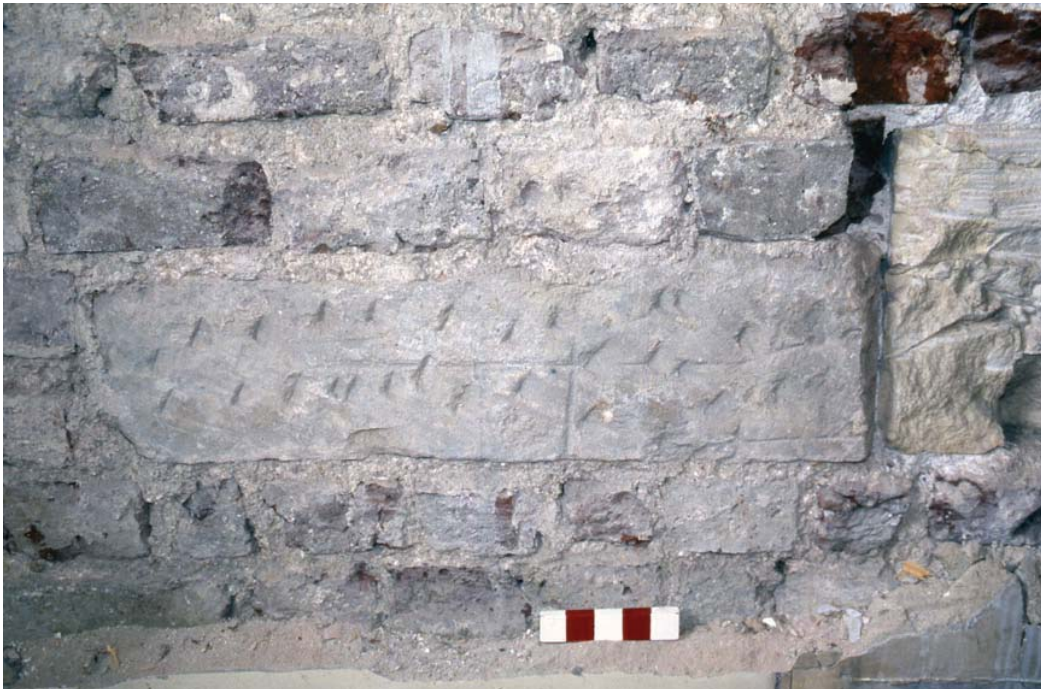
- 4.5.3 Additionally a number of re-used worked stone, squared and built to courses, were laid within the wall (a feature of the north-south partition wall on the second floor). These include; Kentish Ragstone, Fine Taynton or Ancaster Stone with tool marks and a Masons mark and Caen Stone, all originally dating from the medieval period and Portland Stone, with tool marks, dating to the century.

Plate 5. Second Floor, North bathroom. Close up of worked stone, Scale is 10cm

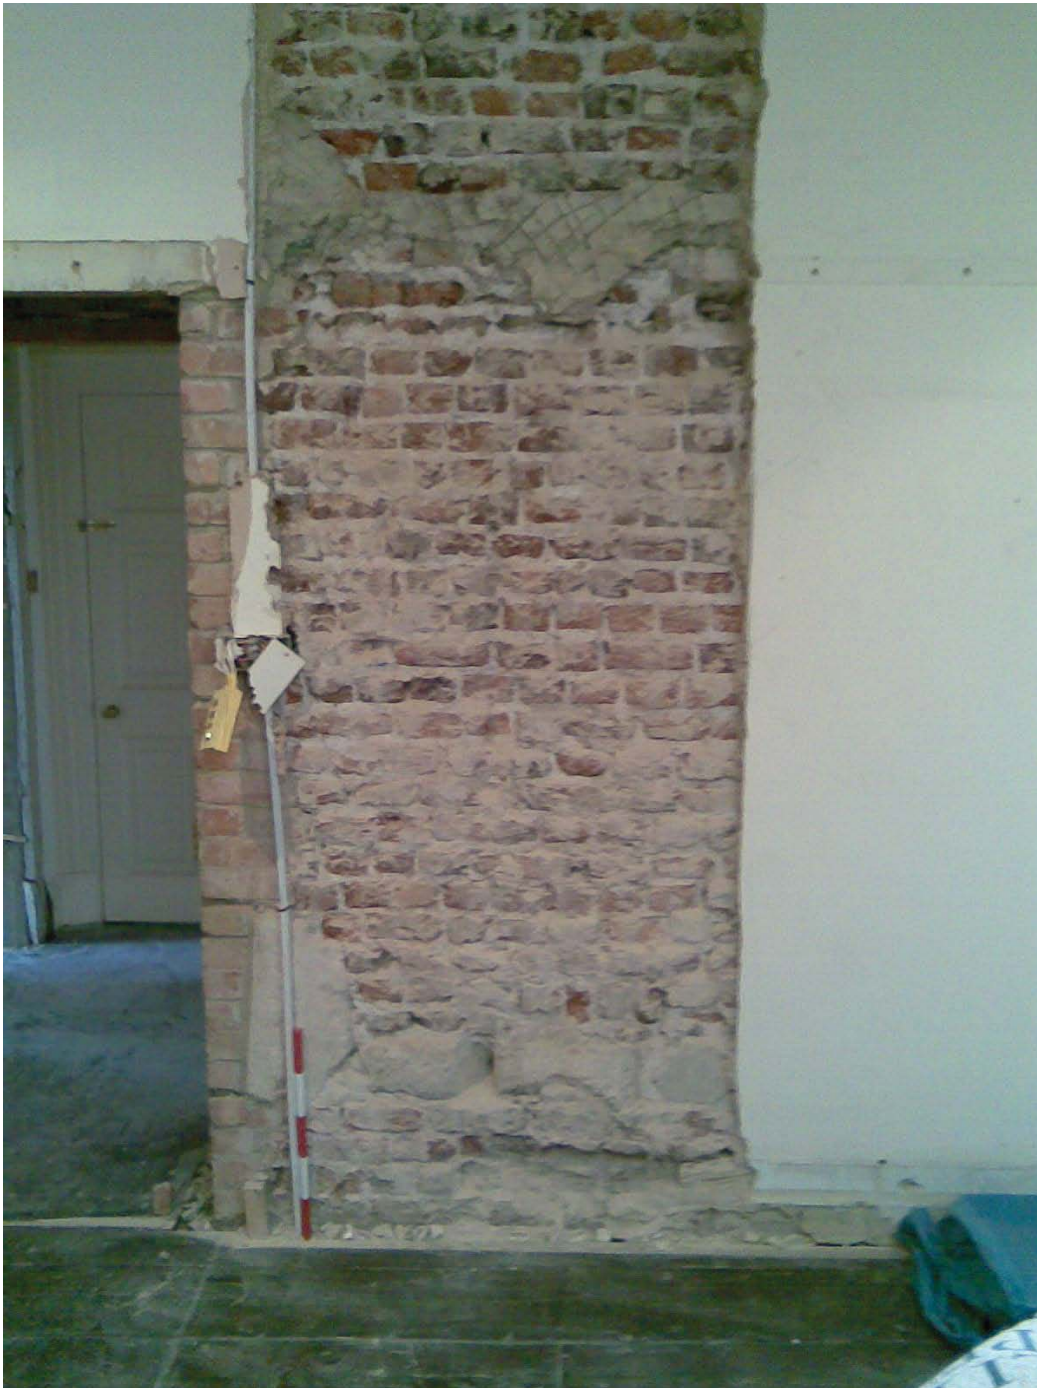
4.7.2 The window is shown to have existed in and century contemporary illustrations of the front of Lindsey House (Fig 7), but is not shown on a 1752 illustration (Fig 8), showing the alterations carried out by Count Zinzendorf, and presumed to have been blocked in at this date (plate 7).

Plate 7. Second floor, bedroom 5, south wall. Scale is 0.50m

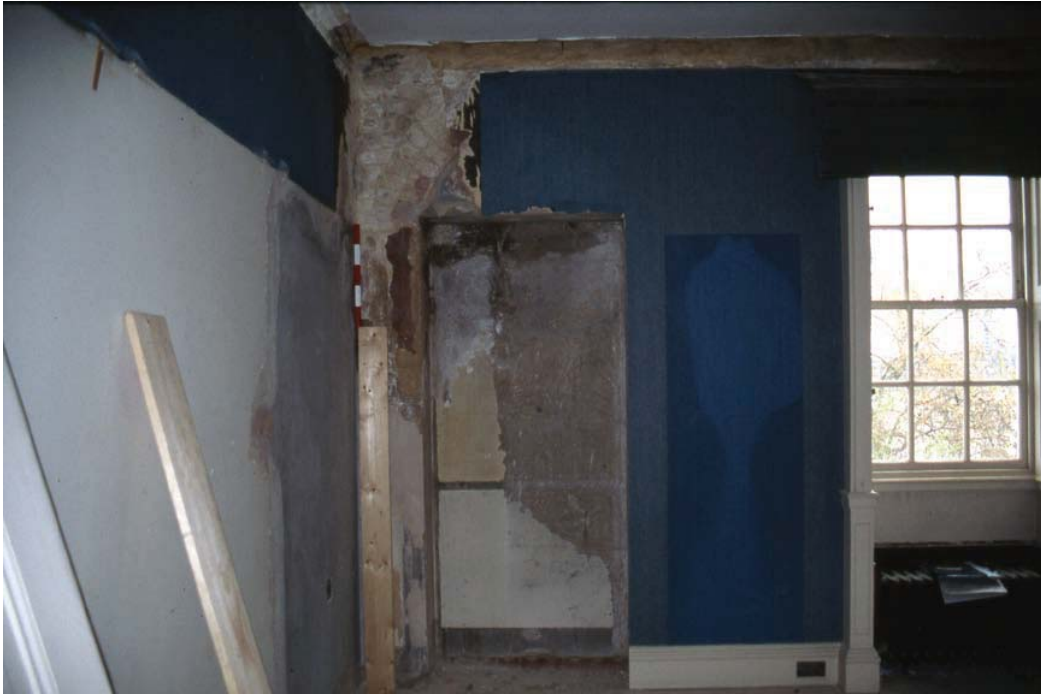
4.8.2 The exposed brickwork [12] was observed to be constructed in a similar fashion as already described above, with an irregular English Bond pattern constructed from a mixture of brick fabric types including: c. 60% 60mm thick stock moulded red brick (fabric type 3032-3034), dated to the century, c. 30% 60mm thick purple/maroon brick (fabric type 3032 transitional 3033), spot dated to pre- century and c. 10% 60mm thick Classic 'Tudor' red brick with a date range of 1400-1700.

Plate 8. Second Floor, bedroom 6, wall[12]. Scale is 0.40m

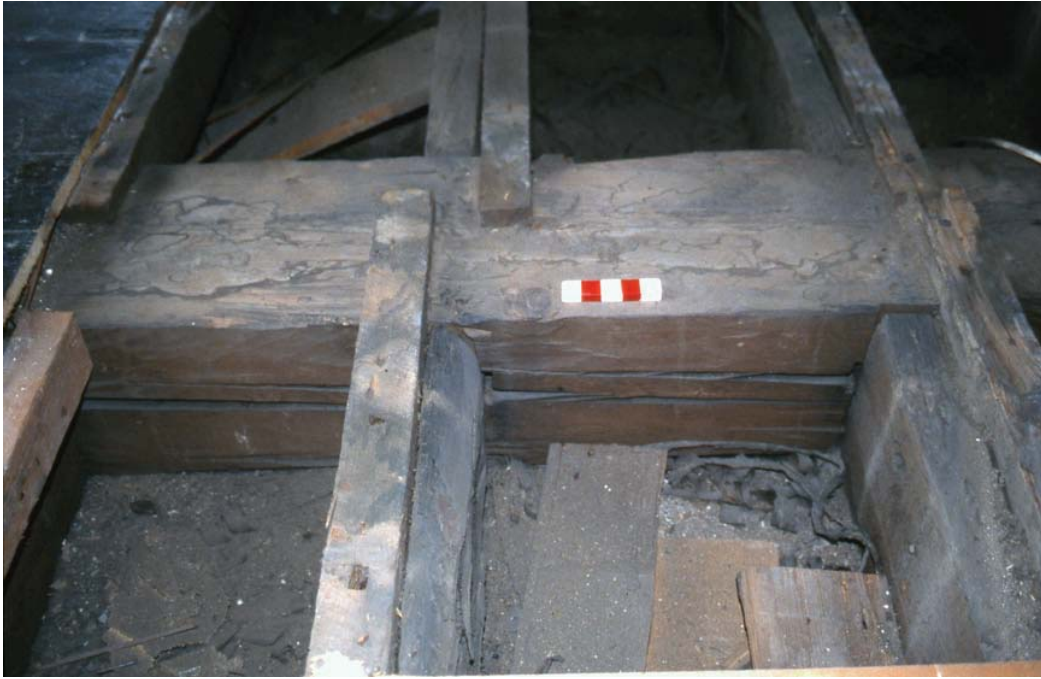
Plate 9. Second Floor, bedroom 6. Floor joists [16]. Scale is 10cm

- 4.8.4 In the centre of the floor of Bedroom 6, an area of modern floorboards was lifted, exposing the 18th century sub-floor structure [16] (Fig 7). This consisted of a large very heavy timber main beam or girder¹² [13] aligned north south, supporting east-west aligned binder and floor joists [14] & [15] (Plate 9). The main timber girder [13] was a large (209mm x 203mm x 2300mm) timber baulk of boxed heart, possibly of pine, with adze marks on the surface.

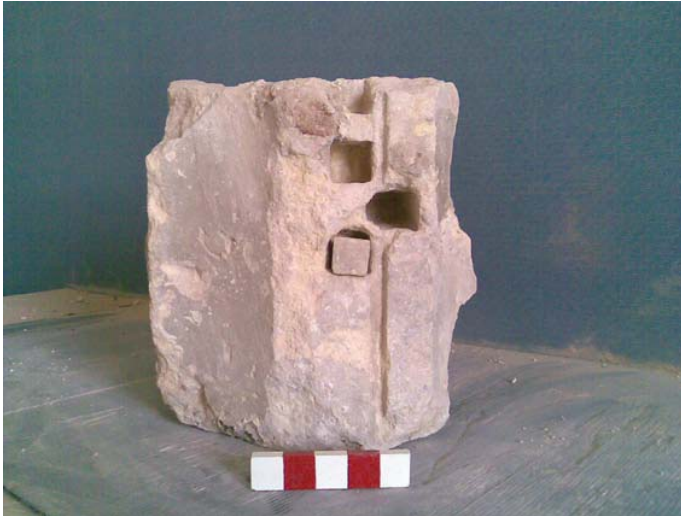
Plate 10
Stone 6, from 2nd floor,
bedroom 6, [12].

Taynton Stone.
Medieval window
moulding. Note stone
'plug' as repair.

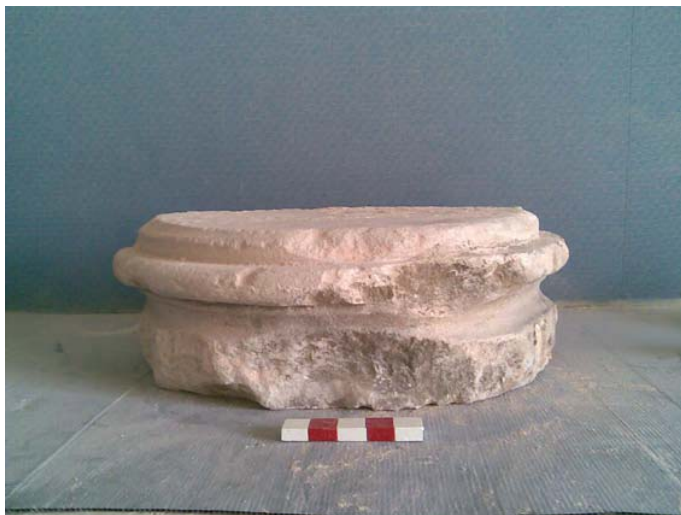
Plate 11
Stone 2, from 2nd
floor, bedroom 6,
[12].

Ketton Stone.
Medieval column
base.

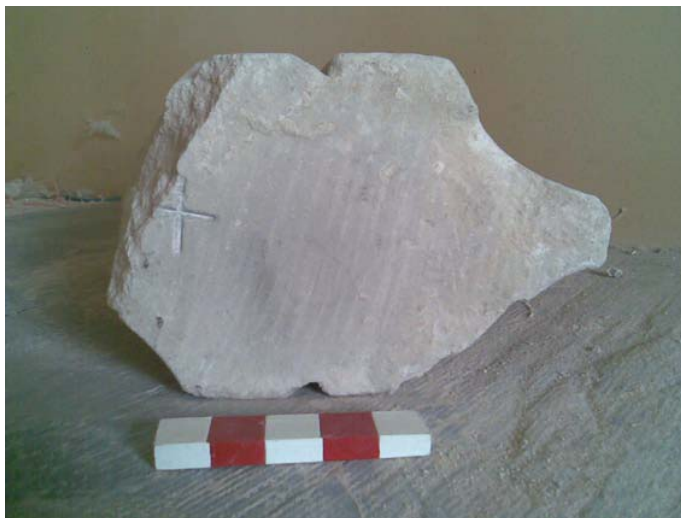
Plate 12
Stone 20, from 2nd
floor, Main landing [11].

Portland Stone.
Note mason's mark.

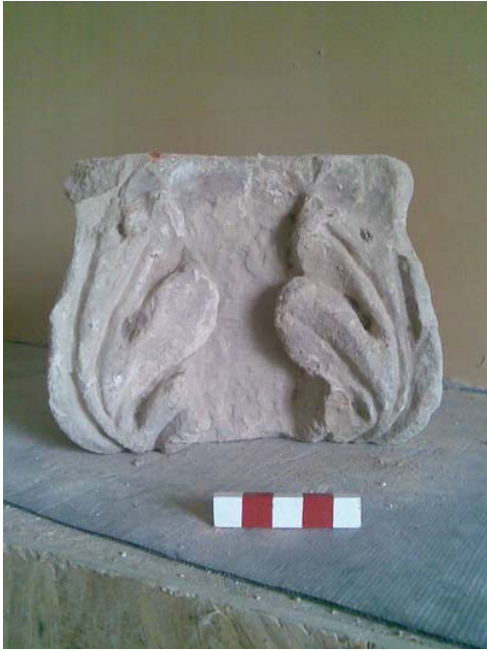
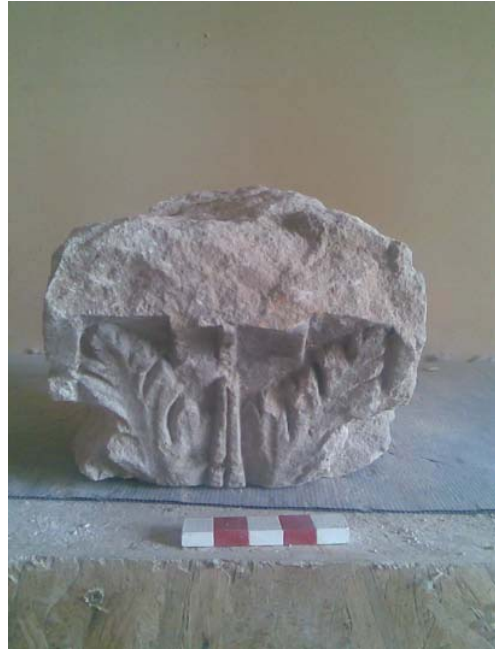
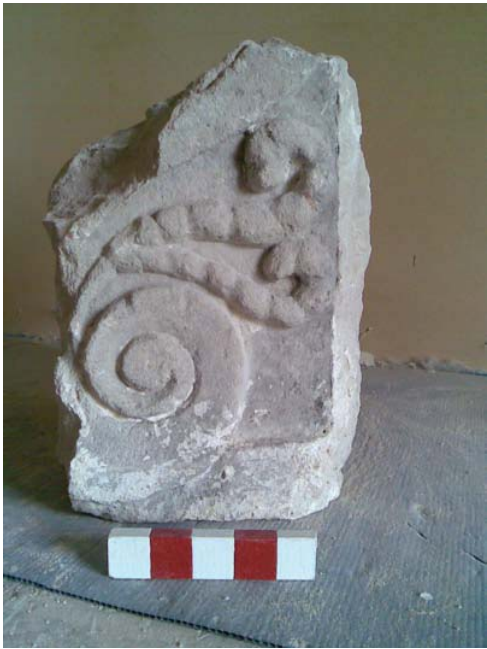
Plate 13. Top left: Stone 19 from 2nd floor, main landing, [11]. Ketton Stone. Medieval fine carved foliage.

Plate 14. Top right: Stone 26 from 2nd floor, main landing [11]. Top view. Portland Stone. Medieval fine carved foliage.

Plate 15. Bottom left: Stone 26, side view.

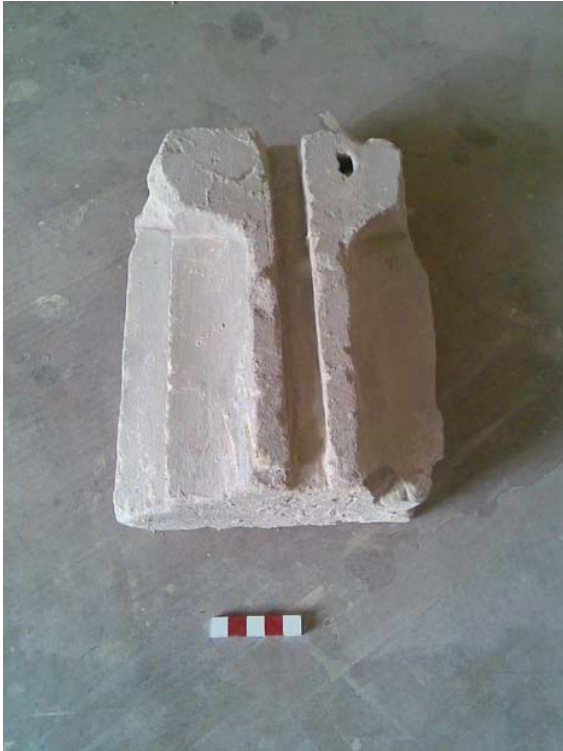
Plate 16. Stone 15, from 2nd floor,
main landing [11].
Taynton Stone. Medieval window
moulding.

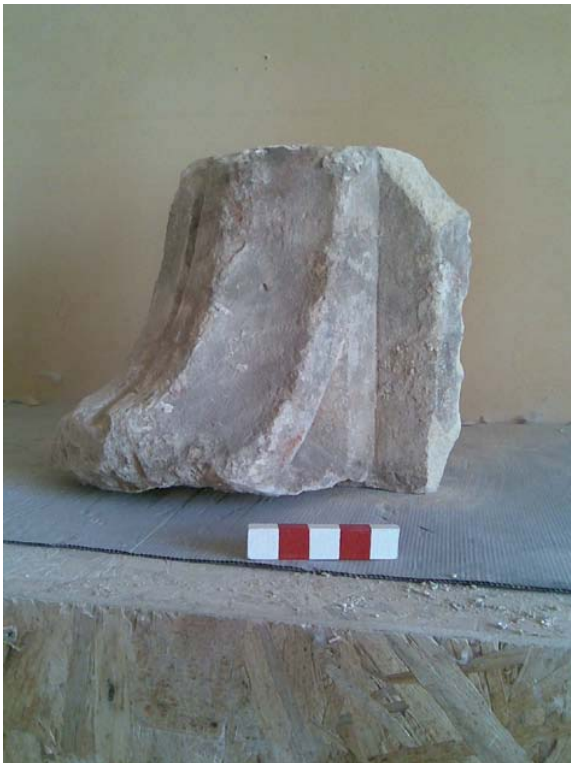
Plate 17. Stone 16, 2nd floor,
main landing [11].
Combe Down Oolite.
14th–15th century window
tracery.
