VALENTINES MANSION, ILFORD, LONDON BOROUGH OF REDBRIDGE

HISTORIC BUILDING RECORDING AND ARCHAEOLOGICAL WATCHING BRIEF

Site Code: VTM04

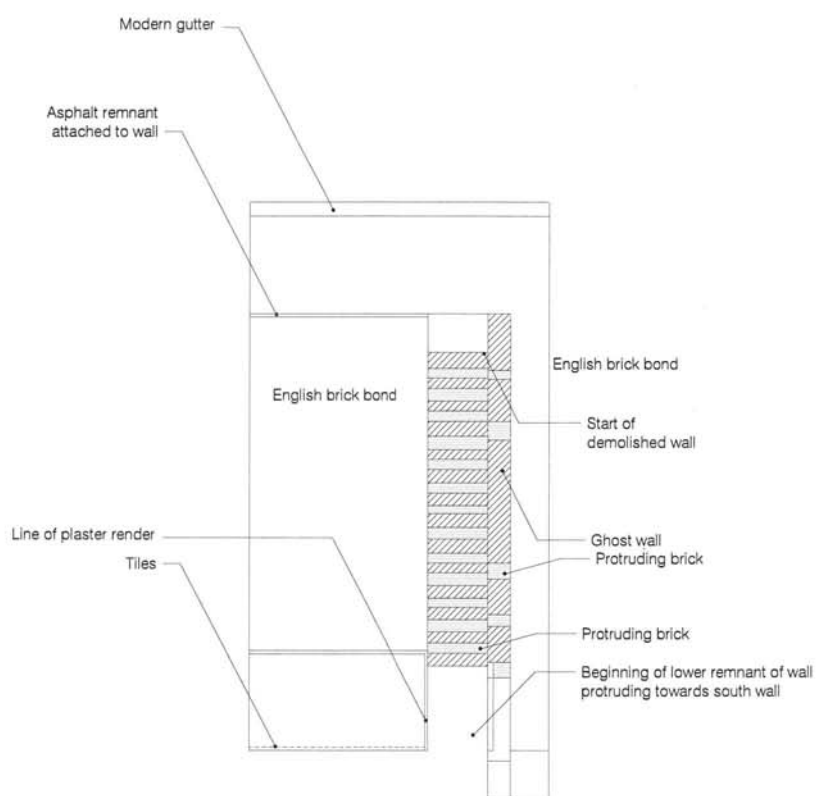
Figure 26
South facing elevation of western quadrant of north wall in Coal Yard
1:50 at A4

- 8.8.5 The upper 3-4 courses of the north wall have been replaced with modern red bricks and modern air bricks have been placed at equally-spaced intervals. There is a trace of removed asphalt roofing on the upper west corner of the wall. The only part of the wall to be affected by the modern alterations is the western end (Figure 26).

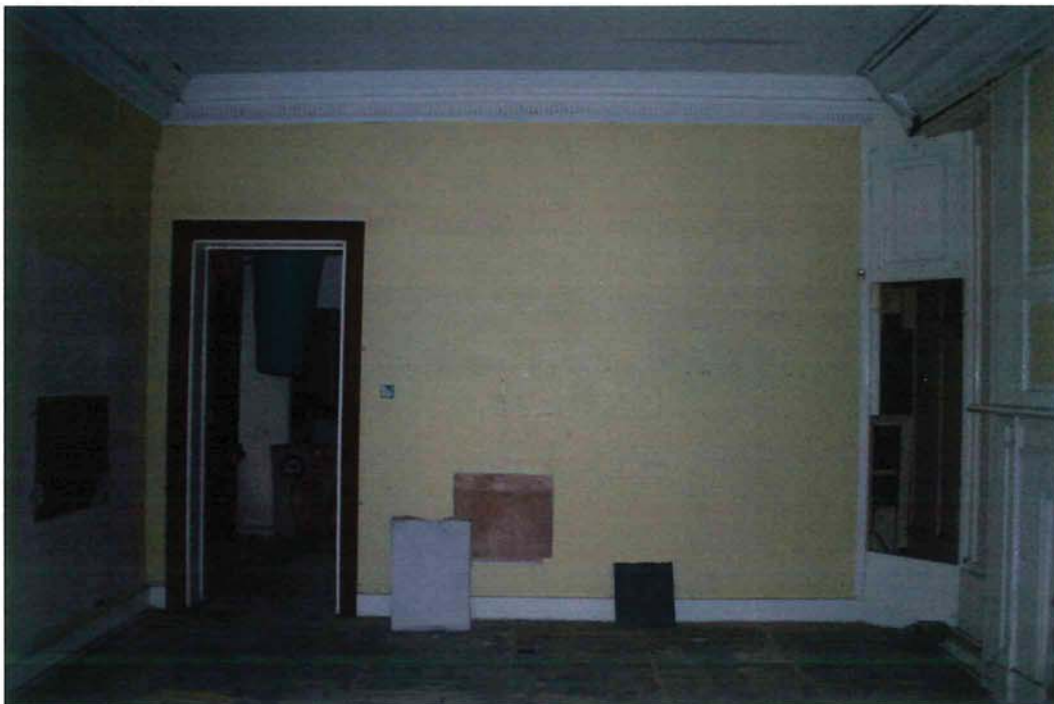
Plate 2: Shot of north wall in Room G04

- 8.5.6 The floorboards are largely original with signs of modern restoration near the north wall. This had been noted during the 2006 phase of assessment, when it was attributed to 1980s restoration after the woodwork suffered from a beetle infestation. The underlying floor joists were modern, and the brick floor sills appeared to be original but were covered in modern cement render (Plate 2).

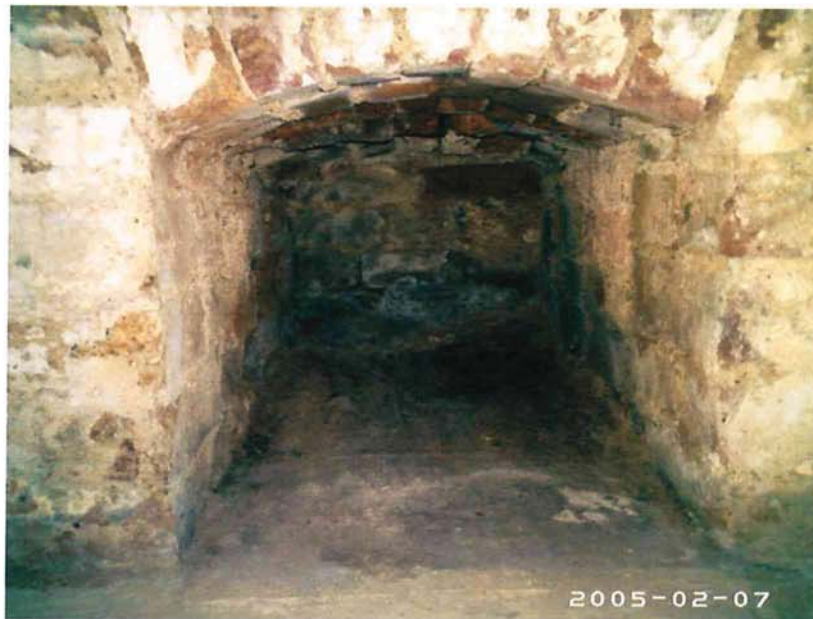
Plate 11: Detailed shot of hearth in Room G19 (Scullery)

8.9.3 The oven is constructed from red stock brick in English bond pattern. Both the oven and lower opening have a single course of soldier-set bricks forming their sills and lintels. The openings and oven floor have been reinforced using iron plating. The western side of the brickwork has suffered damage and been repaired with modern metric bricks set in a stretcher bond pattern (Plates 11 & 12).
