Historic building recording of Pimlico School, Lupus Street, SW1, City of Westminster

Written and researched by: Helen Robertson, Rhiannon Rhys and Guy Thomson

Commissioning client: Bouygues UK Ltd

Contractor: Pre-Construct Archaeology Ltd

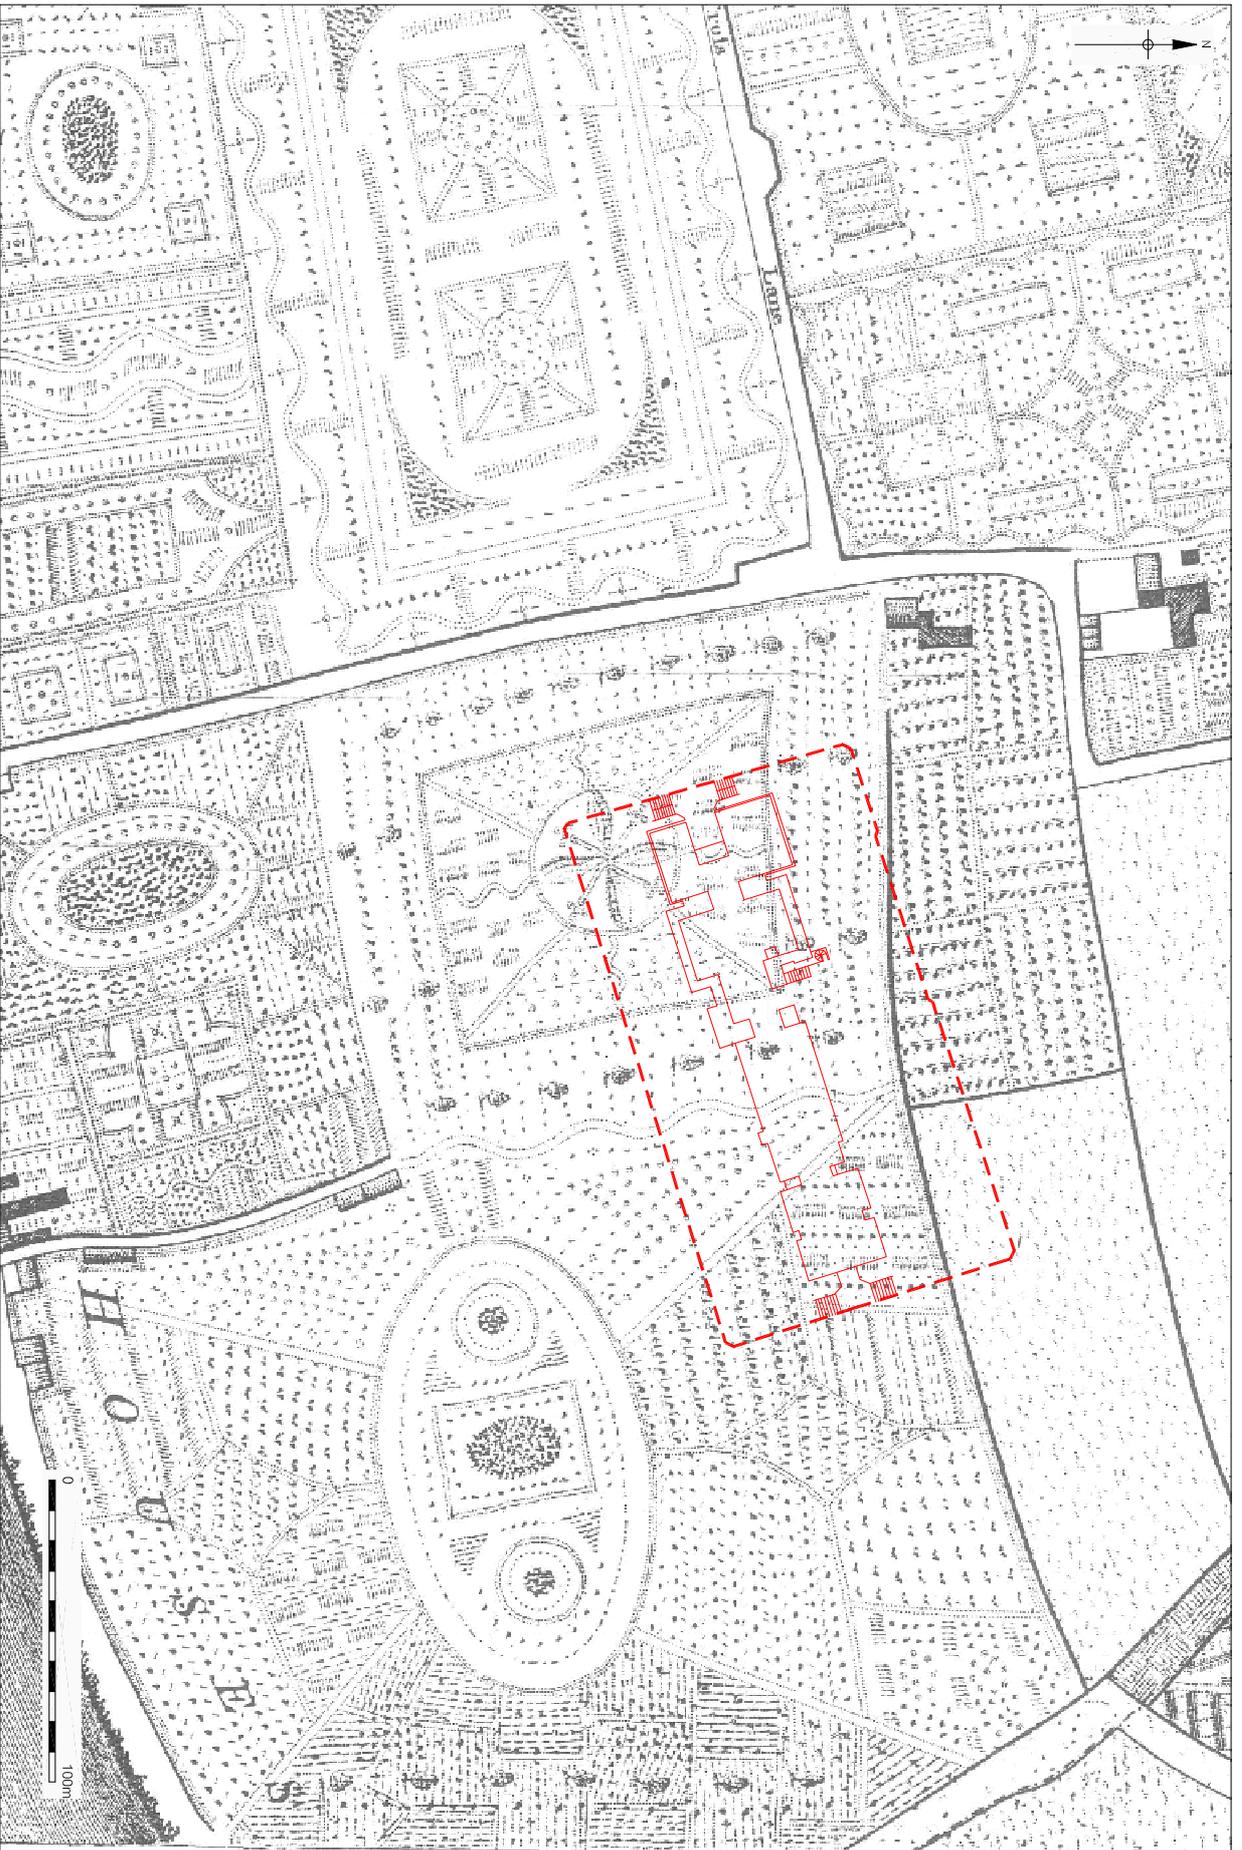
Pimlico School
Figure 3
Horwood, 1793
1:2,500 at A4

- 4.1 The first reference to Pimlico comes from 1626 and stems from a reference to a group of cottages known as the 'Neat Houses', around Ranelagh Gardens. This land lay immediately to the south of the study area and the cottages were part of the manor belonging to the Abbot of Westminster. During the 17th and 18th centuries, these gardens provided produce to be consumed in London (Fig 3).

- 6.2 Phase 1: 1600s to 1830
- 6.2.1 Before the construction of the school, the site was part of an area occupied by large gardens and orchards. The 1793 map (Fig 3) shows the layout of the gardens at that time. The land belonged to the Abbott of Westminster and the produce was regularly sold in London markets.

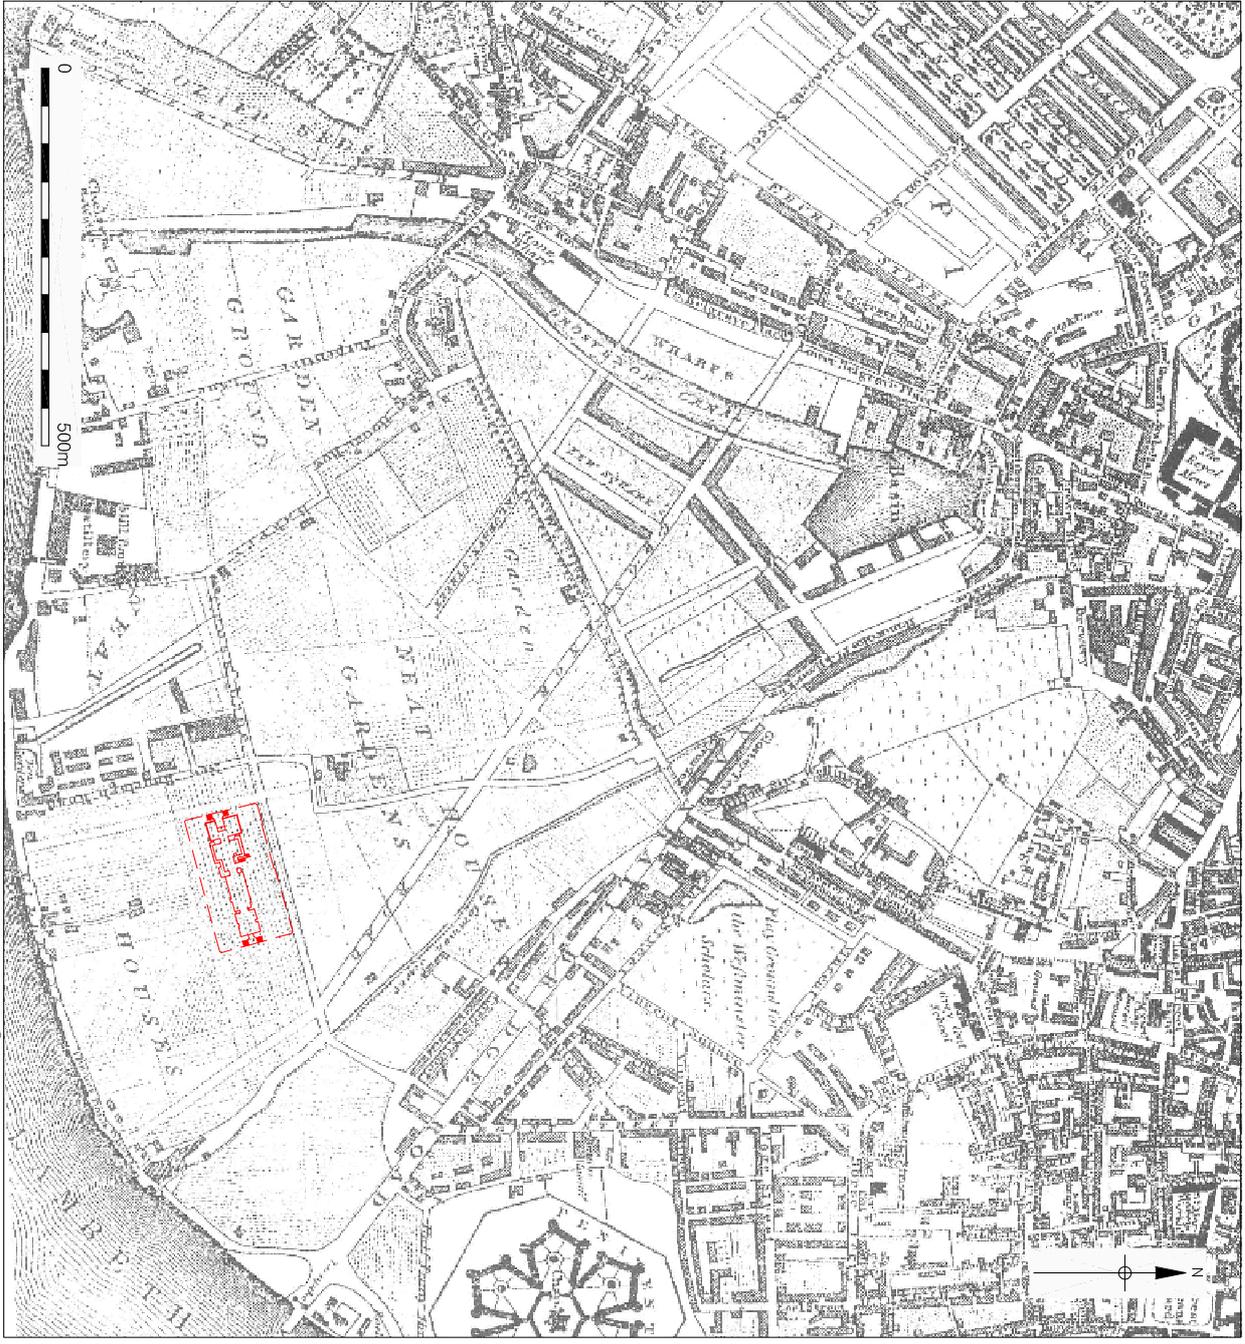
Pimlico School
Figure 4
Greenwood, 1827
1:10,000 at A4

- 4.2 By 1827 (Fig 4), the area the site is located upon was still being used as market gardens. The northern boundary of the site is now secure, modern day Lupus Street is denoted on this map as Crofs (or Cross) Lane. An unmarked road runs on the boundary of the site to west, what is now known as Claverton Street. A lane likely to be the present day Grosvenor Road runs further to the east of the site. Further to the south is the River Thames.

- 6.2.2 The gardens remained on the site until the early 1830s when the land was bought and redeveloped for housing. The 1827 map (Fig 4) shows the gardens and the associated 'Neat Houses' to the south. The northern boundary of the site is now clearly delineated by Crofs (Cross) Lane to the north which separates the original unbroken field system.

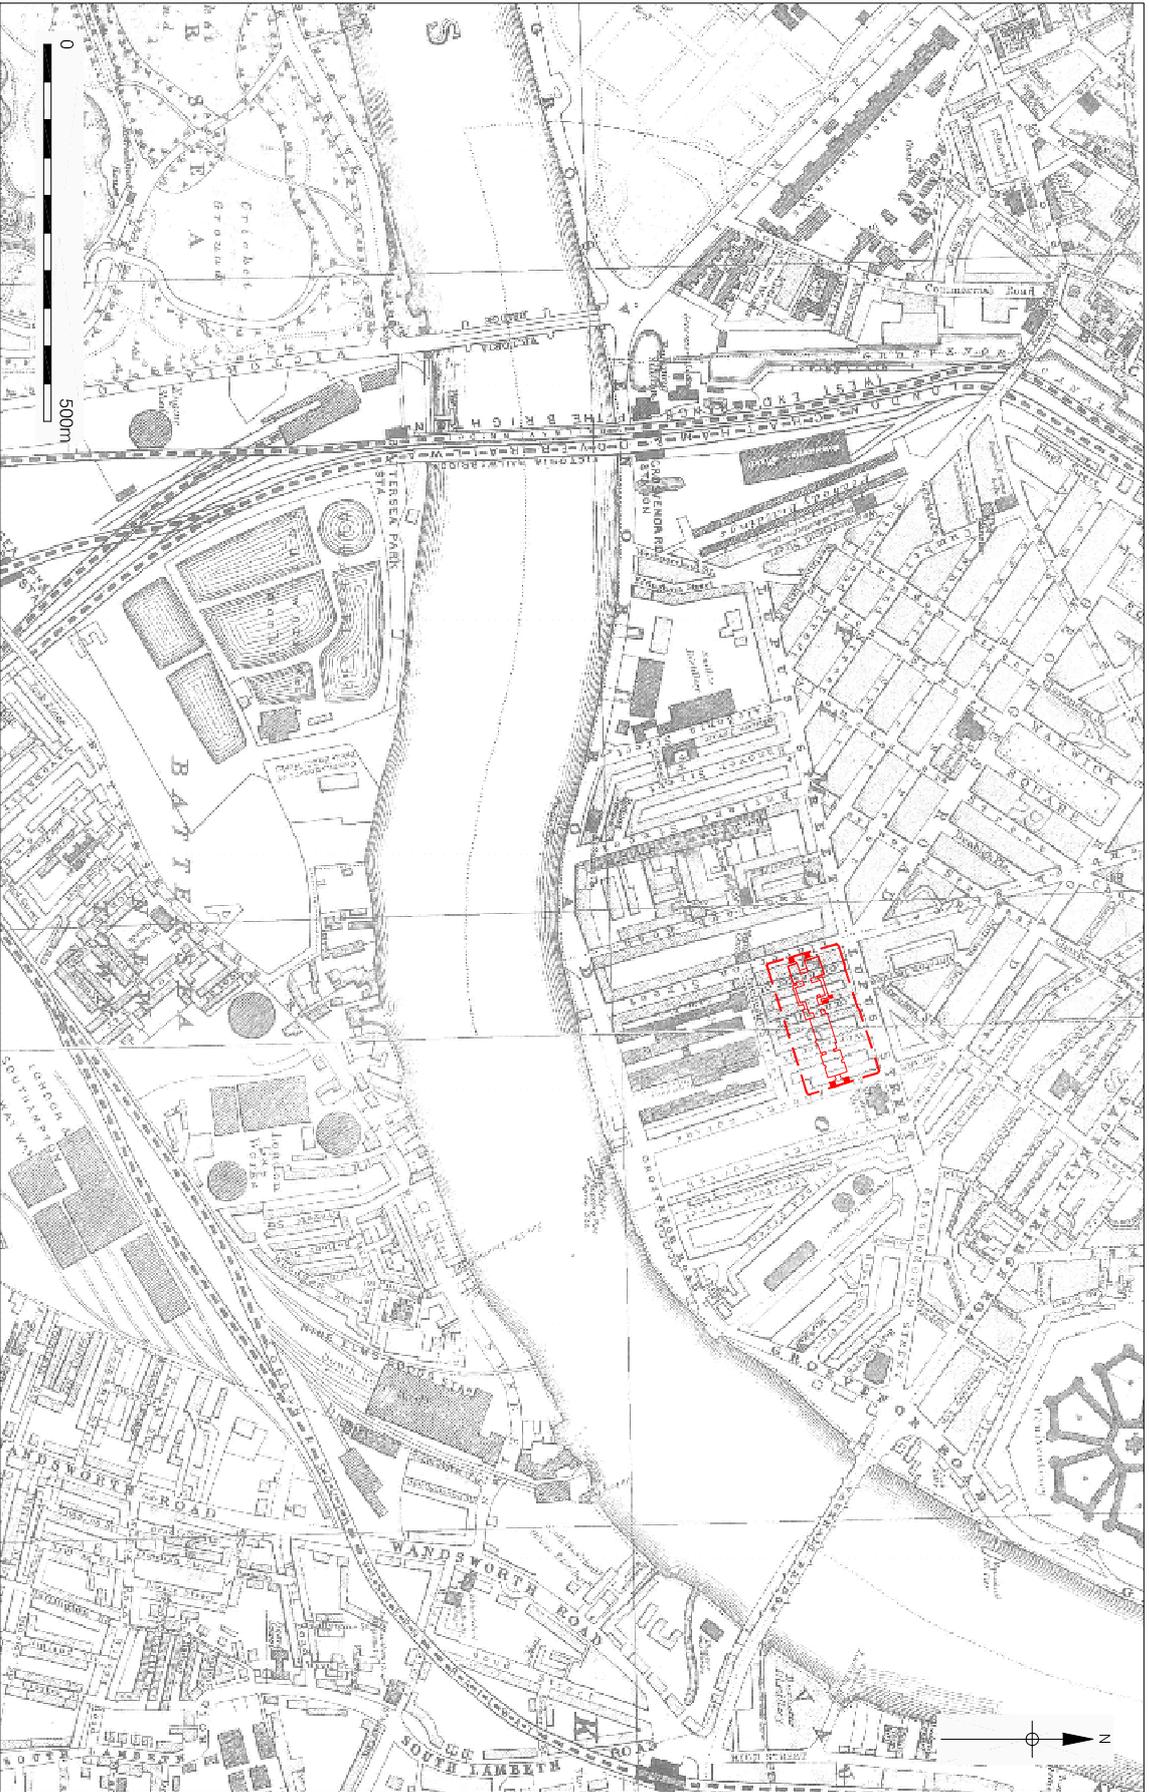
Pimlico School
Figure 5
Bacon, 1888
1:10,000 at A4

- 6.3 Phase 2: 1830 to 1960s
- 6.3.1 The first map to clearly show the boundary of the site is that recorded by Bacon in 1888 (Fig 5). The site is bounded by streets on all sides, with three streets running northwest-southeast within the site showing the buildings designed in the 1830s by Thomas Cubitt and associates. This map is slightly inaccurate, showing the southern boundary further south than it is.

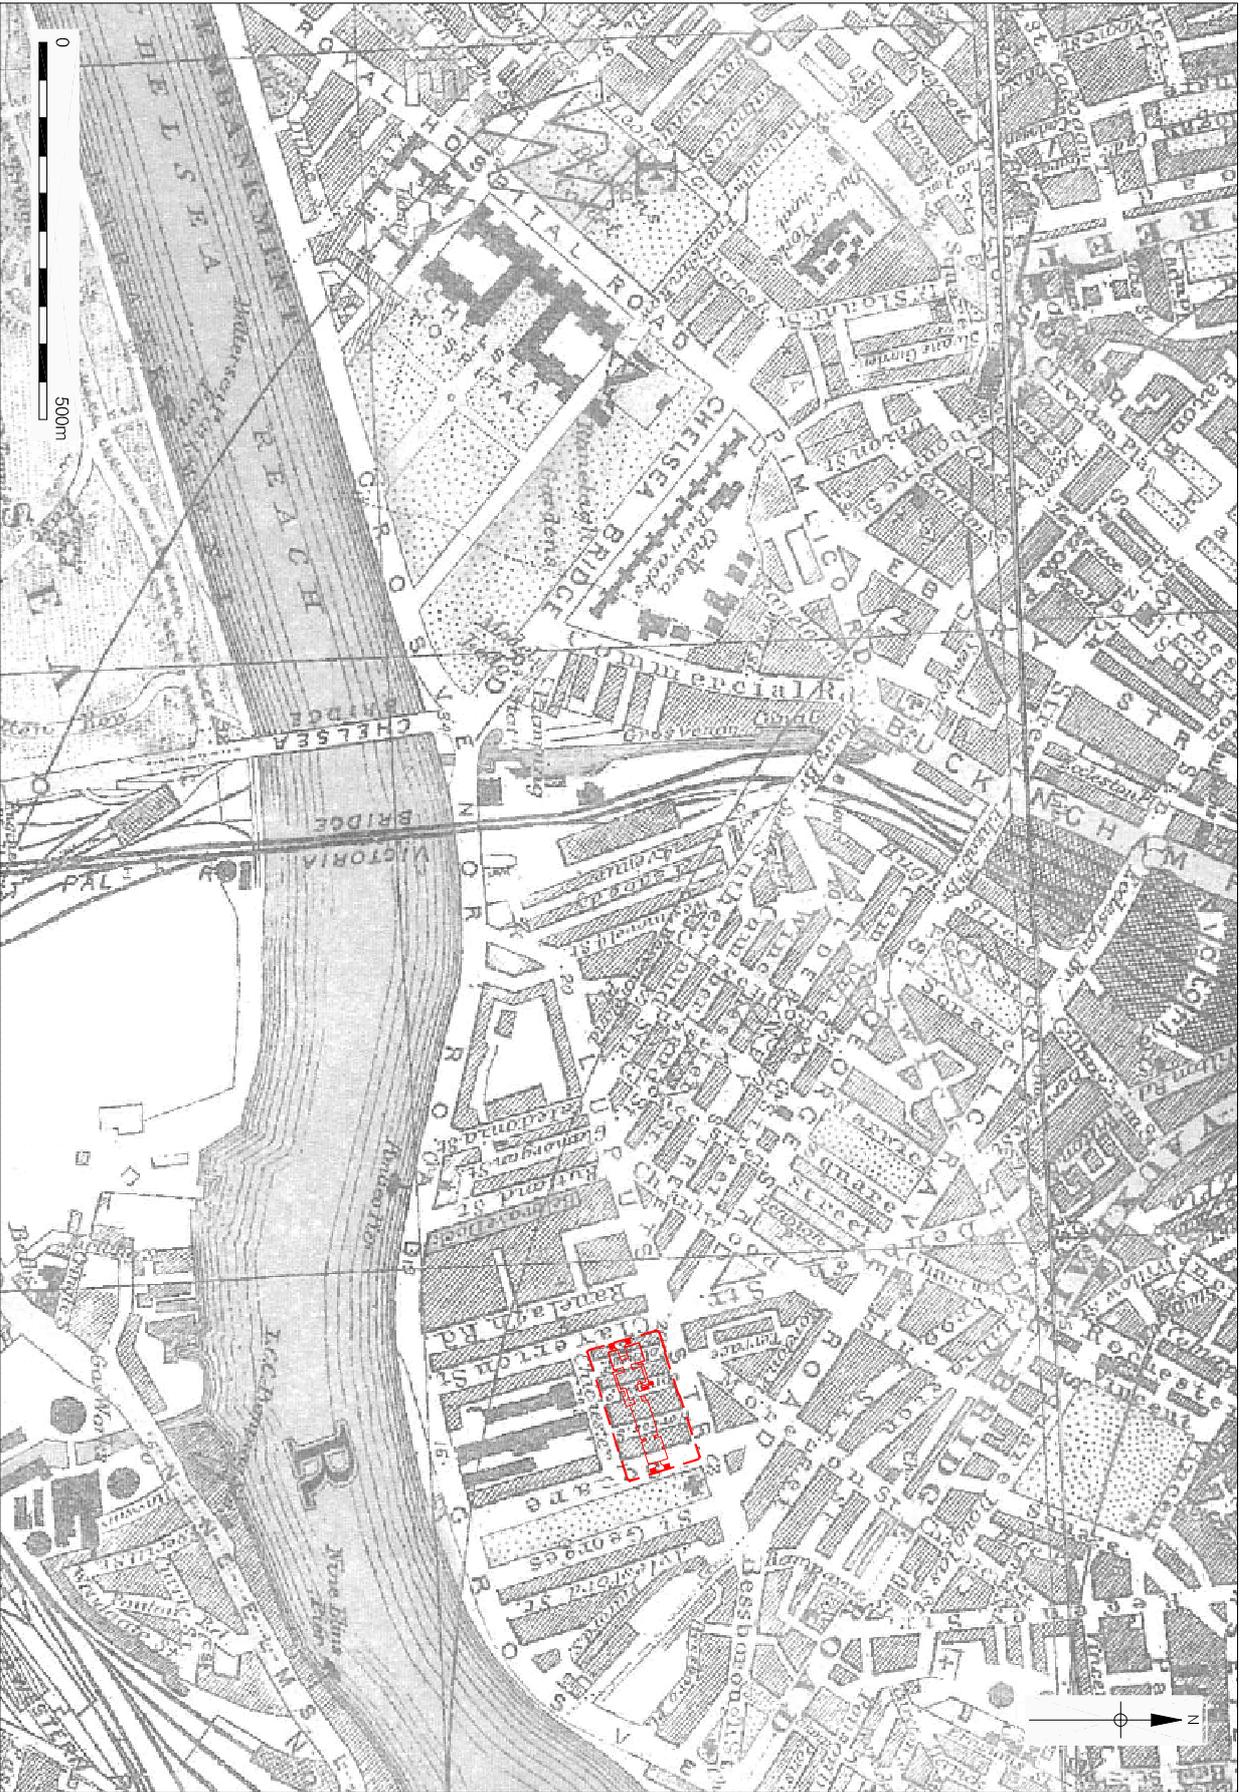
Pimlico School
Figure 6
Bacon, 1912
1:10,000 at A4

- 6.3.2 Bacon also drew a later map of the area (Fig 6), showing the area of the site and its occupation by housing blocks within three streets. This time however, the north-eastern boundary of the site is inaccurate. Bacon has located the streets much closer together than in reality they would be and therefore, St George's Square which forms the north-east boundary of the site is too far to the south-west. The drawings of the structures themselves are also very basic and the map does not allow for any detail of the houses or the associated gardens and outbuildings connected to each in the row.

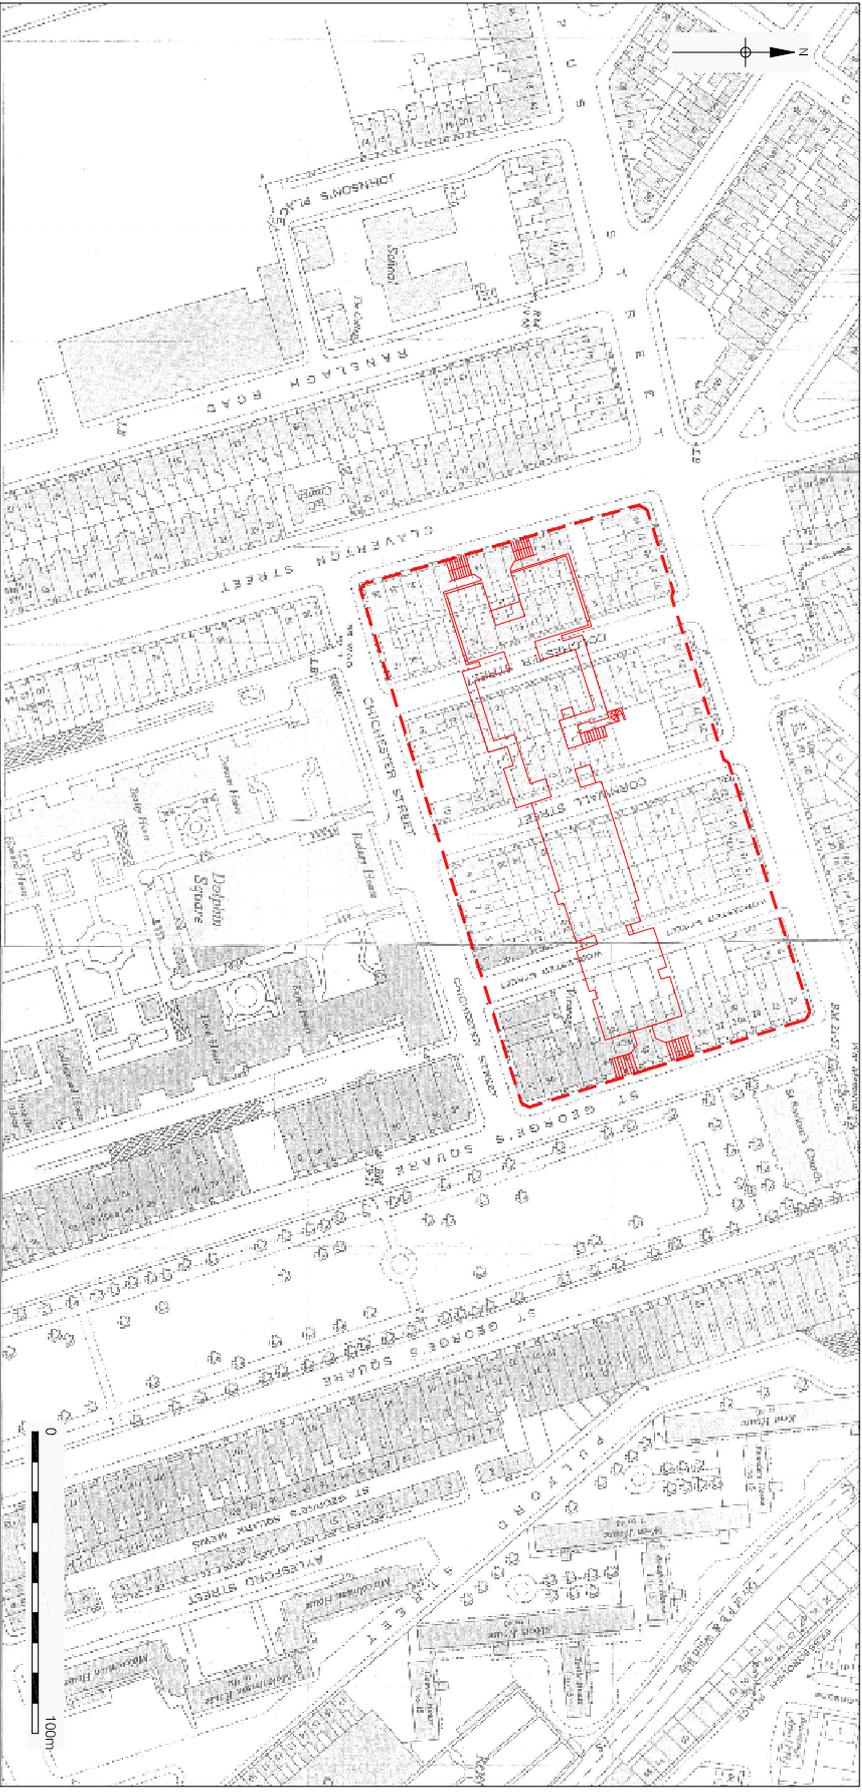
Pimlico School
Figure 7
Ordnance Survey, 1950
1:2,500 at A4

- 6.3.4 The first map to show the true and correct boundary of the site occurs on the Ordnance Survey Map of 1950 (Fig 7). This goes into far greater detail for the houses that were previously located within the school site. The streets can be clearly identified as Colchester Street, Cornwall Street and Worcester Street with their individual garden areas. There are also large areas that are recorded on this map as gaps. This is likely to be due to the destruction of a number of properties around the area by bombing raids during the Second World War. A large proportion of the north-east side of Worcester Street appears to have been removed, as well as patches on the south-west of Cornwall Street, the north-west of Chichester Street and the north-east of Claverton Street. The surrounding area also appears to have suffered heavy damage with sizable blocks erased on the north-east side of Ranelagh Road to the south-west of the site, and very noticeably on the north-west side of Lupus Street to the north-west of the site.

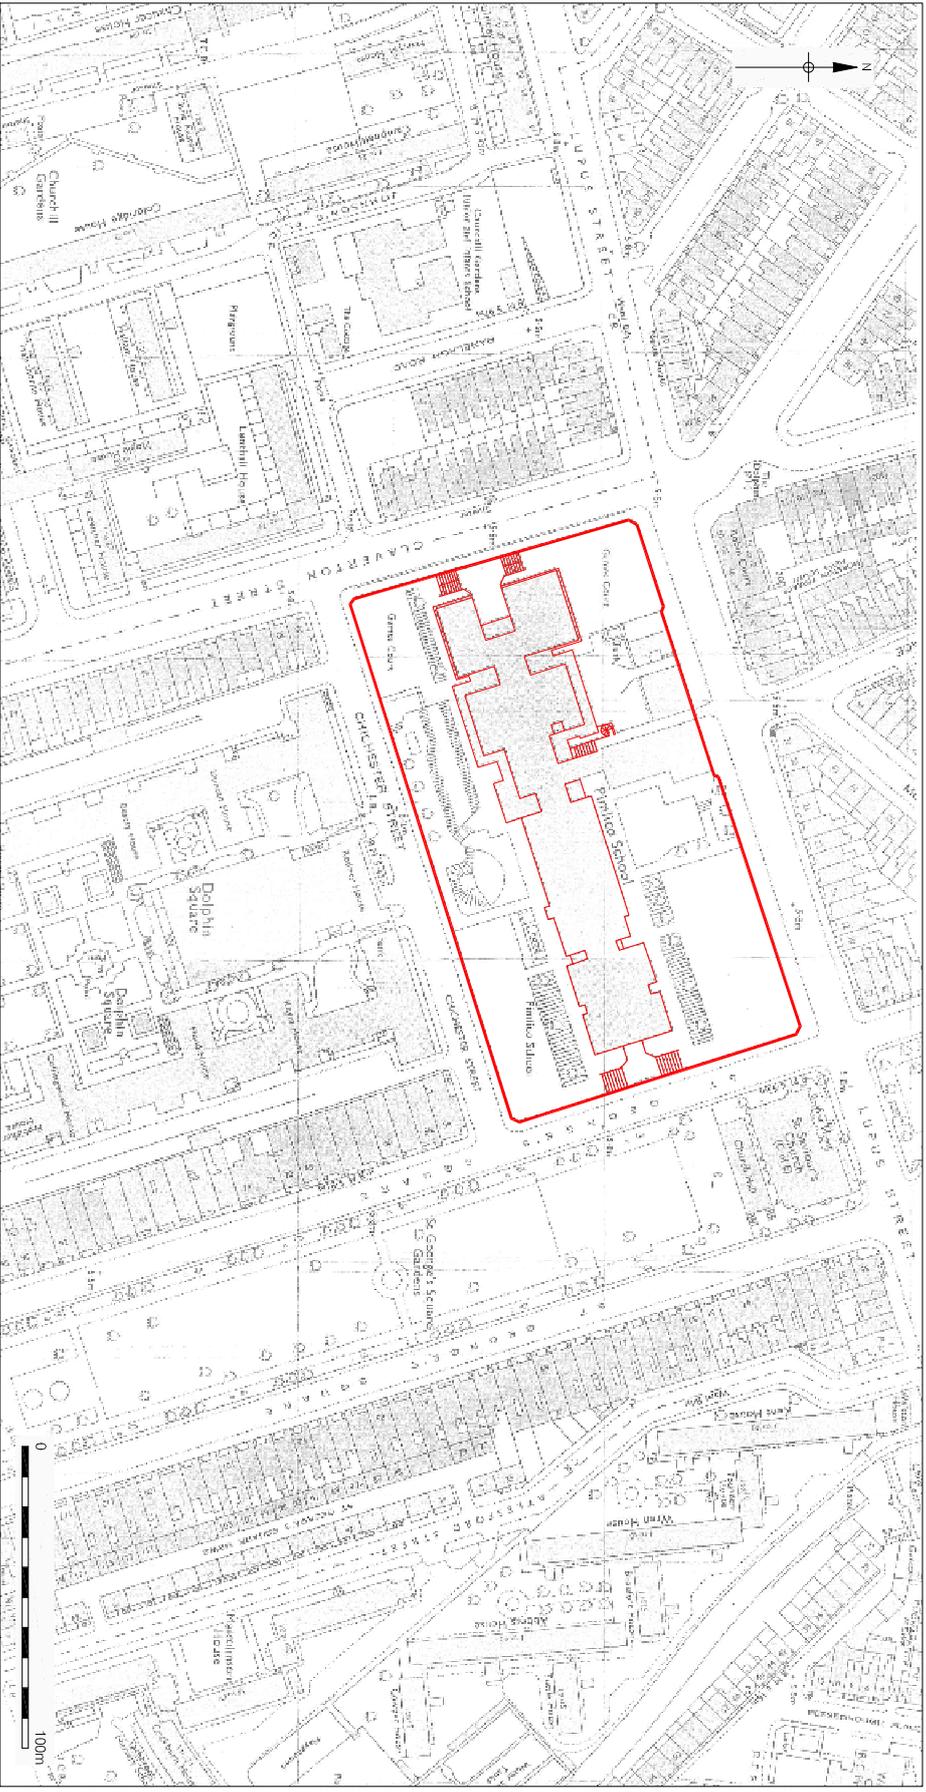
- 4.12 The Ordnance Survey map of 1973 (Fig 8) shows the school and its boundary wall just after the completion of its construction in 1970.

Reproduced from the 1973 1:250 Ordnance Survey map with the permission of Ordnance Survey on behalf of The Controller of Her Majesty's Stationery Office. © Crown copyright PCA Ltd. Unit 54 Brockley Cross Business Centre, London SE4 2PD. Licence number 100020795.

- 6.4.2 The first map to show a structure or structures which appear to correspond with the present-day school building is the 1973 Ordnance Survey map (Fig 8). The

detail on the map is elaborate, showing the outline of the structure and its associated outbuildings and playground area. (Plate 7)

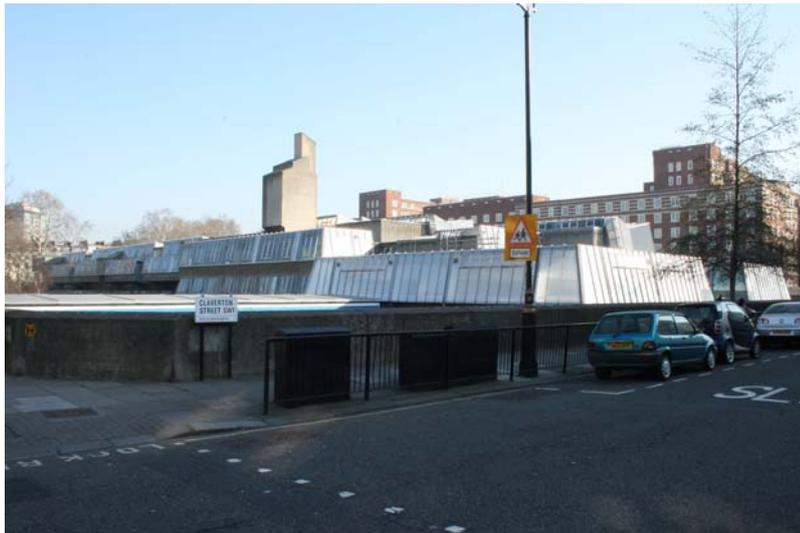
Plate 1 View of Pimlico School from corner of Claverton Street and Lupus Street, looking south-east

- 5.1.6 Bancroft has described the structural element of the building as being formed of "lightweight in-situ concrete used in cross-wall, floor and roof slabs, and for external cladding" (Bancroft 1971; 833) (Plate 1).

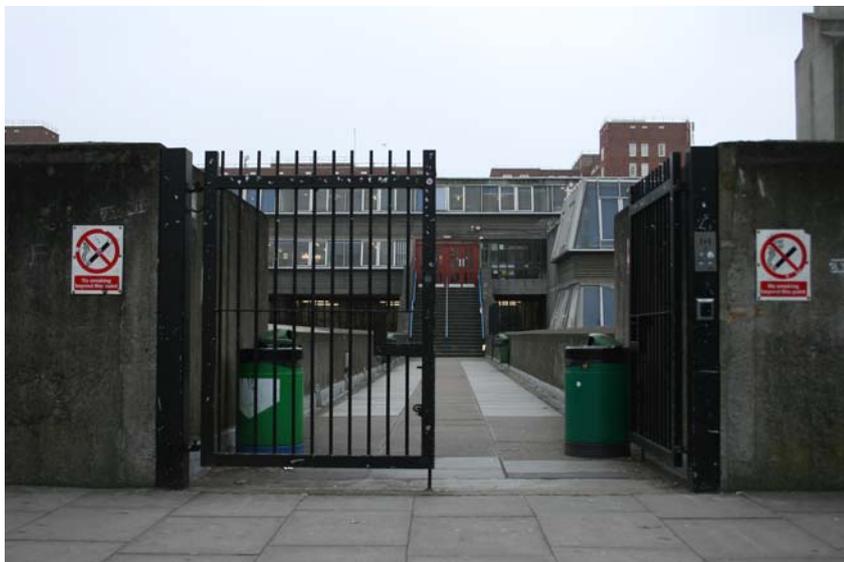
Plate 2 View of visitor's entrance to school, looking south

5.2.3 The main access from Lupus Street to the school grounds is via two ramped entrances to the south-west and north-east of the street. Direct access to the building is via a concrete walkway in the centre of the street which leads directly to the first floor with a double-leaf pedestrian door. On the original plans this entrance is allocated for visitors (Plate 2). Children were to enter the building via two double-leaf pedestrian accesses from Claverton Street and St George's Square.

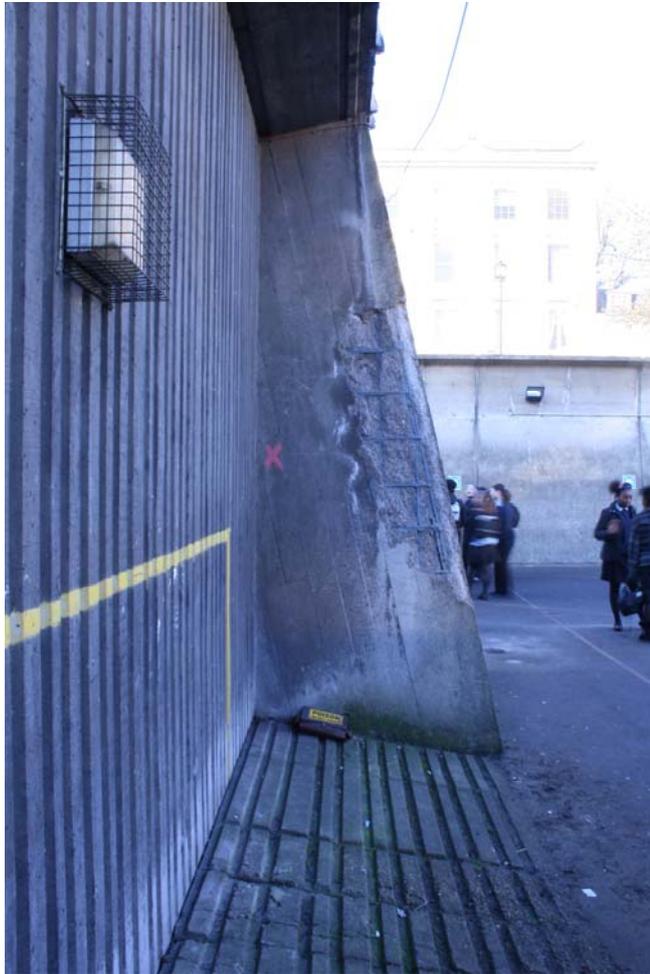
Plate 3 View of detail of buttress on west end of school, looking west

- 5.2.7 The formwork used for the construction of the school is commonly called shuttering. This term indicates the form the 'wet' concrete takes once it is poured. The shuttering is normally constructed of timber or braced metal. Once this has been removed, the concrete is "found to have the texture of the material imprinted upon the surface" (Fleming, Honour, Pevsner 1991; 159). (Plate 3)

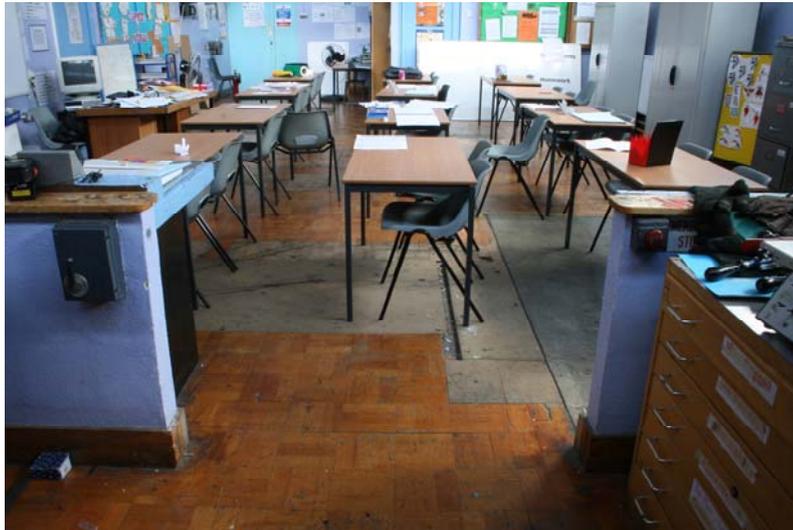
Plate 5 View of a typical woodwork room, showing evidence of scarring on floor, looking east

- 5.3.4 The area to the north had been allocated as woodwork, engineering and metalwork. These rooms have lost their original machinery, although fragments remain and scars on the floor show their previous locations (Plate 4). The rooms

are now geared towards design and computer related subjects, something not envisaged by the original architects.

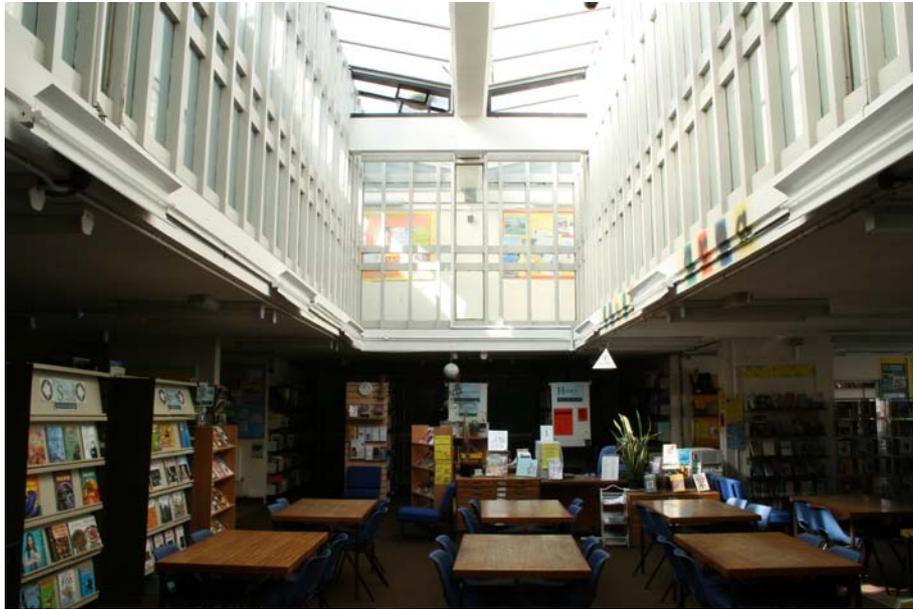
Plate 6 View of Library up to corridor above, looking west .

- 5.3.16 Unfortunately, the large hallways of the ground and first floor caused several problems for the teaching staff who had to deal with the noise levels and echoes, the loitering and disruptions that were caused by having space for a large number of pupils to congregate (pers. comm. Mr Callway, Learning Manager, Pimlico School). (Plate 6)

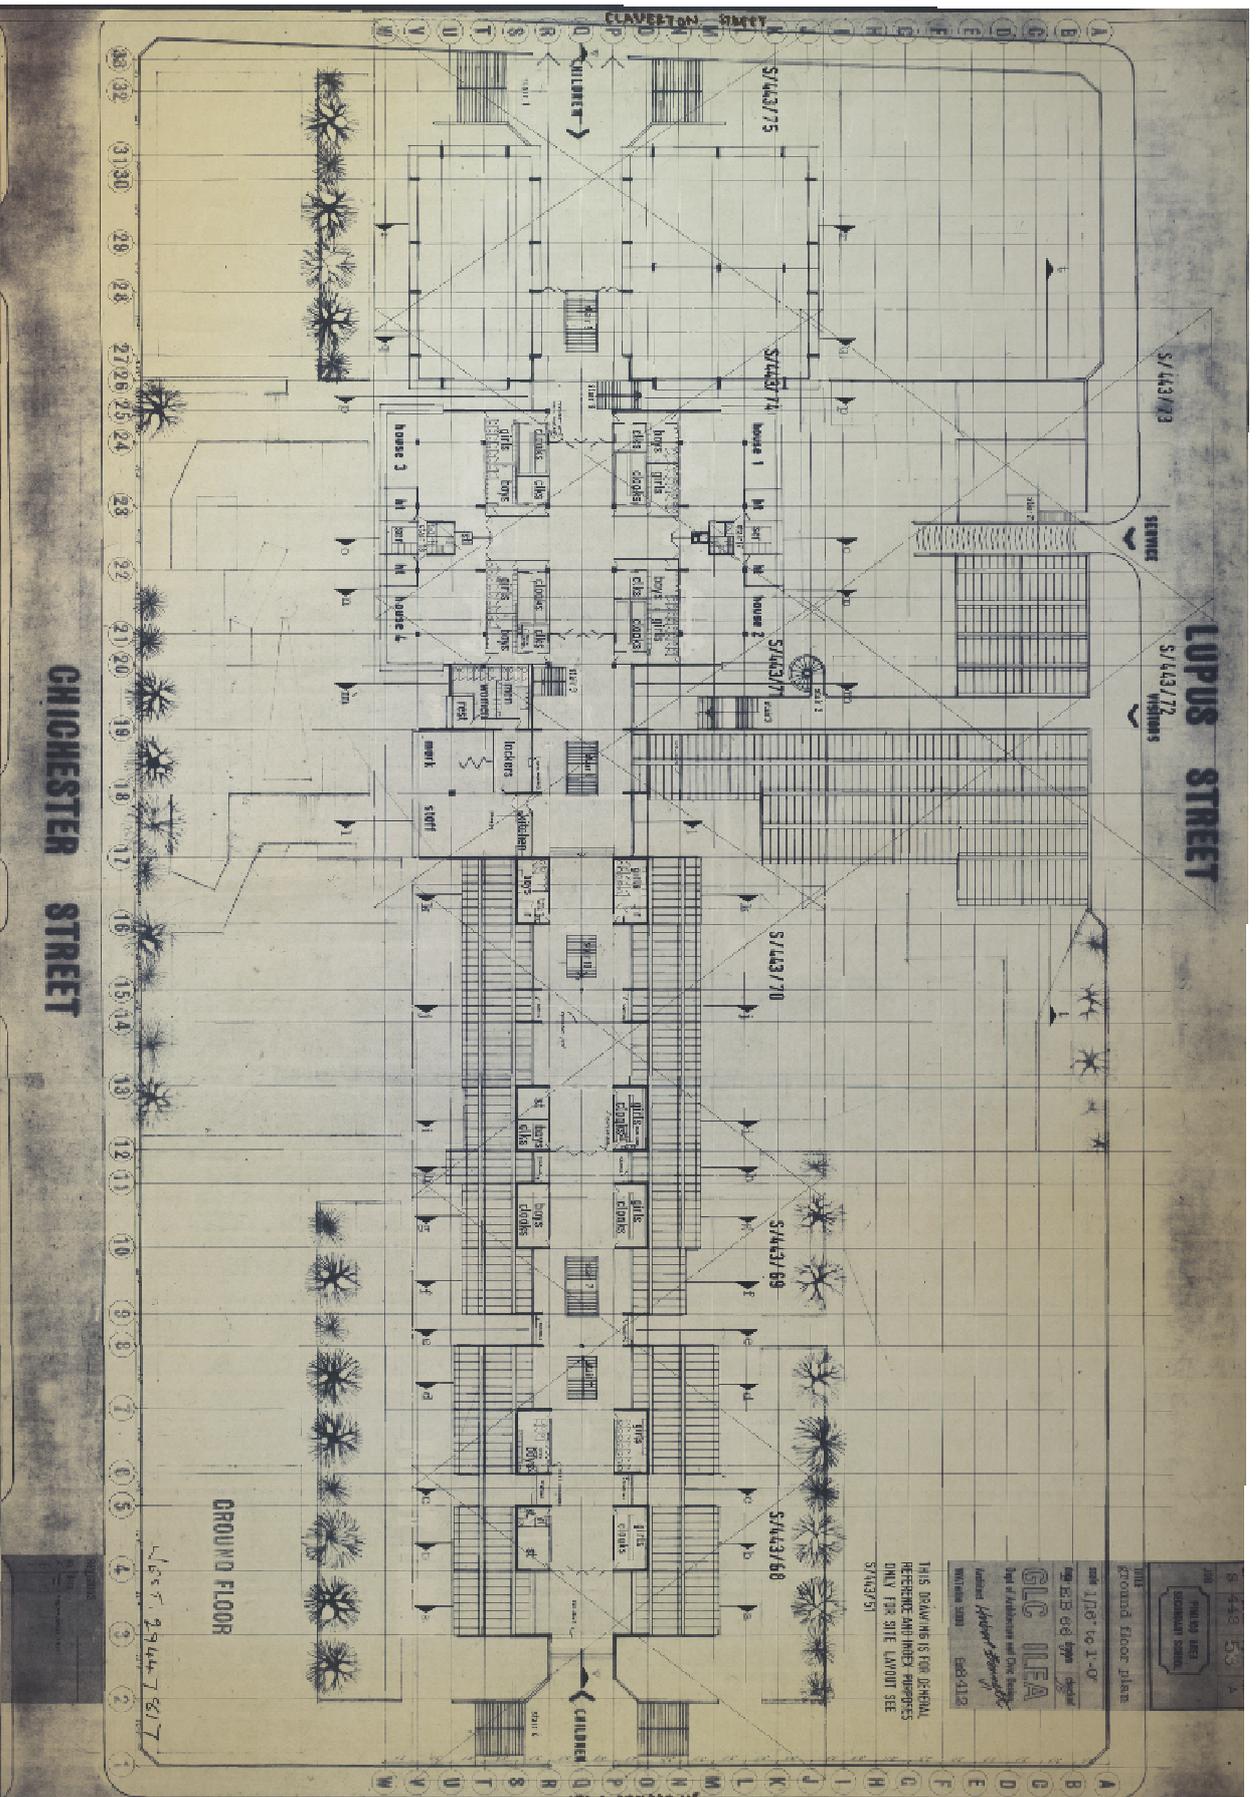
Figure 12

Original drawing created by GLC, ILEA Department of Architecture and Civic Design. Architect: Hubert Bennett

Original Architects' plan, ground floor

- 5.3.5 The rooms towards the north east of the structure consist of classrooms for science and textiles.
- 5.3.6 The ground floor (Fig 12 and Fig 13) consists of a series of various sized rooms, used principally for teaching. There are a number of toilets and cloakrooms as well as offices to the north-east.

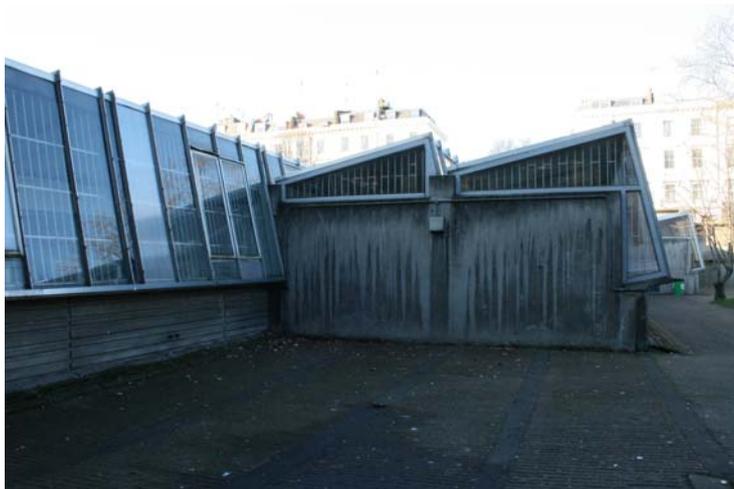
Plate 8 View of shutter marks on concrete, looking north-northwest

“concrete left in its natural state when the formwork has been removed. Sometimes special formwork is used to show clearly the timber graining on the concrete surface.” (Fleming, Honour, Pevsner 1991; 45)

7.1.6 It is also known as board-marked concrete. (Plate 8)

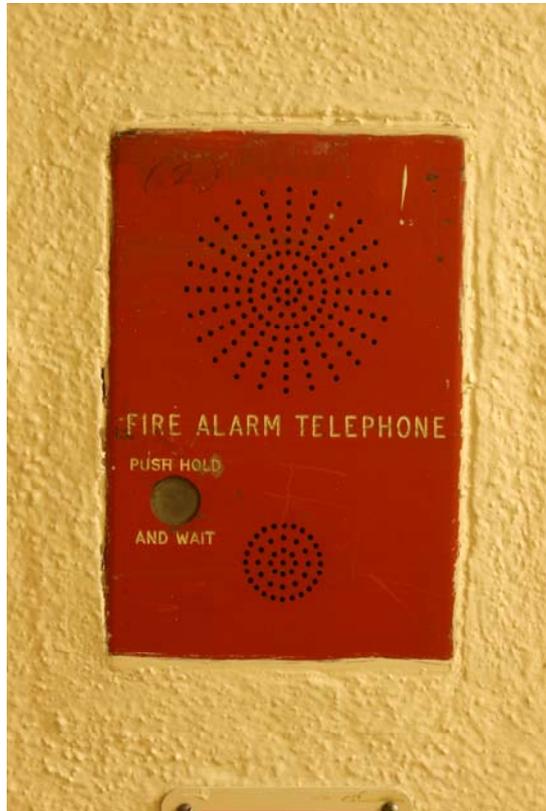
Plate 9 View of original fire alarm located on lower ground floor, kitchen, looking east-northeast

- 7.3.1 Original design features which were recorded include the integrated fire alarm system (Plate 9), which comprised an intercom system for reporting incidents rather than the traditional bell-trigger system; the public address system; a control box for the adjustable external shutters; the pulley system and runners for internal blinds; cupboards; doors; bases and emergency stop buttons for woodworking machinery (now removed), and brackets for blackboards (now removed).
