AN ASSESSMENT OF AN ARCHAEOLOGICAL
EVALUATION AND WATCHING BRIEF

**AN ASSESSMENT OF AN ARCHAEOLOGICAL EVALUATION AND WATCHING
BRIEF ON LAND AT 397-411 WESTFERRY ROAD, ISLE OF DOGS, LONDON
BOROUGH OF TOWER HAMLETS**

SITE CODE: WYM 07

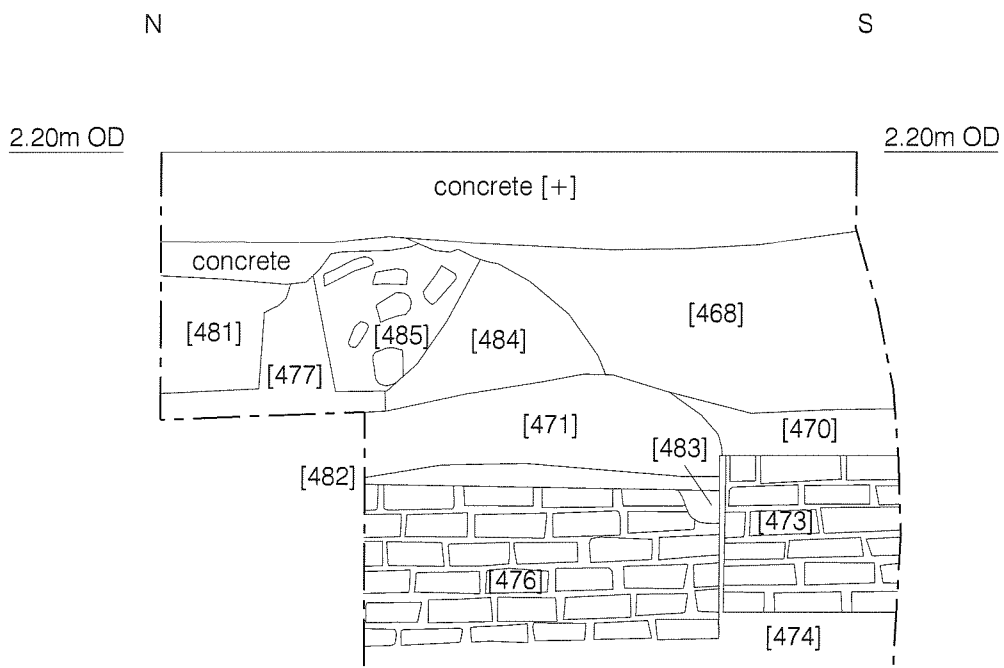
Figure 15
 Phase 6, Section 16, Pile Pit 74-76
 1:20 at A4

Section 16
 Pile Pit 74-76
 West Facing
 Shows three phases of construction, [476] Phase 5, [473]
 Phase 6 and [477] Phase 7

- 7.21.1 In PPs 74-76 a brick flue [477] was recorded aligned NW-SE. The flue was badly constructed using red brick, which had suffered severe heat damage. It was capped with a number of cast iron plates of various sizes. The feature sloped down towards the east, which may be the result of subsidence. A small iron pipe [478] was recorded running across the top of this feature. The top of the feature was at 2.00m OD whilst the lowest level at the base was at 1.40m OD (Figure 15).

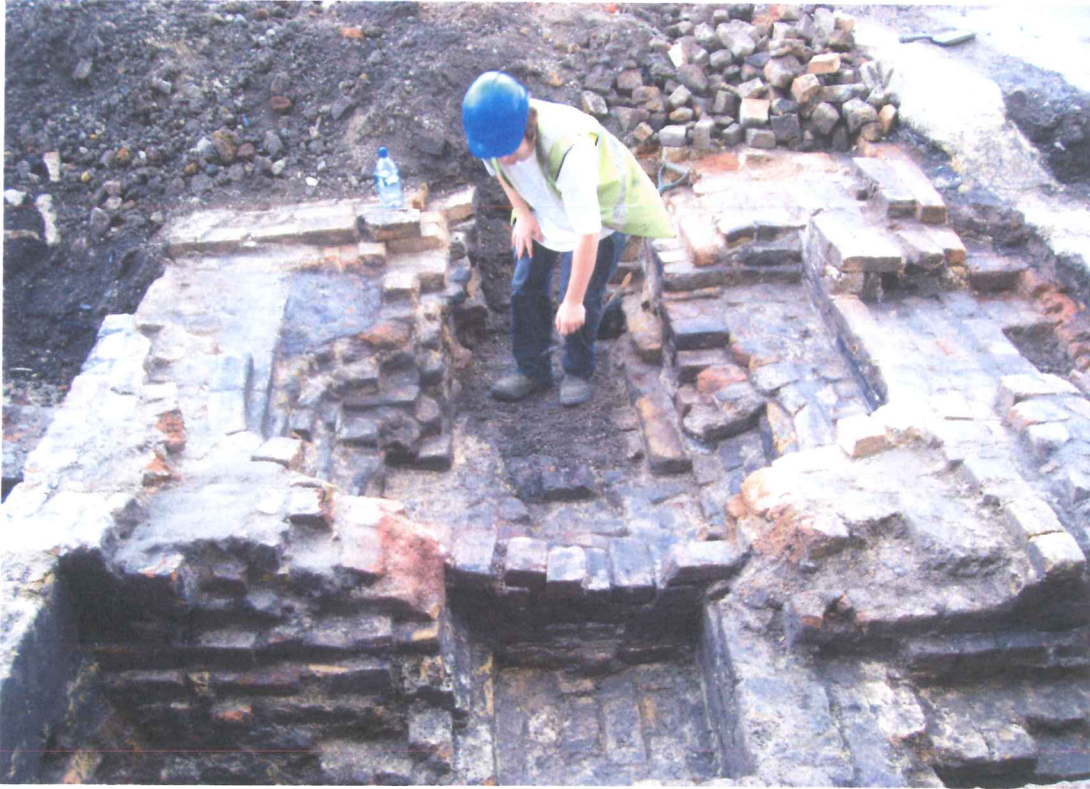
Plate 4: View SW of blast pipe, Phase 7, in PPs 56-58

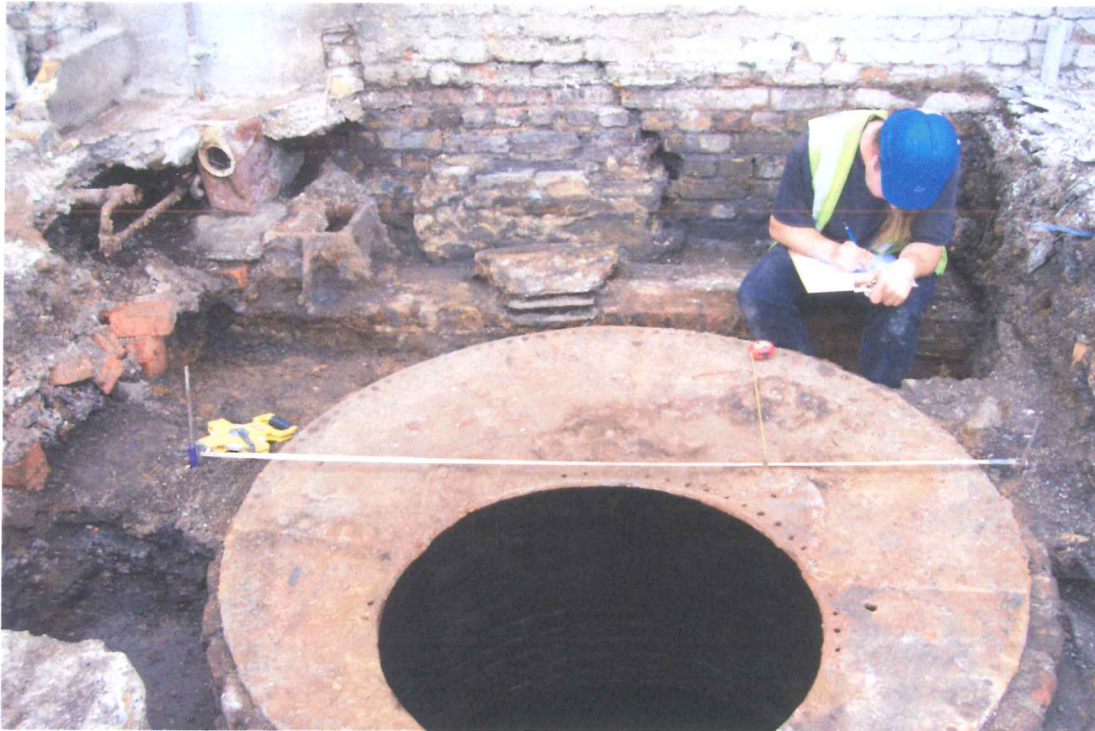
Plate 6: View SE of accumulator base

- 7.25.1 To the northeast of Structure A the remains of what has been identified as an hydraulic accumulator [2] were found (Figure 19 and Plate 6). The feature was founded upon a square concrete base at 1.28m OD of which only one full dimension, 5.2m SW-NE, was seen. Upon the base was a structure built of stock-moulded unfrogged brick, formed to be circular (approximately 13m diameter) in plan on its external edge but stepped and polygonal-shaped internally. This arrangement formed an internal chamber with a diameter of approximately 3.2m, which was lined in at least one area with a timber beam. At the centre of the structure was a cast iron plate, 2.0m in diameter and ¼ inch thick. At four opposing sides of this plate survived vertical threaded bolts, to which the uprights of the accumulator would have attached. On the NE and NW sides two rolled girders sat horizontally to overlap with the structures masonry surround. Their function is unclear but may have either stabilized the structure or served to attach it to ancillary structures. The girder at the NE side was seen to rest at its NE end on another concrete slab or pier base. Curving around the accumulator on its north and east sides was found a curvilinear pipe cut [259], which retained a small iron pipe close to the accumulator. It is possible that this was mechanism for feeding the accumulator, but this remains speculation. Accumulators first came into use in the 1850s although there is no evidence for one on this site until 1894, when it is first seen in an Ordnance Survey map (Figure 18).

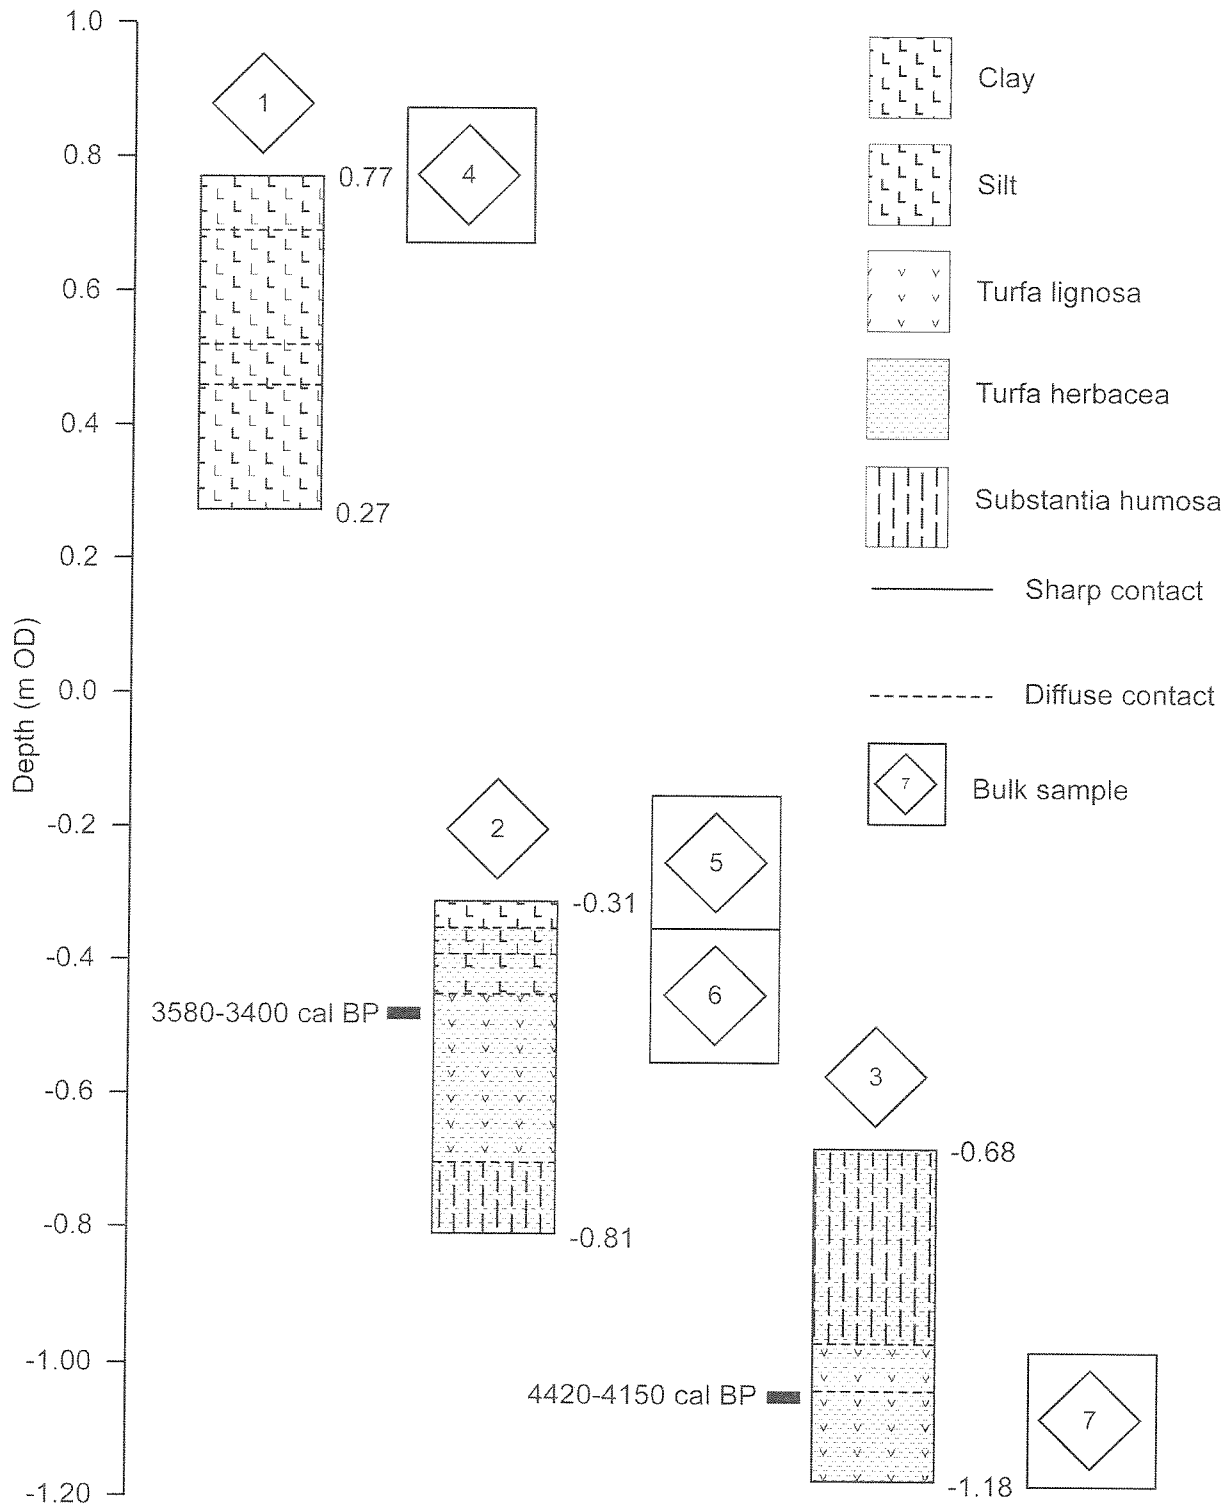
Figure 1: Lithostratigraphy of column samples <1>, <2> and <3> obtained from Former Millwall Iron Works, Westferry Road, London Borough of Tower Hamlets (WYM07)

At the base of the trench, natural sands were recorded in the field by Pre-Construct Archaeology Ltd between -1.25m and -1.18m OD. These sands were overlain by wood and herbaceous peat (c. 60% organic matter; Tables 2, 3 and 4; Figures 1, 2 and 3) between -1.18m and -0.35m OD (context [17]). These sediments most likely indicate the transition from a moderate to high energy fluvial system to semi-terrestrial peat formation. This transition may have been brought about by: (1) a decrease in the rate of relative sea-level rise, or (2) by a change in local factors, such as the natural lateral migration away from the site of a river channel creating a back-swamp area. Between -0.45m and -0.35m OD, there is a gradual change in lithostratigraphy, indicated by decreasing organic matter content from ca. 65% to 30% (Tables 3 and 4; Figures 1 and 3). This transition from context [17] to [16] is suggestive of an increase in bog surface wetness, decreased stability and eventual fluvial inundation of the peat surface (indicated by the deposition of clay-rich sediments above -0.35m OD). This environmental transition may have been caused by one or more of the following: (1) an increase in the rate of relative sea level rise (see Sidell *et al* 2000; Haggart 1995; Devoy 1979; 1982); (2) a change in the proximity of the river channel noted above i.e. its lateral migration towards the site, and (3) human activity on the dry land, such as woodland clearance, causing increased surface runoff onto the floodplain surface. These mineral rich alluvial sediments continued to accumulate until c. 1.00m OD (contexts [16] and [15]; Tables 3, 4 and 5; Figures 1, 3 and 4), and were overlain by made ground deposits (context [14]) according to the field records made by Pre-Construct Archaeology Ltd.

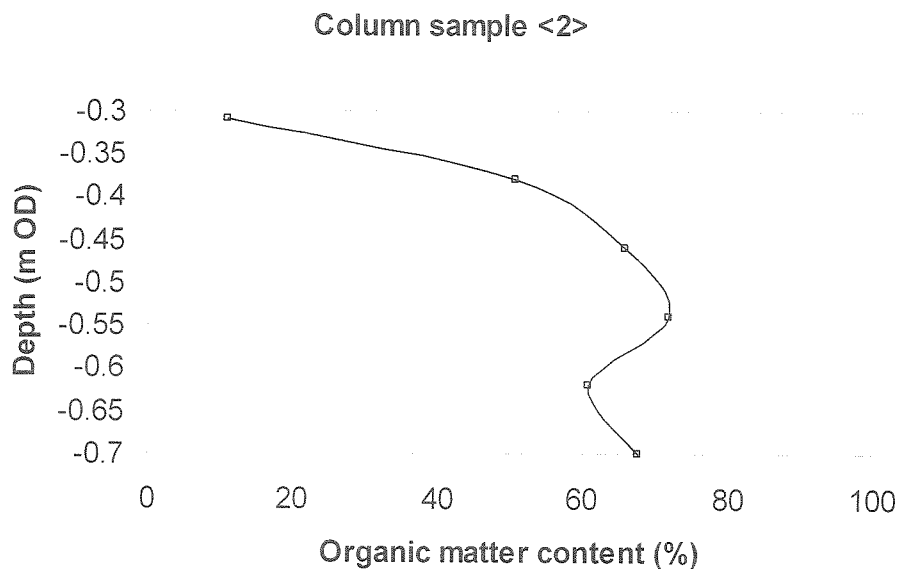
Figure 3: Organic matter content of column sample <2>

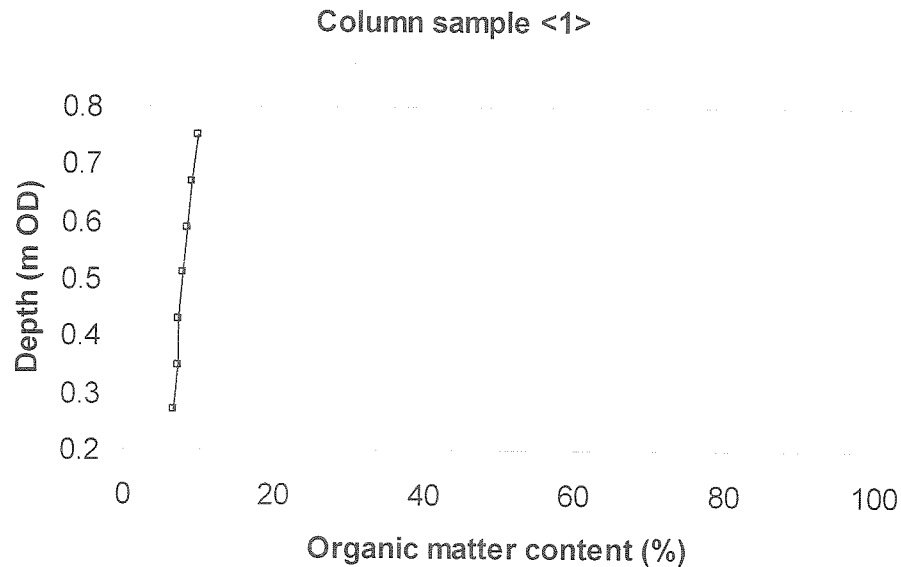
Figure 4: Organic matter content of column sample <1>
