**An Archaeological Watching Brief at Ferry House, Riverside,  
Twickenham, London Borough of Richmond upon Thames.**

**Site Code: FRH08**

**Written by Stuart Watson**

**Pre-Construct Archaeology Limited, November 2008**

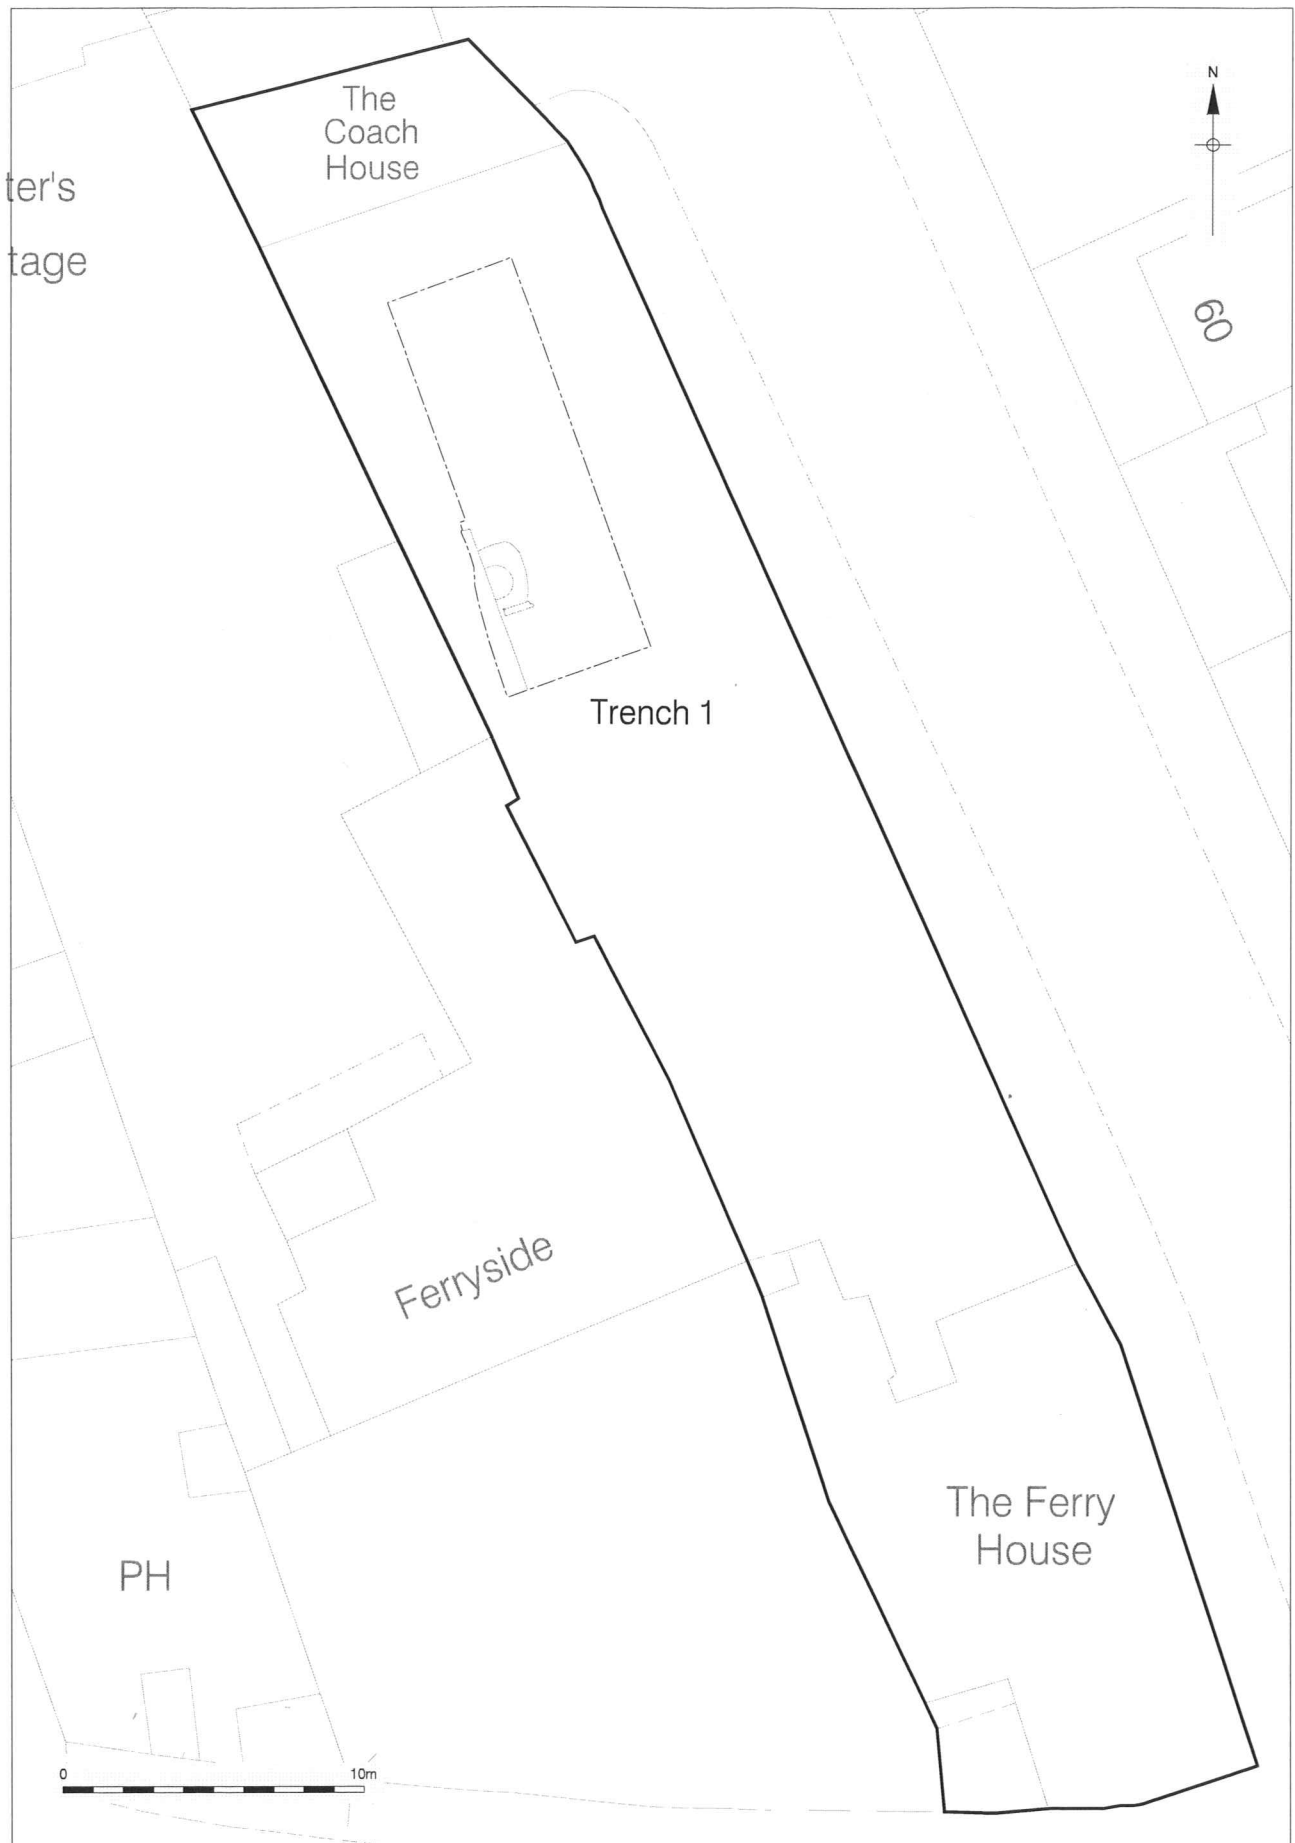
Figure 2  
Trench Location Plan  
1:250 at A4

- 6.2 The study area was located in the grounds of Ferry House, approximately 24m north of the rear of the property. One trench, representing the footprint of the proposed pool, was excavated and the dimensions are as follows: 13.52m north-south by 4.35m east-west, giving a total excavated area of 58.81m<sup>2</sup>.

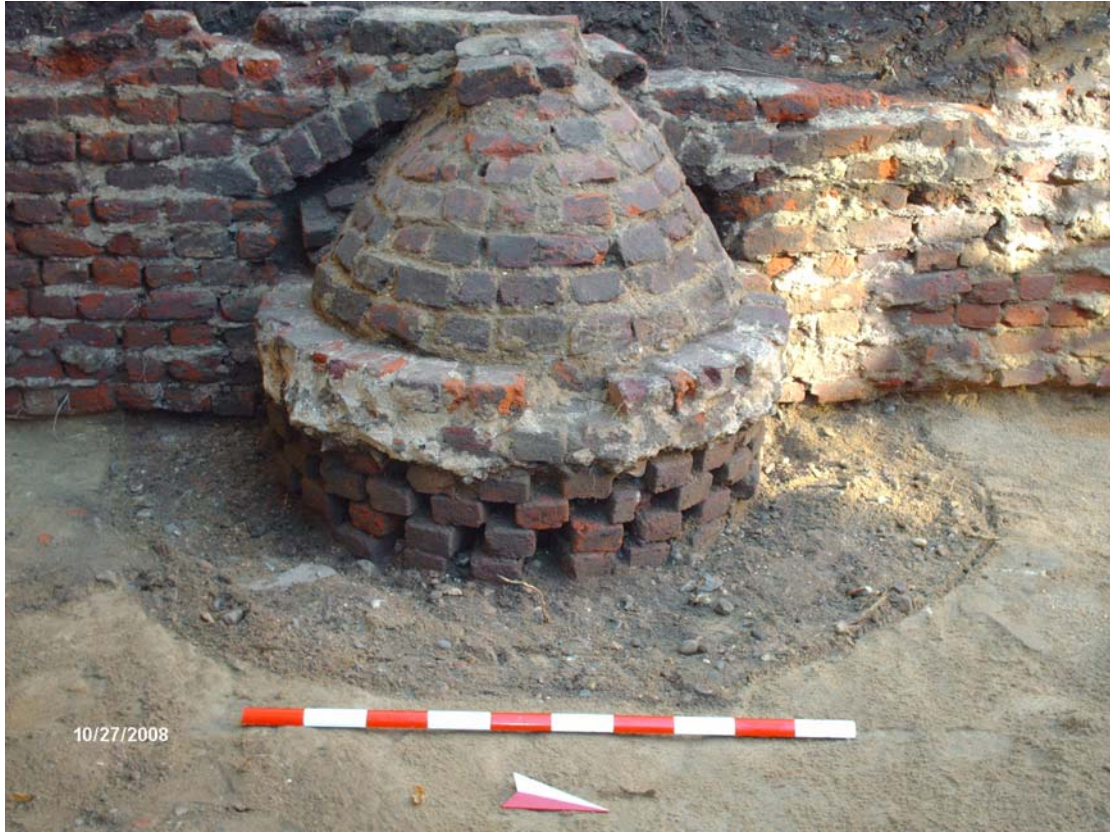
Figure 5. West facing view of wall [6], well [12] and capping [7] (structure No 11). Scale is 1.00m

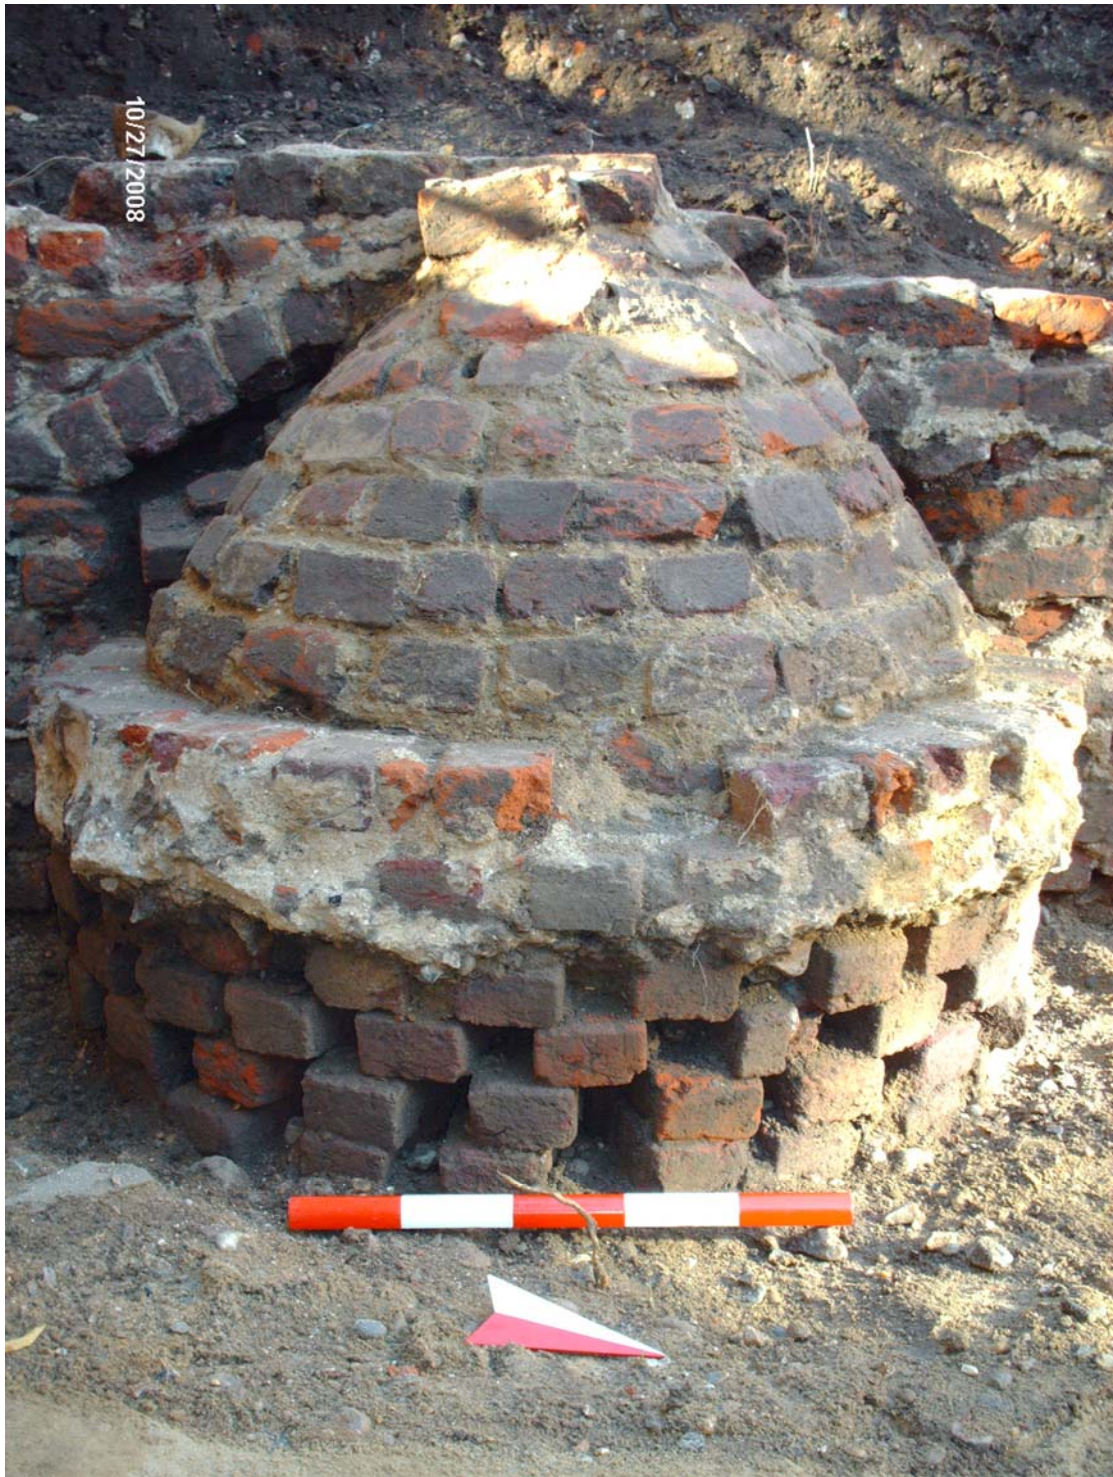
Figure 6. West facing view of well [12] and capping [7]. Scale is 0.5m

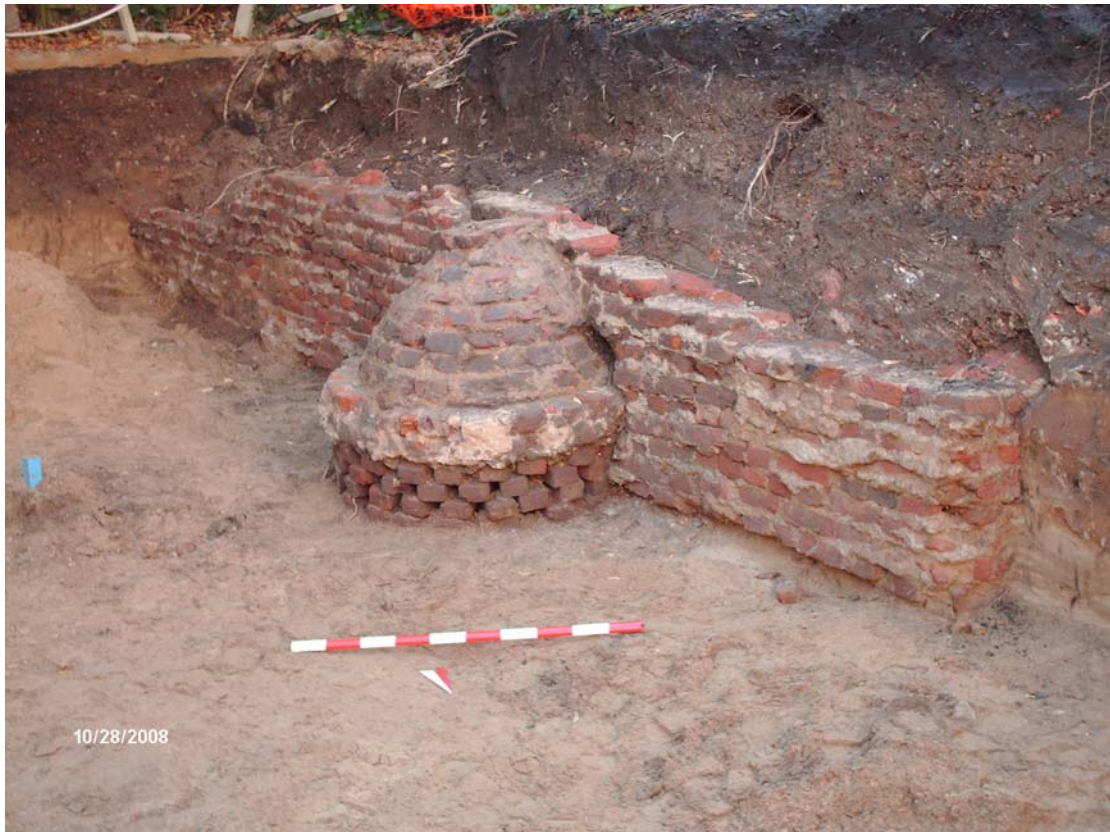
Figure 7. South West view of structure [11]. Scale is 1.00m

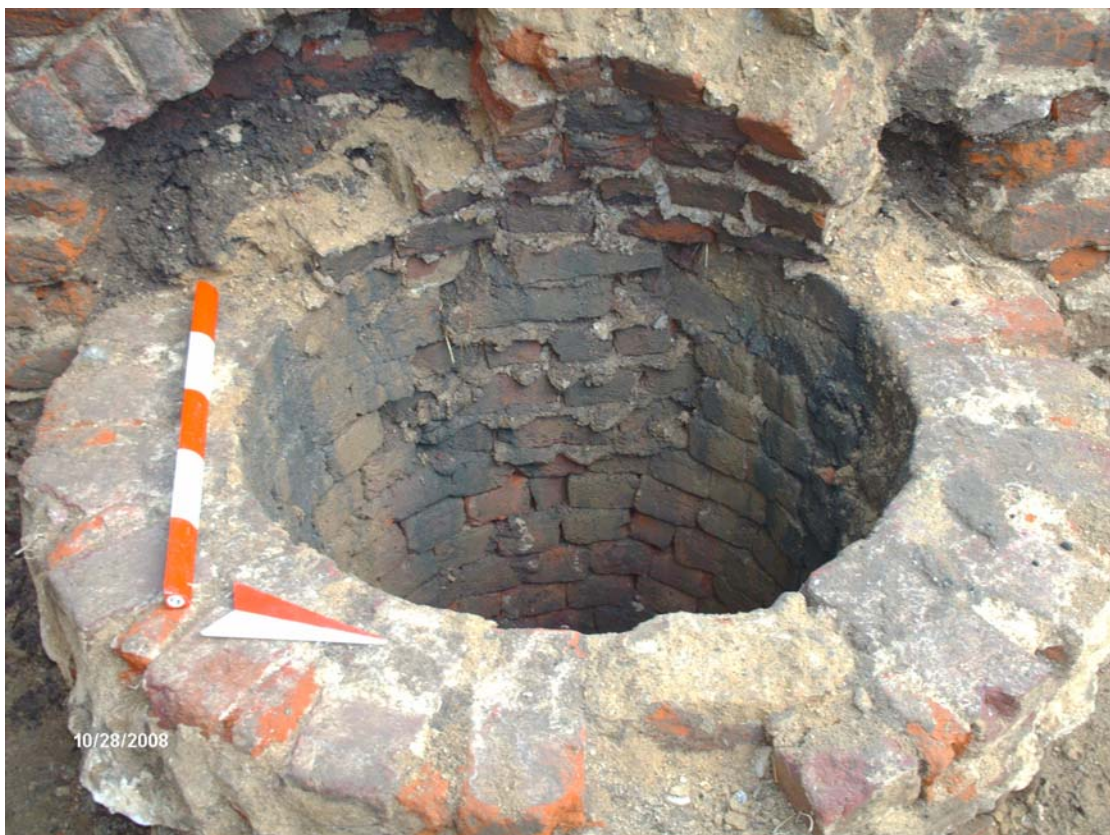
- 7.9 After the removal of the brick cap [7], the brick lining of well [12] was observed to continue down to a depth of at least 2.10m from the base of [7], to c.3.30mOD (Figures 8 & 9). The well had not been backfilled, was dry, and the base appeared to be the natural sand [10].

Figure 8. West facing view of opened well [12]. Scale is 0.5m

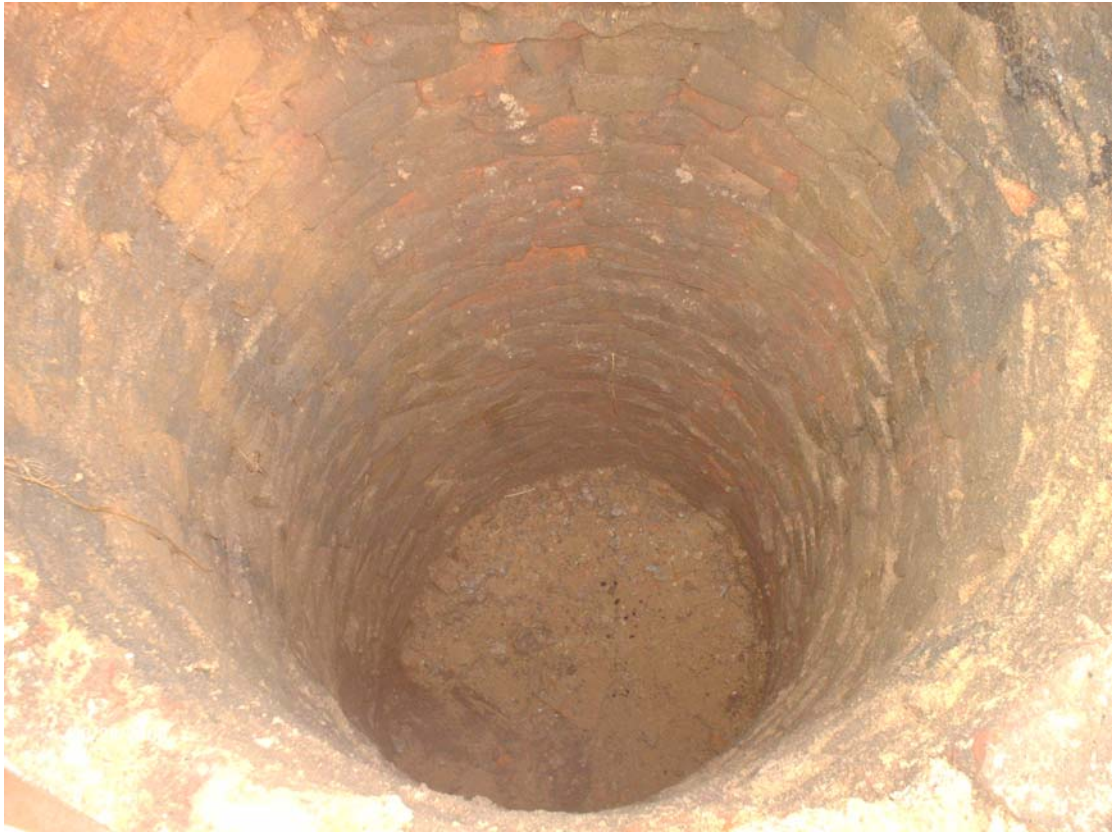
Figure 9. East facing view of interior of well [12].
