**LAND AT MANOR HOUSE,
RIDING MILL,
NORTHUMBERLAND**

**ARCHAEOLOGICAL
EVALUATION REPORT**

AUGUST 2022

Site Code: RMN22

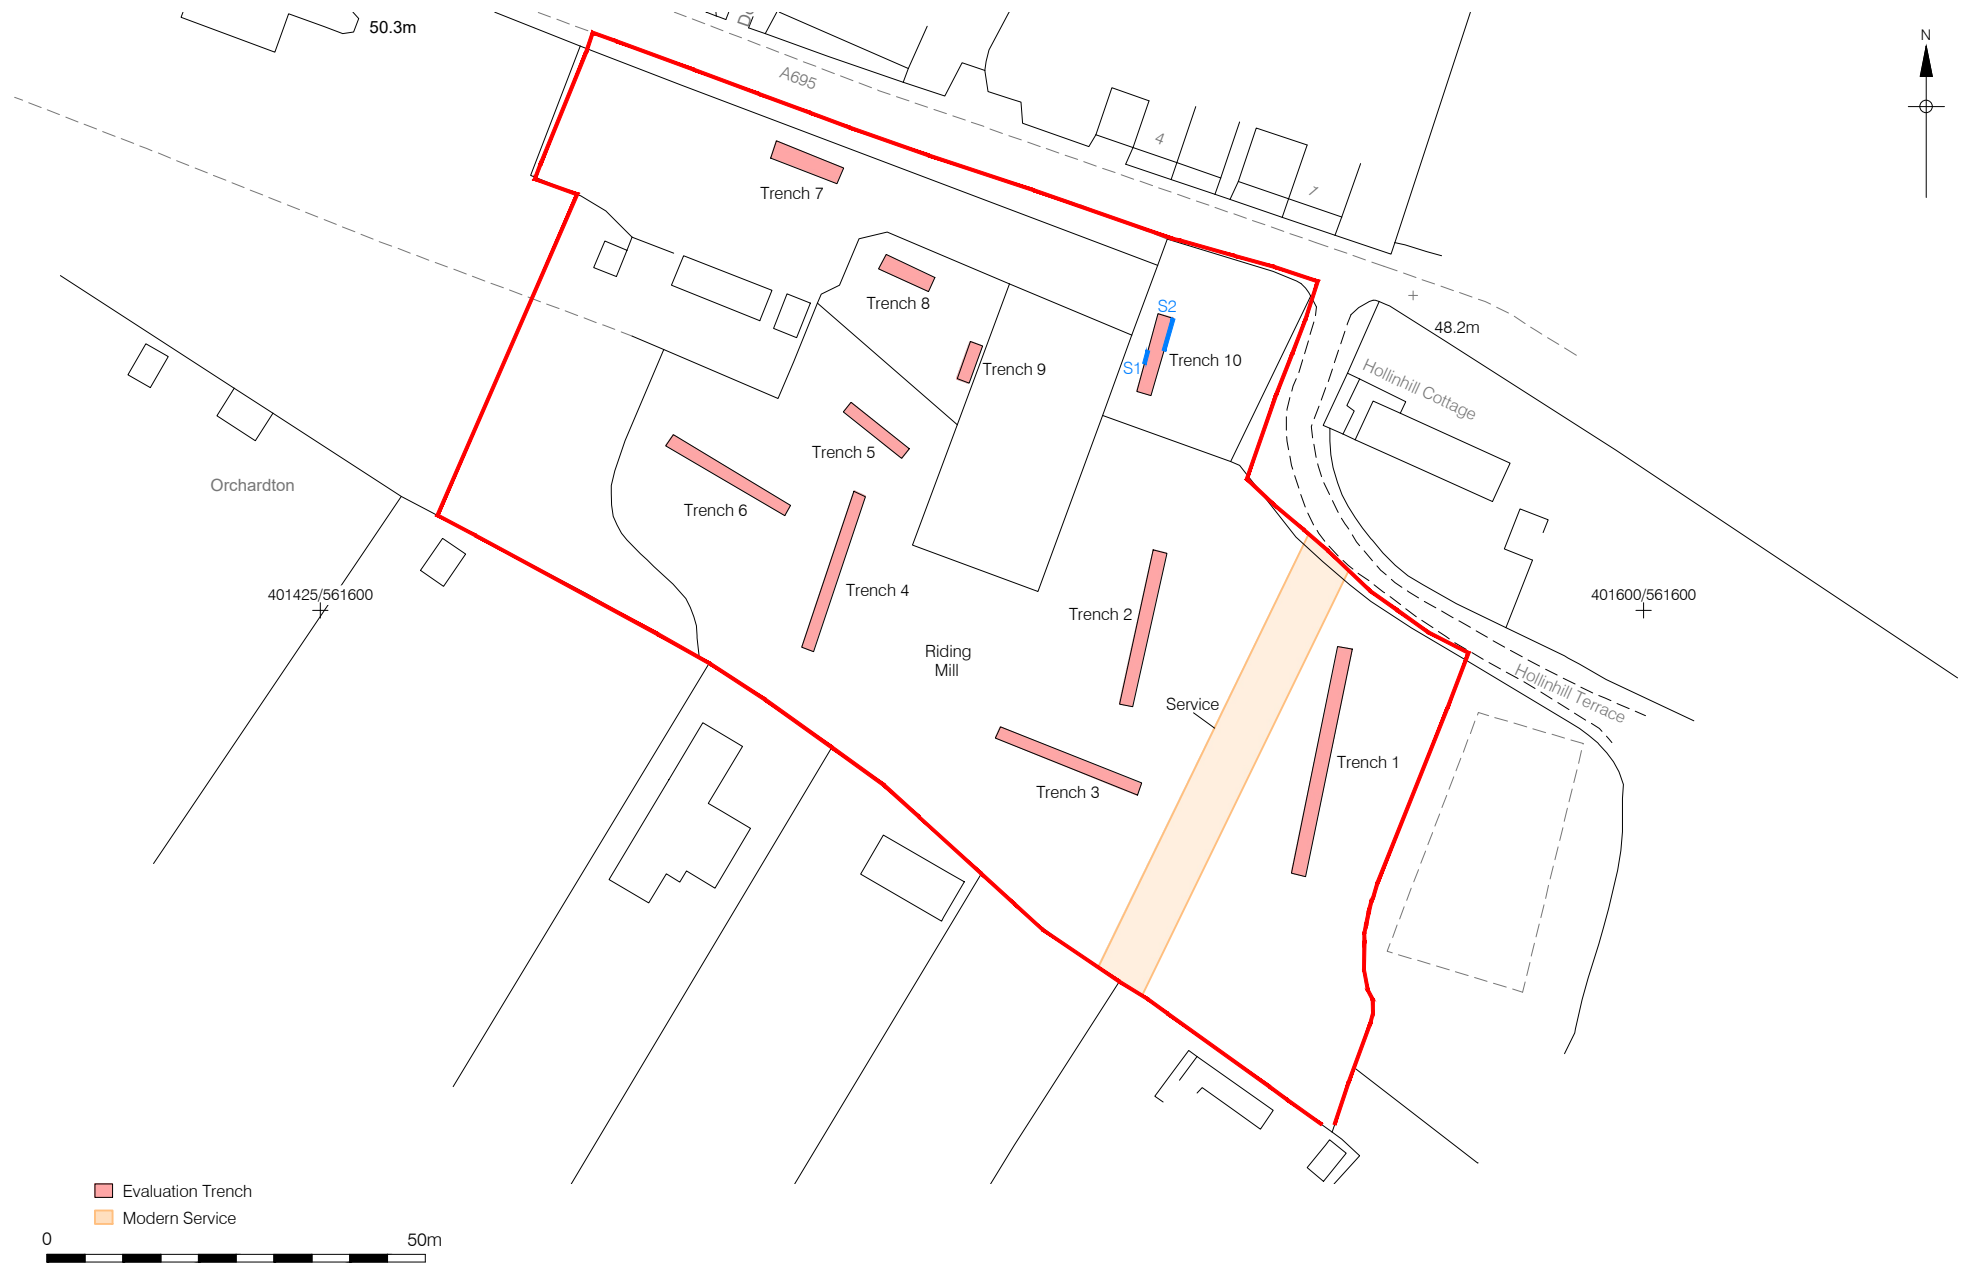
Figure 2
Detailed Site Location
1:1,000 at A4

- 4.1.5 The archaeological evaluation comprised the mechanical excavation of ten trial trenches (Trench 1-10). The trial trenching evaluation was undertaken according to a Written Scheme of Investigation prepared by PCA and approved by Northumberland County Council prior to the commencement of work. Ten trenches (Trenches 1-10) were excavated across the proposed development area where this would aid in assessing the archaeological potential of the site and meet the project aims and objectives (Figure 2). All trenches were excavated in full at their proposed locations.

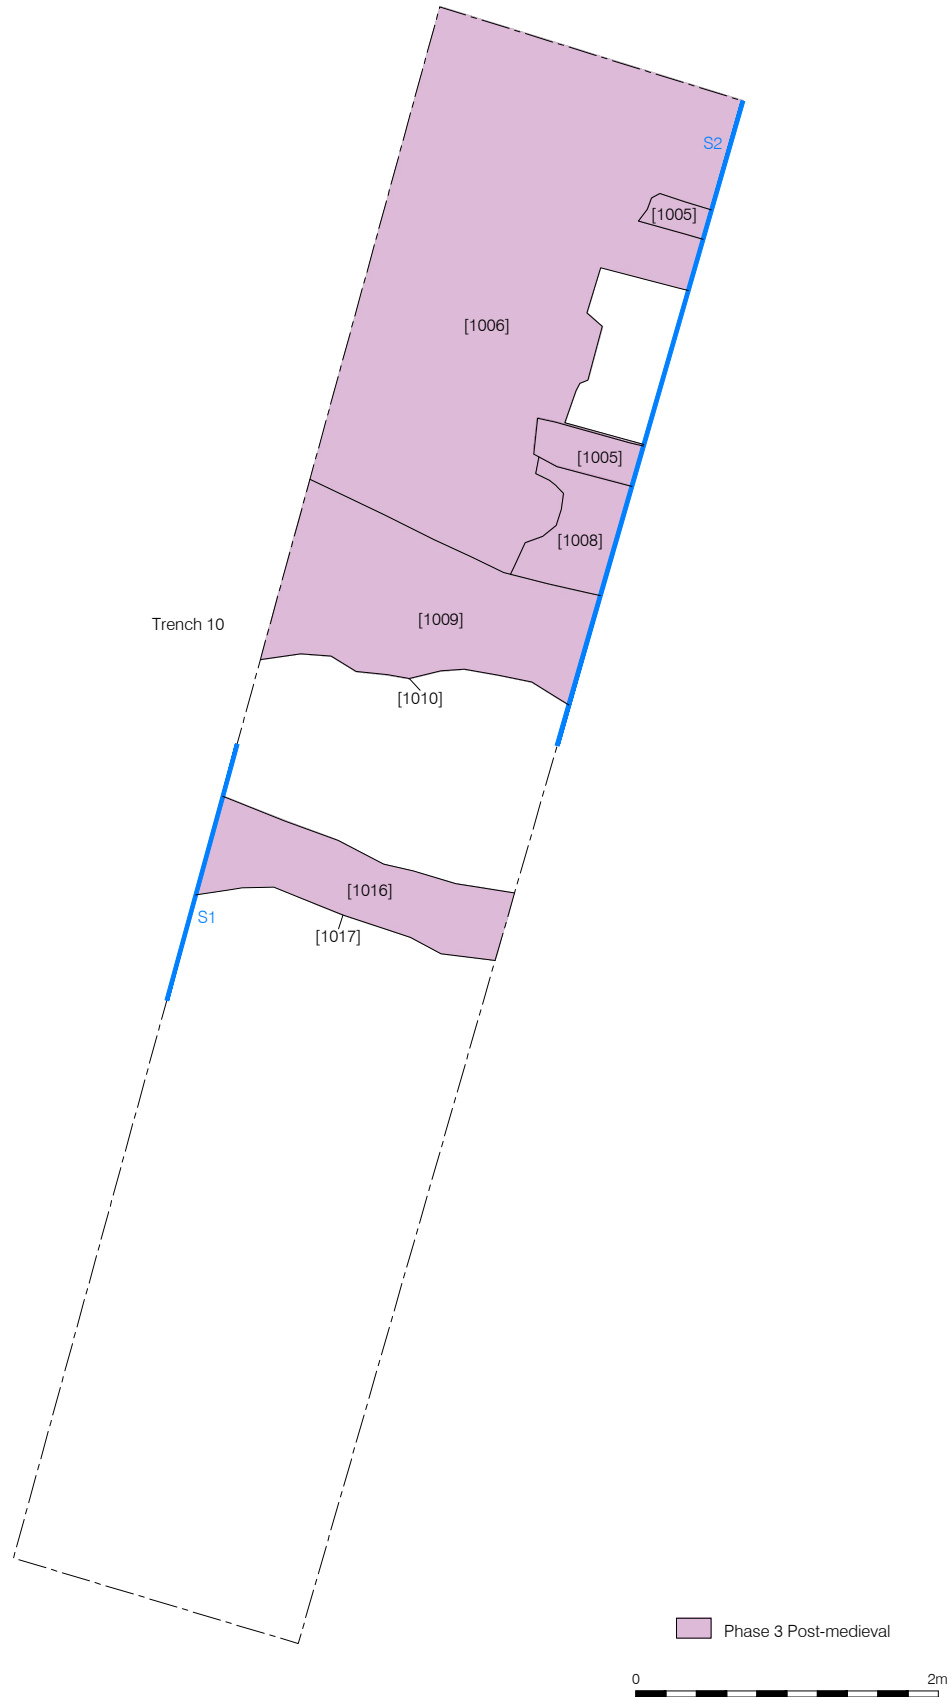
NE 51.46m OD SW 51.46m OD

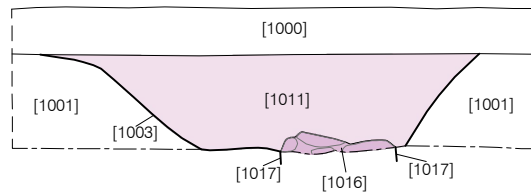
Section 1
Southeast Facing
Trench 10

SW 51.37m OD NE 51.37m OD

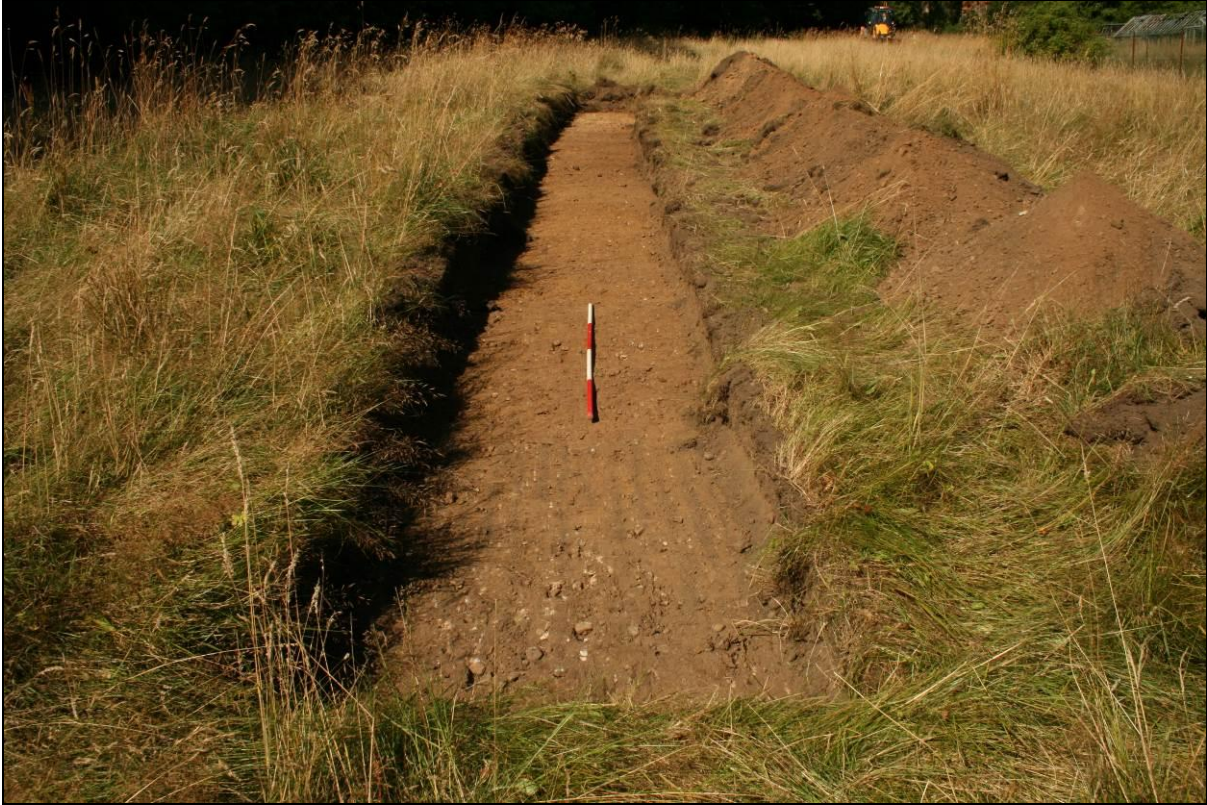
Plate 1: Trench 3, North direction of view, 2m scale.

5.5.4 Topsoil, [100], [200], [300], [400], [500], [600], [700], [800], [900] & [1000], comprised loose, dark grey, clayey sand with very frequent small stone inclusions (Plates 1-6).

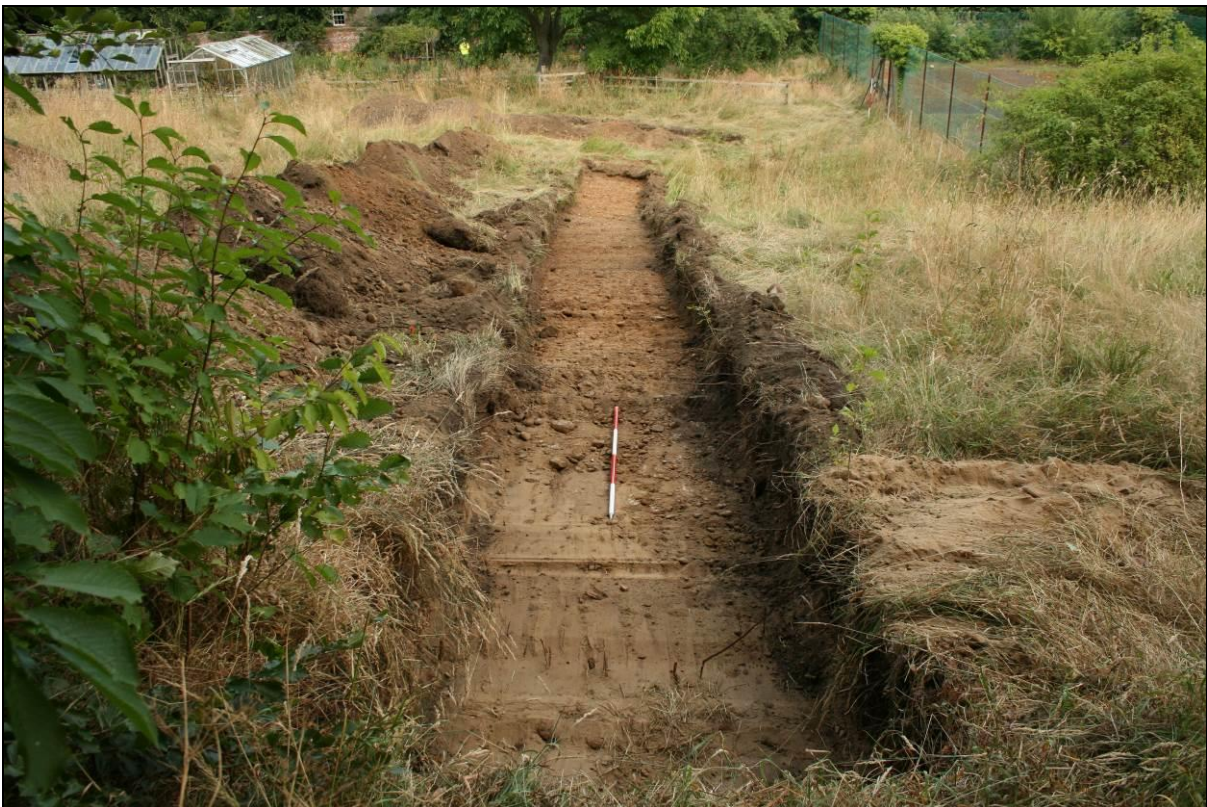
Plate 2: Trench 4, North direction of view, 2m scale.

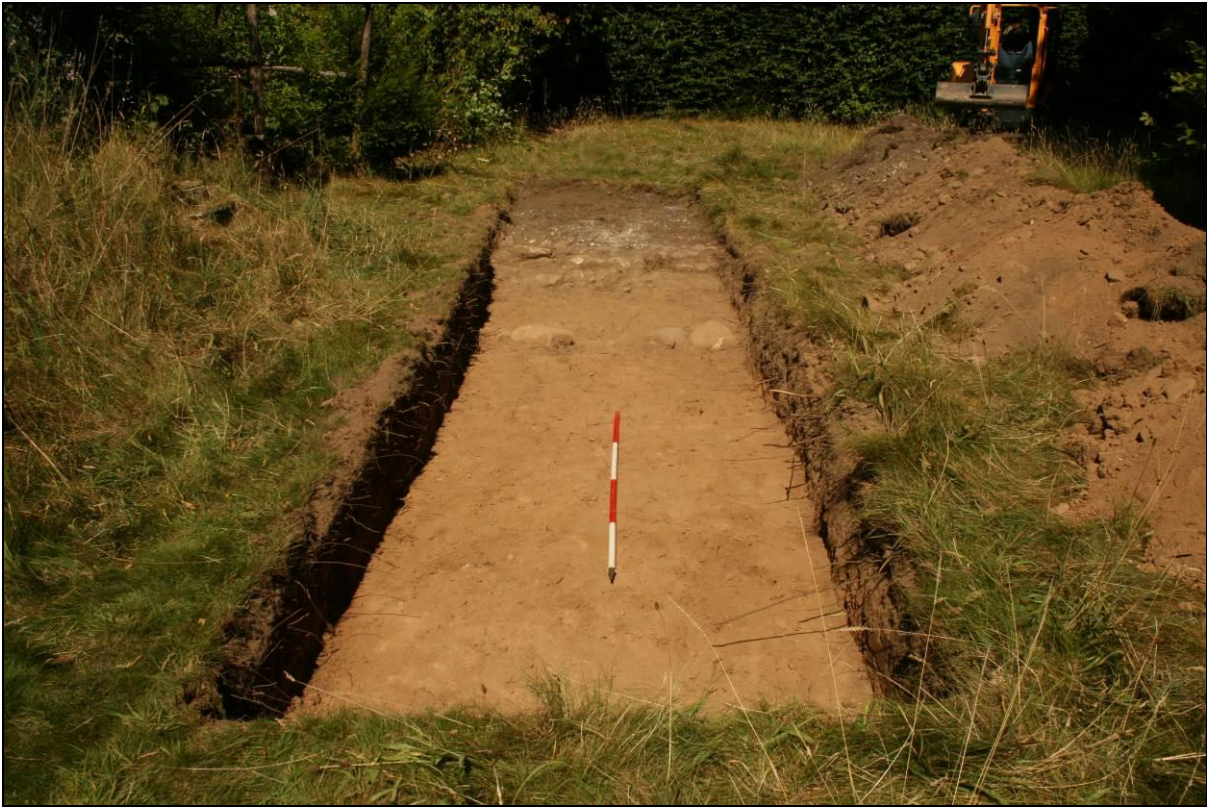
Plate 3: Trench 10, North direction of view, 2m scale.

- 5.2.1 Subsoil was only encountered in Trench 10 and comprised loose, reddish brown sandy clay [1001], encountered at maximum and minimum heights of 51.29m AOD and 50.84m AOD, respectively (Plate 3). No artefactual material was recovered from deposit [1001].

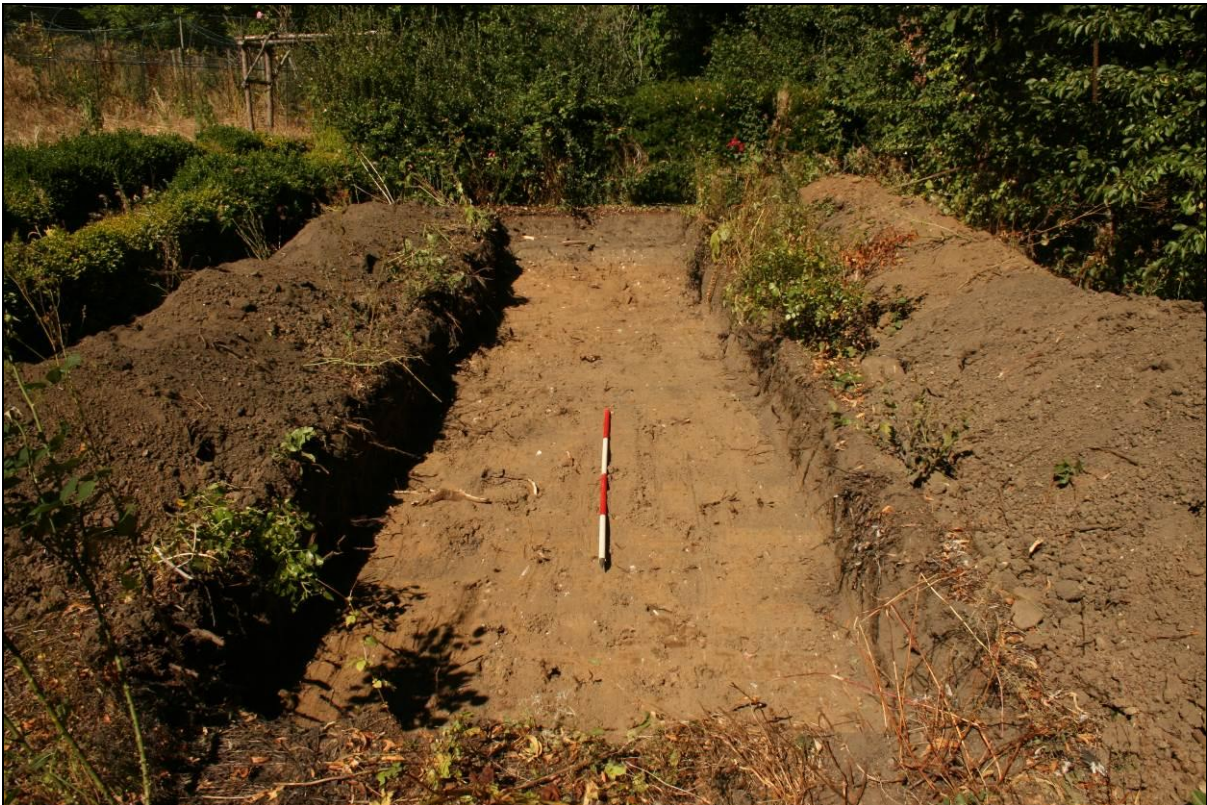
Plate 4: Trench 7, West direction of view, 2m scale.

5.5.2 A levelling deposit recorded extending across Trench 7 comprised loose, dark reddish brown clayey sand [701] up to 0.20m thick, encountered at maximum and minimum heights of 50.61m AOD and 50.39m AOD, respectively. This deposit probably represents cultivation activity within the formal garden area (Plate 4).

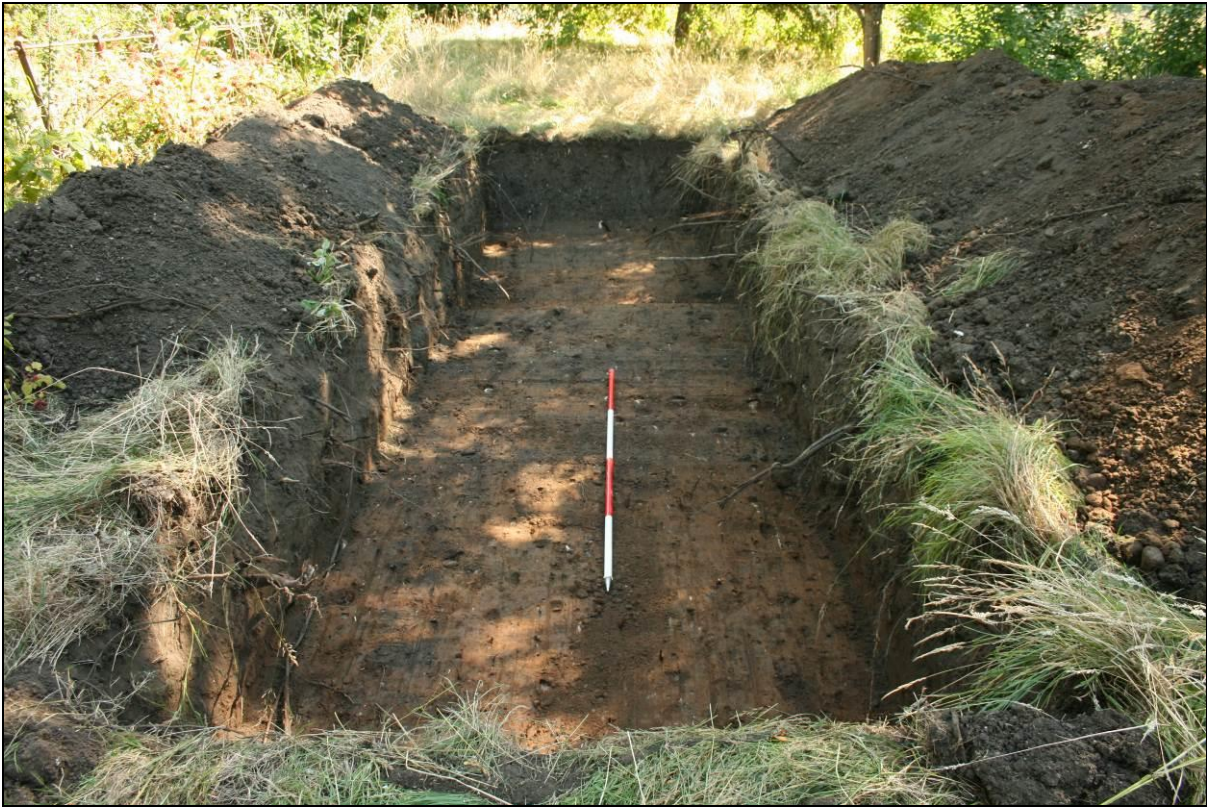
Plate 5: Trench 8, East direction of view, 2m scale.

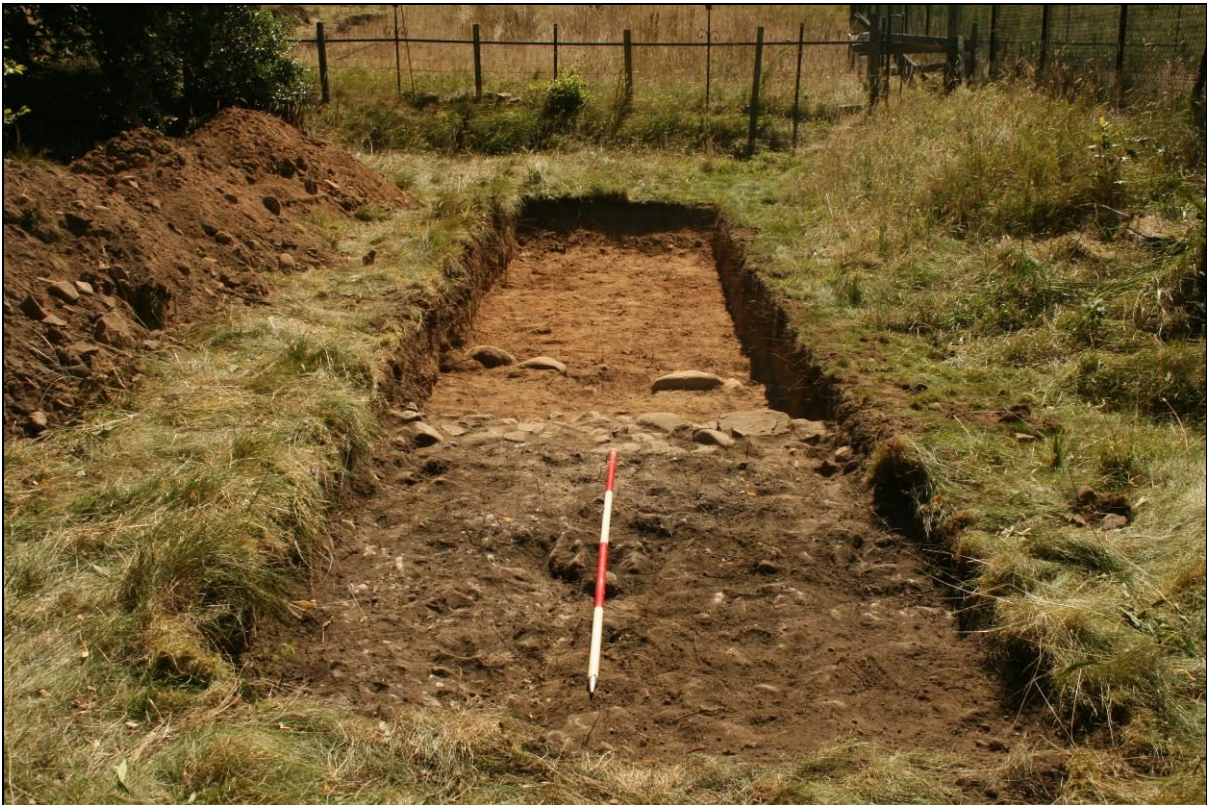
Plate 6: Trench 10, SSW direction of view, 2m scale.

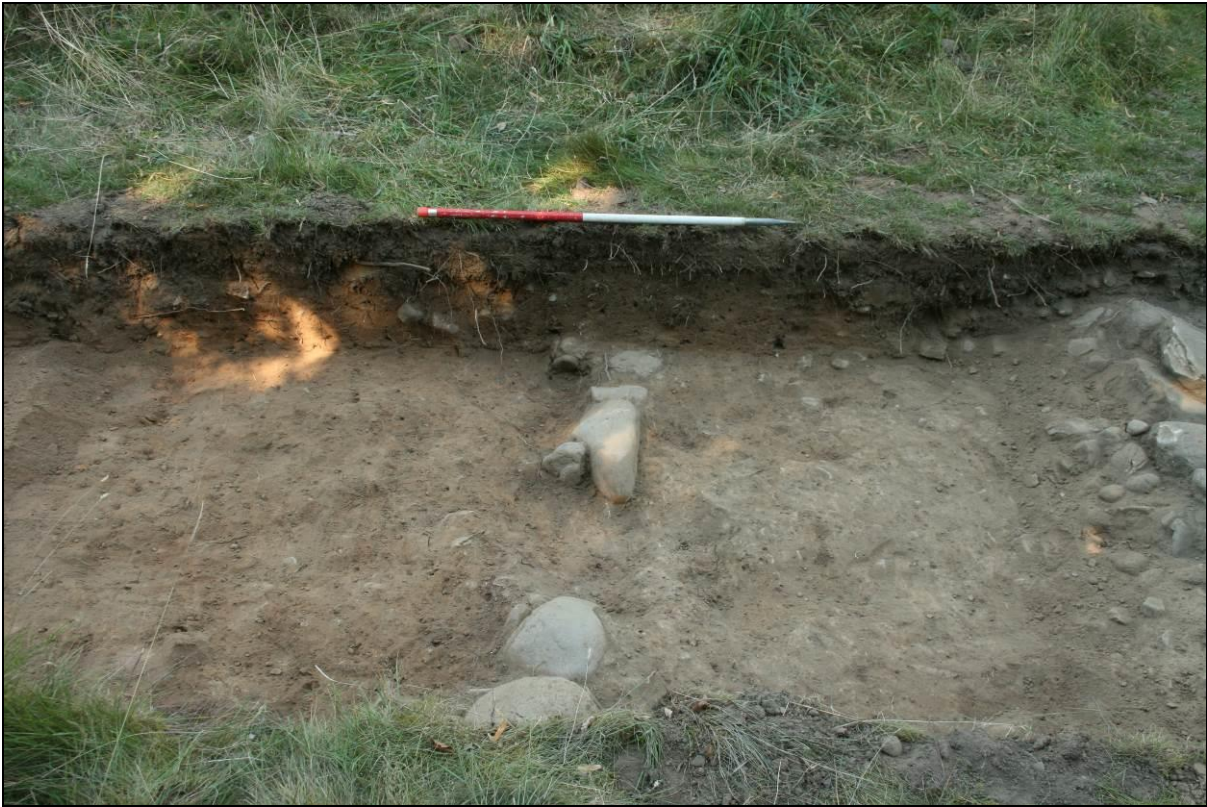
Plate 7: Trench 10, NE facing section of robber trench [1003] and wall [1016], 1m scale.

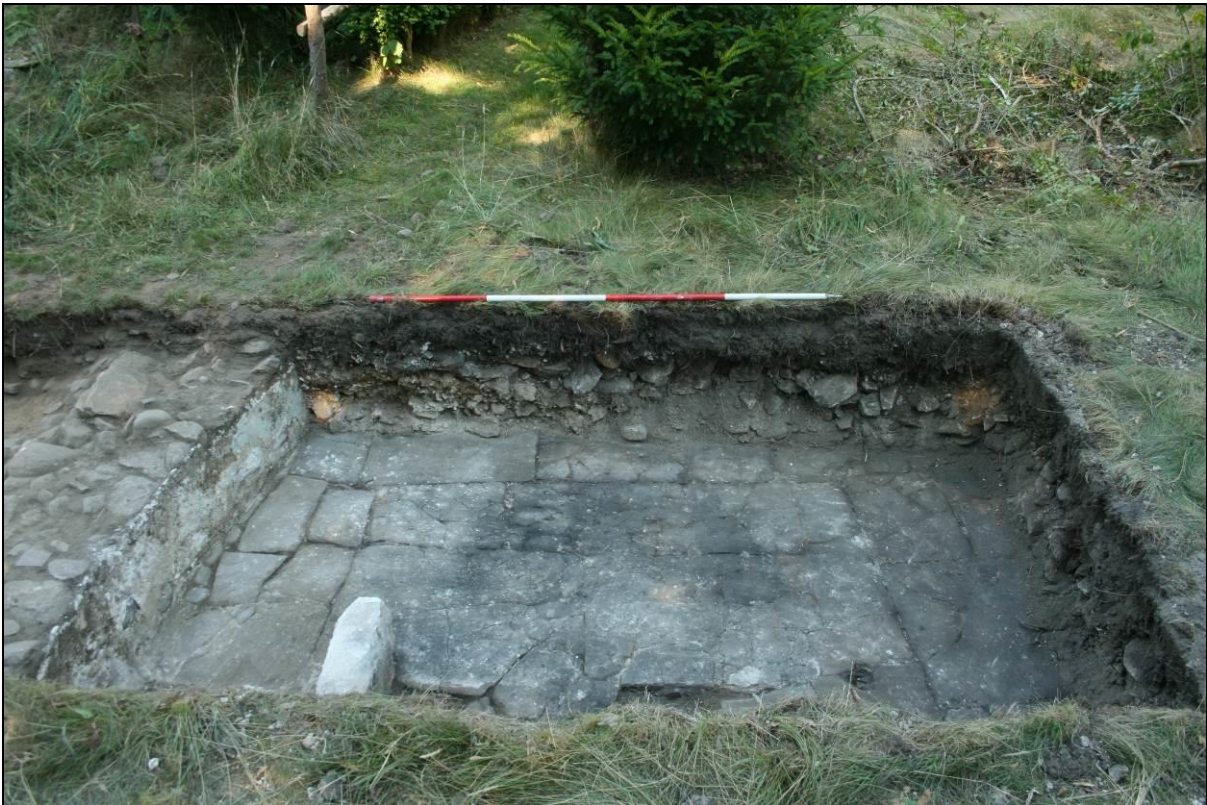
Plate 8: Trench 10, ESE facing section showing demolition deposit [1004], 2m scale.

- 5.4.2 A demolition deposit [1004] up to 0.36m thick, recorded at the NNE end of Trench 10, was exposed for a maximum area of 3.40m NNE-SSW by 2m ESE-WNW and was encountered at maximum height of 51.06m AOD (Figure 4, Section 2; Plates 6 & 8). It comprised small to medium sized cobbles and subangular stones within a loose mid grey sandy silt matrix and contained patches of broken/crushed lime mortar and fragments of red brick. The masonry material observed in the demolition deposit comprised primarily of stone and lime mortar that was probably derived from the walls of the building. No material was observed in this deposit that could be attributed to the roof structure, such as tile or slate, suggesting it may have been a thatch roof building. A small assemblage of post-medieval finds was recovered

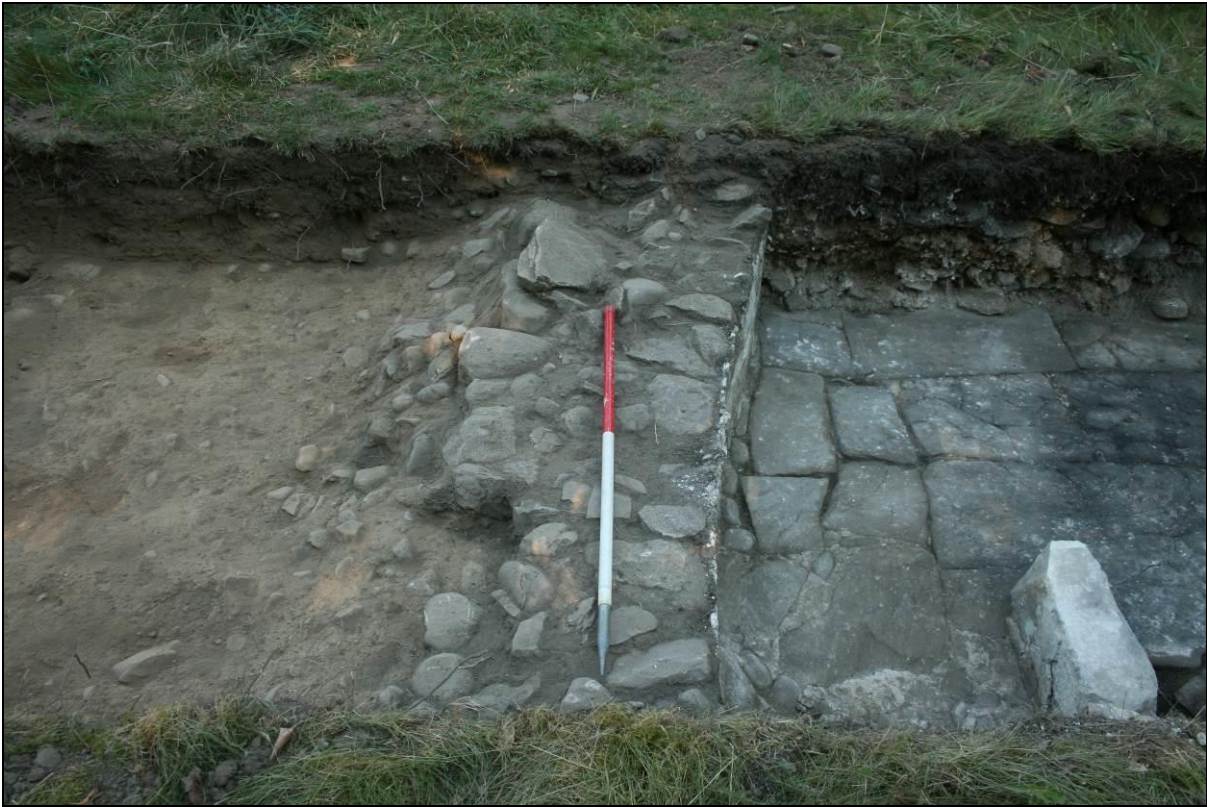
Plate 9: Trench 10, WNW direction of view showing external wall [1009], 1m scale.

- 5.3.3 External WNW-ESE oriented wall [1009] was exposed for a distance of c. 2m (Plates 9 & 10). It was up to 1.20m wide by at least 0.42m high, encountered at a maximum height of 51.09m AOD. The wall itself was built using a combination of medium to large sized cobbles (maximum 300mm x 300mm x 200mm) and small to large sized unworked subangular stones (maximum 310mm x 290mm x 110mm) bonded with firm dark reddish brown sandy clay. The internal elevation of wall [1009] was covered by c. 10mm thick light grey lime mortar render [1015] that had surviving remnants of light blue paint to the WNW part of the exposed walls elevation (Plate 15).

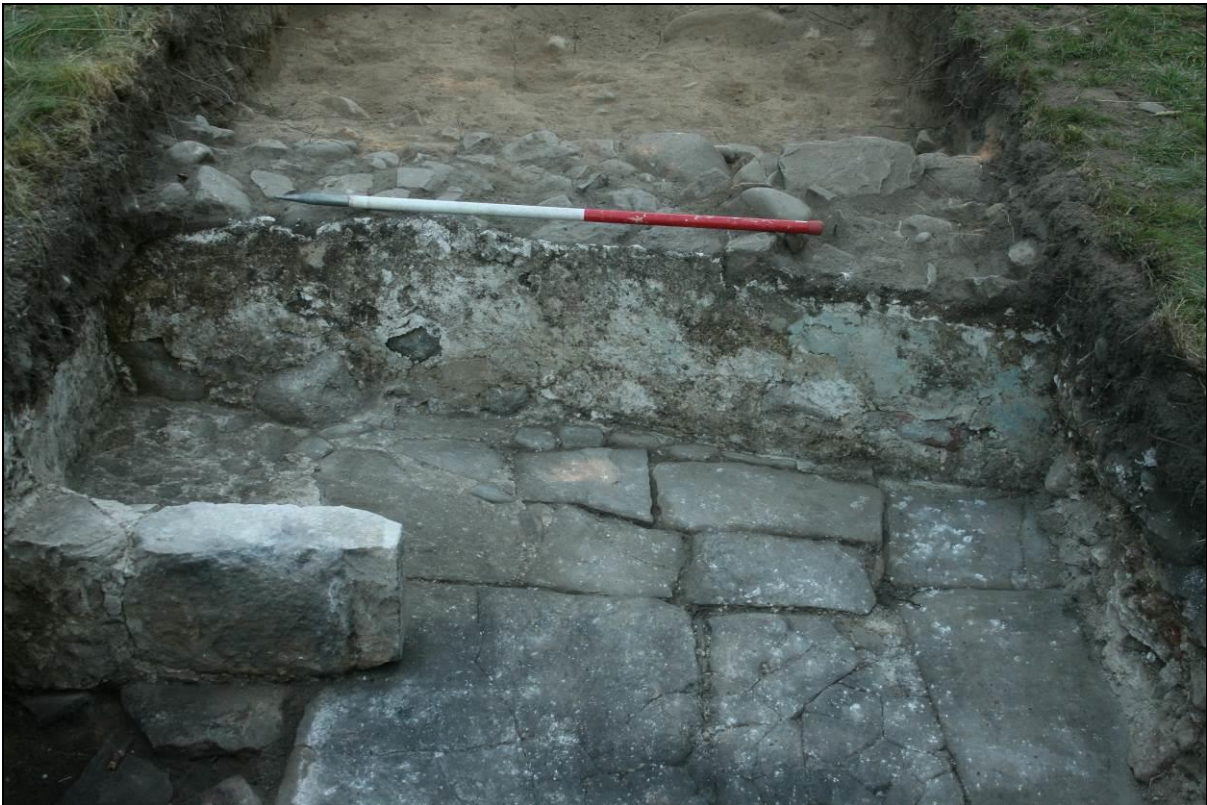
Plate 10: Trench 10, NNE direction of view showing wall [1009], 0.5m scale.

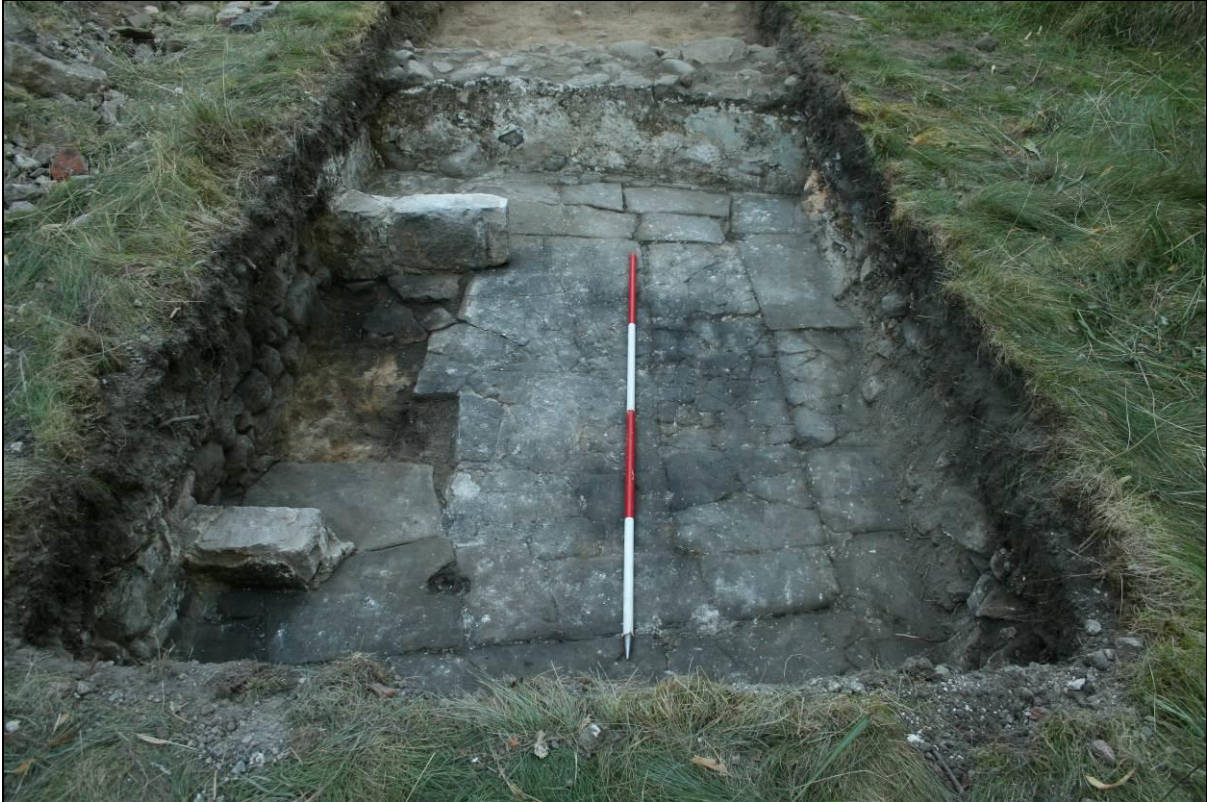
Plate 11: Trench 10, SSW direction of view showing stone flag surface [1006] and hearth/fireplace [1005], 1m scale.

- 5.3.6 The remains of the hearth/fireplace [1005] directly overlay stone flag surface [1006] and comprised two stone-built walls c. 1.40m apart (Plates 11 & 12). Both hearth/fireplace walls abutted wall [1012] and were similarly constructed using large roughly hewn stone blocks (maximum 650mm x 230mm x 250mm) bonded with light grey lime mortar. The external elevations of both hearth/fireplace walls were covered in the same light grey lime mortar render [1015] that covered walls [1009] and [1012]. Also observed was an extensive area of soot covering the stone flag surface [1006] adjacent to the location of the heath/fireplace (Plate 11). The soot covers an area of c. 1.50m WNW-ESE by 1.40m NNE-SSW and probably represents an area that was used for the raking out of ash from the heath/fireplace.

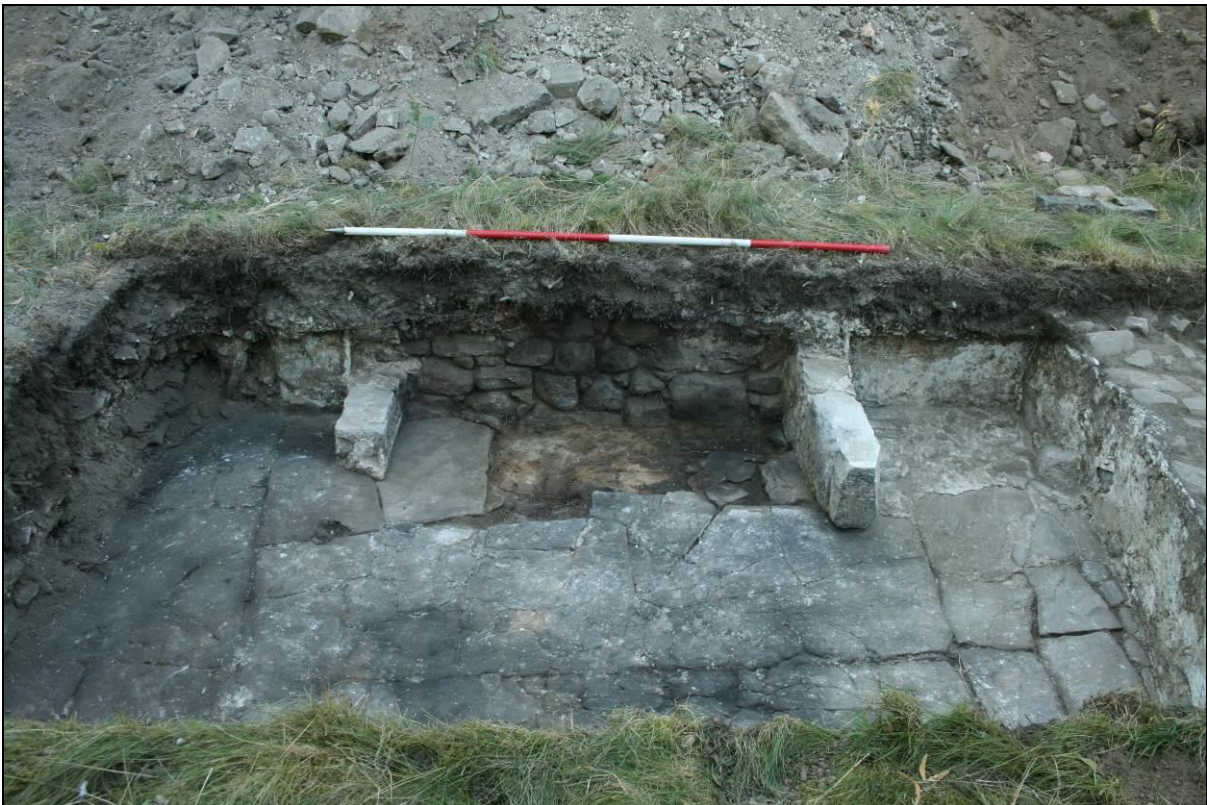
Plate 12: Trench 10, ESE direction of view showing stone flag surface [1006], hearth/fireplace [1005] and wall [1012], 2m scale.

- 5.3.4 Wall [1012], orientated NNE-SSW, was only partially exposed along the ESE limit of Trench 10 and was 2.90m long and survived up to 0.64m high (Figure 4, Section 2; Plate 12). The width of the wall was not established. The NNE & SSW parts of the wall were covered by light grey lime mortar render [1015]. The remains of a hearth/fireplace [1005] was recorded abutting the central part of wall [1012], therefore, there was no lime mortar render applied to the wall at this location and the exposed masonry here was covered in a thick soot. The wall, [1012], was built using unworked and roughly hewn medium to large cobbles and subangular stones (minimum 40mm x 40mm - maximum 600mm x 400mm) bonded with firm dark reddish brown sandy clay. This wall probably represents an internal wall to the building. An entrance to a room to the ESE was observed within the north-eastern corner of the trench formed by the end of wall [1012] and the continuation of the stone flag surface [1006] to the ESE.

- 5.3.7 Located between the SSW hearth/fireplace wall [1005] and the external wall [1009] was a cobble and lime mortar surface [1008] that had dimensions of up to 0.79m NNE-SSW by 0.61m ESE-WNW (Plate 12). This surface probably represents a later repair to the stone flag surface [1006].
