**AN ARCHAEOLOGICAL EVALUATION AT
THE FORMER RAWMARSH DAIRY,
CLAYPIT LANE, RAWMARSH,
ROTHERHAM, SOUTH YORKSHIRE**

**An Archaeological Evaluation at the Former Rawmarsh Dairy, Claypit Lane,
Rawmarsh, Rotherham, South Yorkshire**

Site Code: CLR 03

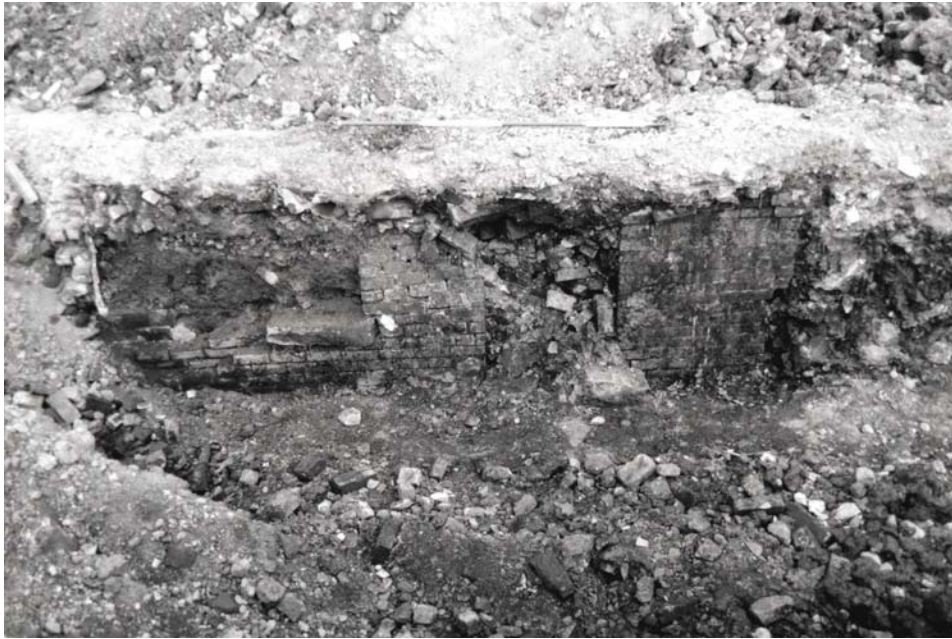
Plate 1. Trench 1, Structures [2] and [5] in section (*2m scale*).

- 7.1.2 The earliest archaeological remains recorded in this trench were structural remains of 19th century buildings. To the west, within the south-facing section of the trench, were two brick walls, [2] and [5], comprising yellow, unfrogged firebricks, possibly of local manufacture (Plate 1). Both structures were aligned east west and did not appear to continue to the south. Wall [2] measured 2.90m east-west and survived to a height of 1.40m. It had an opening, presumably the location of a former window, with part of a large lintel surviving. This measured 0.70m x 0.10m x 0.30m and was made of the same firebrick material as the rest of the structure (Appendix 3). Stone tiles faced the internal north-south wall at the western end of the structure. Structure [5] was located c. 0.85m to the east of structure [2], the gap presumably representing the location of a former door. This brickwork measured 1.10m east-west and survived to a height of 1.42m, at c. 41.50m OD. These structural remains are interpreted as parts of the southern wall of the ground floor of the western ancillary building of the Meadow Works (Figure 2).

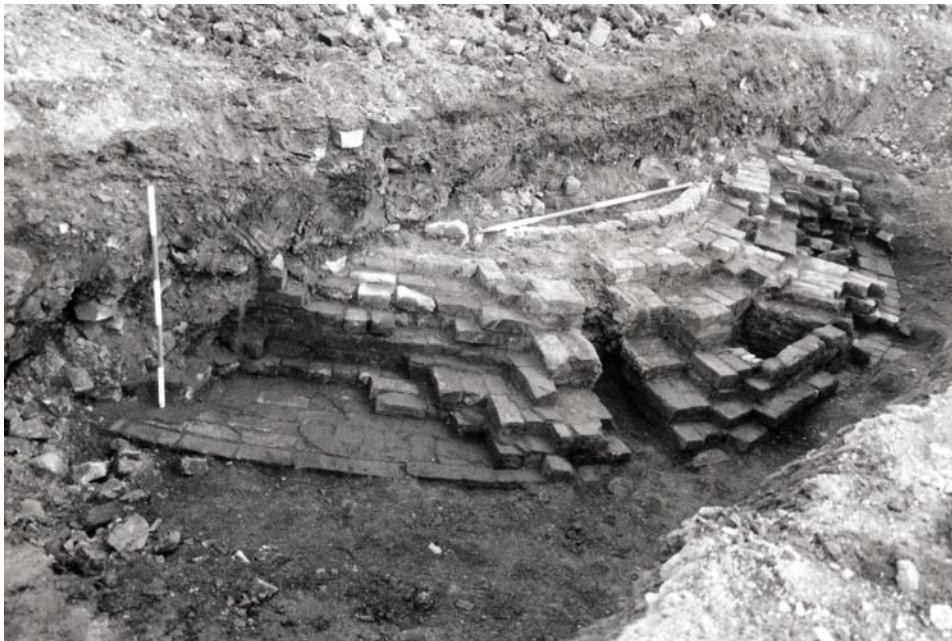
Plate 2. Trench 2, Structure [2] (*1m/2m scale*).

- 7.2.3 The main archaeological feature in this trench was exposed in plan against the northern limit of excavation. It was the southern part of a large circular structure, [12], comprising various phases of brickwork and has been interpreted as the surviving part of one of the circular bottle-kilns of the Meadow Works (Plate 2). The structure was revealed at a maximum height of c. 40.80m OD, c. 0.70m below the existing ground level. The central area of the kiln could not be excavated as only a small part of it was revealed against the limit of excavation

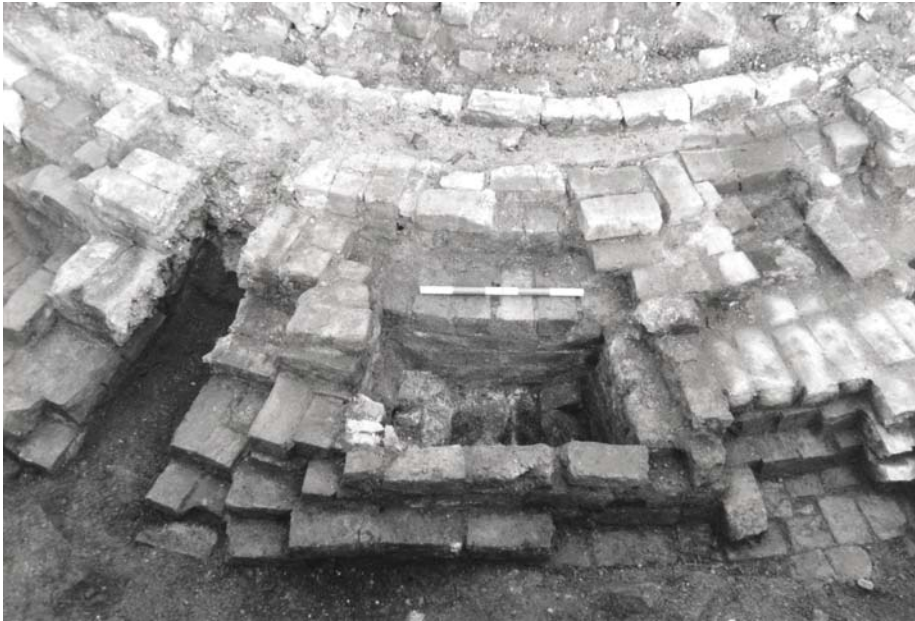
Plate 3. Trench 2, Structure [12], detail of parts [11] and [14] (0.5m scale).

- 7.2.4 The earliest structural element of the kiln was an inner circle of brickwork, [22], which was 0.50m wide and was exposed to a height of 0.50m. The bricks within this part of the structure were hand-made and can be broadly dated to the mid 19th century. To the outside of brickwork [22] was an outer circle of brickwork, [13], again comprising hand-made bricks. This part of the structure was 0.80m wide and it had been constructed directly against the inner, earlier element. A pair of brick 'shafts', [14] and [15], were recorded within the southern and eastern part of brickwork [13]. These were backfilled with demolition rubble and were not fully excavated. Their purpose is unclear, but they may have been for ventilation or temperature control. Shaft [15] may have been incorporated into the structure during construction of brickwork [13] (Plate 4). In contrast, shaft [14] may have been a later addition, as the bricks used for its construction were very soft and generally different in nature to those used for the construction of brickwork 13] (Plate 3).

- 7.2.6 On the south-western edge of the exposed part of the kiln was a brickwork flue, [11], which penetrated both the inner and outer circle of brickwork (Plate 3). While this flue may have been part of the original fabric of the structure, it had certainly been rebuilt at a later date, being constructed of machine-made bricks. The flue was 1.20m in length and survived to a height of 0.40m to the limit of excavation. The aperture was c. 0.30m wide.

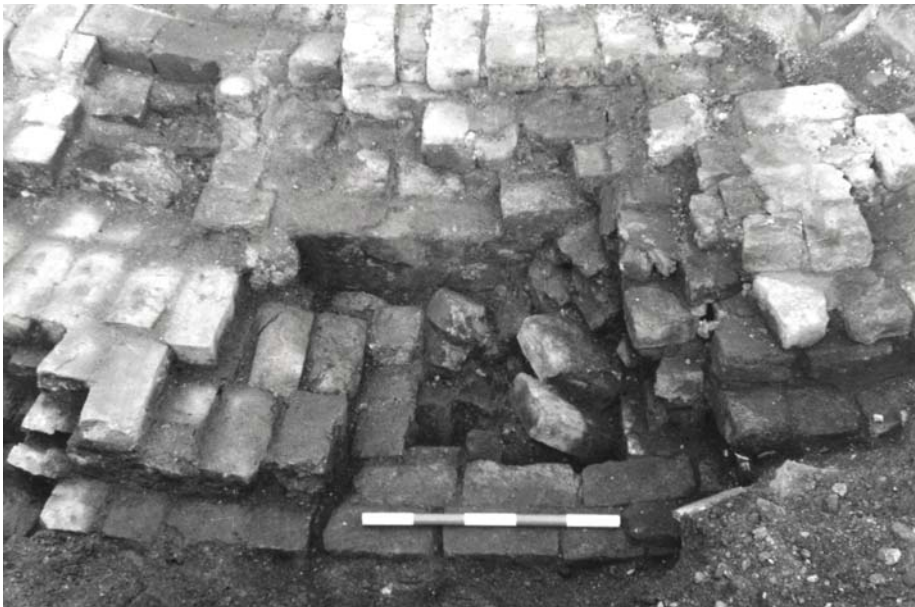
Plate 4. Trench 2, Structure [12], detail of part [15] (0.5m scale).
