SIGNAL BOX, PLATFORM 11, STRATFORD STATION STRATFORD

A REPORT ON THE HISTORIC BUILDING RECORDING

REFERENCE: K1953-HBR-1

**Historic Building Recording of a Signal Box, Platform 11, Stratford Station, London
Borough of Newham**

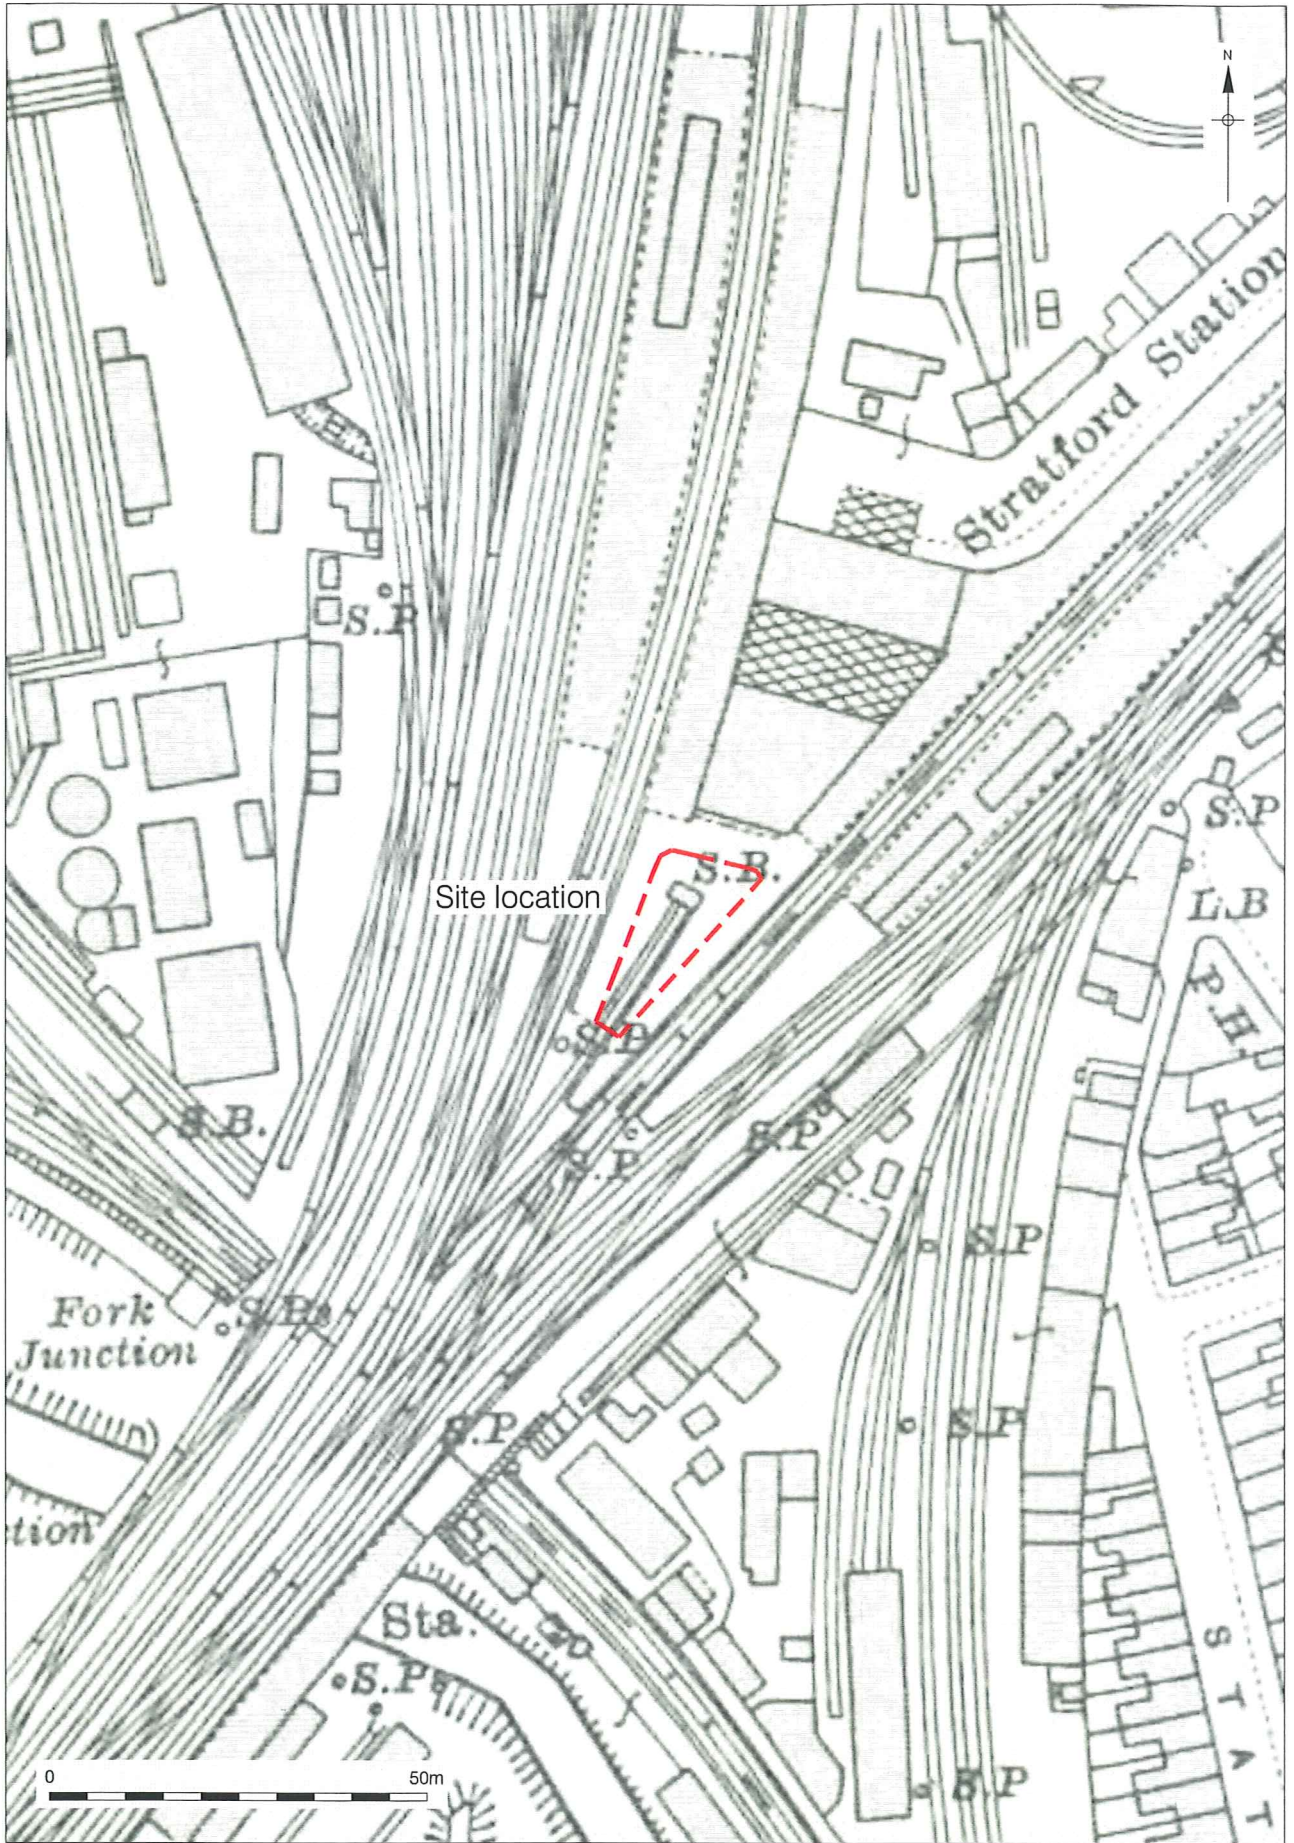
Figure 3
Ordnance Survey map, 1914
1:1000 at A4

5.2.1 Before the construction of the 1947 signal box, the 1914 map (**Figure 3**) shows that the site was occupied by an earlier smaller 19th century signal box.

- 3.6 In February 1939, W.C. French was awarded the contract to demolish the station buildings at Stratford, construct new subways, platforms and retaining walls. The estimated cost at the time was £24,672 13s and 1d. The contract included the demolition of the 19th century signal box, which preceded the signal box which is the subject of this report, on the then platform one. The earlier signal box is labelled 'S.B'. on the 1914 Ordnance Survey map (**Figure 3**).

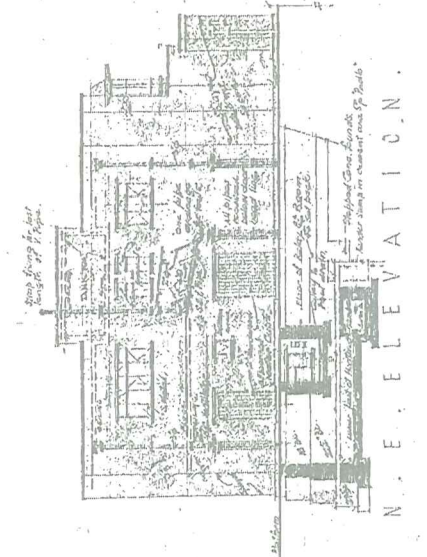
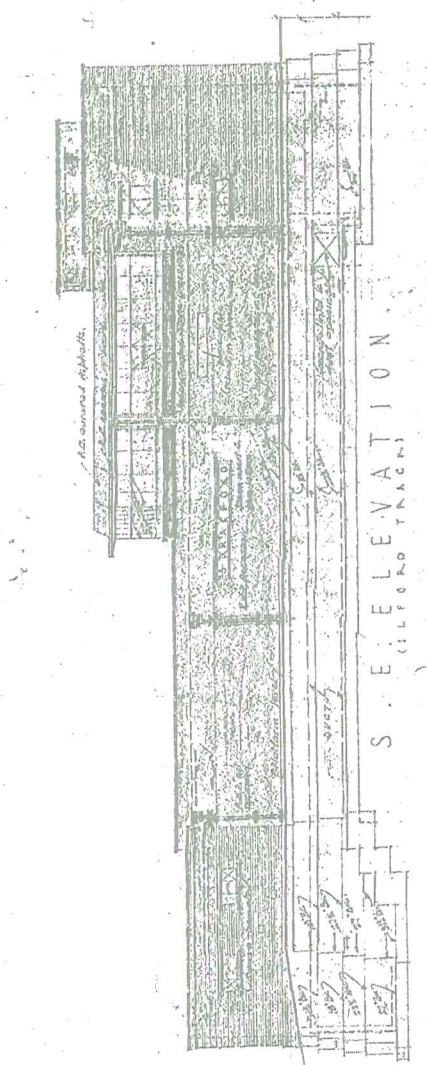
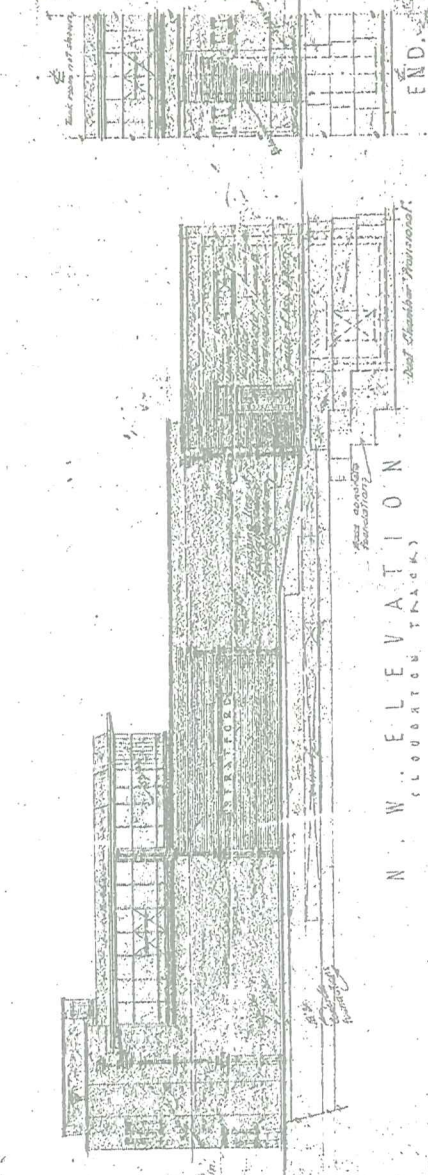
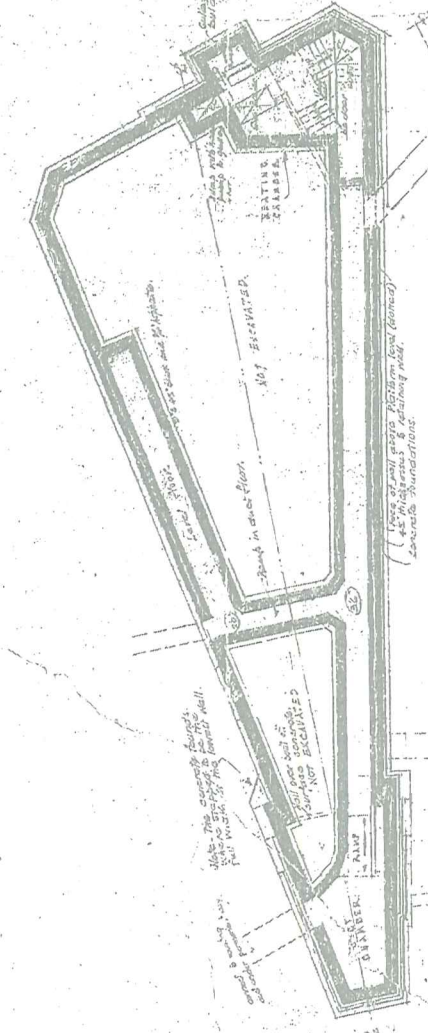
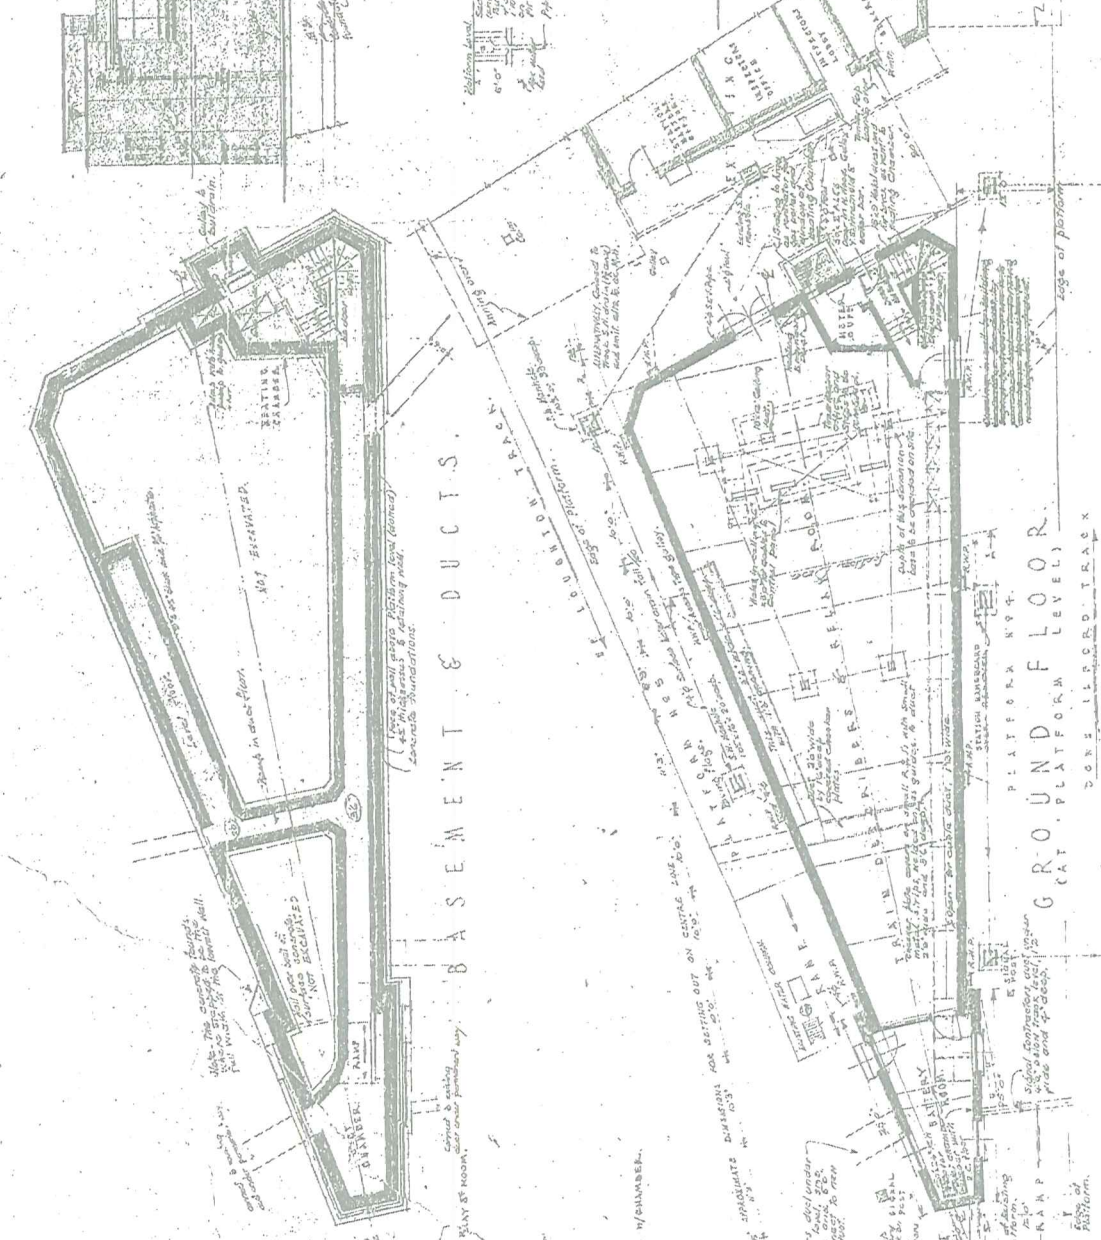
Figure 4
Original Plan and Elevations of building, 1946
not to scale

duct chamber, tank room, signal cabin, mess room and cloak room (**Figure 4**). Fletton and Southwater Engineering bricks with Portland cement were to be used in the construction of the walls and foundations of the building (Rail 390/1363).

5.1.1 It is clear from a comparison of the 1946 proposed drawings of the signal box (**Figure 4**) and the building at the time of the survey that the building was largely unchanged.

5.4.1 The ending of the Second World War allowed the re-building and updating of the station to continue. The signal box was built in 1947 (**Figure 4**) and is shown on the 1951 and 1970 Ordnance Survey maps (**Figure 5** and **6**). The building had the same footprint at the time of the survey apart from the battery room at the southern end which had been removed.

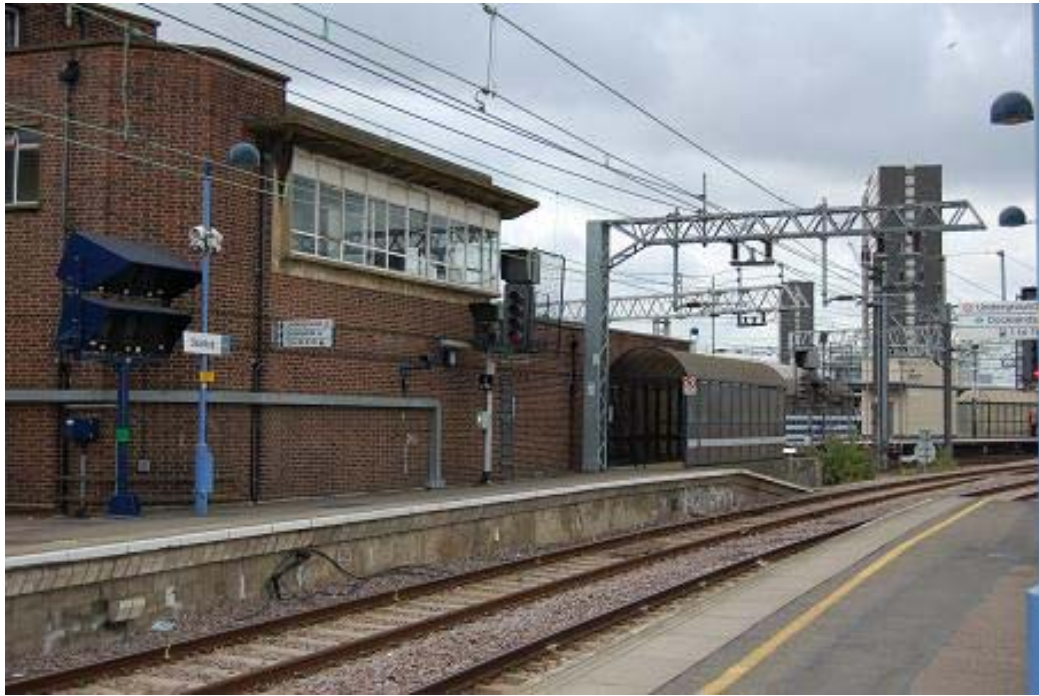
Plate 1: West elevation of signal box

4.2.1 The west elevation faced onto platform 11 (**Plate 1**). There were no windows at ground floor level, with metal framed windows of the signal cabin at first floor level. The concrete roof over these windows acted as a simple sun awning. The flat roof of the signal box was surrounded by a parapet wall, which was capped by concrete coping slabs. A modern metal and glass tunnel, in front of the south end of the signal box, led to a passenger subway under the railway lines. Queen closers (half bricks) had been used to edge corners, including where pipework had been placed in set back brickwork (**Plate 2**), and down the brickwork sides to window openings.

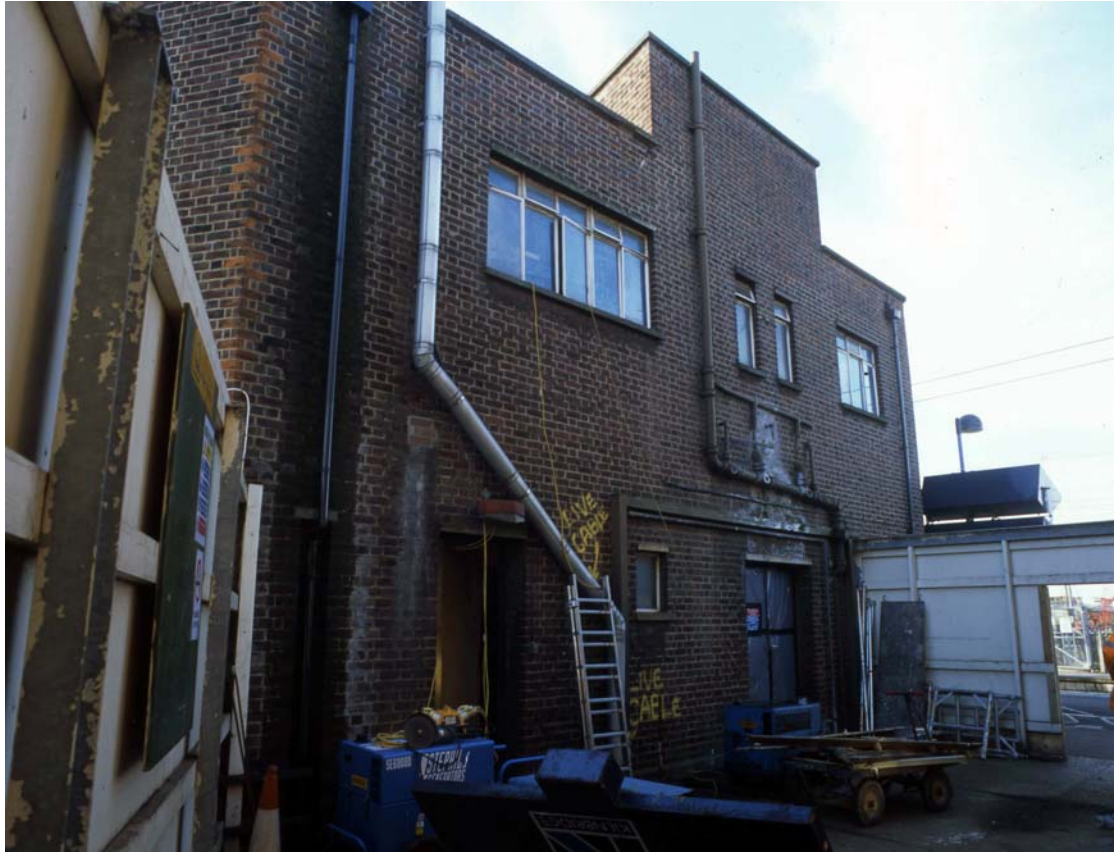
Plate 3: North elevation of signal box

4.2.2 The north elevation (**Plate 3**) faced the southernmost of the 19th century station buildings. A single door with concrete step at the east end of the elevation gave access to a corridor, while a double door in the centre gave access to the relay room. The windows, one at ground floor level and four at first floor level, all had their original concrete sills and lintels. The original metal windows, some of which were fixed while others were opening casements, were still extant at the time of the building recording. Queen closers had been used down the sides of corners and on some of the brickwork edges to window openings. Boxed electrical wiring surrounded the western double door and ground floor fixed window.

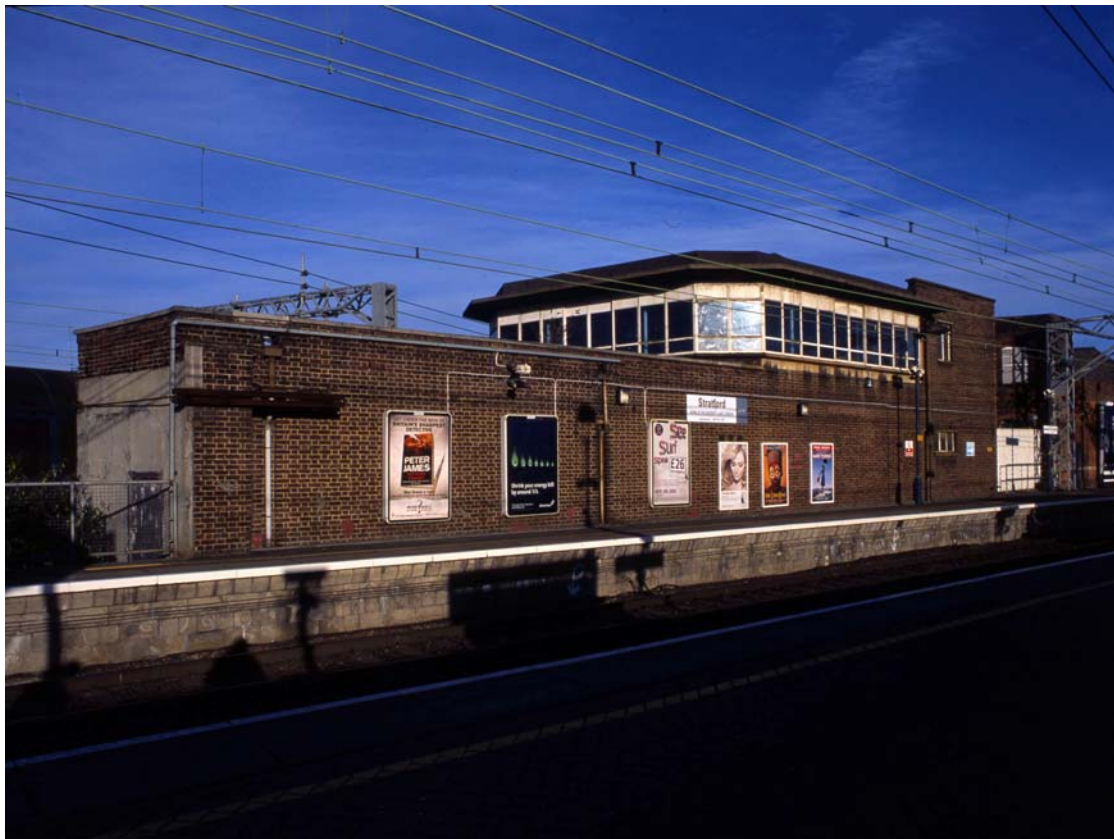
Plate 4: South-east elevation of signal box

4.2.3 The south-east elevation faced onto platform 10a (previously platform 10), like the west elevation, the first floor signal cabin windows were the most prominent feature in this elevation (**Plate 4**). Two windows at the south end of the elevation, one at ground floor level and one at first floor level, provided light to the stairwell. Queen closers had been used down the edges of corners. The flat roof of the signal box was surrounded by a parapet wall, which was capped by concrete coping slabs. Modern posters, a station name plaque and lighting had been attached to this elevation.

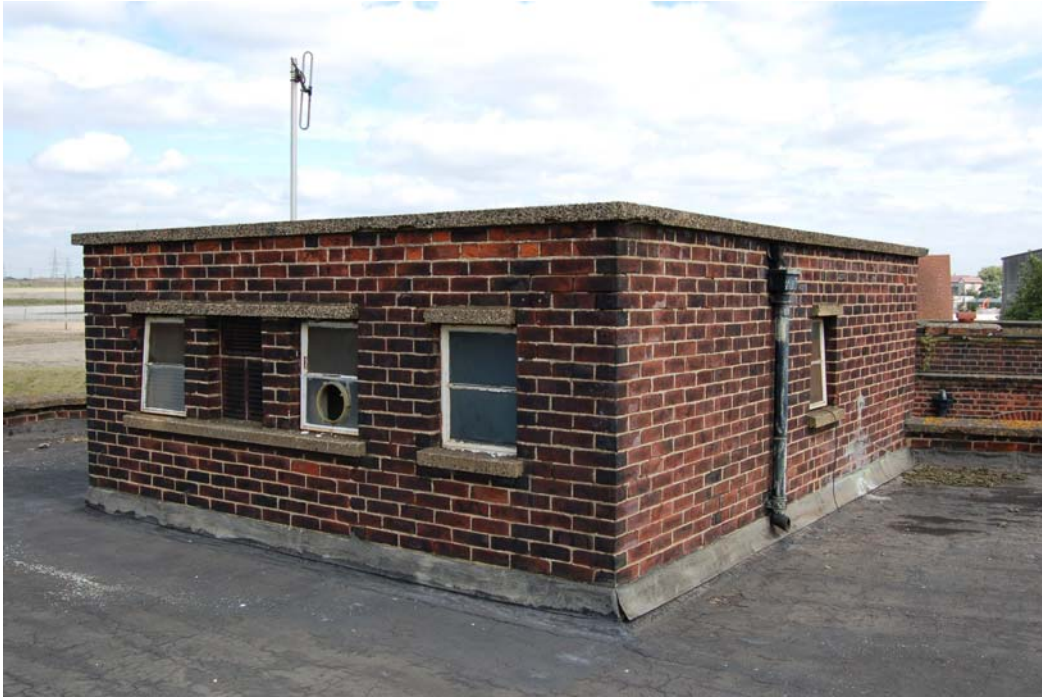
Plate 5: Second floor structure at the north end of the roof

4.3.2 The roof was in a good state of repair with the waterproofing having remained intact. At the north end of the roof, the original second floor structure built in stretcher bond was still extant (**Plate 5**). Windows in this structure had concrete sills and lintels.

covered with cream ceramic tiles capped with black ceramic tile beading to a height of 1.4m and their floors were covered in red ceramic quarry tiles. Both rooms had a ceramic tile skirting, 0.16m in height, at the base of the walls. Room F3 had two ceiling heights; the north end was 4.8m high, while the south end was 3.14m high, which was the same height as room four. The east wall of room F3 contained a small fixed metal window, just below ceiling height in the higher part of the room (**Plate 16**). The higher part of the room formed part of the second floor structure (**Plate 5**).

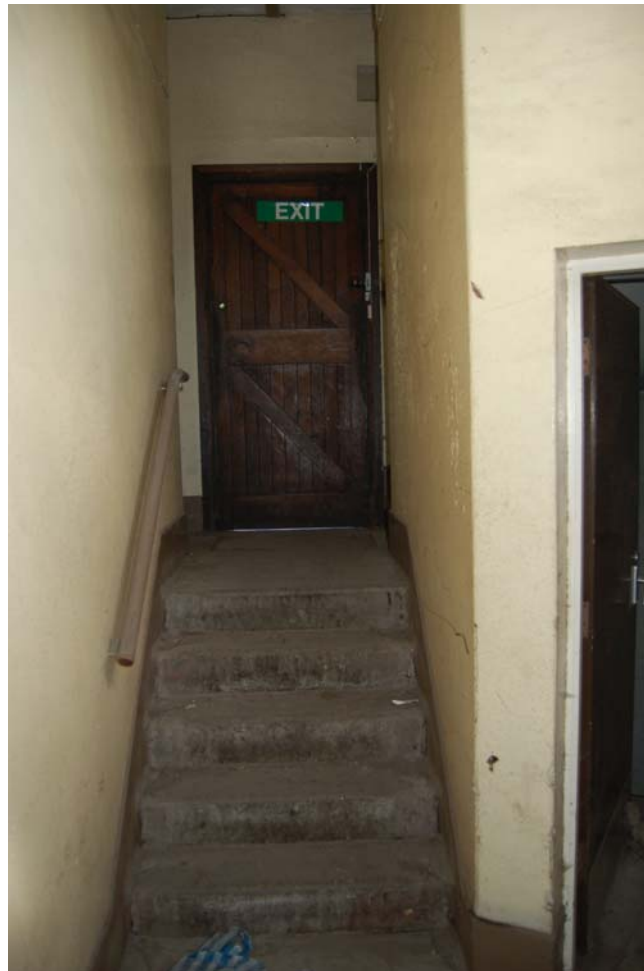
Plate 6: Main access door in corridor on ground floor

- 4.4.2 Room G1, the corridor, was accessed via a wooden door in the north elevation. The corridor was divided into two parts, with a northern higher part situated immediately in front (south) of the access doorway (**Plate 6**). On the east side was the main concrete stairway (**Plate 7**) and on the west side was room two. A flight of steps led down to the lower southern half of the corridor, which gave access to room three and the basement. The floor of room one was constructed from concrete; with the walls rendered and painted cream. Integral cement skirting at the base of the walls had been painted brown. All doorways had original timber frames which had been painted white (**Plate 8**).

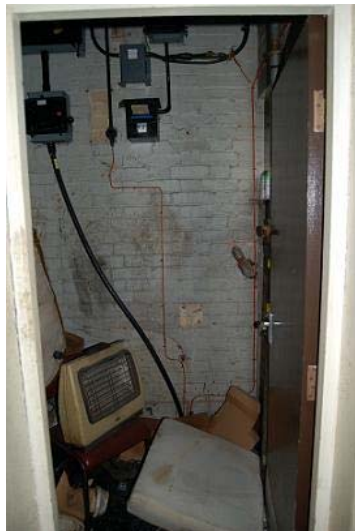
Plate 9: Small store room on ground floor

- 4.4.3 Room G2 was a small store room, which contained some cleaning equipment and modern fuse-boxes. Its floor was constructed from concrete. The walls had not been plastered and the Flemish bond brickwork had been painted white (**Plate 9**).

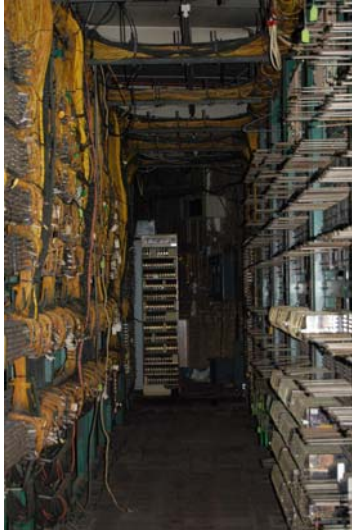
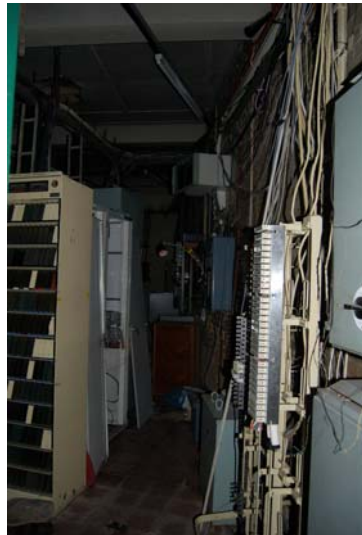
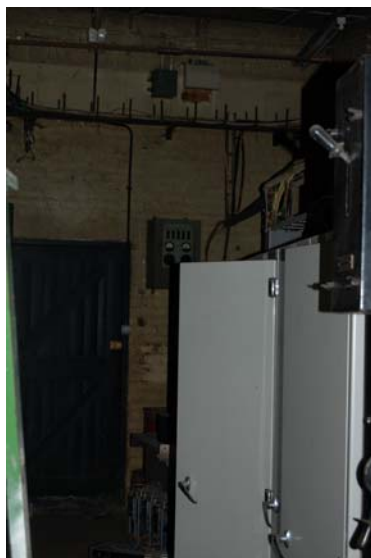
- 4.4.4 Room G3 contained the modern relays, which, before their decommissioning and removal, controlled Stratford station's track signalling. This room was being stripped at the time of the survey and access for Pre-Construct Archaeology was not possible, however, digital images of the room before the stripping took place were provided by Norwest Holst Ltd (**Plates 10, 11 and 12**).

Plate 10: Relay room on ground floor

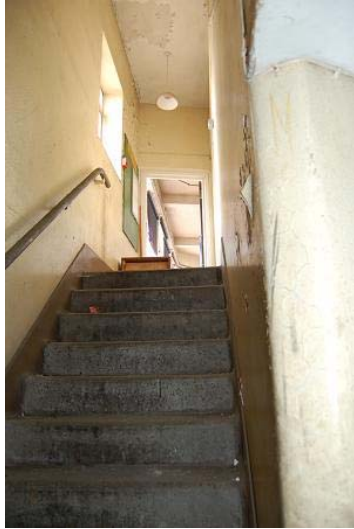
Plate 13: Stairwell and corridor (room F1) on first floor

- 4.4.6 Room F1, the stairwell and corridor, in the north-east corner of the building, gave access to rooms F2 (a kitchen) and F7 (the signal cabin). The floor was constructed from poured concrete. The corridor was 3.16m in height. The walls had been plastered and painted cream. Integral cement skirting, 0.22m high, had been painted brown (**Plate 13**). A metal window with obscured security glass provided natural light. Its internal sill was constructed from red ceramic quarry tiles.

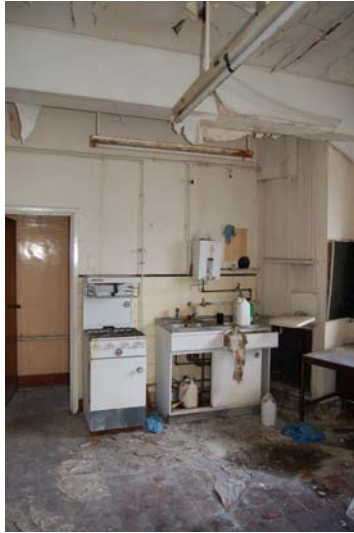
Plate 14: Kitchen area in room F2 on first floor

- 4.4.7 Room F2, a kitchen, in the northern part of the building, gave access to rooms F1 (the stairwell and corridor) and F3 (a toilet). The room was 3.14m in height. The walls had been plastered and painted cream. The floor was constructed from poured concrete, which had been covered in red ceramic quarry tiles. The room had a red ceramic quarry tile skirting measuring 0.16m in height at the base of the walls. The lower part of the west wall was covered with cream ceramic tiles and capped with black tile beading in front of the sink and cooker (**Plate 14**). A metal window with a red quarry tile internal sill in the north wall with a combination of casement and fixed lights provided natural light. The window was 1.17m in height.

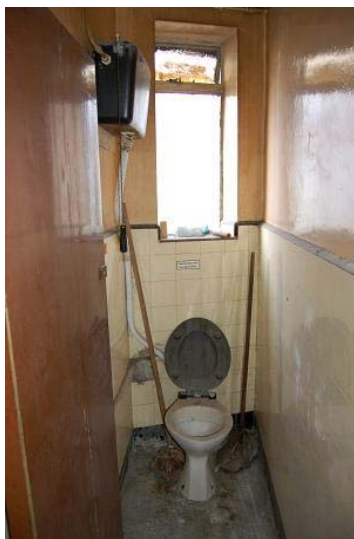
Plate 15: Room F3 on first floor

- 4.4.8 Rooms F3 and F4 were both toilets with sink areas, which were accessed via rooms F2 (kitchen) and F5 (small room with ladder), respectively. Both rooms had a metal window in the north wall (**Plate 15**). The lower part of both rooms was

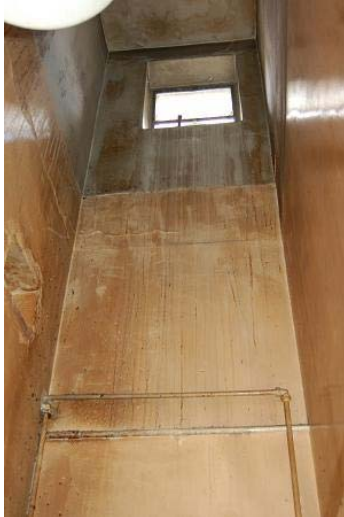
Plate 16: Small metal window at ceiling height in room F3 on first floor

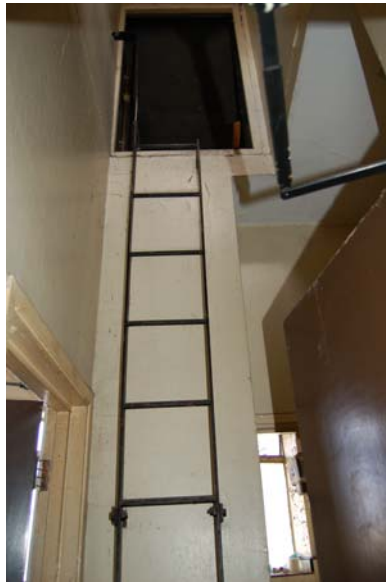
- 4.4.9 Room F5 was a small room with access to rooms F4, F6 and F7. Like room F3, it had two ceiling heights, the north end measured 4.8m and the south end was 3.14m in height. The floor was covered in red ceramic quarry tiles, with a tile skirting, which measured 0.16m at the base of the walls. An original metal ladder was attached to the north wall and gave access to the second floor structure (**Plate 17**).

Plate 17: Original metal ladder in room F5 on first floor

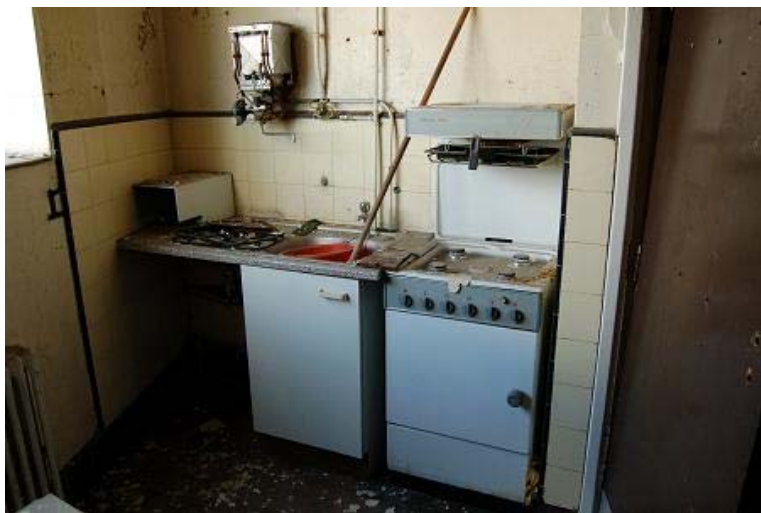
Plate 18: Kitchen area in room F6 on first floor

- 4.4.10 Room F6, a kitchen in the north-west corner of the building, gave access to room F5 (ladder room). It was 3.14m in height. The floor was covered by red ceramic quarry tiles. The room had a tile skirting, some 0.16m high, at the base of the walls. The walls had been plaster and painted cream. A metal window in the north wall with a combination of casement and fixed lights provided natural light. Its internal sill was constructed from red ceramic quarry tiles. The north-east corner of the room was covered with cream ceramic tiles and capped with black ceramic tile beading in front of the sink and cooker (**Plate18**).

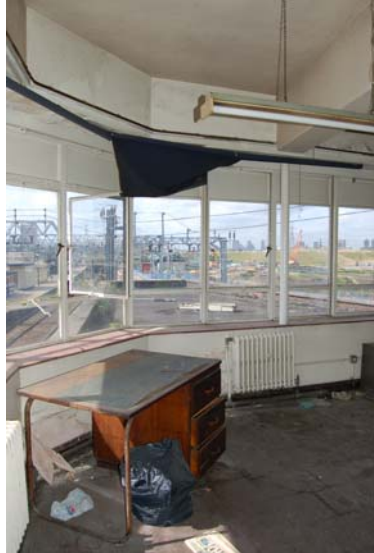
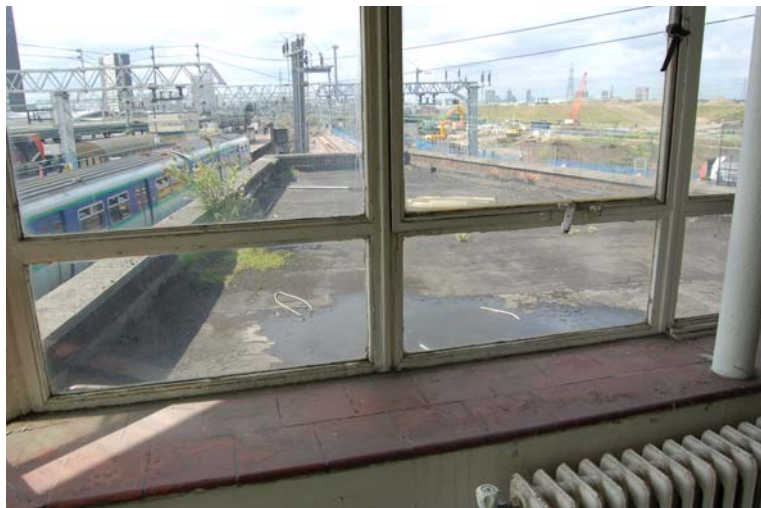
- 4.4.11 Room F7, the signal cabin, gave access to rooms F1 (corridor) and F5 (ladder room). It was 3.14m in height. The walls had been plastered and painted cream. The floor was covered with modern linoleum but due to the soft strip, areas of the original poured concrete flooring had been exposed. Holes had also been knocked through to the relay room below. At the base of the walls were wooden chamfered skirting boards, which were painted brown and measured 0.16m in height. Metal ribbon windows were a prominent feature of this room in all but the north wall. The panes were pivot set (**Plates 19 and 20**). The signal control system (**Plates 21, 22 and 23**) had been mostly removed at the time of survey.

Plate 19: Metal windows in room F7 on first floor

Plate 20: Metal window with ceramic tile sill in room F7 on first floor

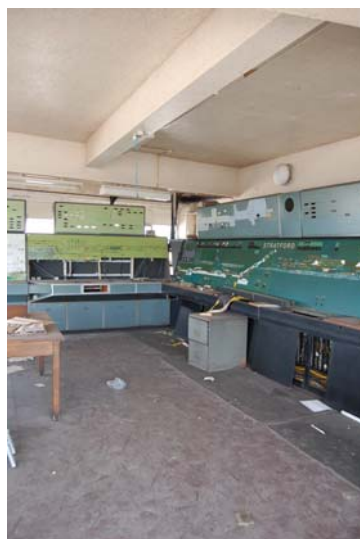
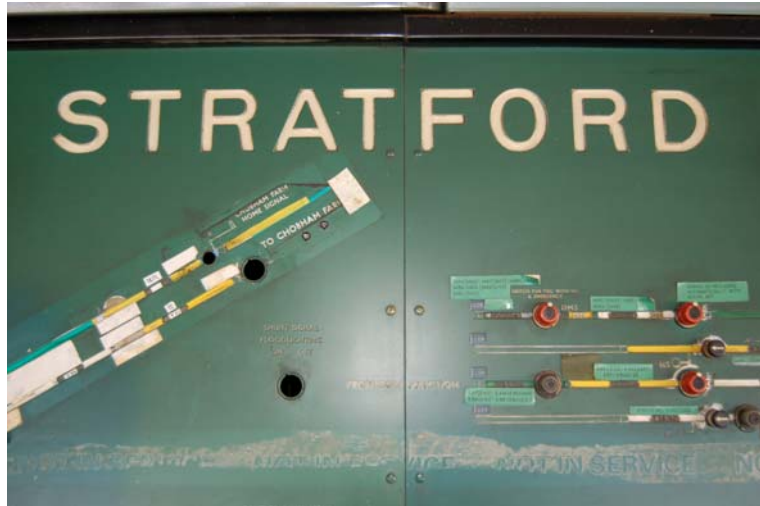
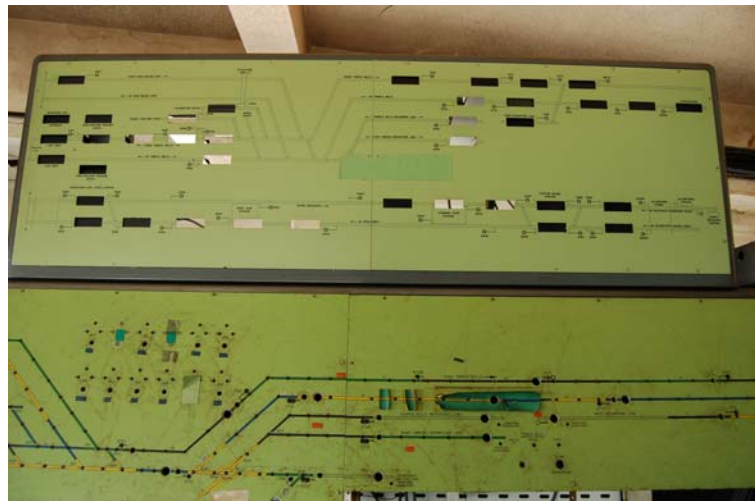
Plate 21: Signal control boards in room F7 on first floor
