An Archaeological Excavation at The Jacobean Barn, Hall Place, Bourne Rd, London Borough of Bexley.

**Site Code: BXL 09
Central National Grid Reference: TQ 5022 7431
Written by Guy Seddon and John Payne
Pre-Construct Archaeology Limited,
March 2009**

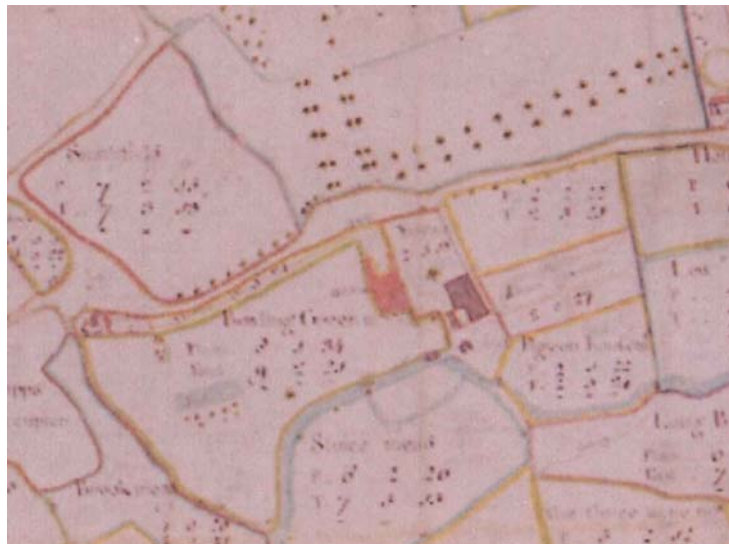
Plate 1 John Bowra, 1768

- 6.11. The earliest cartographic evidence is John Bowra's map dating to 1768, which although of relatively small scale does show the location of a large L-shaped ancillary building, which may represent the Jacobean Barn and a small rectangular building to the west. The space created between these two buildings may have formed a semi enclosed courtyard area and it is possible that the remains of the exterior floor surface revealed in the excavation may have been associated with this phase of activity.
