**BUILDING RECORDING OF  
JACOBEOAN BARN, HALL PLACE,  
BOURNE ROAD, LONDON  
BOROUGH OF BEXLEY**

**SITE CODE: BXL 09**

Building Recording

**Historic Building Recording of the Jacobean Barn, Hall Place, Bourne Road,  
London Borough of Bexley**

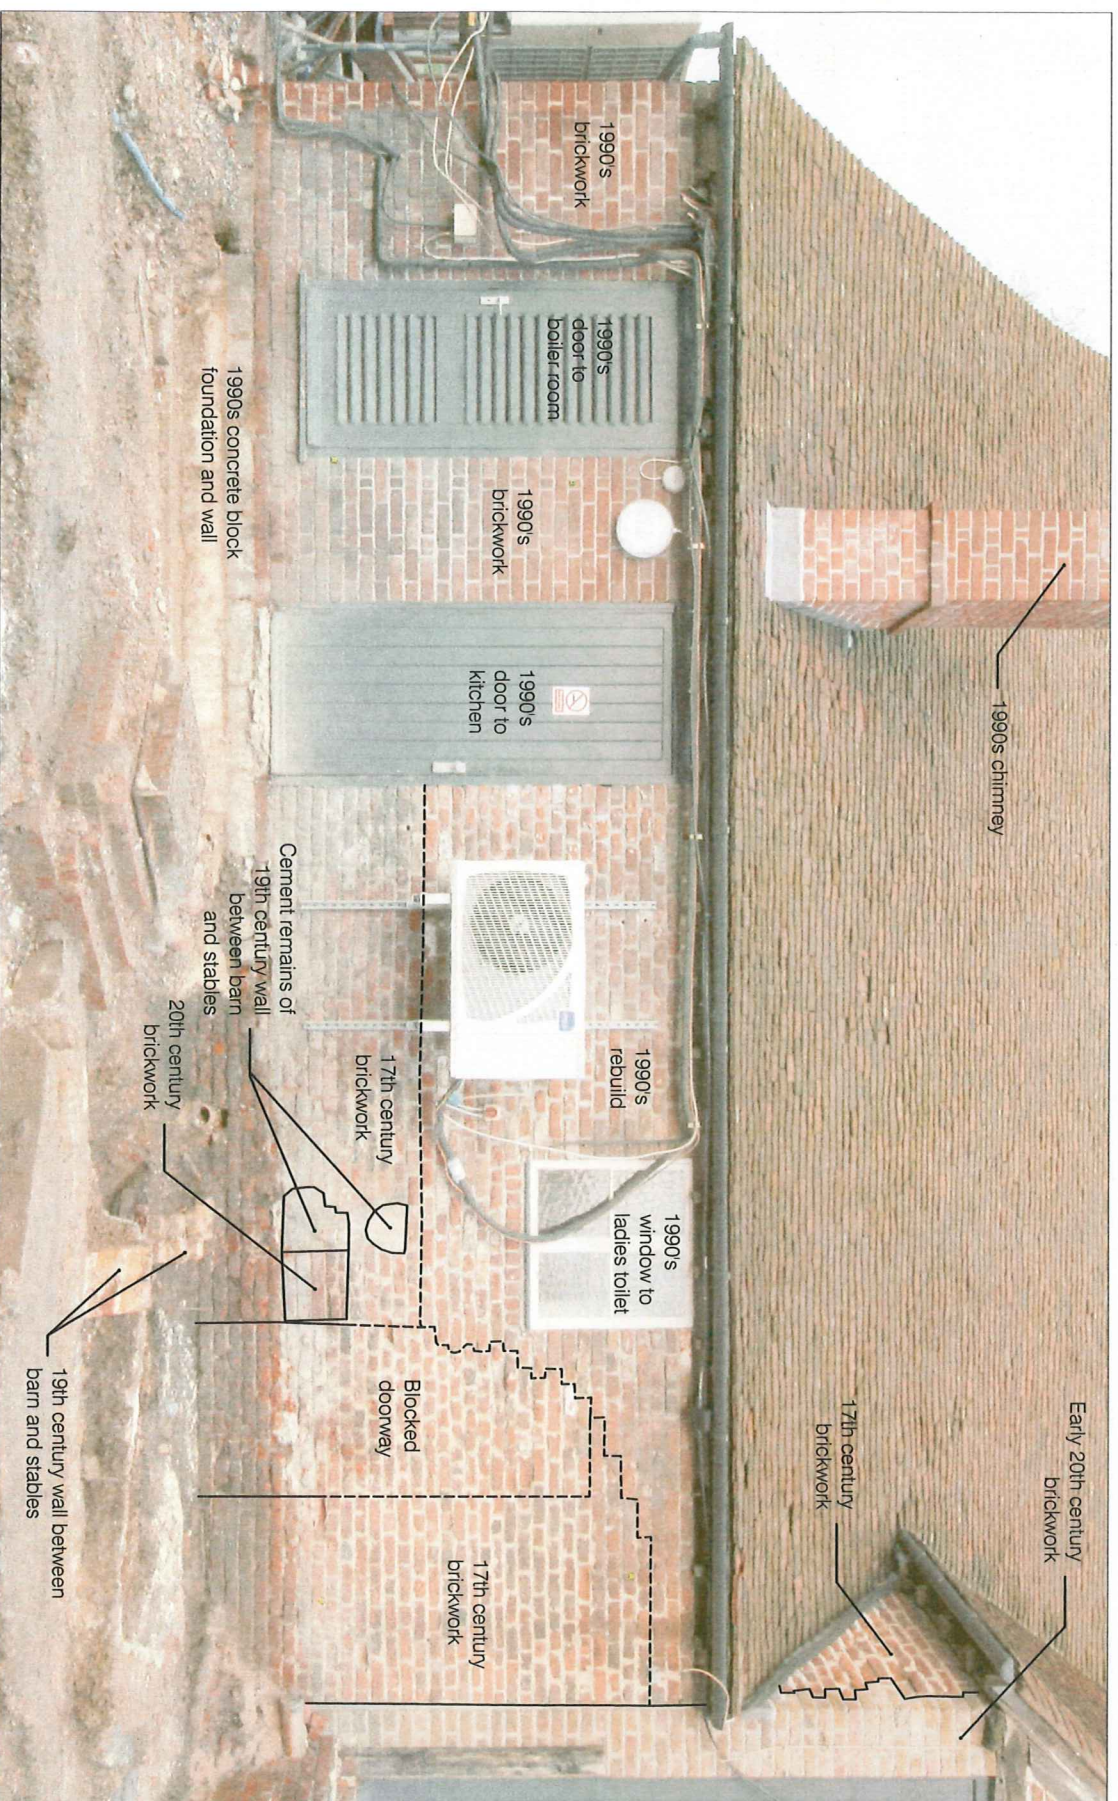
Figure 4  
Annotated rectified photograph of the west  
end of the south wall of the Jacobean Barn  
1:40 at A4

- 5.2 The brickwork to the east of the blocked former doorway is late 17<sup>th</sup> century in appearance. These red bricks, measuring 24cm x 6cm x 12cm, had roughly been laid in Flemish bond. Similar brickwork existed to the west of the blocked doorway and to the east of the kitchen door. The upper part of this wall was rebuilt in the 1990s when the window shown in the 1986 photograph was removed, although the foundations and lower part of the wall appear to be original. A mid grey mortar had been used on the lower part of the wall.

- 5.3 When the former doorway was infilled with brick, this blocked doorway and the wall to the east was repointed in a sandy yellow mortar. This doorway was presumably blocked when the windows shown in the 1986 photograph (**Plate 4**) were inserted. It had clearly been blocked before the 1990's (Ladies toilet) window was inserted.

- 5.4 The wall between, and to the west of, the two 1990's inserted doors had been entirely rebuilt in modern red metric bricks in the 1990s on a new foundation wall of concrete blocks when a modern boiler system and chimney was installed at this end of the building. A line of queen closers was visible on the eastern side of the boiler room doorway.

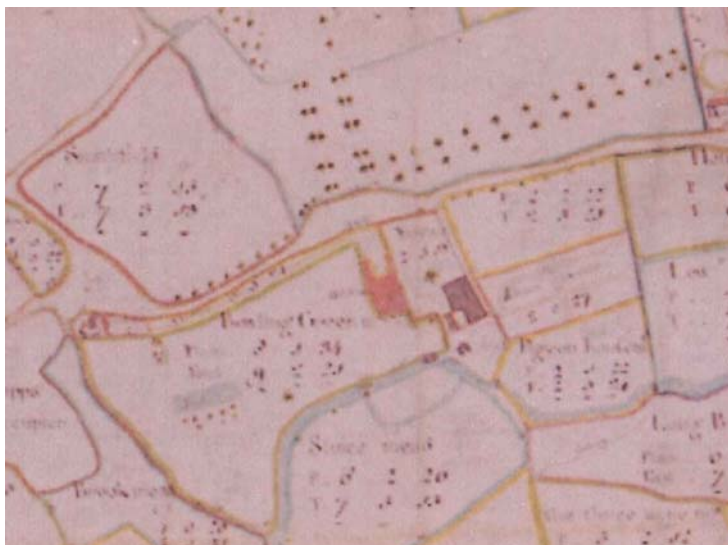
Plate 1 John Bowra, 1768

- 4.6 The earliest cartographic evidence for Hall Place is John Bowra's map dating to 1768 (**Plate 1**), which although of relatively small scale does show the location of a large L-shaped ancillary building, which may represent the Jacobean Barn and a small rectangular building to the west. The space created between these two buildings may have formed a semi enclosed courtyard area and it is possible that the remains of an exterior floor surface found in the recent excavation may have been associated with this (Pre-Construct Archaeology 2009).

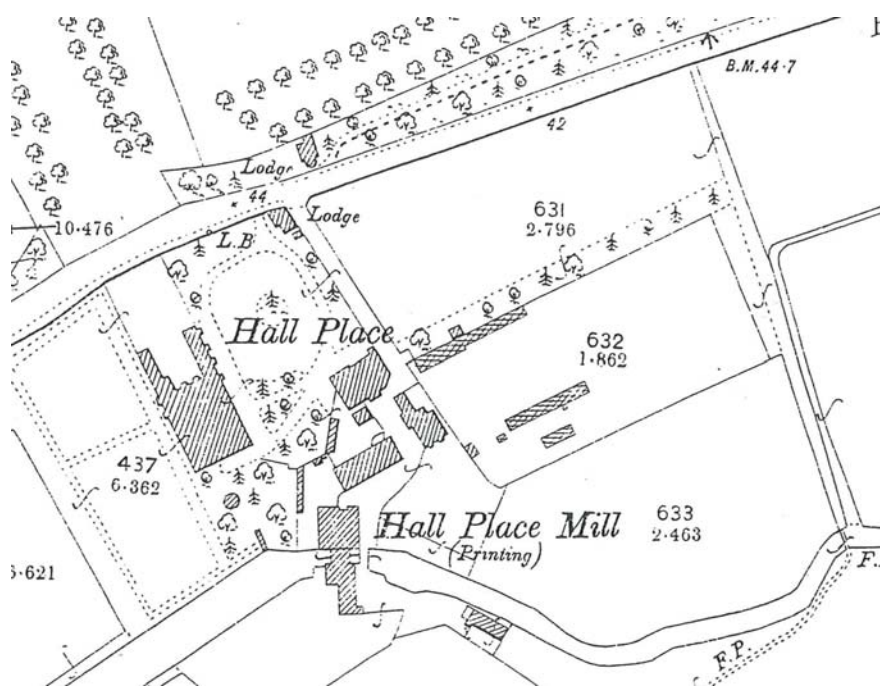
Plate 2 1895-1897 Ordnance Survey Map

- 4.12 The 1895-97 Ordnance Survey map (**Plate 2**) shows numerous changes to the farm complex. The extension to the southeast corner of the barn has been removed. A porch appears to have been added to the large central opening on its south wall. A small square building has also been incorporated into the western side of the wall which connects the barn and the stables to the south. Under the heading '*Hall Place Mill*' is written '*Printing*'.

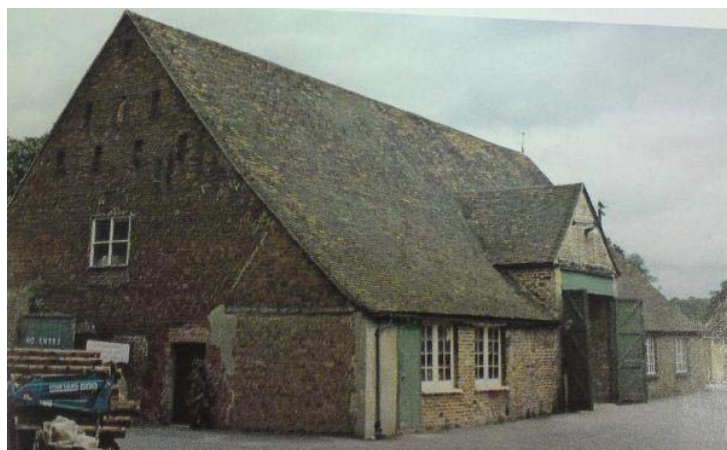
Plate 4: Photograph of the west and south elevations of the Jacobean Barn taken in 1986

- 5.1 The south wall to the west of the large central barn door porch (hereafter investigated wall) would originally have contained no window or door openings. The 1986 photograph (**Plate 4**) shows that two window and door openings had been inserted by this date. These were removed and replaced with two doors and a window (**Plate 5**) in the 1990s when the barn was converted into a restaurant. Evidence for a former inserted doorway and infilled with red brick, is also visible as straight joints in the brickwork towards the east end of the investigated wall (**Figures 3 and 4**). This doorway had presumably been infilled before the window and door arrangement shown in the 1986 photograph (**Plate 4**). The insertion of door and window openings in the investigated wall has resulted in much of the brickwork in this wall either being rebuilt, replaced or repointed.
